October 12, 2009

Mr. David Simon
Wisconsin Department of Transportation-Roadside Facilities
4802 Sheboygan Avenue, Room 501
Madison, WI 53702

Re: Kenosha SWEF Holding Tank

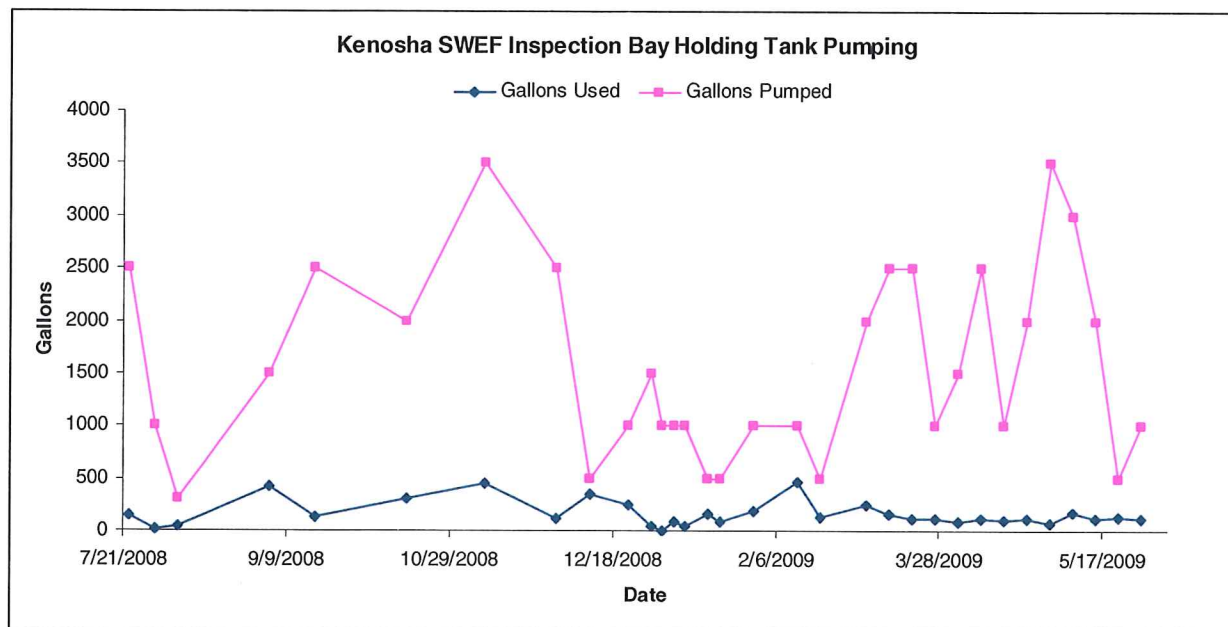
The issue at hand is that the amount of water being pumped out of the holding tank is significantly exceeding water use in the inspection building. Some of the excess water can be attributed to snow melt off of the vehicles in the winter, but the trend is seen throughout the year. This can be seen in the graph below. In some instances, the amount of water removed from the holding tank is more than 10 times greater than the amount of water used. It is suspected that ground water is infiltrating into the system causing the excessive volumes of water within the tank.

of water wastewater pumped for the months indicated above. The data showed that on average, the monthly volume of water pumped from the inspection building holding tank was 10 or more times higher than the actual volume of water used in the inspection building. Some of the excess water can be attributed to snow melt off of the trucks in the winter months, but the trend continued through the spring and summer months when snowmelt is not a factor. Given the data, it appeared that ground water was infiltrating into the system somewhere from the trench drains through the holding tank.

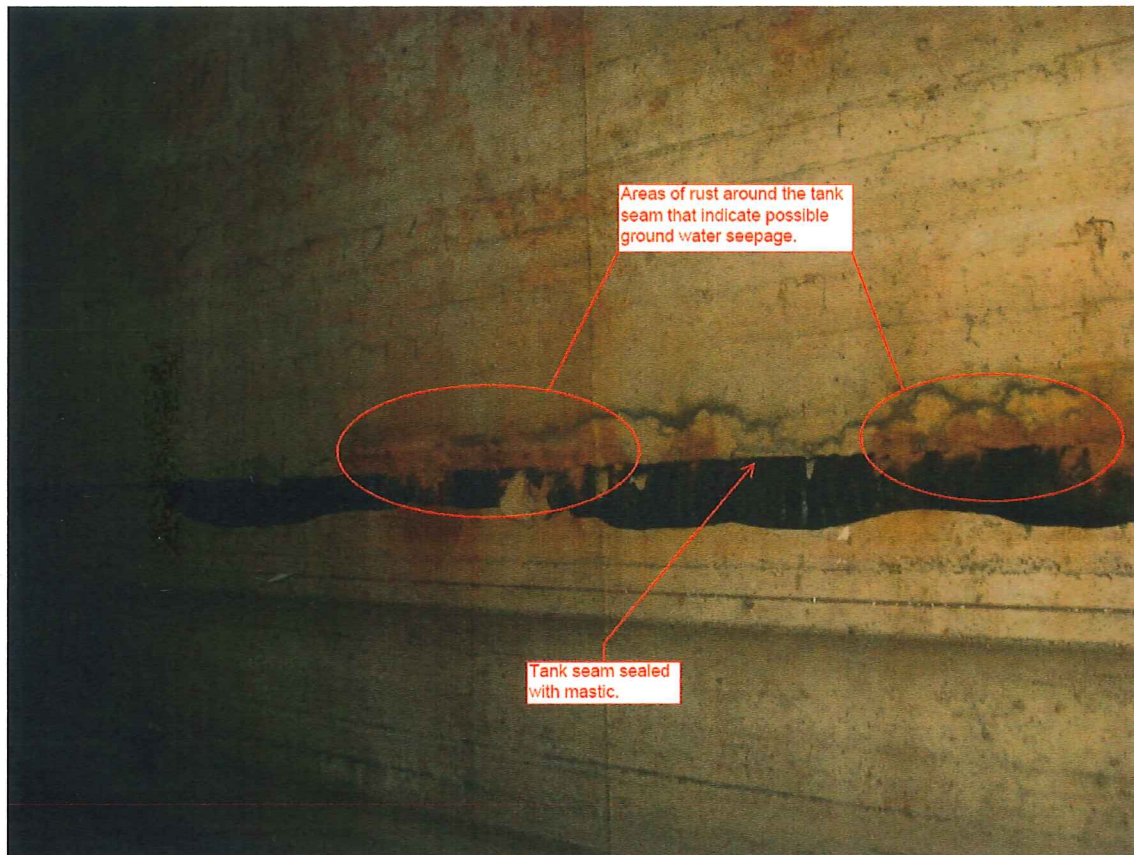
The still camera was used to photograph the side walls of the inside of the tank. Photos of the inside of the tank were very clear. The images show many areas of rust that could be caused by one of three methods listed below.

1. The rust could be caused by ground water outside of the tank with a high iron concentration infiltrating through cracks in the tank walls. Once the iron rich water enters the interior of the tank, it oxidizes in the presence of free oxygen and forms the orange iron stains.

2. The rust could be caused by groundwater outside of the tank, not necessarily with a high iron concentration, infiltrating through cracks in the tank walls. The infiltrating water comes in contact with rebar within the tank walls. Iron from the rebar dissolves into solution with the infiltrating water. As the water enters the interior of the tank, it oxidizes in the presence of free oxygen and forms the orange iron stains.
3. The rust could be caused by water and/or other liquids within the tank seeping through internal cracks and making contact with the rebar within the wall of the tank. Iron from the rebar dissolves into solution with the water and/or other liquids. This iron in the liquids then oxidizes as it comes in contact with free oxygen in the tank.

If groundwater is infiltrating into the tank, none of the areas of rust appeared to be a major contributor of ground water seepage, but collectively, the areas of seepage could add up to a significant volume of water depending on the elevation of the water table outside of the tank. Many of the areas were around the seam of the tank, which contradicts the findings of the underwater camera. Also, the photographs indicate that the southwest corner of the tank is not leaking in the location indicated with the underwater camera. The photos on the following pages show examples of the rust colored stains that indicate possible leakage.

Figure 1: Areas of Rust on South Side of Inspection Building Holding Tank

1. SWEF maintenance staff shall take water level measurements within the tank under the conditions listed above. Measurements should be taken from a fixed point, i.e. the top of the riser. If the water level rises without any input into the tank, the holding tank should be internally inspected by a certified tank inspector with appropriate safety equipment to locate and confirm infiltration.
2. If no infiltration is apparent in the tank, the next step is to use televising equipment to view the underground piping between the oil/water separator and the holding tank. There are companies that specialize in this service that have sophisticated viewing equipment that will find any break, cracks, or separation in the piping.
3. If no infiltration is apparent in the underground piping, then the oil/water separator should be inspected via the same method as the holding tank.

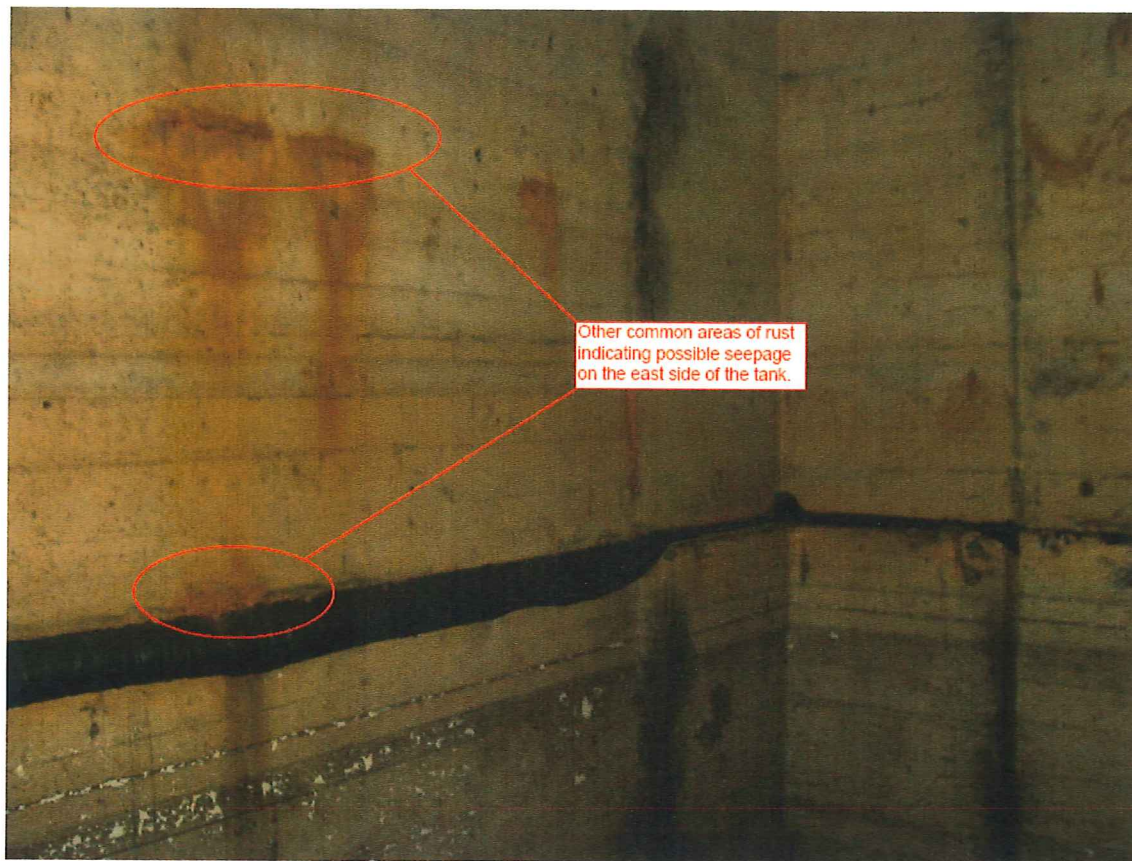
Figure 2: Areas of Rust on East Side of Inspection Building Holding Tank

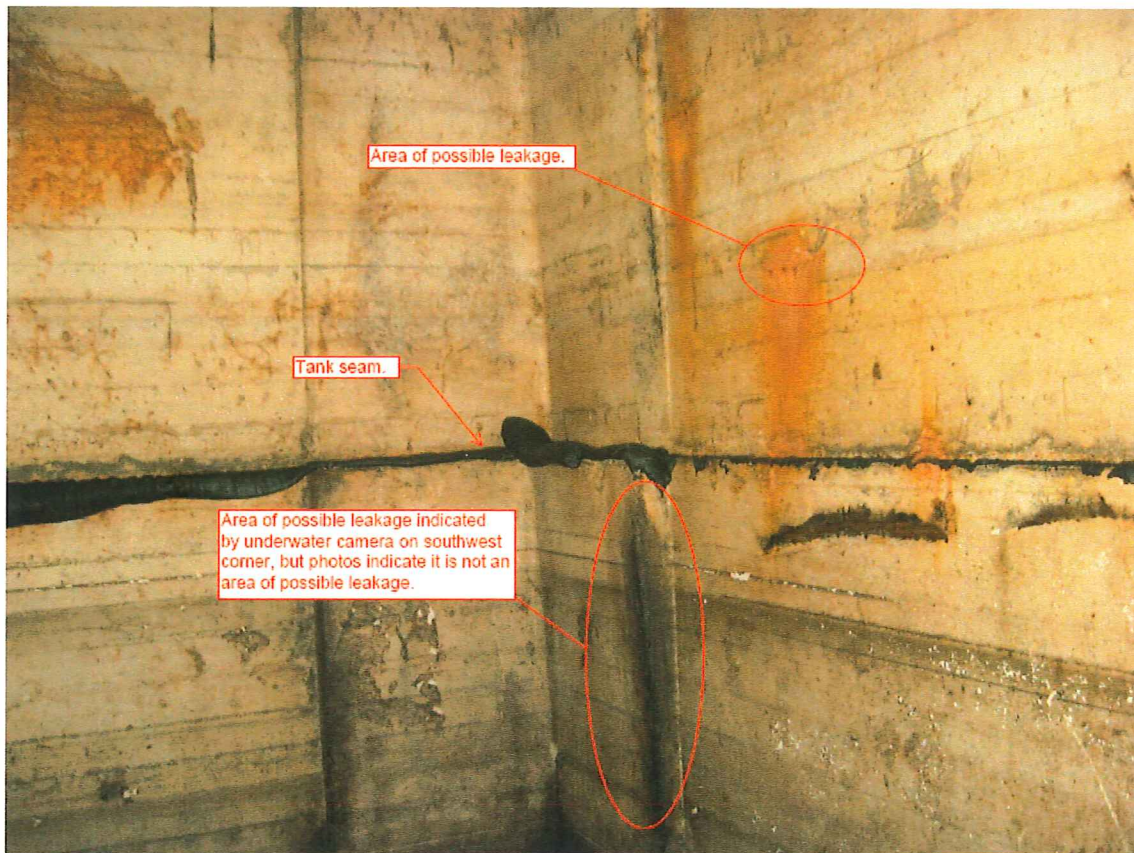
Figure 3: Areas of Rust on Southwest Corner of Inspection Building Holding Tank
