Region: North Central

County: Iron
Site ID: 7-26-24-3
Facility Type: Dome

Site Address: N5308 USH 51, Mercer

Date: March 9, 2016
Inspector: Todd Laska

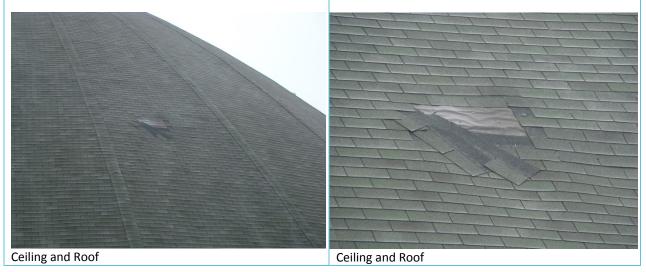
Asset	Comments	1 – Excellent	2 - Good	3 – Okay	4 – Poor	5 - Bad
Apron and Pad	None		Χ			
Ceiling and Roof	Roof repair made, roof still functioning as intended.			Х		
Walls	None		Χ			
Doors	None		Х
