**STH 95
HIXTON – MERRILLAN
JACKSON COUNTY
PCC PAVEMENT DISTRESS INVESTIGATION**

Findings and Recommendations

Prepared by:
Jed P. Peters, P.E.
Pavement Research and Warranty Engineer

March 6, 2013

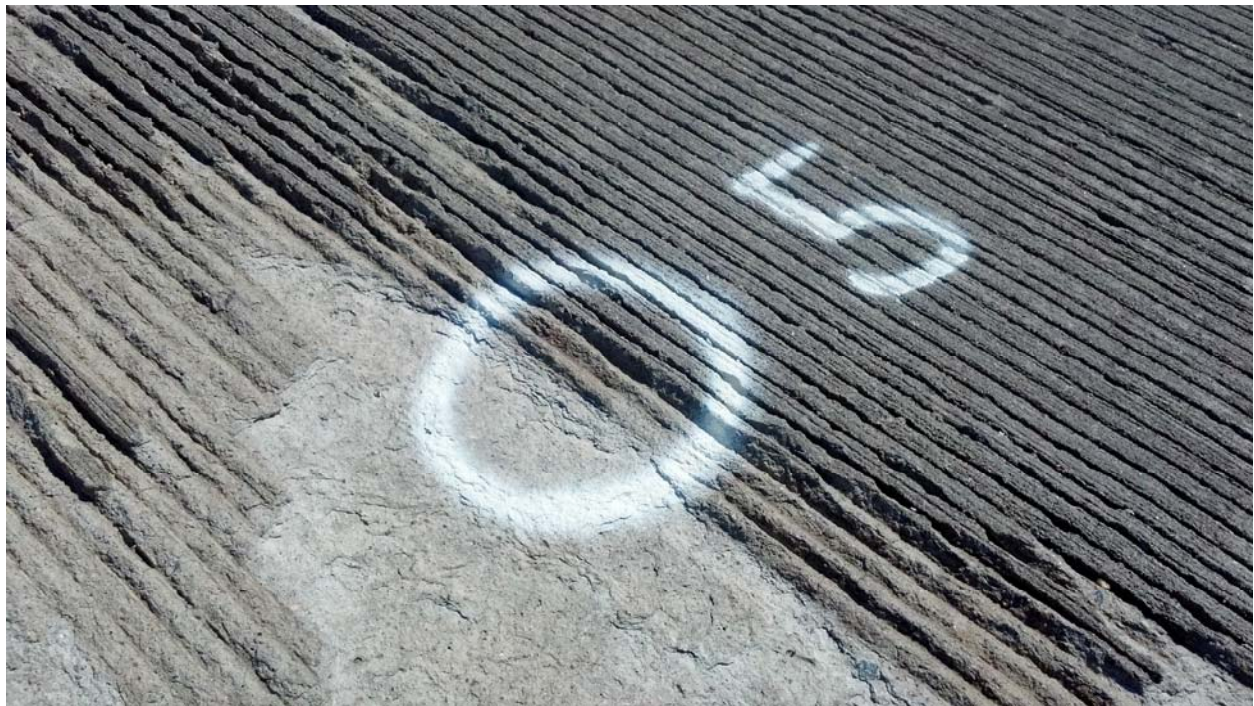
Since the completion of these investigations, widespread spalling has become problematic, again bringing into question the possibility of substandard materials and workmanship. Figure 1 depicts the typical distress being investigated in this report. Additional images depicting distress locations, and core locations prior to extraction are available in Appendix A.

Figure 1 – Typical Observed Distress

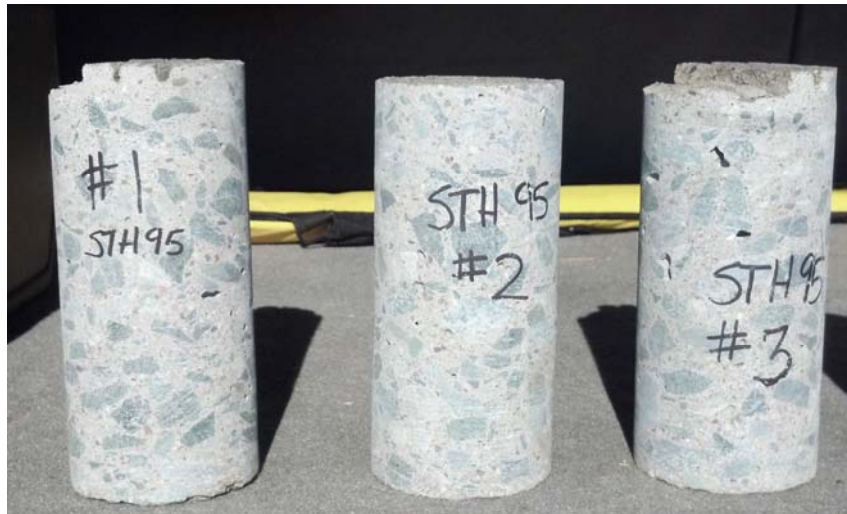
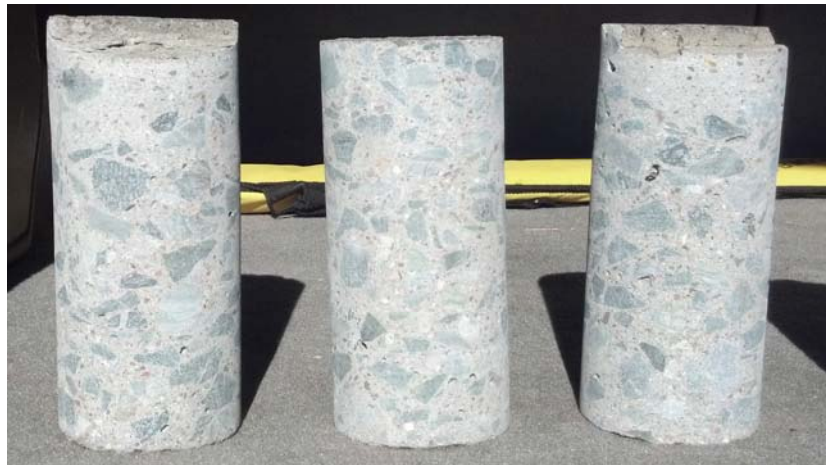
Figure 2 – Cores 1, 2, and 3 (“Front” and “Back”)

As was mentioned previously, while collecting cores, and as can be seen in Figures 2 – 5, it was noticed that the distressed cores (cores 1, 3, 5, and 8) all have little or no coarse aggregate near the surface of the pavement structure. This segregation of the aggregate is also evident in cores collected to represent areas that appear to be in early stages of spalling, particularly cores 4 and 7. Figures 6 and 7 show the pavement surface condition at the locations of cores 4 and 7 respectively.

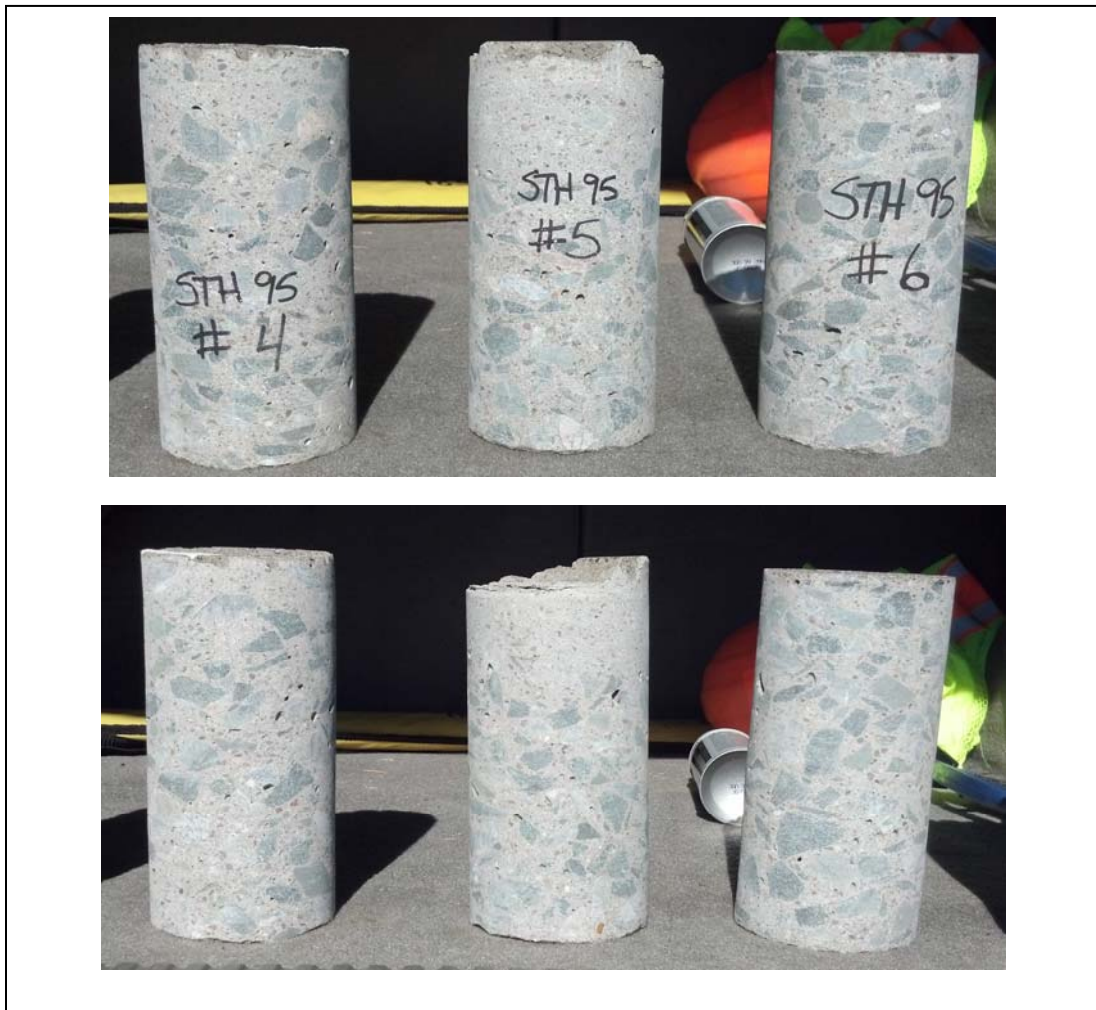
Figure 3 – Cores 4, 5, and 6 (“Front” and “Back”)

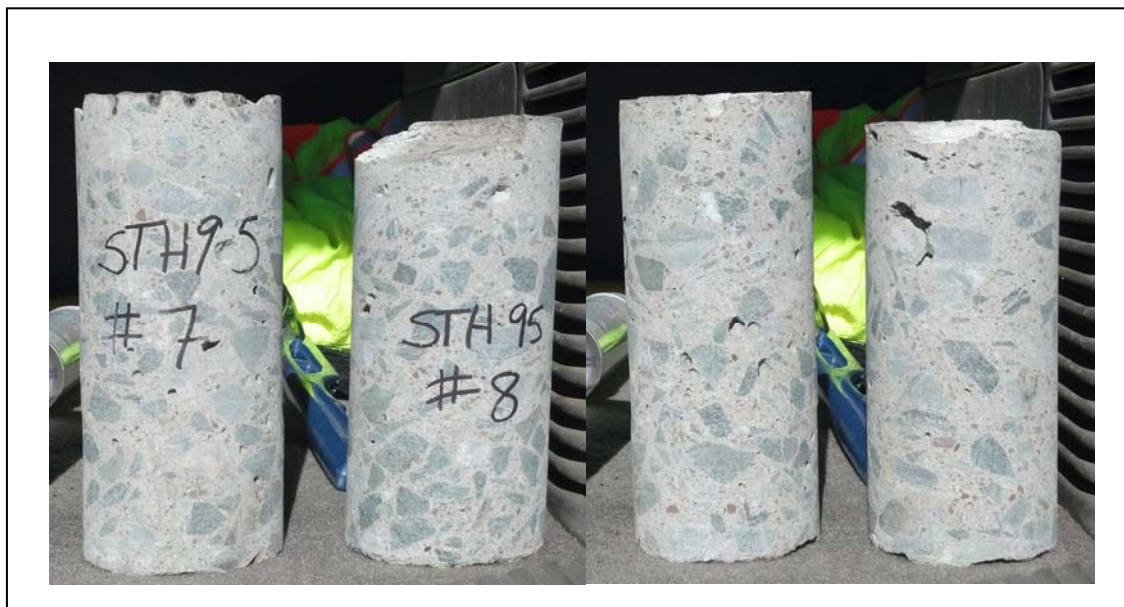
Figure 4 – Cores 7 and 8 (“Front” and “Back”)

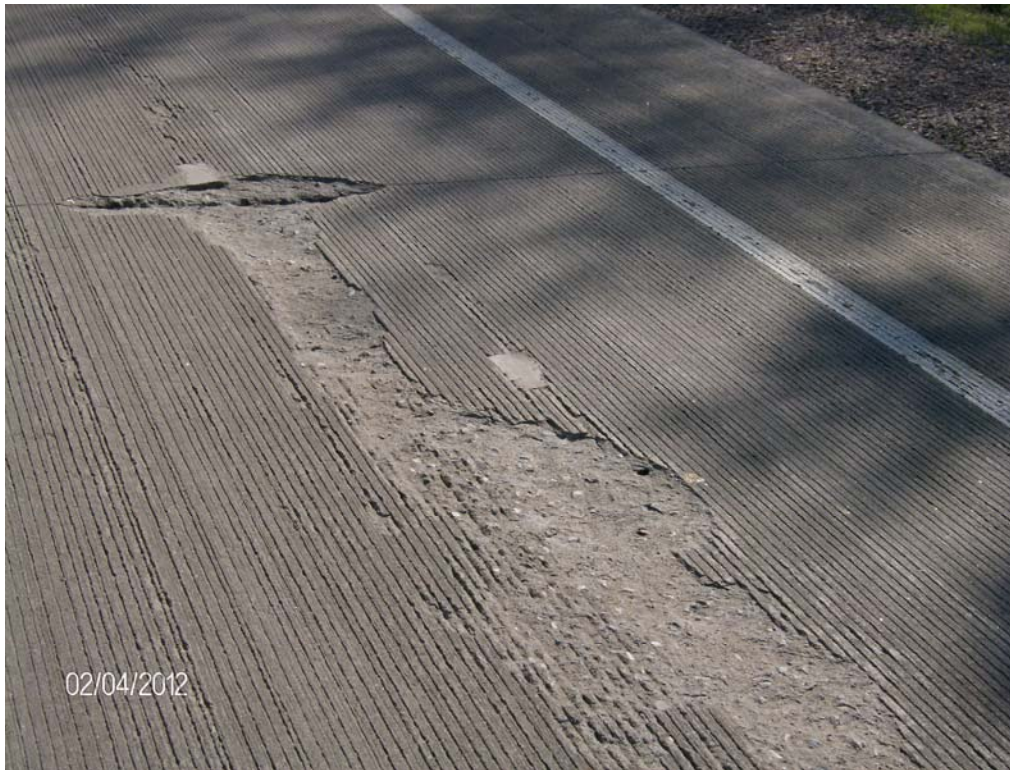
Figure A.1 – Wheel Path Spalling

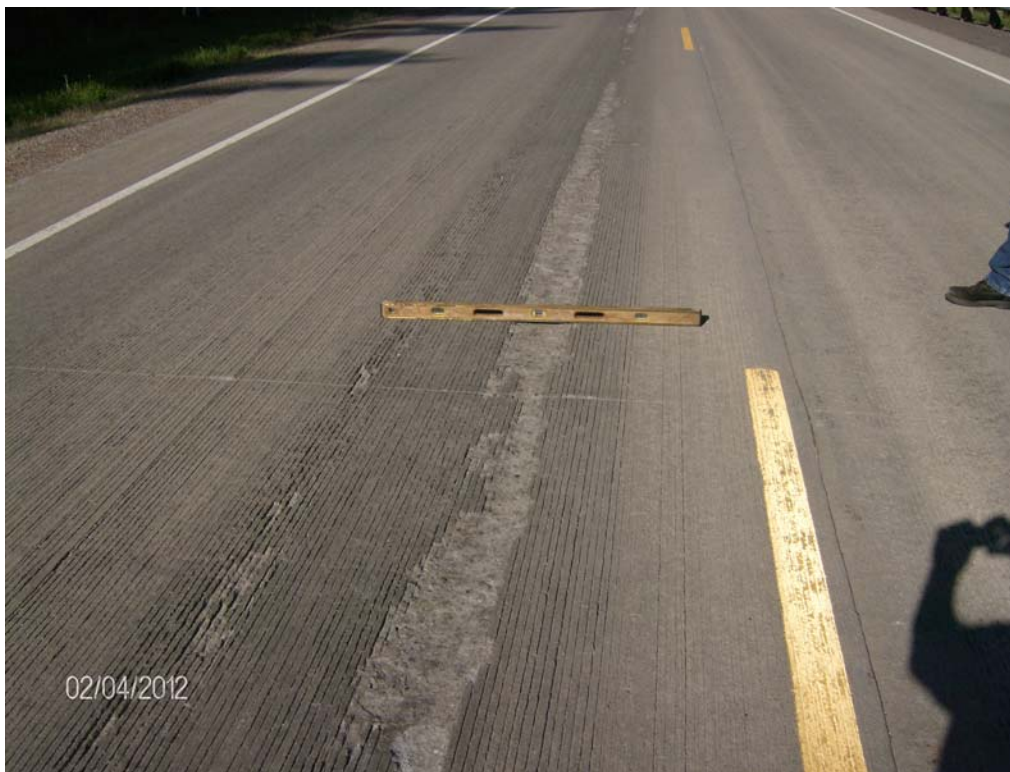
Figure A.2 – Wheel Path Spalling

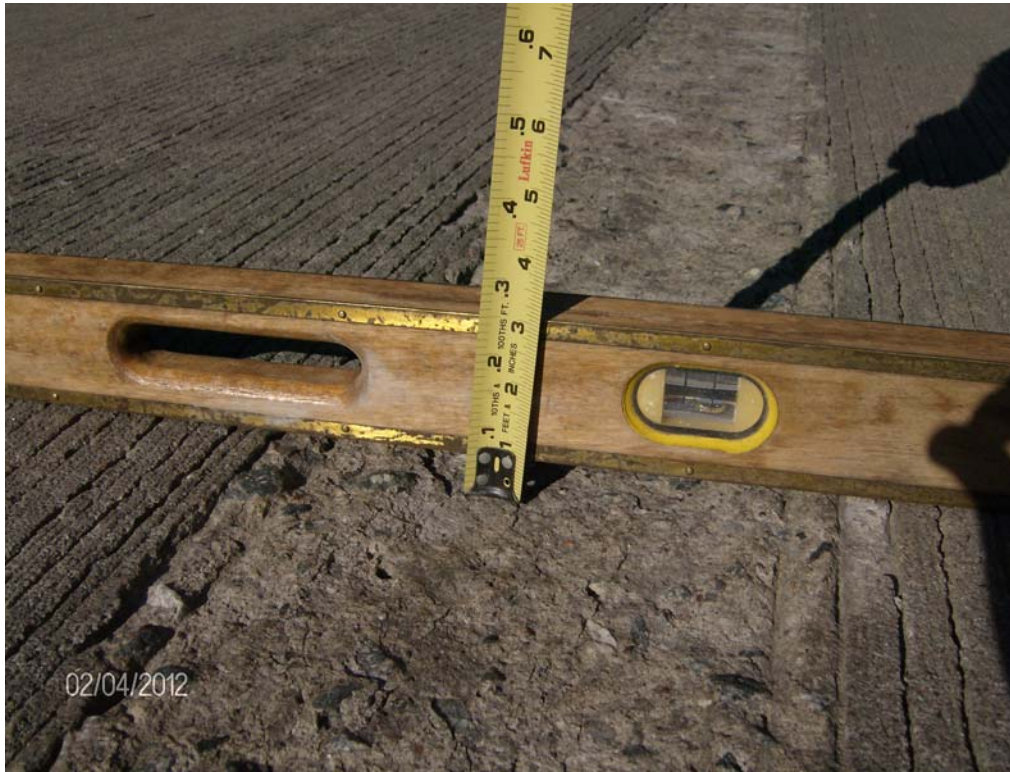
Figure A.3 - Wheel Path Spalling Depth

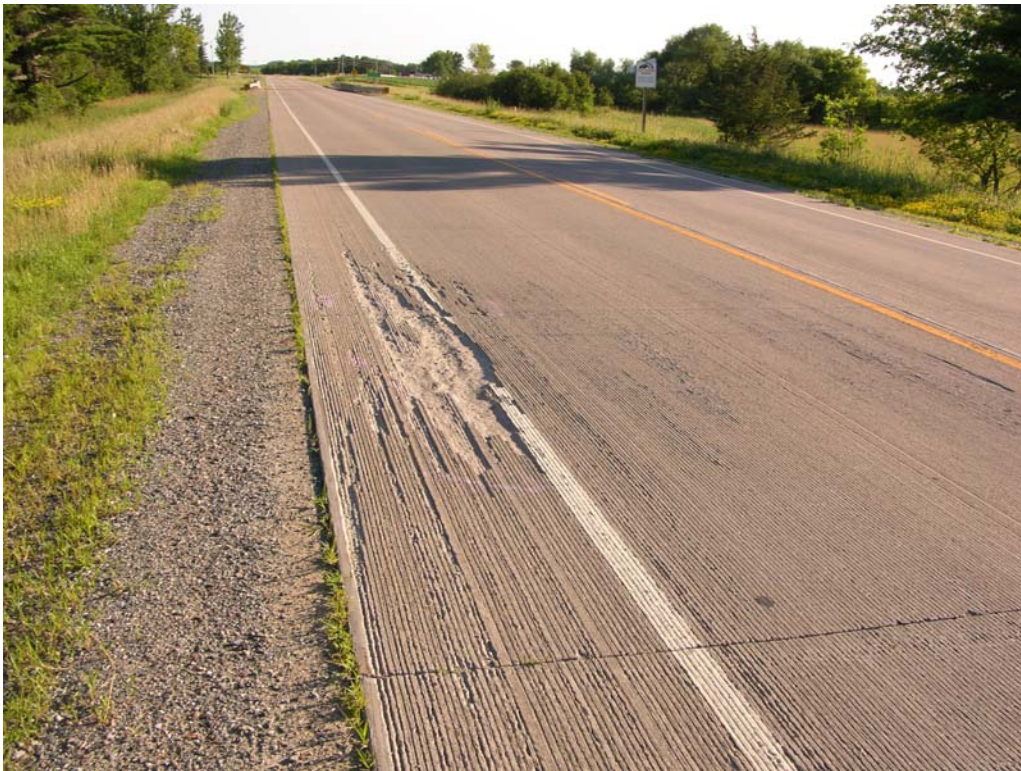
Figure A.4 - Shoulder Spalling

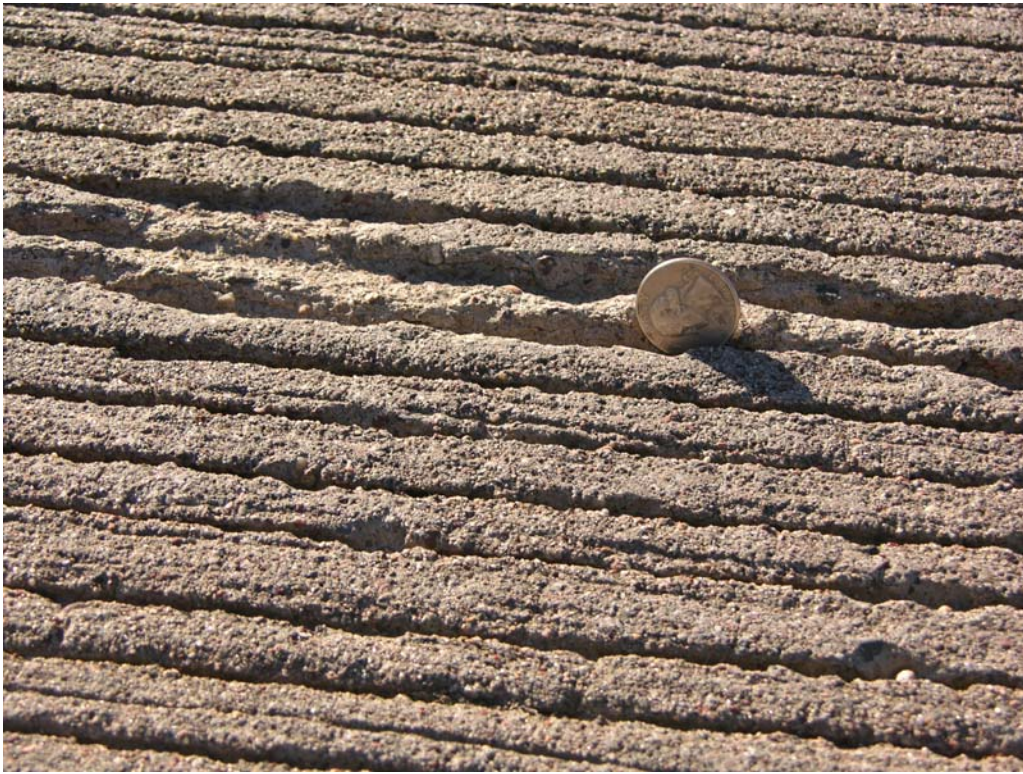
Figure A.5 - Early Stage Spalling

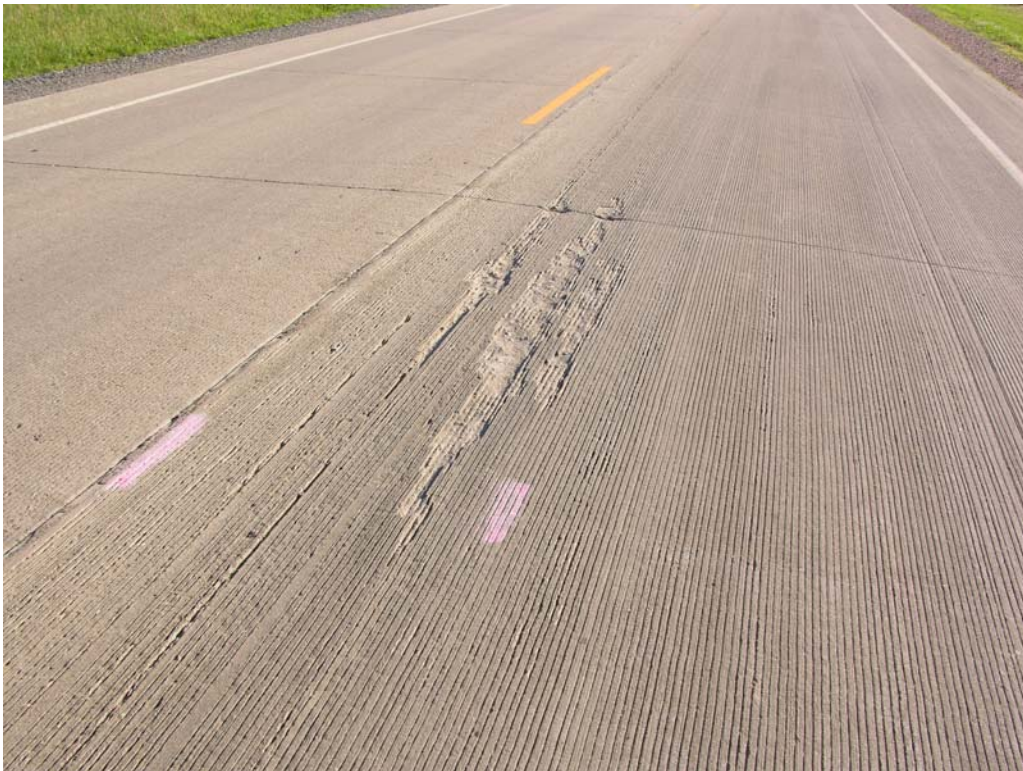
Figure A.6 - Wheel Path Spalling with Early Stage Spalling Surrounding It

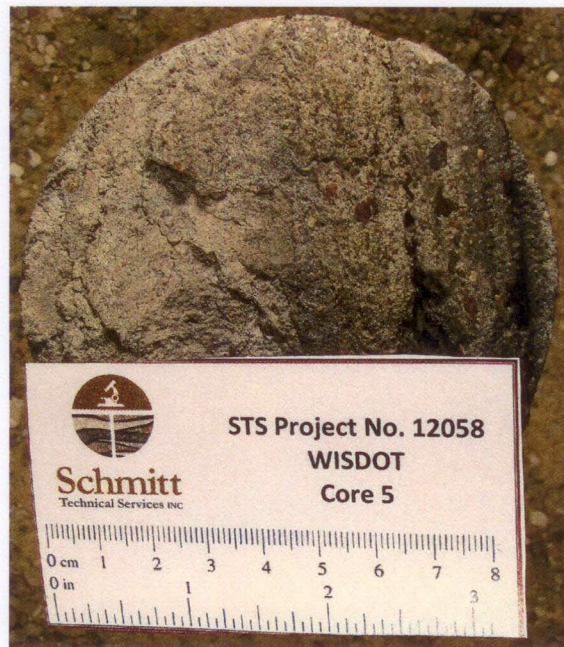
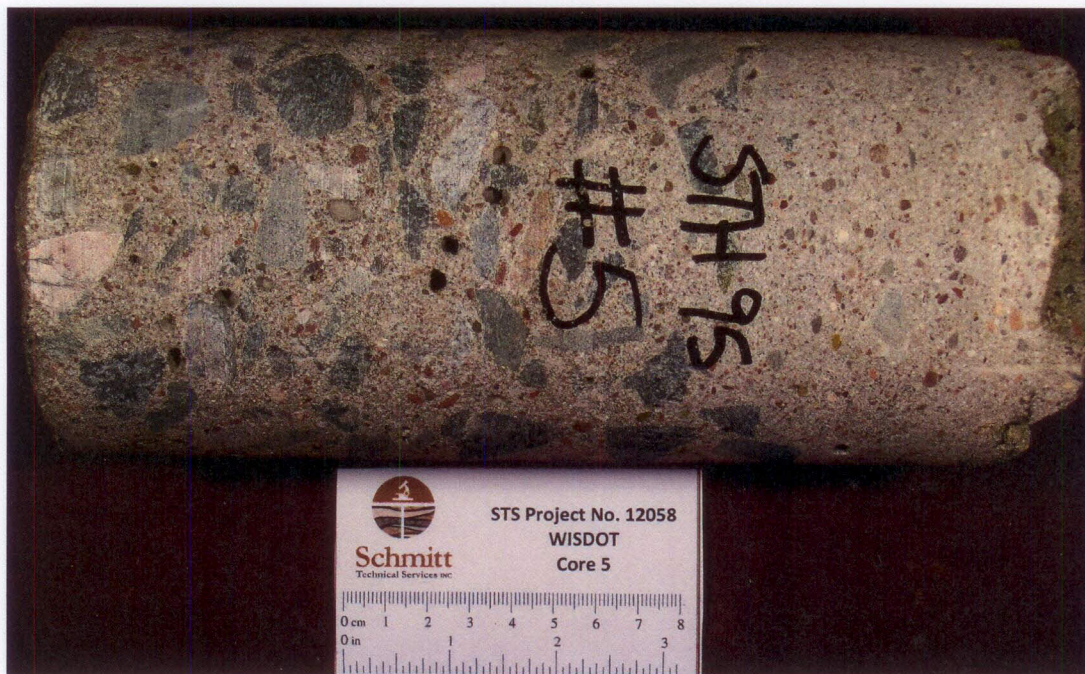
Figure 1. Core "5" as received for petrographic, hardened air content and chloride analyses. Top scales are in millimeters and centimeters. Bottom scales are in inches.

The core top is a very rough surface that has experienced severe delamination to a depth of 10 mm or about 3/8 in. (Figure 1a). There are remnants of a broom finish that has been tined to have grooves. Significant cracking and microcracking is observed parallel to the wearing surface at depths ranging up to 18 mm (0.7 in.) below the original wearing surface (Figure 4).

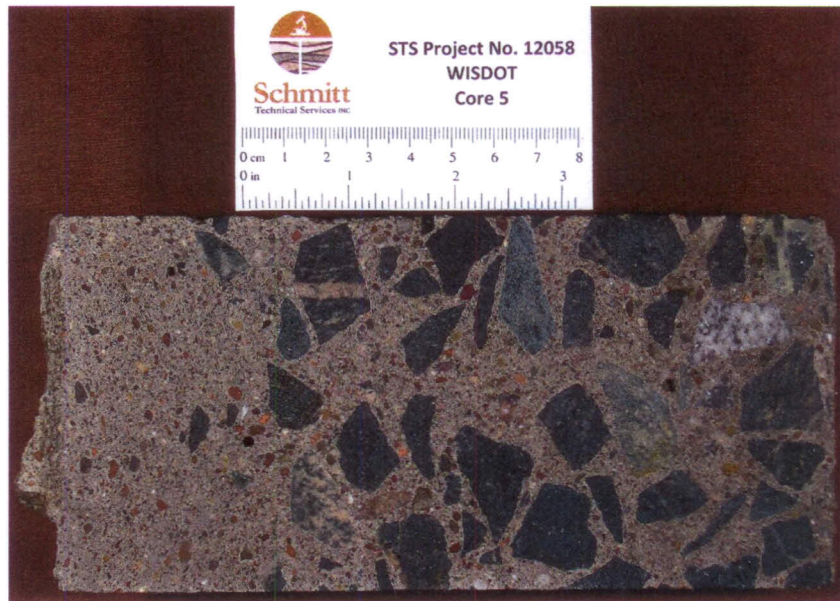
Coarse aggregate is well-graded but very poorly dispersed throughout the concrete. Coarse aggregate is concentrated in the lower ¾ of the core, with virtually no coarse aggregate observed within 58 mm (2.3 in.) of the current wearing surface (Figure 3). Measured maximum aggregate size is 19 mm (3/4 in.). Fine aggregate is well-graded and uniformly dispersed.

Figure 3. Lapped section of Core “5” illustrating the poor distribution of coarse aggregate particles, which are concentrated in the lower $\frac{3}{4}$ of the core. Core top is to the left. Top scale is in millimeters and centimeters. Bottom scale is in inches.

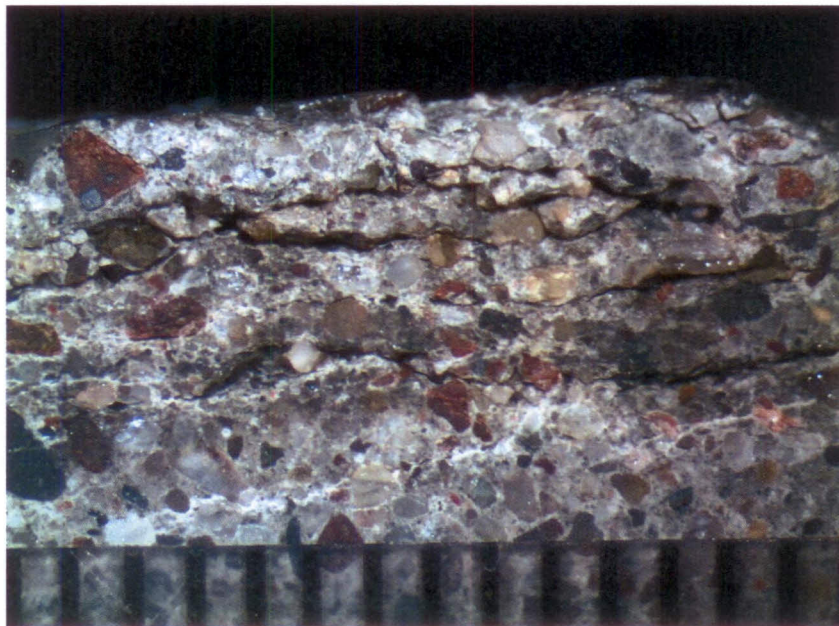
Figure 4. Photomicrograph of lapped section of Core “5” showing cracking and delamination of the wearing surface. Cracks are filled with secondary white calcite. Scale is in millimeters

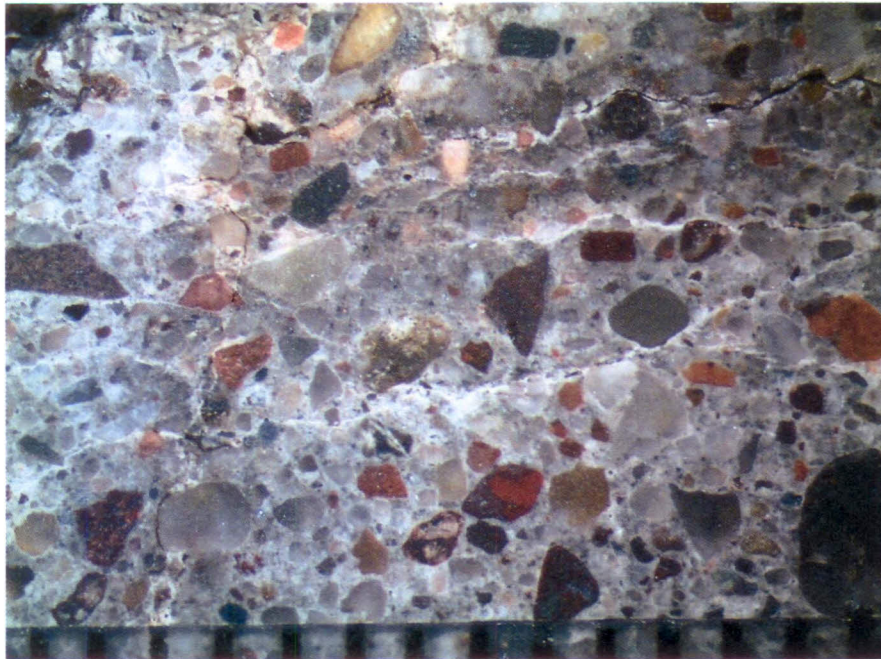
A vertical microcrack is observed in the core extending from the wearing surface to a depth of 40 mm (1.6 in.). The crack passes around coarse and fine aggregate particles (Figure 5), indicating that the crack likely formed prior to the development of adequate paste aggregate bond, as could occur by early shrinkage.

Figure 5. Photomicrograph of lapped section of Core "5" illustrating both horizontal and vertical microcracking near the wearing surface. Scale is in millimeters.

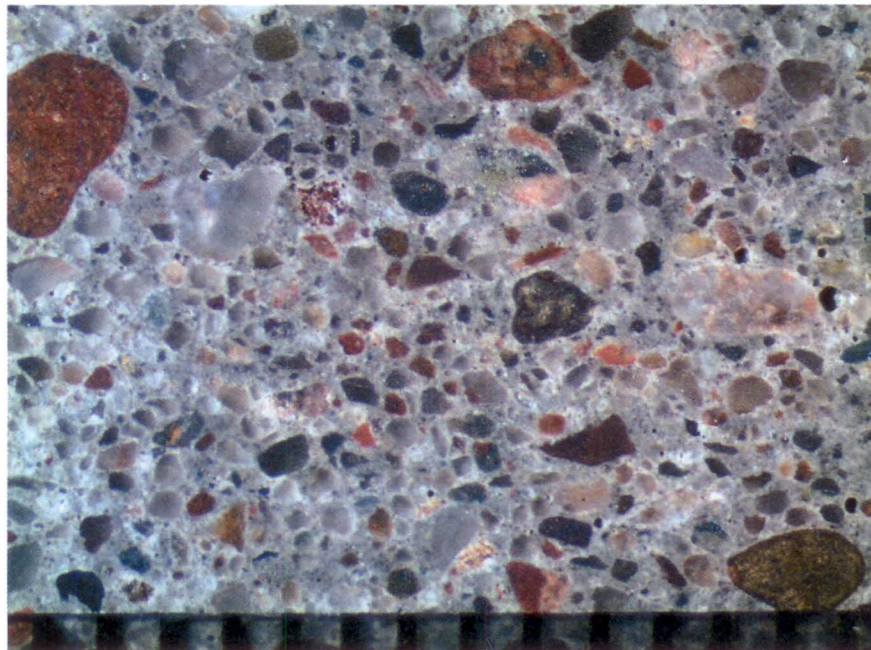
Figure 6. Photomicrograph of lapped section of Core "5" illustrating low air content in the upper 58 mm (2.3 in.) of the core. Scale is in millimeters.

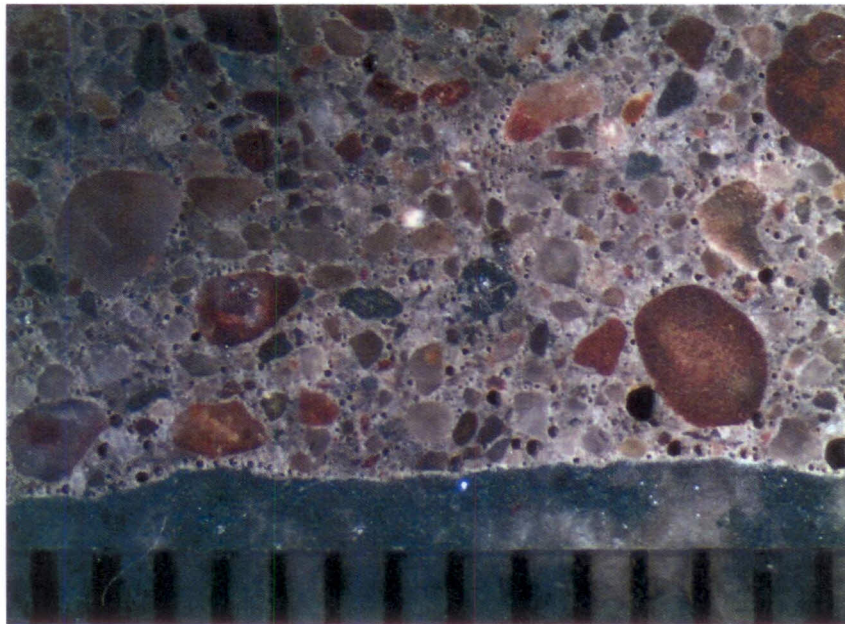
Figure 7. Photomicrograph of the lapped section of Core "5" illustrating clustering of air voids in the paste and adjacent to aggregate particles at greater depths. Scale is in millimeters.

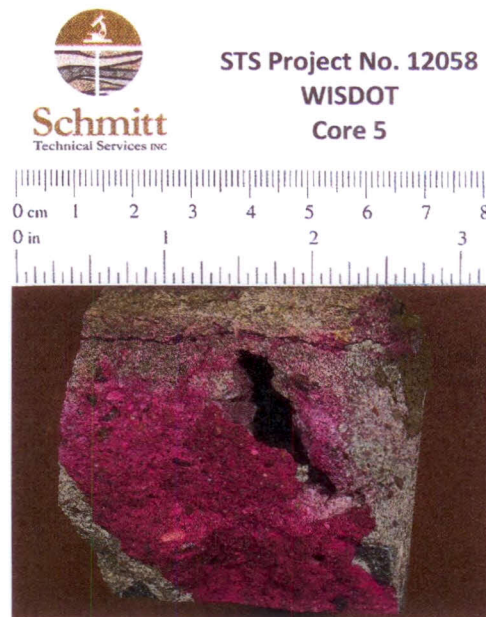
One large, 35 mm (1.4 in.) deep by 5-to-15 mm (0.2-to-0.6 in.) wide void was encountered at a depth of 13 mm (0.5 in.) below the wearing surface (Figure 8).

Figure 8. Core "5" showing a 35 mm (1.4 in.) deep by 5-to-15 mm (0.2-to-0.6 in.) wide void at a depth of 13 mm (0.5 in.) from the top of the core. Core top is toward top of photograph. This figure also illustrates the depth of carbonation from the wearing surface which is 25 mm (1.0 in.). Top scale is in millimeters and centimeters. Bottom scale is in inches.

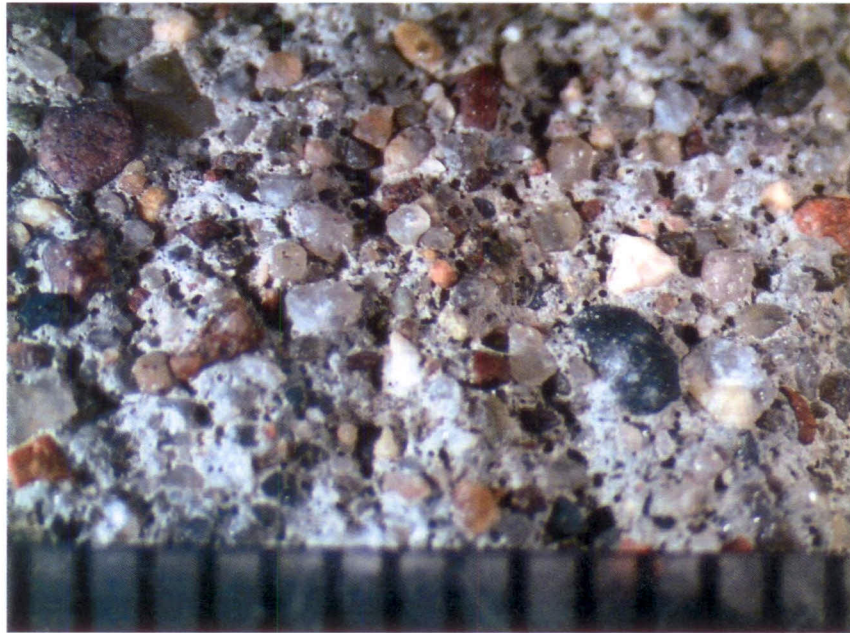
Figure 9. Photomicrograph of the wearing surface of Core “6” illustrating the degree of surficial aggregate exposure, due to abrasion of paste at the wearing surface. Scale is in millimeters.

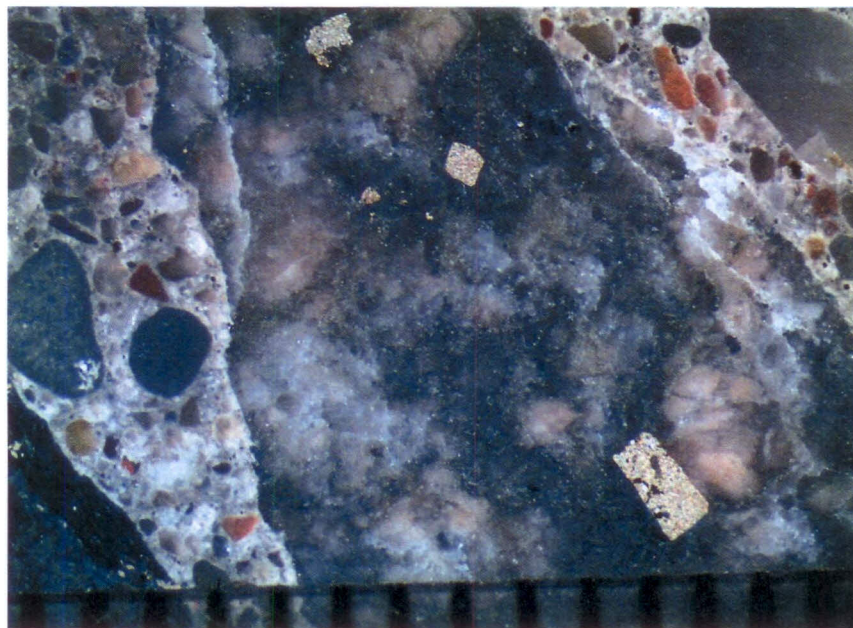
Cracks and microcracks are observed occasionally within the coarse aggregate particles, but the cracks do not extend into the adjacent cement paste. The cause of the coarse aggregate cracking is not readily apparent. Pyrite is observed in some of the coarse aggregate particles (Figure 10), but not in large enough quantities to be considered deleterious.

Figure 10. Photomicrograph of Core “6” showing the occurrence of pyrite in coarse aggregate particles. This interior portion of the core also exhibits lower air content. Scale is in millimeters.
