**I-43 Leo Frigo Memorial Bridge
B-5-158
ID 1220-15-01
Green Bay, Wisconsin**

Investigation Report Volume I: Text, Tables and Exhibits

May 2015

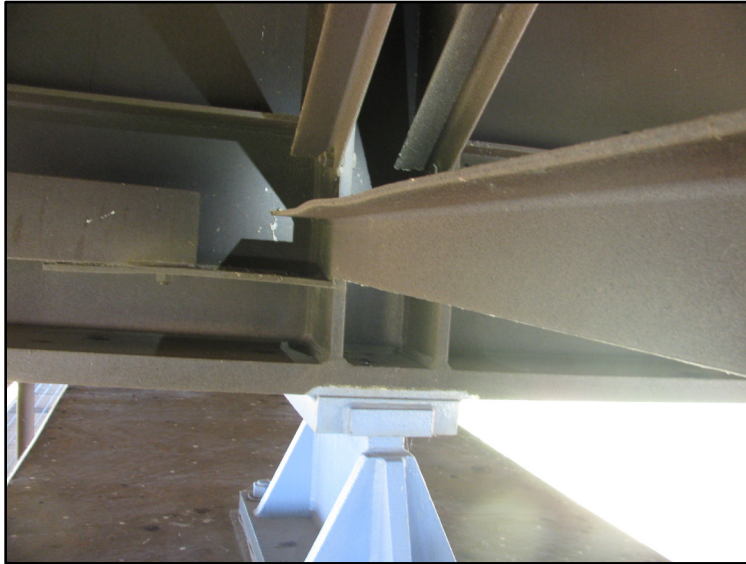
- a) One horizontal angle of a vertical cross-brace that was slightly buckled by 3/8-inch (see Figure 3.2)
- b) Very minor spalling at the top flange/bottom of the deck interface at girders 1 and 2

Figure 3.2: Buckled Angle at Vertical Bracing between Girders 6 & 7

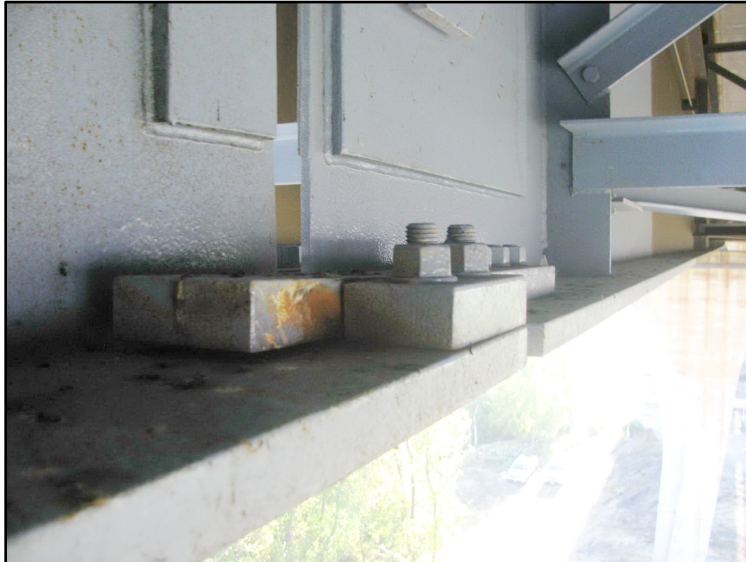
Figure 3.6: Span 23 Pin & Hanger Wind Lock Plates at Girder 6

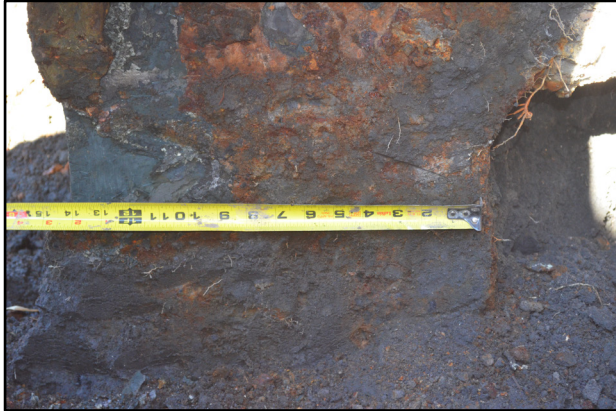
Pier 25 South Column Pile 17
(Visual Condition Rating 2)

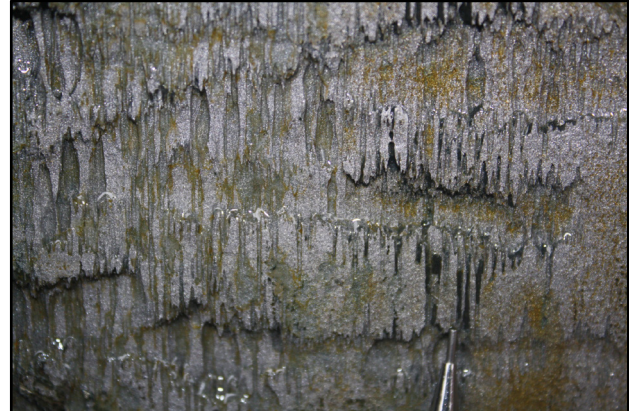
Pier 39 North Column Pile 20
(Visual Condition Rating 6)

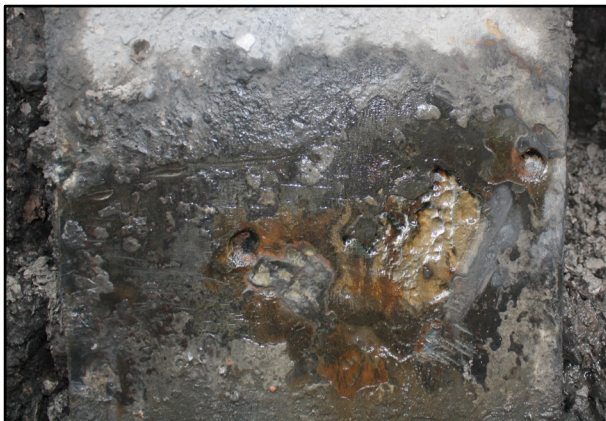
Pier 13 North Column Pile 33
(Visual Condition Rating 8)

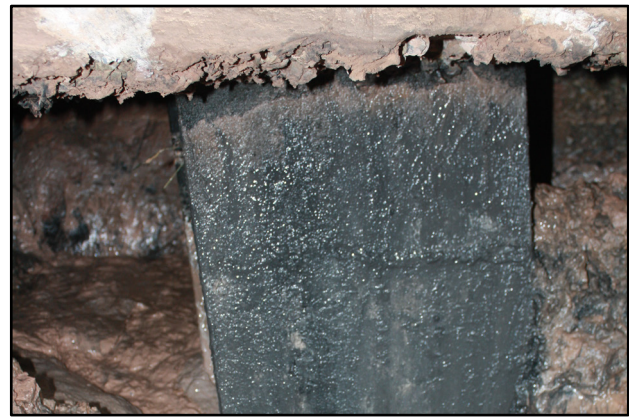
Pier 5 North Column Pile 10
(Visual Condition Rating 10)

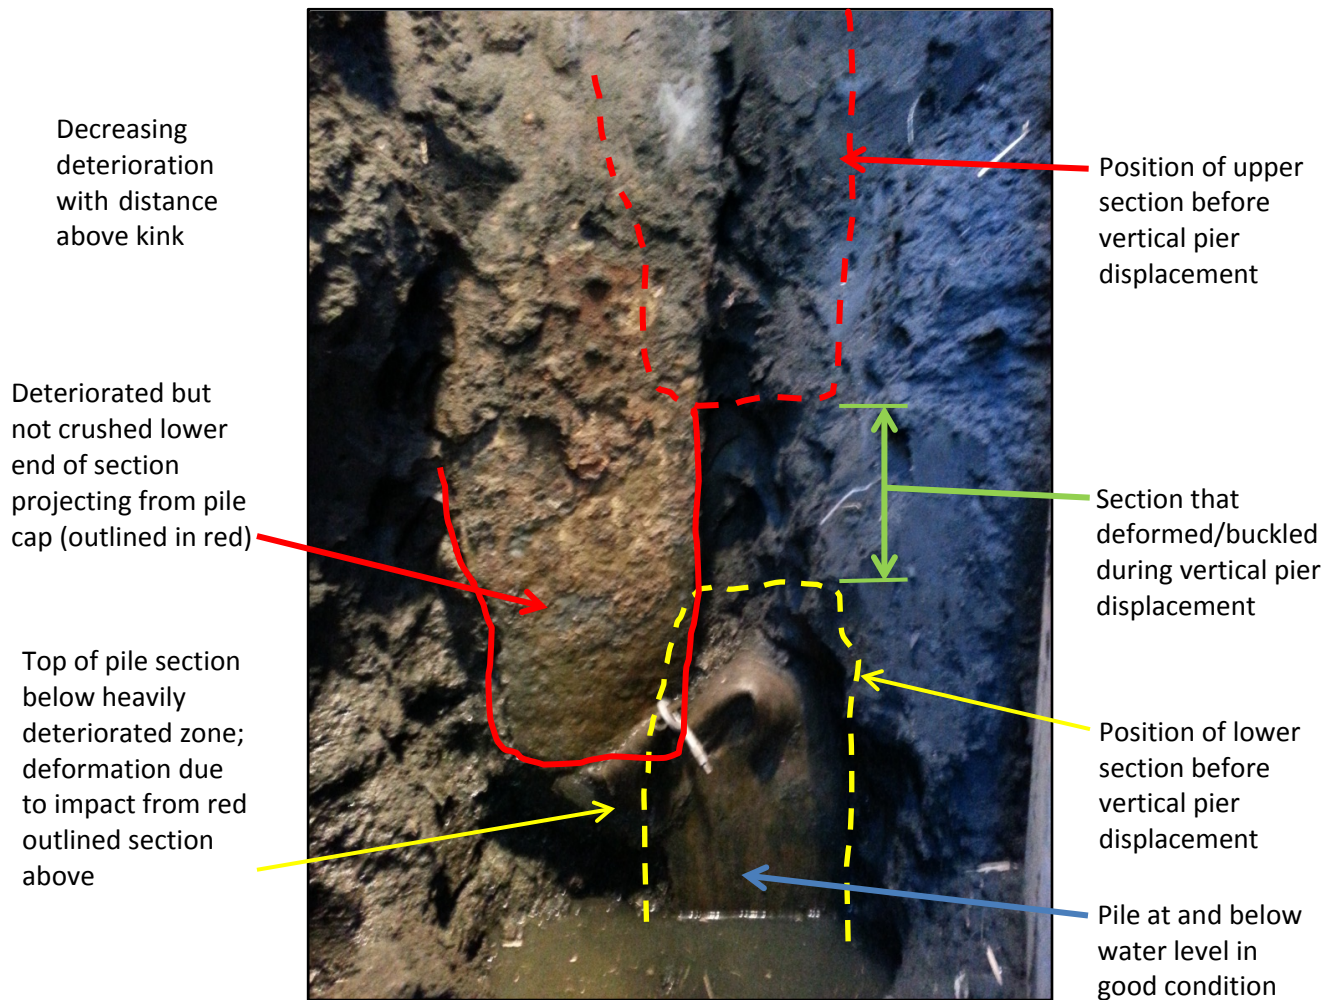
As discussed above there were various types of corrosion activity present at the site, but it appears that Accelerated Low Water Corrosion (ALWC) was mainly responsible for premature section loss of the steel piling at Pier 22 that led to crushing/buckling of the steel HP14x73 foundation piles as described below.

Figure 4.3: Buckled Pile #27 at Pier 22

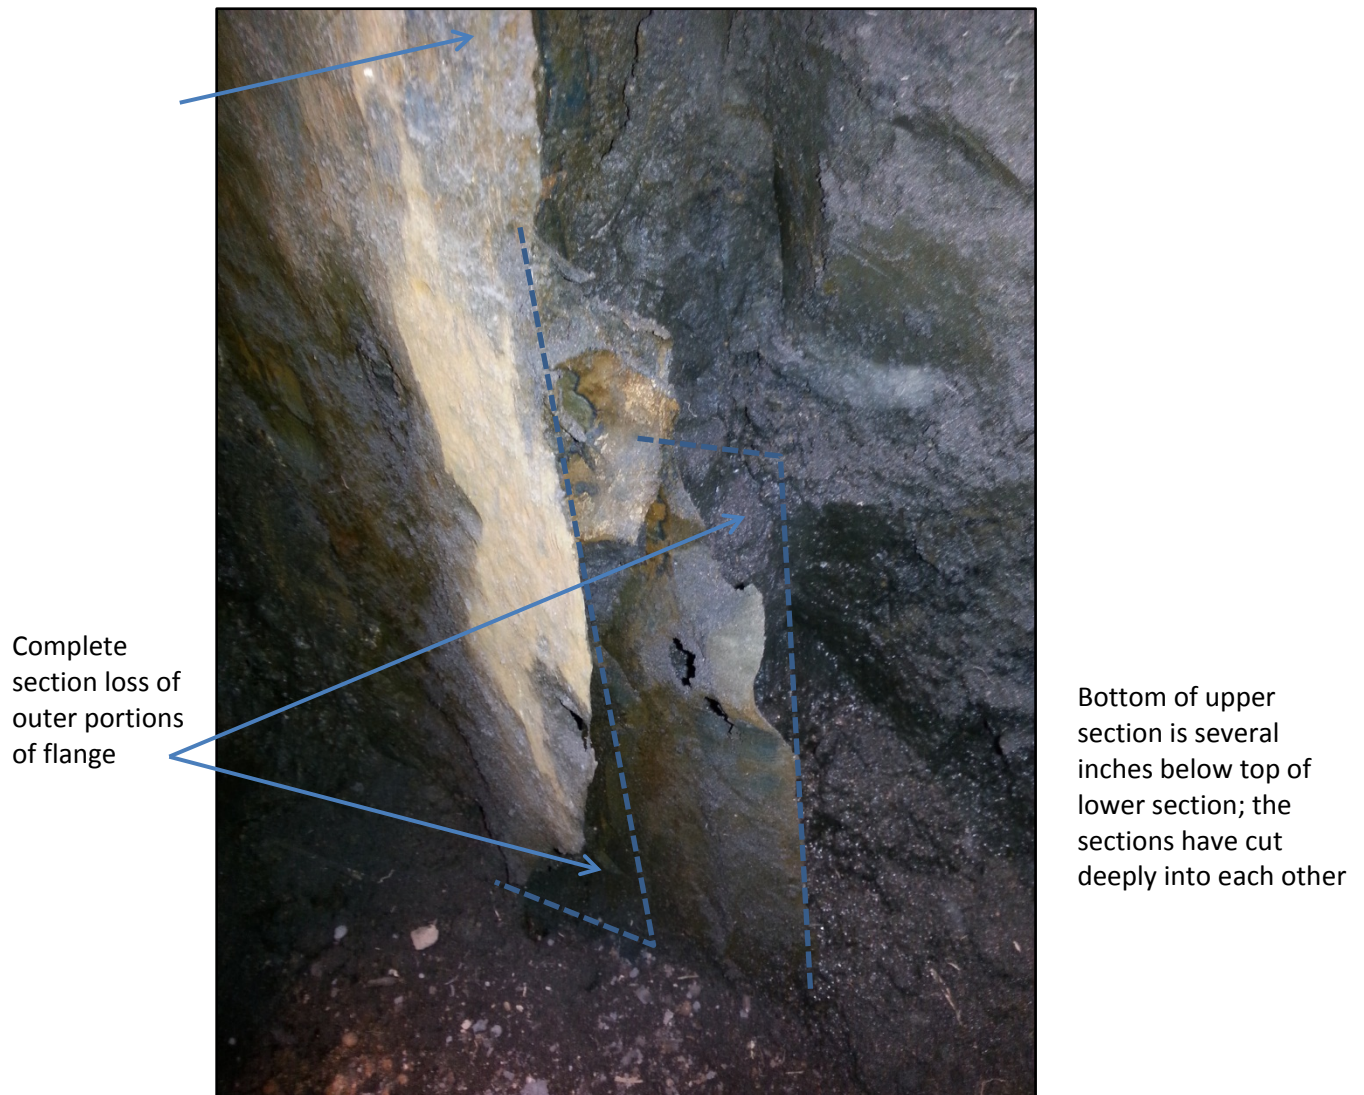
The outboard flanges of two piles located near the southwest corner of the south footer (Pile # 1 and Pile #2) were exposed to a similar depth as Pile #27. Figure 4.3 shows the lower section of Pile #2. In each case, a small offset in the flange was visible about 6 to 7 feet below the bottom of the footer, and the offset represented the interface between two sections of pile that had been widely separated before the recent vertical displacement occurred. As with Pile #27, a section of pile between the currently visible portions above and below the offset had crushed. As shown in Figure 4.3, the upper and lower sections of pile cut several inches into each other, causing significant overlap in the exposed remains of the outboard flange.

Figure 4.4: Crushed Pile #2 at Pier 22

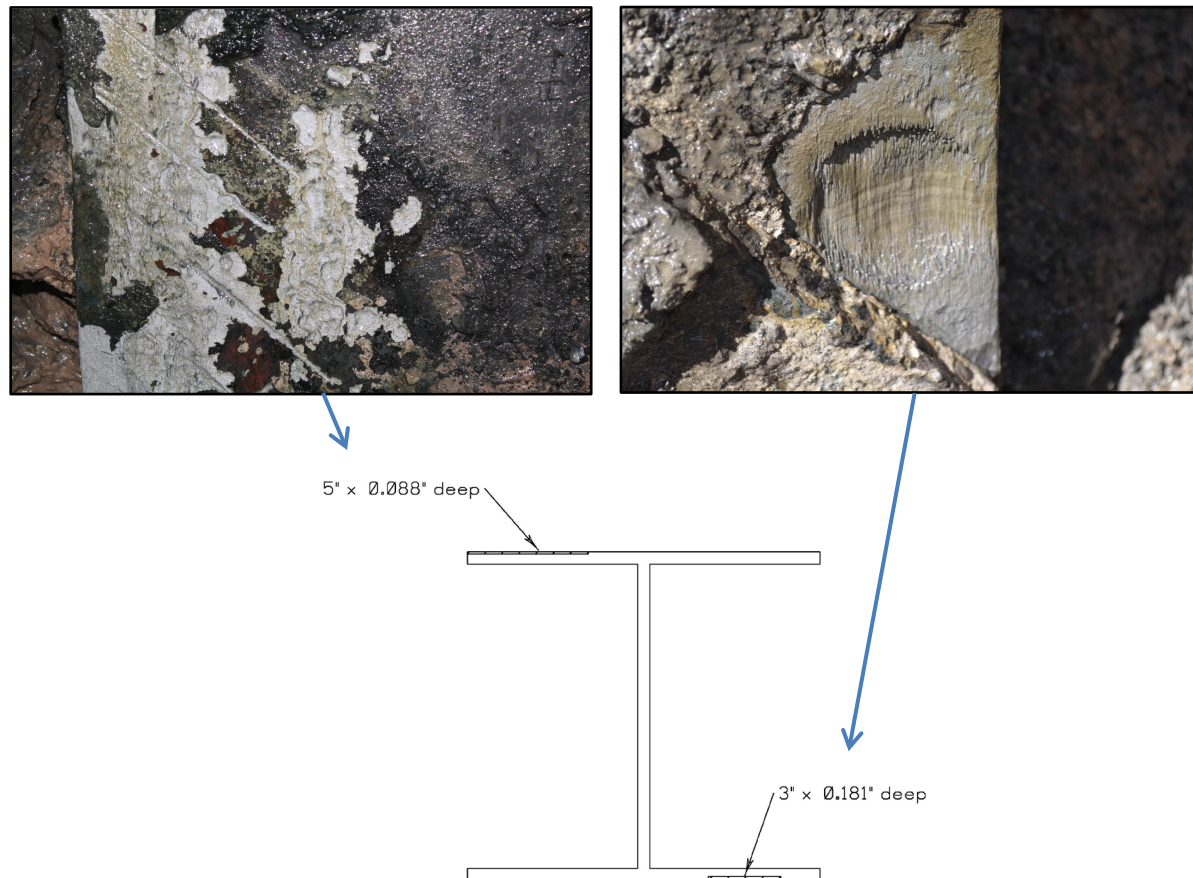
Figure 4.8: Observed Corrosion and Initial Pile Section Loss Illustration

per year (0.003 to 0.010 inches per year) were then applied to the local section loss based upon historical deterioration data for steel in corrosive environments.
