## **Non-Destructive Testing Inspection Report**

**B-27-0053**

**Castle Mound Road over IH-94 near Black River Falls, WI**

**January 8<sup>th</sup>, 2021**

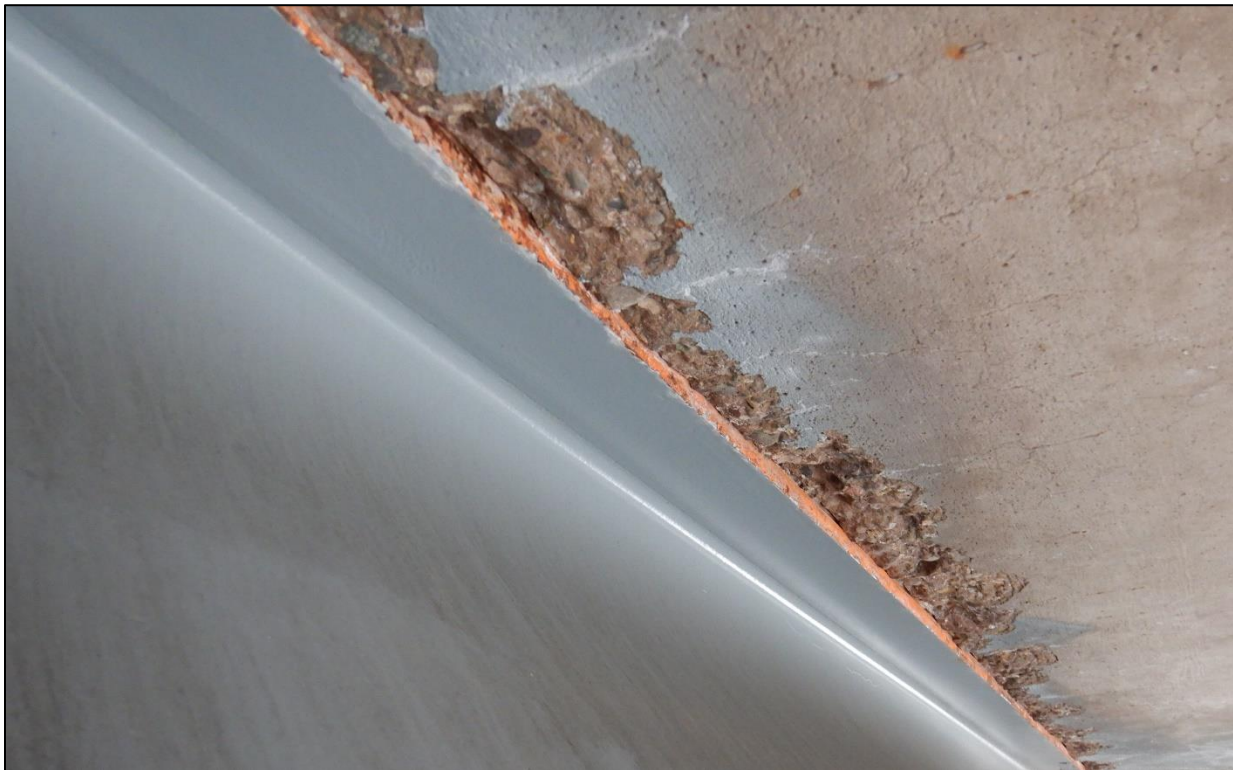
Girder 4 from the field splice to the East Abutment will be replaced as part of the repair contract and did not require an in-depth inspection. The deck above Girder 4 was called out in the July 24<sup>th</sup>, 2020 inspection as being delaminated from the Girder 4 top flange for 20 ft. and was no longer acting compositely. In the area called out as being delaminated, the deck along the edges of the top flange had spalled with up to 1.5 in. of penetration, exposing the top edge of the top flange in isolated locations (**Photo 6**).

- 6 1. GIRDER 4 FROM FIELD SPLICE TO EAST ABUTMENT WILL BE REPLACED AS PART OF REPAIR CONTRACT AND DOES NOT REQUIRE IN-DEPTH INSPECTION. THE DECK ABOVE THE GIRDER WAS SPALLED WITH UP TO 1.5 IN. OF PENETRATION AND THE TOP EDGE OF THE TOP FLANGE EXPOSED IN ISOLATED AREAS. THE DECK DID NOT APPEAR TO BE DELAMINATED FROM GIRDER AS STATED IN PREVIOUS DAMAGE REPORT.

**Photo 6** : Looking west along Span 2, Girder 4 at top flange to deck interface with spalling up to 1.5 in. deep.

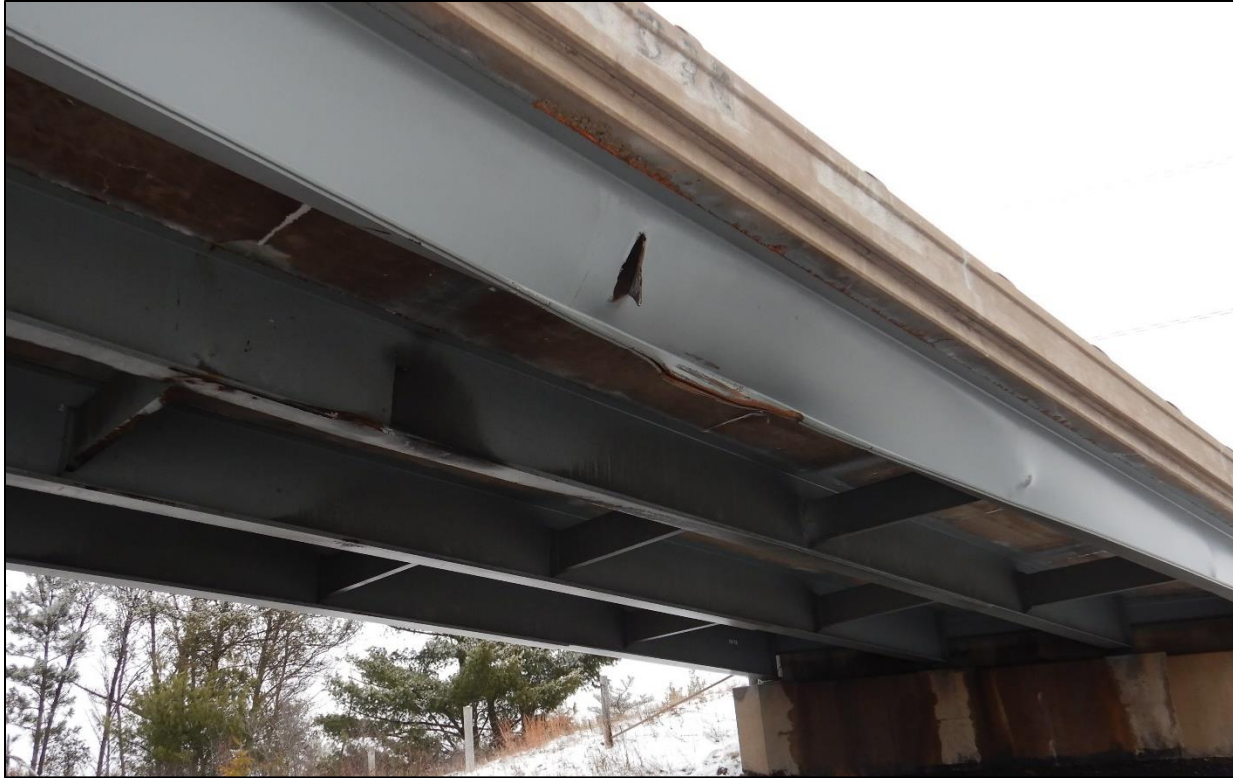
- 7 2. DIAPHRAGM 11 WAS BROKEN OUT AND HAD PUNCHED AN APPROXIMATELY 2 FT. HOLE IN GIRDER 4.
- 8 3. THE SPLICE PLATES WERE ALL VERTICAL WITH NO DISTORTION. CORROSION AND MINOR PACK RUST WAS NOTED AT ALL FIELD SPLICES.

**Photo 7** : Looking northeast at Span 2, Girder 4 at area of impact. Note tear in web at missing Diaphragm 11 Location.

HNTB determined that the portion of Girder 4 east of the field splice in Span 2 will be replaced along with Bay 3, Diaphragm 11 which was broken out due to impact damage.

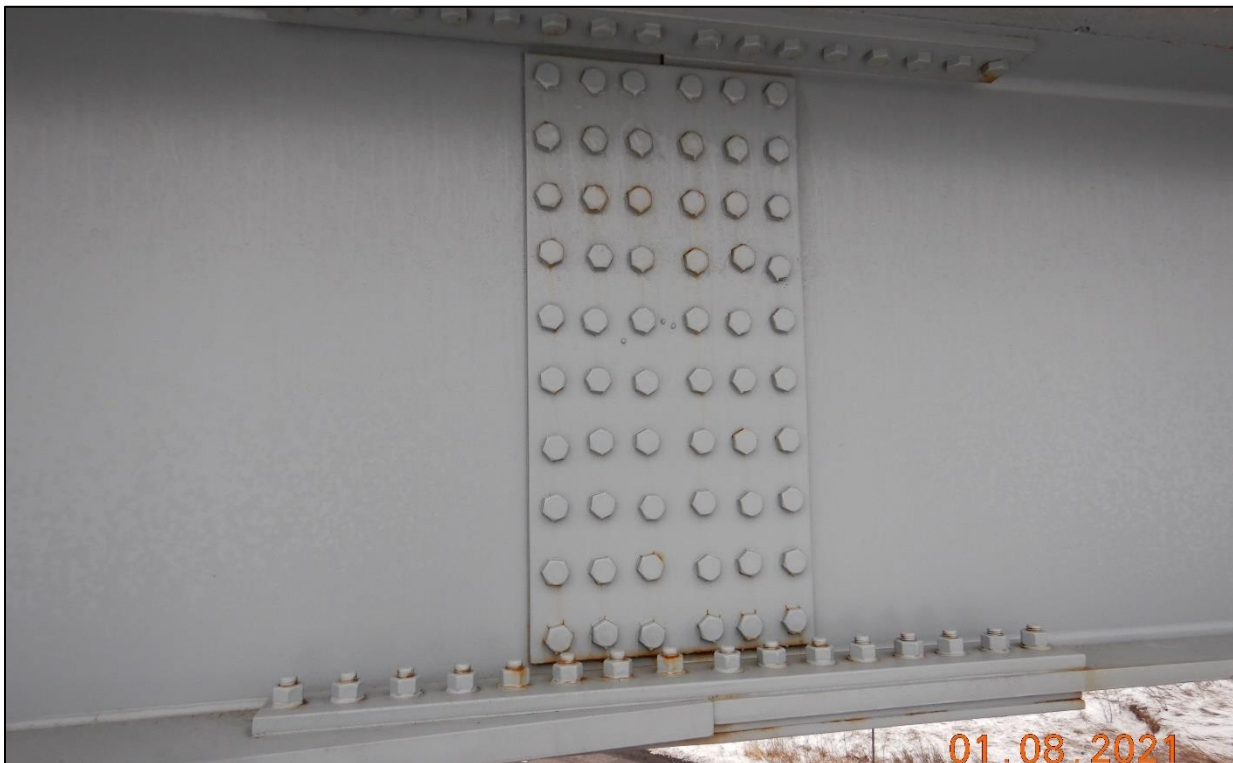
The Span 2 field splice was not displaced or rotated, and the splice plates had no distortion or damage (**Photo 8**). Moderate corrosion with negligible pack rust buildup was found in the faying surfaces of the field plates on all four girder field splice plates.

**Photo 8** : Looking north at Span 2, Girder 4 Splice Connection.

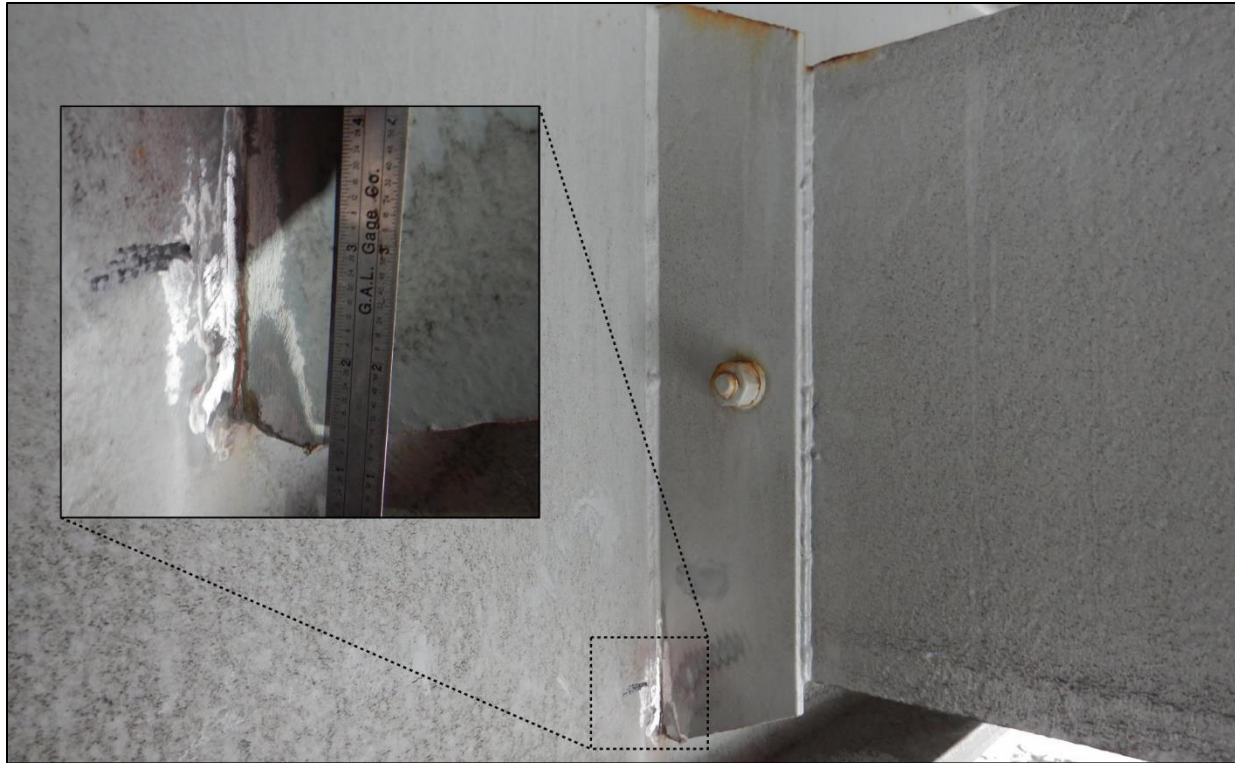
- 9 4. THE DIAPHRAGM TO WEB WELD HAD A 1.75 IN. CRACK STARTING AT THE BOTTOM EDGE.
- 10 5. THE DIAPHRAGM TO WEB WELD HAD A 1.75 IN. CRACK STARTING AT THE BOTTOM EDGE. THE DIAPHRAGM HAD BEEN PUSHED 1.5 IN. EAST AND THE WEB WAS DISTORTED UP TO 2 IN. TO THE SOUTH WITH NO CRACKING TO THE WEB NOTED. THE DIAPHRAGM STIFFENER TO DIAPHRAGM WELD WAS CRACKED THROUGH.

**Photo 9** : Looking northeast at Span 2, Girder 3, Diaphragm 10 to web weld with 1.75 in. crack starting at the bottom edge.

It is recommended that the areas of impact damage on Girders 1 and 3 be heat straightened and the 20 in. section of cracked cover plate to bottom flange weld on Girder 3 be ground out and a bolted retrofit be installed after heat straightening. The seven cracked diaphragm to web welds should have crack arrest holes drilled to capture the crack tips after all heat straightening is performed.

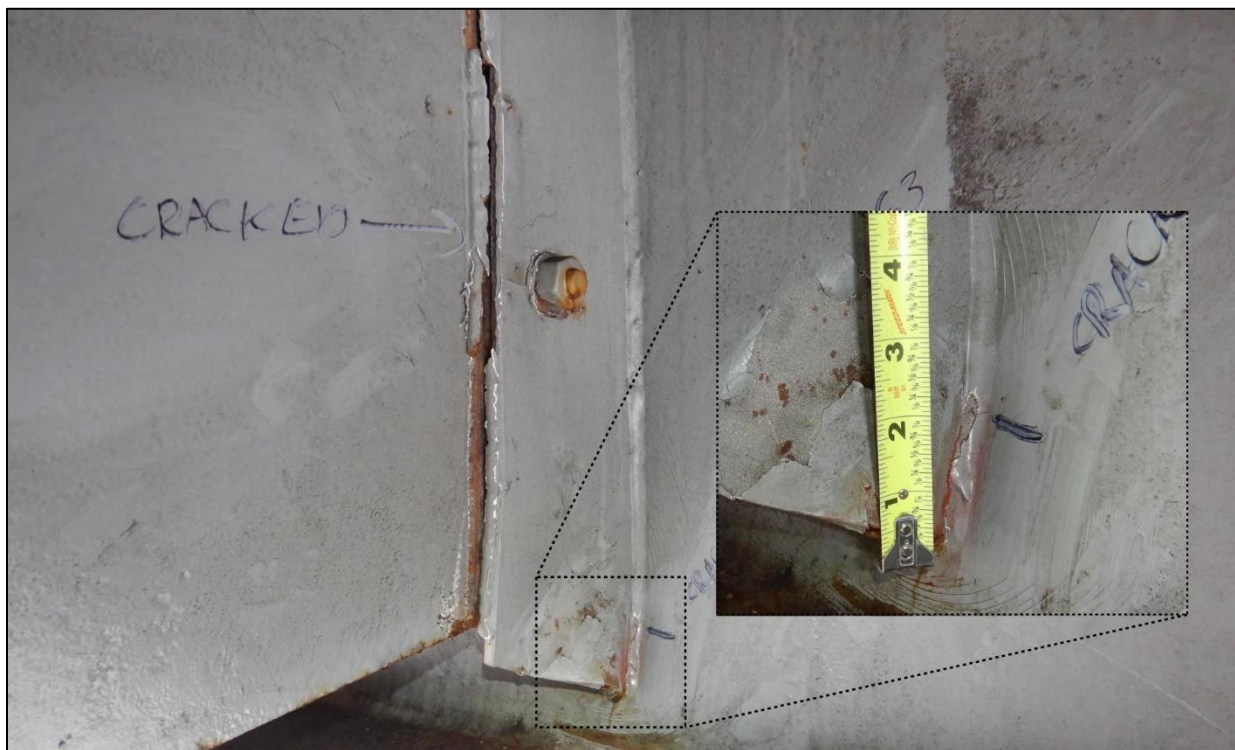
**Photo 10** : Looking southeast at Span 2, Girder 3, Diaphragm 11 to web weld with 1.75 in. crack starting at the bottom edge. The diaphragm had been pushed 1.5 in. east and the web was distorted up to 2 in. to the south with no cracking noted. The diaphragm stiffener to diaphragm weld was cracked through.

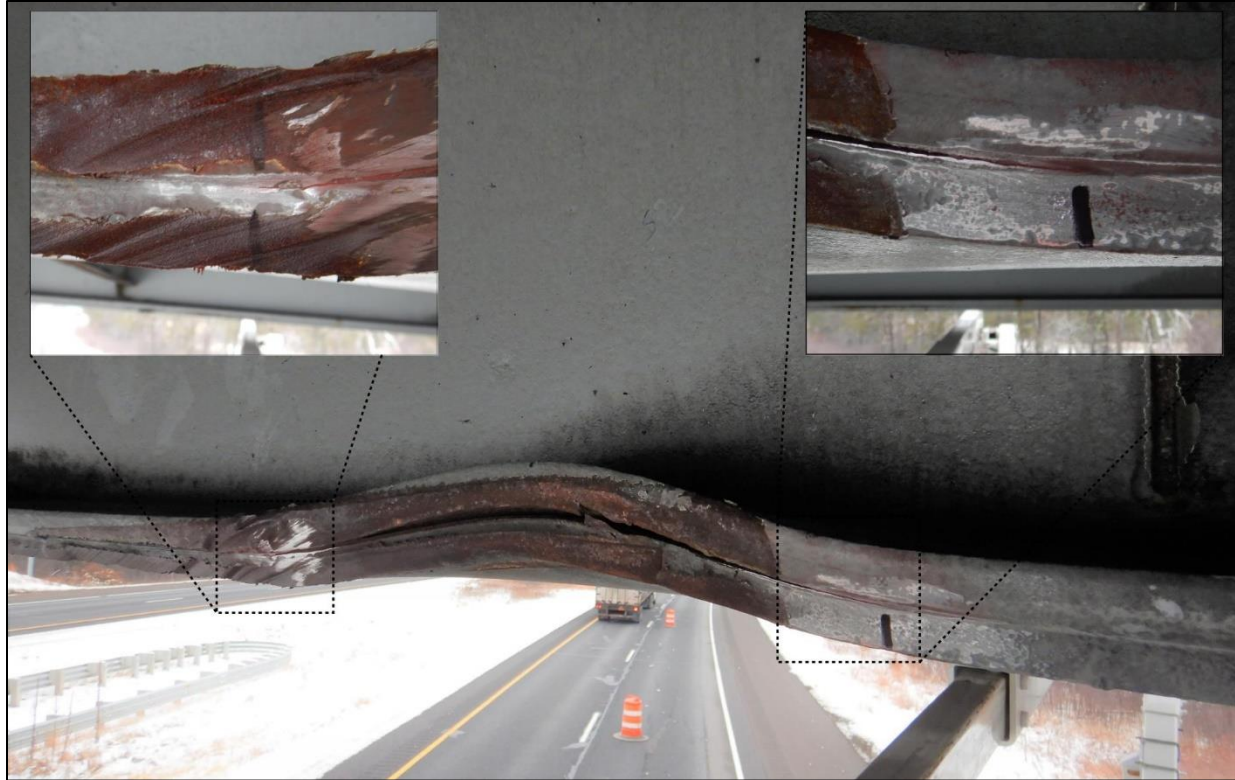
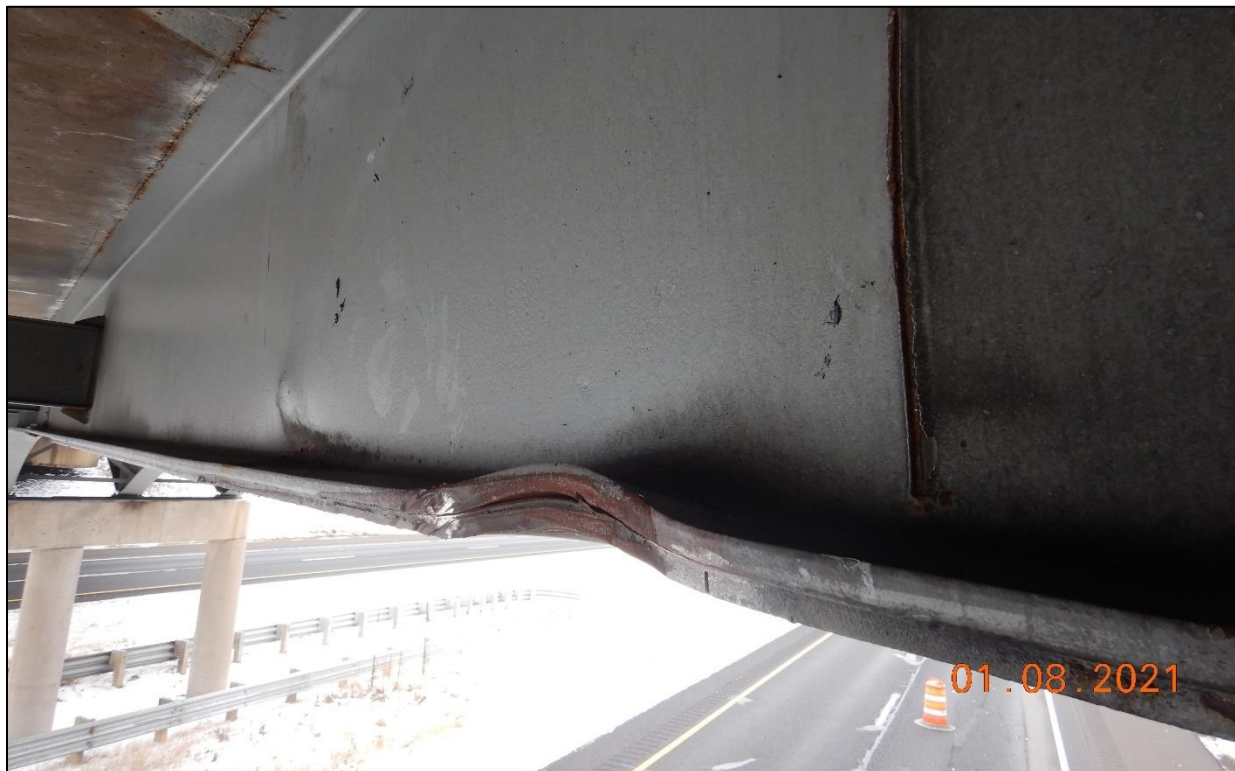
Girder 3 had an area of impact damage located 4 in. west of Bay 3, Diaphragm 11 (the diaphragm was broken out due to impact to Girder 4). The cover plate to bottom flange weld was cracked and the flange was bent up to 1 in. upwards over a 20 in. length in the area of impact damage (**Photo 11/Photo 12**). The web to the east of this impact damage, was distorted up to 2 in. out-of-plane with no indication of cracking in the girder web (**Photo 13**).

- 11, 12 6. IMPACT DAMAGE TO BOTTOM FLANGE STARTING 4 IN. WEST OF DIAPHRAGM 11 WELD FOR 20 IN. THE COVER PLATE TO BOTTOM FLANGE WELD WAS CRACKED AND THE FLANGE WAS BENT UPWARDS UP TO 1 IN.

**Photo 11** : Looking north at Girder 3 impact damage to bottom flange starting 4 in. west of Diaphragm 11 weld for 20 in. with the cover plate to bottom flange weld cracked and flange was bent upwards 1 in.

**Photo 12** : Looking northwest at Girder 3 impact damage overview.

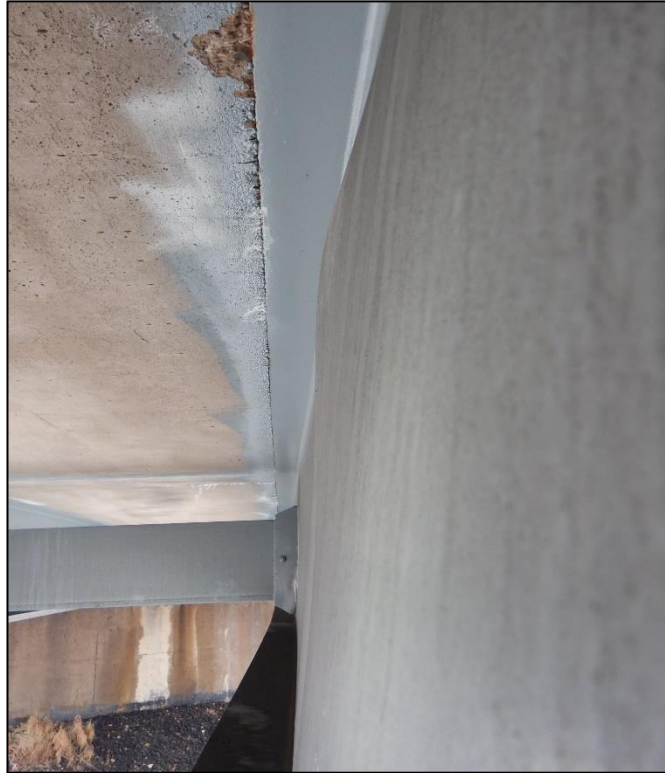
- 13 7. THE WEB AT THE TOP OF THE DIAPHRAGM WELD WAS UP TO 2 IN. OUT-OF-PLANE TO THE NORTH WITH NO CRACKING NOTED.
- 14 8. THE DIAPHRAGM TO WEB WELD HAD A 6.25 IN. CRACK STARTING AT THE BOTTOM EDGE WITH UP TO 1/2 IN. SEPARATION BETWEEN DIAPHRAGM AND WEB AT BOTTOM EDGE.

**Photo 13** : Looking east along Girder 3 at Diaphragm 11 with the web distorted up to 2 in. out-of-plane.

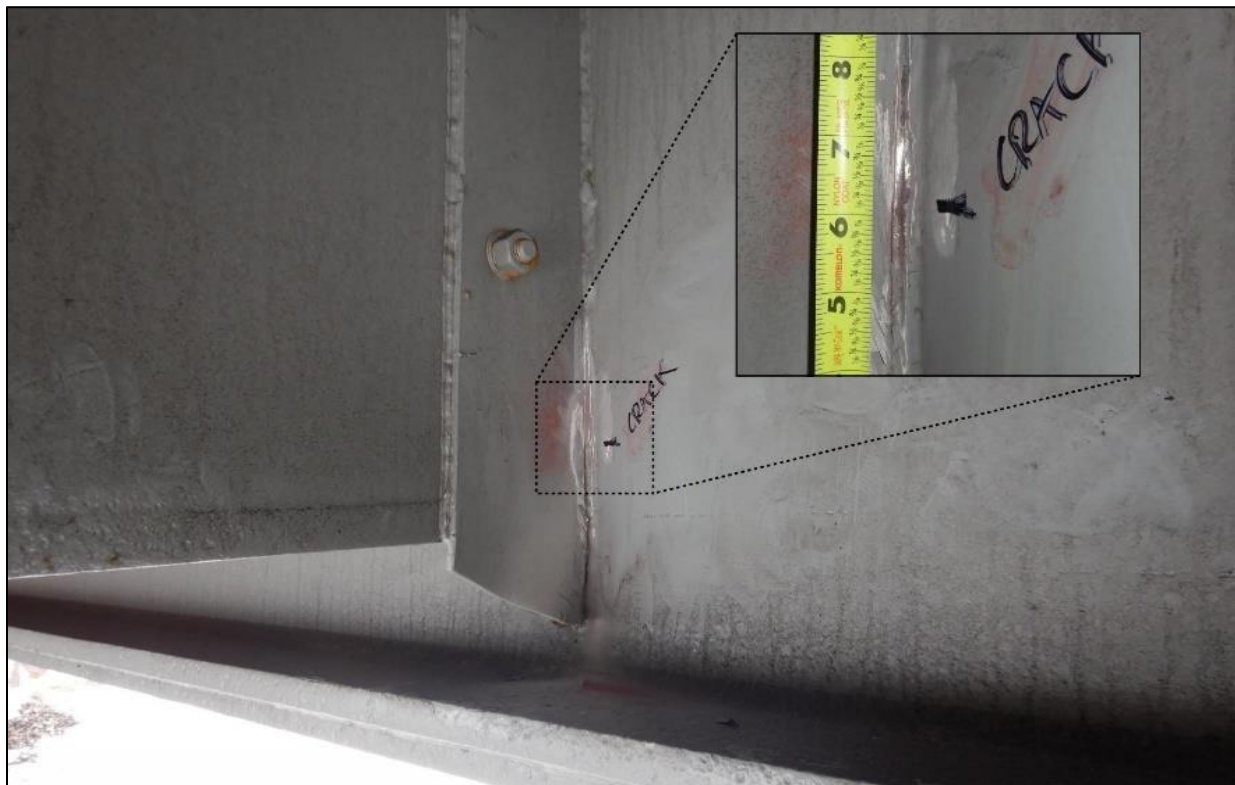
**Photo 14** : Looking southeast at Span 2, Girder 3, Diaphragm 12 to web weld with 6.25 in. long crack starting at the bottom edge with up to 1/2 in. of separation between diaphragm and web at bottom edge.

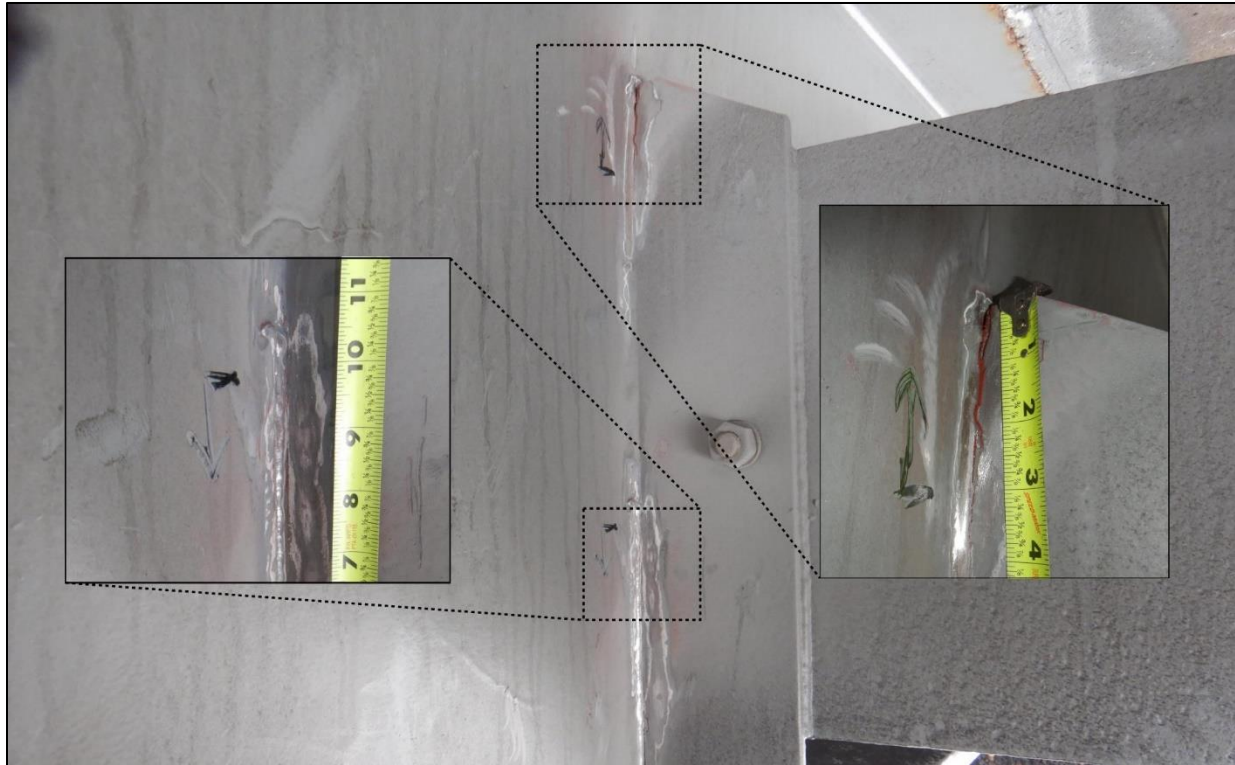
- 15 9. THE DIAPHRAGM TO WEB WELD HAD A 10 IN. CRACK STARTING AT THE BOTTOM EDGE AND A 3 IN. CRACK STARTING AT THE TOP EDGE WITH UP TO 1/4 IN. SEPARATION BETWEEN DIAPHRAGM AND WEB AT BOTTOM EDGE.

**Photo 15** : Looking southeast at Span 2, Girder 3, Diaphragm 12 to web weld with 10 in. long crack starting at the bottom edge and 3 in. long crack starting at the top edge with up to 1/4 in. of separation between diaphragm and web at bottom edge.

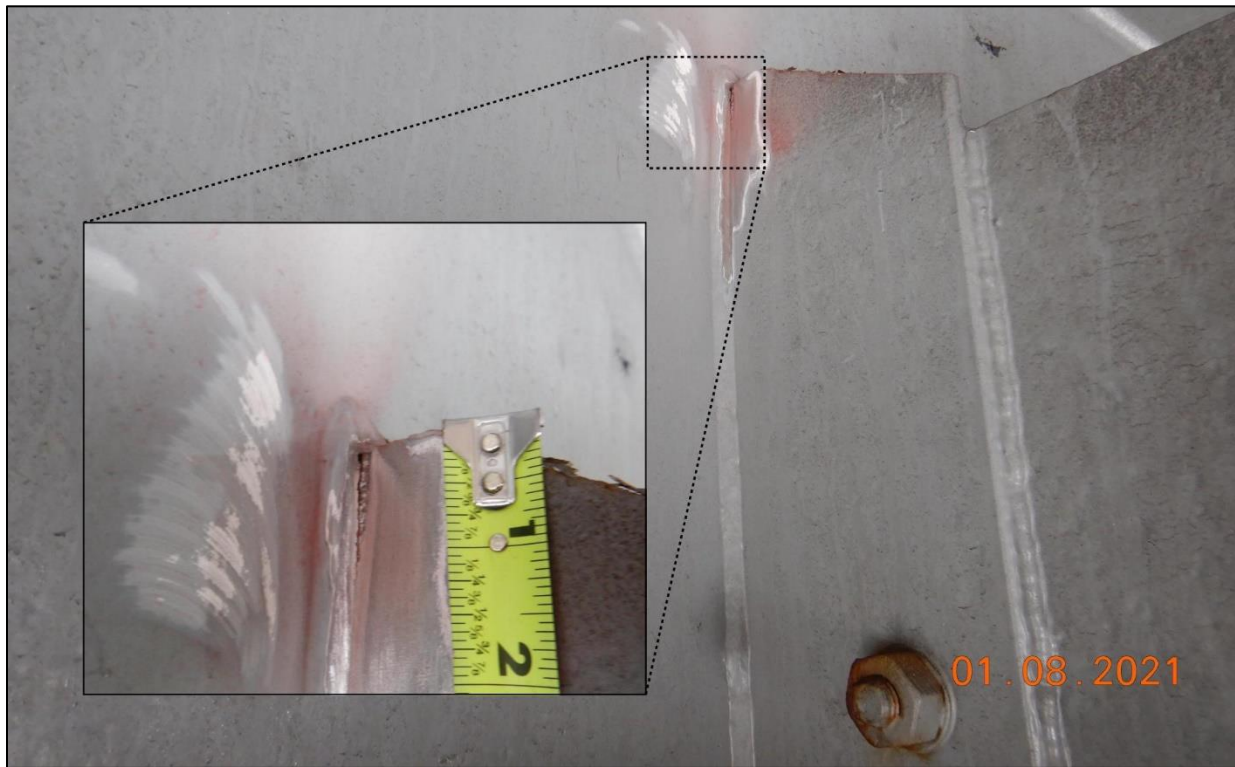
Girder 2 had one cracked web to diaphragm weld on Span 2, Girder 2, Bay 2, Diaphragm 11 (**Photo 16**). The girder bottom flange was deflected up to 1 in. to the north with the web rotated up to 1.5 degrees from Diaphragm 11 to the East Abutment.

**Photo 16** : Looking northeast at Span 2, Girder 2, Diaphragm 11 to web weld with 1.25 in. long crack starting at the top edge.

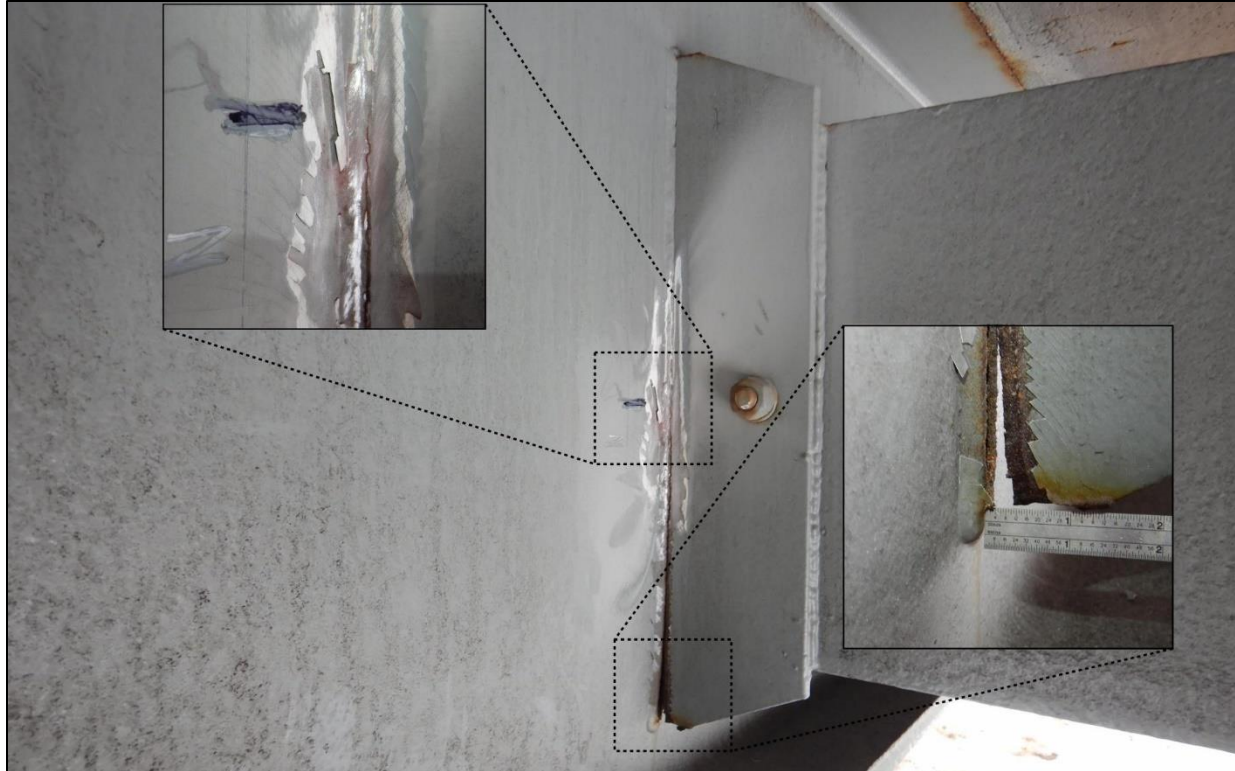
**Photo 17** : Looking northeast at Span 2, Girder 1, Diaphragm 10 to web weld with 11.75 in. long crack starting at the bottom edge with up to 3/8 in. of separation between diaphragm and web at bottom edge.

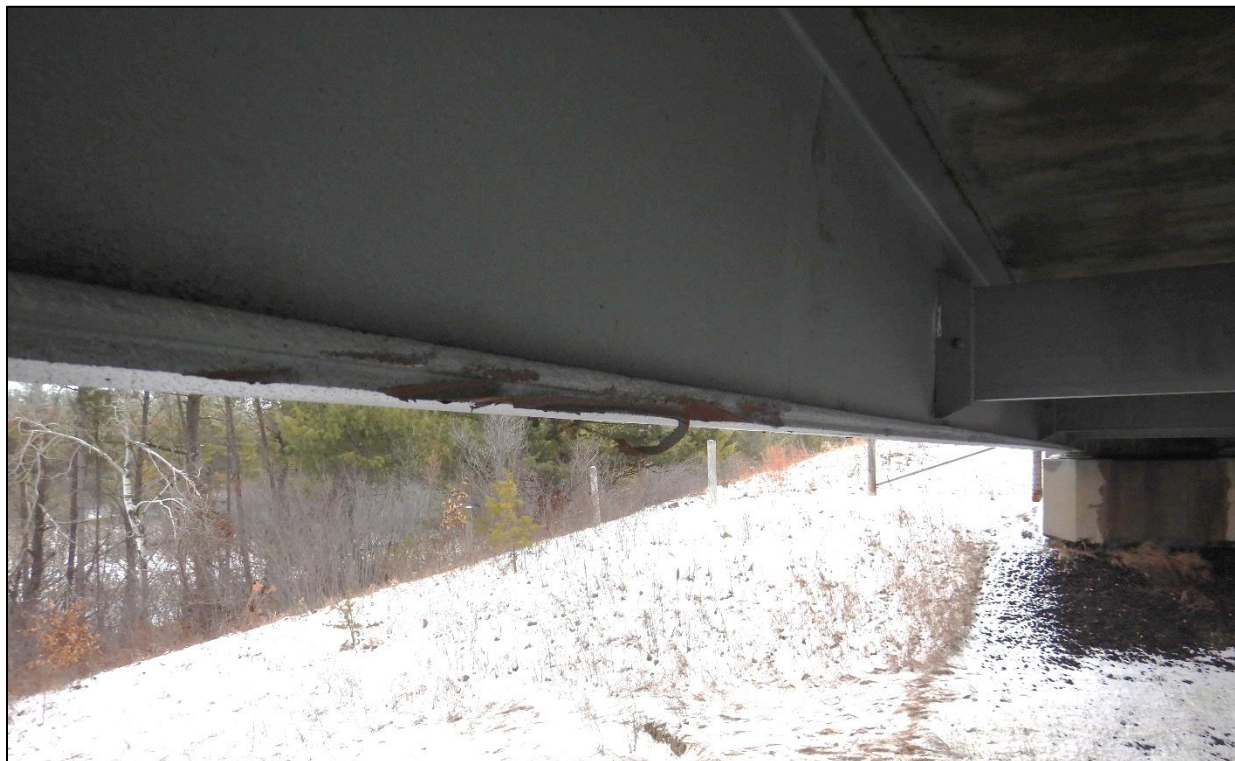
Girder 1 had an area of impact damage starting 8 ft. east of Diaphragm 10 and was 4 ft. long with a 1 ft. long area of torn steel up to 1/4 in. thick (**Photo 18**). Both Diaphragm 10 (**Photo 17**) and Diaphragm 11 (**Photo 19**) web to diaphragm welds were cracked. The girder bottom flange was deflected up to 1 in. to the north with the web rotated up to 3 degrees between Diaphragms 10 and 11 in the area of impact.

- 18 12. THE SOUTH BOTTOM FLANGE HAD 4 FT. OF IMPACT DAMAGE STARTING 8 FT. EAST OF DIAPHRAGM 10. THE BOTTOM FLANGE HAD A 1 FT. LONG AREA OF TORN STEEL UP TO 1/4 IN. THICK.

**Photo 18** : Looking east along Span 2, Girder 1 south, bottom flange with 4 ft. of impact damage starting 8 ft. east of Diaphragm 10. The bottom flange had a 1 ft. long area of torn steel up to 1/4 in. thick.

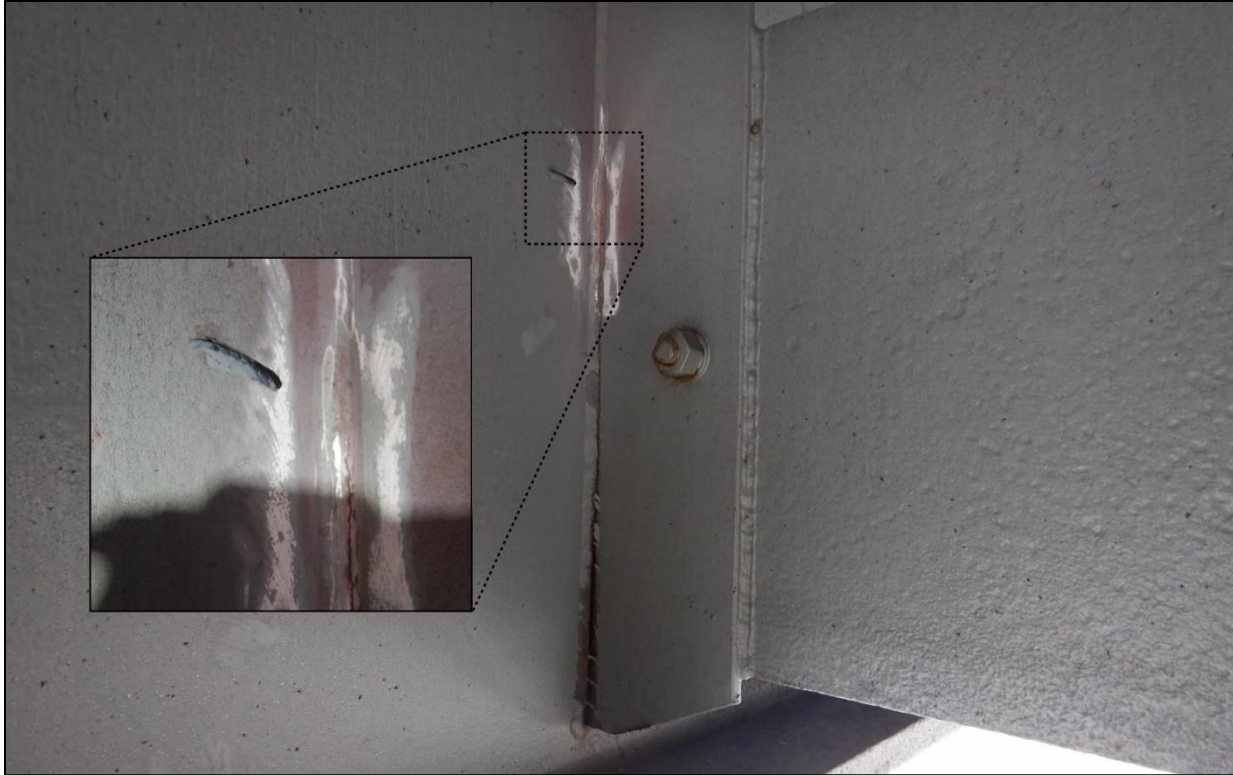
- 19 13. THE DIAPHRAGM TO WEB WELD HAD A 17 IN. CRACK STARTING AT THE BOTTOM EDGE WITH UP TO 3/8 IN. SEPARATION BETWEEN DIAPHRAGM AND WEB AT BOTTOM EDGE.

**Photo 19** : Looking northeast at Span 2, Girder 1, Diaphragm 11 to web weld with 17 in. long crack starting at the bottom edge with up to 3/8 in. of separation between diaphragm and web at bottom edge.

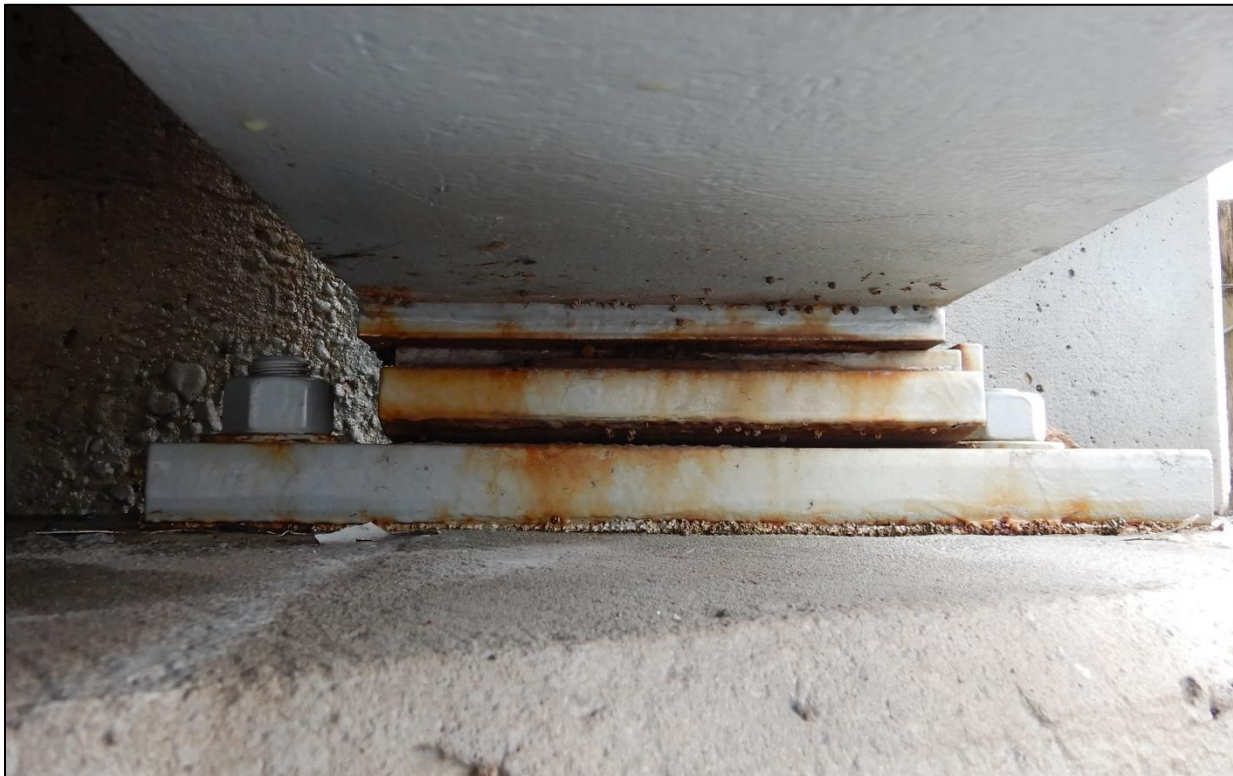
**Photo 20** : Looking east at East Abutment, Girder 4 Bearing with the north keeper broken off and the girder shifted 5/8 in. to the north.

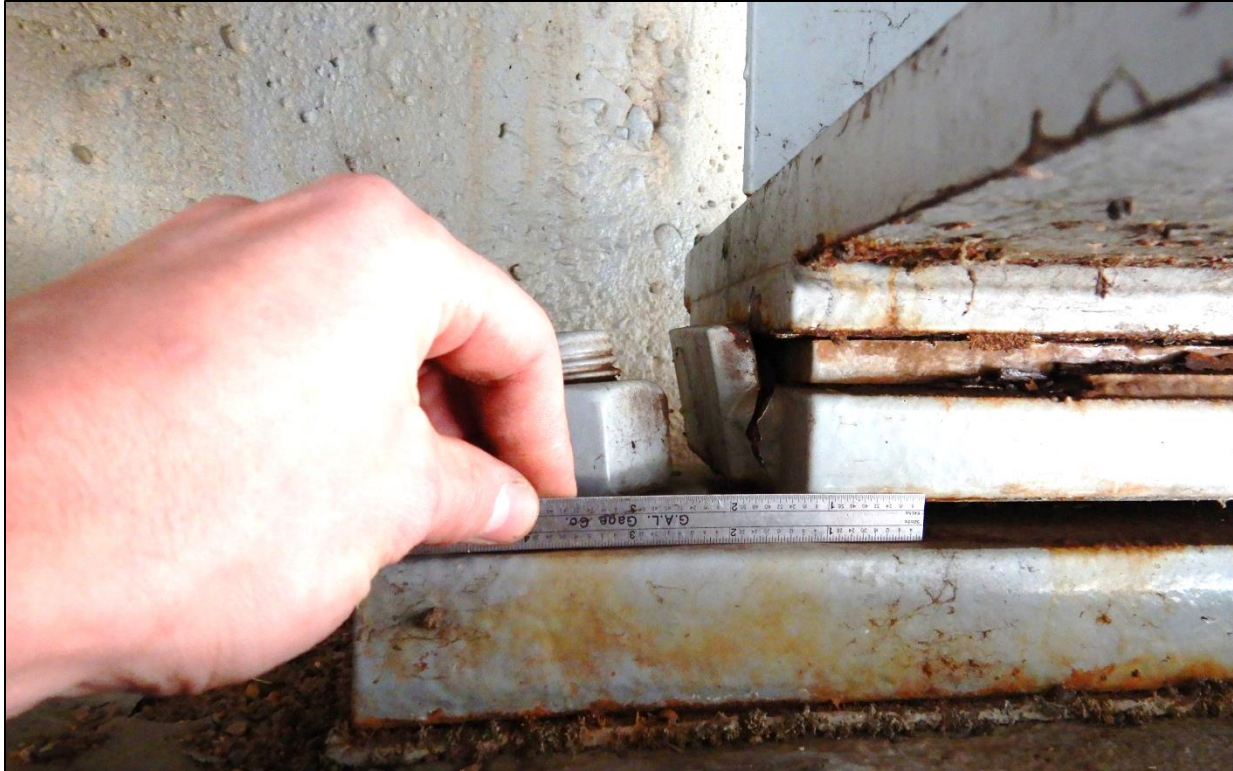
**Photo 21** : Looking east at East Abutment, Girder 3 Bearing with the north keeper cracked and the girder shifted 1/4 in. to the north.

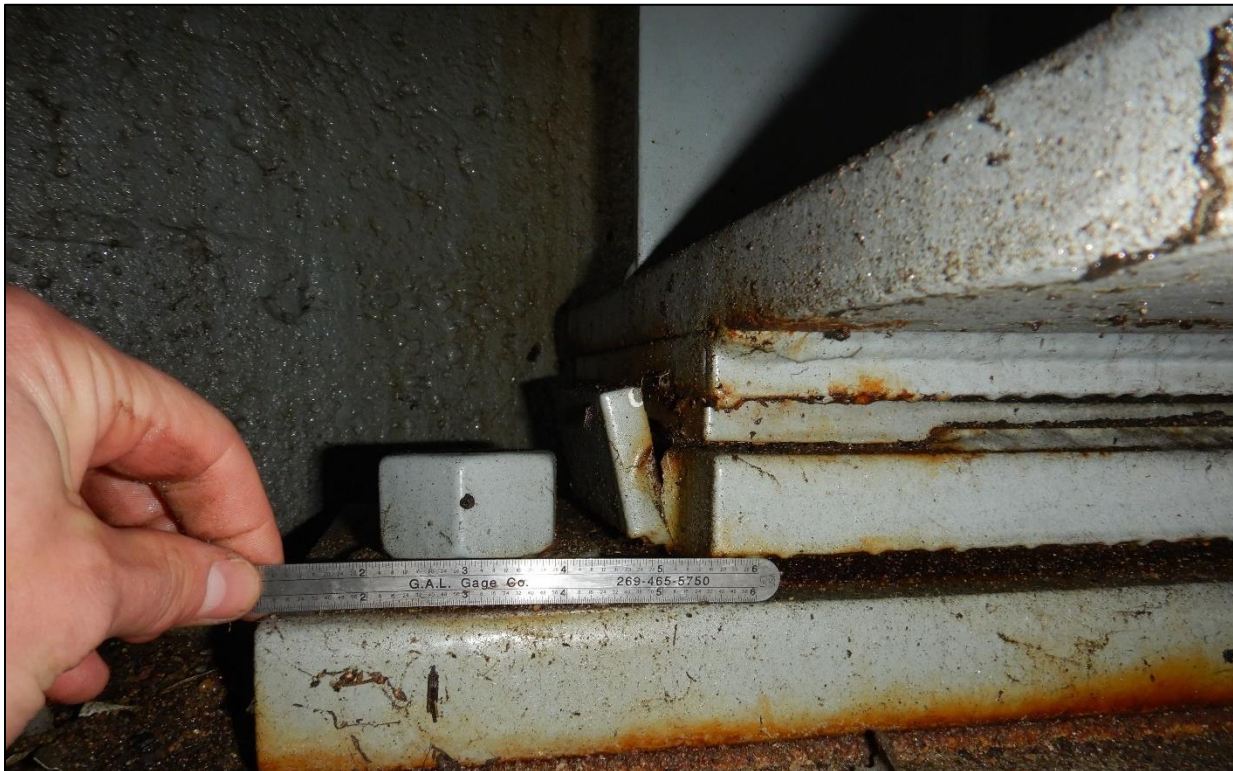
**Photo 22** : Looking east at East Abutment, Girder 2 Bearing with the north keeper cracked.

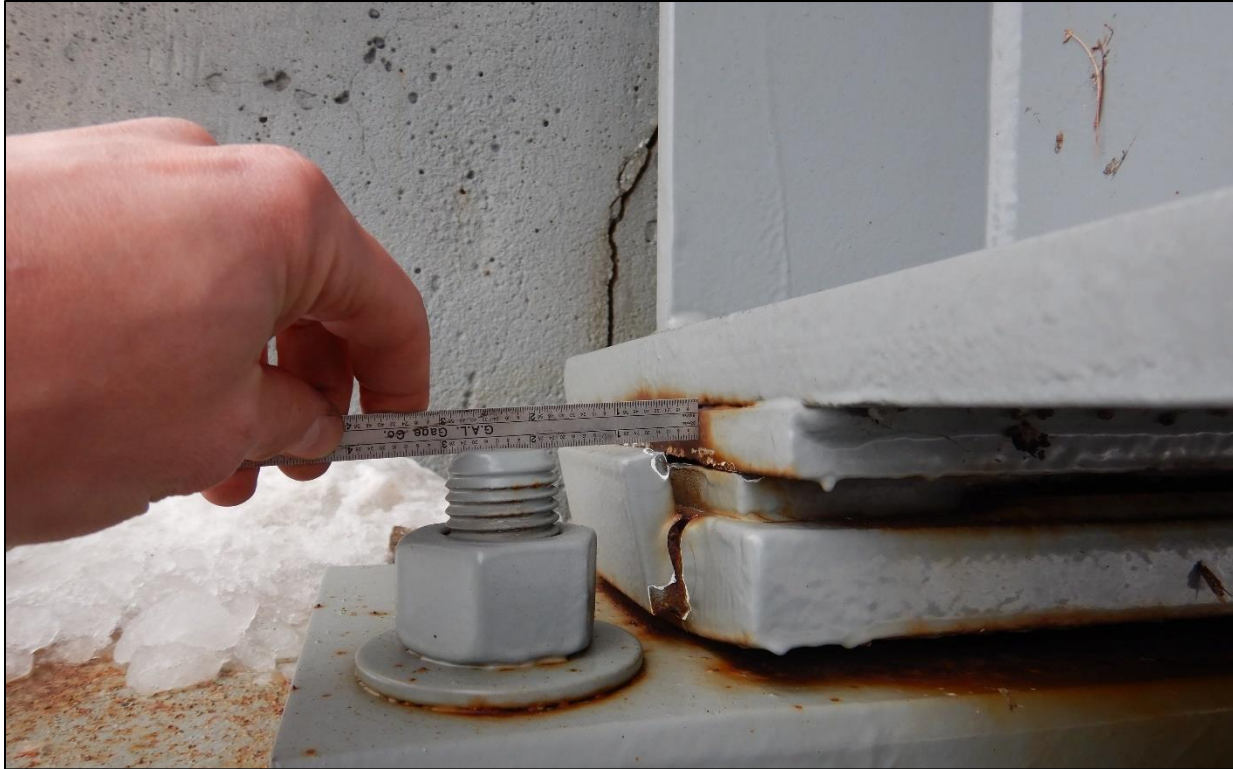
**Photo 23** : Looking east at East Abutment, Girder 2 Bearing with both girder keepers cracked.
