Inspection Report for

**B-27-053**

**CASTLE MOUND RD over IH 94**

**Jul 24, 2020**

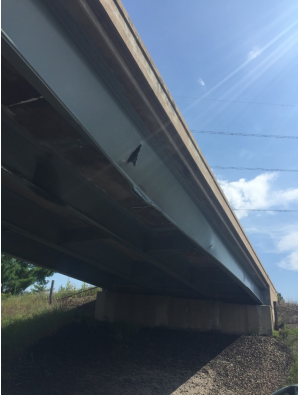
<p>b27-053_20_Cd1.jpg</p>
--	---

Action Plan: Critical - Partial Closure	Created: 27-Jul-2020	Due: 22-Sep-2020
Overall Notes: on 7/24/2020 approximately 50 ft. of girder 1 over the west bound lanes was struck by a backhoe and bent out plane by over 2 ft. the 3rd diaphragm in completely broke out and punched a 2 ft. hole in the girder. 10 ft. of the bottom cover plate also broke away from the bottom flange. Girder 2 sustained less damage but still bent out of plane by approximately 6 in. Girder 4 has about 1 ft. of the girder "peeled" down but does not appear to be affecting the capacity.

**Critical Finding Item 1**

Short Term Plan:  
Leave Castle Mound rd posted at 8 tons and barrel off area directly above the damaged areas.

Long Term Plan:  
Have state maintenance crews look at repairing. If not get a contractor to heat straight and strengthen damaged girder. Bridge will be repaired under a let project due to the extensive damages.

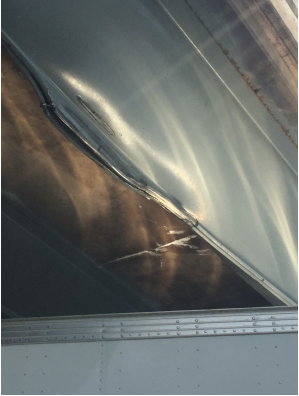
<p>b27-053_20_Cd2.jpg</p>
--	--

**Critical Finding Item 2**

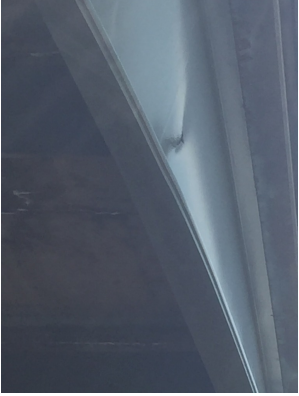
<p>b27-053_20_Cd3.jpg</p>
--	---

**Critical Finding Item 3**

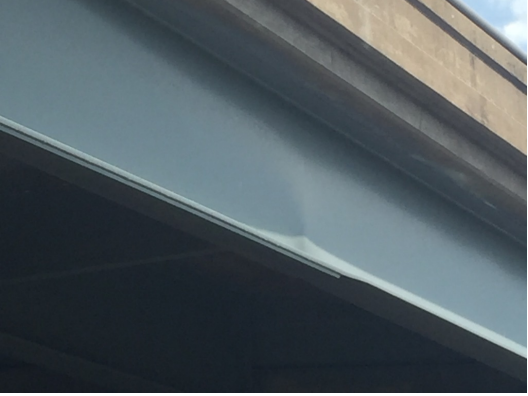
<p>b27-053_20_Cd4.jpg</p>
--	--

**Critical Finding Item 4**

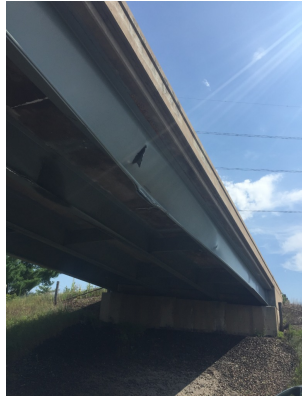
b27-053\_20\_Dd1.jpg

7-24-2020 Bridge Hit on Girder 3

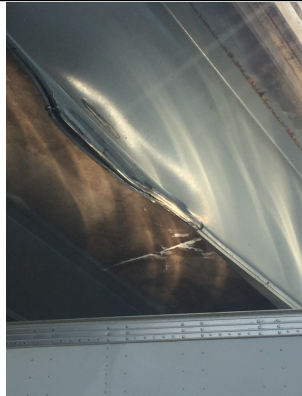
b27-053\_20\_Dd2.jpg

7-24-2020 Bridge Hit on Girder 3

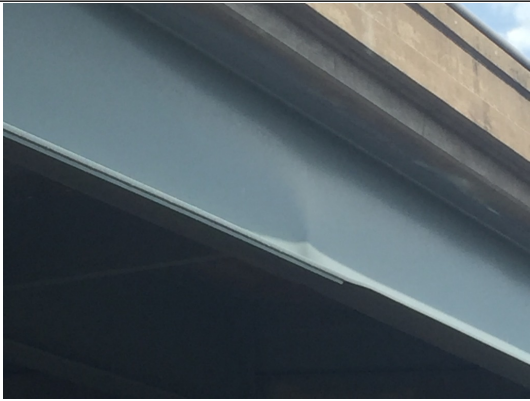
b27-053\_20\_Dd4.jpg

7-24-2020 Bridge Hit on Girder 3

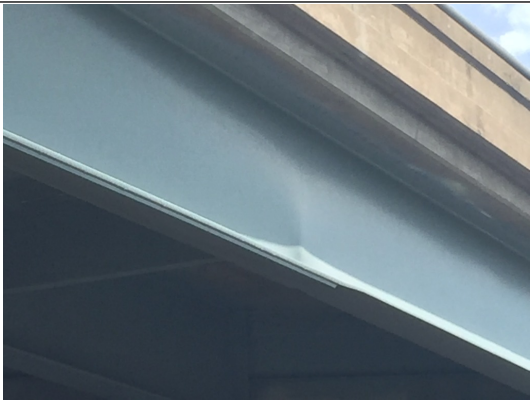
b27-053\_20\_Dd5.jpg

7-24-2020 Bridge Hit on Girder 3

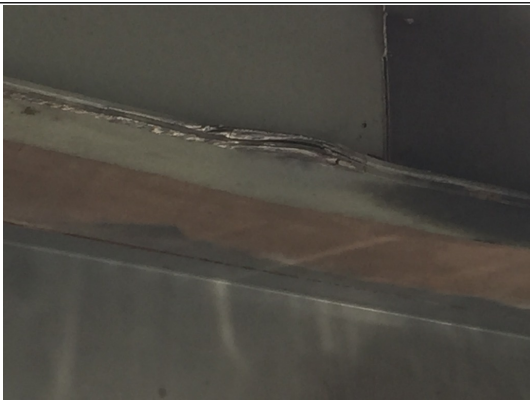
b27-053\_20\_Dd6.jpg

7-24-2020 Bridge Hit on Girder 2
