Subject: Asbestos Survey
Structure Name/Location: USH 12 over Sheridan Spring Road, Walworth County
Structure Number: B-64-31
WisDOT ID Number: 1080-12-00

Executive Summary

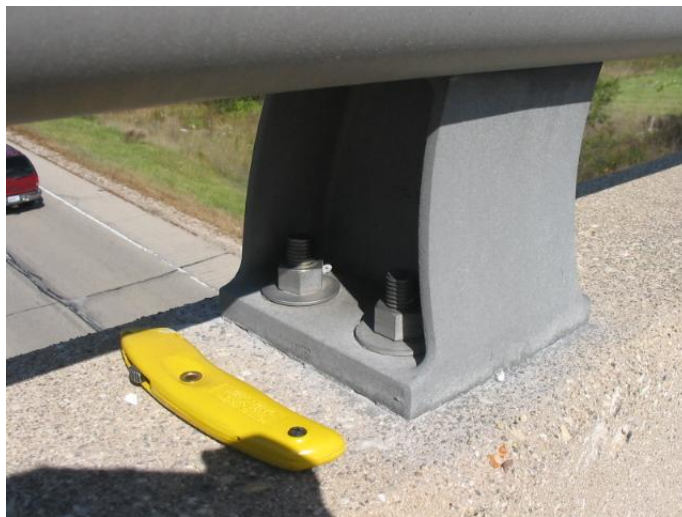
RMT, Inc., conducted an asbestos survey of the above-referenced bridge on October 7, 2009. The bridge located at USH 12 over Sheridan Spring Road, Walworth County was identified, sampled, and laboratory-analyzed as potentially asbestos-containing material (ACM). The gray pad in the guardrail tested positive for asbestos.

As indicated in the attached table, gray pad, located in the guardrail, contains 2% category II non-friable asbestos.

Pad in Guardrail Support (7" long x 1/4" wide chisel)

If the ACM will be disturbed during the painting, the ACM must be removed prior to the painting of the existing bridge. Standard Special Provision (STSP) 203-005 requiring the abatement of the ACM under the bridge construction contract and bid item 203.0210.s. should be incorporated into the plans.

If the ACM will not be disturbed during the painting, STSP 107-120 should be included in the plans.

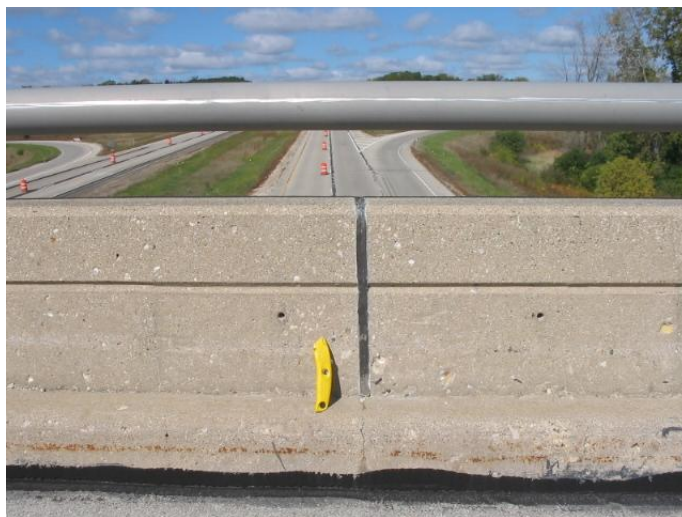
Caulk in Parapet Expansion joint (7" long x 1/4" wide chisel)
