Subject: Asbestos Survey
Structure Name/Location: USH 12 over Como Creek, Walworth County
Structure Number: B-64-37
WisDOT ID Number: 1080-12-00

Executive Summary

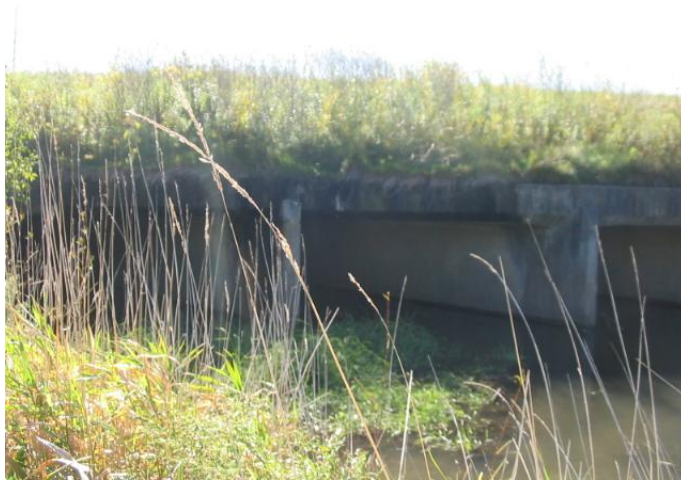
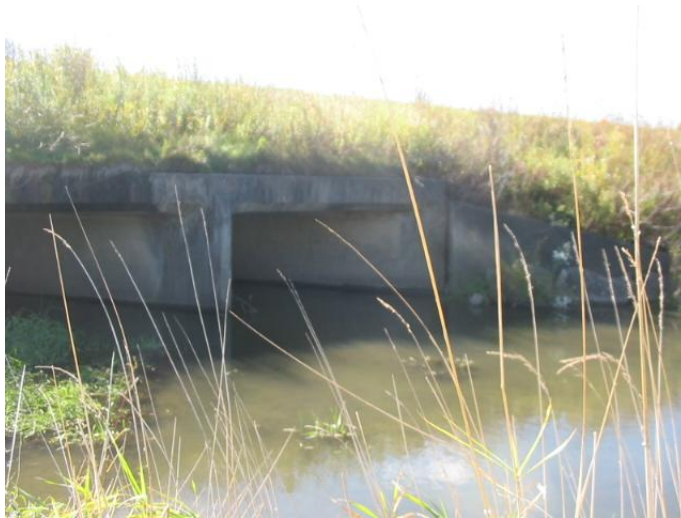
B-64-37

A visual walkover of the surface and underside of the bridge was performed, at which time no potentially asbestos-containing materials were identified. Since no material was identified as potentially contained asbestos, no samples were collected.

No ACM is present on the structure; therefore, the wingwall replacement of the existing bridge can proceed as planned. Standard Special Provision (STSP) 107-125 should be included into the plans.
