Subject: Asbestos Survey
Structure Name/Location: USH 12 over Como Creek WB, Walworth County
Structure Number: B-64-38
WisDOT ID Number: 1080-12-00

Executive Summary

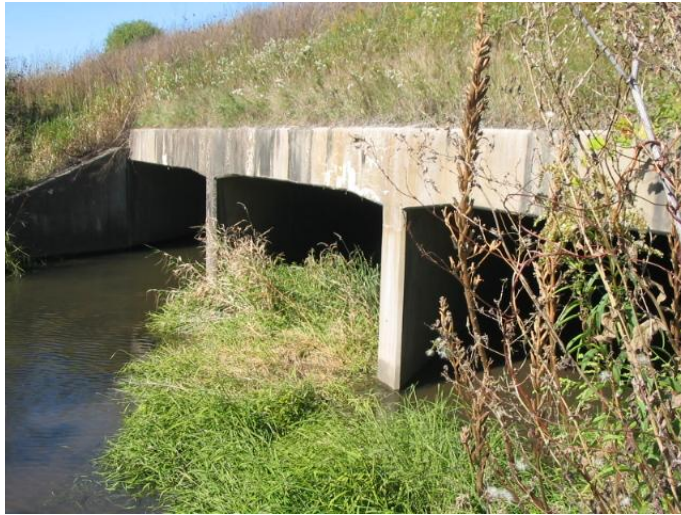
B-64-38

A visual walkover of the surface and underside of the bridge was performed, at which time no potentially asbestos-containing materials were identified. Since no material was identified as potentially contained asbestos, no samples were collected.

No ACM is present on the structure; therefore, the wingwall replacement of the existing bridge can proceed as planned. Standard Special Provision (STSP) 107-125 should be included into the plans.
