Subject: Asbestos Survey
Structure Name/Location: USH 12 over Jackson Creek, Walworth County
Structure Number: B-64-61
WisDOT ID Number: 1080-12-00

Executive Summary

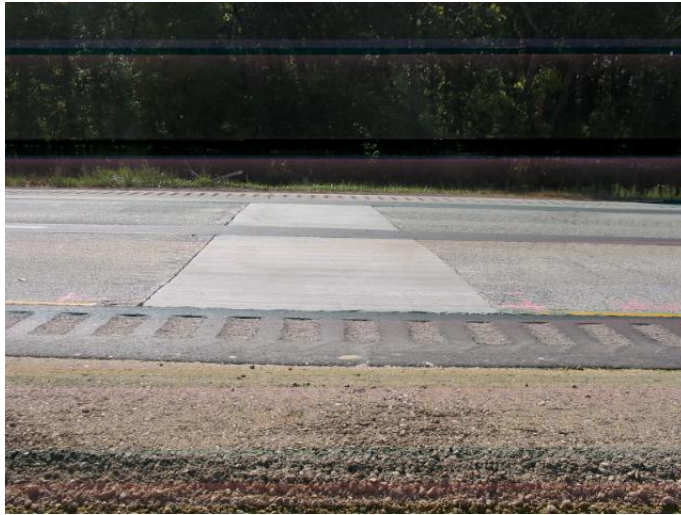
B-64-61

A visual walkover of the surface and underside of the bridge was performed, at which time no potentially asbestos-containing materials were identified. Since no material was identified as potentially contained asbestos, no samples were collected.
