APPENDIX G – STRUCTURAL ANALYSIS

The purpose of this Appendix is to provide information regarding the current status and the anticipated future conditions for all structures on the WIS 441 corridor.

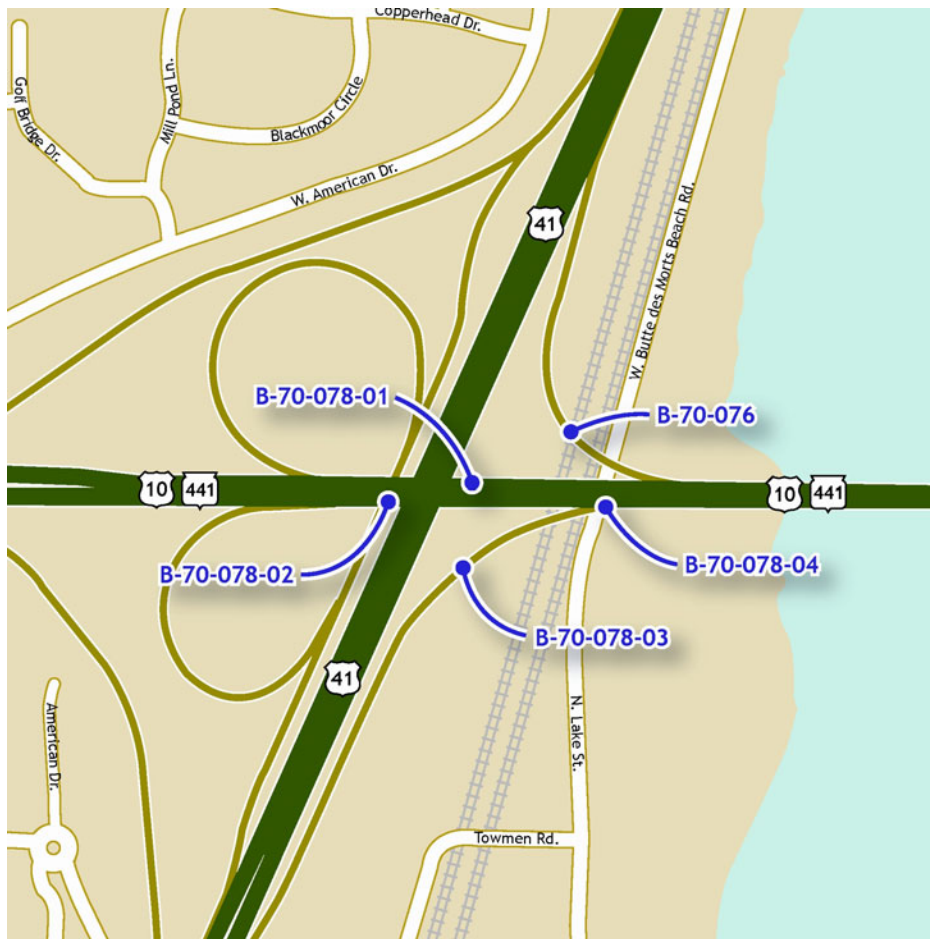
Figure 1: US 41 and US 10/WIS 441 Bridge Numbering

The southbound WIS 441 Bridge over Butte des Morts Beach Road (B-70-078-01) is anticipated to have an NBI substructure rating of 4 near the year 2035. The pack rust value is anticipated to reach a 4 and the underside of the concrete deck is predicted to have a rating of 3. Since the bridge is predicted to have these three “poor” ratings and its age will reach 60 years old, it is recommended that this bridge be replaced.

Because B-70-078-01 is recommended for replacement, it is also recommended that B-70-078-02 and B-70-08-04 be considered for replacement. This is justified because B-70-078-02 is a twin structure to B-70-078-01 and when one structure is replaced it is recommended its twin receive similar treatment. B-70-078-04 is also of the same vintage and same structure system being the link from the northbound US 41 ramp to northbound US 10/WIS 441 mainline (For bridge numbering clarification see **Figure 1**). Since these structures are all part of one similar structure system and have similar faults, they are all recommended to be replaced at or near the same time.

The ramp from northbound US 41 to northbound US 10/WIS 441 (B-70-078-03) does not need immediate replacement when the other three bridges in the B-70-078 series are replaced (it is not considered a “twin”). B-70-078-03 does however have deficiencies that should be addressed at or near 2035. It is predicted to have an HSI deck rating of 3 as well as an underside concrete deck rating of 3. Due to both of these contributing ratings along with the structure’s age and use of uncoated bars, it is recommended that the deck be replaced.
