**STATE OF WISCONSIN
DEPARTMENT OF TRANSPORTATION**

**Inspection Report for
C-13-2023**

**STH 89 over BR OF MUD CREEK
May 23, 2019**

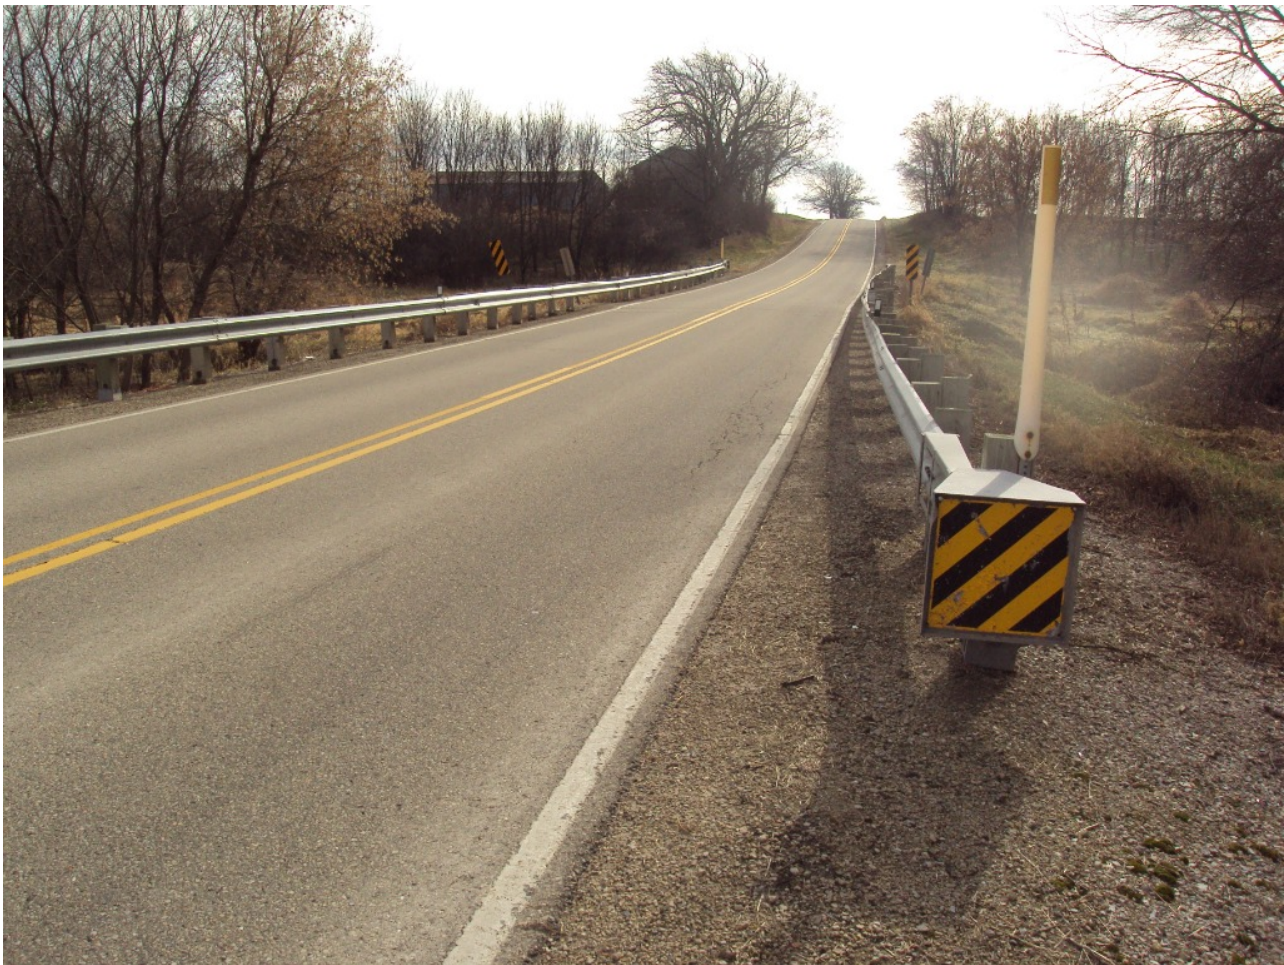
Culvert
Document Comment/Description
Roadway over Structure

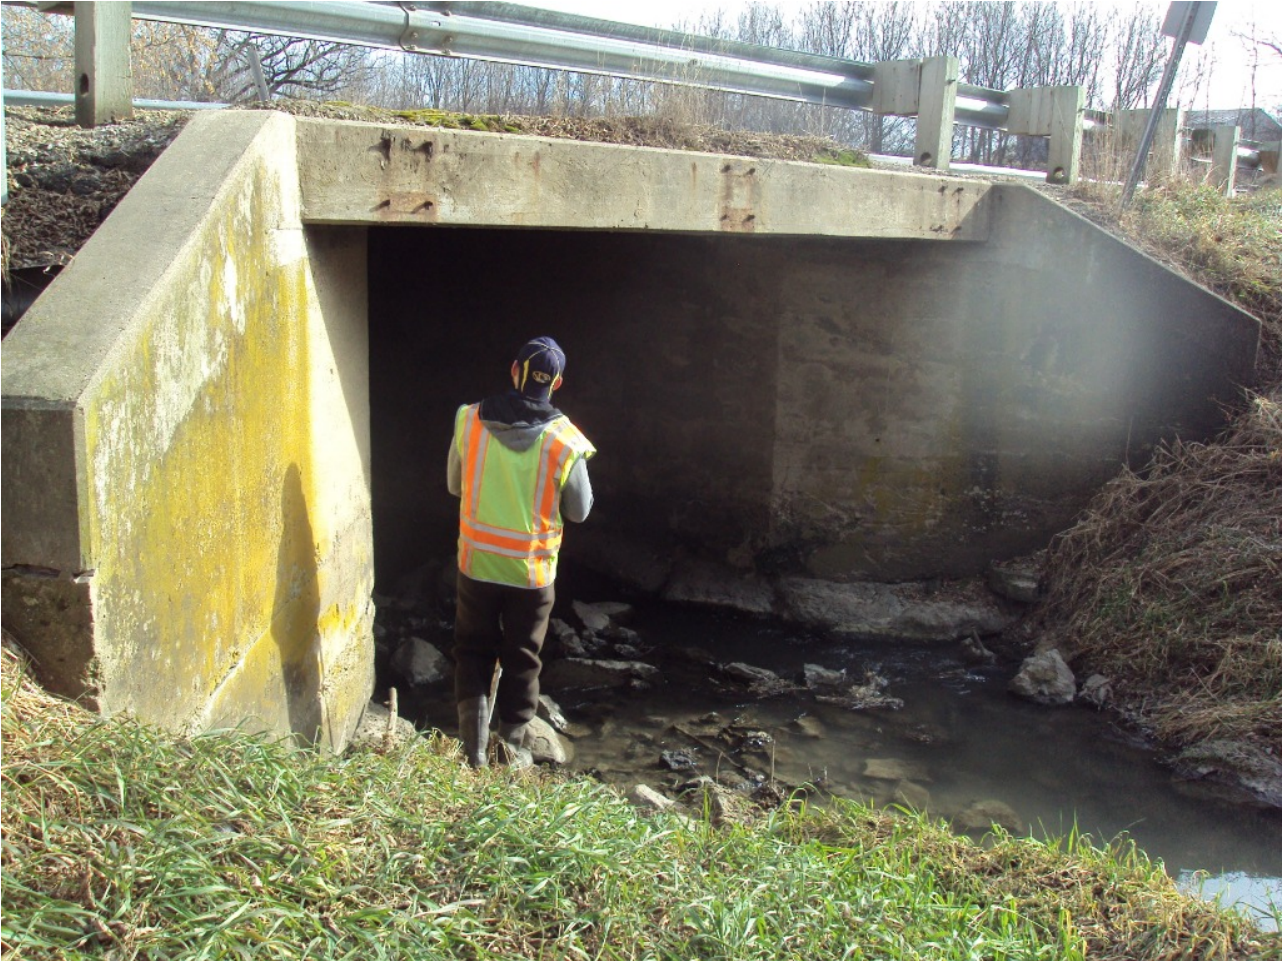
West end of Structure.

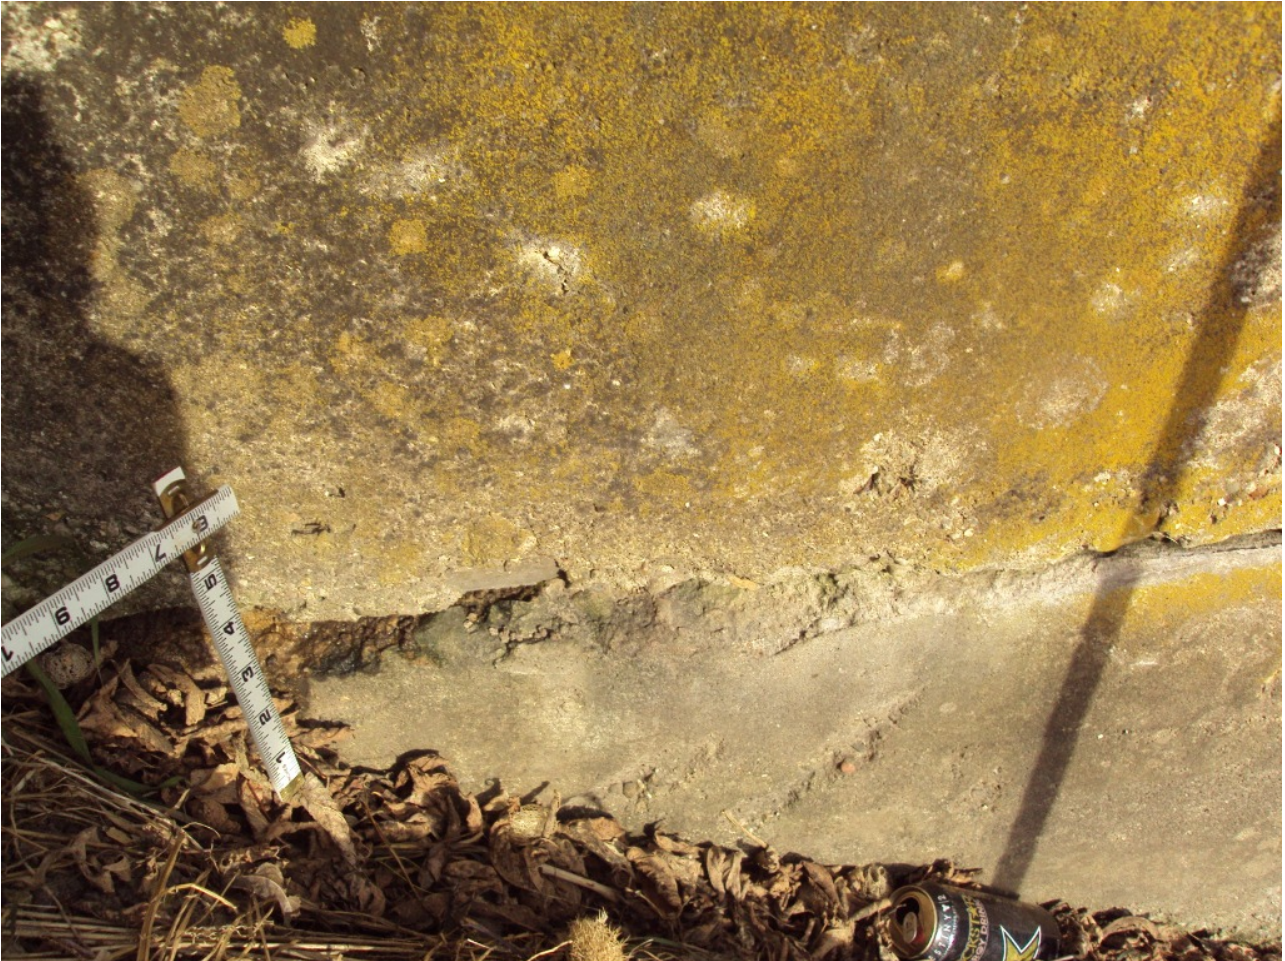
Scour	LF		0	0	48	20
		6000	South abutment undermined up to 1'0" under footing for 2/3 of width of structure. Cannot tell, but there does not appear to be piling, so the assumption is this is a spread footing. North abutment has footing exposed						
			Slight undermining of North Abutment, about 3-6 in						
X	330		Metal Bridge Rail	LF	22	22	0	0	0
			Continuous Beamguard over bridge (Not connected to structure). One block broken on NW side (off bridge). Some deformations (pack rust) of beamguard, but is performing its intended function.						
X	8400		Integral Wingwall	EA	4	0	2	2	0
			Erosion behind upstream wingwall						
			Wall Deterioration	EA		0	2	2	0
		8903	Spalls at wing to abutment connections typical throughout. Large spalls in NE and SE Wings (see photos). Spall at end of NW wing near construction joint.

NW Wing Extension construction joint.

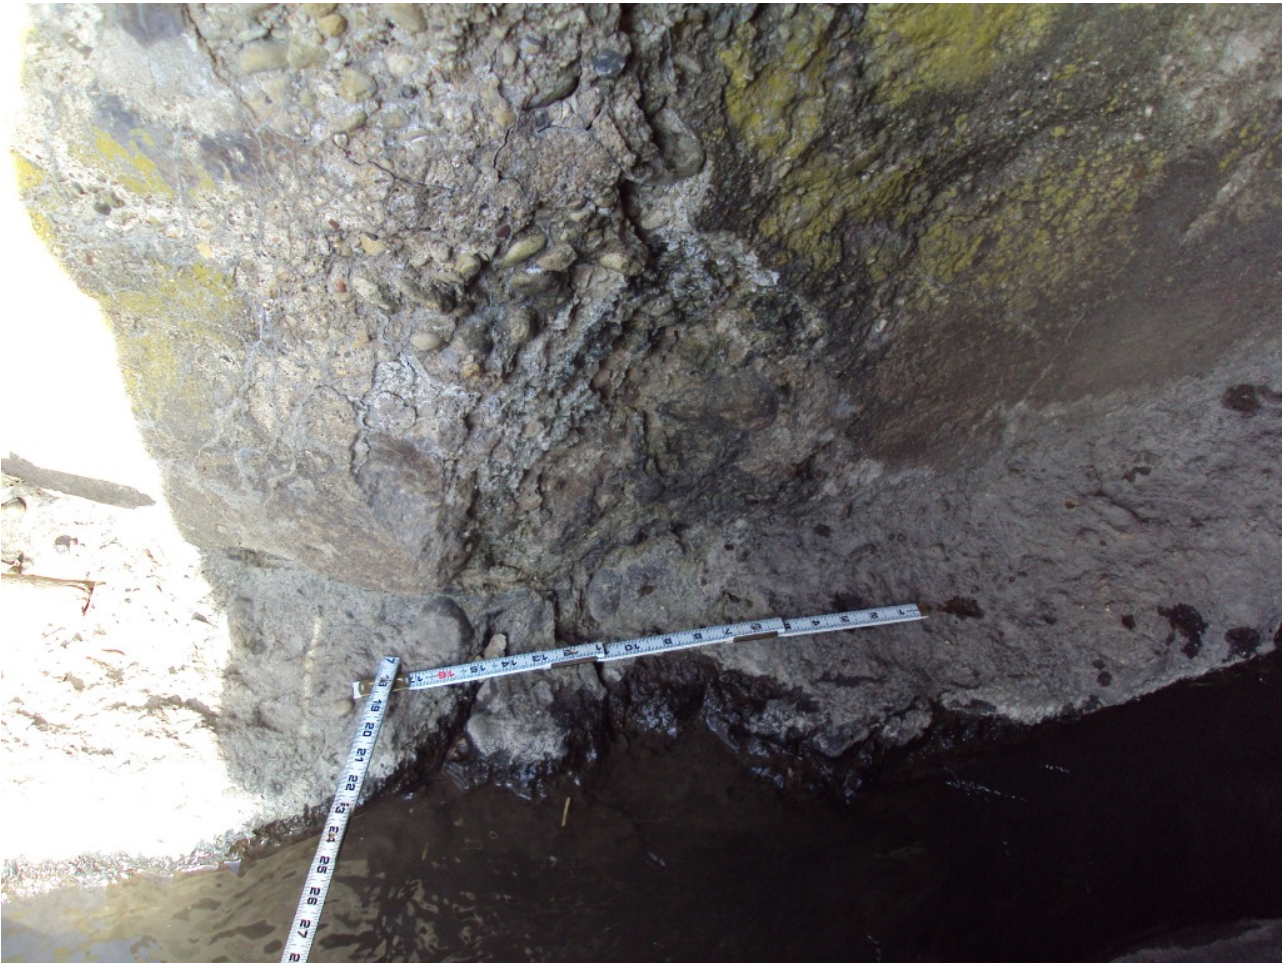
North Footing to NW wing interface with abrasions and spalls.

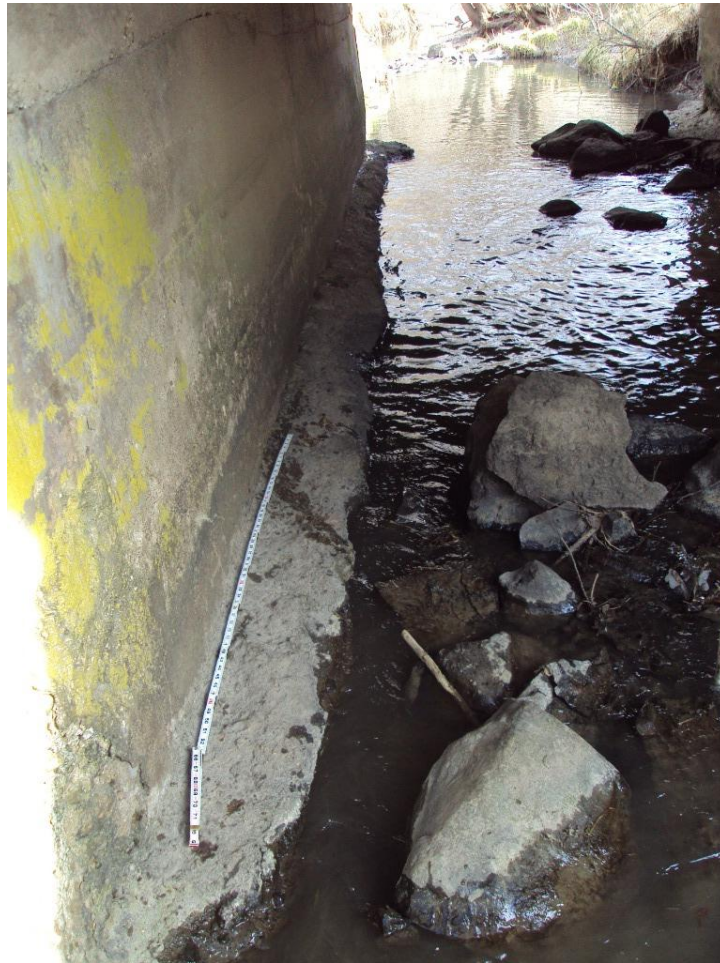
North Footing.

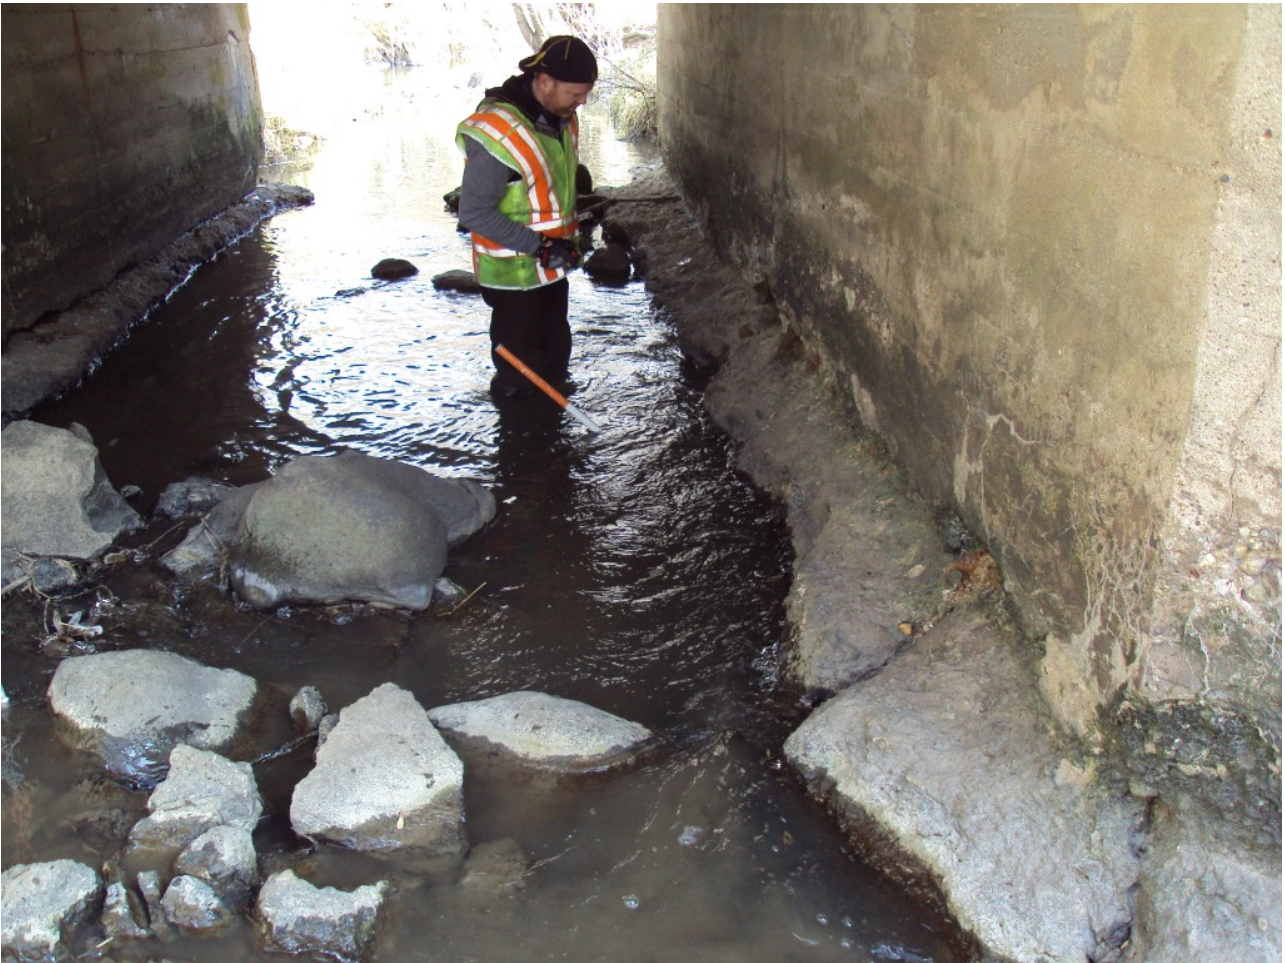
Scour hole forming under south abutment.

Scour evident under south abutment.

South Footing (undermined).

Item	Priority	Recommended by	Status	Status change
IMP-Structure Replacement	HIGH	Doocy, Steve (9028)	IDENTIFIED	12/11/18
Recommend replacement.

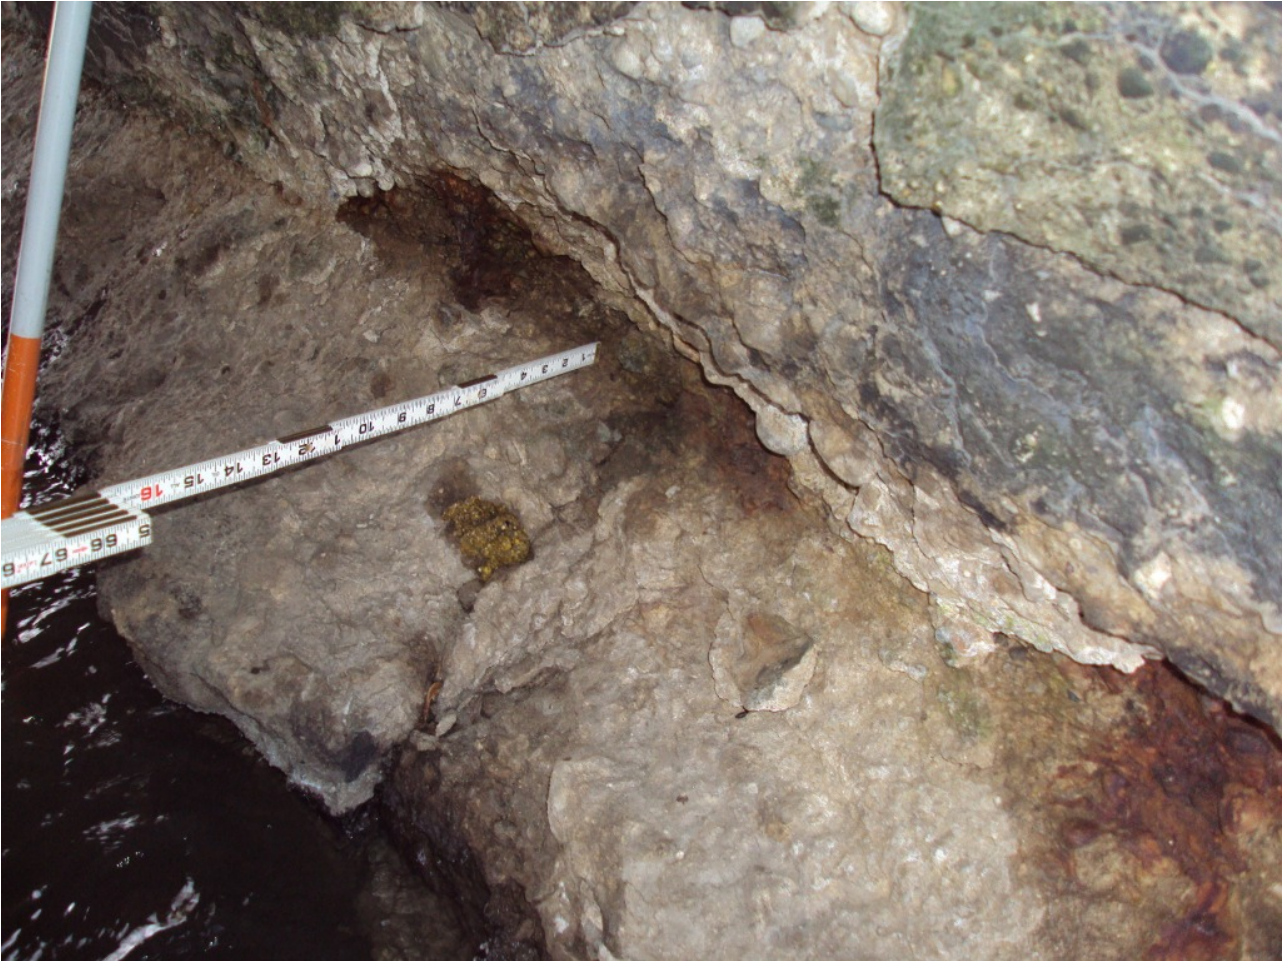
Typical cracks, abrasions, and deterioration of footing to abutment wall interface.

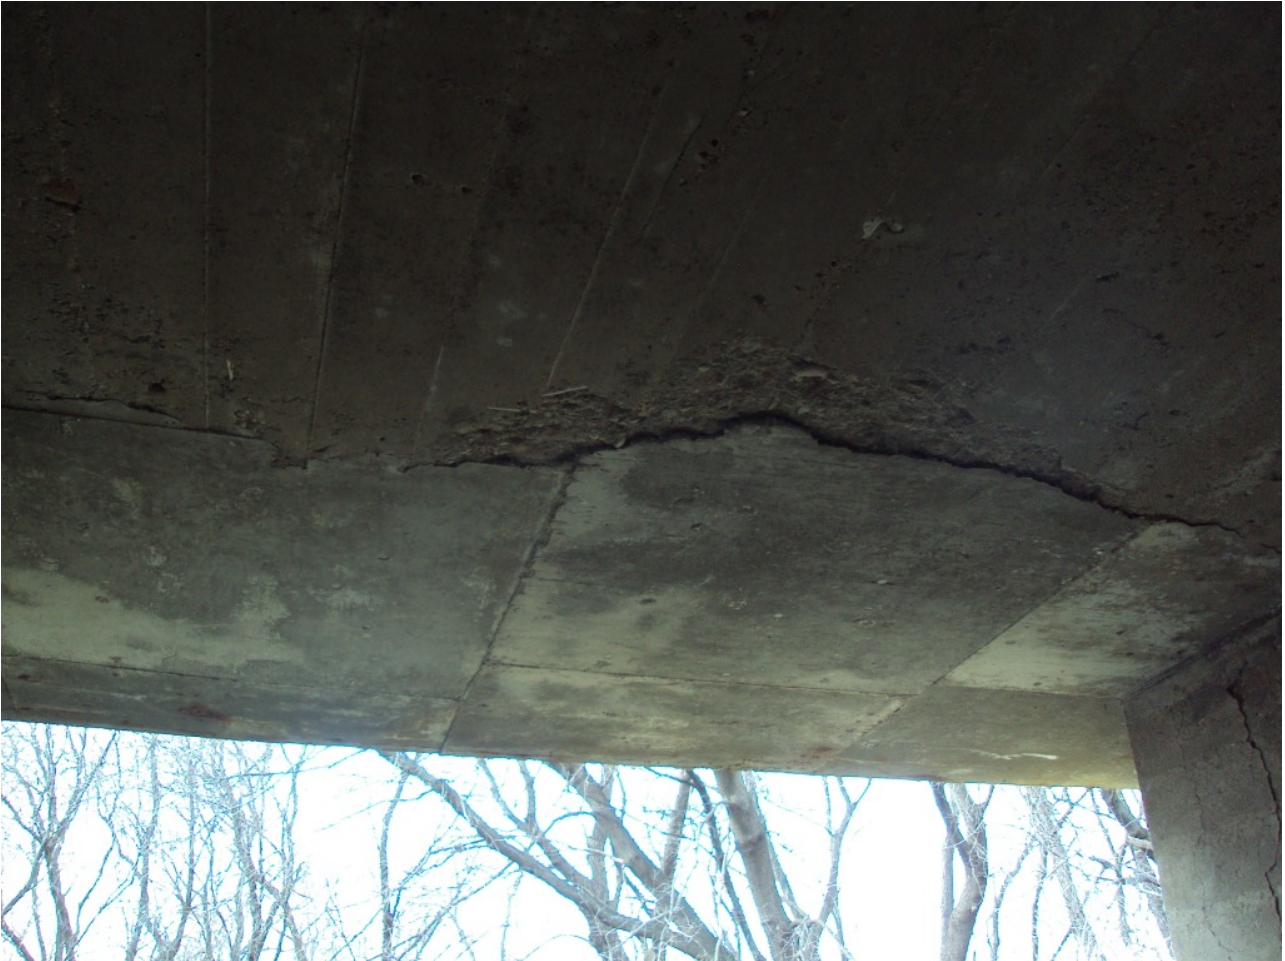
Spalls and delaminations of widened portion of slab

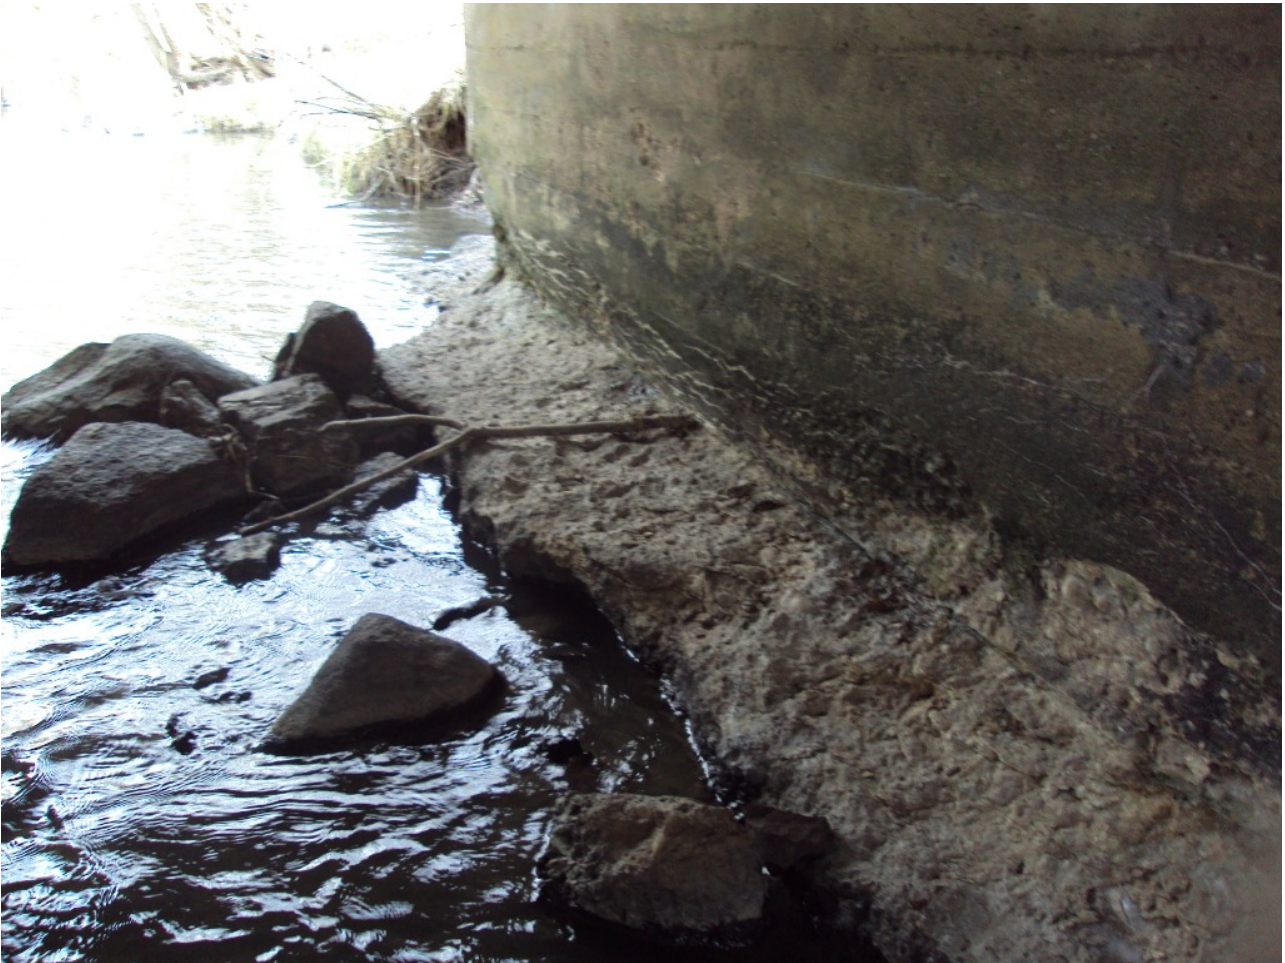
Typical footing

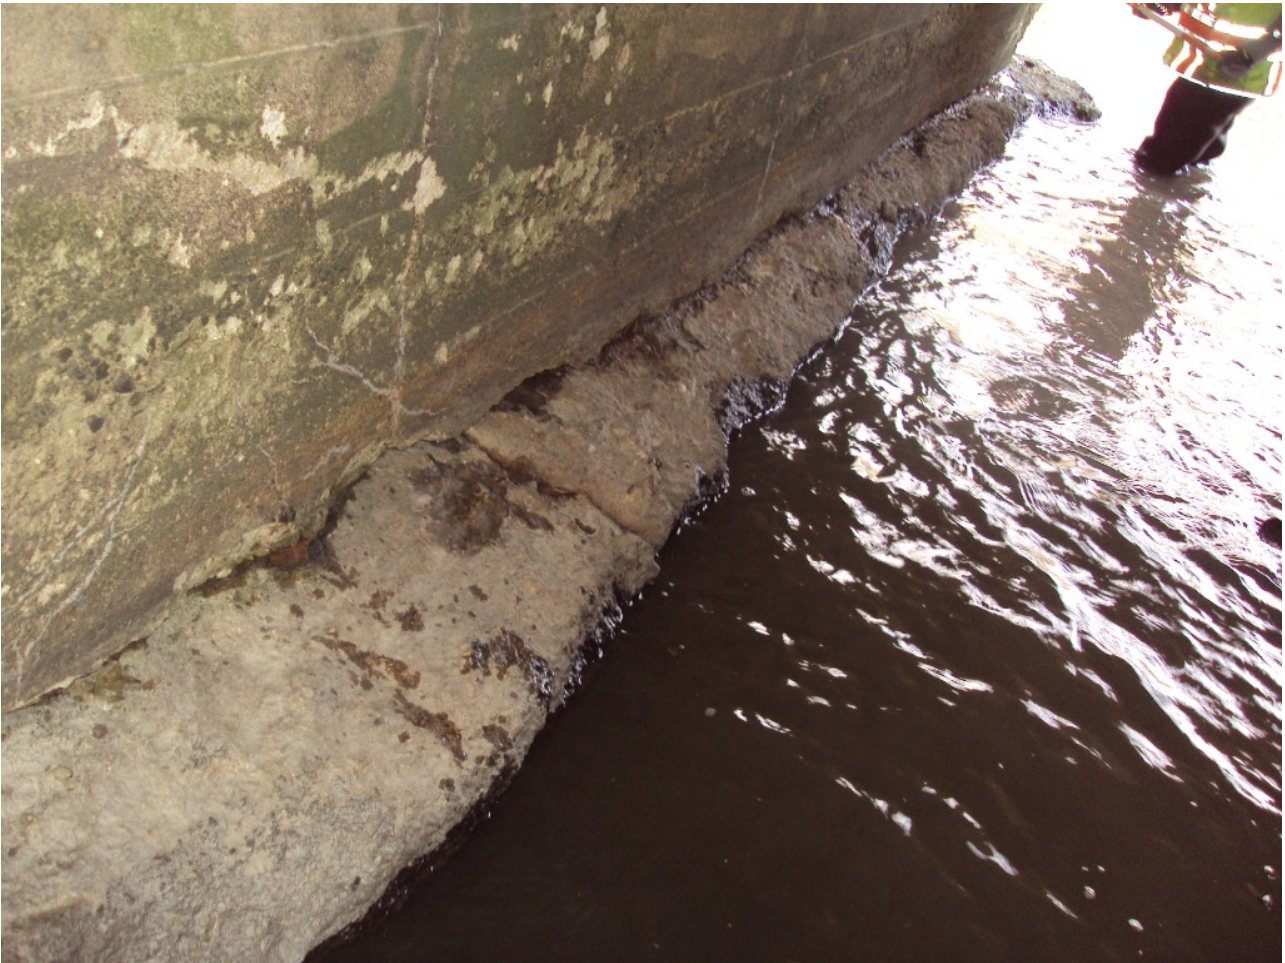
Typical Footing.

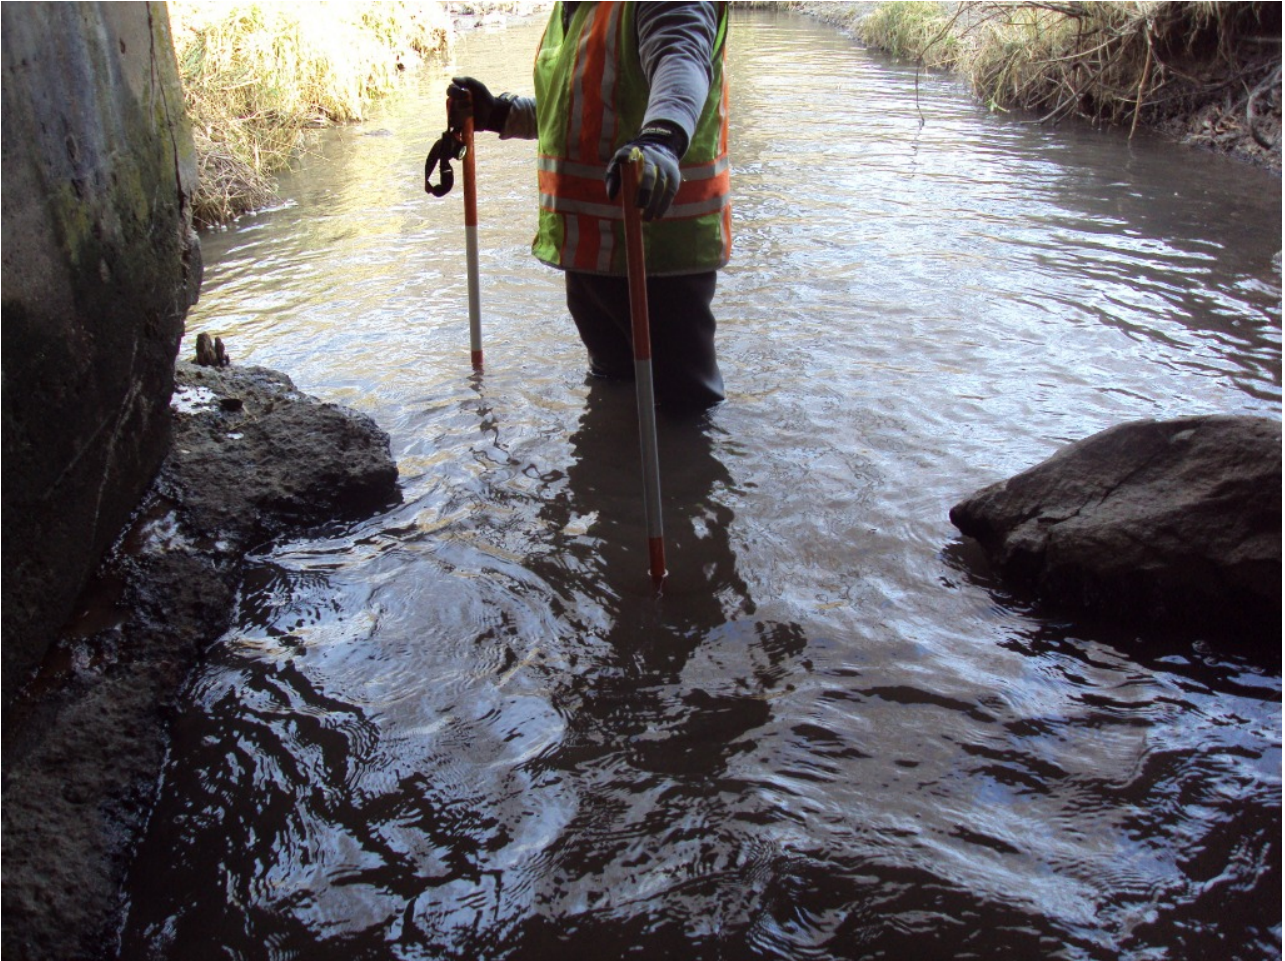
NE Corner of bridge.

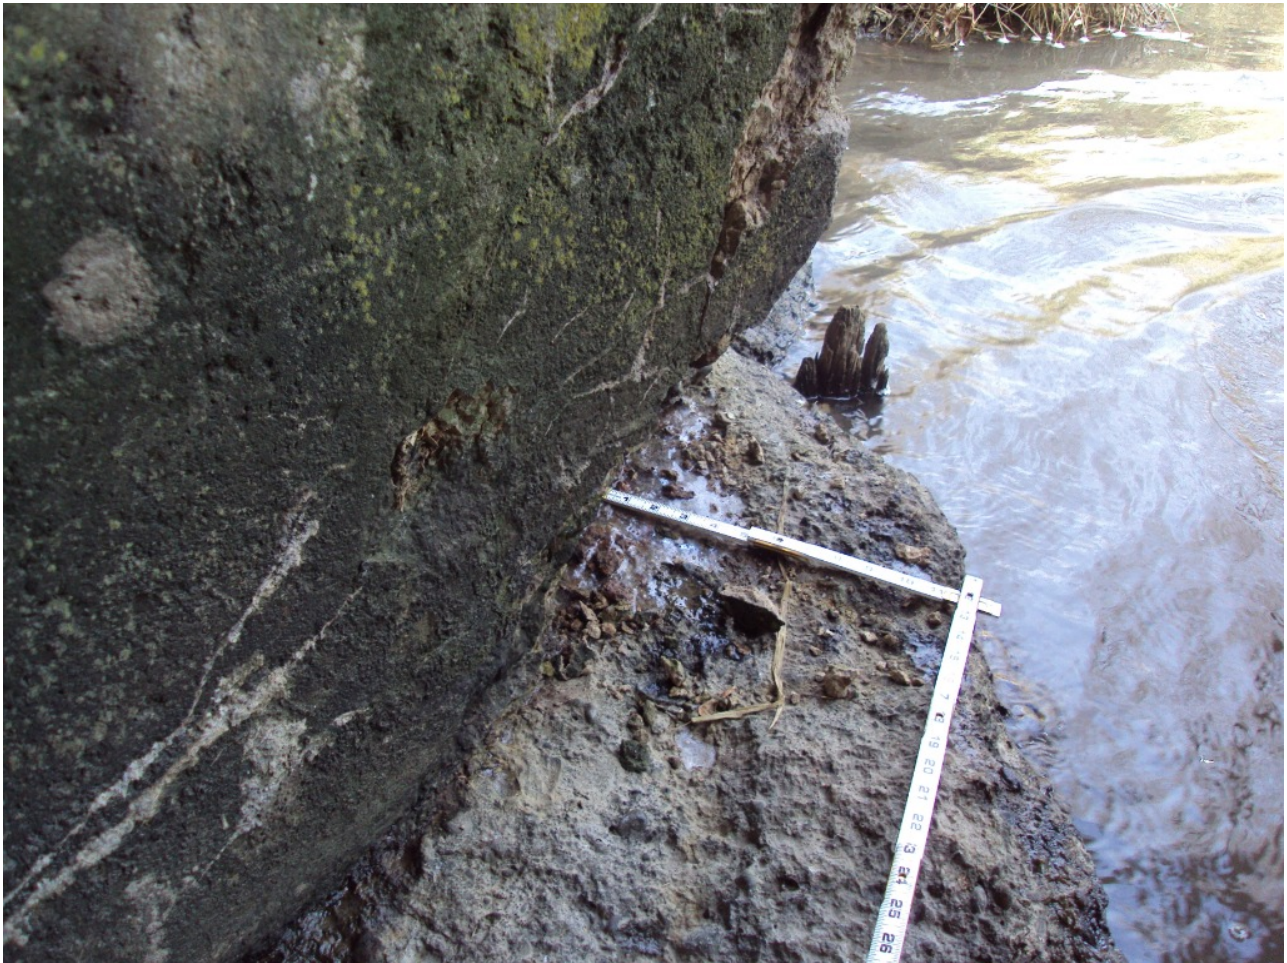
NE Wing to abutment interface

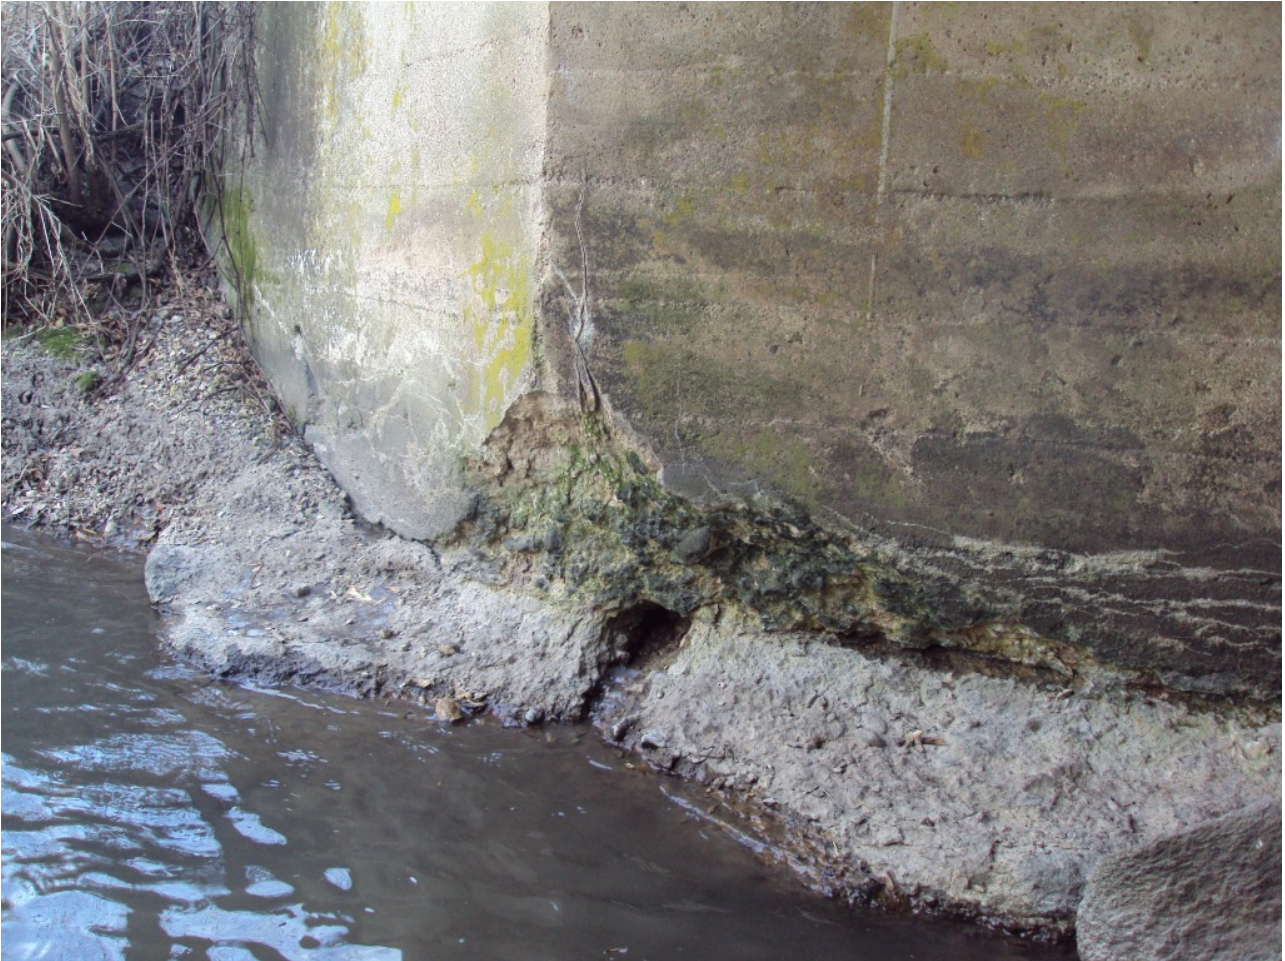
SE Wing to abutment interface.

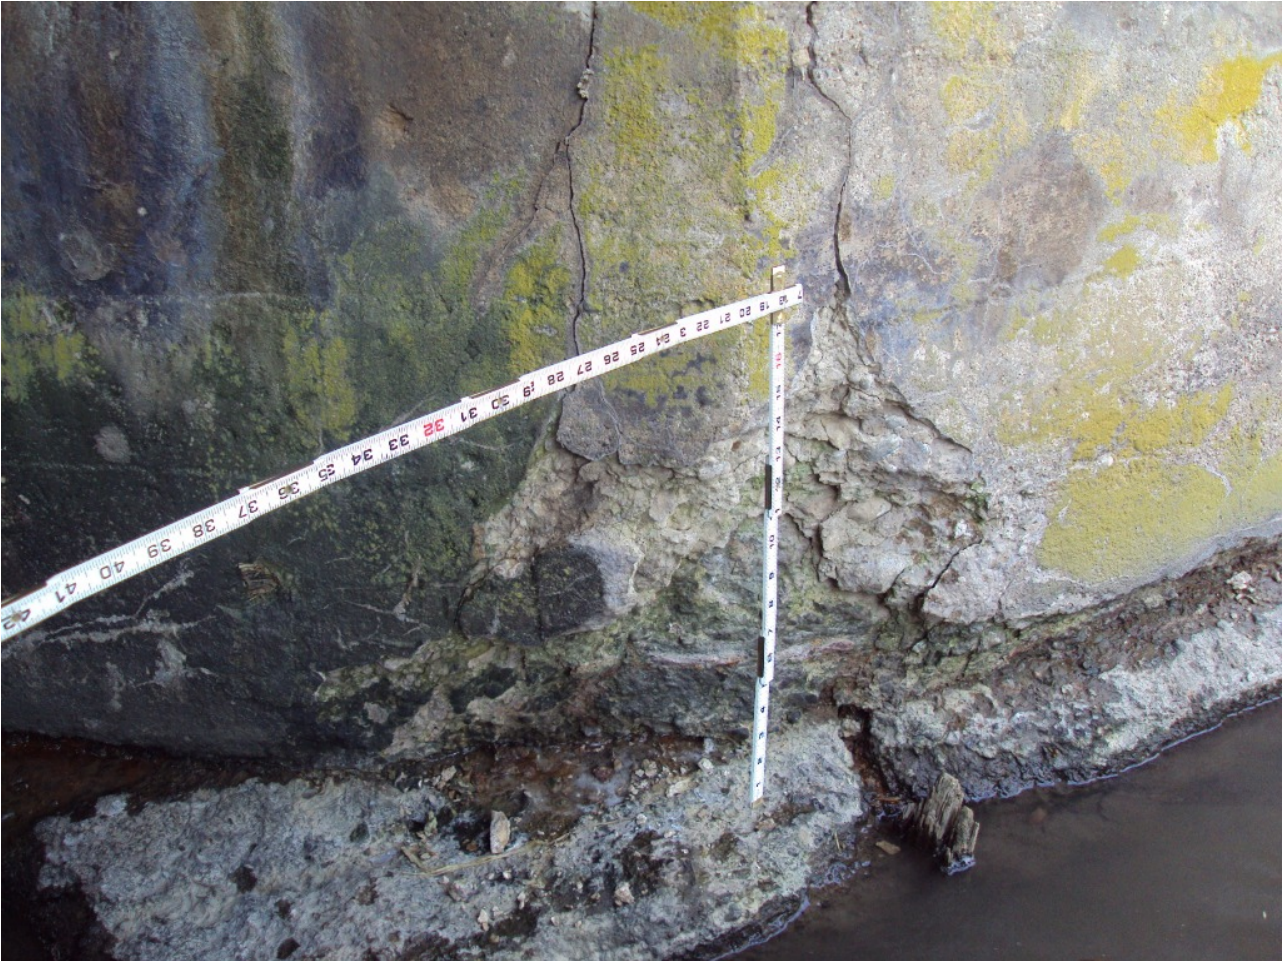
NE Wing to abutment interface.

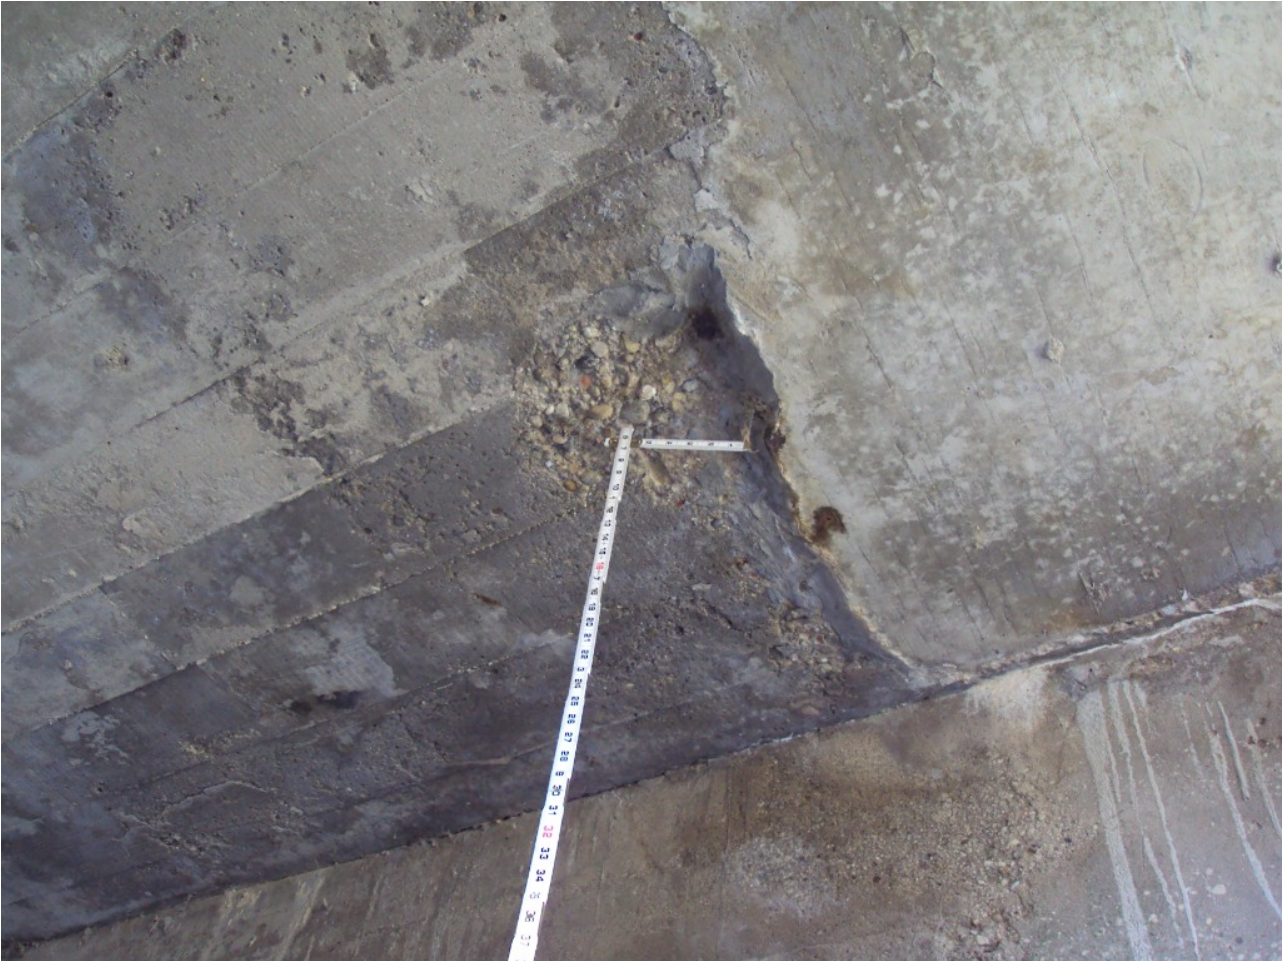
East side slab widening.

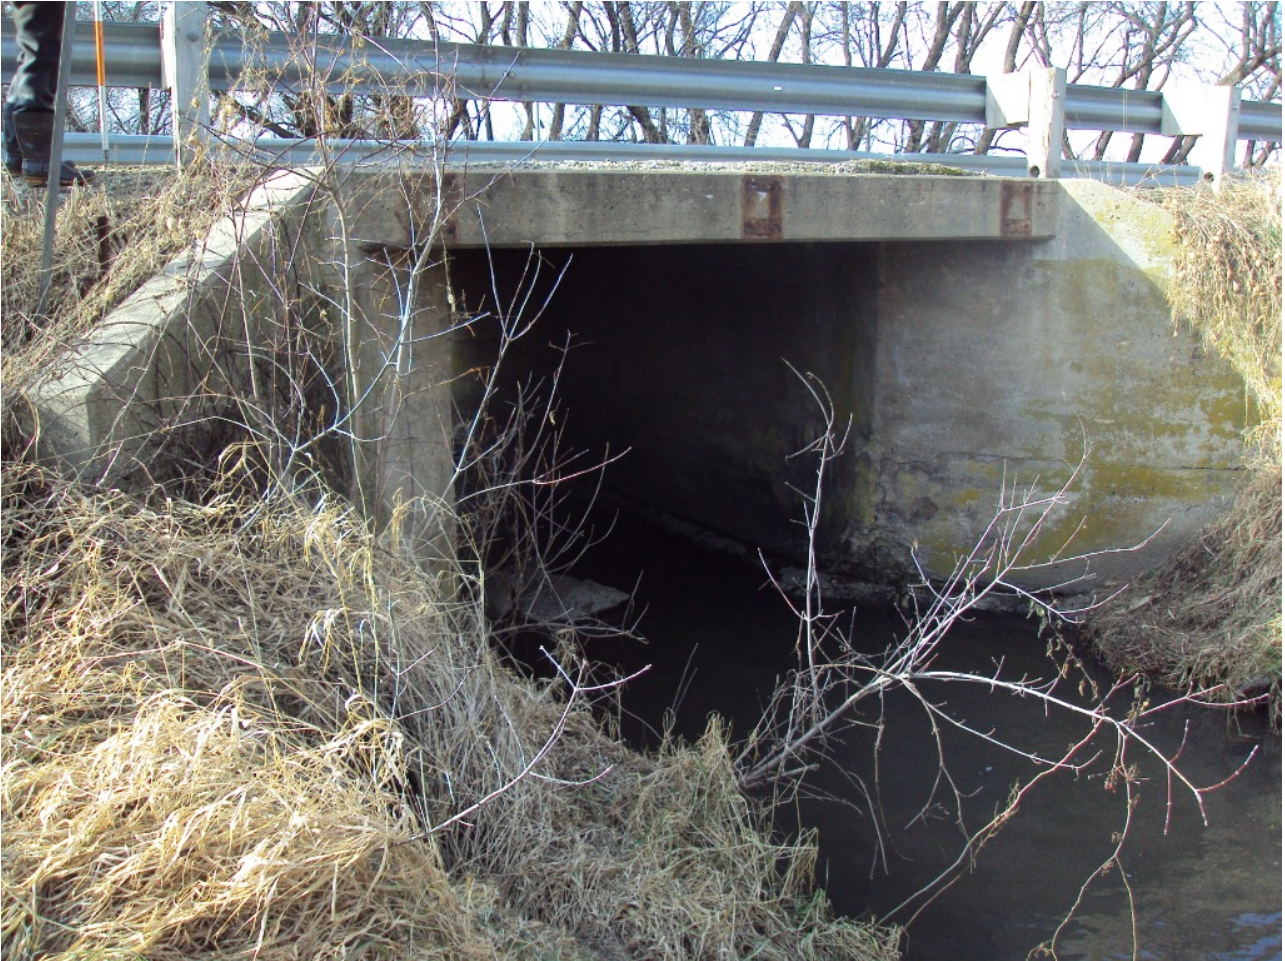
East end of bridge.

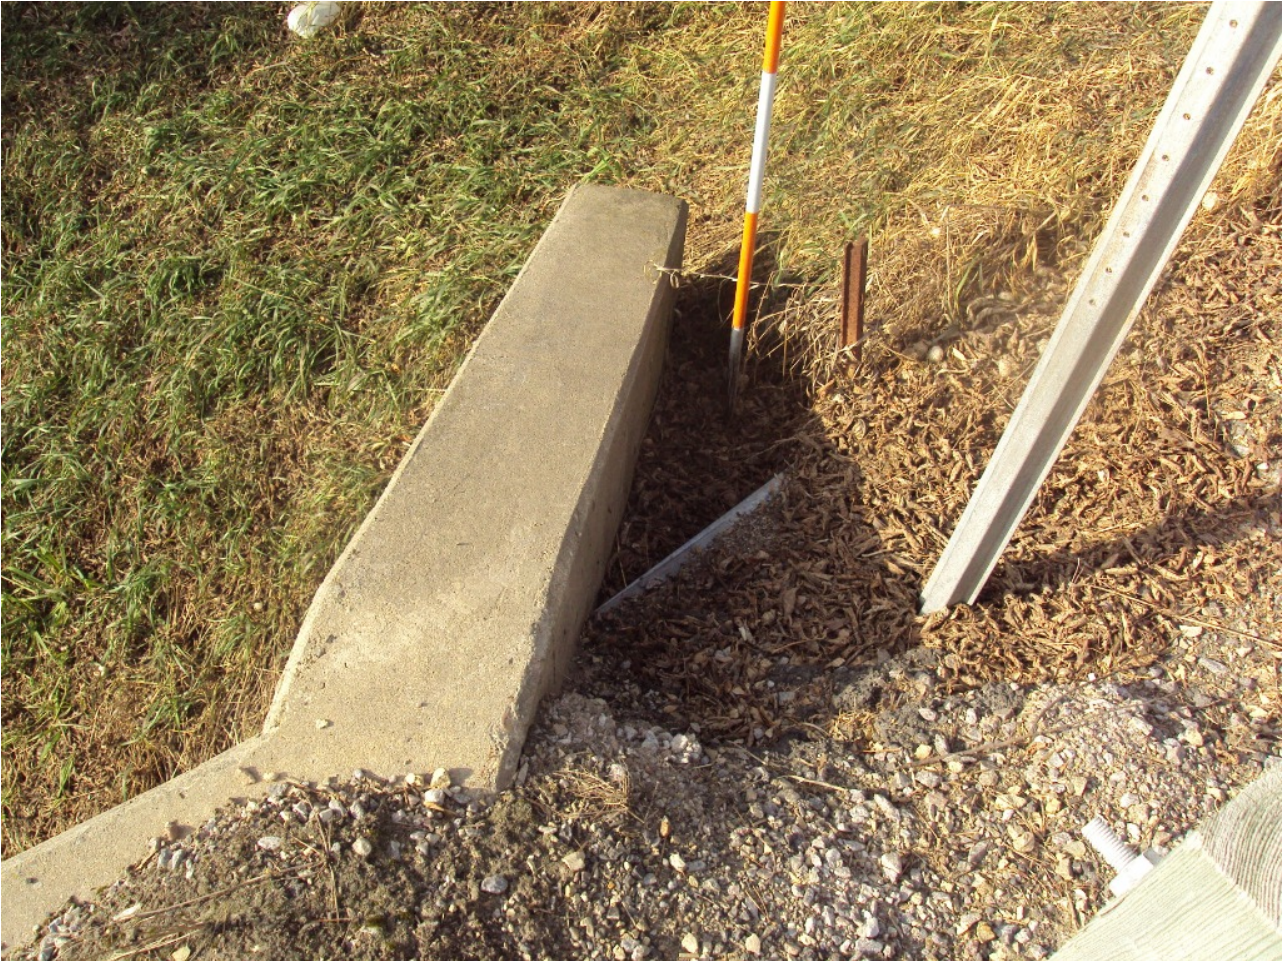
Chk	Element	Defect	Description	UOM	Total	Quantity in Condition State			
						1	2	3	4
X	9001		Drainage - Ends of Structure NW corner has some erosion behind wing.	EA	4	3	1	0	0
X	9030		Signs - Object Markers All but one marker needs re-adjustment; leaning away from roadway.	EA	4	1	0	3	0
X	9323		Approach Roadway - Asphalt Settled on North End.	EA	2	1	1	0	0

NW Wing erosion

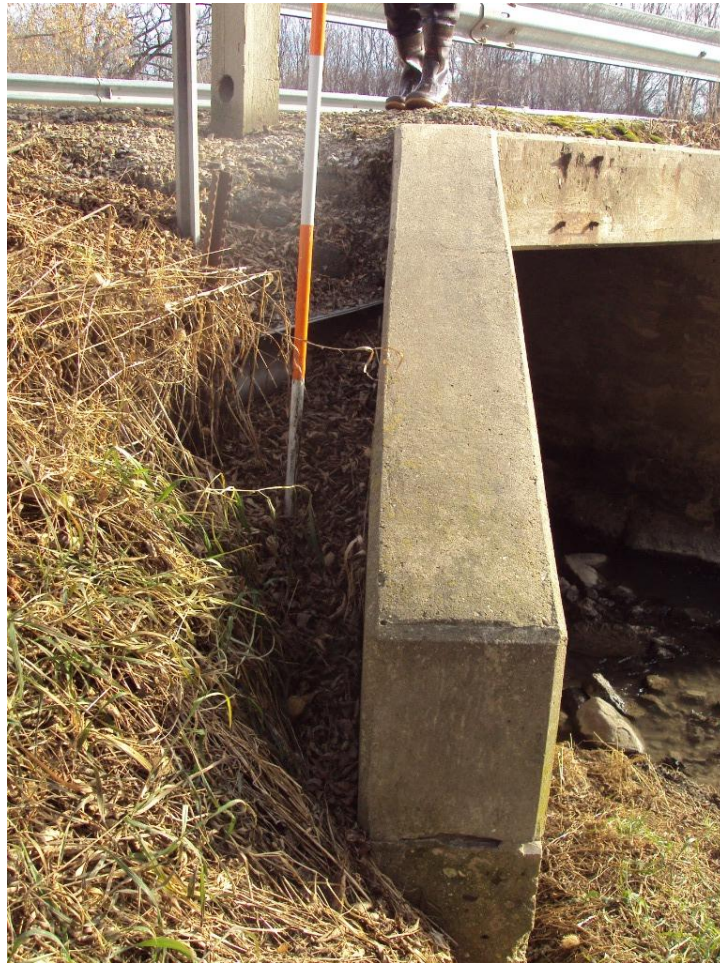
NW Wing erosion.
