WisDOT Project 1133-10-00
 Structure B-05-0064
 US HWY 41 southbound
 over Velp Avenue
 Brown County, Wisconsin
 Inspected 8-10-07
 Jeffrey S. Carlson, Inspector
 License # All-3420
 STS Consultants, LTD

WisDOT Project 1133-10-00
 Structure B-05-0064
 US HWY 41 Southbound over Velp Avenue
 Brown County, WI

August 20, 2007

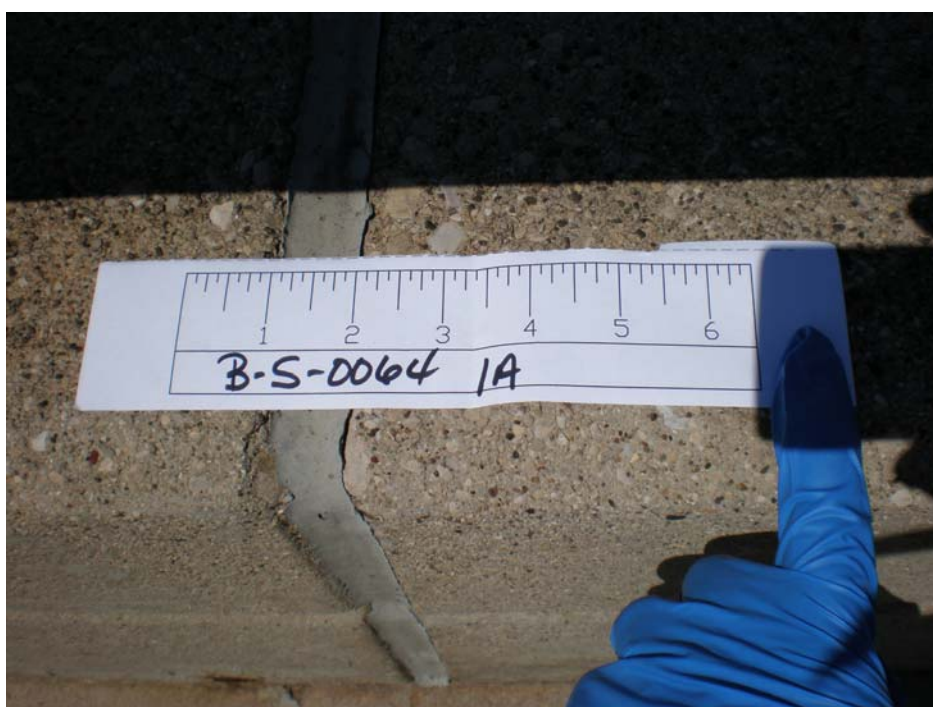
Gray caulk located on the parapet wall joint of Structure B-05-0064.

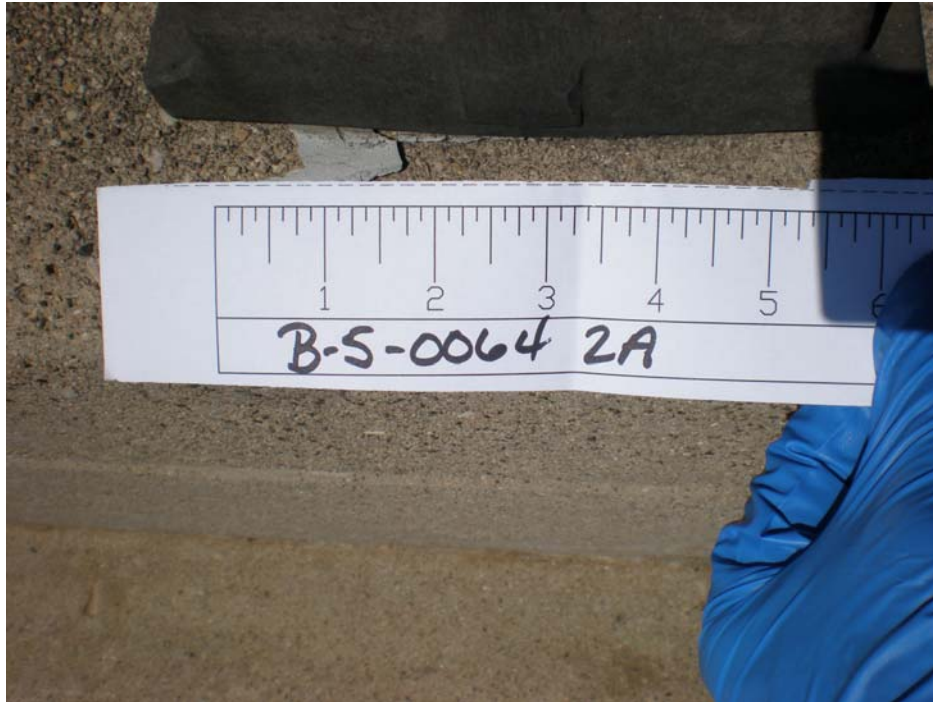
Bulk Sample(s) B-05-0064 – 2A – 2C, guard rail base plate gasket material, also located on the north and south sides of the structure between the guard rail post base and the top of the parapet wall of the structure contain 2% chrysotile asbestos. The material is damaged and is considered friable asbestos containing material.

Guard rail base plate gasket material located on the parapet walls of Structure B-05-0064.

Because the identified caulking (good condition) and gasket material (poor condition) could become comingled in demolition debris the material is regulated and should be removed prior to disturbance.

Because the structure is scheduled for replacement and the material will likely be disturbed, Standard Special Provision (STSP) 203-005 requiring the abatement of the ACM under the bridge construction contract bid item 203.0210.s. should be incorporated into the Special Provision.

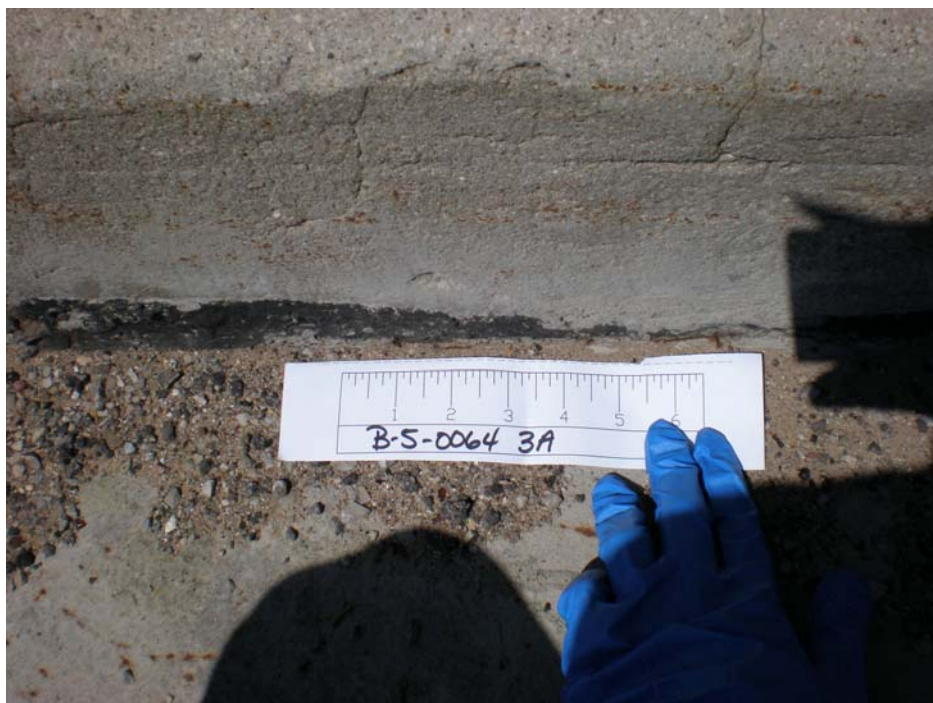
Black tar located on the deck of Structure B-05-0064.

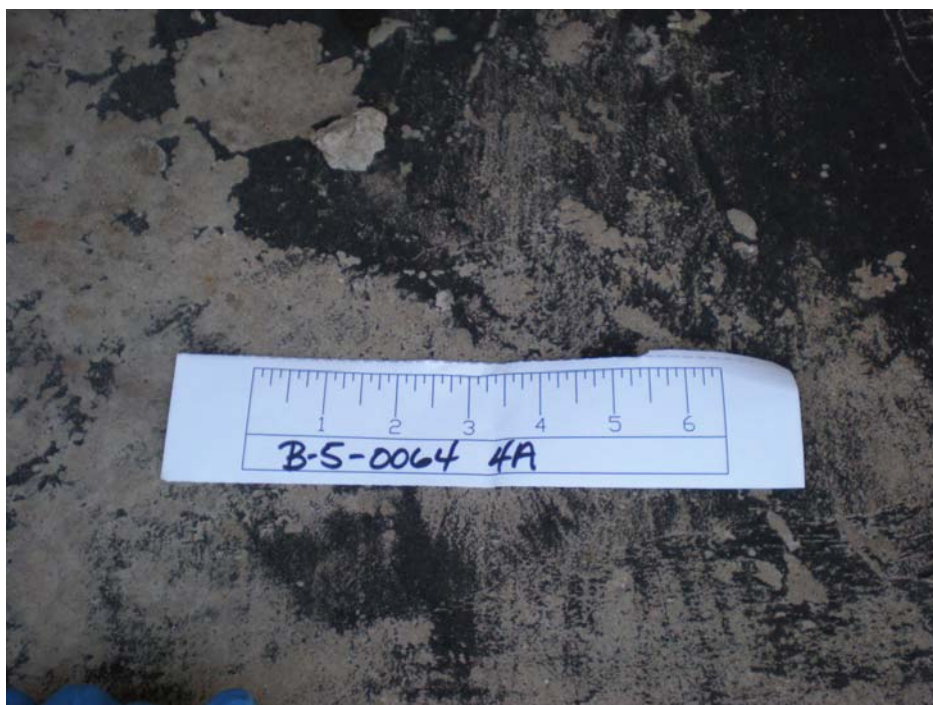
Black paint/tar located on the underside of Structure B-05-0064.

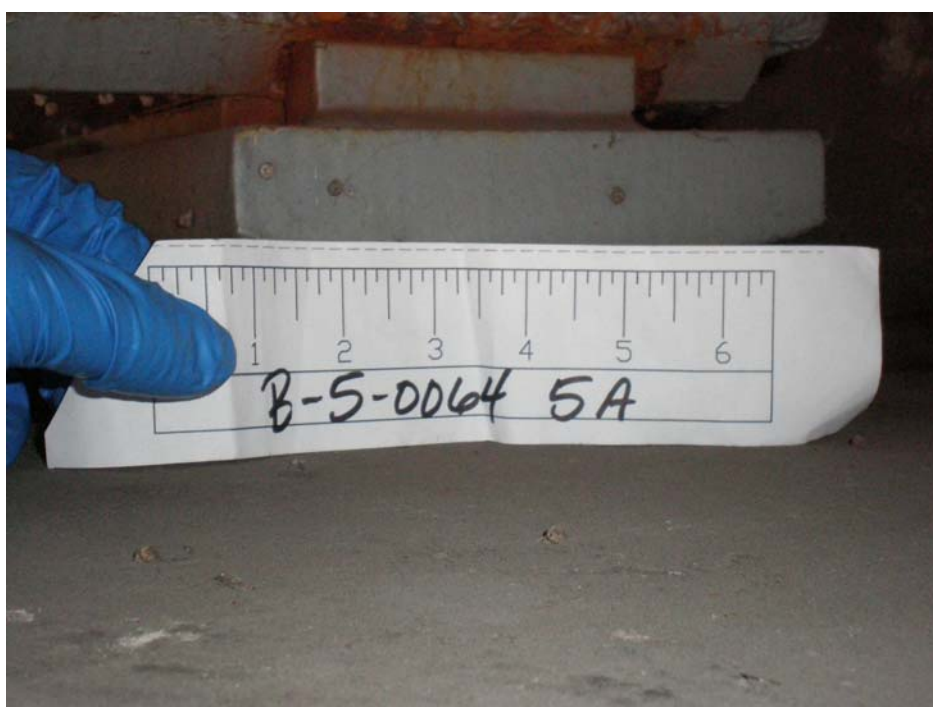
Silver paint located on the underside of Structure B-05-0064.

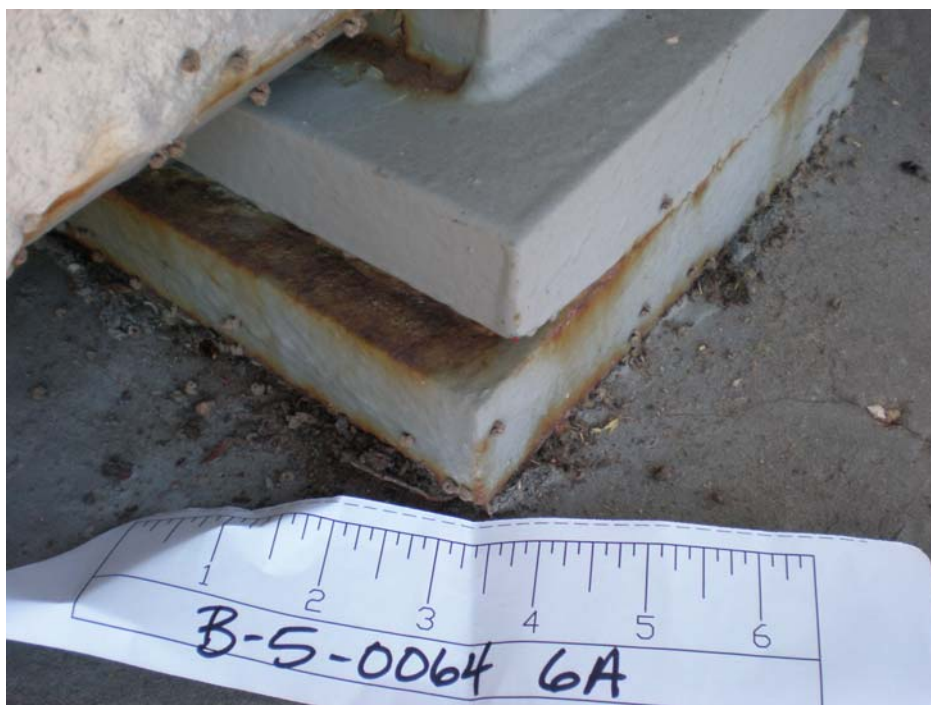
Brown fibrous gasket located beneath bearing pad under structure B-05-0064.

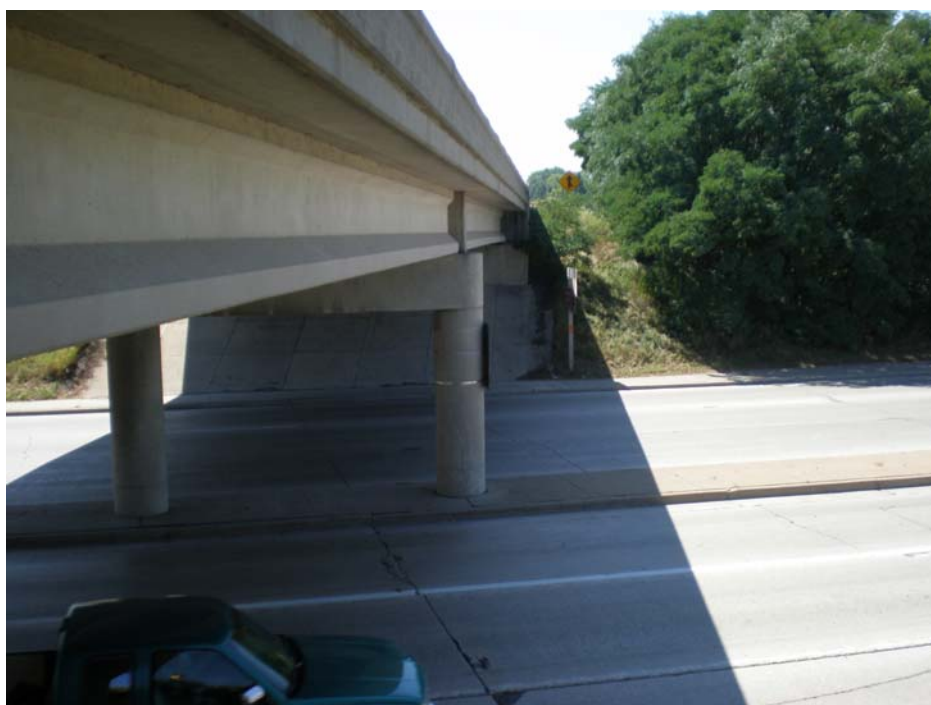
Looking to the south at the west side of Structure B-05-0064.

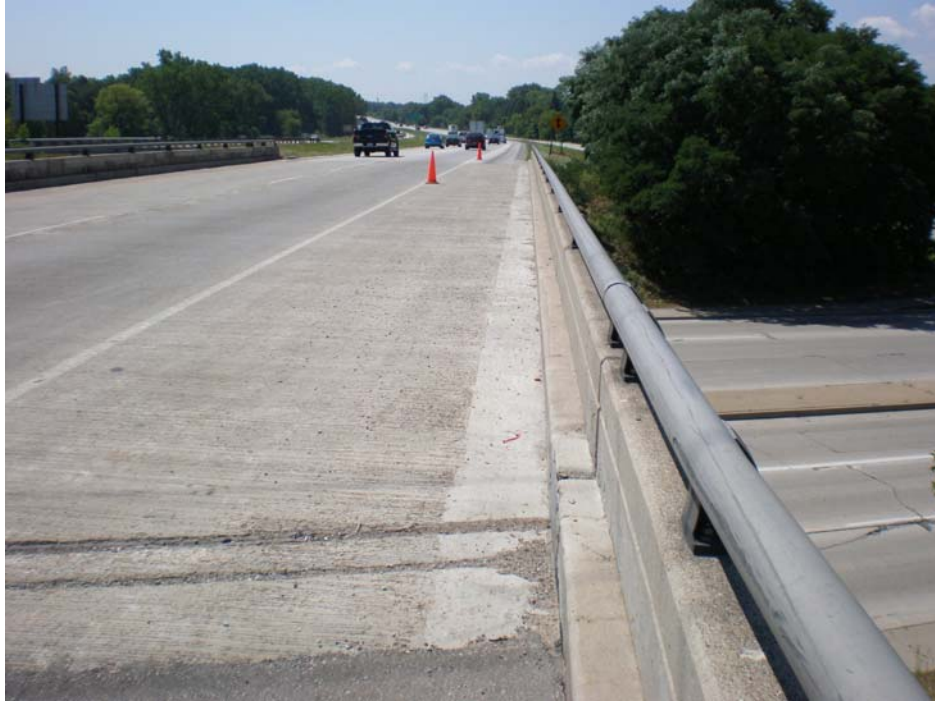
Looking to the south at Structure B-05-0064.
