WisDOT Project 1133-10-00 Structure B-05-0065 Northbound USH 41 over Velp Avenue Brown County, Wisconsin Inspected 8-8-07 Jeffrey S. Carlson, Inspector License # All-3420 STS Consultants, LTD

WisDOT Project 1133-10-00 Structure B-05-0065 Northbound USH 41 over Velp Ave Brown County, WI

August 16, 2007

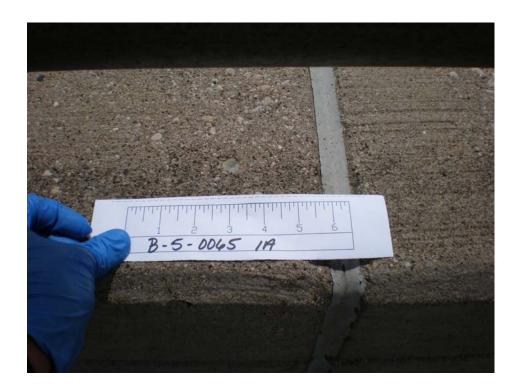
Gray parapet wall caulk located on Structure B-05-0065.

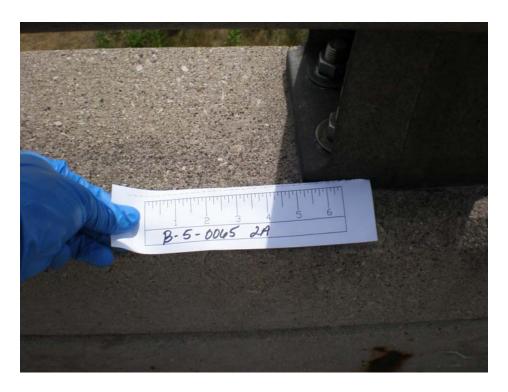
Because the identified gasket material was observed to be in poor condition and is friable, the material is regulated and should be removed prior to disturbance.

Bulk Sample(s) B-05-0065– 2A – 2C, gray gasket material, located on the east and west sides of the structure between the guard rail post base and the top of the parapet wall of the structure contain 2% chrysotile asbestos. The material is damaged and is considered friable asbestos containing material.

Guard rail base plate gasket located on the parapet wall of Structure B-05-0065.

Because the structure is scheduled for replacement and the material will likely be disturbed,

Standard Special Provision (STSP) 203-005 requiring the

abatement of the ACM under the bridge construction contract bid item 203.0210.s. should be incorporated into the Special Provision.

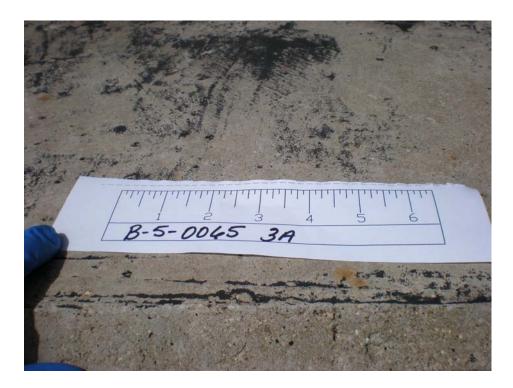
Black paint/tar located on the underside of Structure B-05-0065.

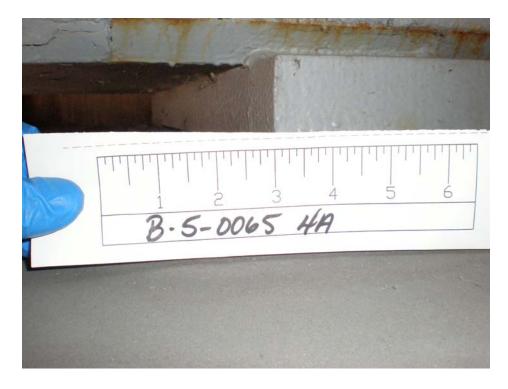
Silver paint located on the underside of Structure B-05-0065.

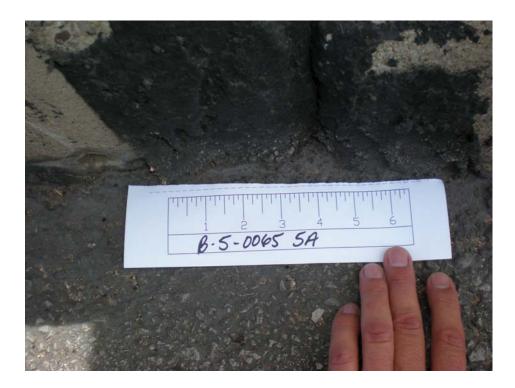
Black tar located on the deck of Structure B-05-0065.
