WisDOT Project 1133-10-00
 Structure B-05-0067
 Northbound USH 41
 over CN RR
 Brown County, Wisconsin
 Inspected 8-9-07
 Jeffrey S. Carlson, Inspector
 License # All-3420
 STS Consultants, LTD

WisDOT Project 1133-10-00
Structure B-05-0067
Northbound USH 41 over CN RR
Brown County, WI

On August 9, 2007, STS Consultants, Ltd. (STS) conducted a survey of suspected asbestos containing materials (ACM) at the structure located on the northbound lane of USH 41 spanning the CNW RR in Brown County, Wisconsin (B-05-0067). Mr. Jeffrey S. Carlson, Wisconsin Asbestos Inspector Number All-3420 conducted the survey. A gray gasket material located between the guard rail post base and the top of the parapet wall contains 2% chrysotile asbestos. The material is located on the east and west sides of the structure, was in poor condition, and is classified as a friable asbestos containing material. Standard Special Provision (STSP) 203-005 requiring the abatement of the ACM under the bridge construction contract bid item 203.0210.s. should be incorporated into the Special Provisions.

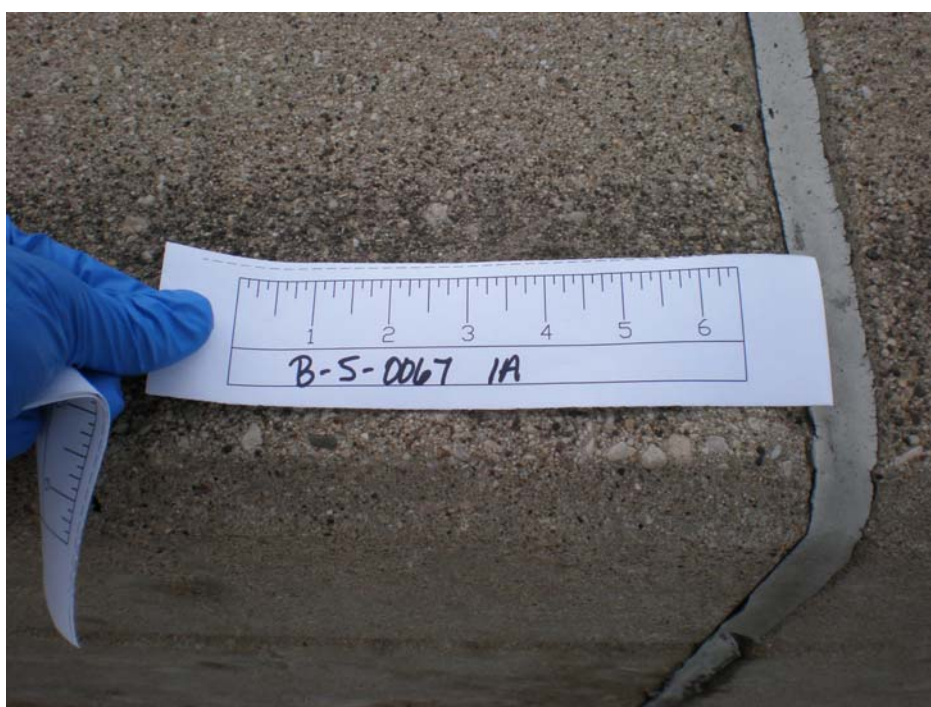
Gray caulk located on the parapet walls of Structure B-05-0067.

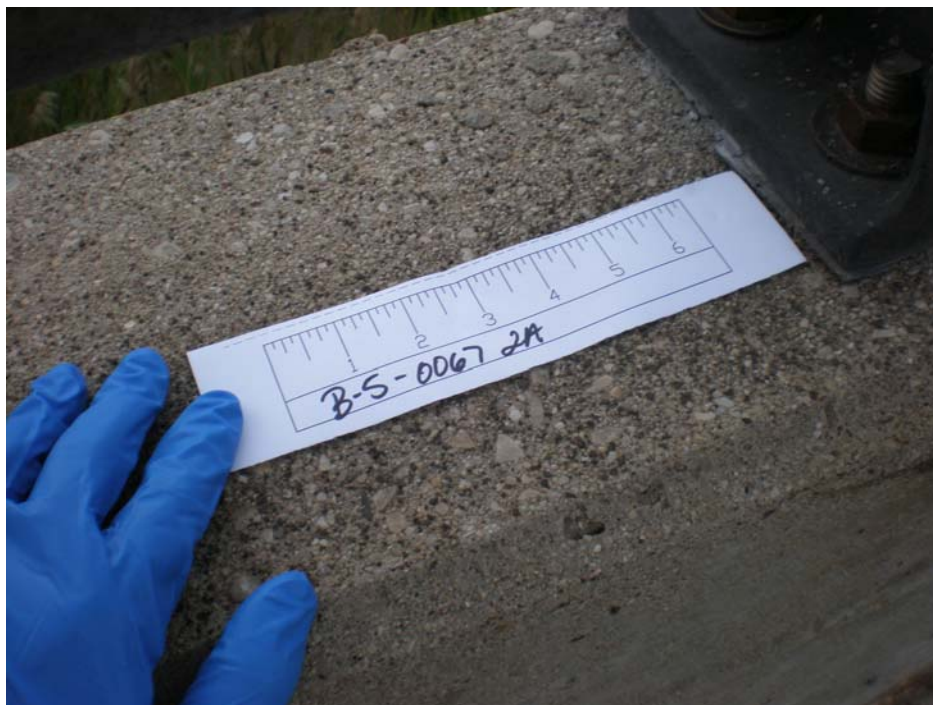
Because the identified gasket material was observed to be in poor condition and is friable, the material is regulated and should be removed prior to disturbance.

Bulk Sample(s) B-05-0067– 2A – 2C, gray gasket material, located on the east and west sides of the structure between the guard rail post base and the top of the parapet wall of the structure contain 2% chrysotile asbestos. The material is damaged and is considered friable asbestos containing material.

Guard rail base plate gasket located on the parapet walls of Structure B-05-0067.

Because the structure is scheduled for replacement and the material will likely be disturbed, Standard Special Provision (STSP) 203-005 requiring the abatement of the ACM under the bridge construction contract bid item 203.0210.s. should be incorporated into the Special Provision.

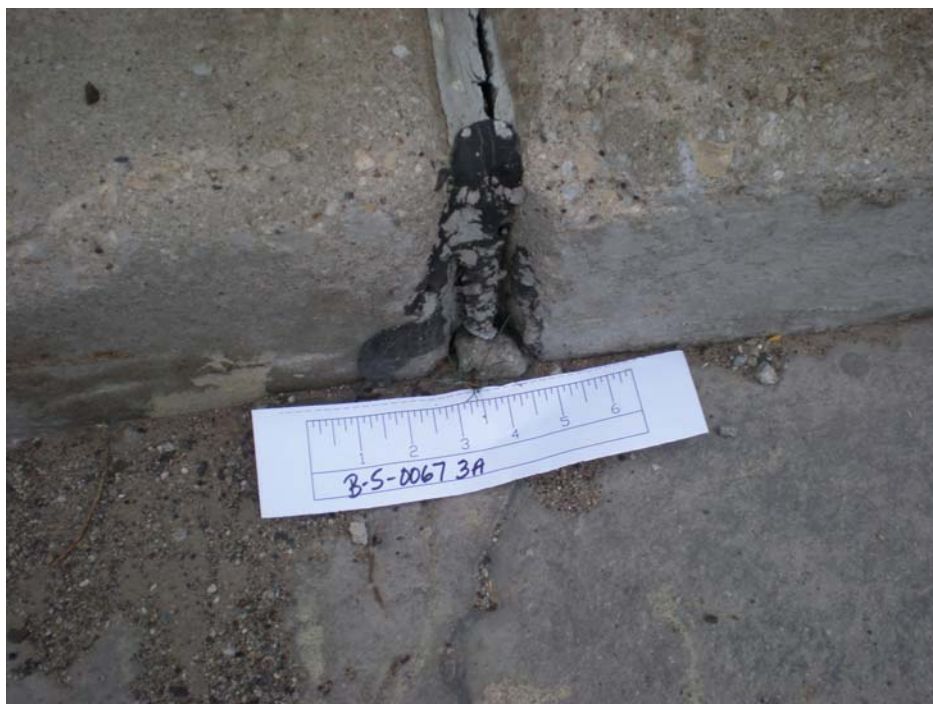
Black tar located on the deck of Structure B-05-0067.

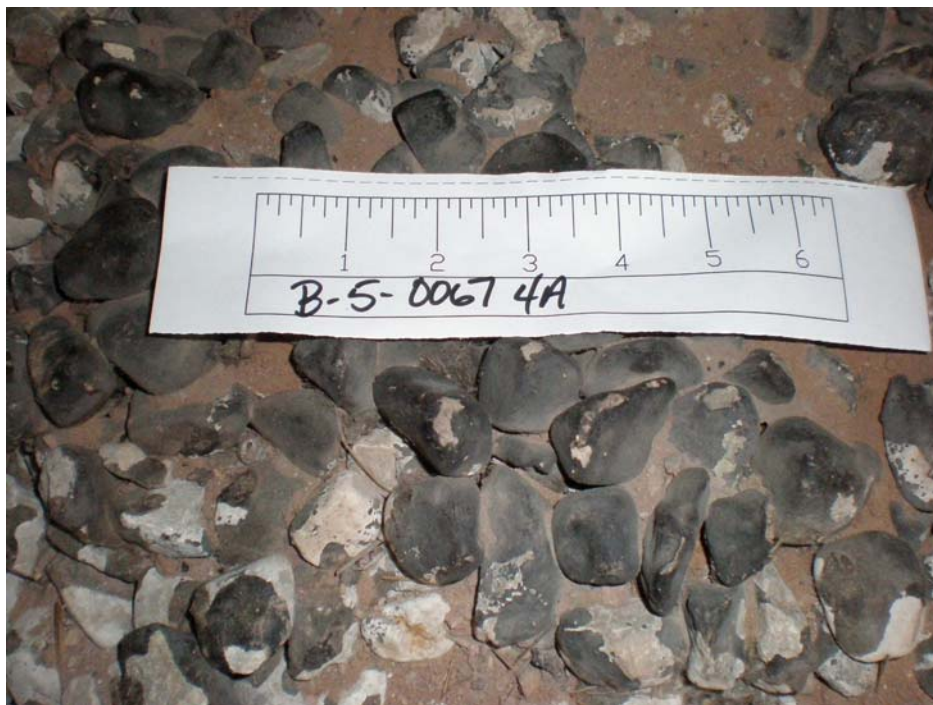
Tar covered rocks located beneath Structure B-05-0067.
