WisDOT Project 1133-10-00  
 Structure B-05-0133  
 Ramp at 41 Northbound-43 Southbound  
 over US Interstate HWY 43  
 Brown County, Wisconsin  
 Inspected 8-15-07  
 Jeffrey S. Carlson, Inspector  
 License # All-3420  
 STS Consultants, LTD  
 Asbestos Containing Material (ACM) is present in this structure

WisDOT Project 1133-10-00  
 Structure B-05-0133  
 Ramp at 41 Northbound-43 Southbound  
 over US Interstate HWY 43  
 Brown County, WI

September 10, 2007

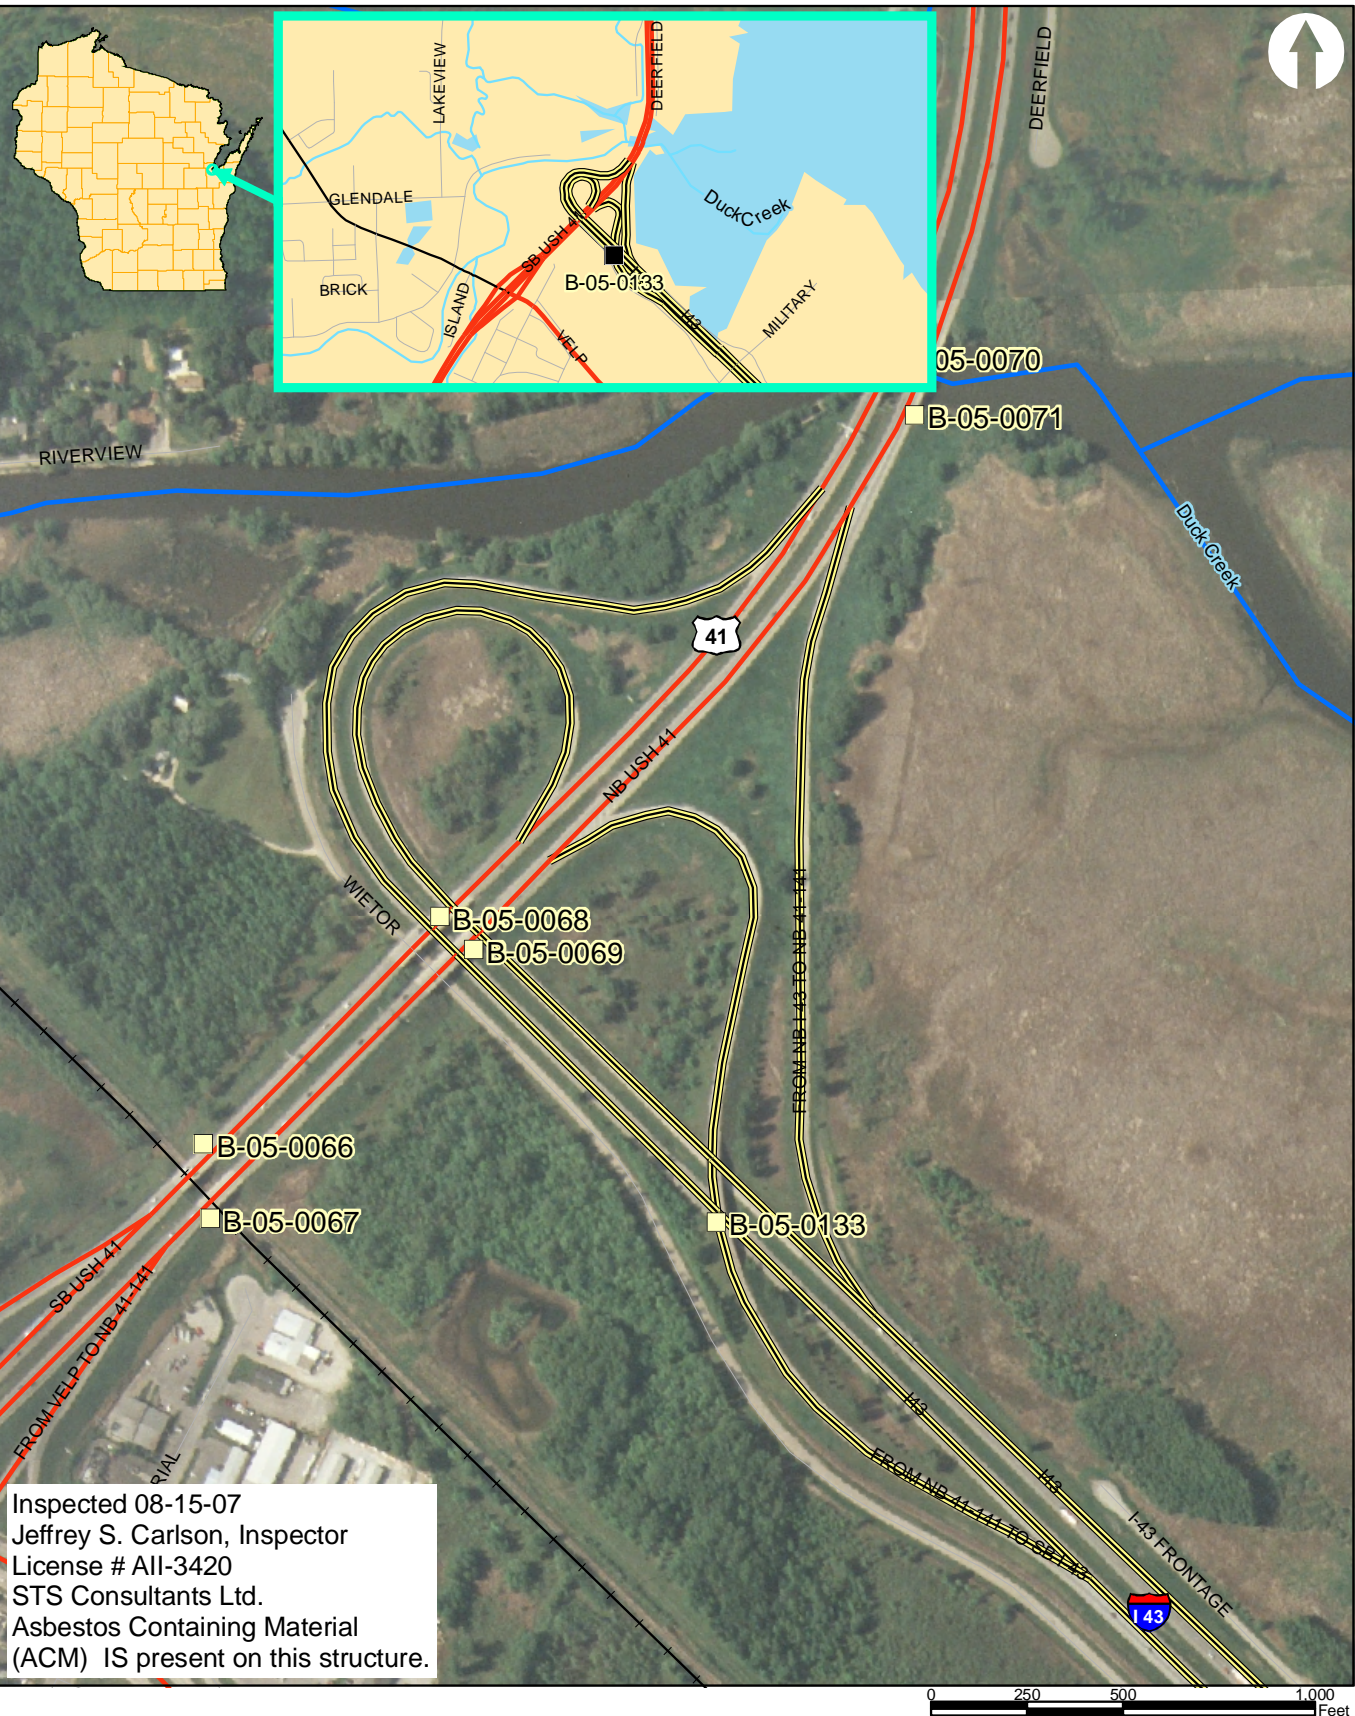
DESIGNED BY	ATV	09-24-07
DRAWN BY	ATV	09-24-07
APPROVED BY	PMG	09-24-07
FILE	SCALE As Shown	
STS PROJECT NO.	FIGURE NO.	
200605948	B-05-0133

Inspected 08-15-07  
 Jeffrey S. Carlson, Inspector  
 License # All-3420  
 STS Consultants Ltd.  
 Asbestos Containing Material  
 (ACM) IS present on this structure.

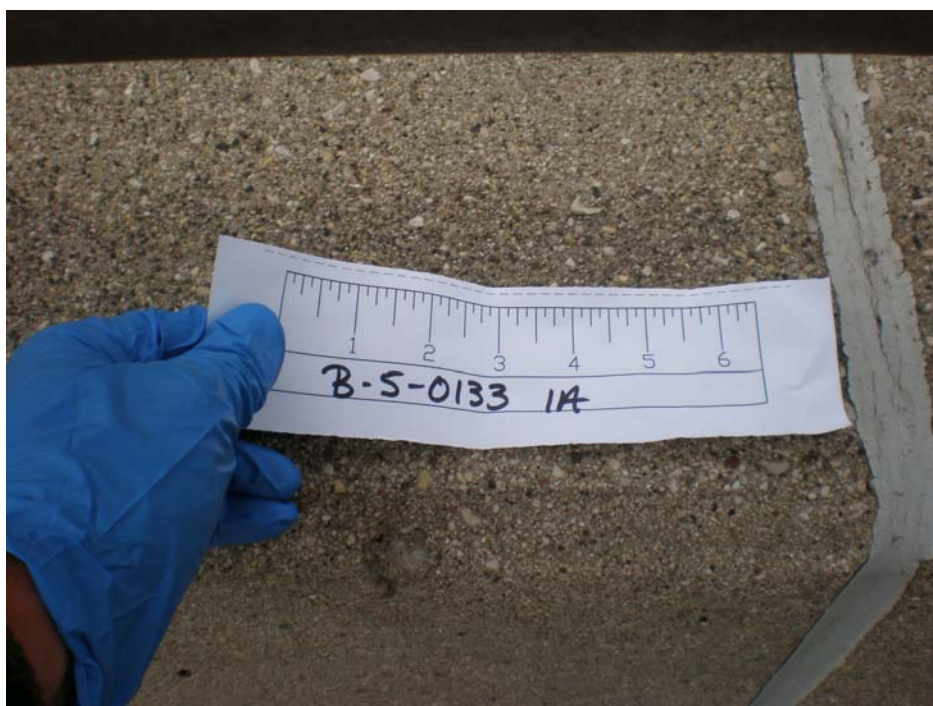
Gray caulk located on the parapet walls of Structure B-05-0133.

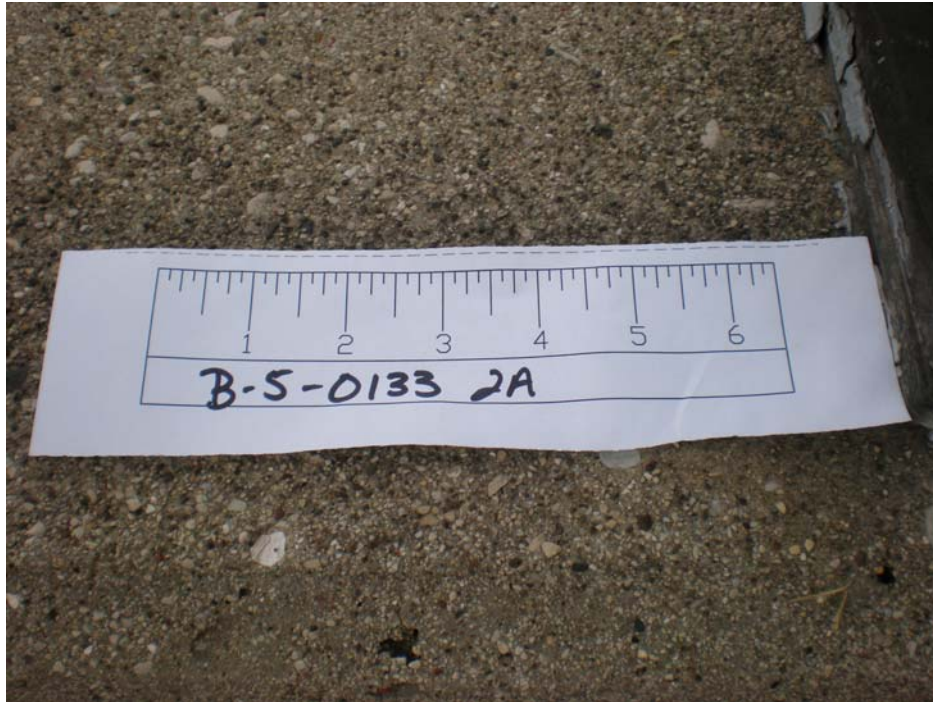
Bulk Sample(s) B-05-0133 – 2A – 2C, gray gasket material, is located on the north and south sides of the structure between the guard rail post base and the top of the parapet wall of the structure contains 2% chrysotile asbestos. The guard rail gasket material is damaged and is considered friable asbestos containing material.

Guard rail base plate gasket material located on the parapet walls of Structure B-05-0133.

All samples were collected following WisDOT standard sampling procedures for bridge inspections found in FDM Procedure 21-35-40. Because the identified gasket material (poor condition) could become comingled in demolition debris the material is regulated and should be removed prior to disturbance. Because the structure is scheduled for replacement and the material will likely be disturbed, Standard Special Provision (STSP) 203-005 requiring the abatement of the ACM under the bridge construction contract bid item 203.0210.s. should be incorporated into the Special Provisions.

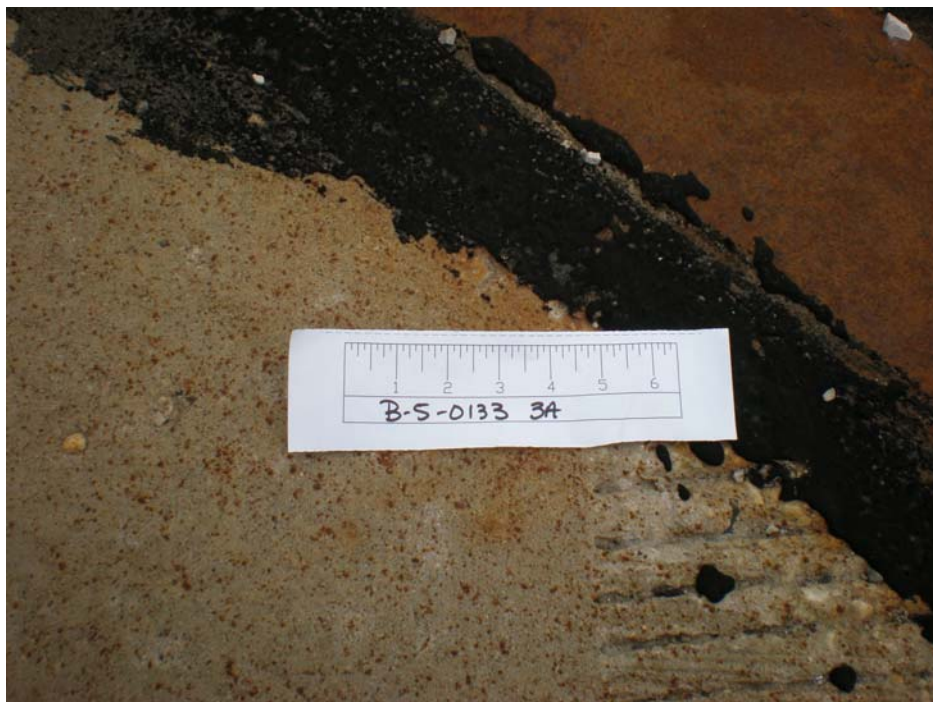
Black tar located on the deck of Structure B-05-0133.

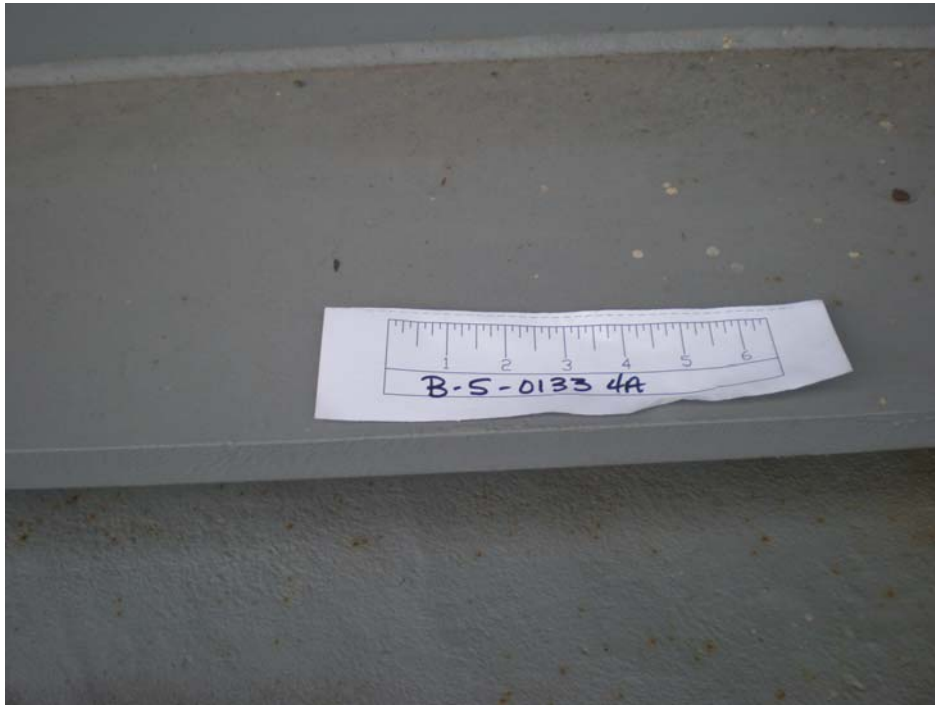
Silver paint located on the underside of Structure B-05-0133.
