CORRESPONDENCE/MEMORANDUM

Date: September 9, 2005

Subject: Site Investigation Report – Roadway
id 7090-05-34
USH 12
(Elk Mound –STH 124)
Dunn, Chippewa and Eau Claire Counties

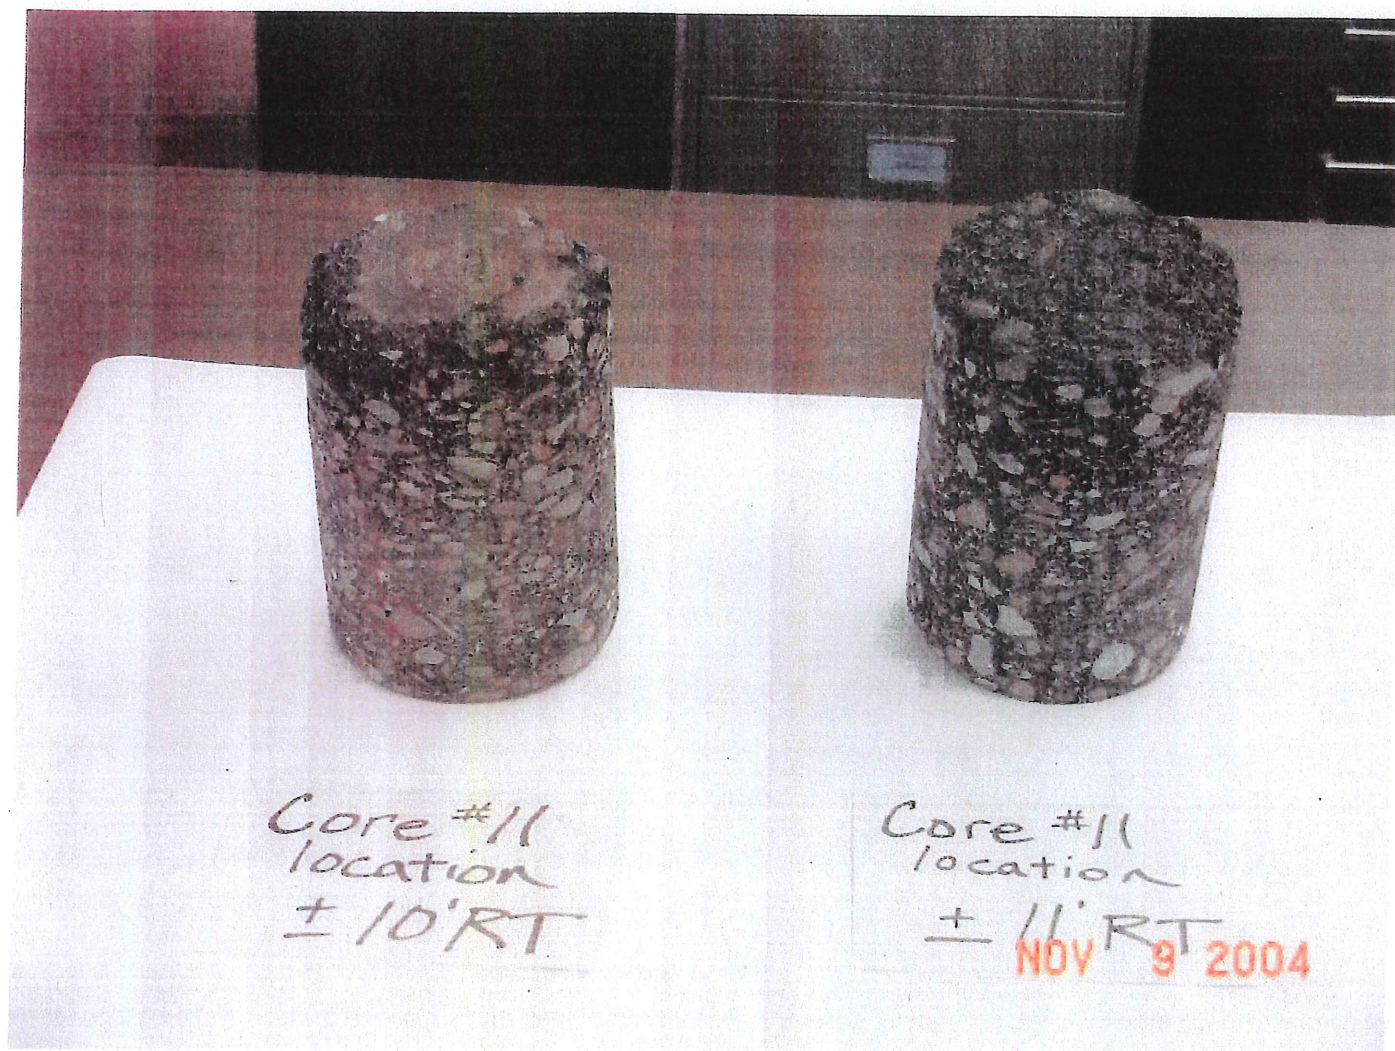
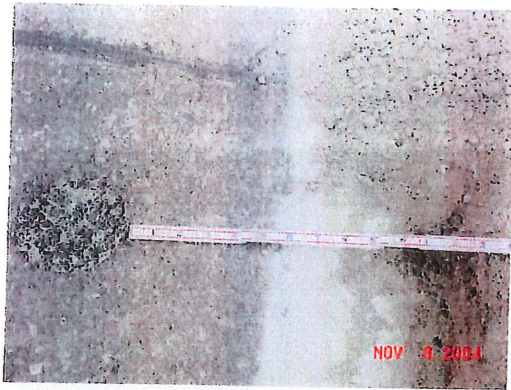
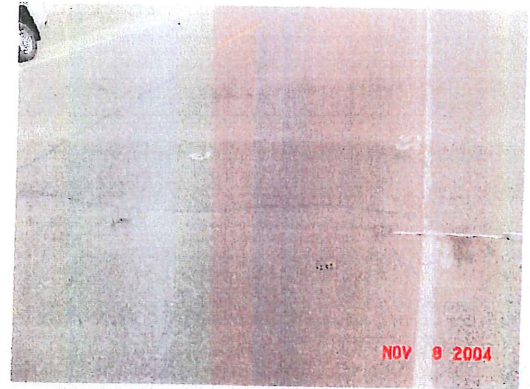
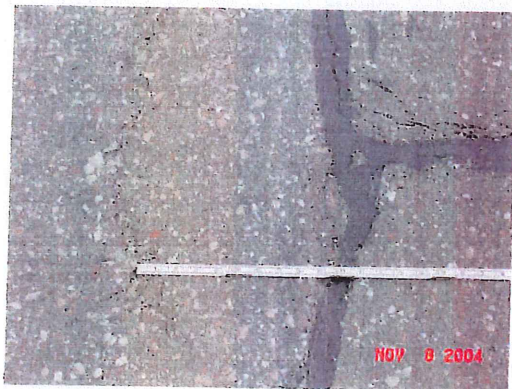
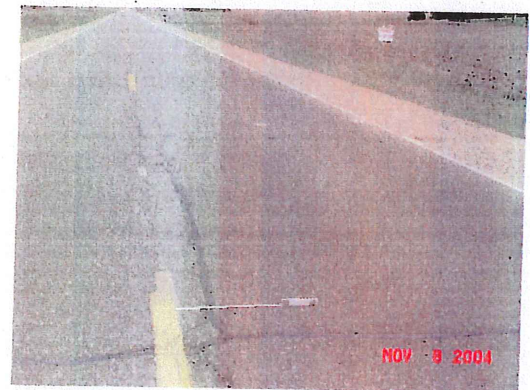
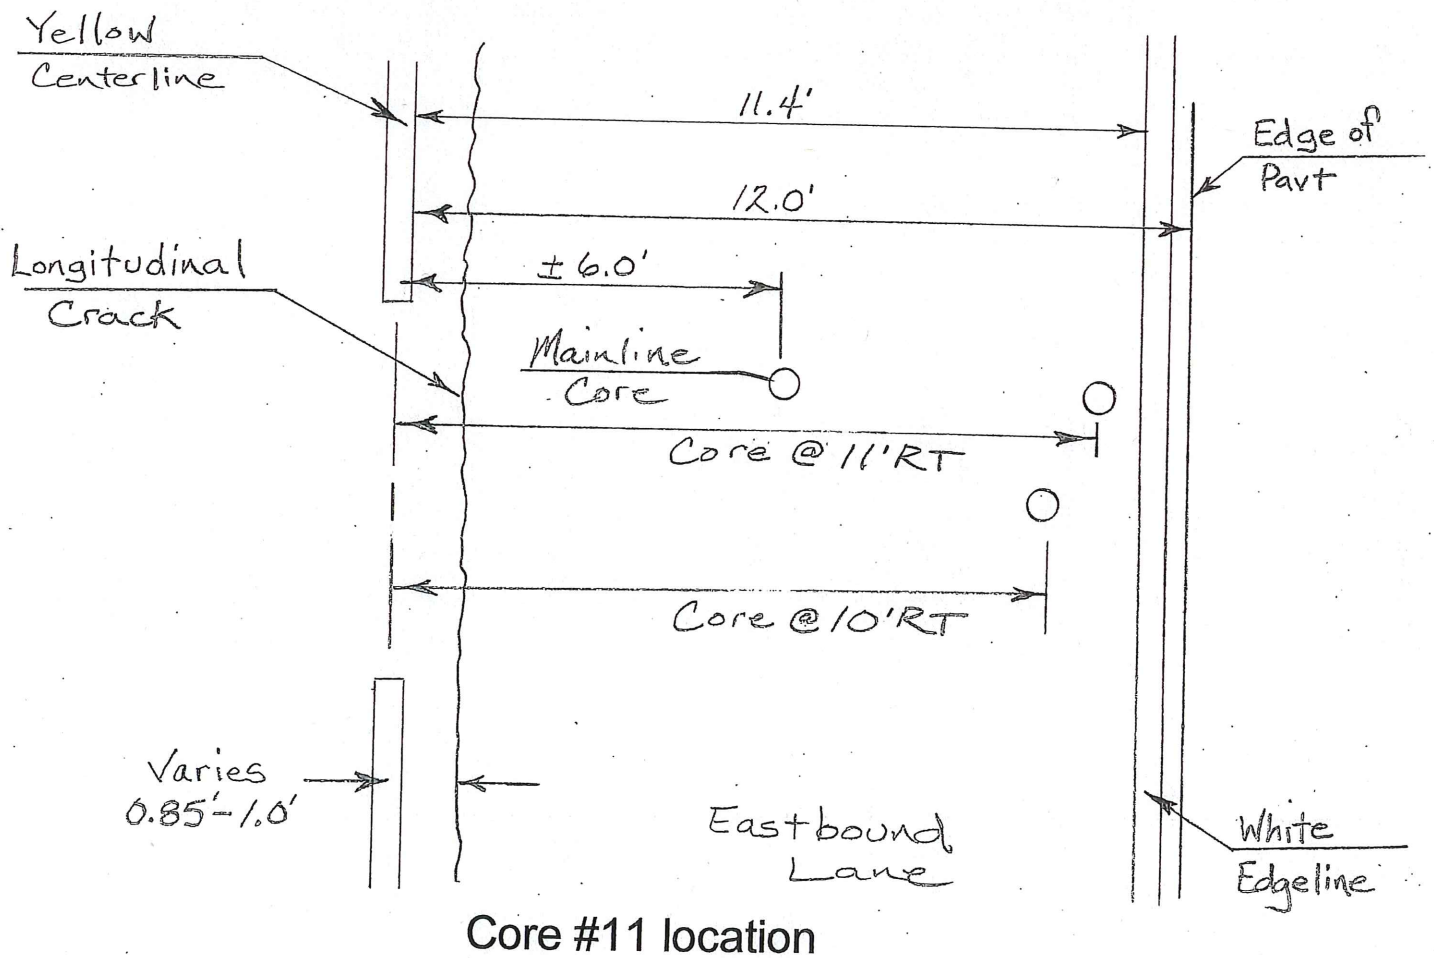
Core # 11 location
had cores taken at
10' RT and 11' RT

- Core 11A located 10' right of the centerline longitudinal crack had underlying pcc pavement. Core 11B located 11' right had underlying base course. The cores' photos serve to substantiate the type of underlying material present. The bottom of Core #11A is flat while Core #11B has a rough surface indicative of underlying base course.

- Cores #11A and #11B each had an asphalt depth of 6 ½". Of interest, note the lack of a longitudinal crack in the asphalt where the underlying pcc pavement and base course meet. (See attached ***Photos***).

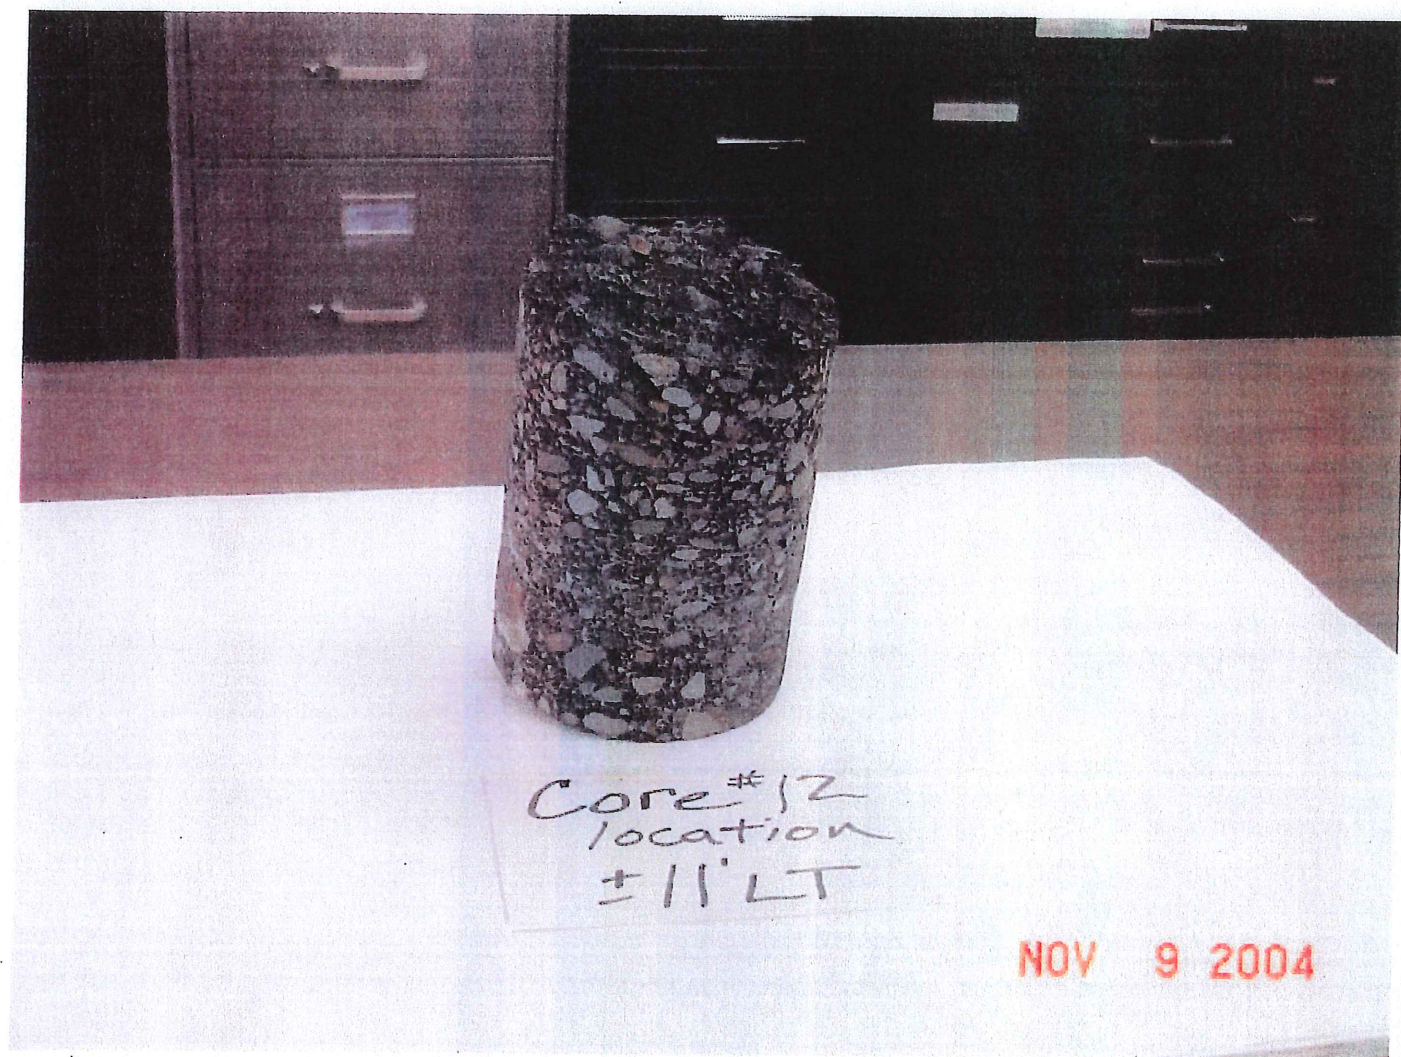
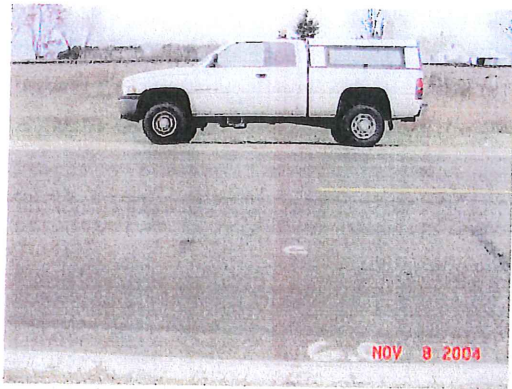
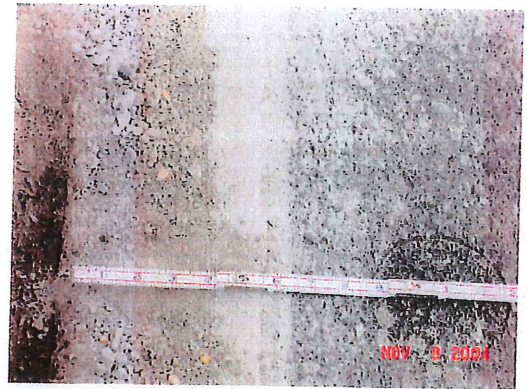
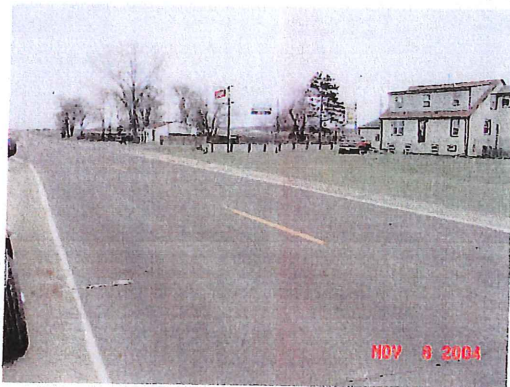
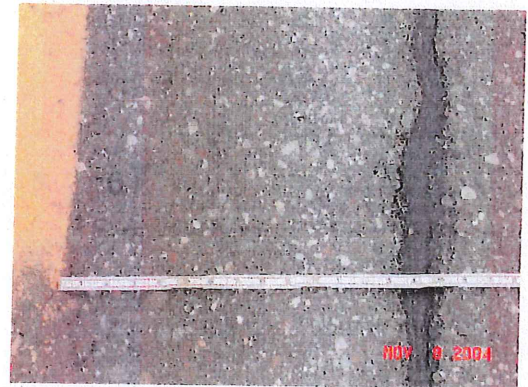
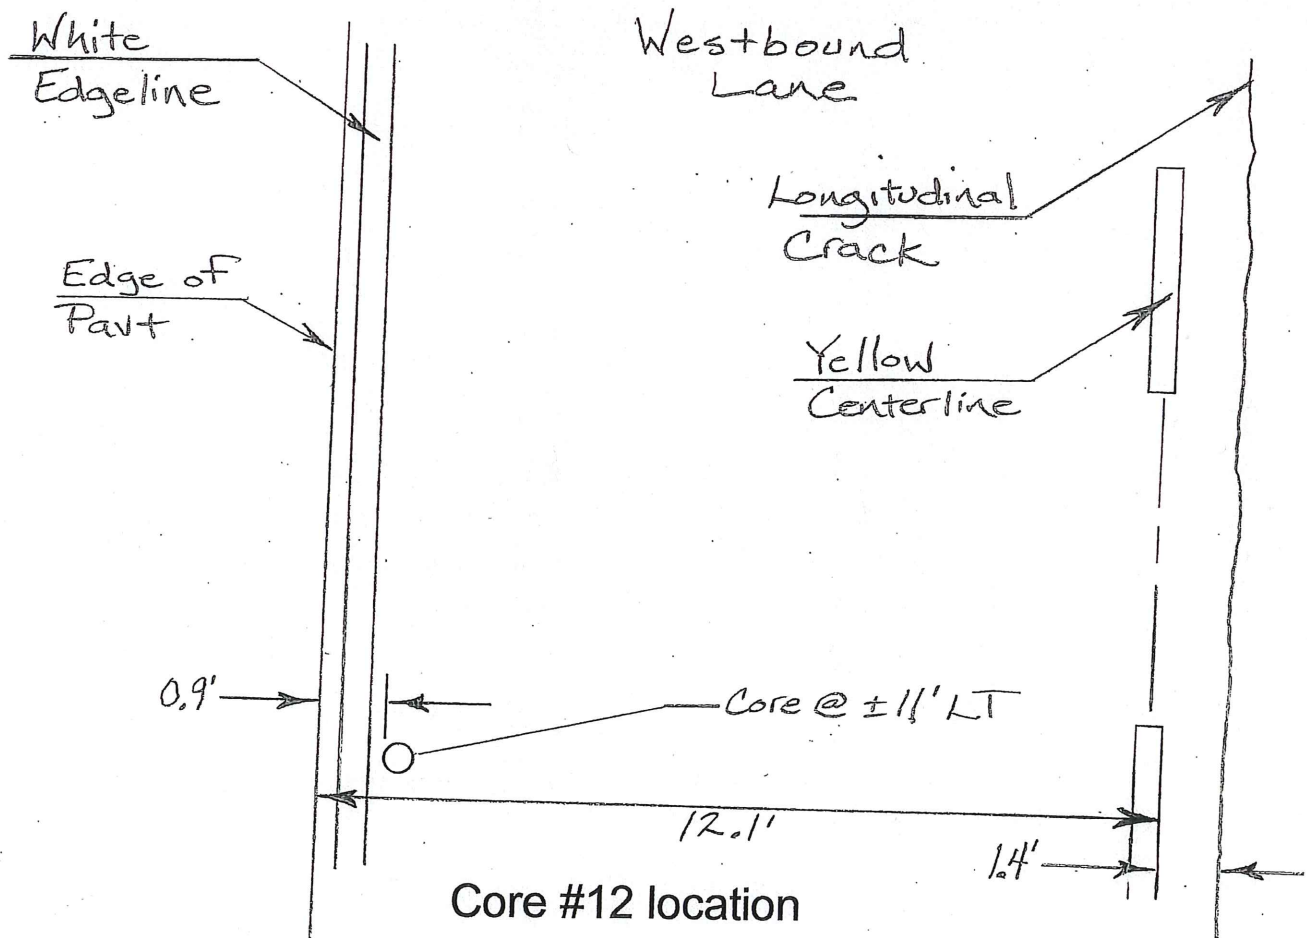
Core #12 location
taken 11' LT

5.5 11A	3.4	10' RT	6 1/2"	PCC	
5.5 11B	3.4	11' RT	6 1/2"	BASE	
6.0 12A	3.7	11' LT	6 1/2"	BASE	
6.5 13A	4.0	11' RT	17 1/2"	BASE

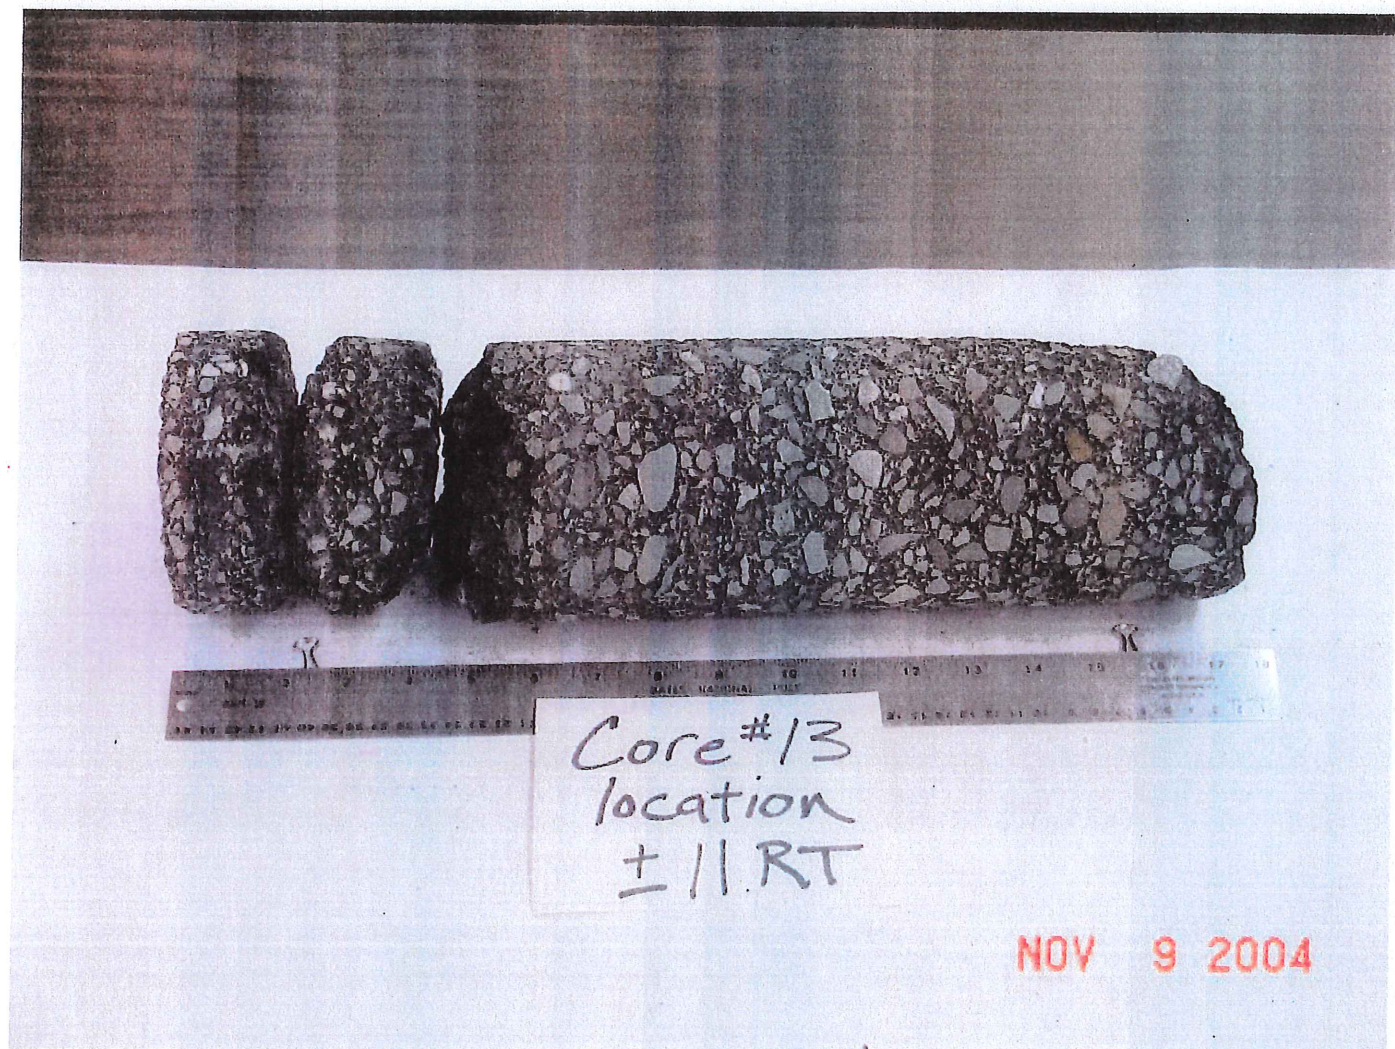
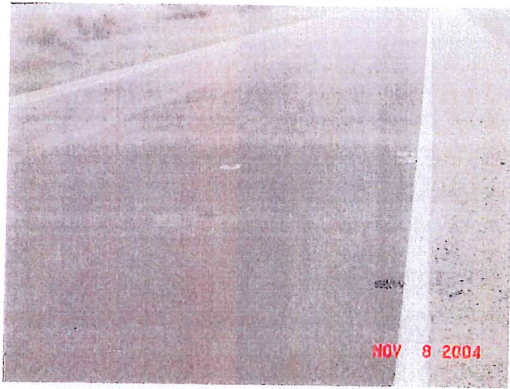
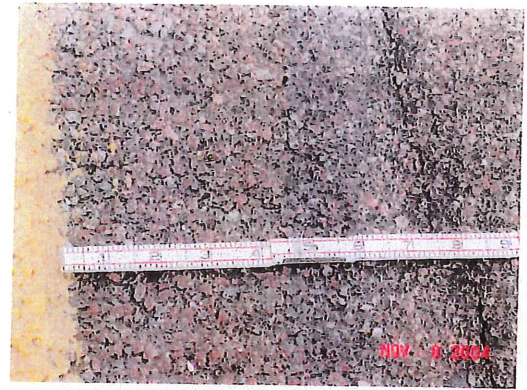
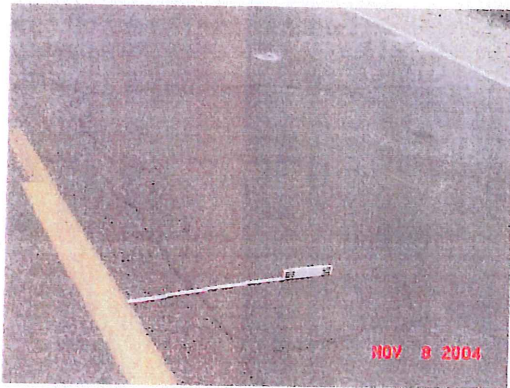
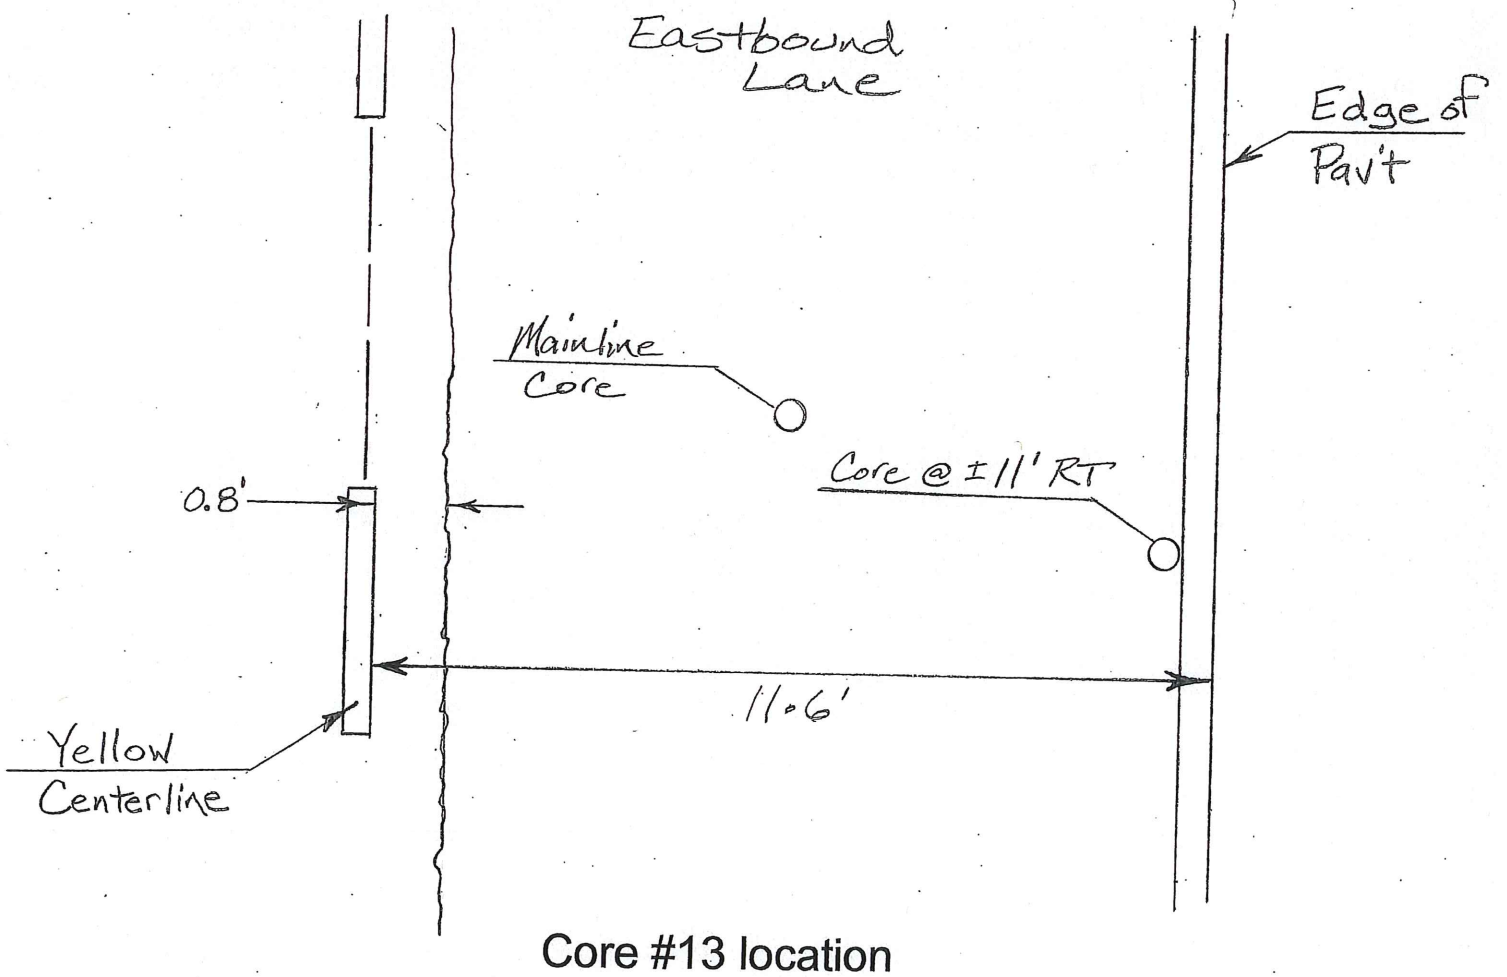
Core # 13 location
taken at 11' RT

- Cores #11, #11A, #11B, #12 and #12A are located in Chippewa County.
- Core #13 has a depth of 7" of asphalt located 7' right of centerline. Core #13A has a depth of 17 ½" located ± 11' right.
