BRIDGE REHABILITATION REPORT

Main Street over the Red Cedar River

Structure B-03-0002

City of Rice Lake

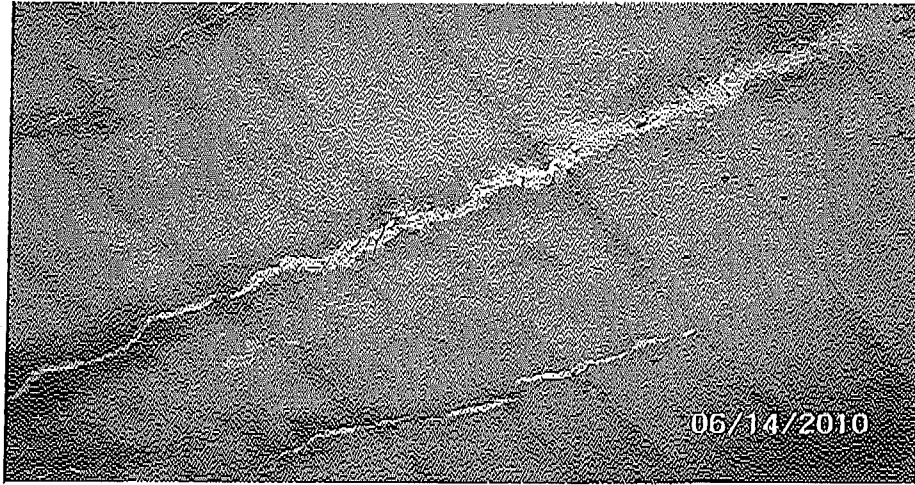
Deck: The cast in place deck shows significant deterioration throughout the entire deck area. The 2010 inspection report identifies delamination over 37% of the total deck area. The total deck area is 17,754 Sq. Ft. with a total roadway area of 13,988 Sq. Ft. thus 37% delamination represents 5,176 Sq. Ft. The delamination of the roadway area on the deck has accelerated over the last two years since the last regular inspection as evidenced by the rapid decline in deck ratings. In addition there are several cracks on the underside of the deck that show efflorescence, a strong indication of full depth seepage and possible full depth deck failure, resulting in significant increased possibilities of "pop throughs." The 2012 Routine Inspection shows continued deck deterioration with increased delamination, the estimated area of deck delamination is currently 40%- 45%. In addition there has occurred since the 2010 routine inspection, significant deterioration of the longitudinal joint between the two different structure types, resulting in full depth failure along this joint area.

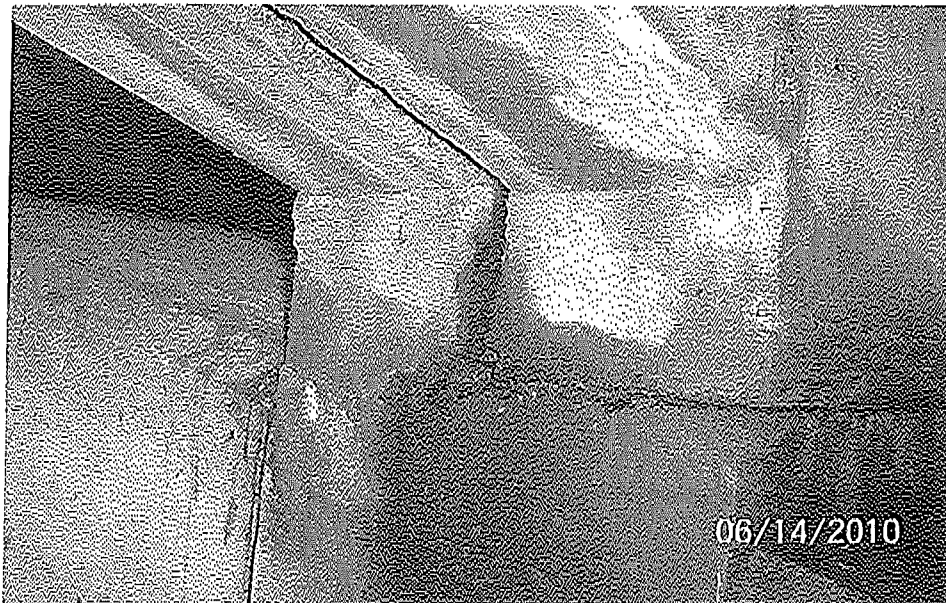
Spandrel Arch & Pre-stress Concrete Girders: The 2012 Routine inspection identified the same minor to moderate cracks in the existing Spandrel arches near the abutment seats and the Pier seats, and around the abutment and pier seats of the Pre-stress Girders. The concrete abutments and abutment seats also show concrete spalls and pop-outs around the pre-stress girders. This is consistent with the 2010 Routine Inspection.

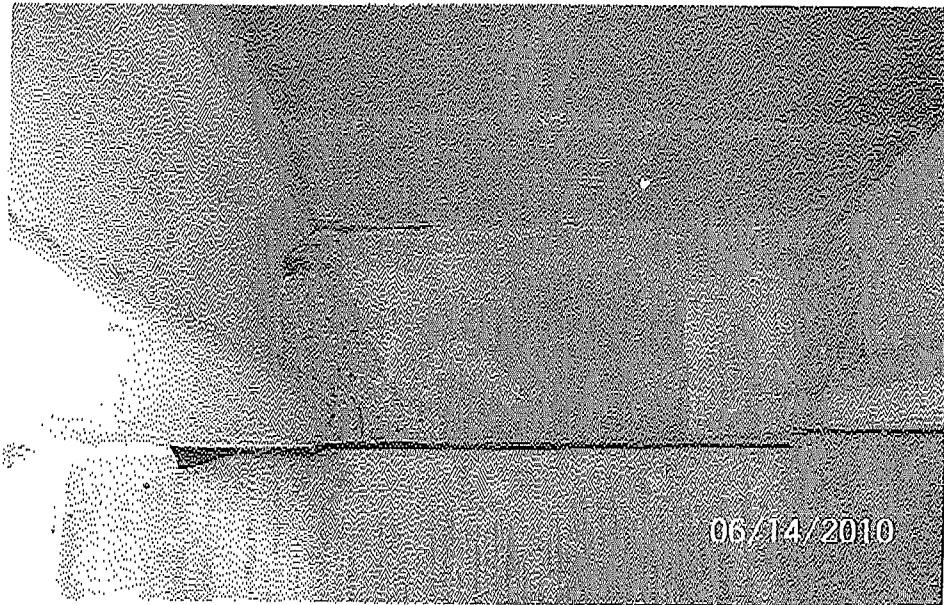
Abutment Spalding around Girders

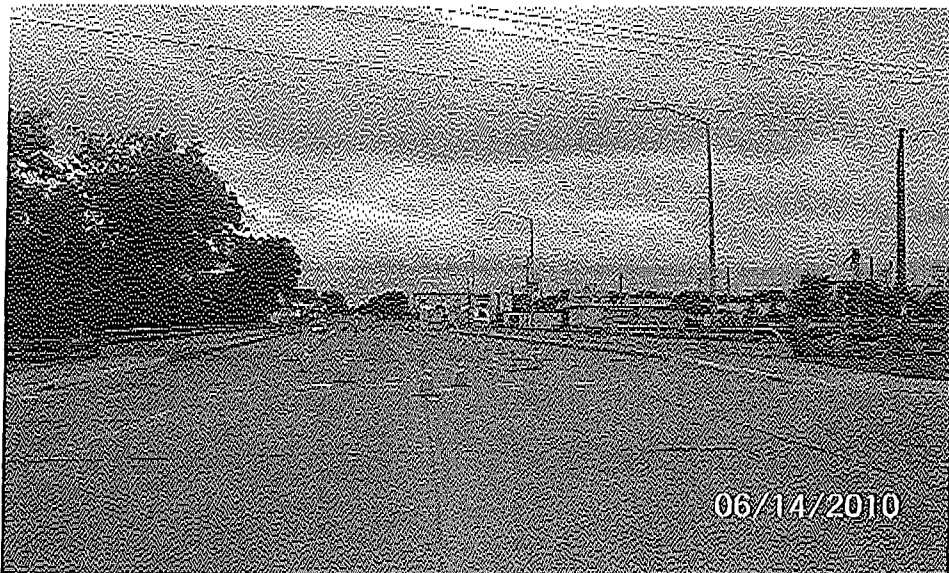
Roadway: As indicated the most recent inspection identified 40%-45% of roadway surface area delaminated. The entire Roadway deck area was checked for delamination and delaminated areas were marked and measured in 2010 and compared the areas sounded with a chain drag in the 2012 routine inspection.

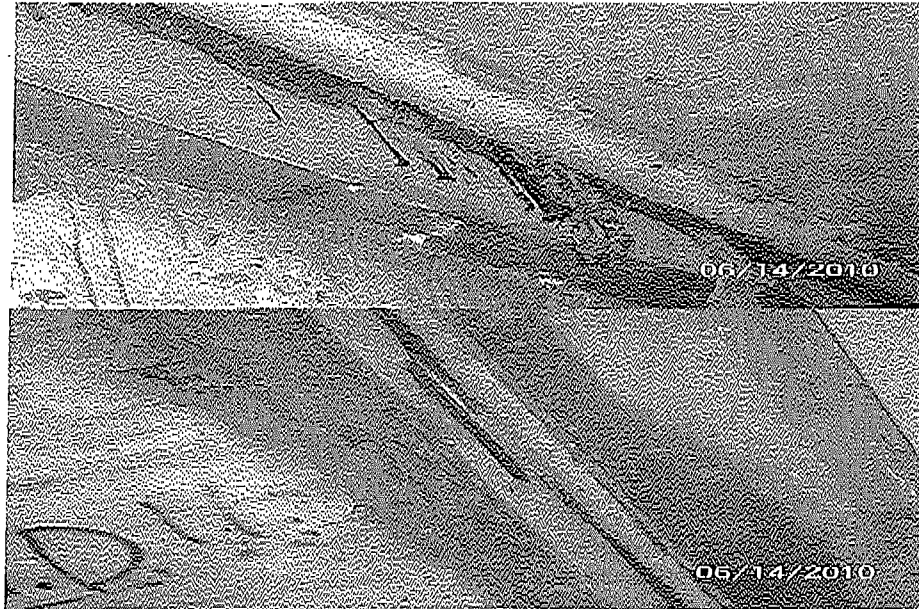
Existing Joints: The most recent inspection and previous inspection reports identified failed joints on the Main Street Structure with significant seepage and debris through the Joints. Both the joints at each end of the bridge and the joint that runs parallel to the centerline between the portion of the bridge with the Spandrel arches and the portion of the bridge with the Pre-stress girders. These joint failures allow debris and seepage through to the sub-

structure components which accelerates the deterioration of the sub-structure components. The 2010 Routine inspection recommended periodic inspections (6 month interval) of the bridge joints due to the failed condition and increased potential for complete failure of the joints creating a safety concern. The interim inspections and the 2012 routine inspection identified the failure of the longitudinal joint between the structures and the subsequent temporary repairs.
