Engineering Study for Bridge Rehabilitation Structure No. B-47-45

Prepared for:
Pierce County Highway Department

Prepared By:
HDR Engineering, Inc.
701 Xenia Avenue South
Suite 600
Minneapolis, MN 55416

Bridge Inspection
Photographs

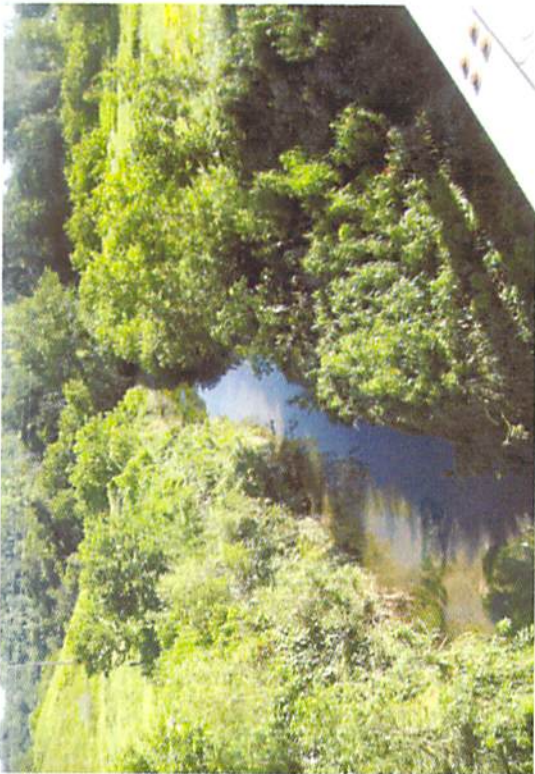
File Name: IMG_6090.jpg

- **Channel and Channel Protection:** The stream enters the structure at an approximately 30-degree skew from perpendicular. This is causing the slope protection to degrade along the West Abutment. The channel is well vegetated both upstream and downstream of the structure.

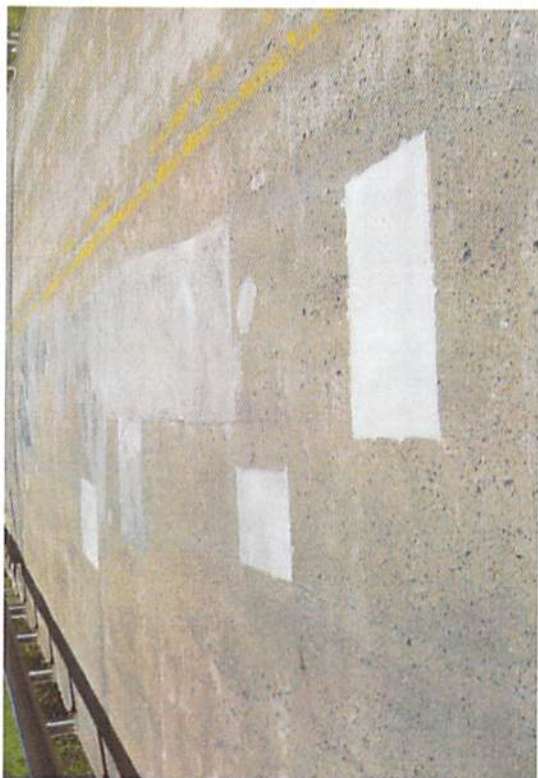
File Name: IMG_6115.jpg

- **Deck:** Several repairs are located in the eastbound lane of the structure. The repaired areas are sound, but there are several areas of delaminated concrete on adjacent areas when sounded with a hammer. There are also several delaminated areas of concrete along the longitudinal reflective cracks in this same area of deck (see Appendix for Photo 6115).

The deficiencies noted in our inspection were found in the existing deck and superstructure. Replacing the existing superstructure with a new, rolled steel girder superstructure will correct these deficiencies and would extend the life of this bridge for more than 10 years. In addition to the superstructure replacement, HDR recommends that the County take action to repair the slope protection at the West Abutment in order to minimize further undermining. Replacement of the superstructure of this bridge is approximately half the cost of a complete replacement. Using a new steel superstructure and an ASD design approach for the existing abutments, we believe this is a cost effective way to extend the useful life of this structure and increase the sufficiency rating to a value greater than 80.

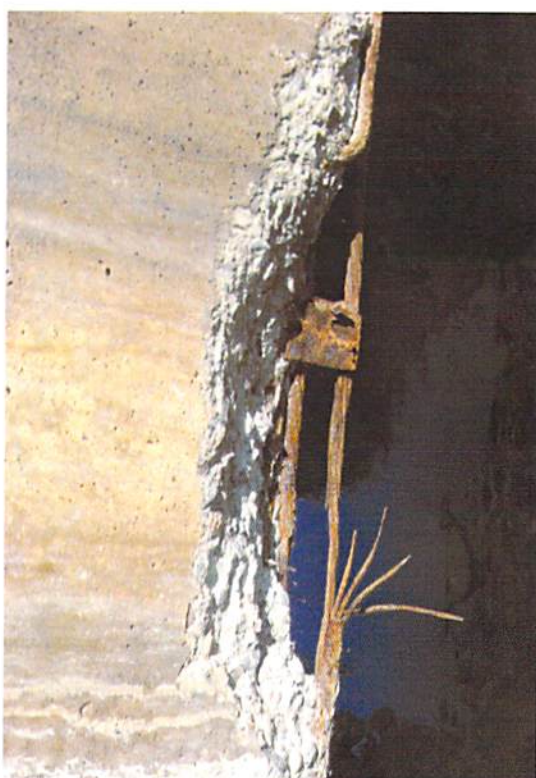
File Name: IMG_6116.jpg

- **Superstructure:** The precast channel beam on the south fascia is in poor condition. There is a large spall in the outside channel leg measuring 4 feet long by 8 inches tall at the midspan of the bridge with exposed strands and up to four broken wires in the bottom strand (see Appendix for Photo 6116). The north fascia precast beam is showing longitudinal cracking along the bottom of the outside channel leg with rust staining, but there is no spalling at this time.
