**STATE OF WISCONSIN
DEPARTMENT OF TRANSPORTATION**

**Inspection Report for
B-16-038-0003**

**USH 2 over BN Rail Road
Oct 19, 2015**

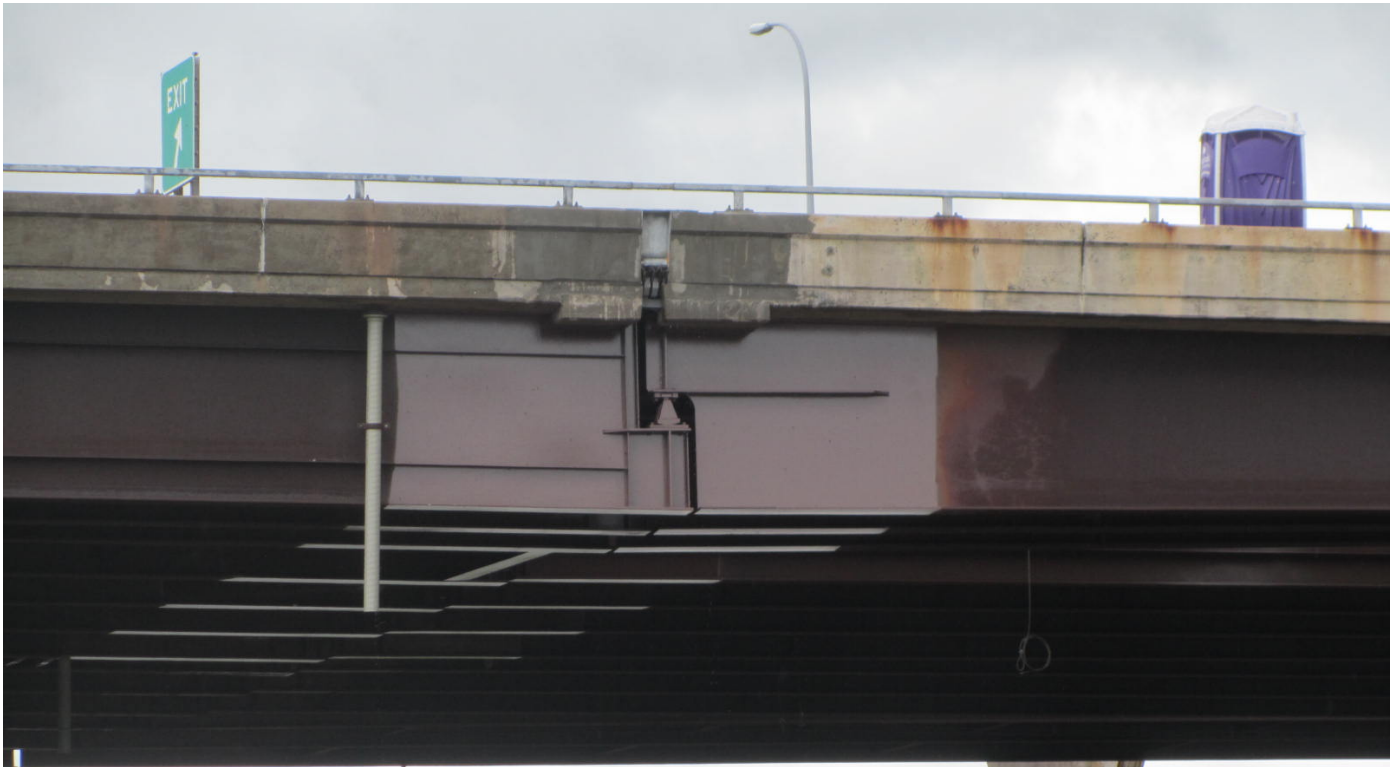
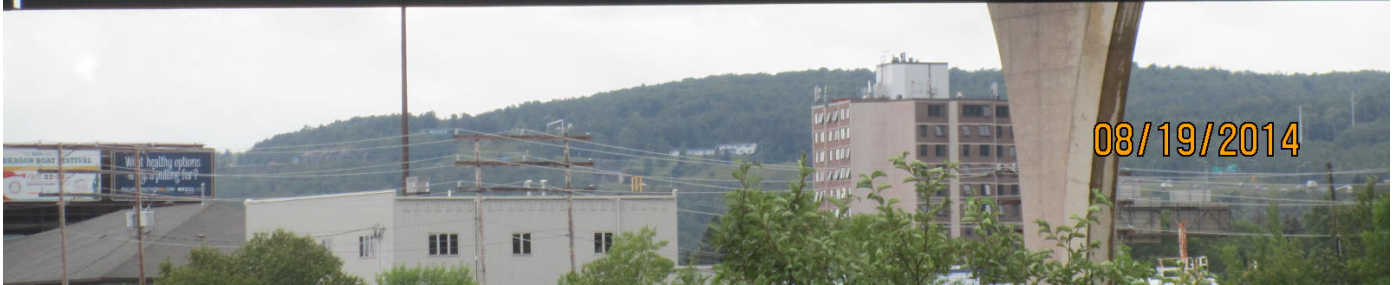
Joint 3-4 showing modular joint replacement and paint in progress, also new drain tube.

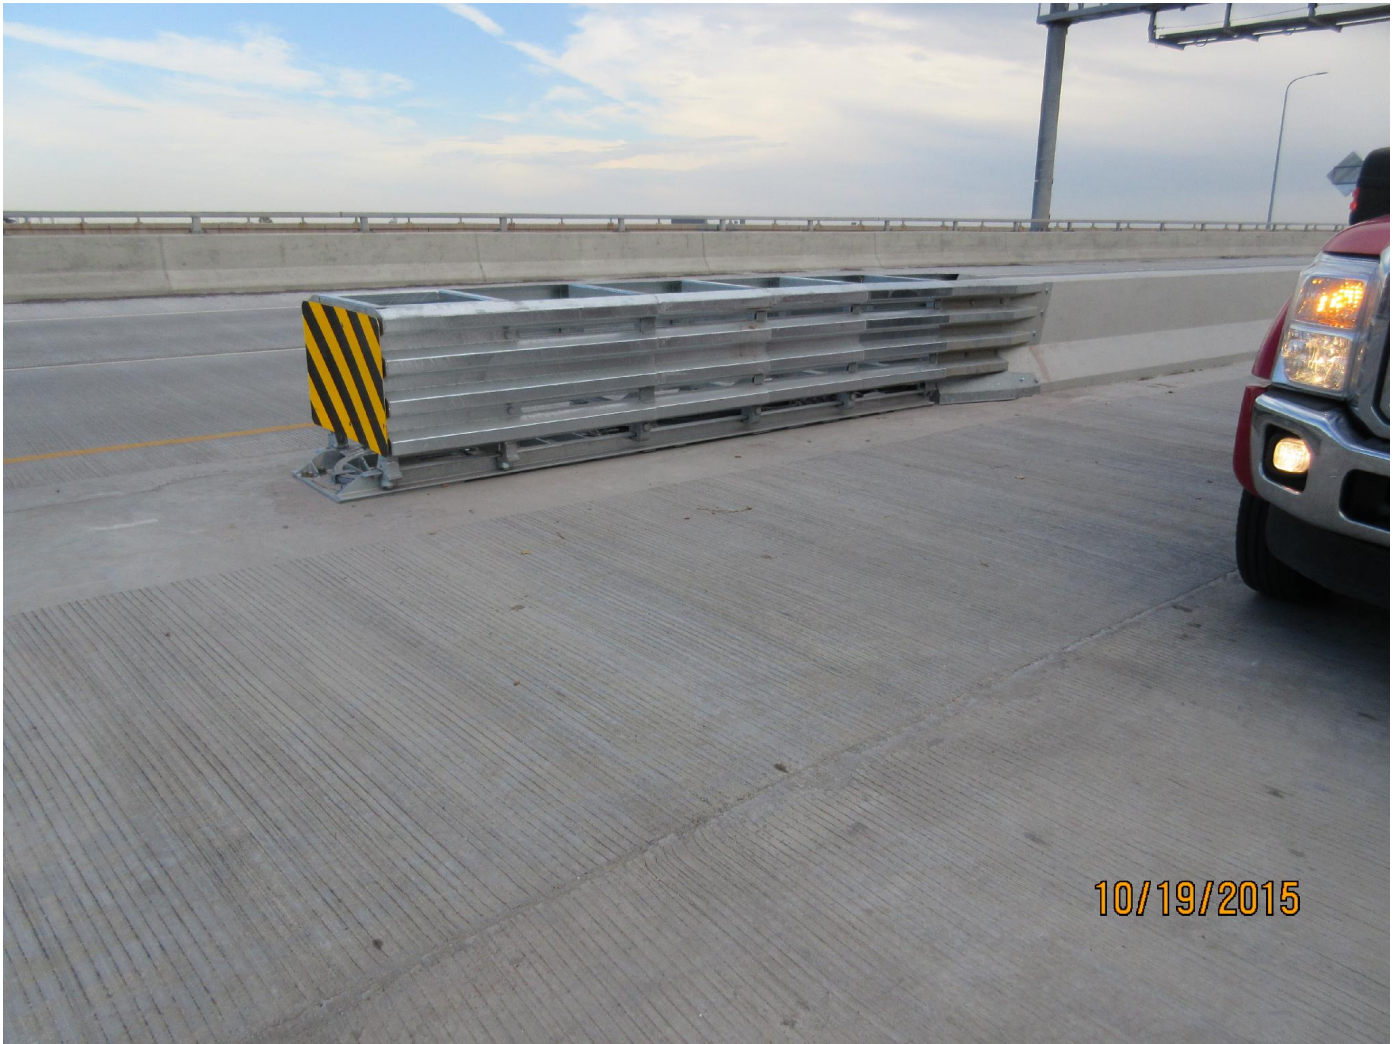
Crash Cushion new 2015.

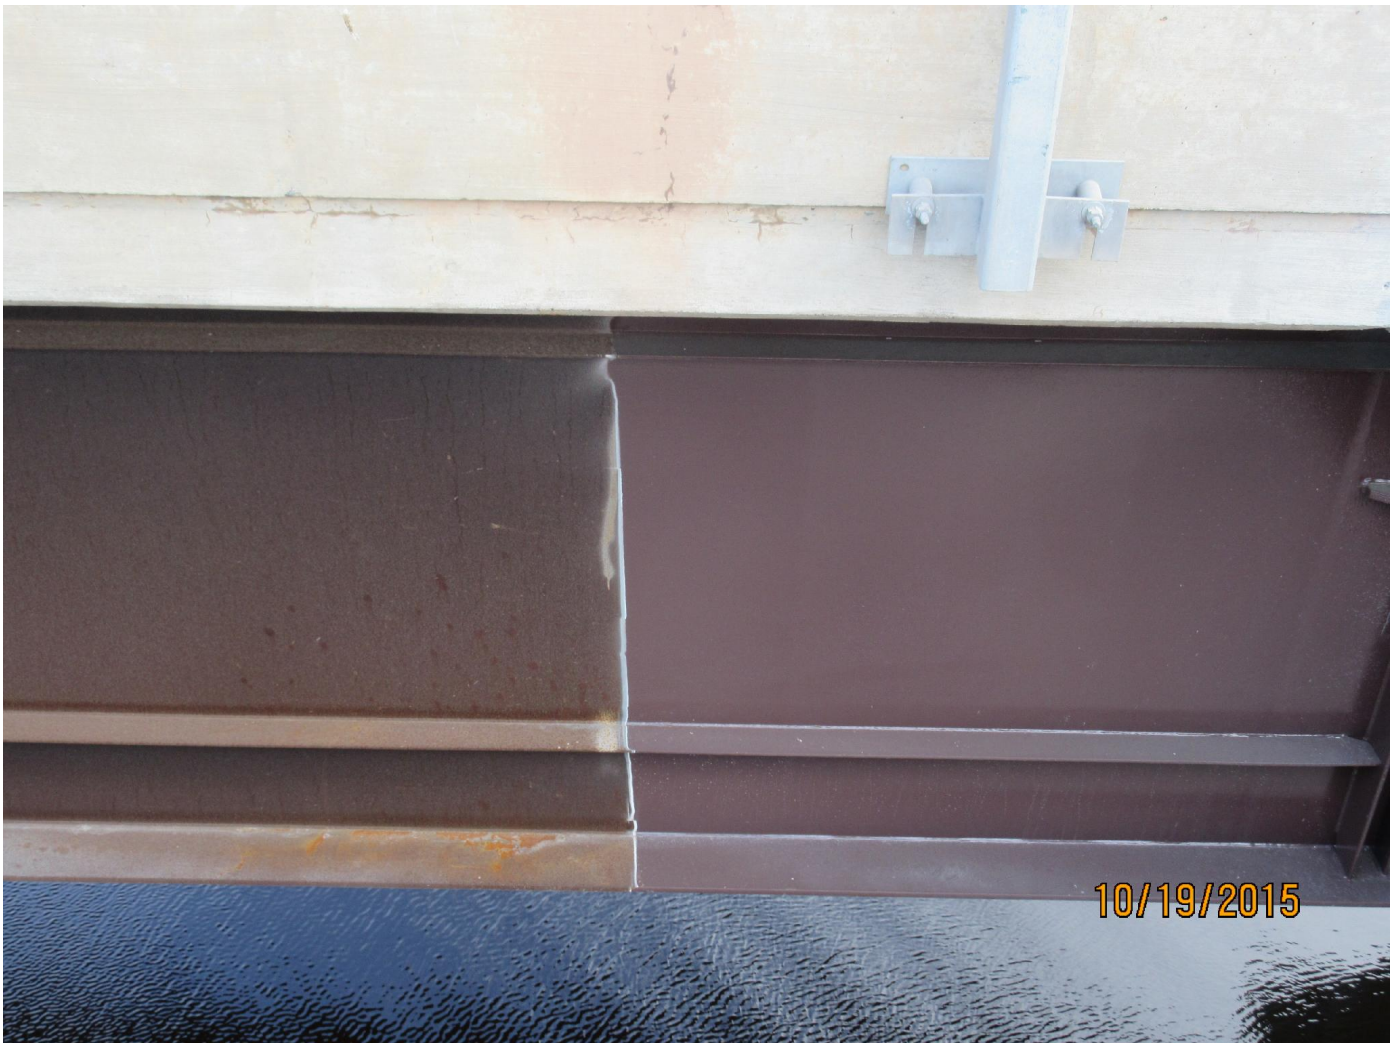
Typical transition at paint.

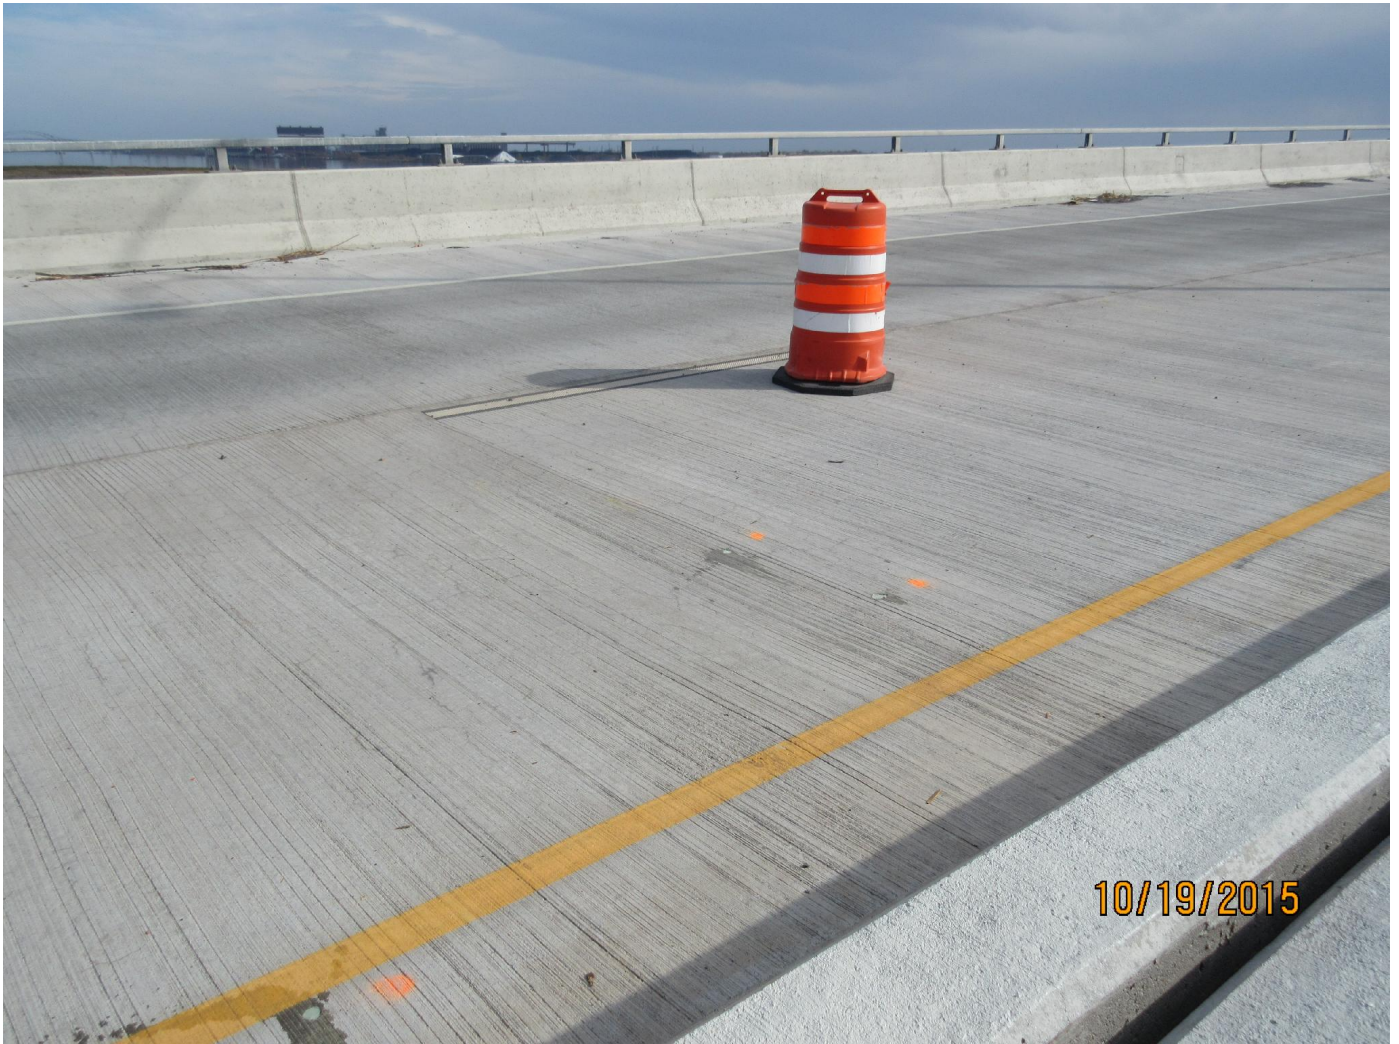
Typical cracks in overlay.

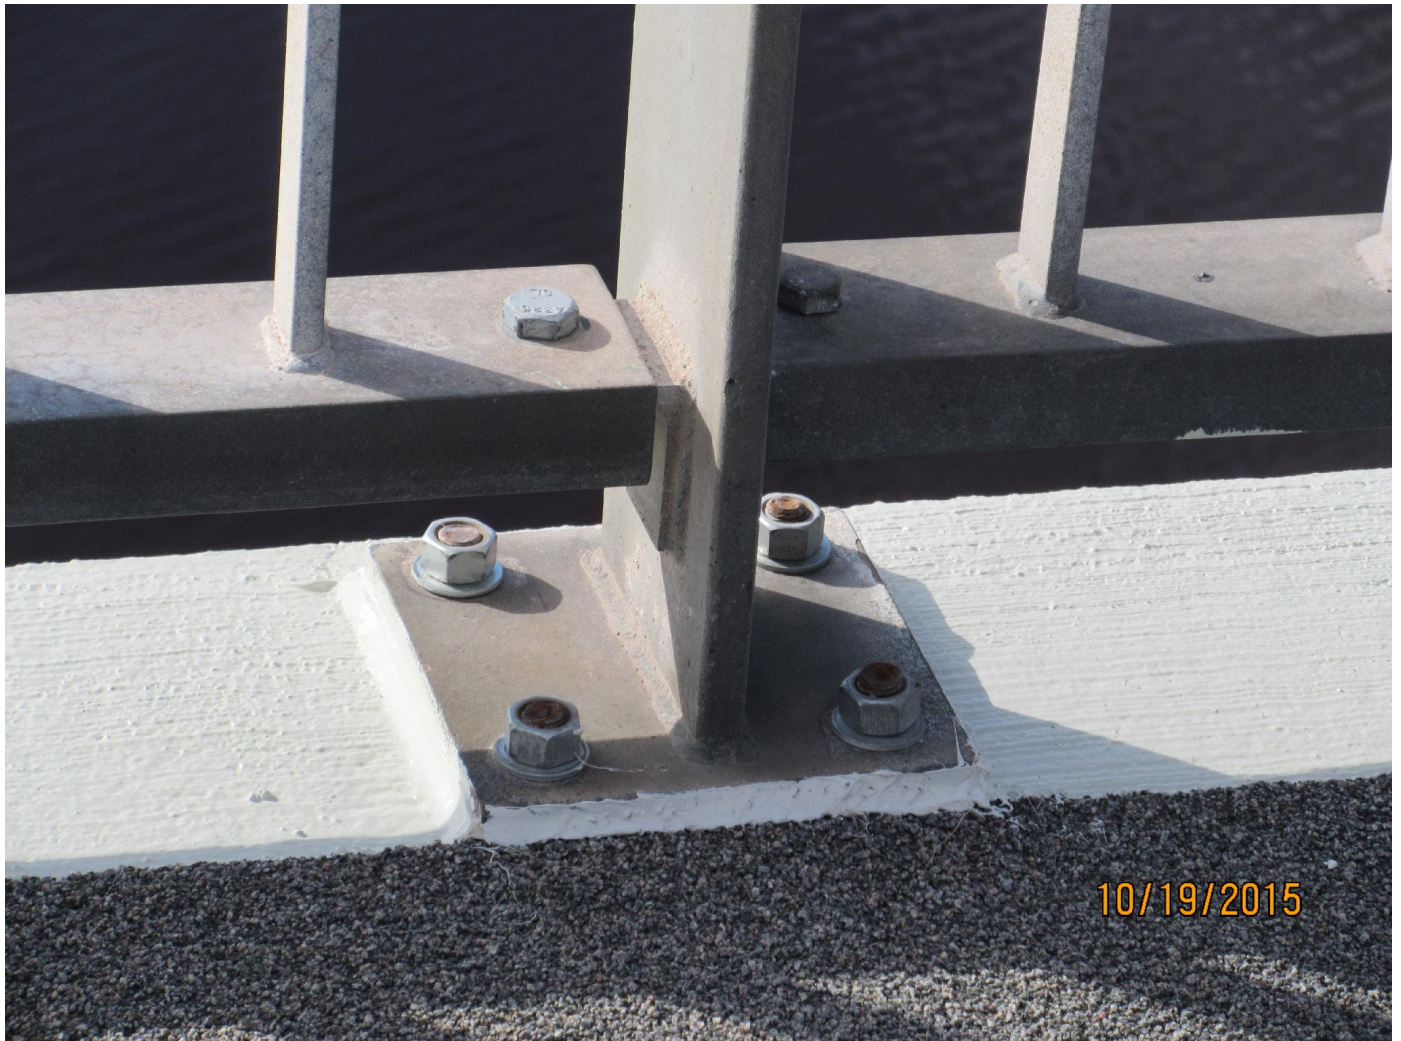
Typical work on sidewalk included adding a polymer overlay from parapet to base of rail, epoxy sealer from poly overlay to exterior girder, and caulking around rail base.

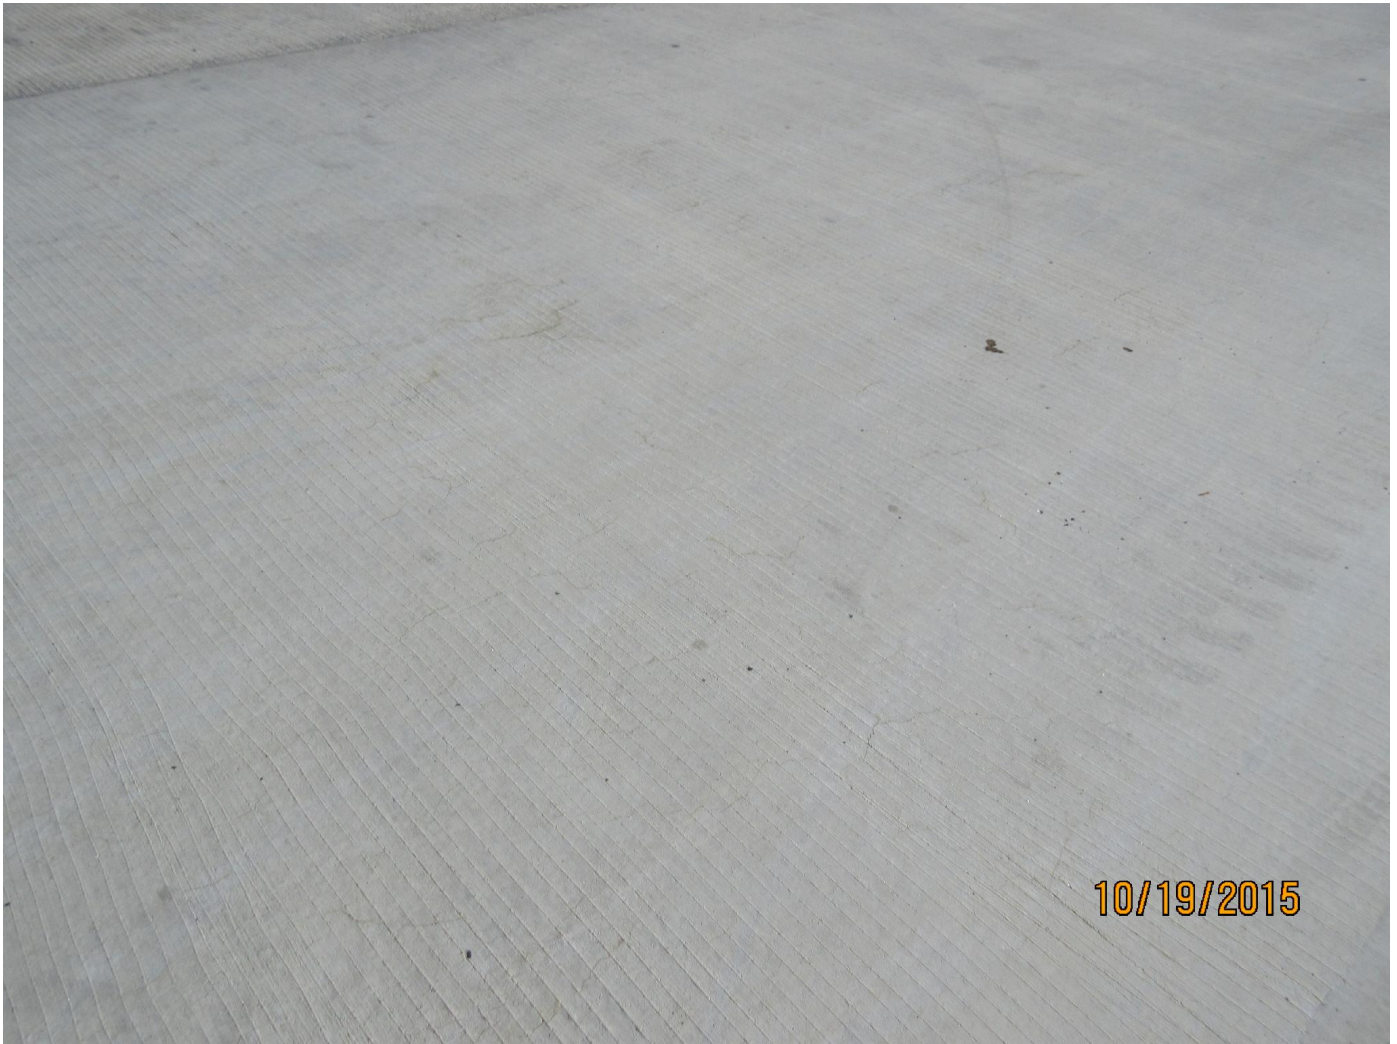
Typical cracking in overlay.

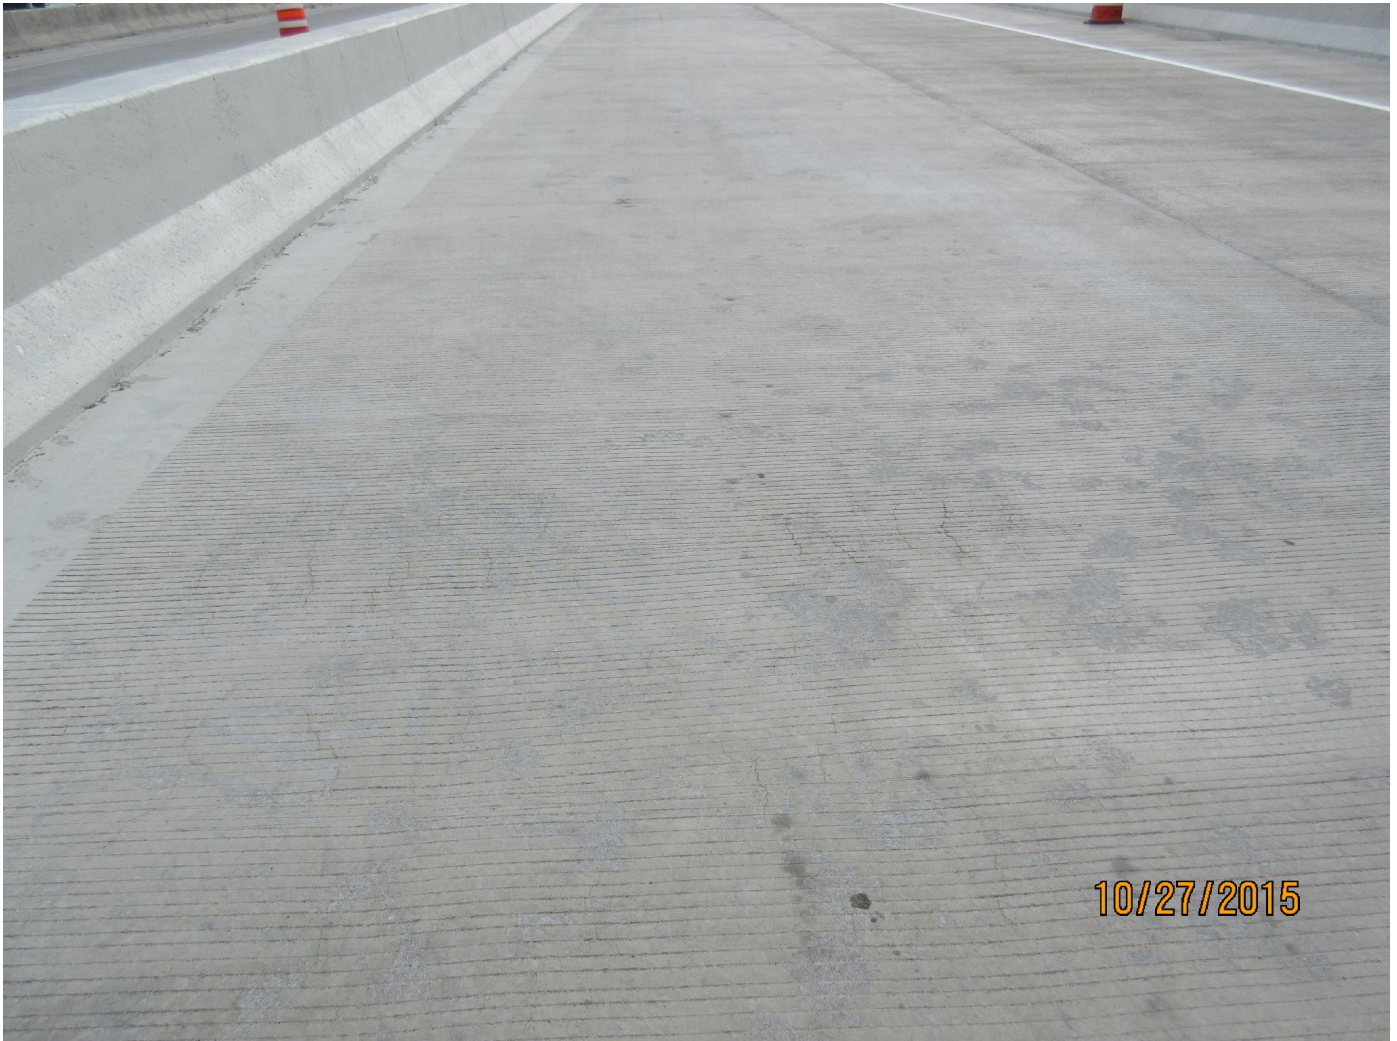
Typical overlay cracking.

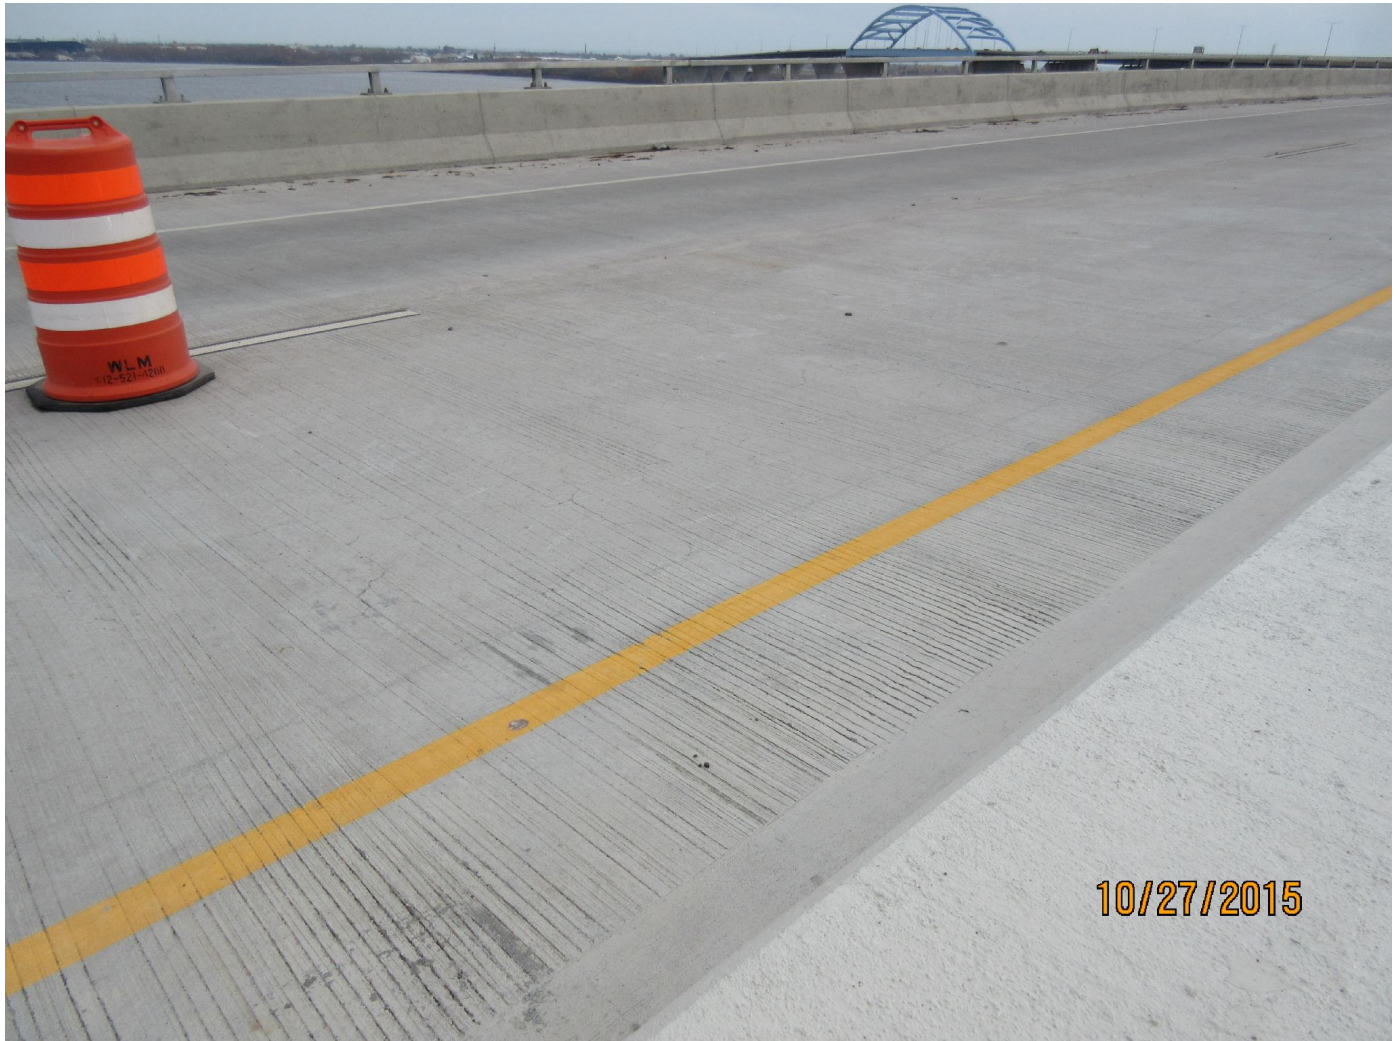
Typical cracking in overlay.

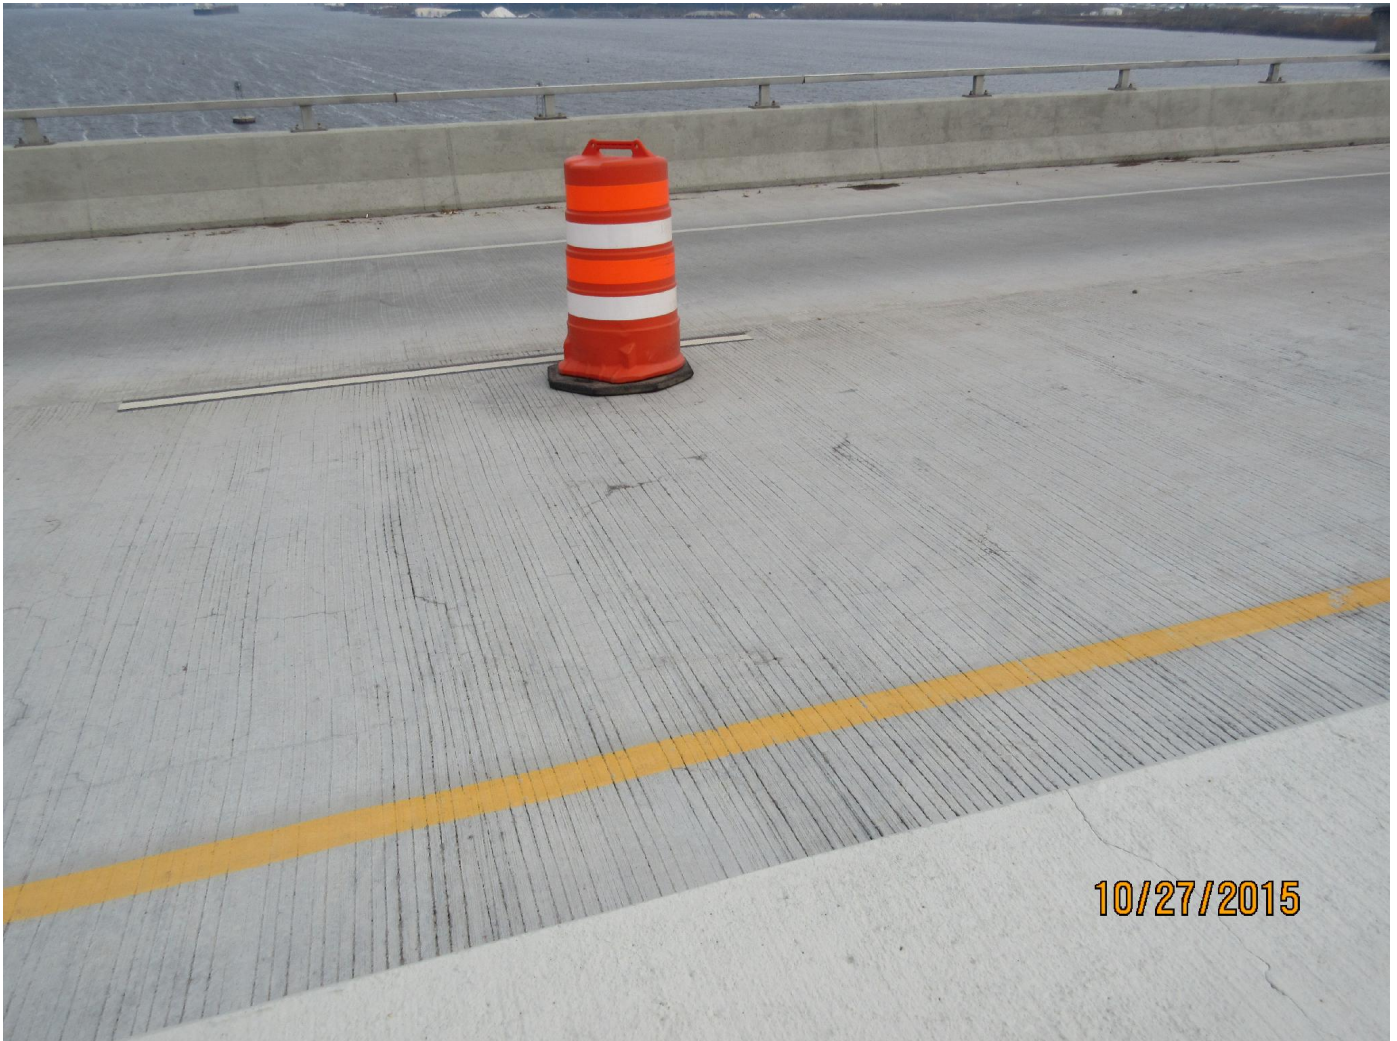
Typical cracking in overlay.

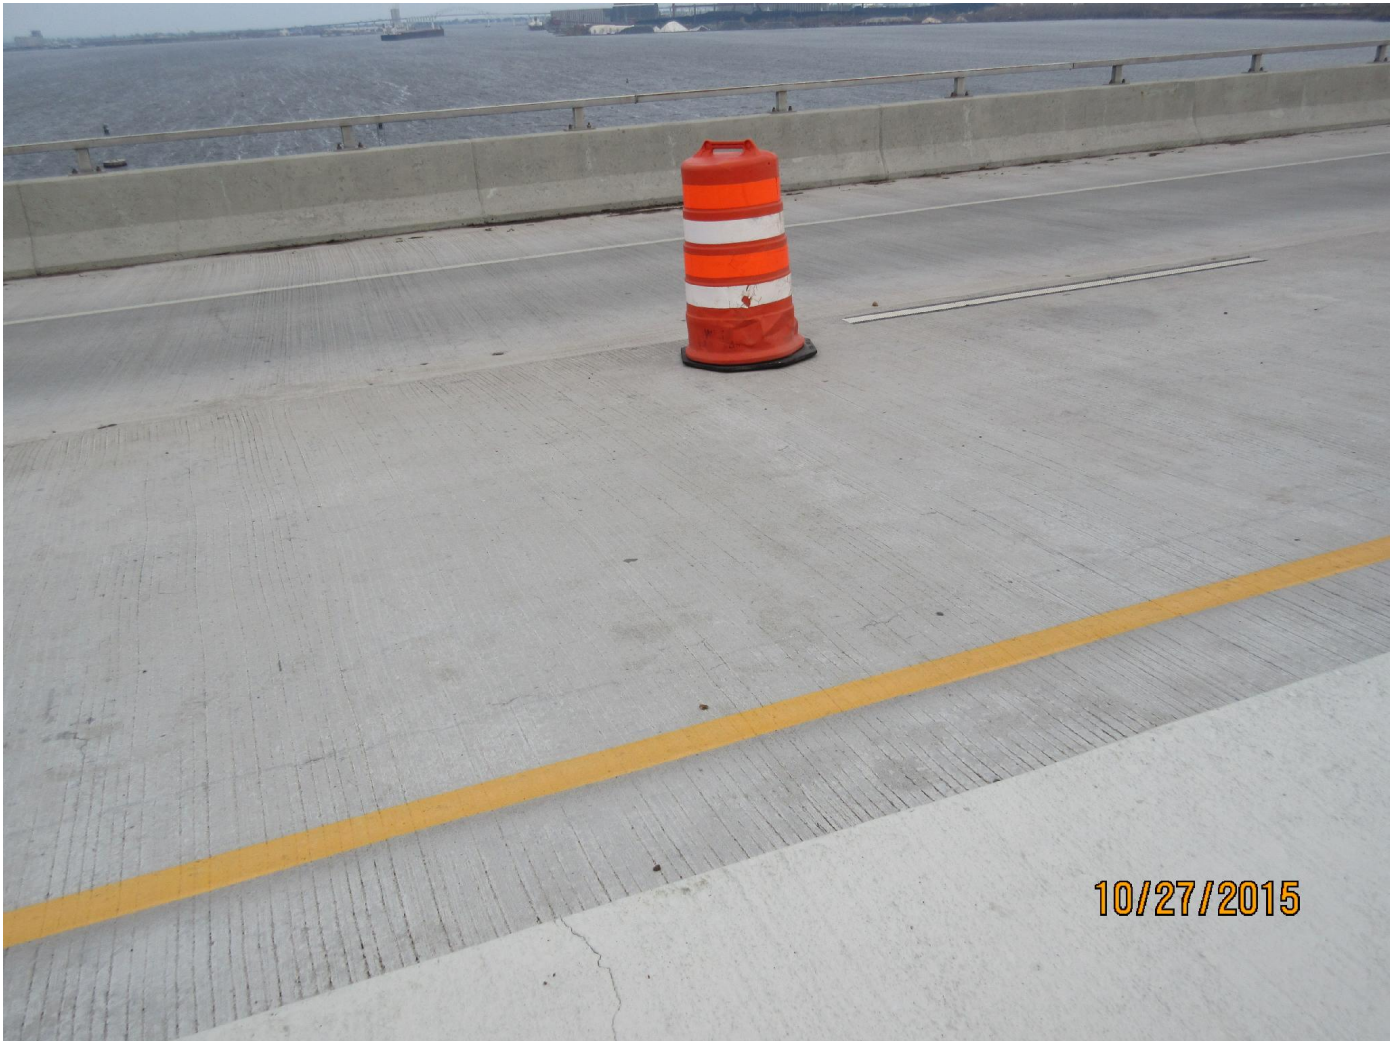
Typical cracking in overlay.

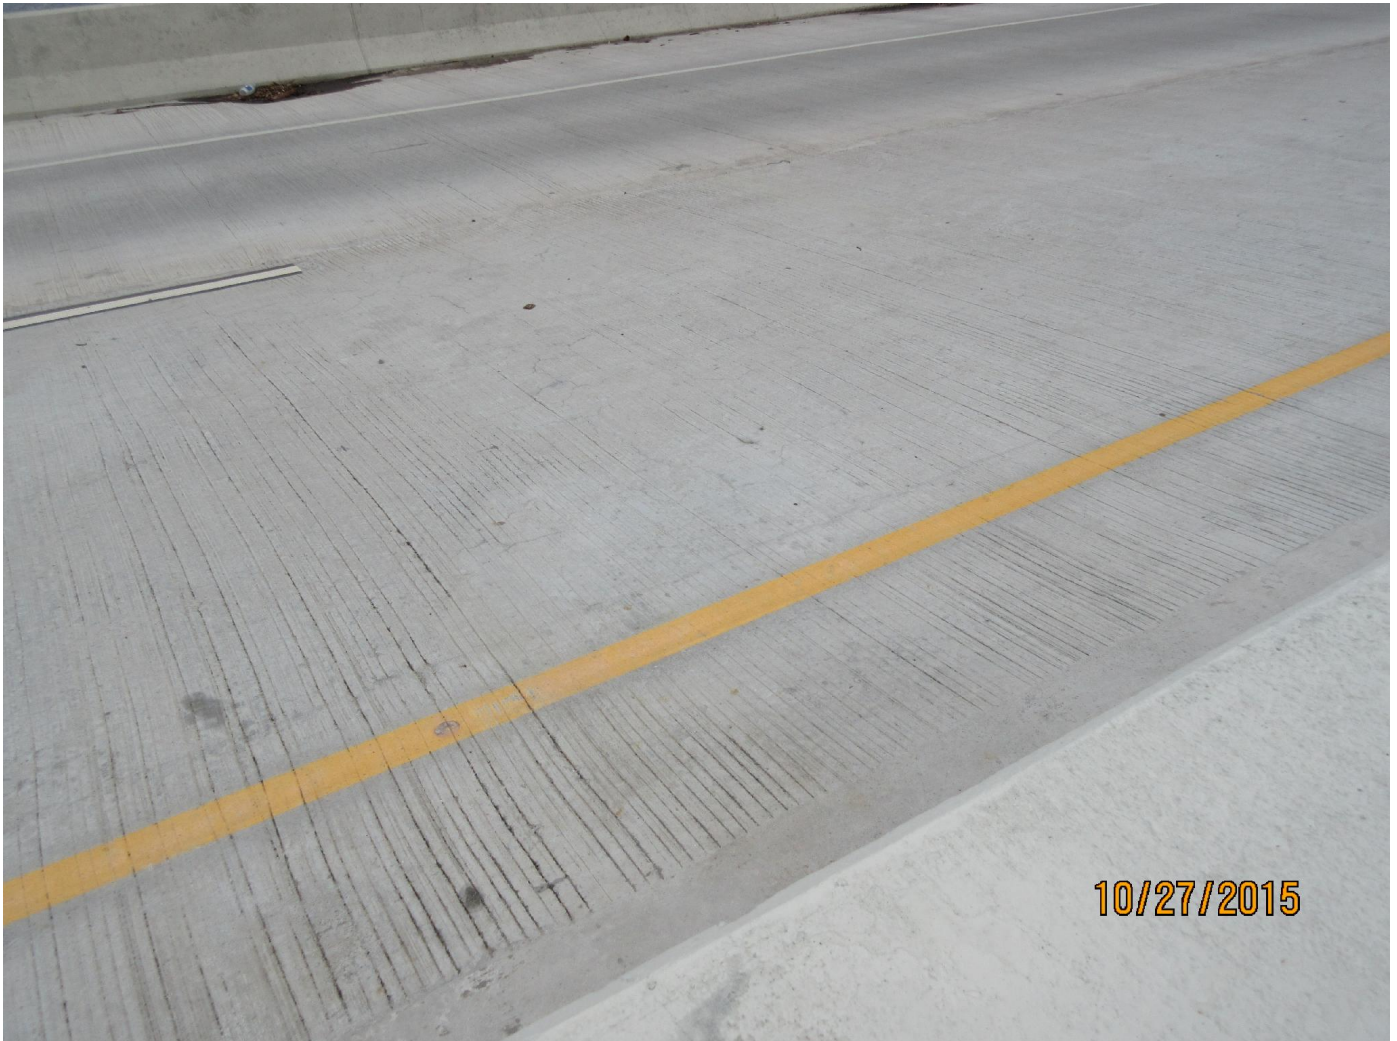
Typical cracking in overlay.

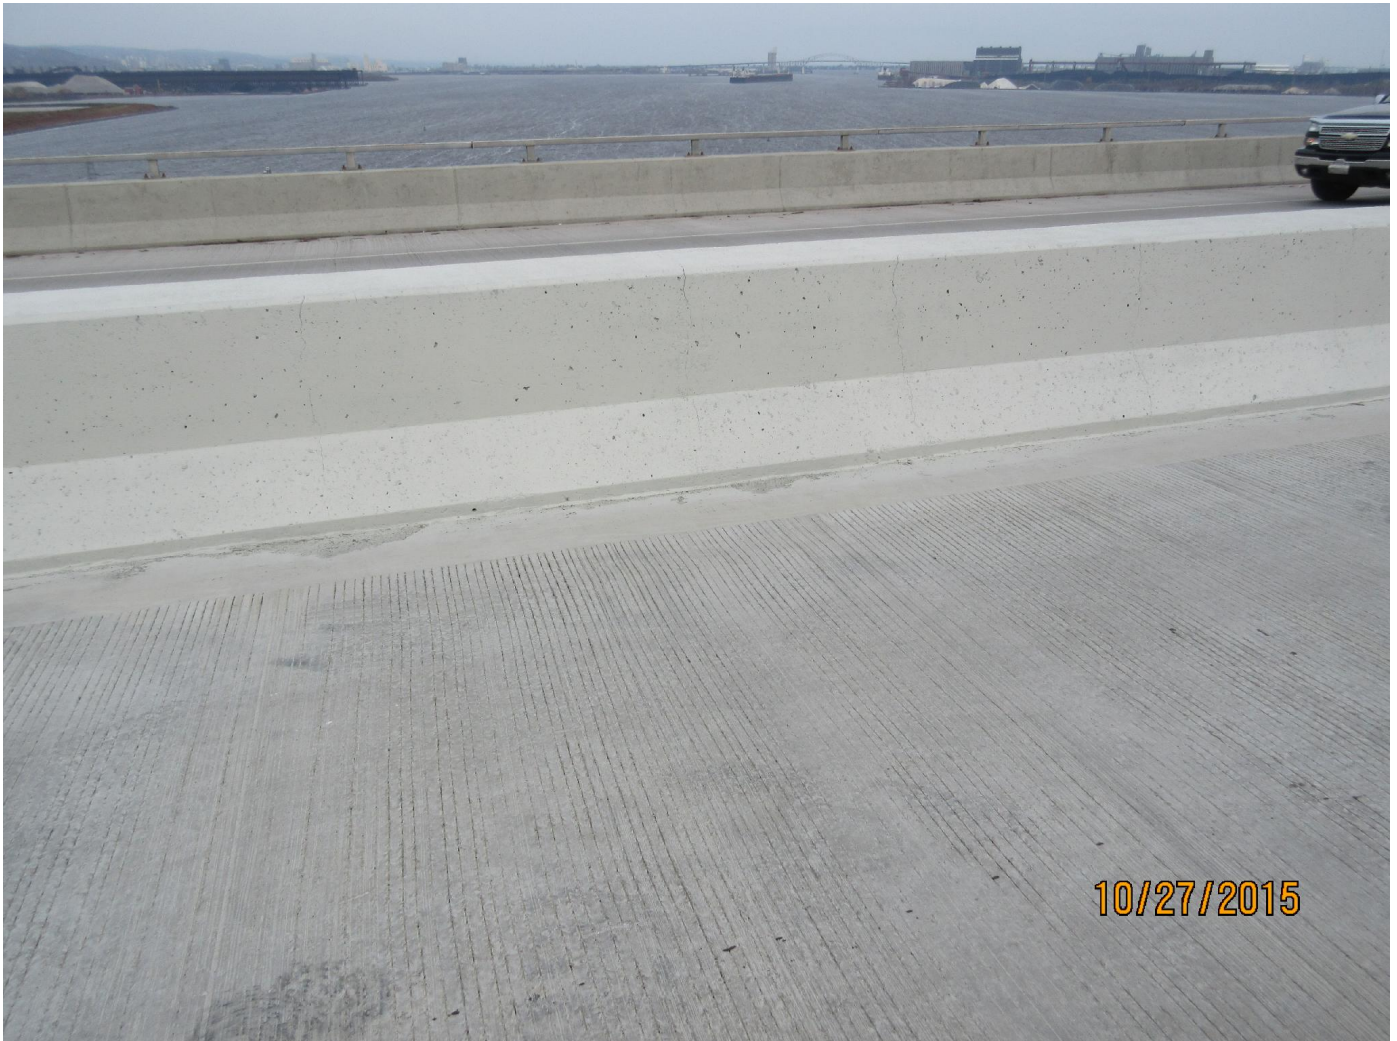
Typical cracking in parapet.

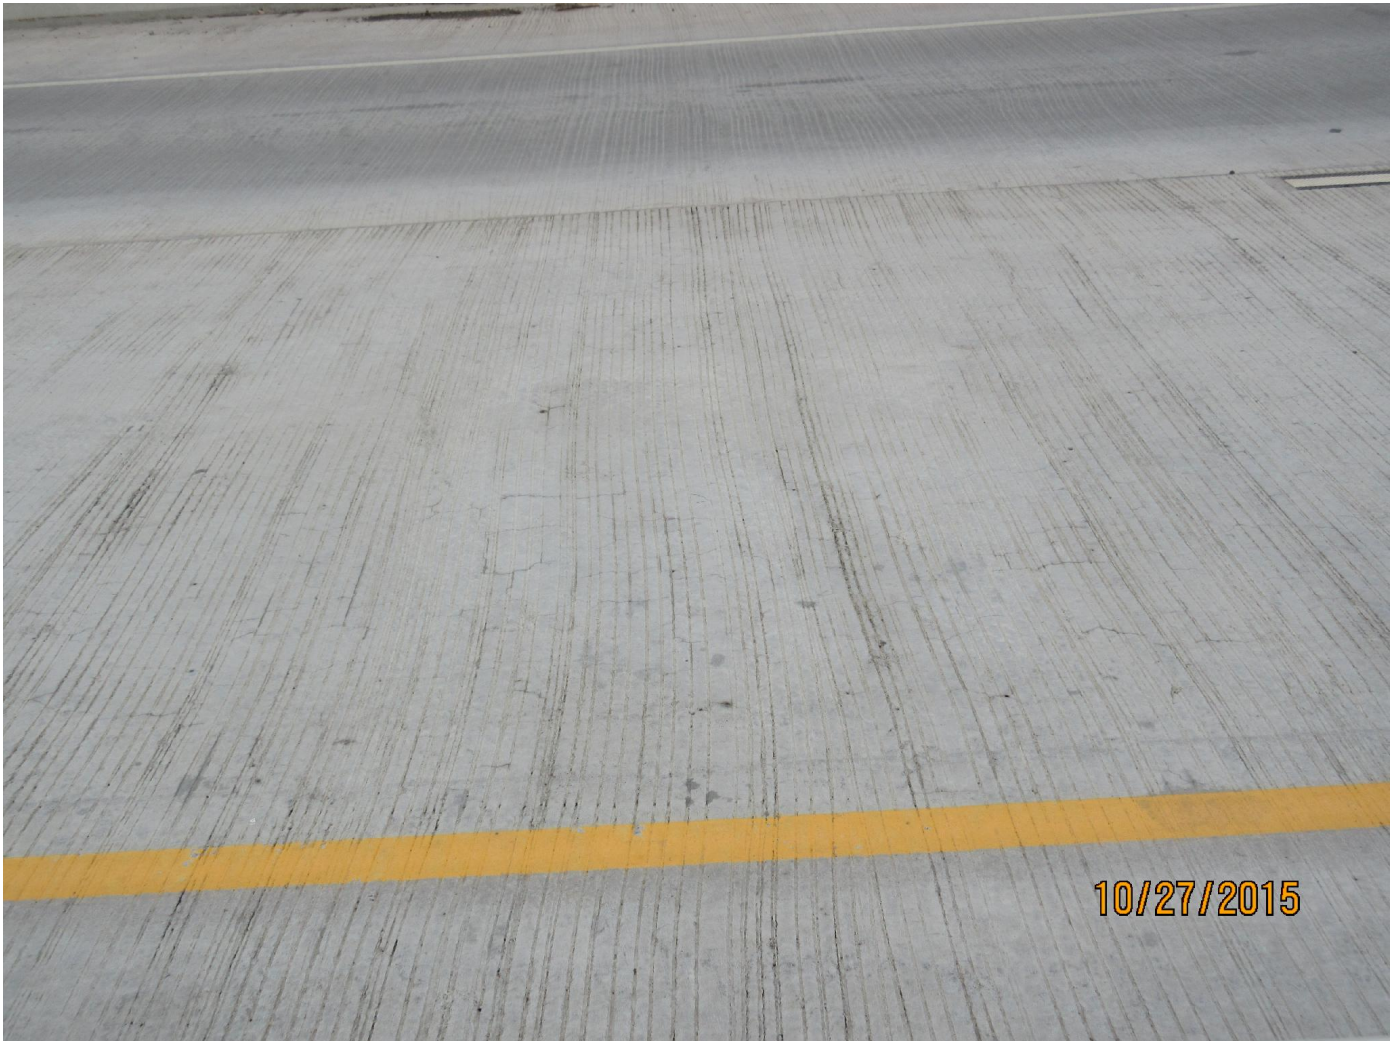
Typical cracking in overlay.

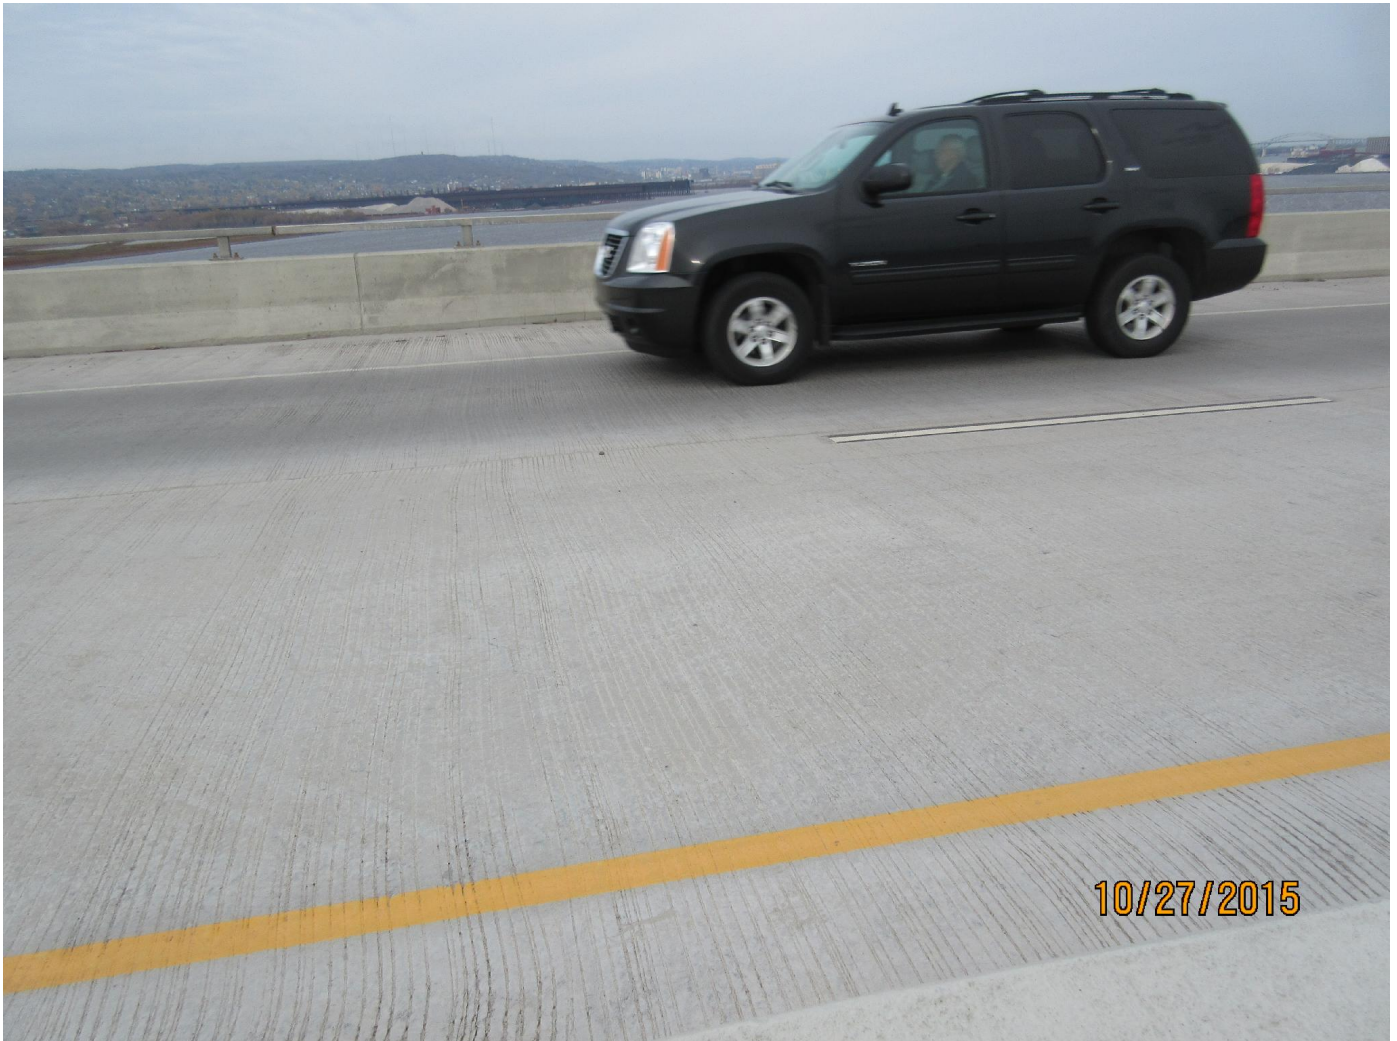
Typical cracking in overlay.

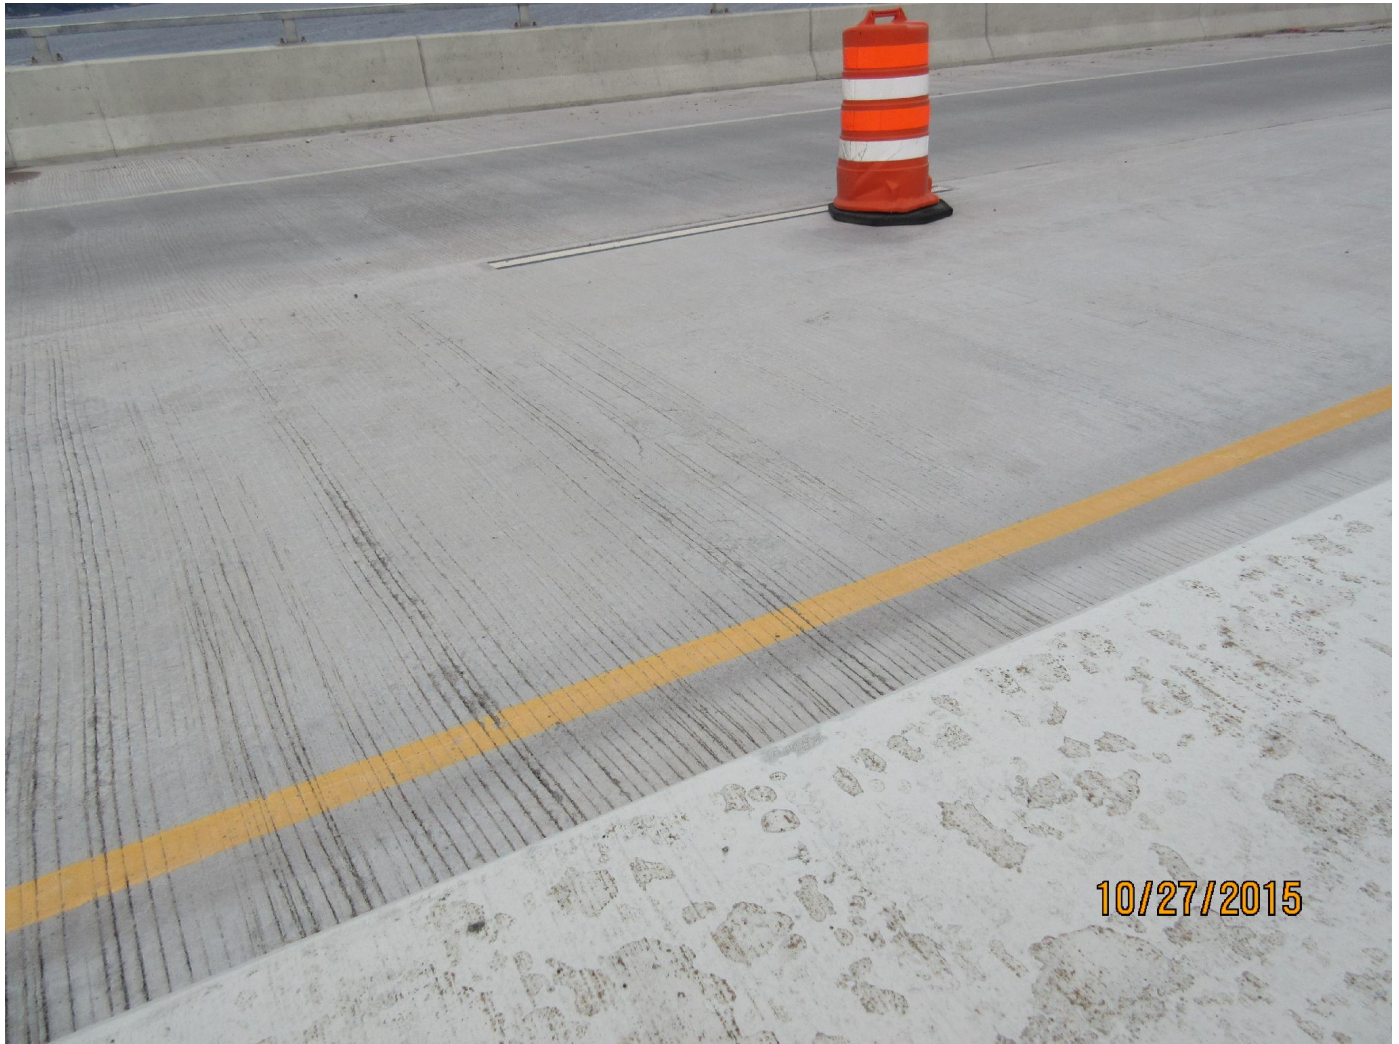
Typical cracking in overlay.
