**STATE OF WISCONSIN
DEPARTMENT OF TRANSPORTATION**

**Inspection Report for
B-16-038-0003**

**USH 2 over BN Rail Road
Oct 19, 2015**

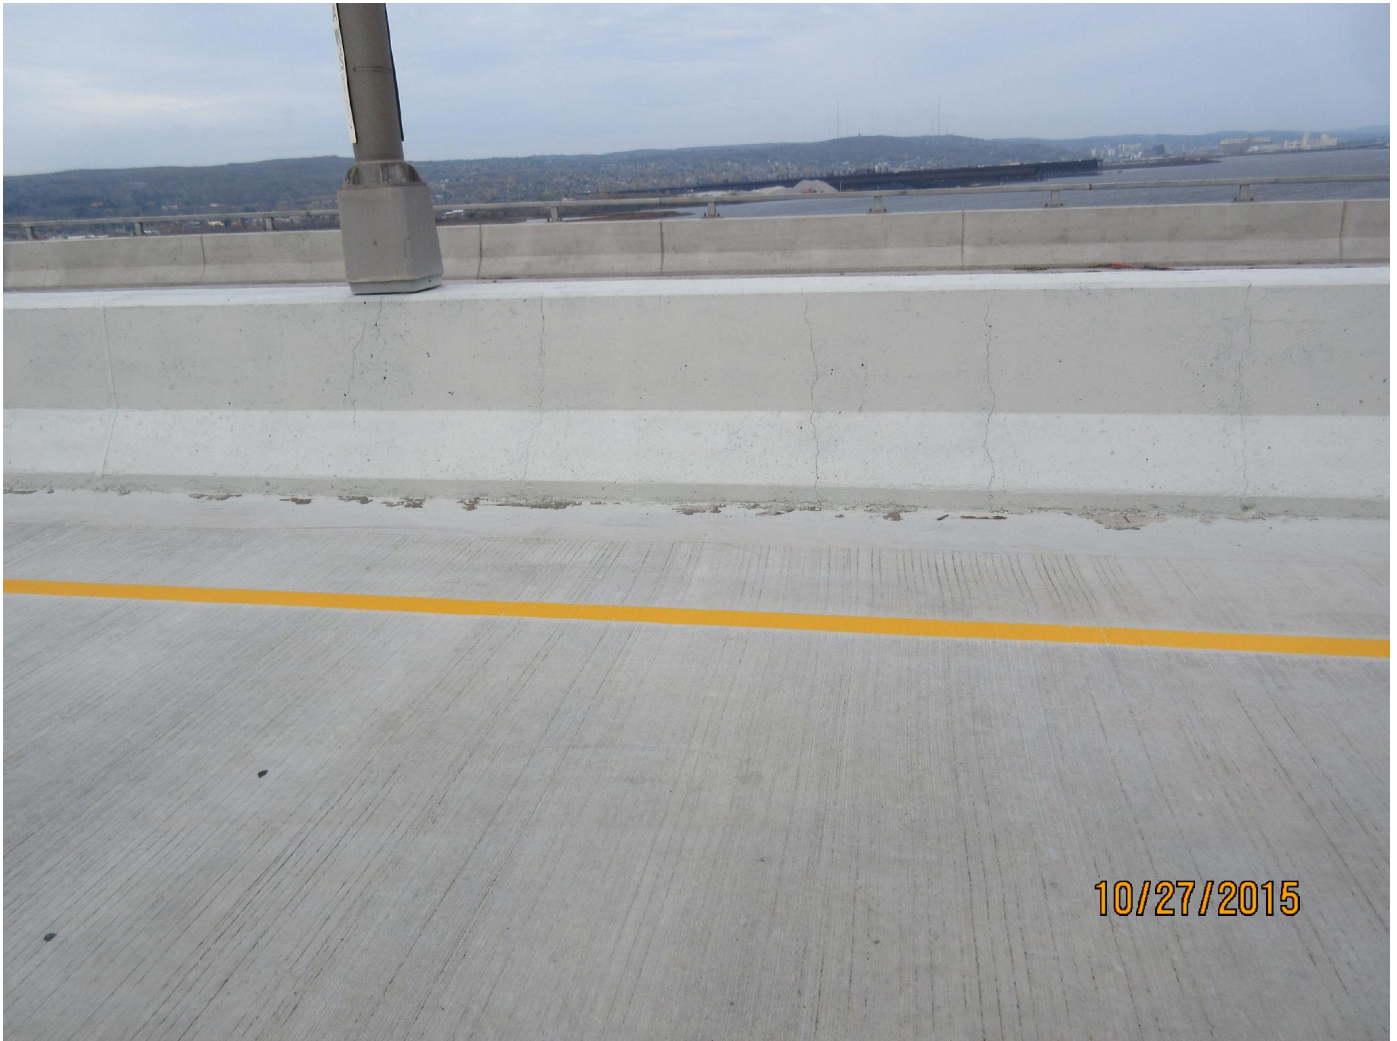
Cracking in median parapet.

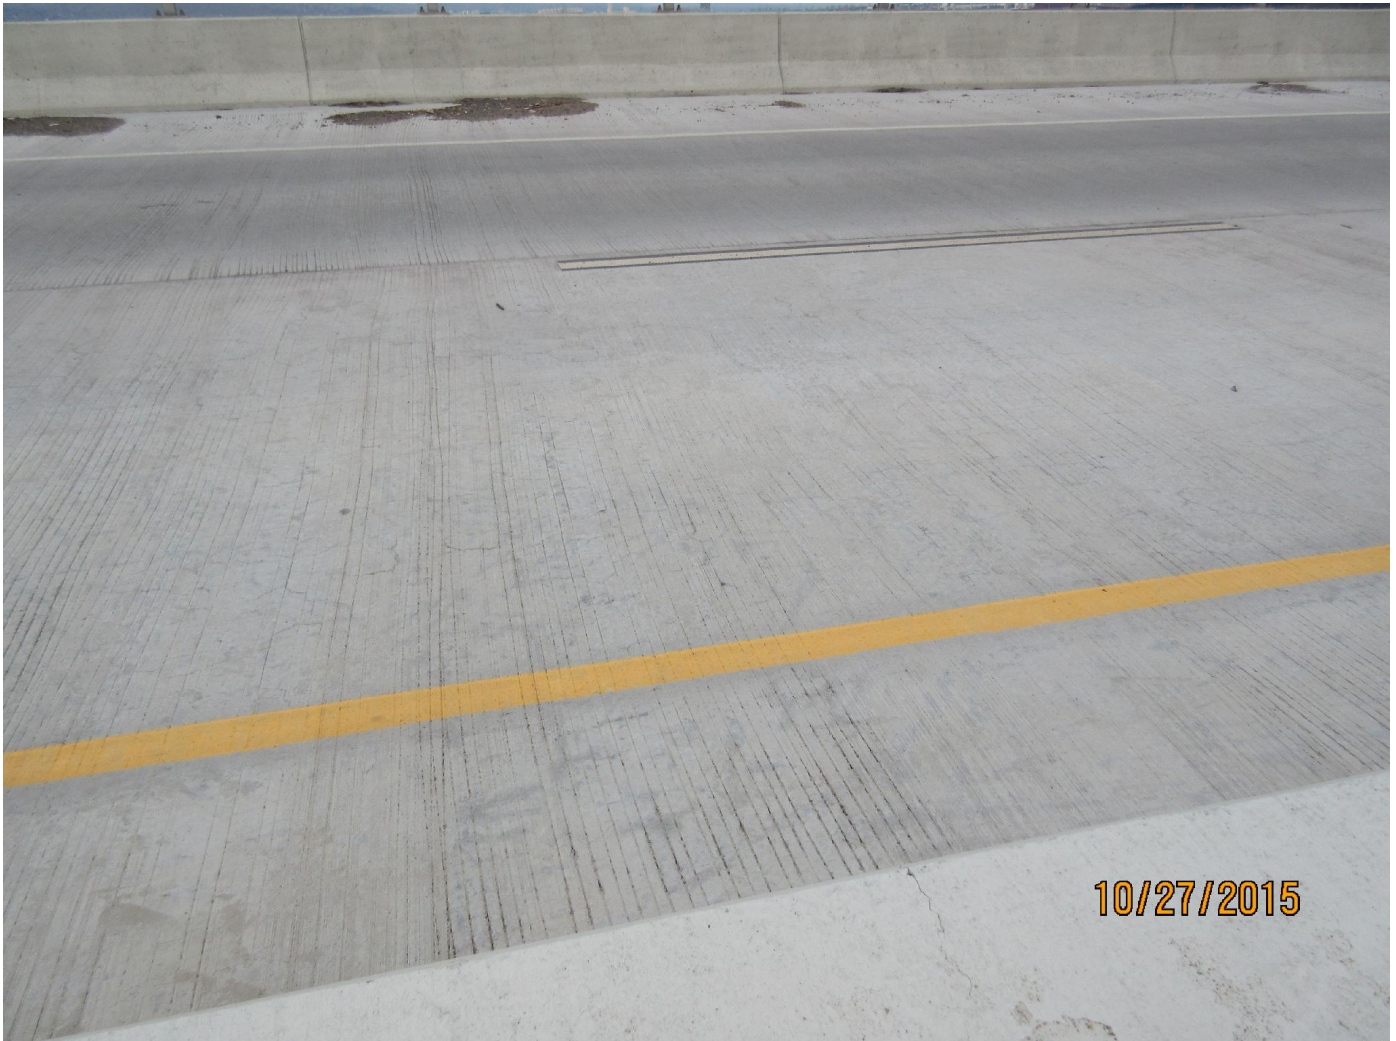
Typical cracking in overlay.

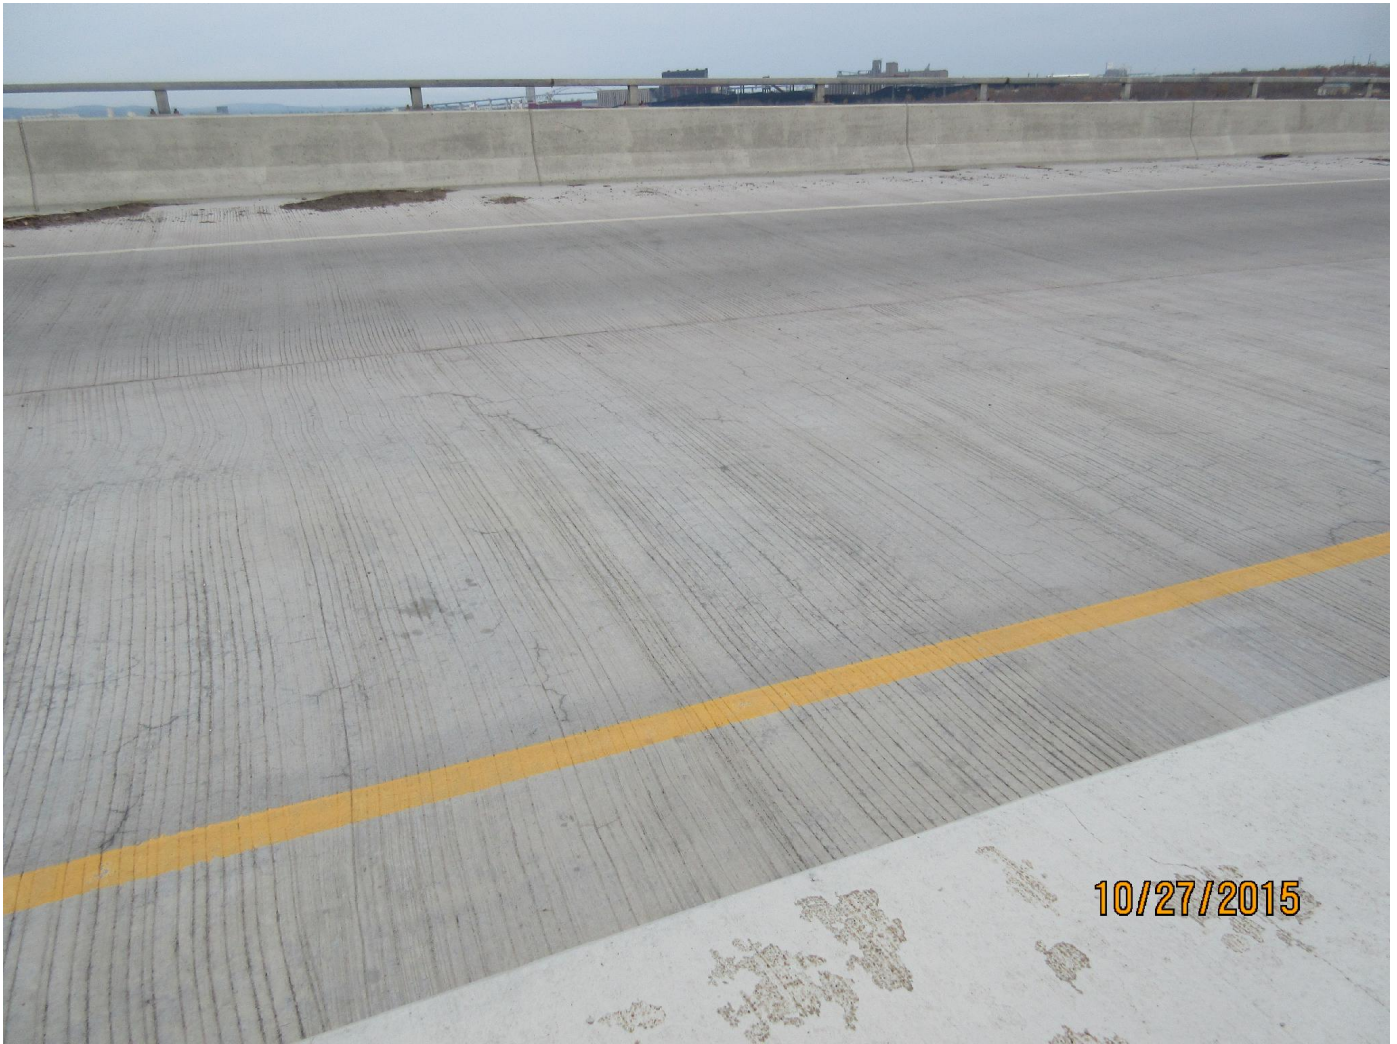
Typical cracking in overlay.

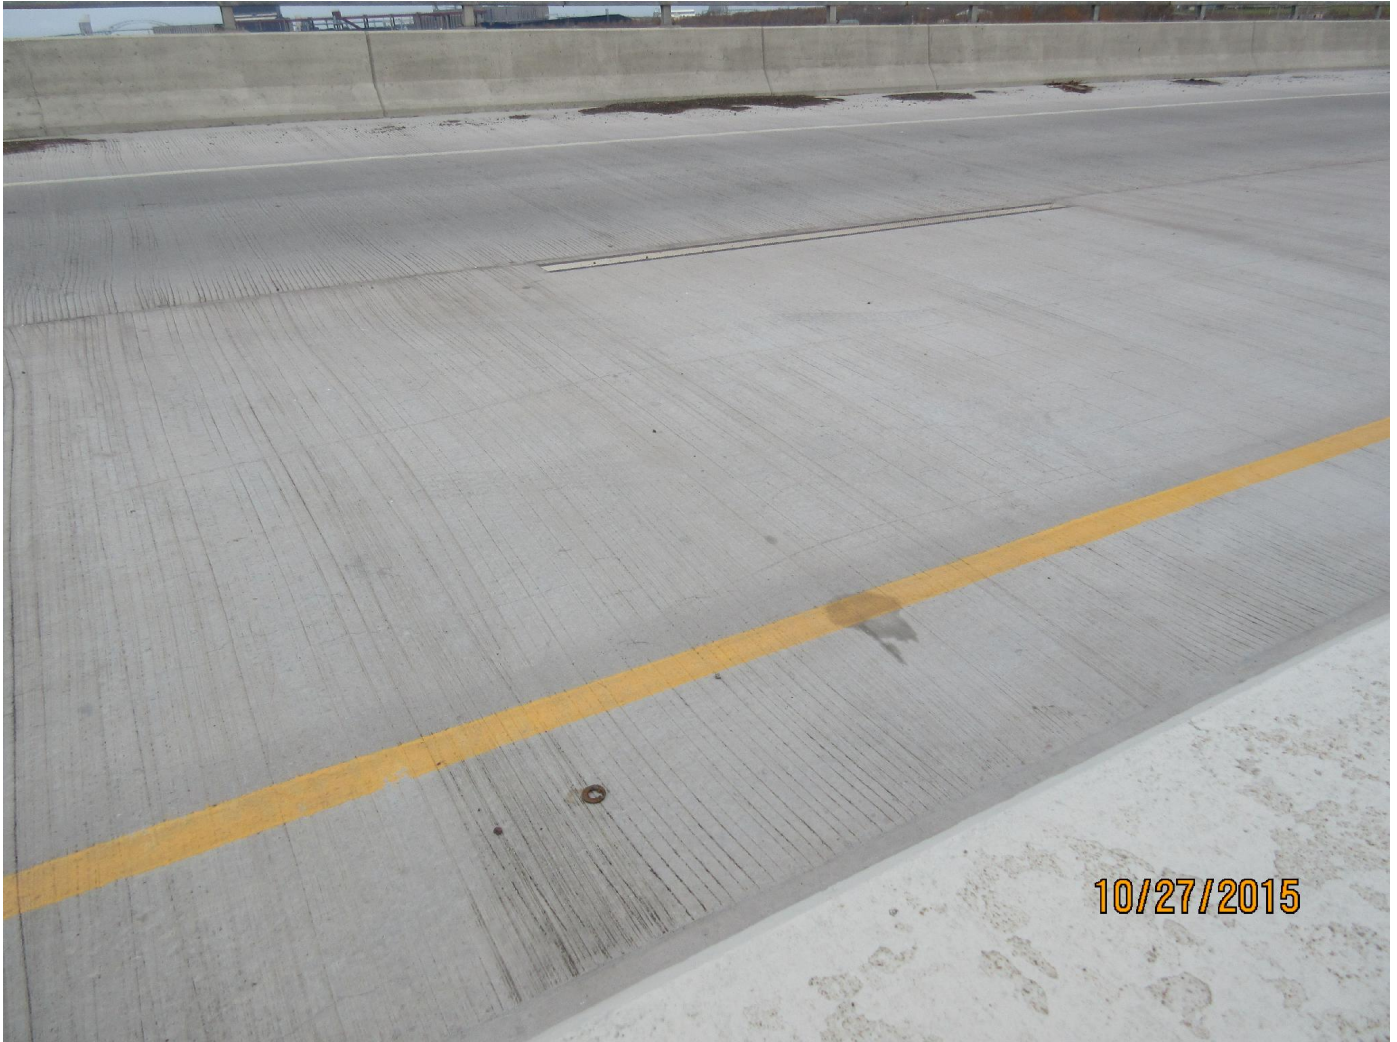
Typical cracking in overlay.

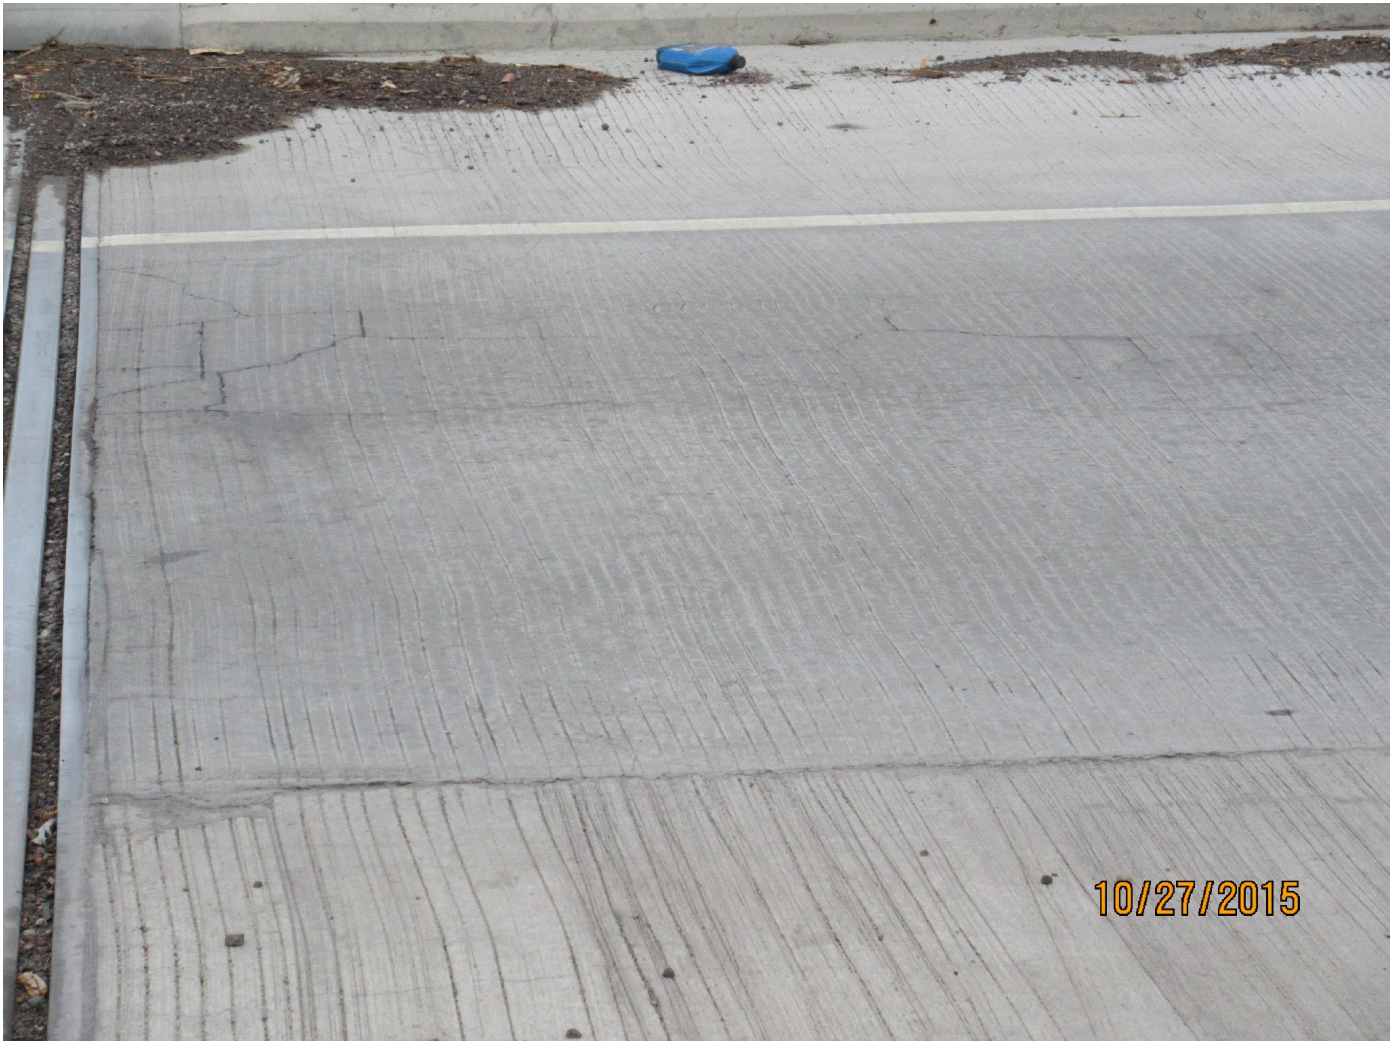
Typical overlay cracking.

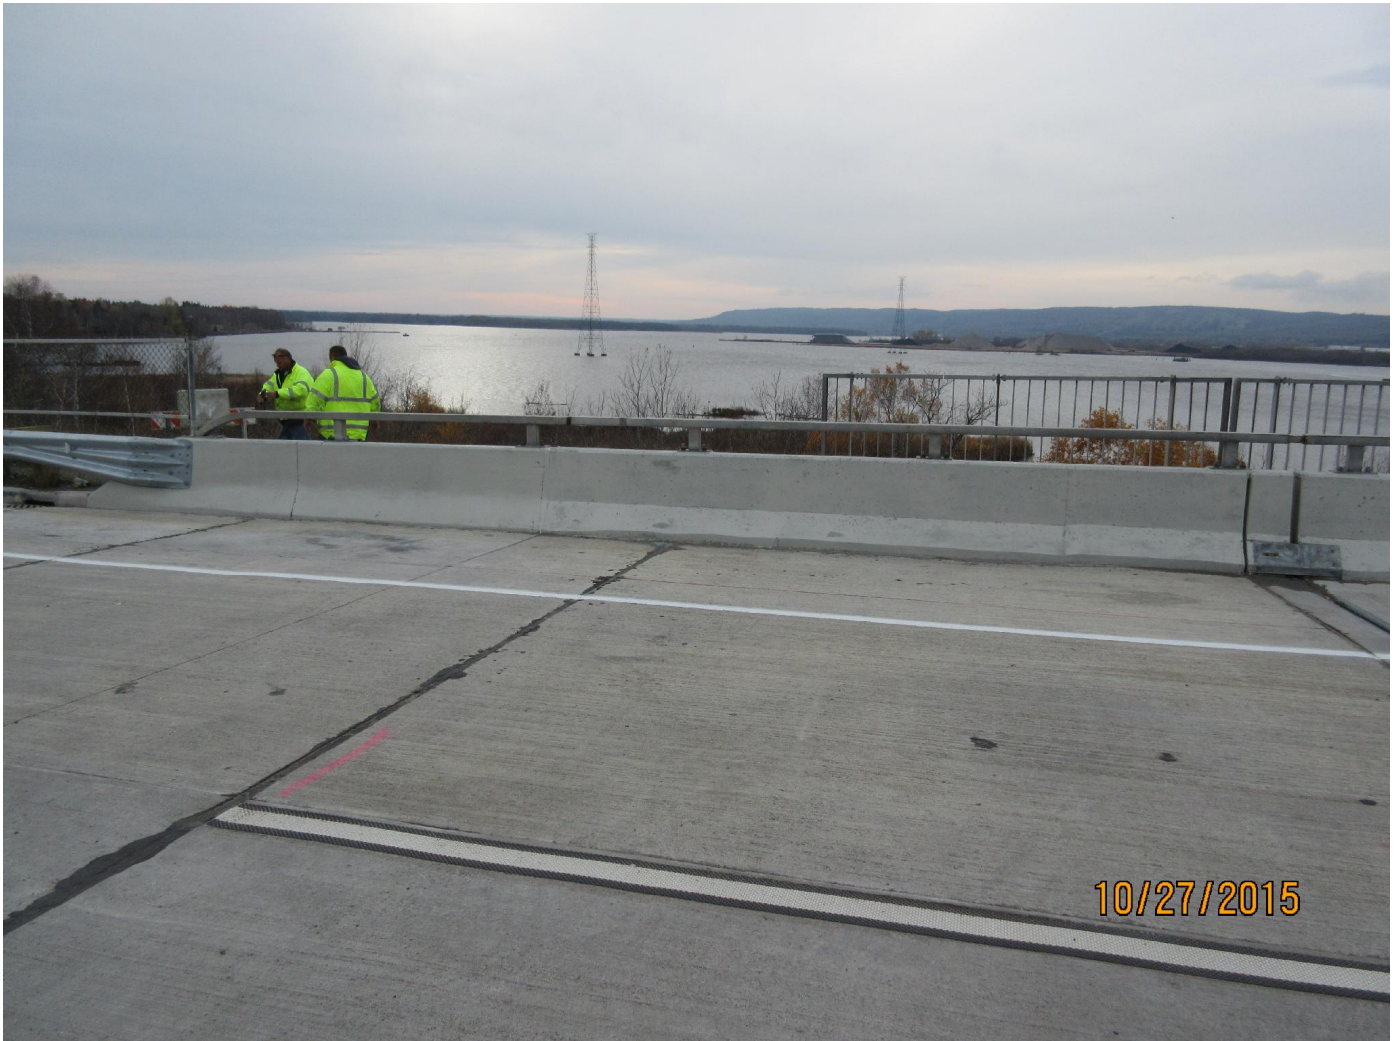
Repaired SE approach parapet.

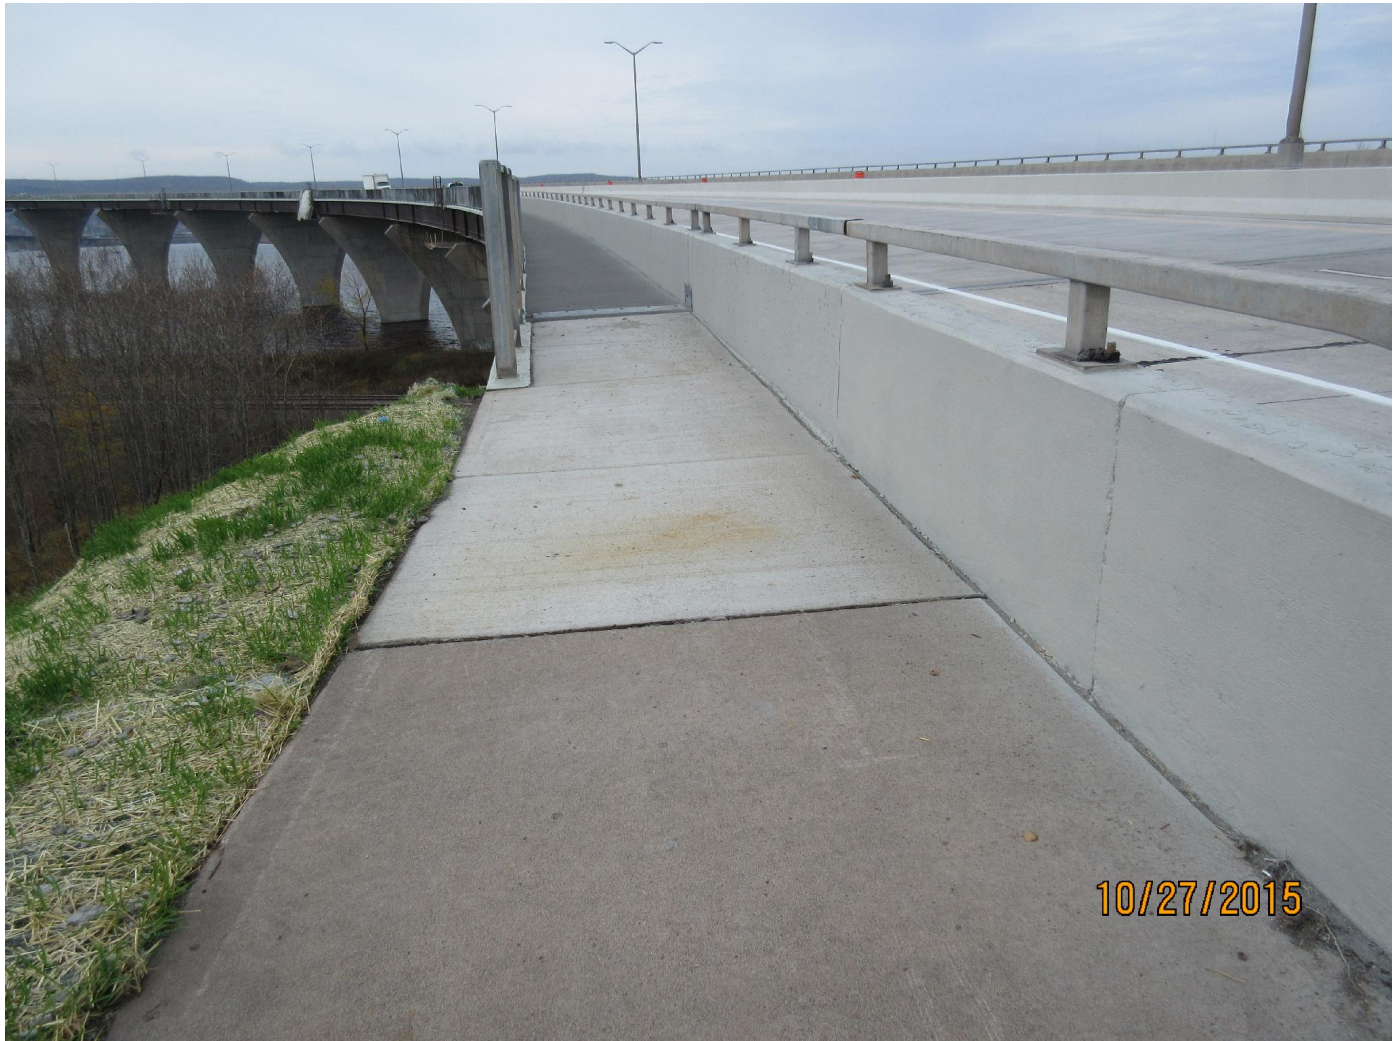
Repaired SE approach sidewalk.

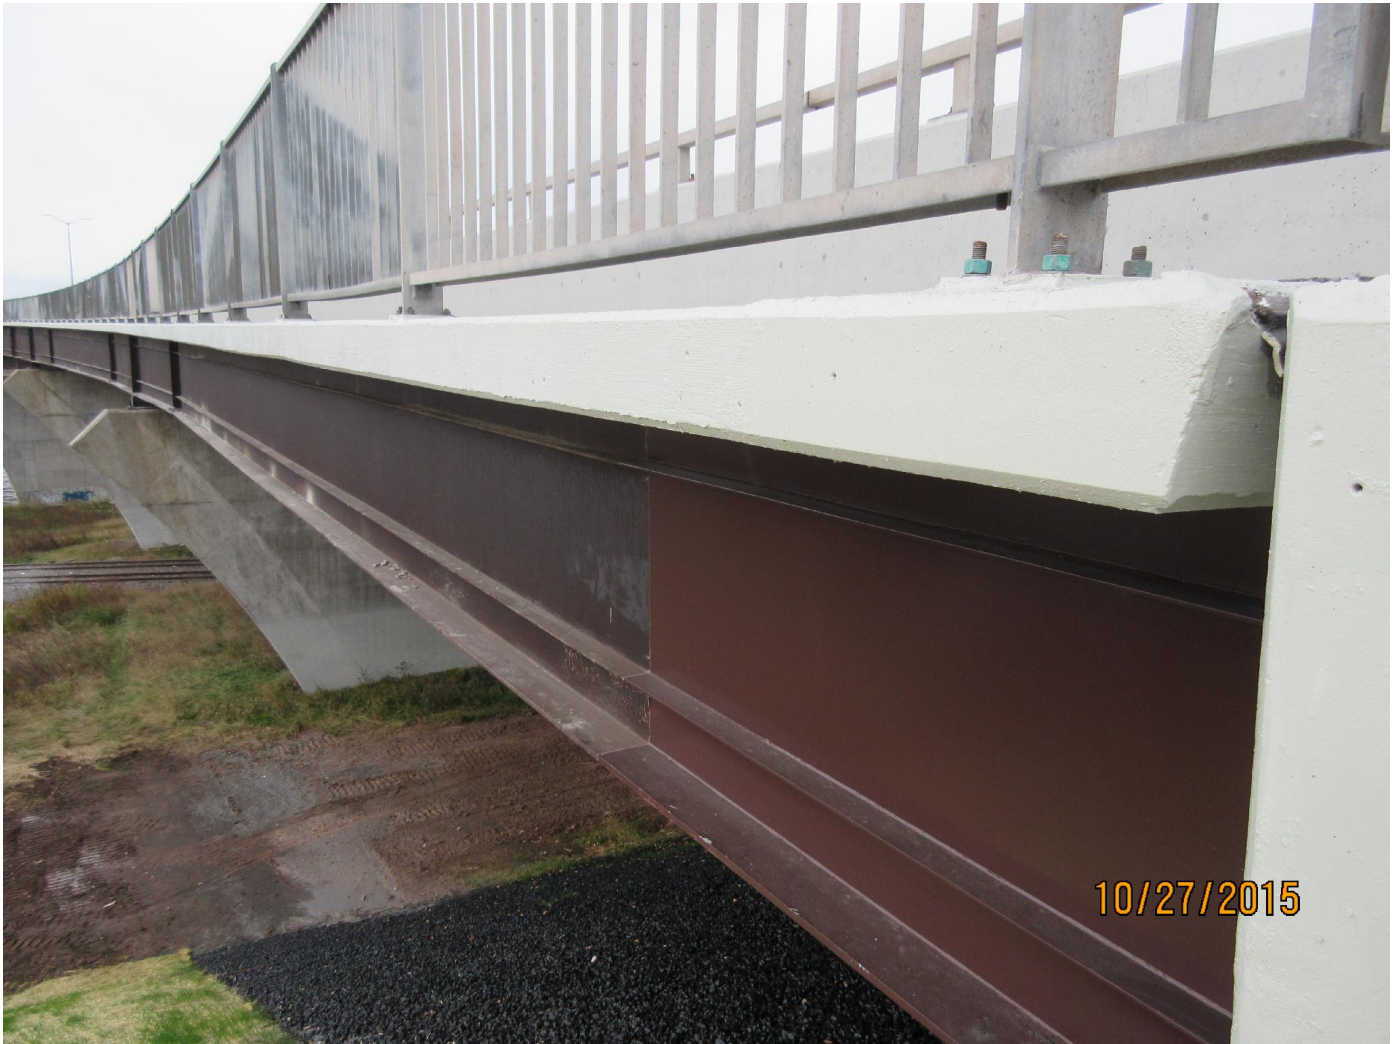
Typical sidewalk edge repair.

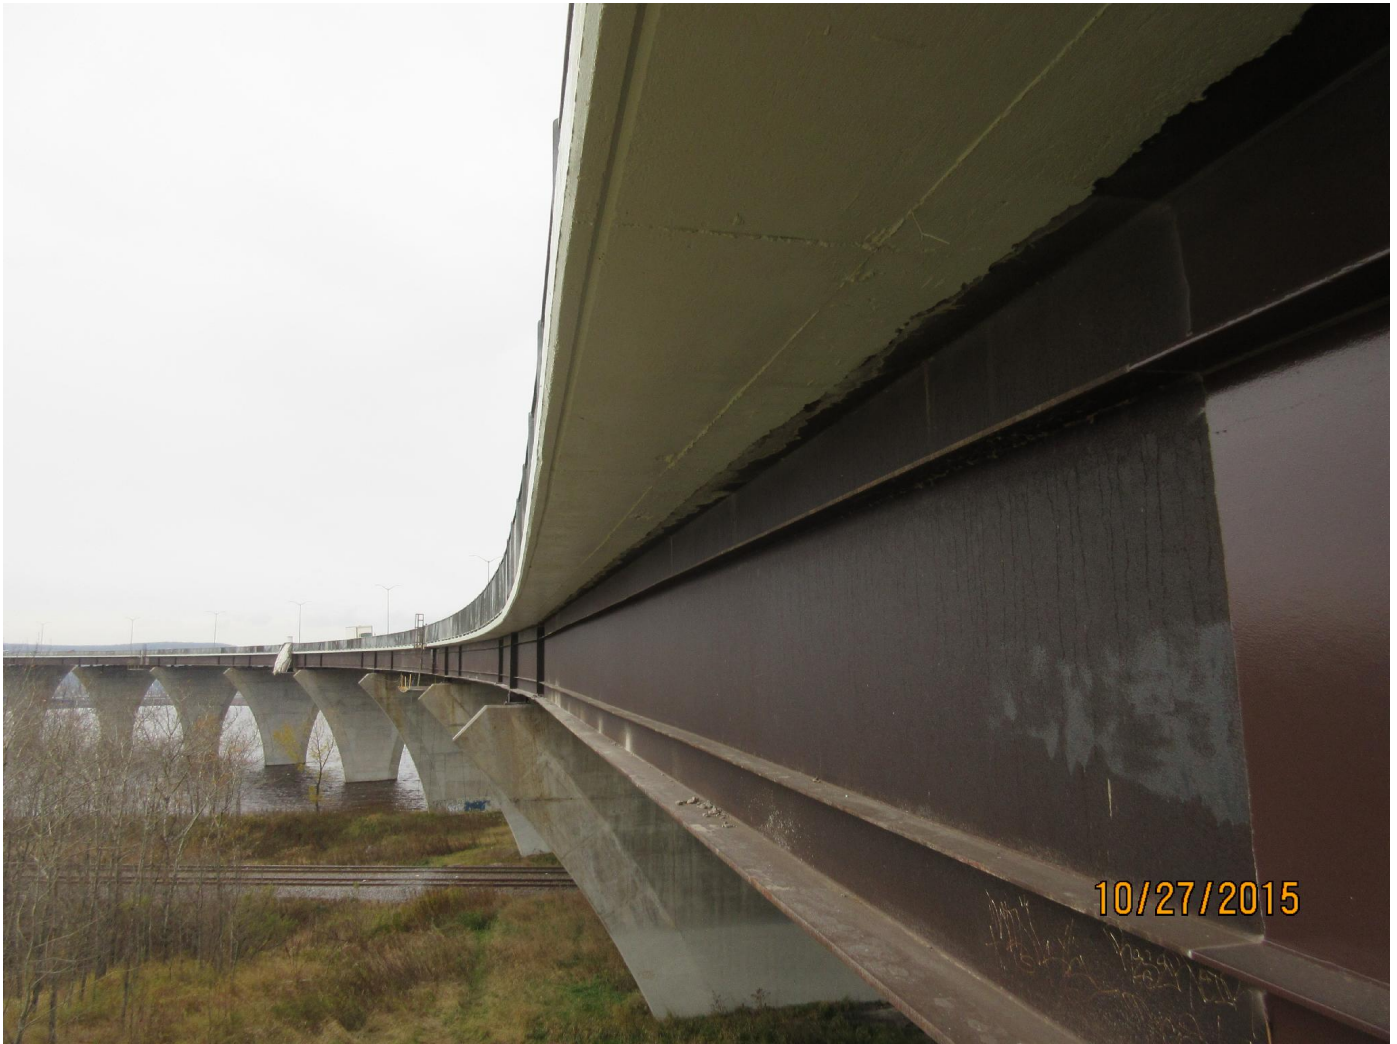
Typical sidewalk edge repair.

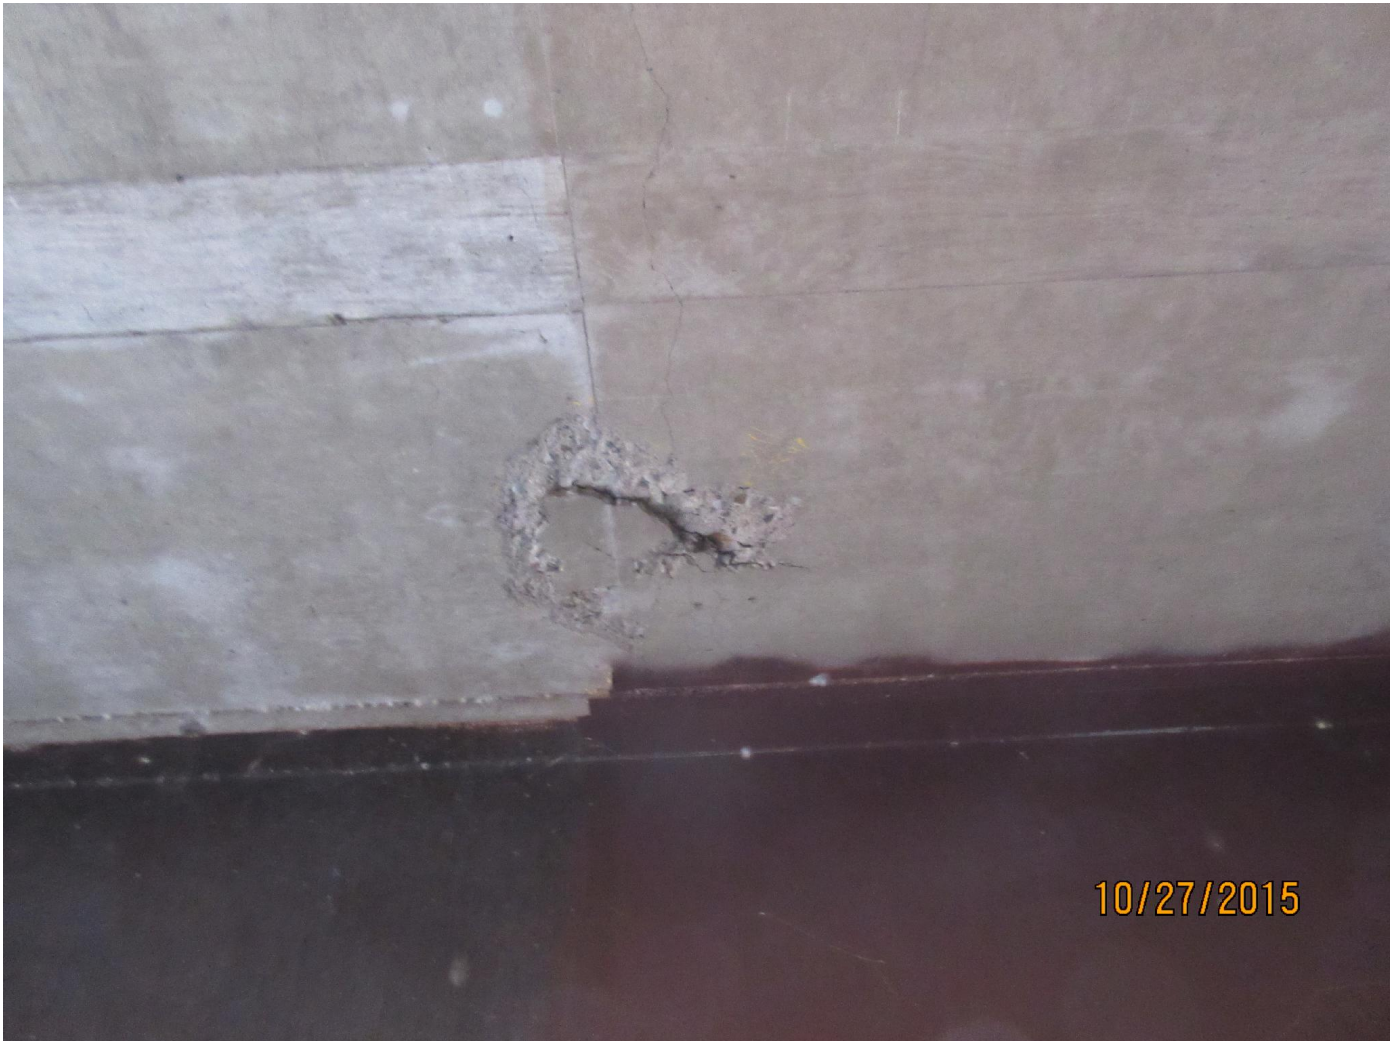
Spall in bay 2 near east abutment.

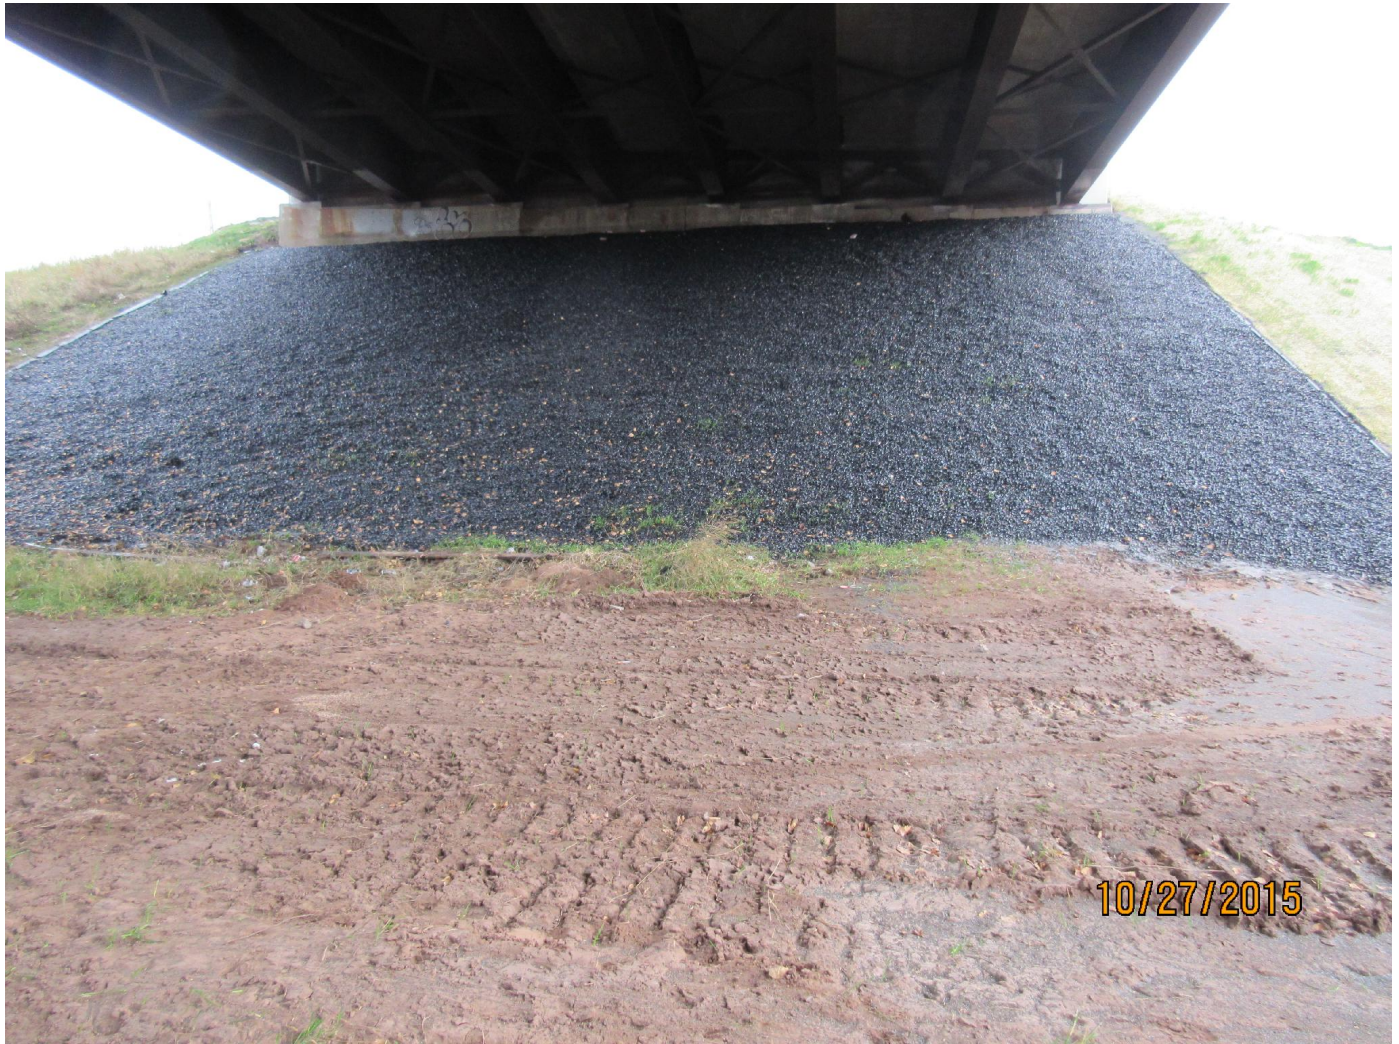
Restored and resealed east slope paving.
