**Inspection Report for
B-16-038-0001**

**USH 2 over IH 35-MINNESOTA
Oct 19,2015**

Feature On: USH 2	Section Town Range: S08 T49N R14W	Structure Number: B-16-038-0001
Feature Under: IH 35-MINNESOTA	County: DOUGLAS(16)	
Location 1.1M W MINN STATE LINE	Municipality: CITY-SUPERIOR(16281)	Structure Name:

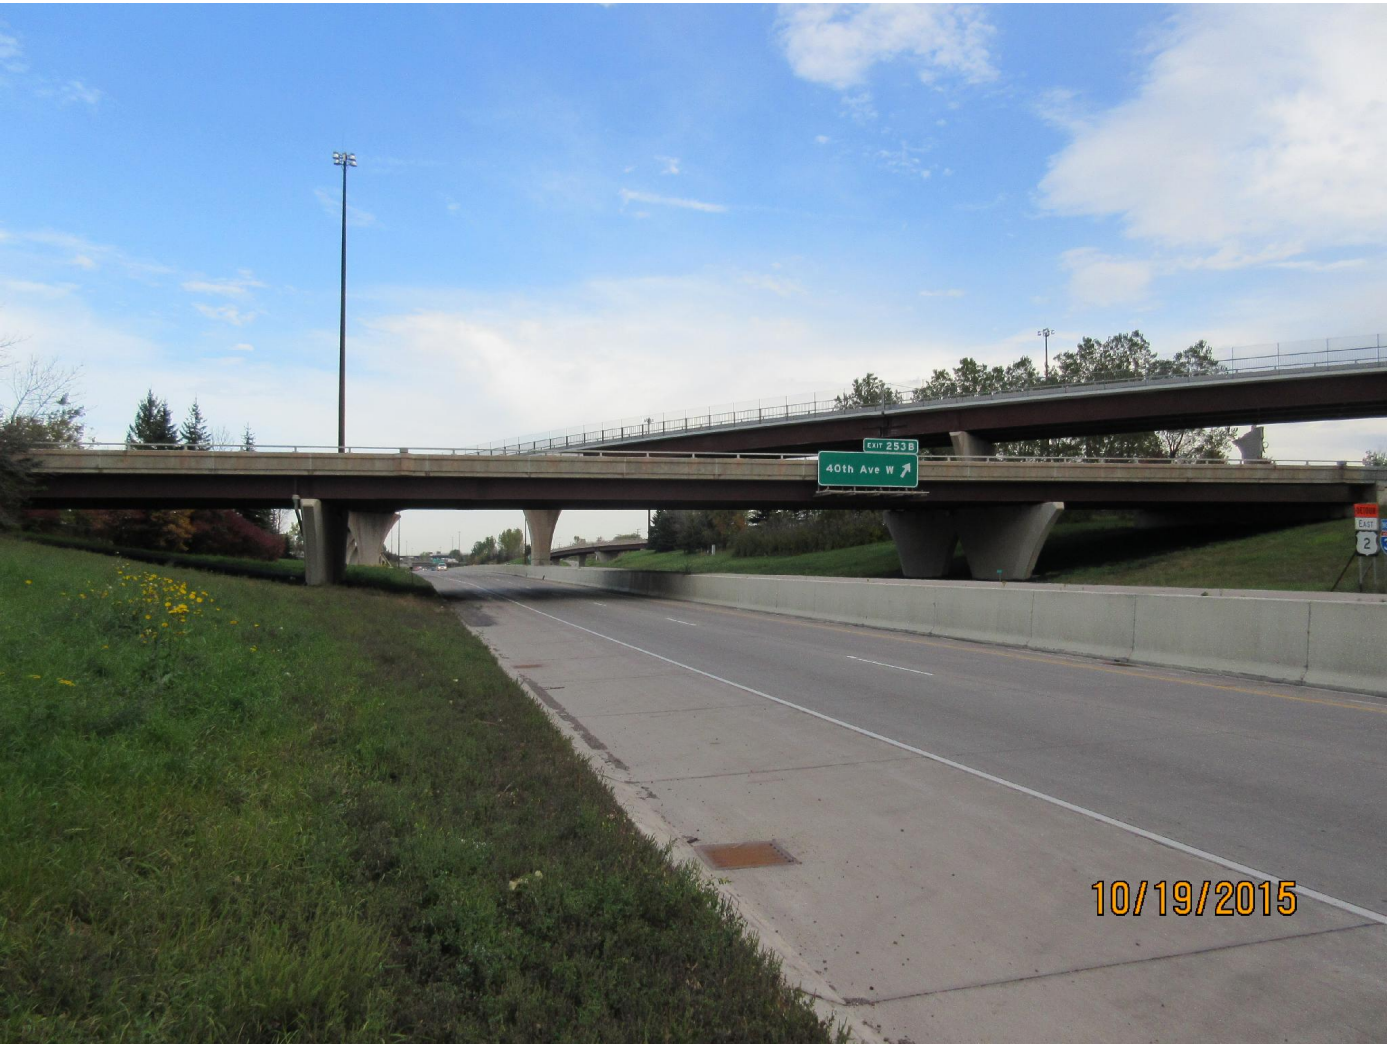
Routine
Document Comment/Description
Looking North from I35

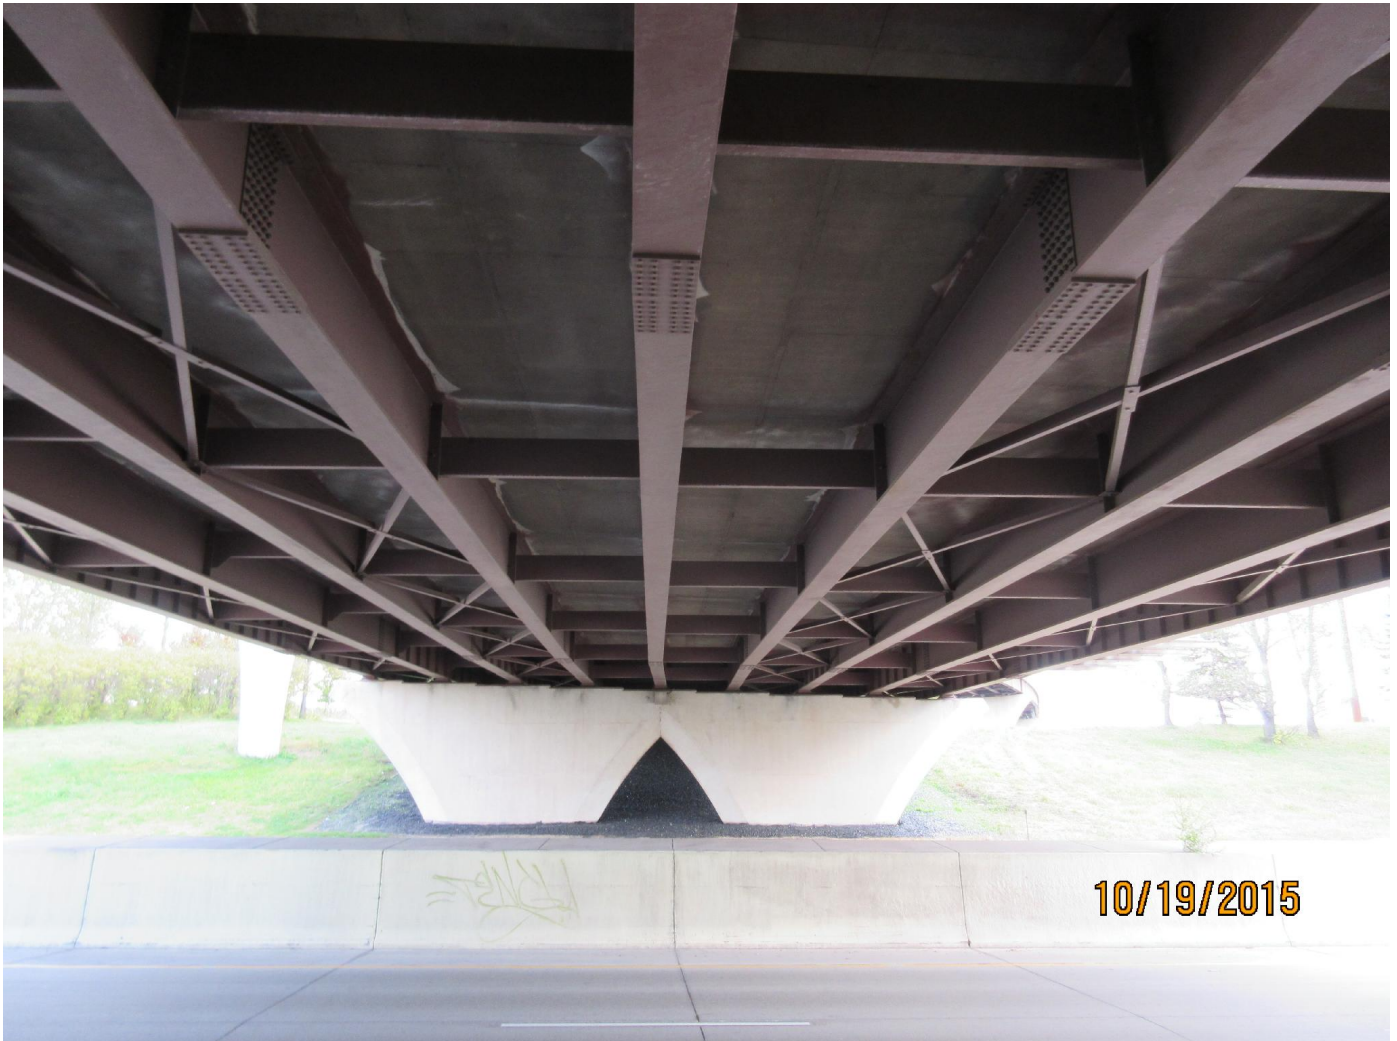
Typical underside over I35.

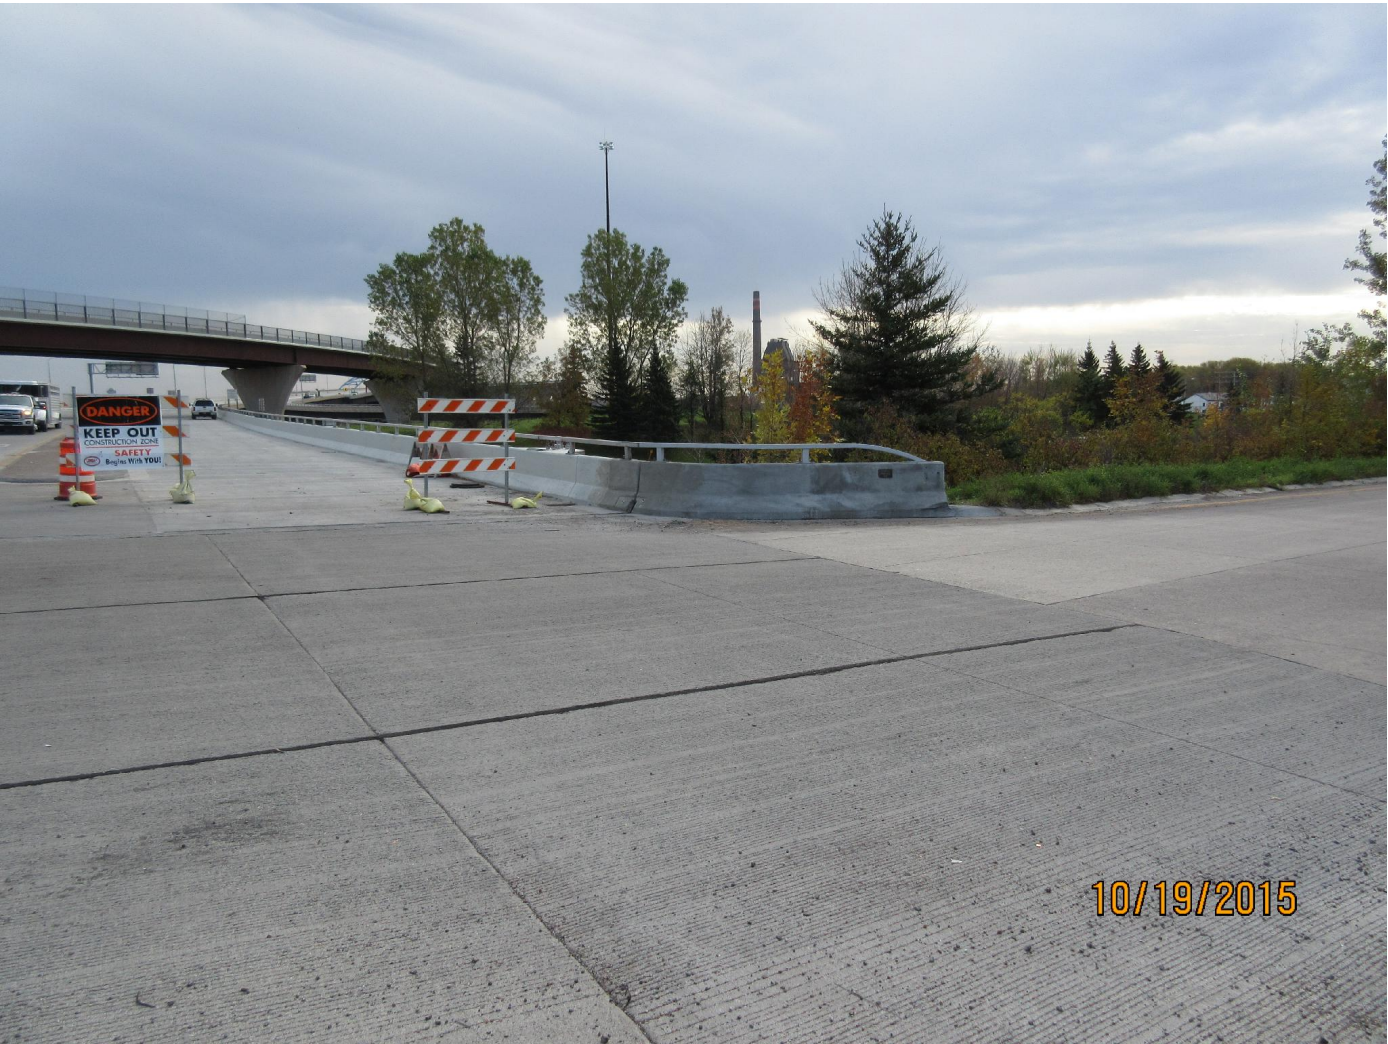
Repaired SW wing.

SW corner top. Repaired 2015.

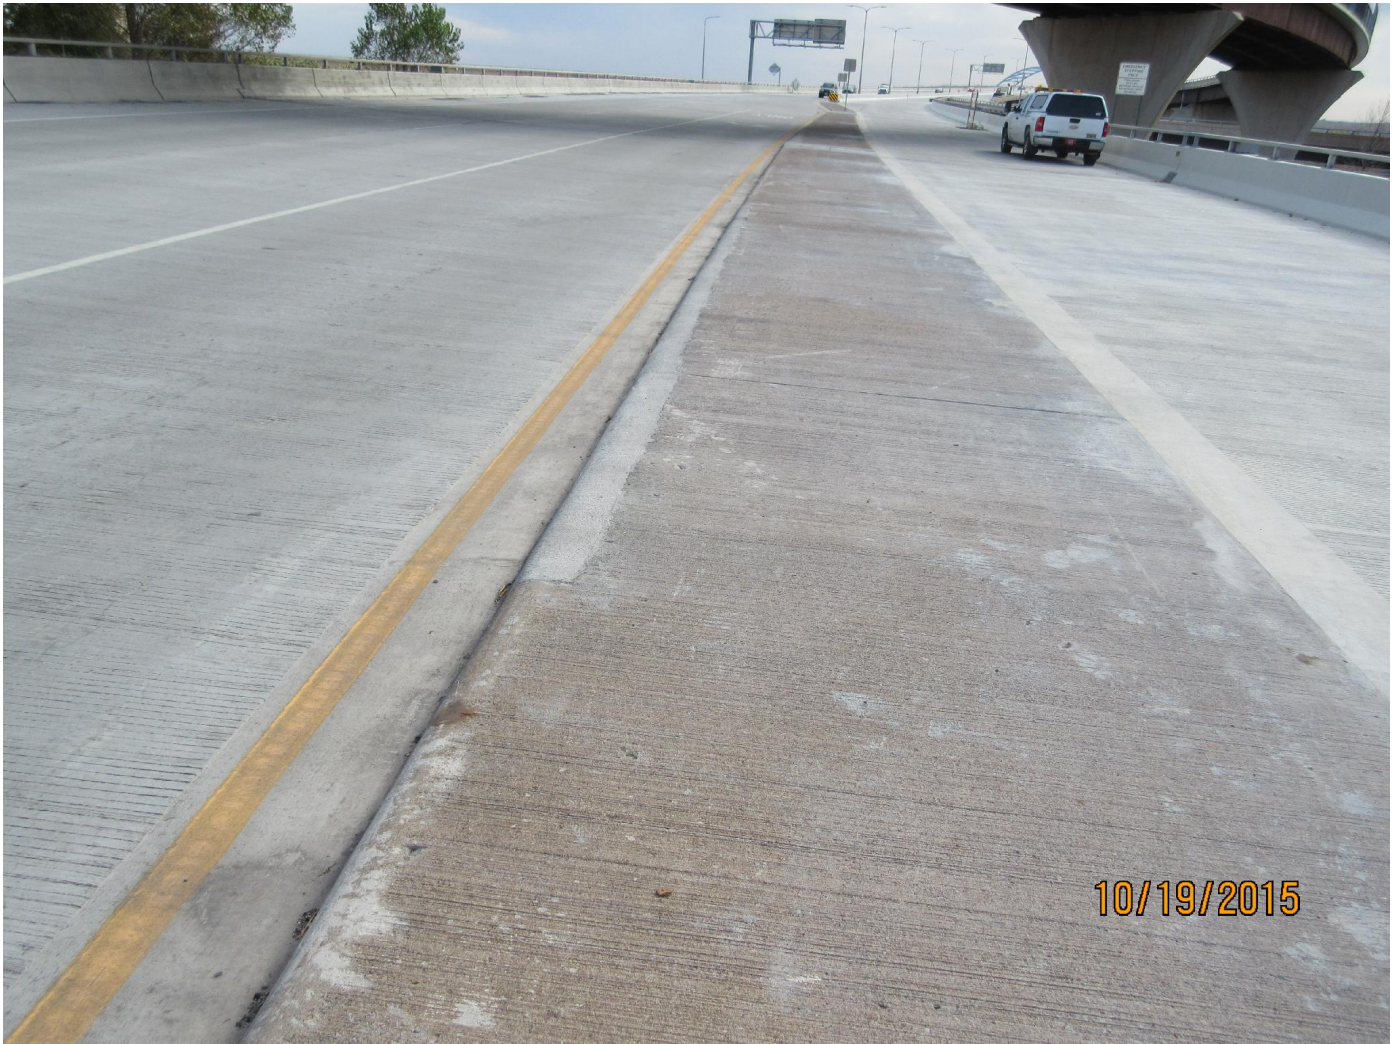
Repaired curb on median.

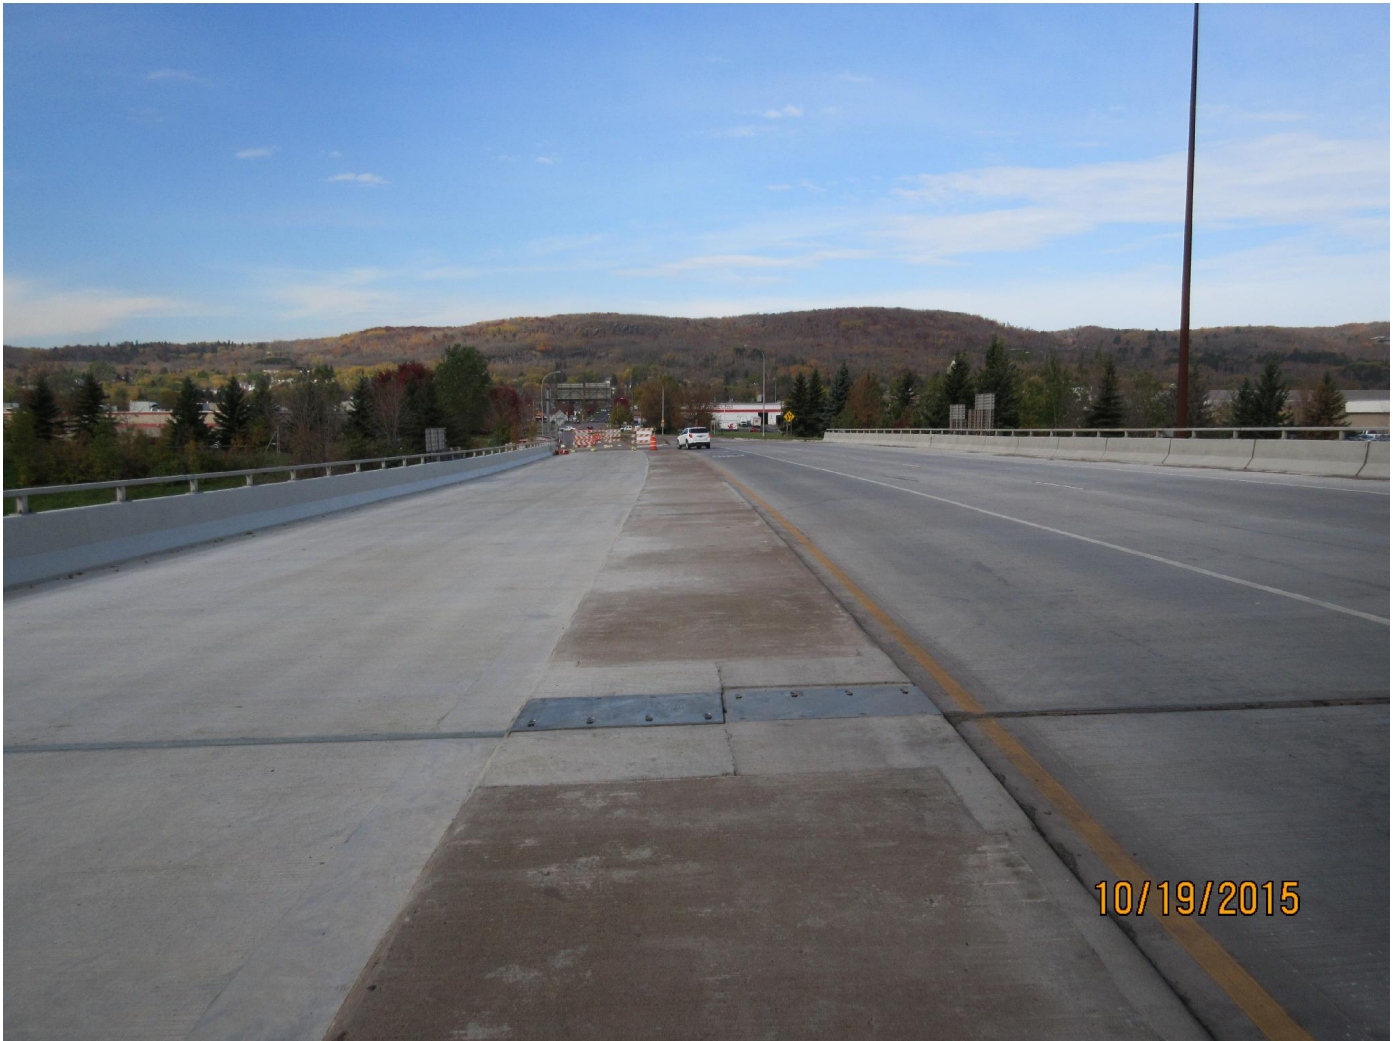
Looking west. Note new coverplates on median.
