**STATE OF WISCONSIN
DEPARTMENT OF TRANSPORTATION**

**Inspection Report for
B-16-038-0002**

**USH 2 over LAND
Oct 19,2015**

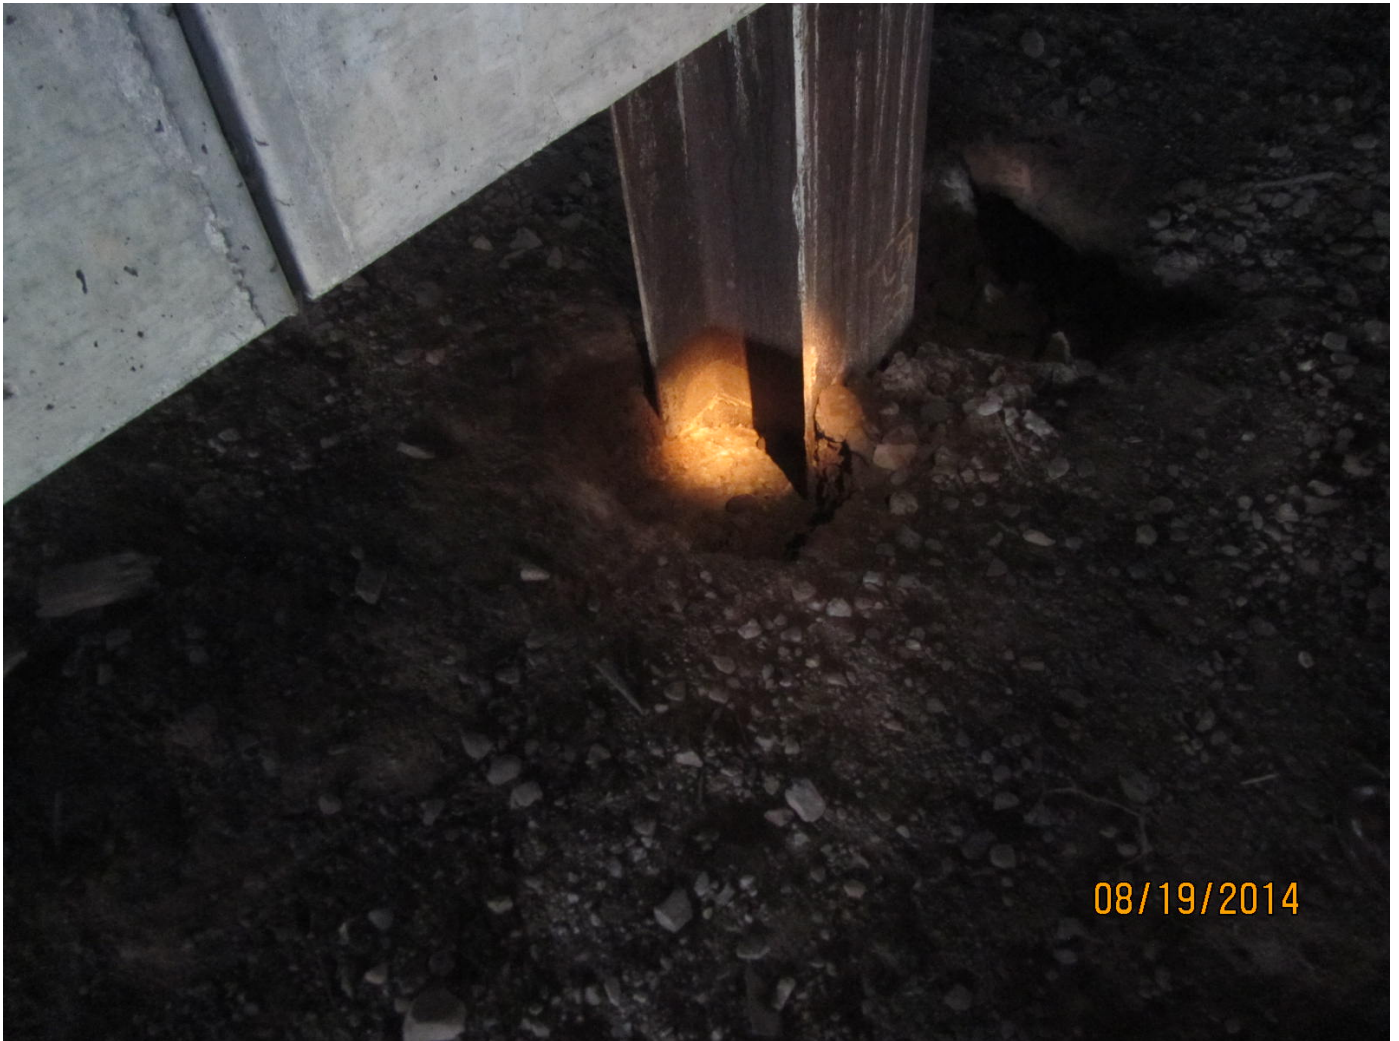
8516	Painted Steel	SF	855	0	855	0	0
			Rust forming. Extensive rust on pilings and 24 inch deep settlement around piles piers 3A,3B, 3C (2013) Piles have no paint on them from start. seem to be Core 10 steel.						
		3440	Effectiveness (Steel Protective Coatings)	SF		0	855	0	0
X	210		Reinforced Concrete Pier Wall	LF	75	72	3	0	0
		1130	Cracking (RC)	LF		0	3	0	0
			SW corner cracked vertical						
X	234		Reinforced Concrete Cap	LF	229	229	0	0	0
X	300		Strip Seal Expansion Joint	LF	75	75	0	0	0
			New WB 2014 and EB 2015.						
		2310	Leakage, Seal Adhesion, Damage, Cracking	LF		0	0	0	0

Settlement around pile pier 3A

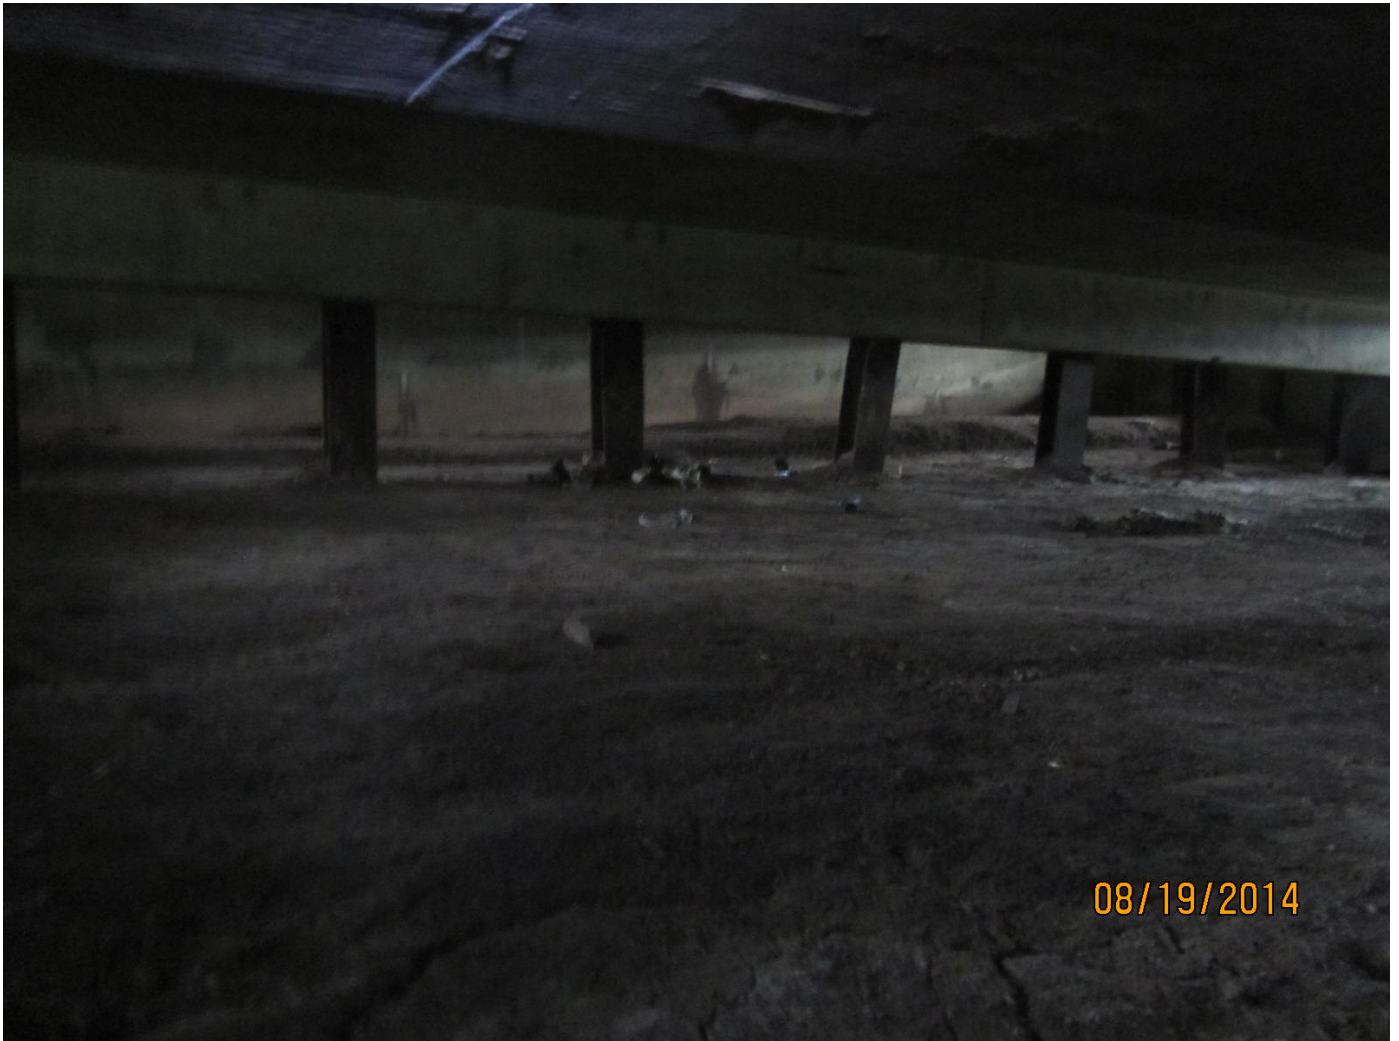
pier 3C dry under bridge

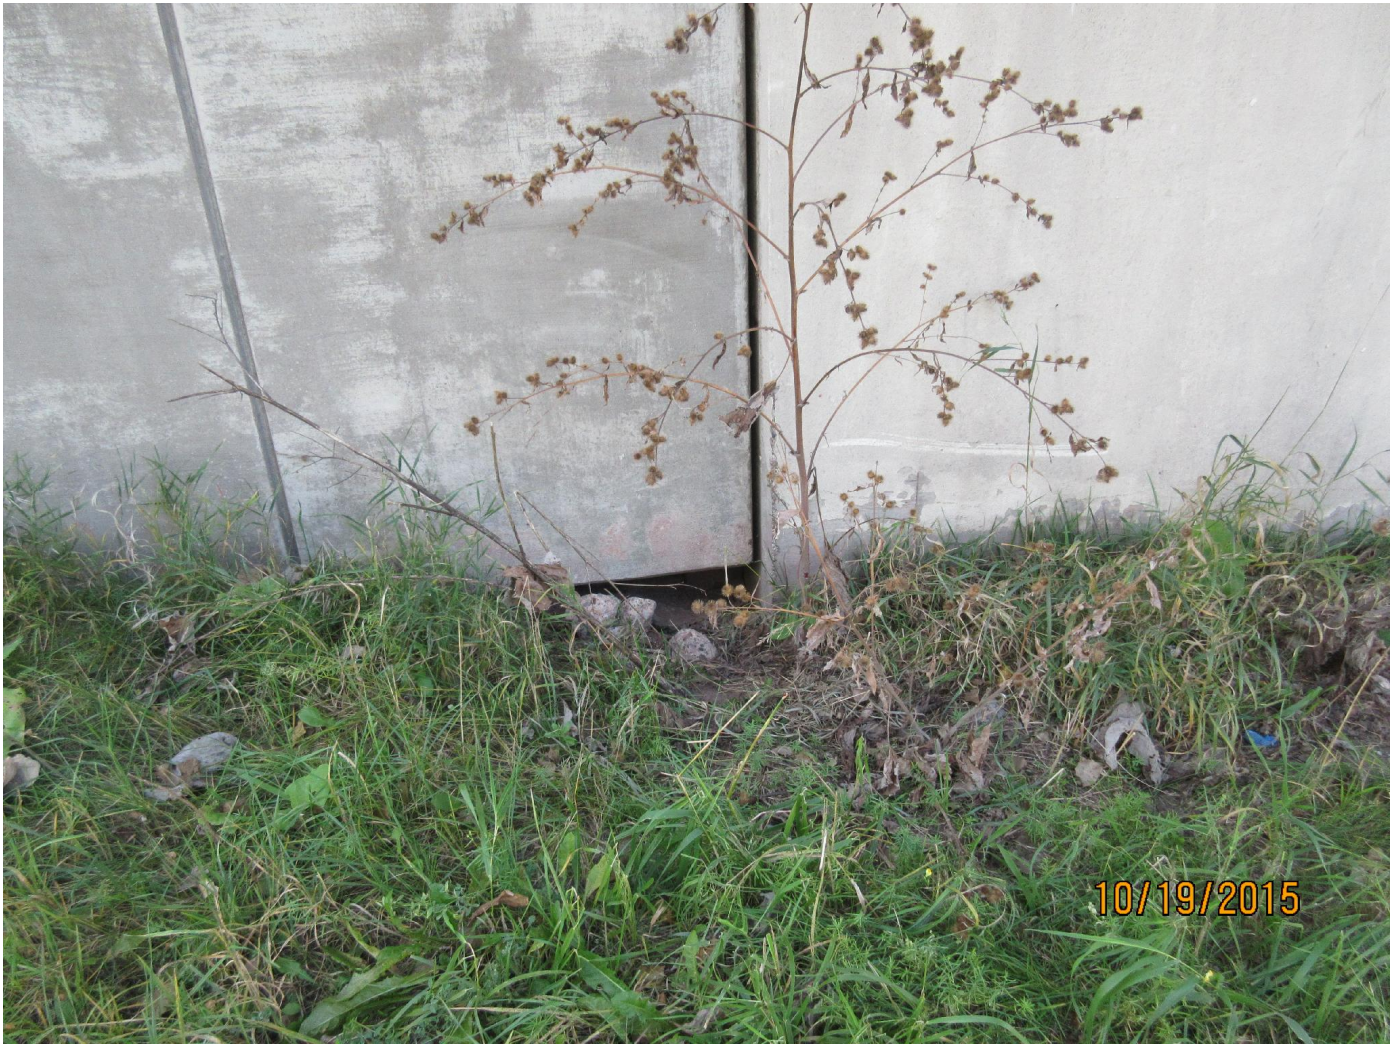
Undermine of wall at NW corner, also NE similar.
