STATE OF WISCONSIN
DEPARTMENT OF TRANSPORTATION

Inspection Report for B-16-038-0013

USH 2 over ST LOUIS RIVER
Sep 17, 2015

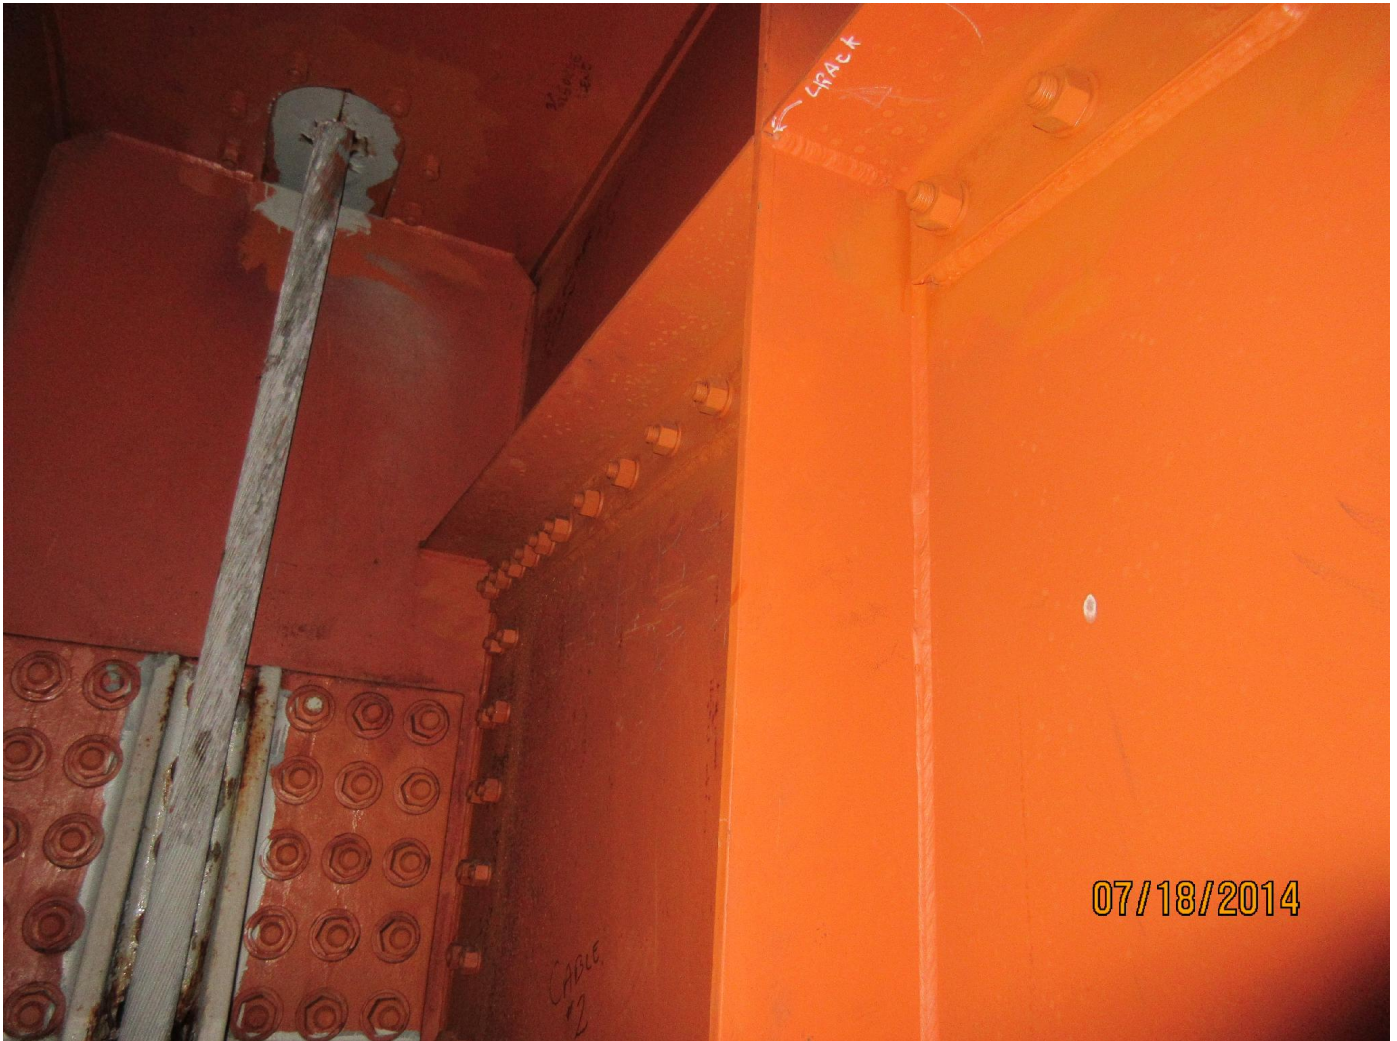
Crack located on upper horizontal stiffener for FB 3 on east side of hanger 2 in south tie girder.

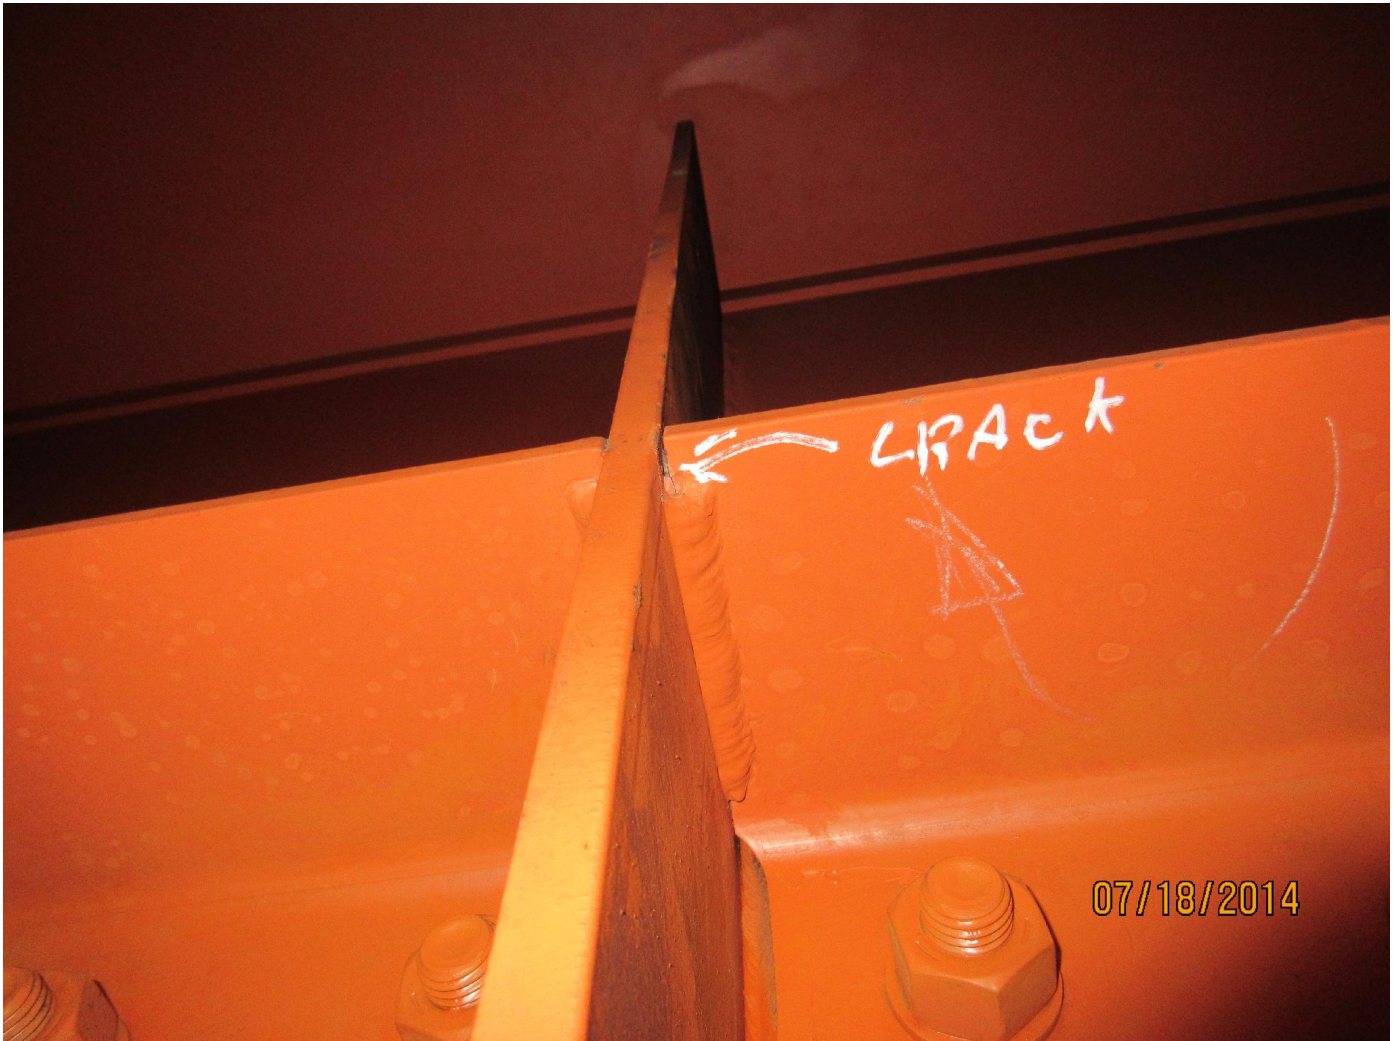
Close up of crack in south tie girder on east side of hanger 2.

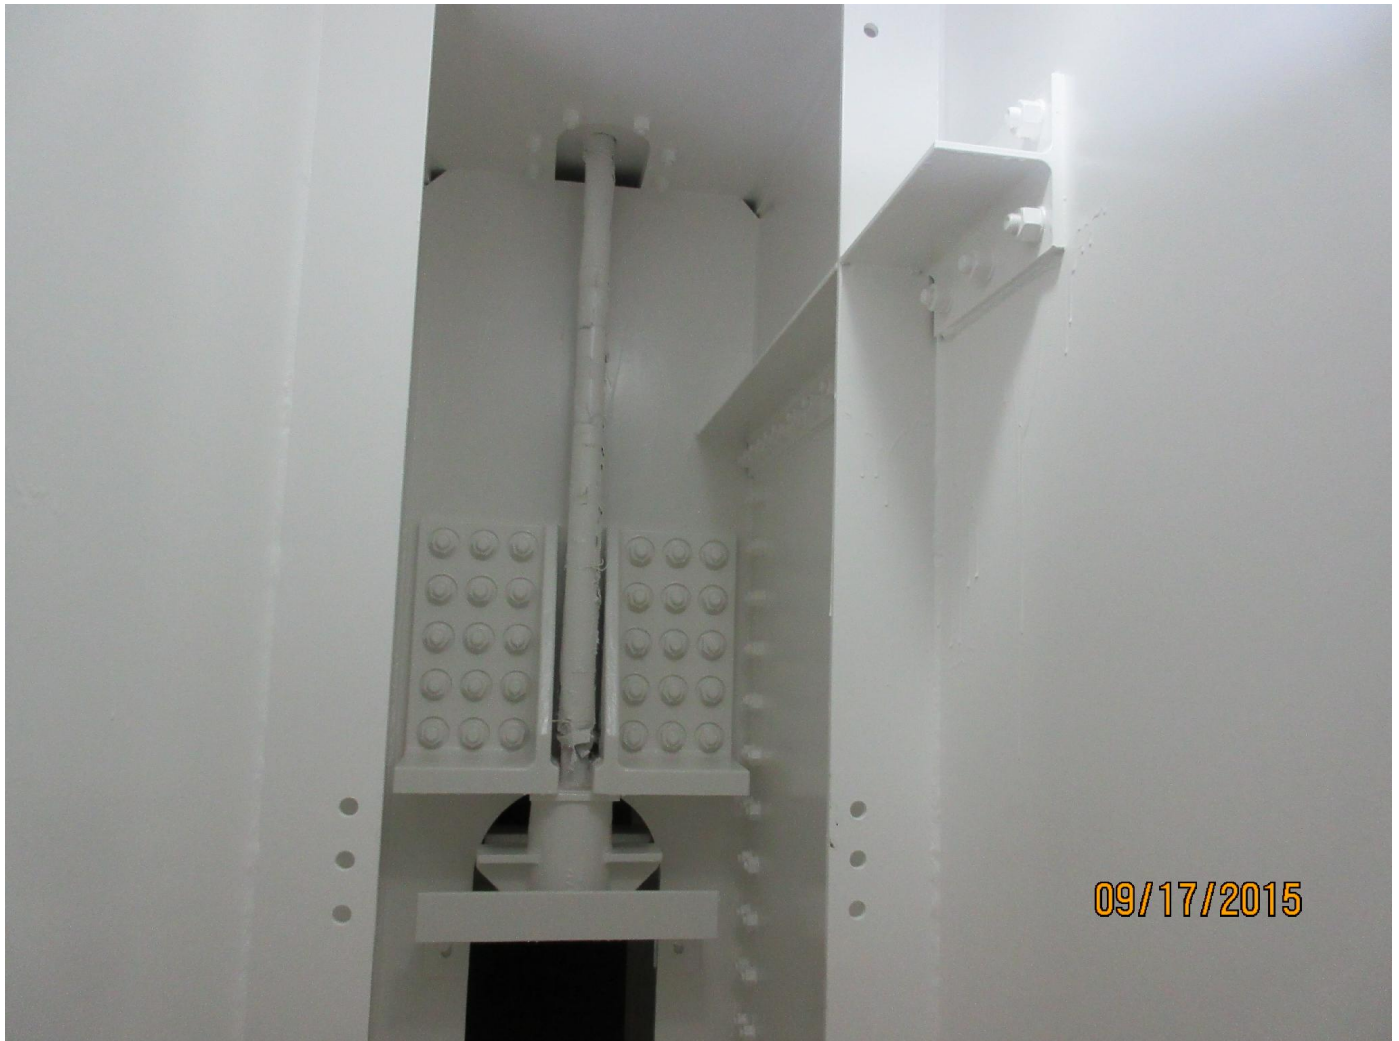
Crack located on upper horizontal stiffener for FB 3 on east side of hanger 2 in south tie girder. After paint 2015. Note protective covering of cable in place yet.

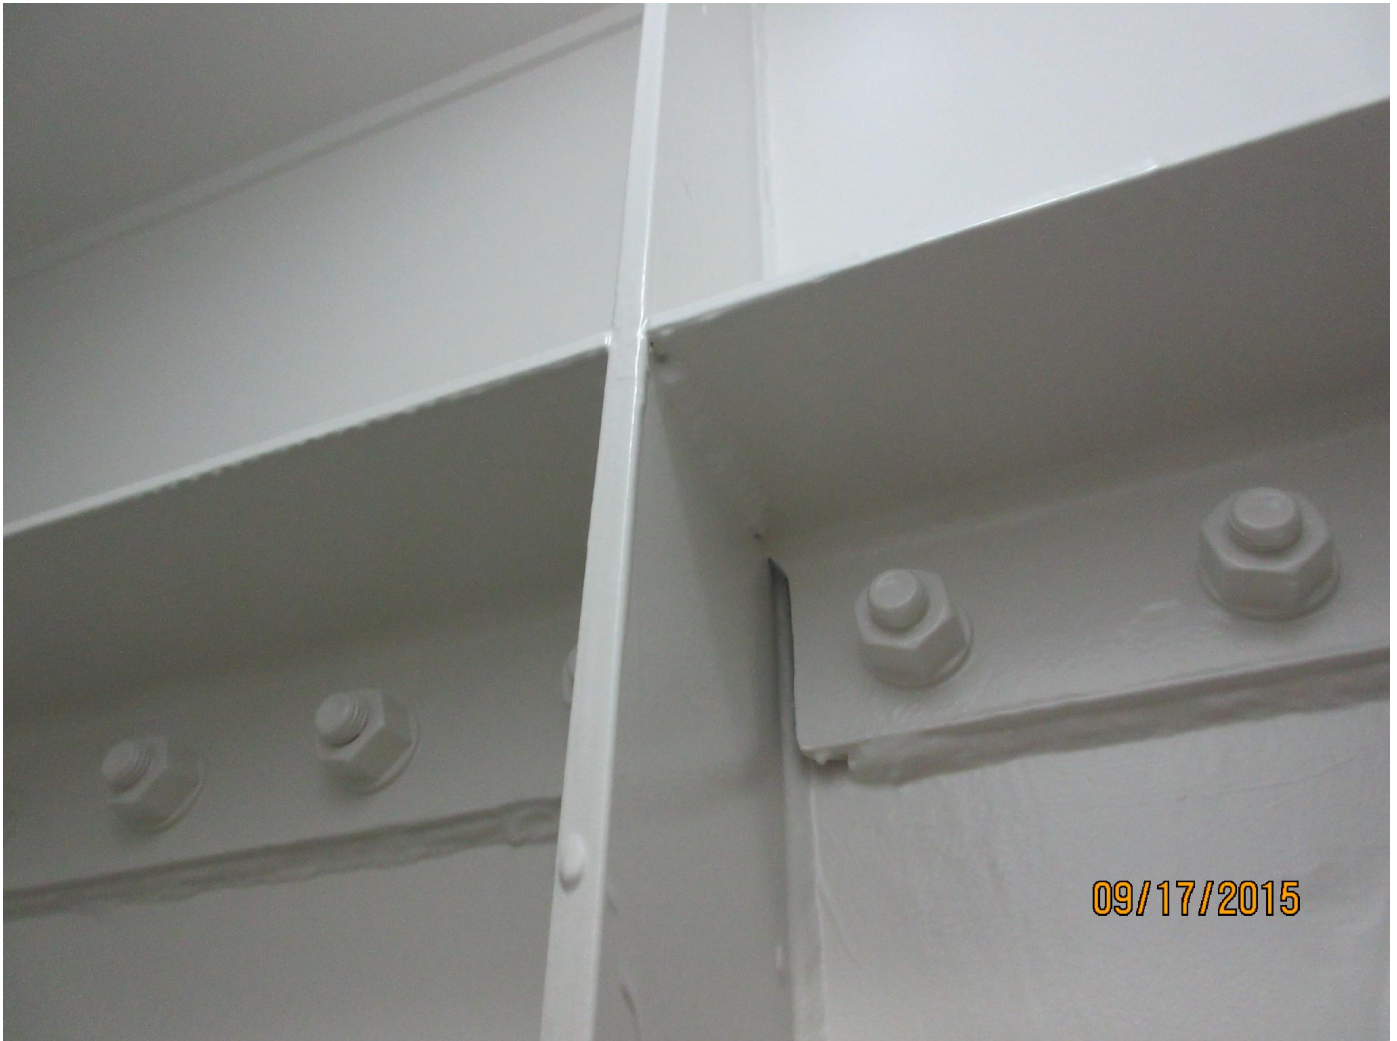
Close up of crack in south tie girder on east side of hanger 2. After paint 2015. Monitor.

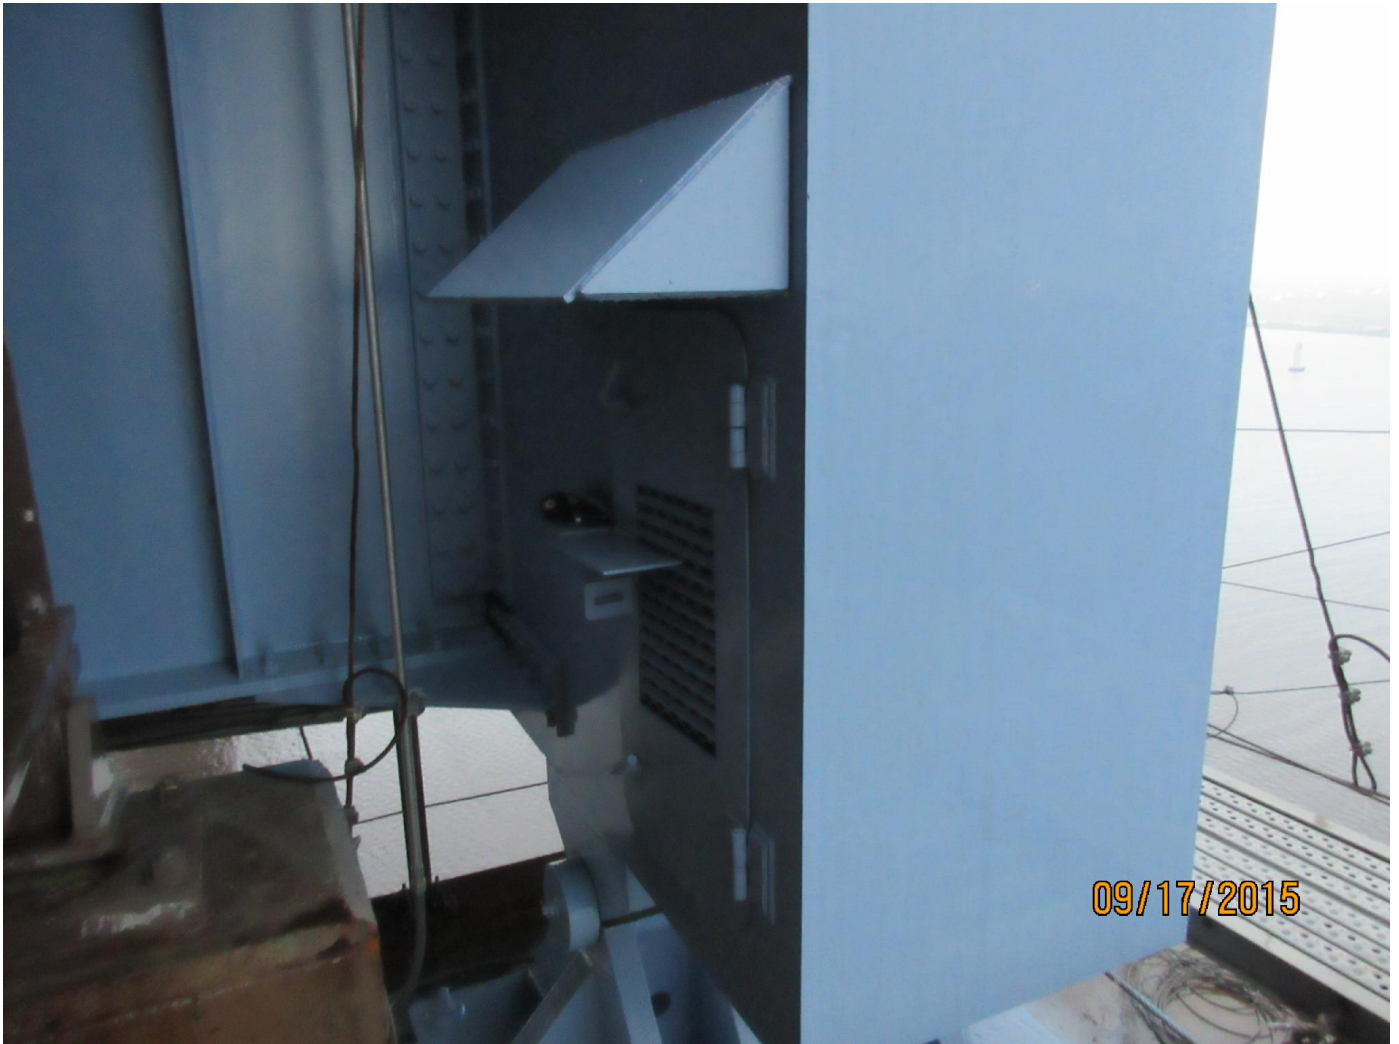
Typical tie girder access door modifications. Note larger "roof" over both the door and the lock.

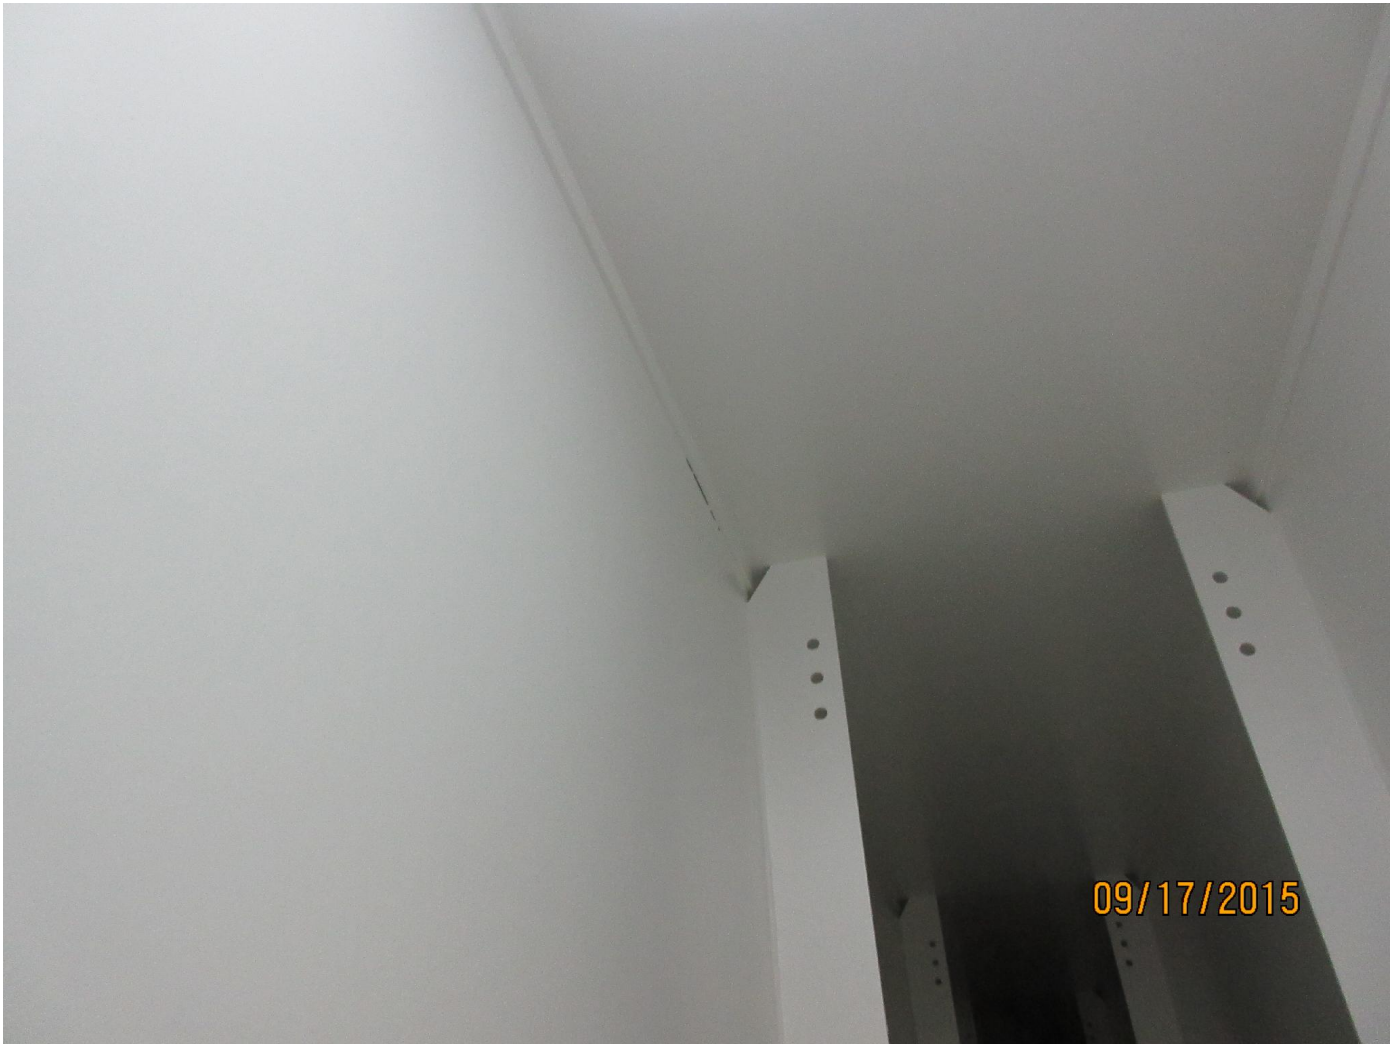
Backer bar separation of 8 inches on upper inner corner approx. 11ft east of hanger #7 north.

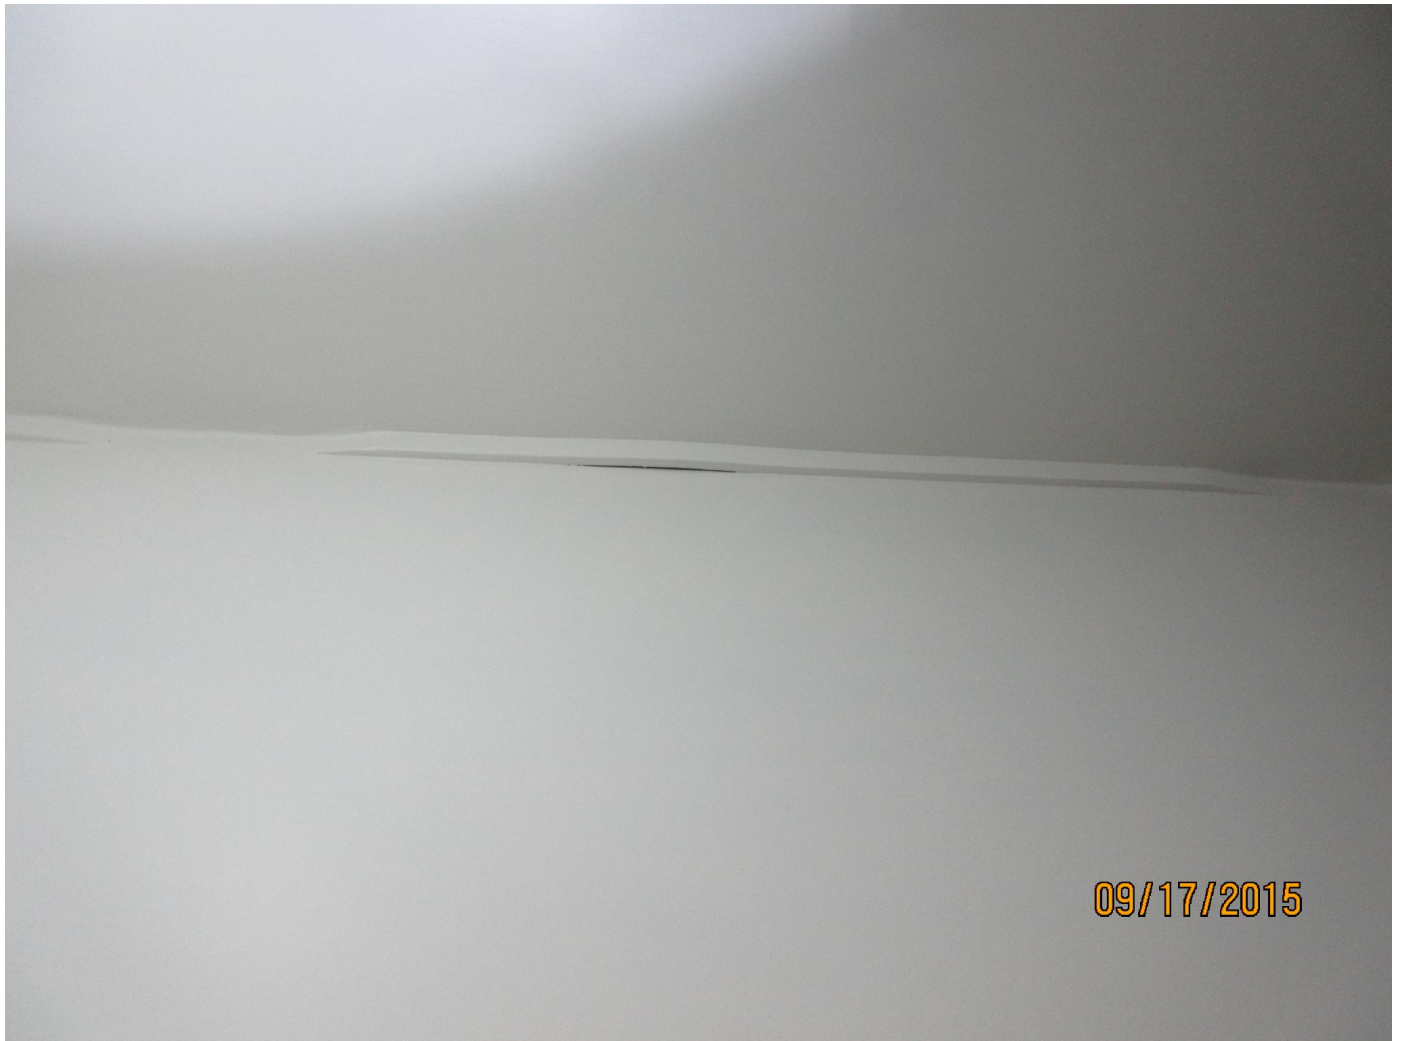
Backer bar speration of 6 inches at upper exterior corner approx. 15ft west of hanger #5 north.
Note the two areas previously ground out. Recommend removal between these two areas, approx. 3 ft.

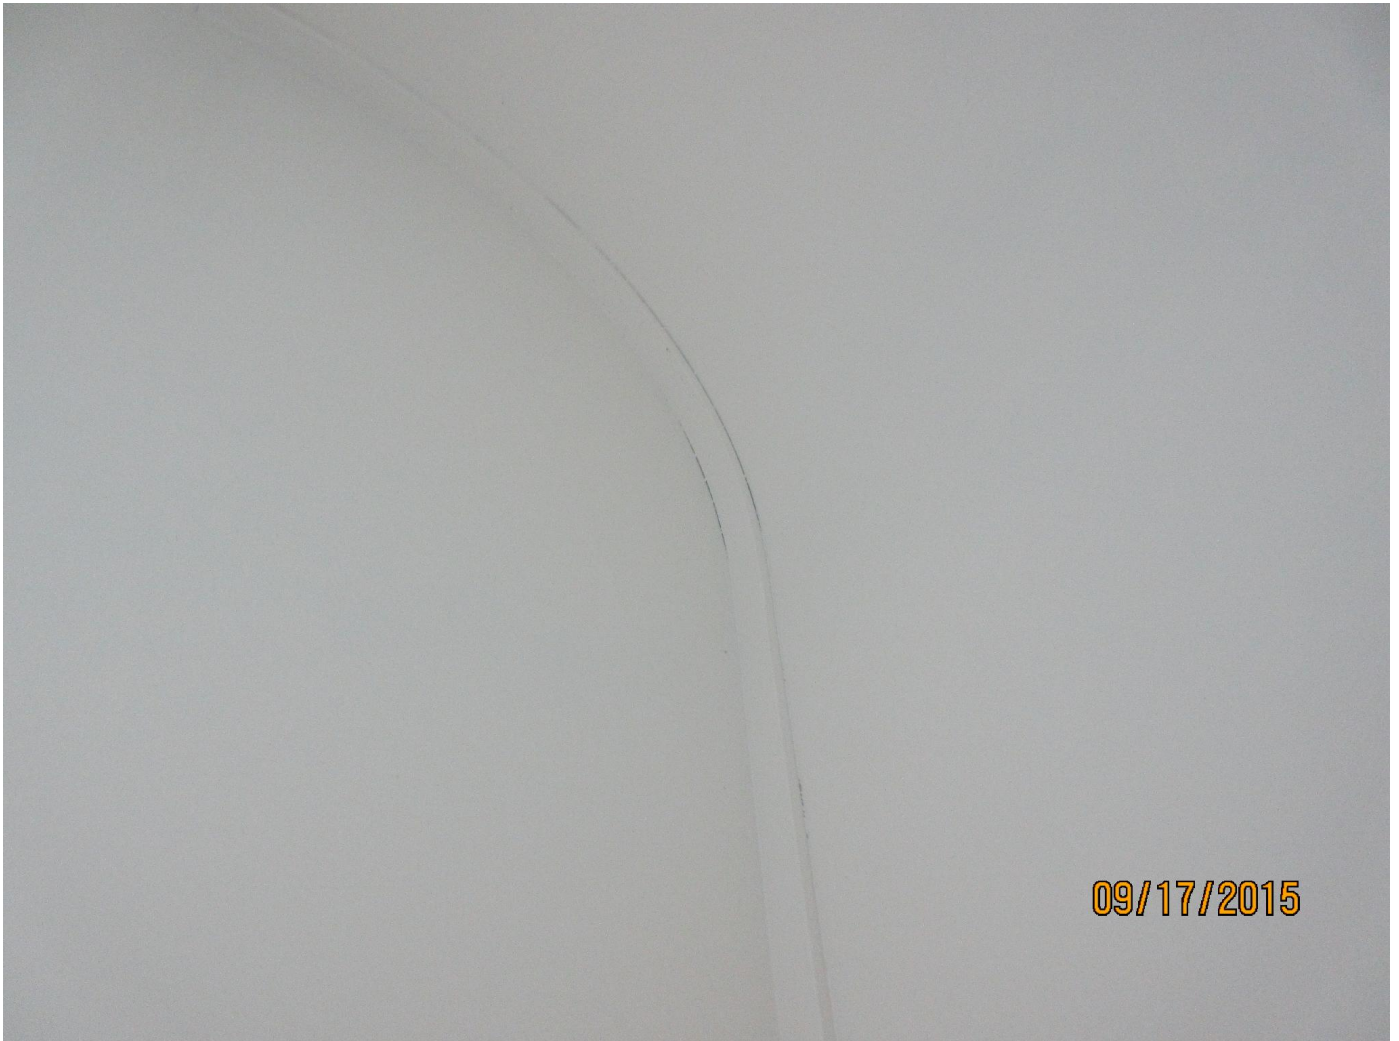
Backer bar separation, approx. 3ft., in north tie girder at the west entry inside edge.

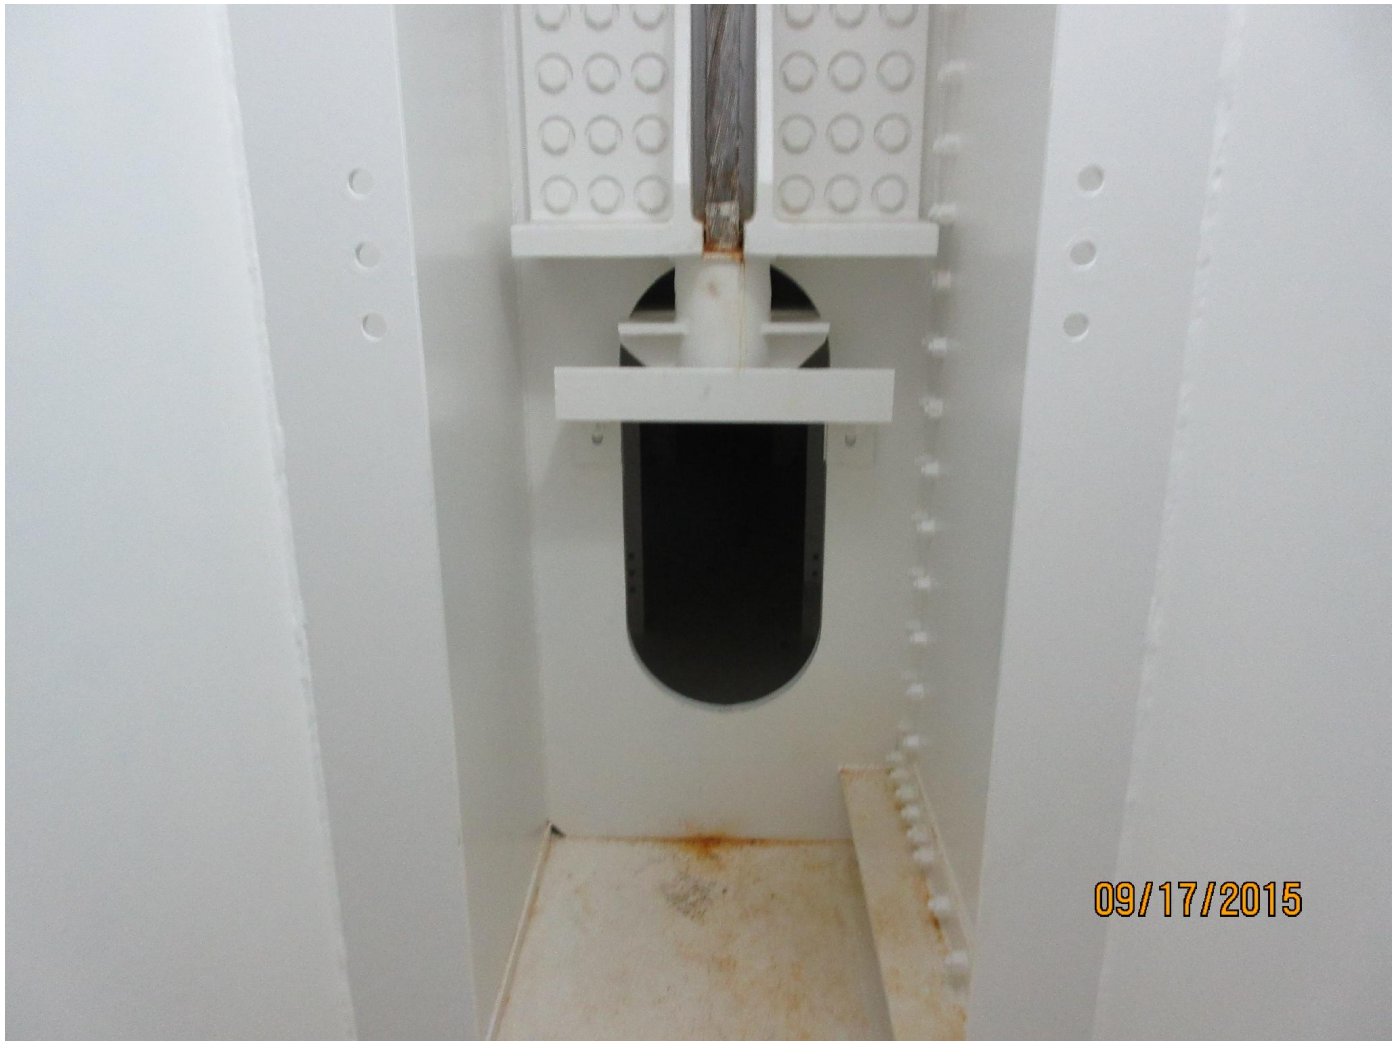
N 4 E. Note rust staining. Where checked the paint was intact under staining. This was the only cable were leaking was noted on the north girder.

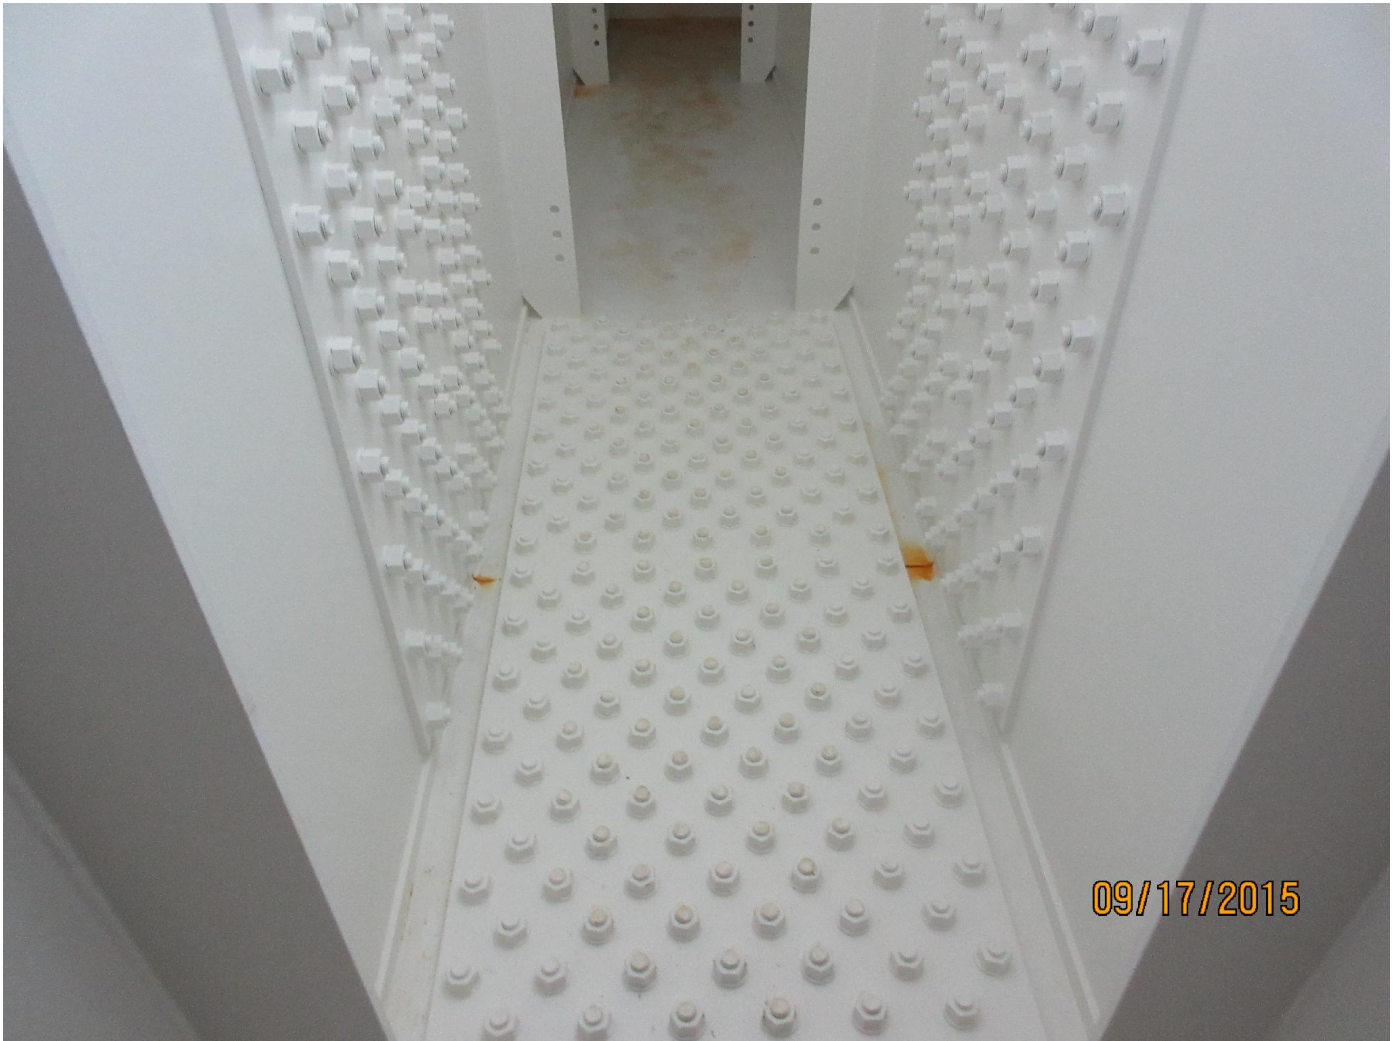
North field splice #2. Staining on floor at joint.

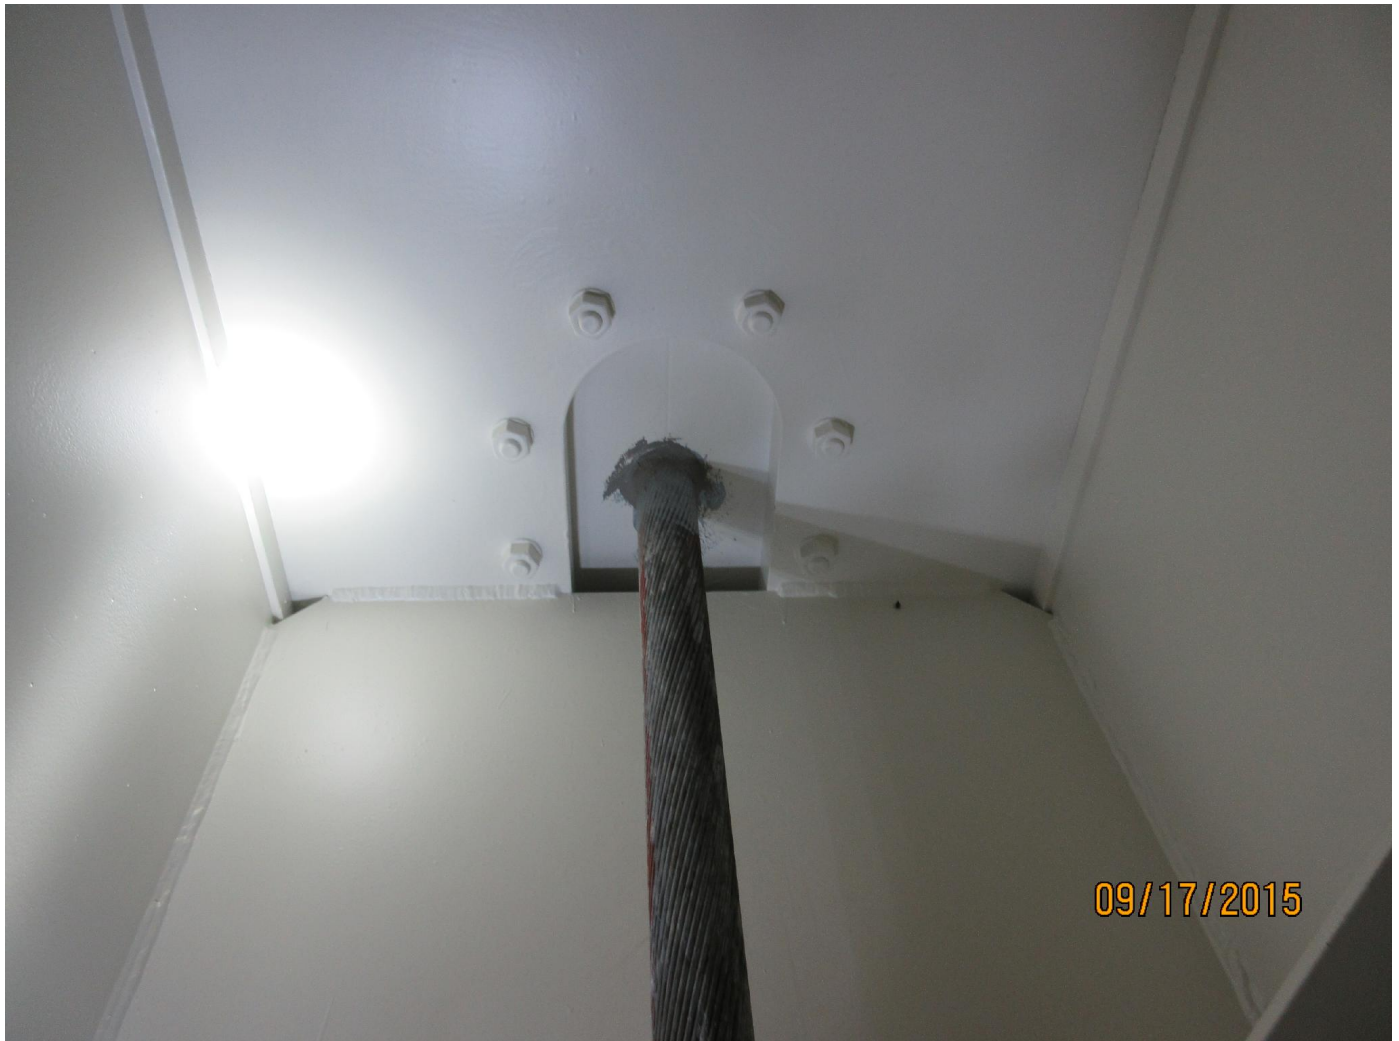
Typical caulking of cable through cover plate on north tie girder. Caulking to hold in rubber sealer.

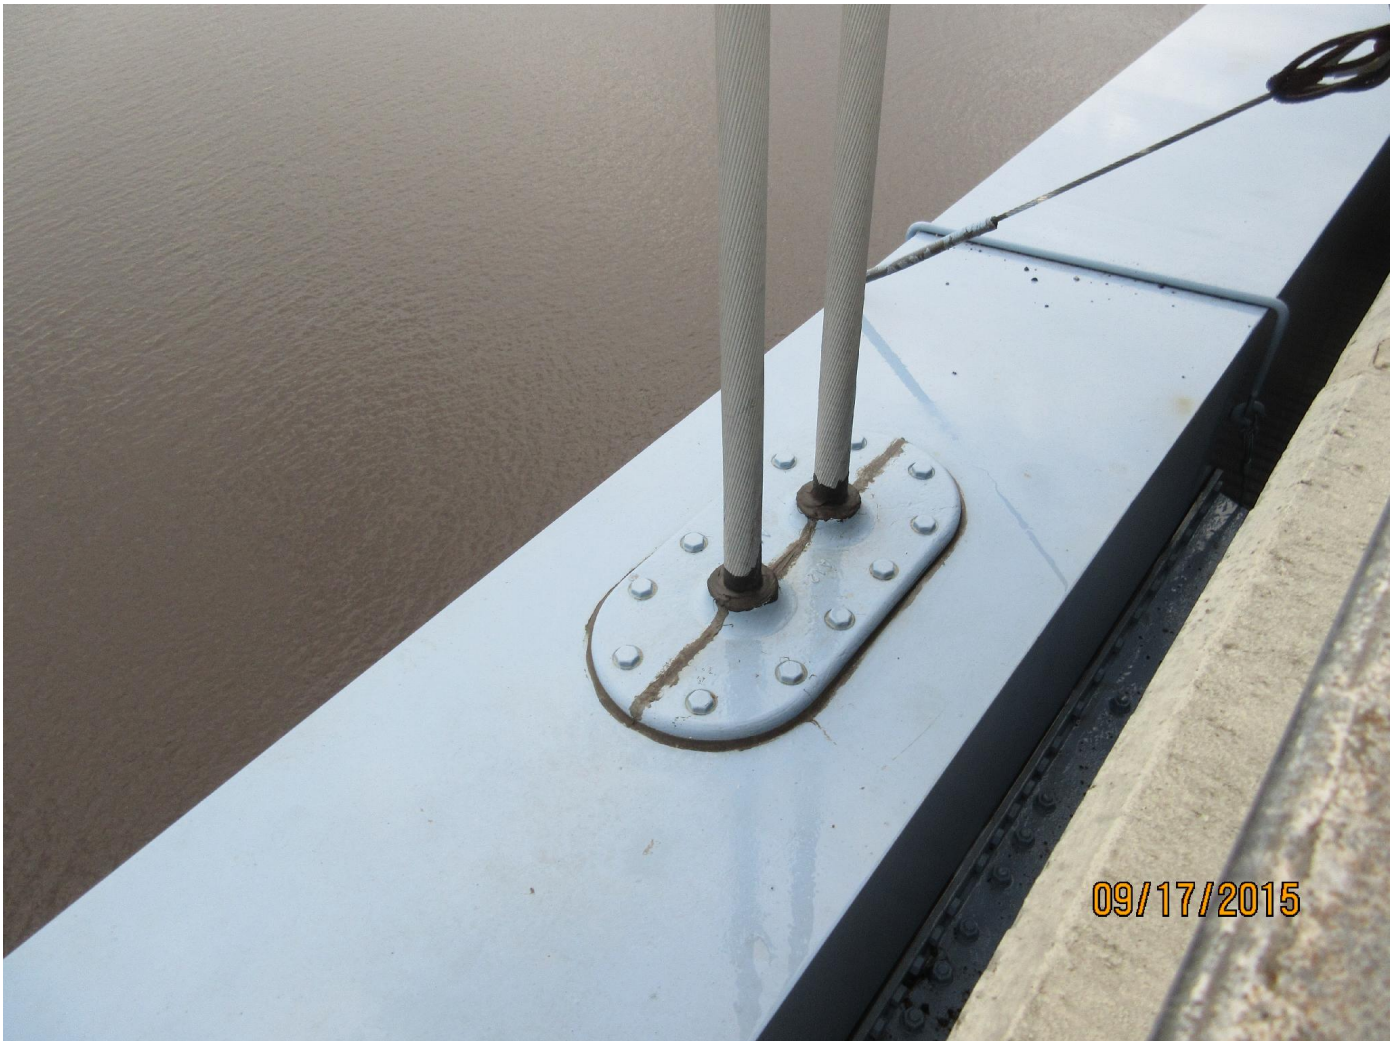
Typical cover plate on north tie girder. Cables are coated with Briden Metalcoat. A rubber compound is placed in the gap around the cable through the cover. The cover is caulked at all joints.

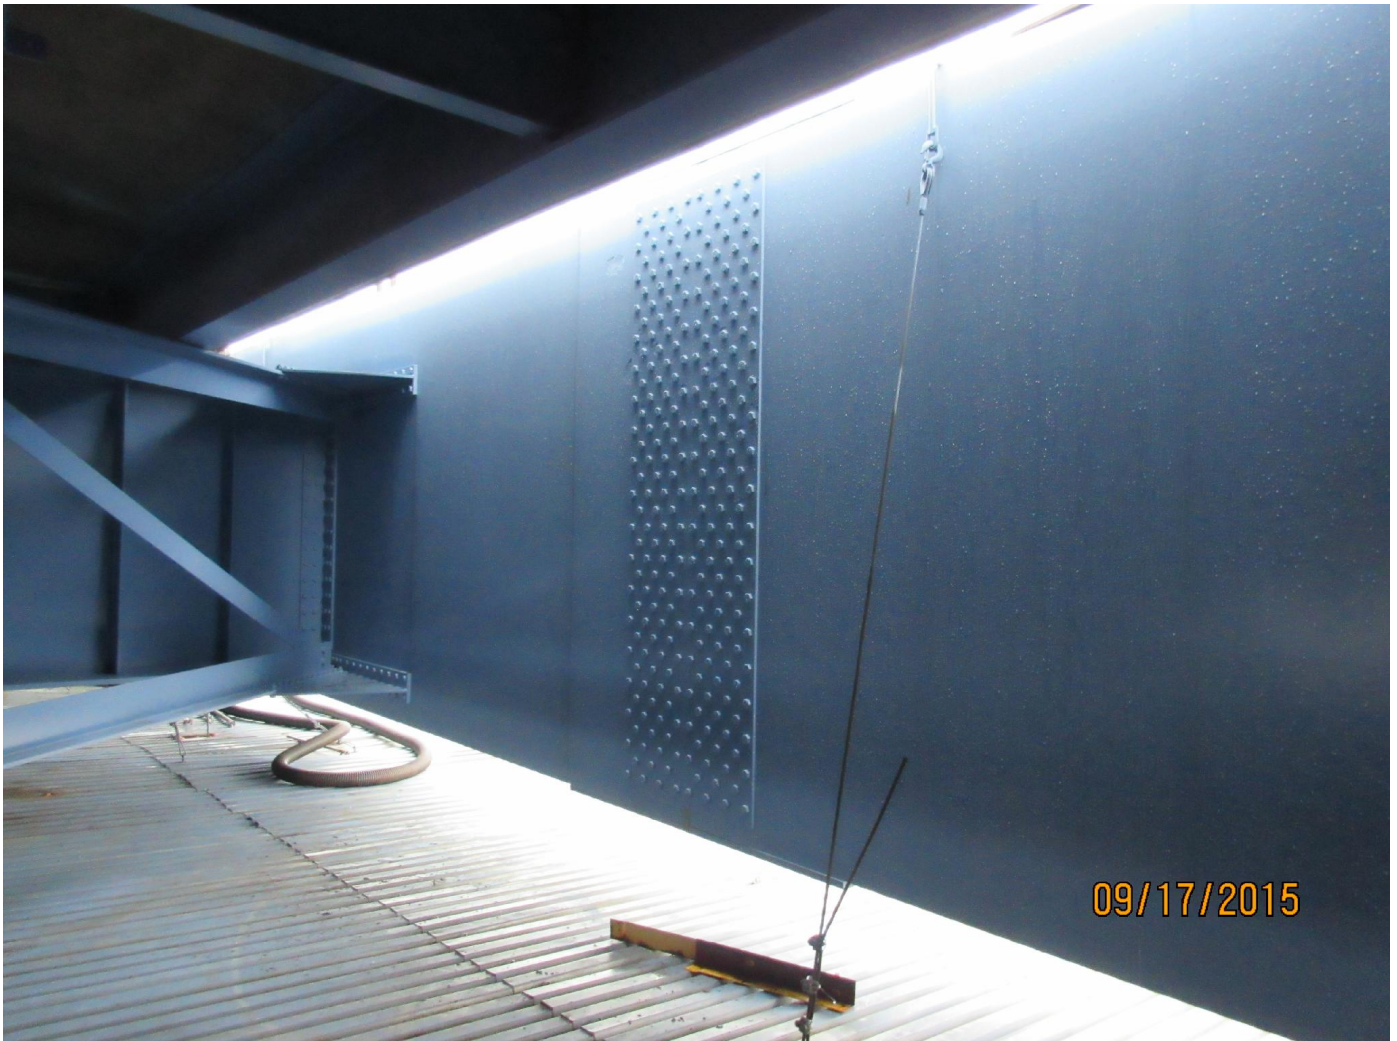
Typical exterior. Note painted over section loss adjacent to field splice. Also, note supports for Safe Span decking, which requires touch up to the paint.
