STATE OF WISCONSIN  
DEPARTMENT OF TRANSPORTATION

# Inspection Report for B-47-040

USH 10 over ST CROIX RIVER 01

Apr 13, 2017

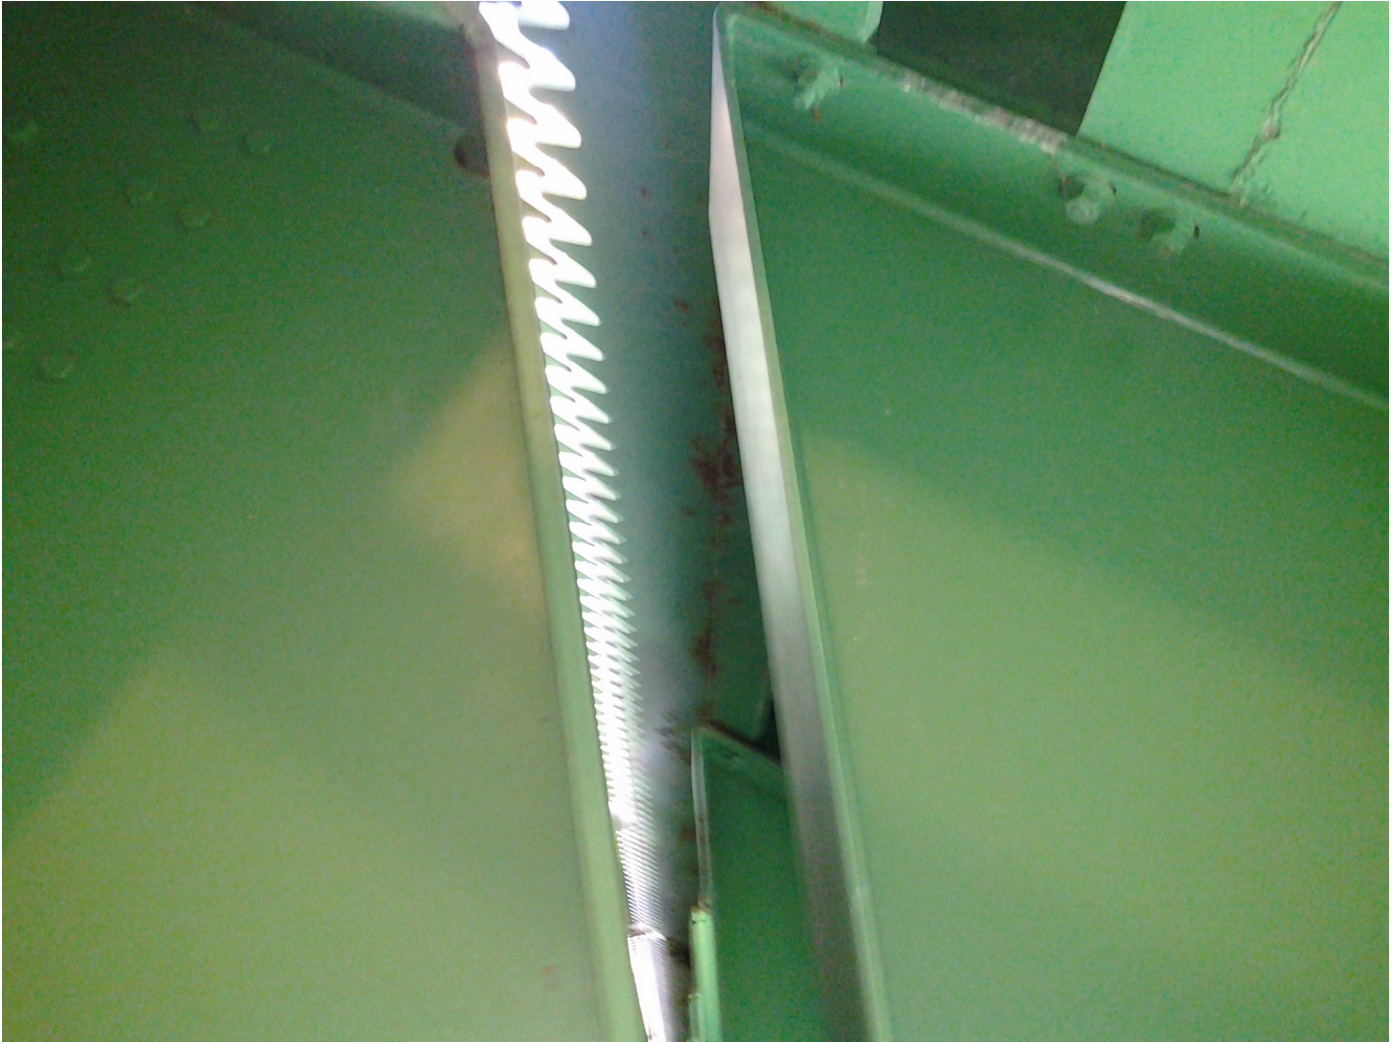
Wisconsin finger joint with spalling concrete under (Part of counterweight)

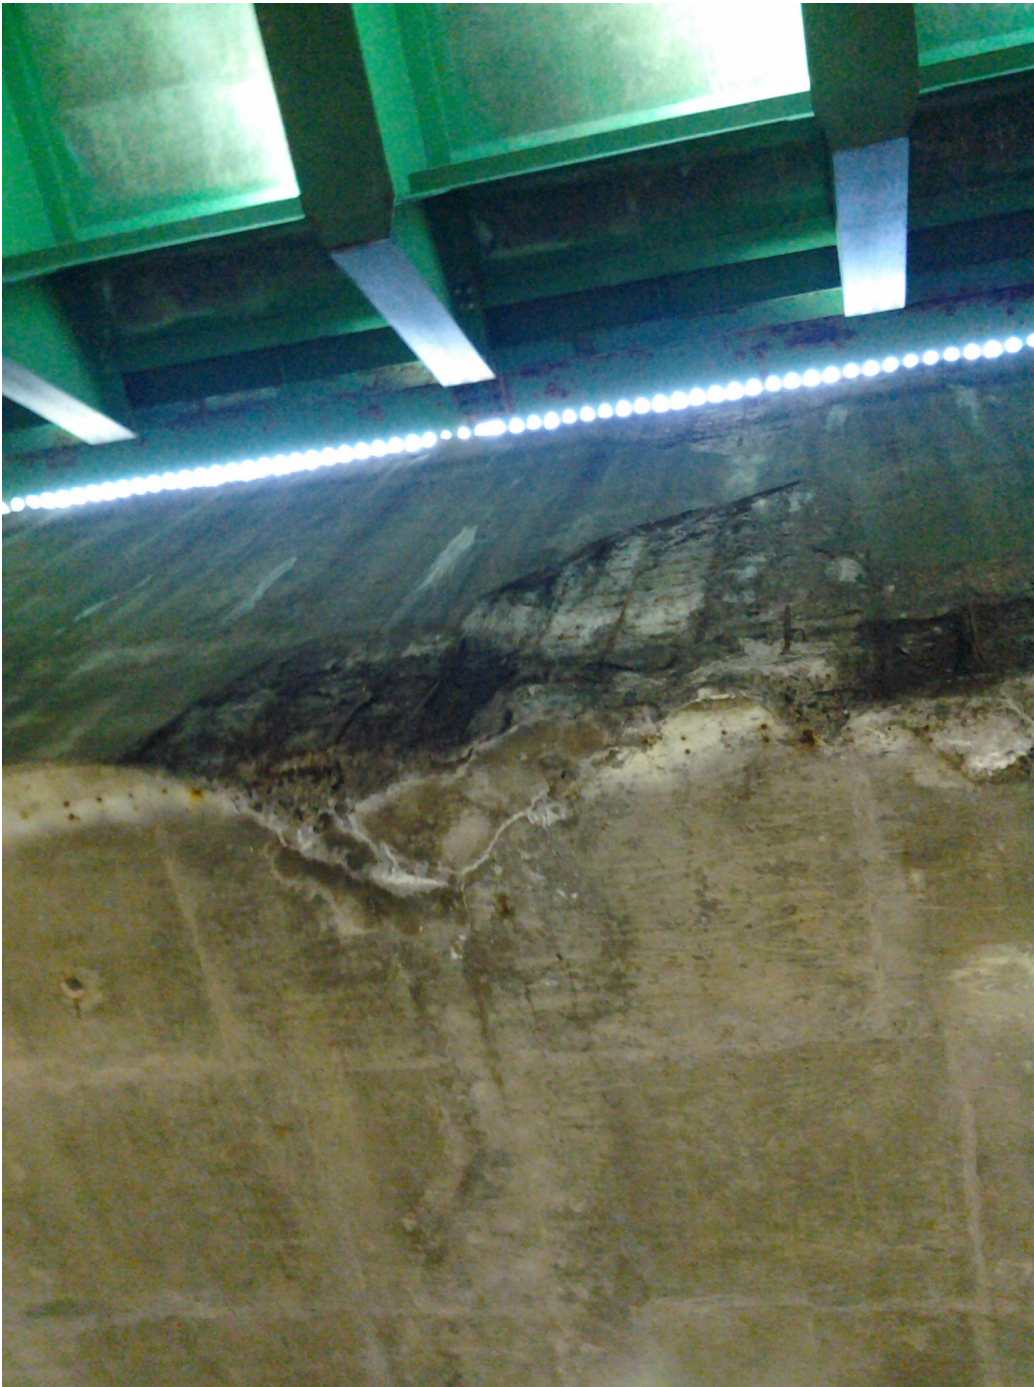
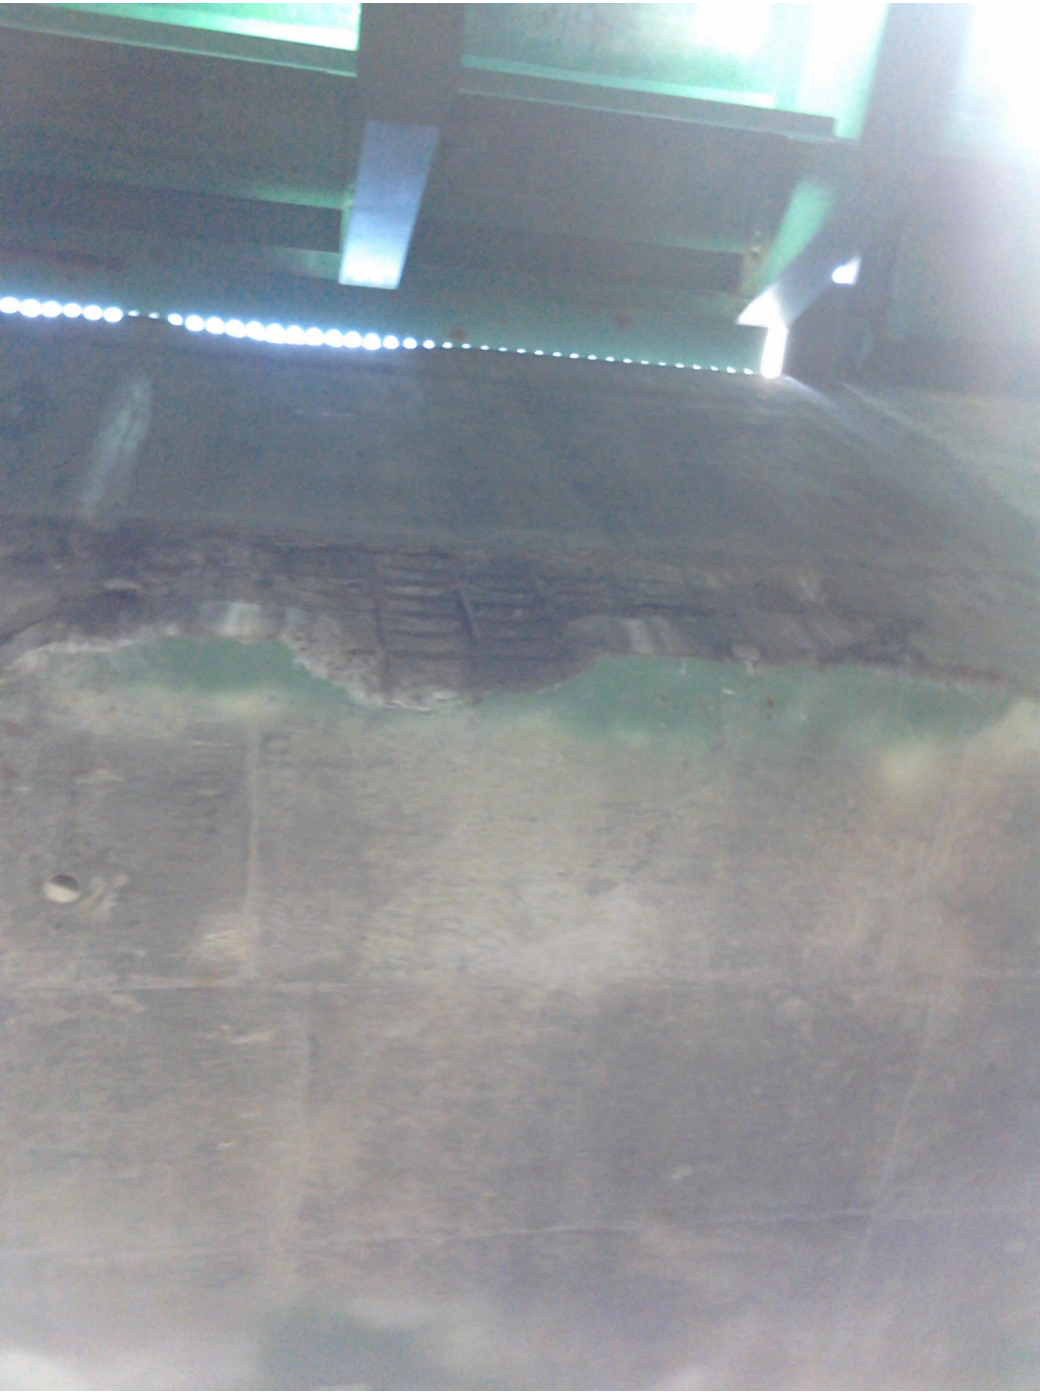
Bottom and face of counter weight (Wisconsin side)

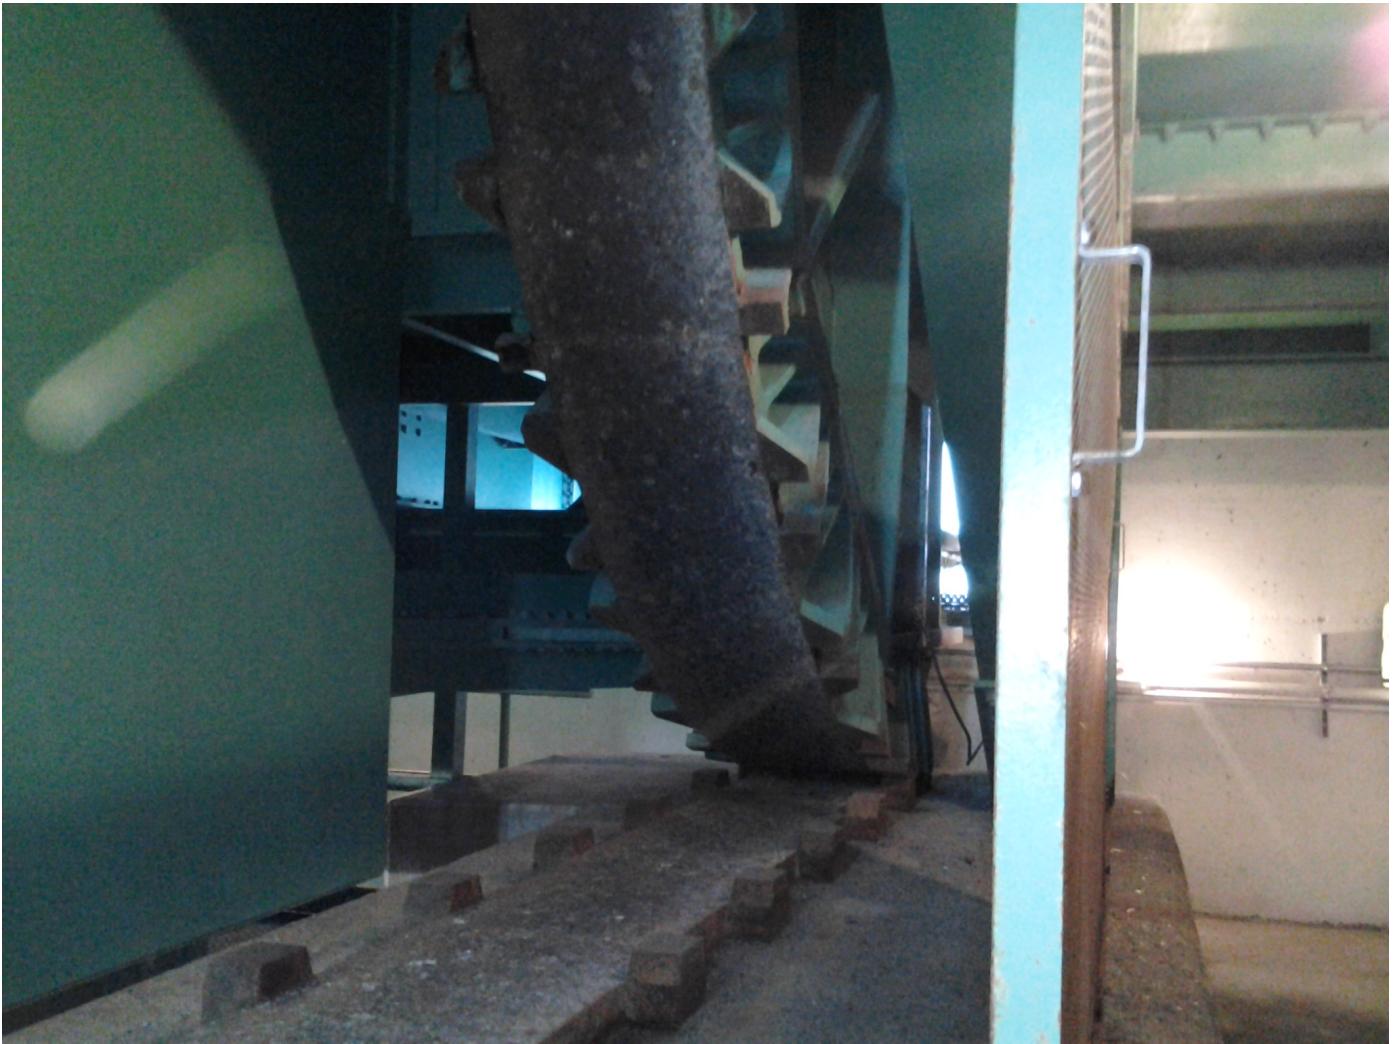
Northeast Rocker

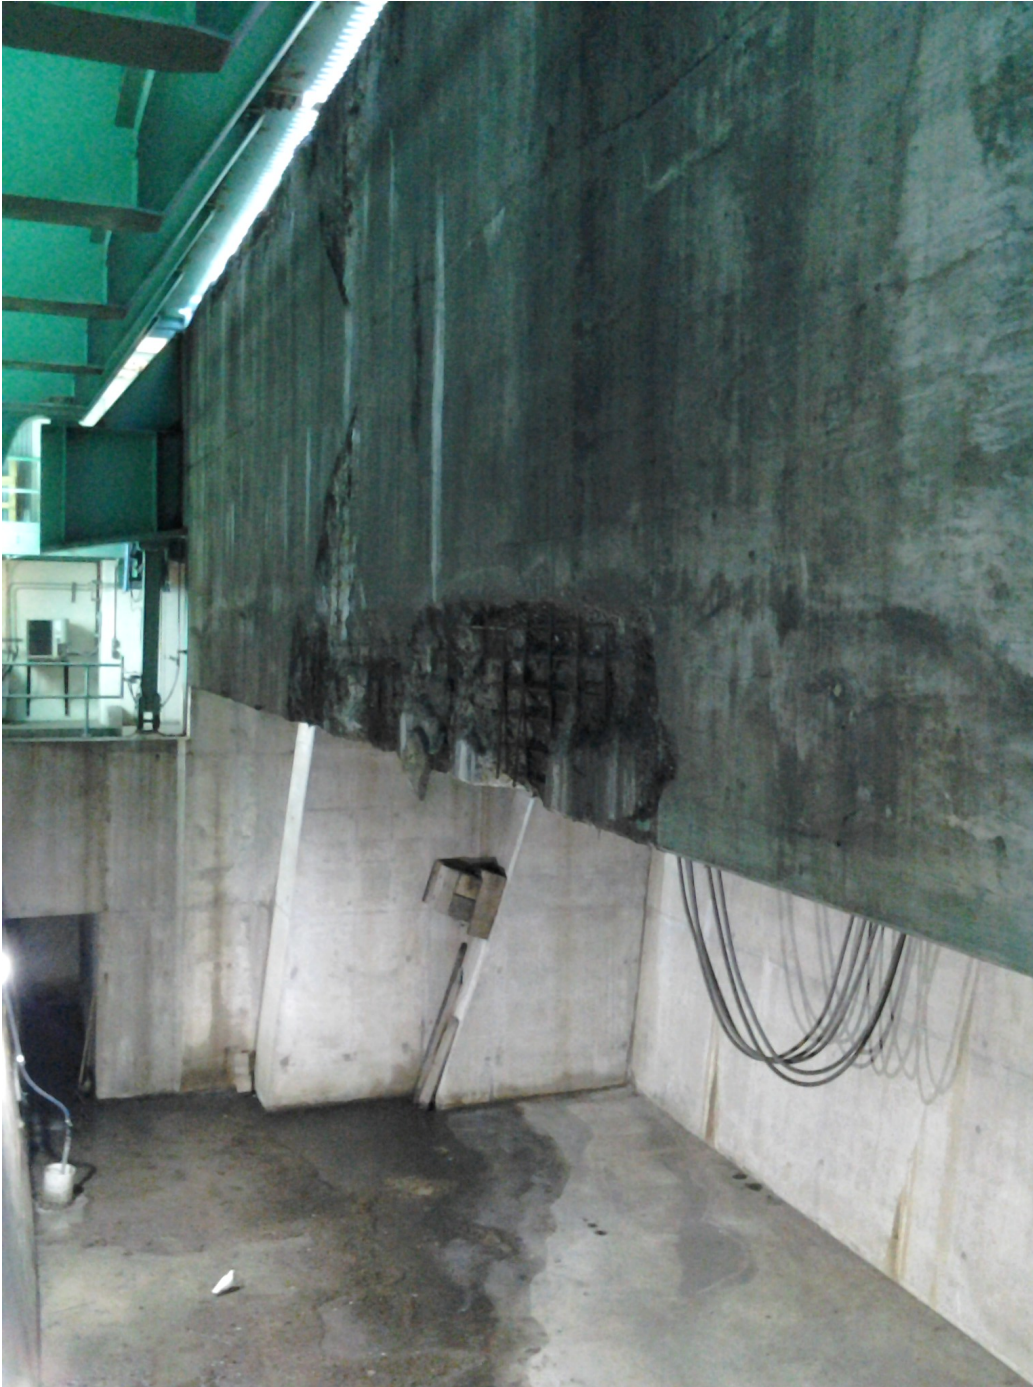
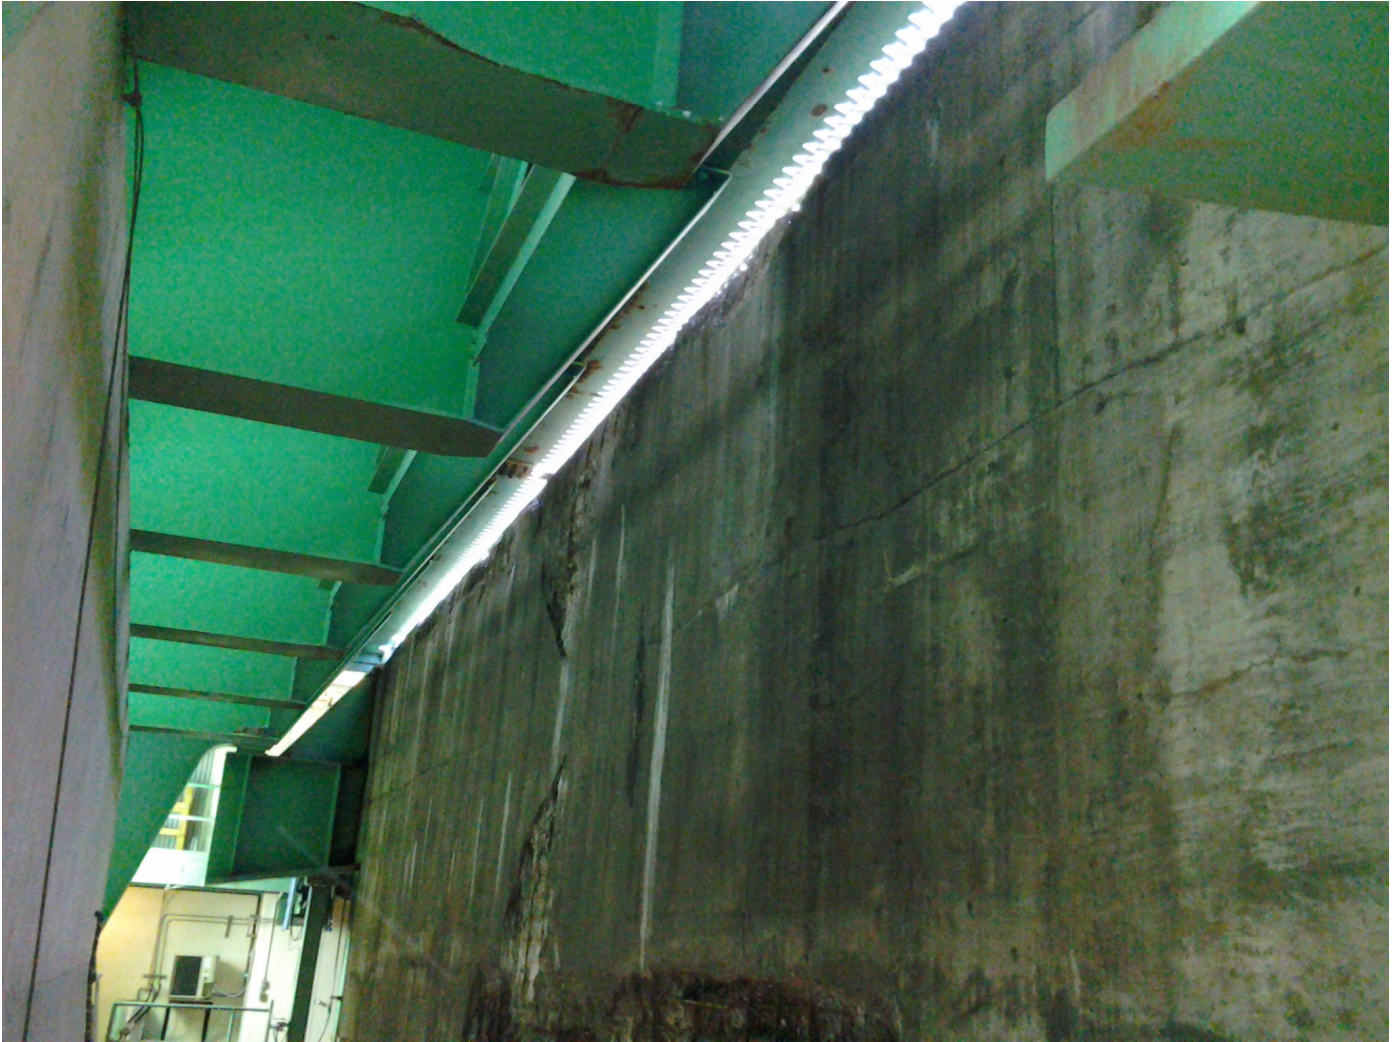
Wisconsin side counterweight

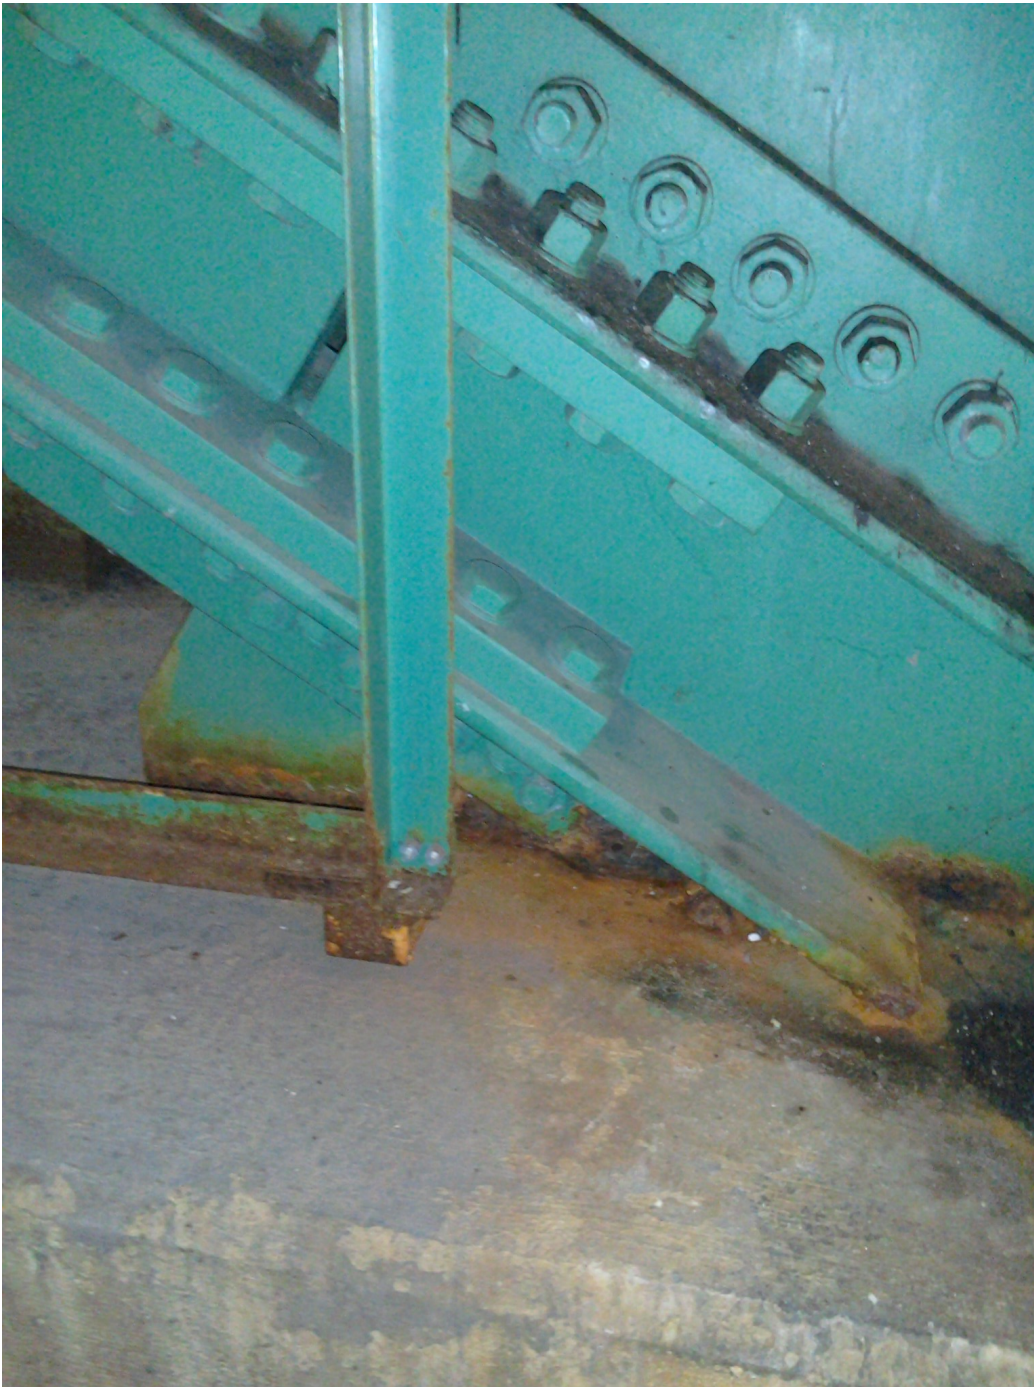
Northeast connection near the northeast rocker (minor corrosion)

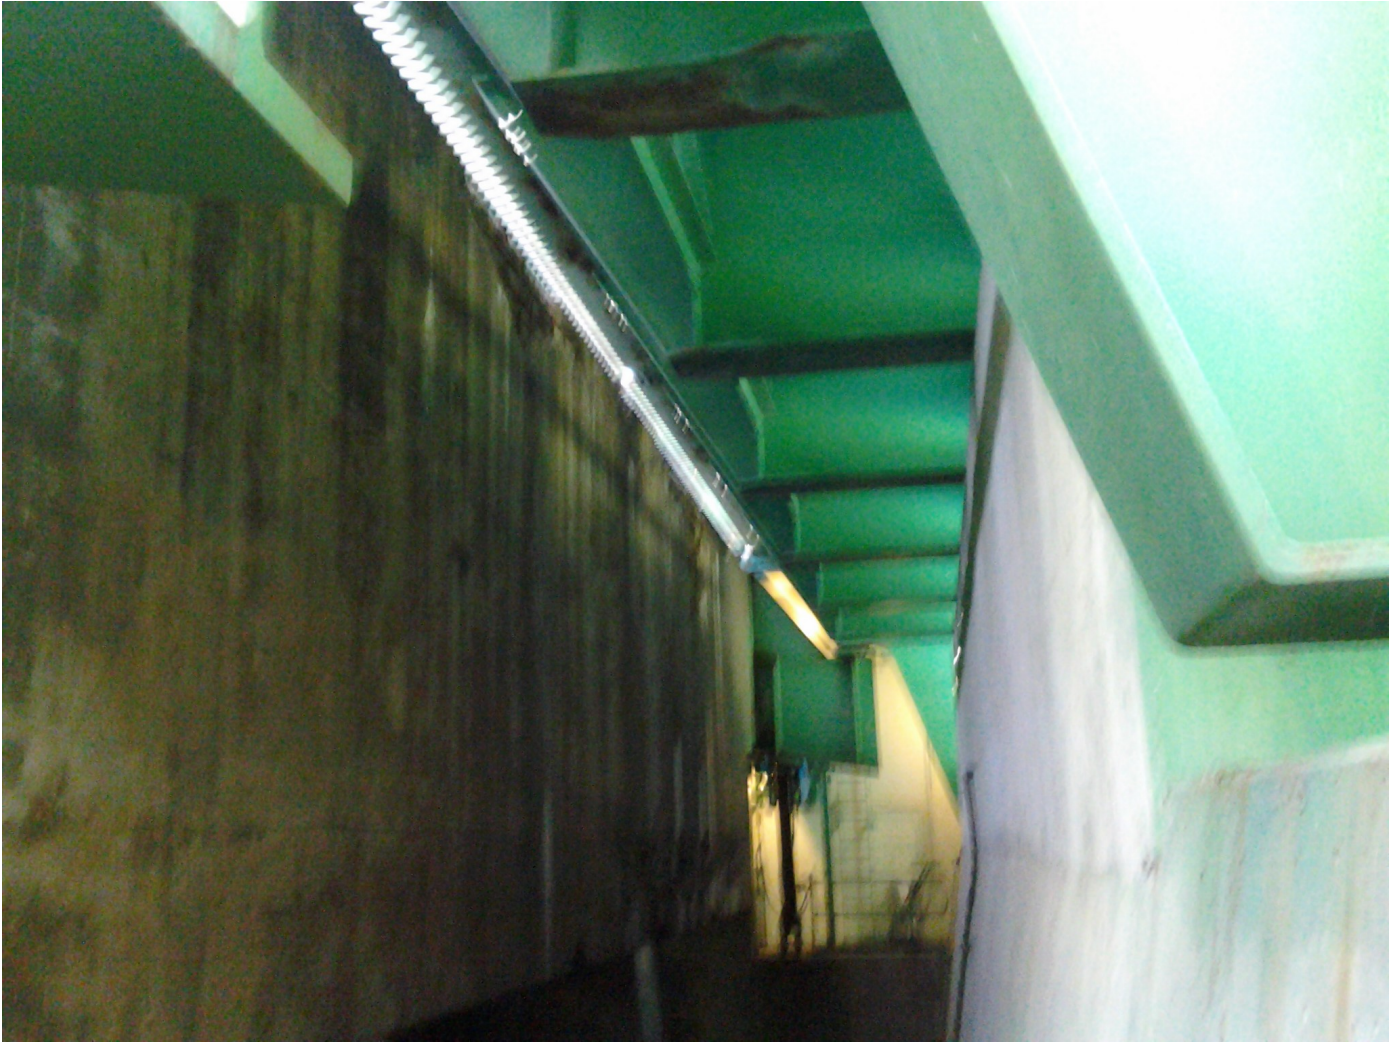
Minnesota side counterweight

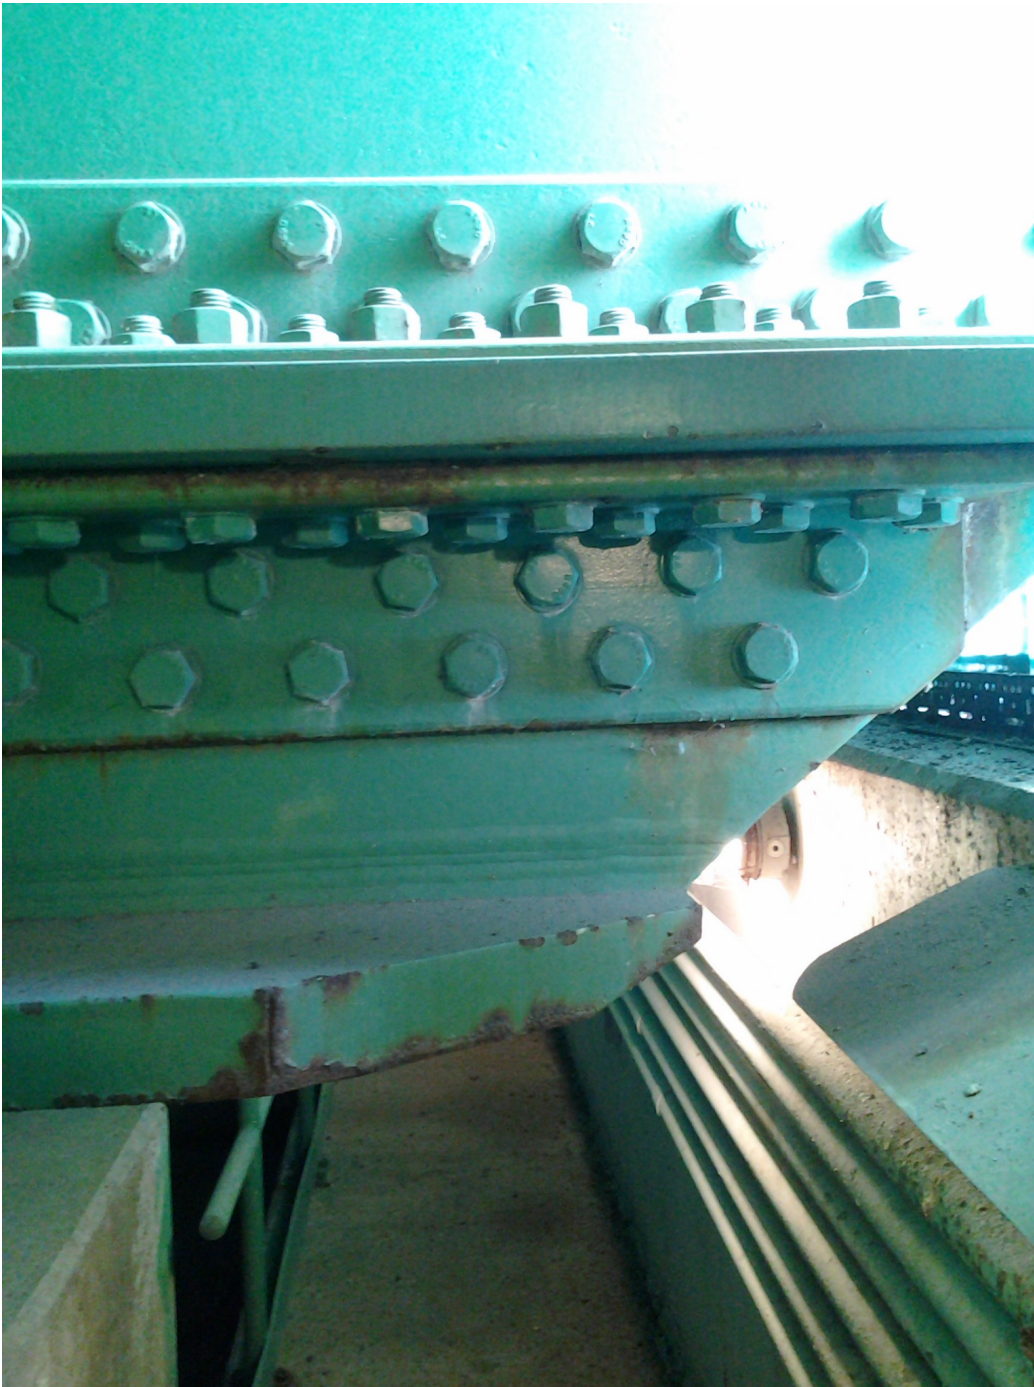
Minor corrosion in the southwest connection just in front of the counterweights.

Minor corrosion in the southwest connection just in front of the counterweights. (backside)

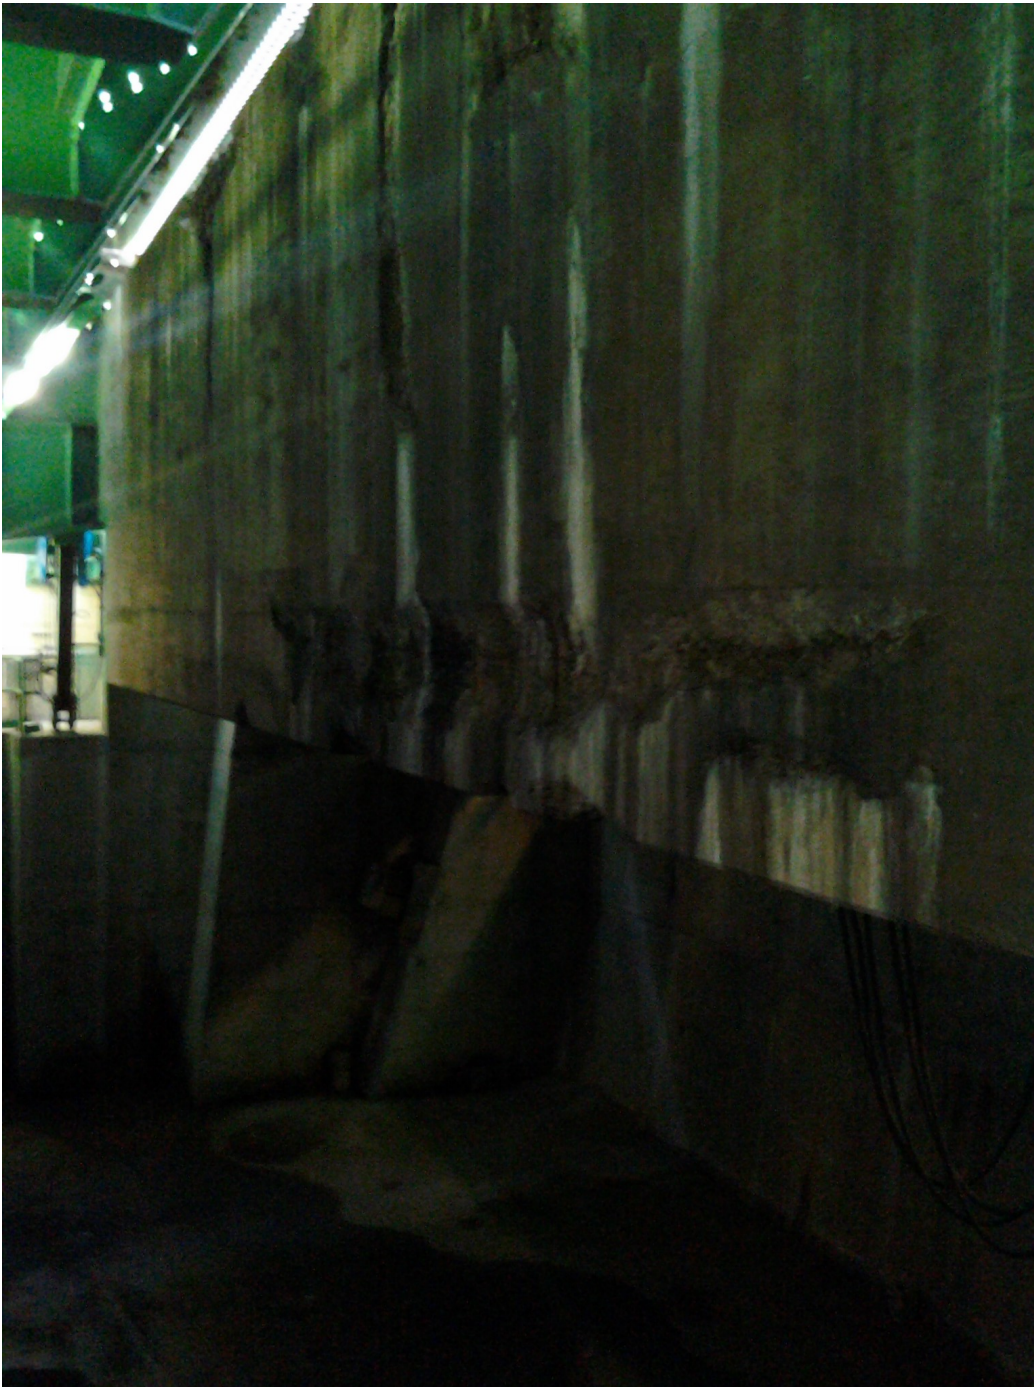
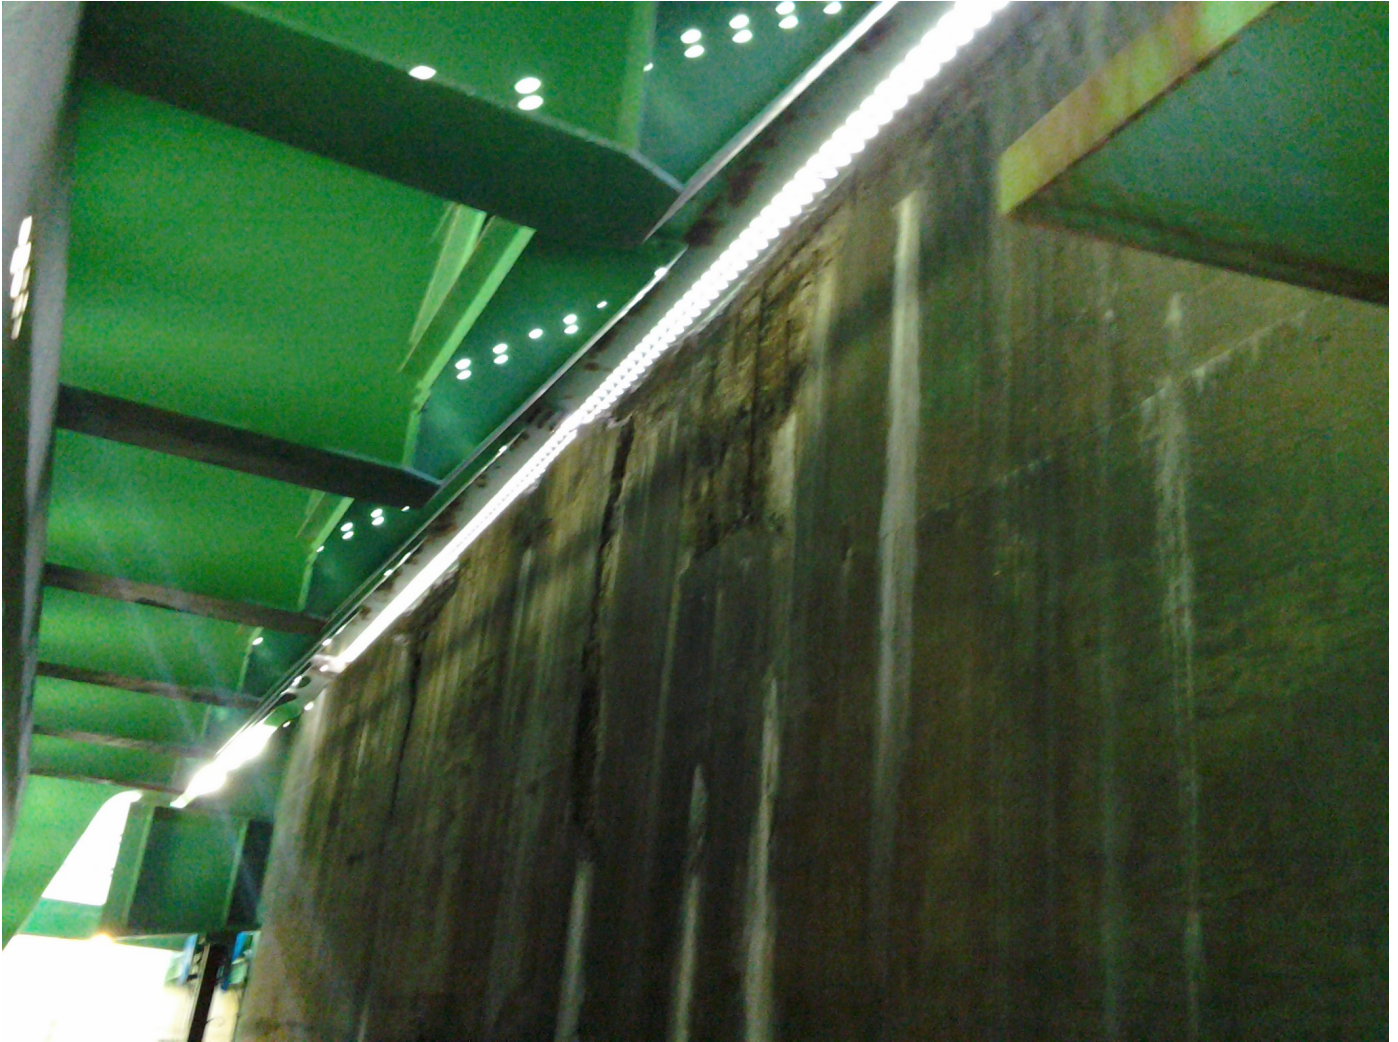
Minnesota counterweight

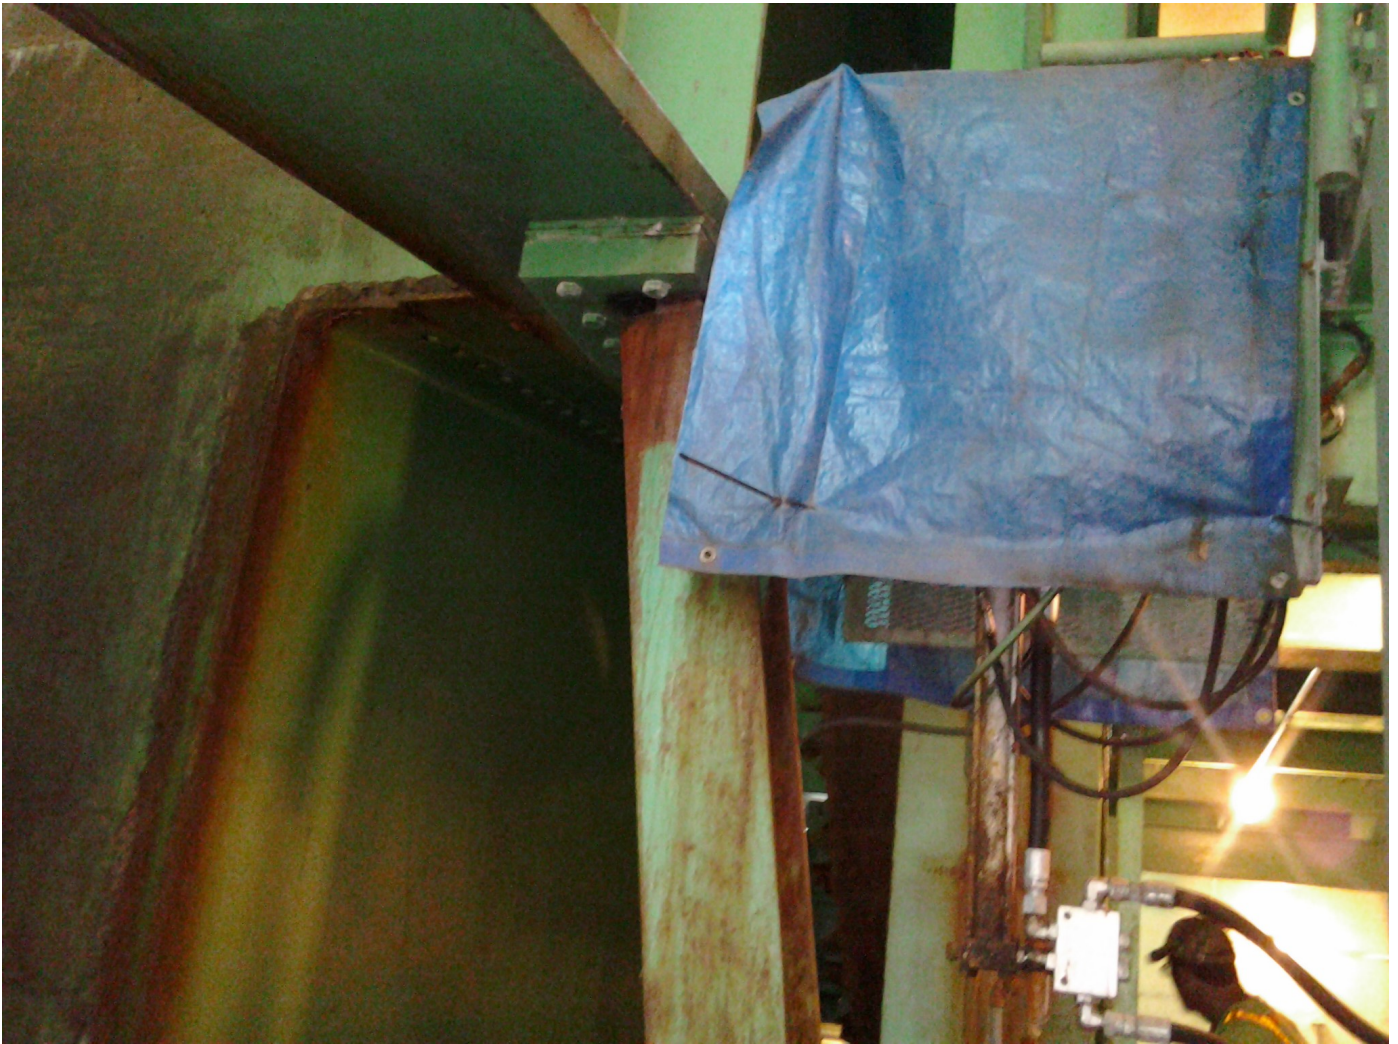
Southwest rear lock corrosion

Item	Priority	Recommended by	Status	Status change
<b>Misc - Paint Spot / Complete</b>	MEDIUM	Haig, Gregory (5014)	IDENTIFIED	06/02/15
Ends of Span 3 girders and surrounding areas will need paint soon.				
<b>Superstructure - Other Work</b>		Haig, Gregory (5014)	IDENTIFIED	04/29/14
Clean, paint and protect the southwest corner rear lock

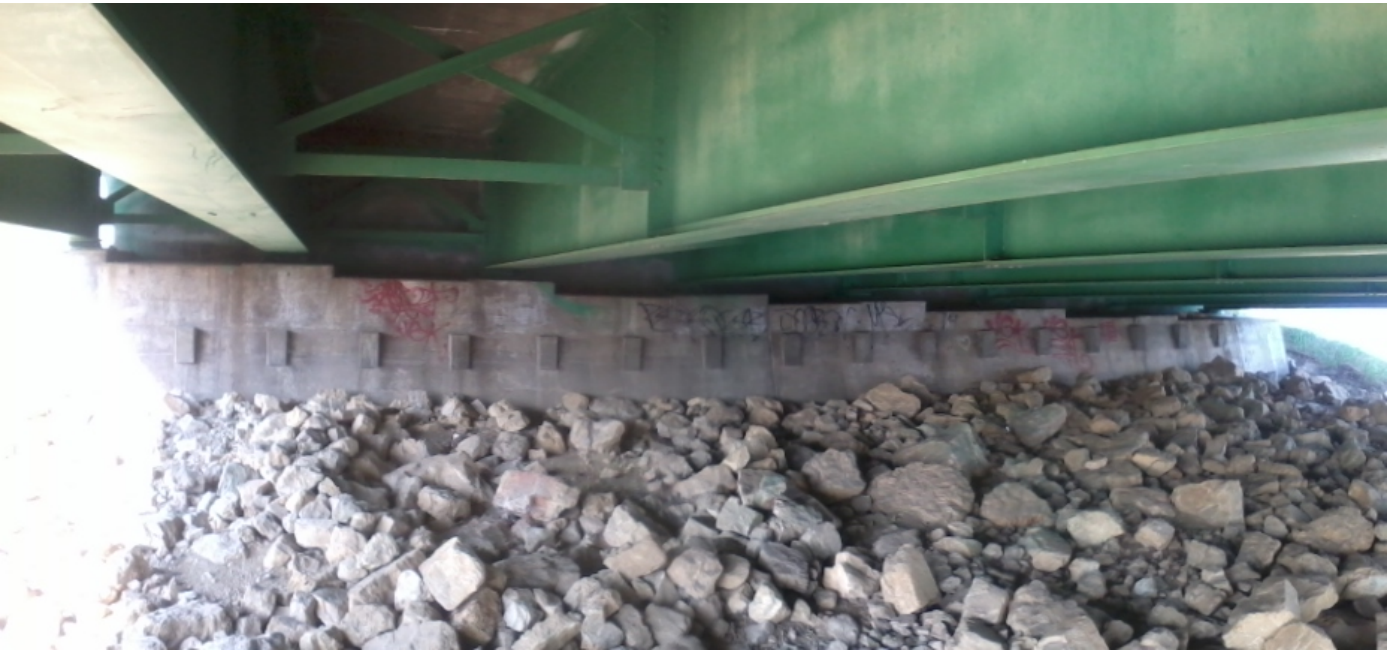
NBI rating is a 6 for substructure because of the movement of the West abutment which seems to be stable now. Oil Aurs gave the structure and hydrolic systems a tune up the fall of 1998 - Ed says still not working correctly. Welded 1/16 inch shims on the male to female mating mechanism in 1999. Extended 1 1/2 inch pump pipe on outside of pier wall in 2001 to the to keep pier wall from staining.

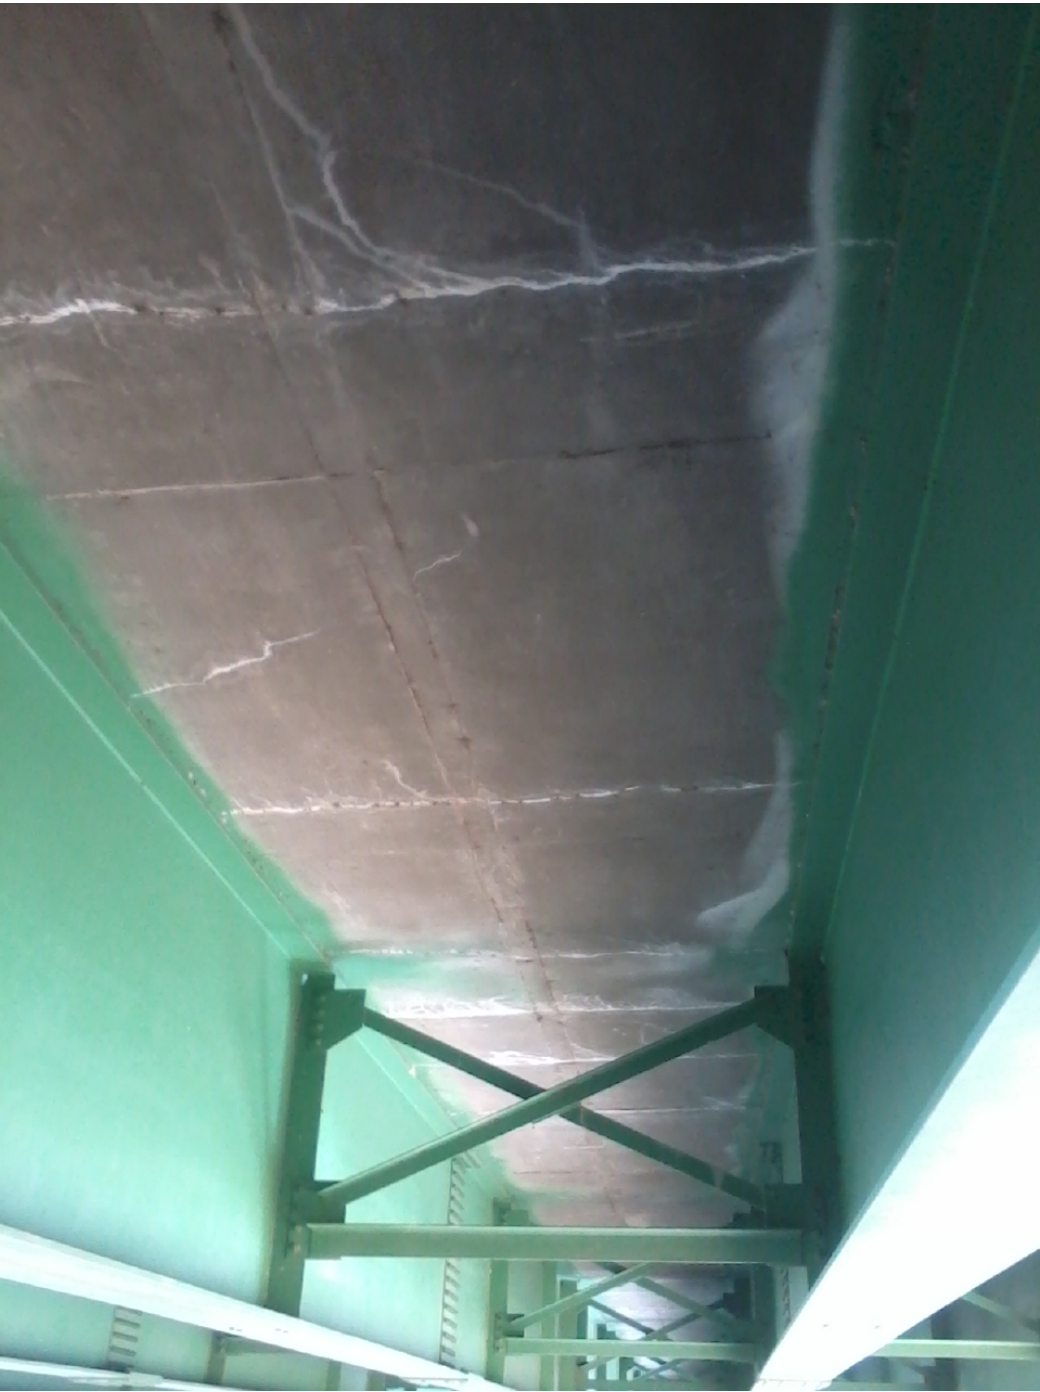
Chk	Element	Defect	Description	UOM	Total	Quantity in Condition State			
						1	2	3	4
X	12		<b>Reinforced Concrete Deck-Coated Reinforcing</b>	SF	45,079	39,779	5,000	300	0
			Cracking (RC)	SF		0	5,000	300	0
		1130	Underside - numerous hairline (about every 4 ft) transverse cracks with light/medium efflorescence leaching. Cracks are located throughout the entire underside of the bridge. Bay 3 between girders 4 and 5 in span 3 has numerous cracks with rust staining. Rust is leaching through on top of girder 4 in span 3. The soffit on the outside north edge along the sidewalk has numerous vertical cracks at rail posts with rust staining.						
		8000	Wearing Surface (Bare)	SF	45,079	43,078	2,000	1	0
		3210	Debonding/Spall/Patched Area/Pothole	SF		0	0	1	0
			Small spall (6 in. x 6 in.) near finger joint on Wisconsin side located in the center of the left east bound lane.						
X	28		<b>Steel Deck With Open Grid</b>	SF	1,001	100	901	0	0

Span 1 - deck underside (typ.)

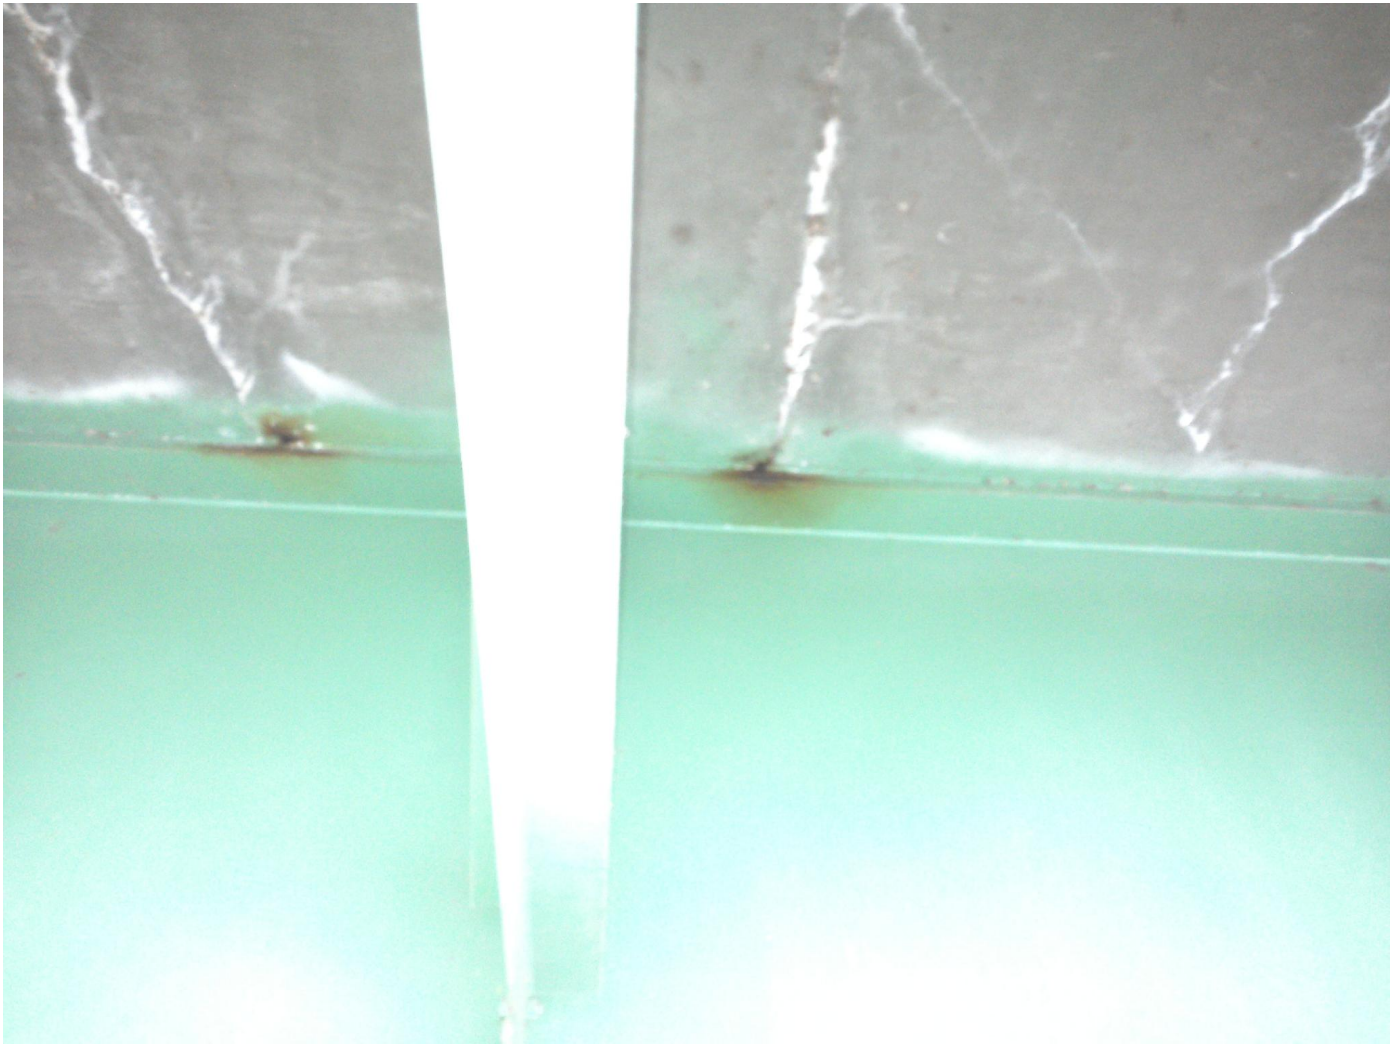
Rust staining on the bottom of the deck in span 4 between girders 4 and 5.

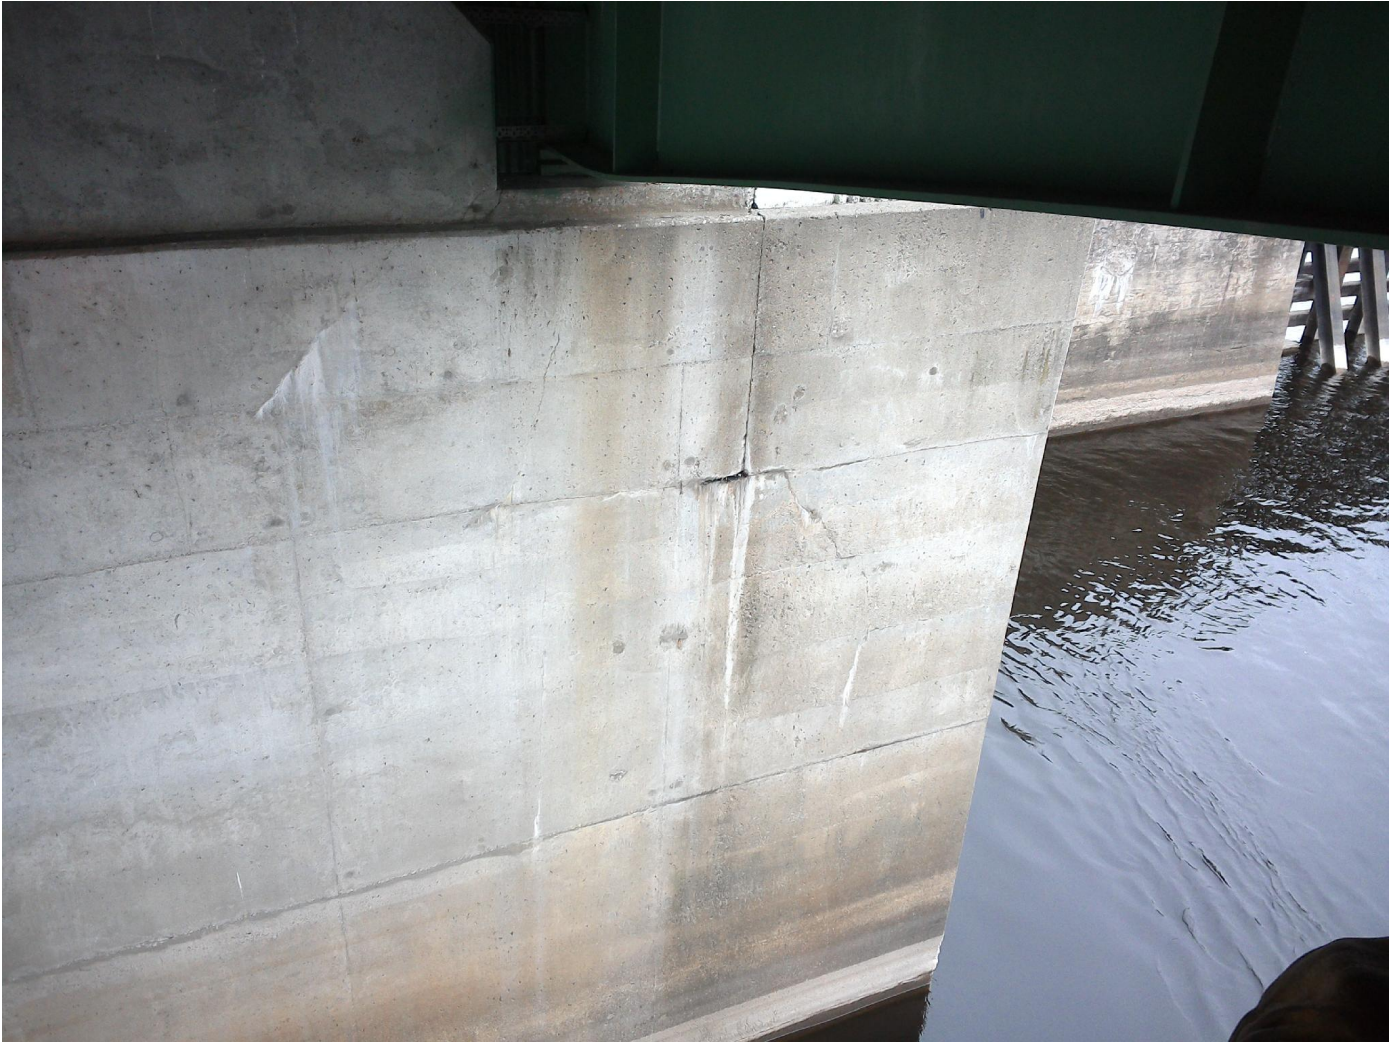
Cracks in pier 3. Looking west at the northwest corner.
