STATE OF WISCONSIN  
DEPARTMENT OF TRANSPORTATION

# Inspection Report for B-47-040

USH 10 over ST CROIX RIVER 01

Apr 13, 2017

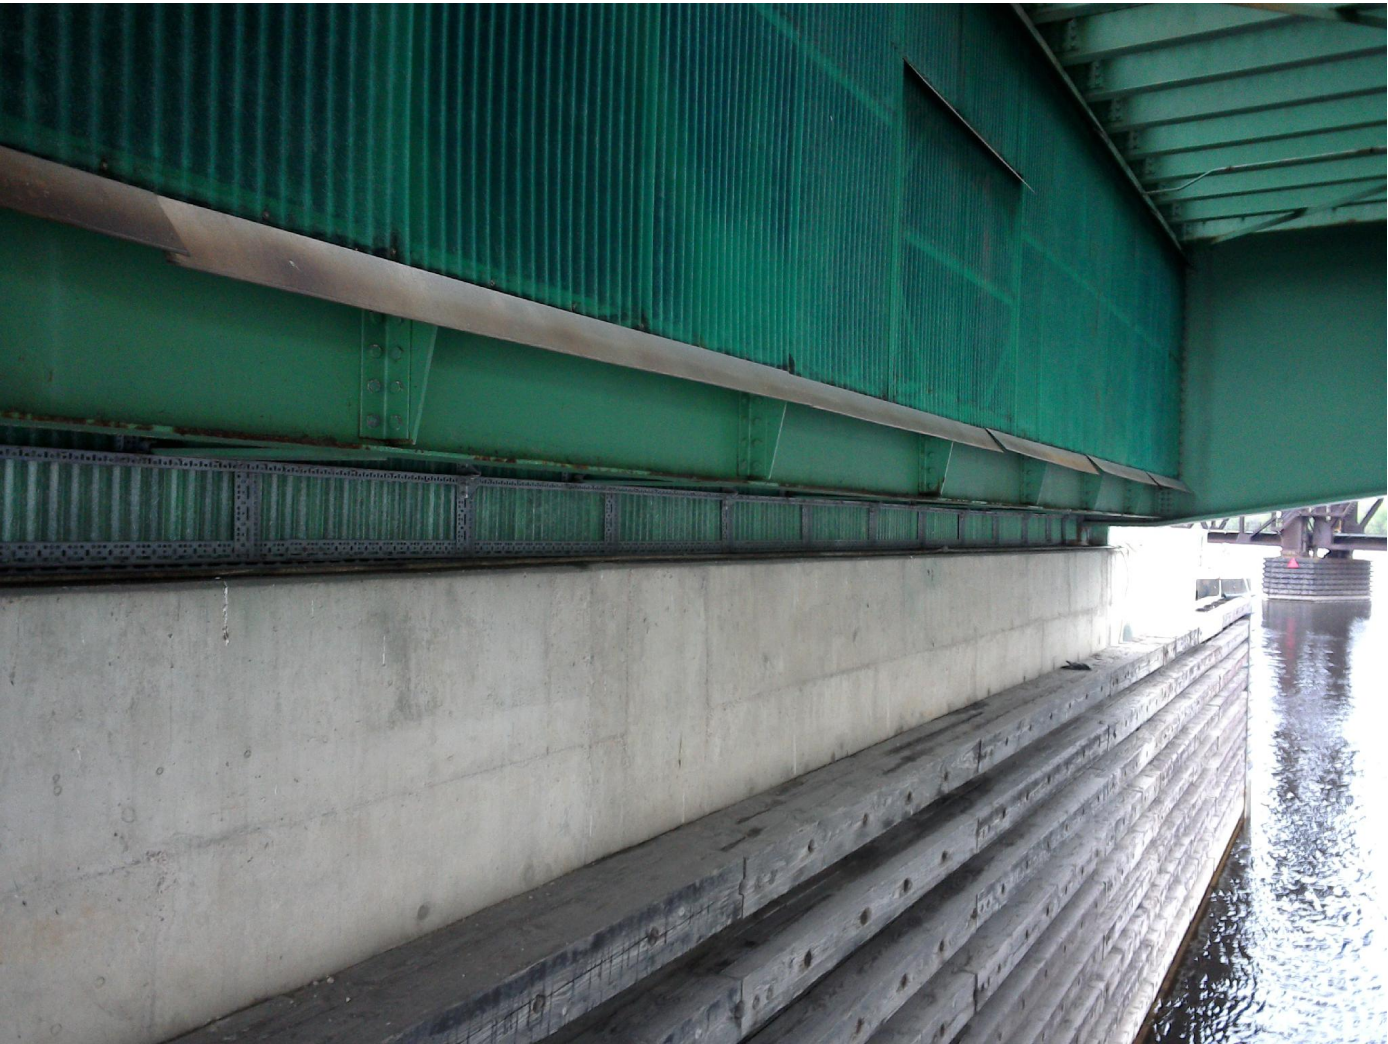
Diaphragm corrosion on the west side of pier 3.

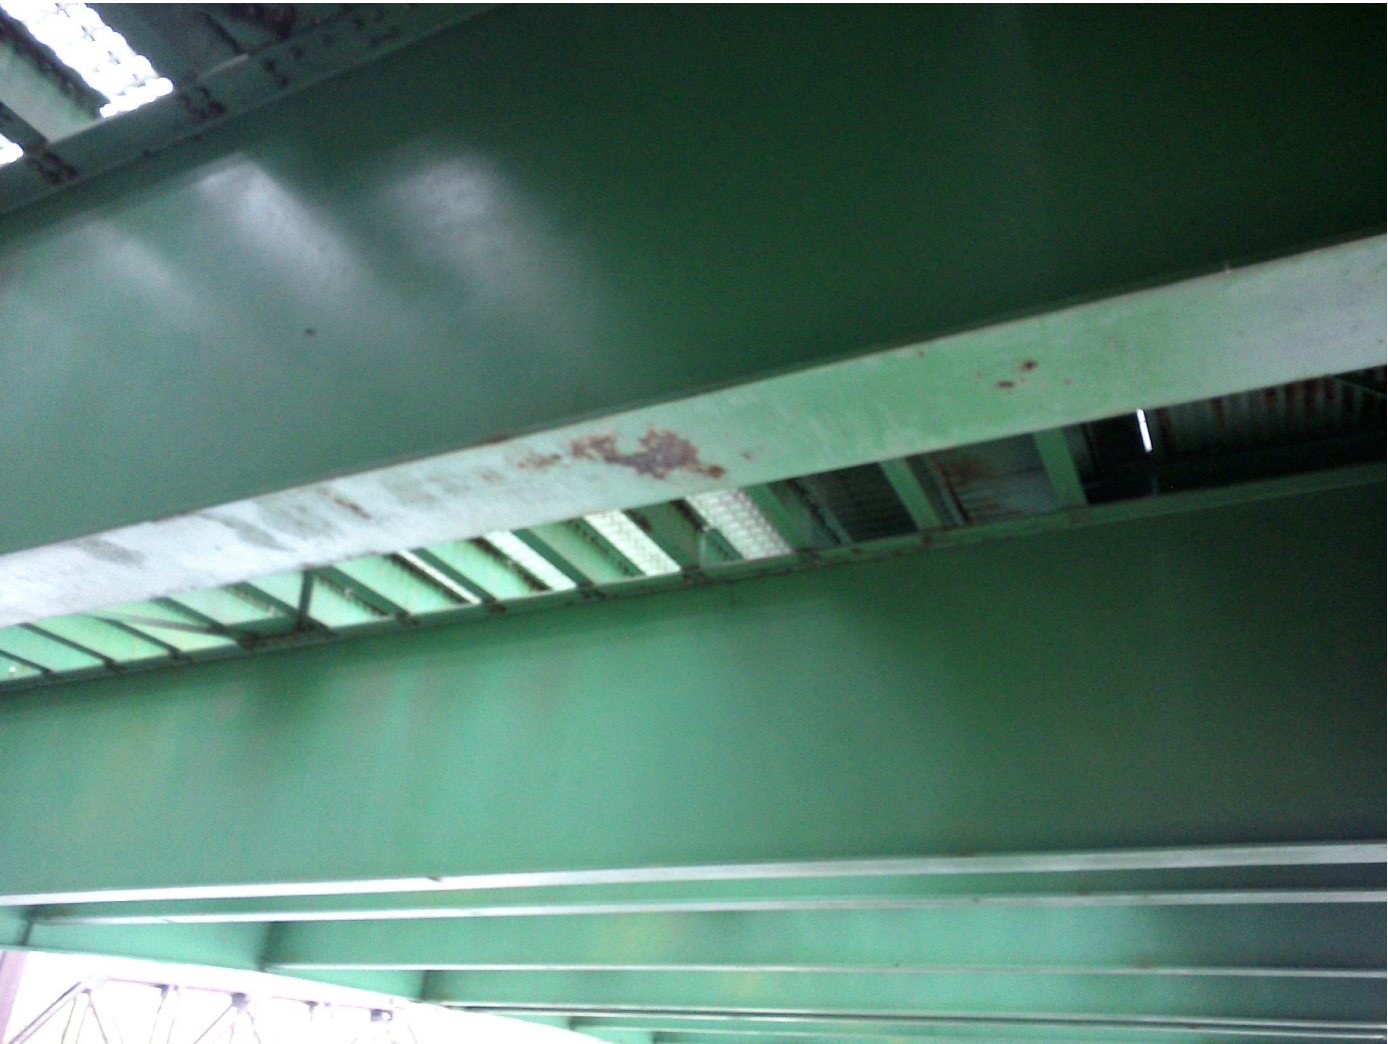
X	152		<b>Steel Floor Beam</b>	LF	652	601	51	0	0
		1000	Corrosion	LF		0	51	0	0
			The bascule span had approximately 3 ft. of exposed steel that is actively rusting in each floor beam.						
X	210		<b>Reinforced Concrete Pier Wall</b>	LF	215	161	50	4	0
			The concrete surfaces at Piers 1 through 4 were typically smooth, sound, and in good condition. Piers 2 east face and pier 3 west face have treated timbers bolted to them.						
		1130	Cracking (RC)	LF		78	50	4	0
			See attached sketches for cracks and locations.						
X	215		<b>Reinforced Concrete Abutment</b>	LF	130	124	6	0	0
		1130	Cracking (RC)	LF		0	6	0	0
			East abutment backwall has a couple hairline/medium horizontal/vertical cracks. Joints are leaking badly on to abutment footing causing staining. OLD NOTE: West abutment is moving East about 2", Dead men were place behind west abutment and abutment seems to have stablize. 2016- bearings appear to be about 4 in. off center at 50 degrees f. It appears to be the same as previous inspections.

Spot rusting in the bascule span floor beams.

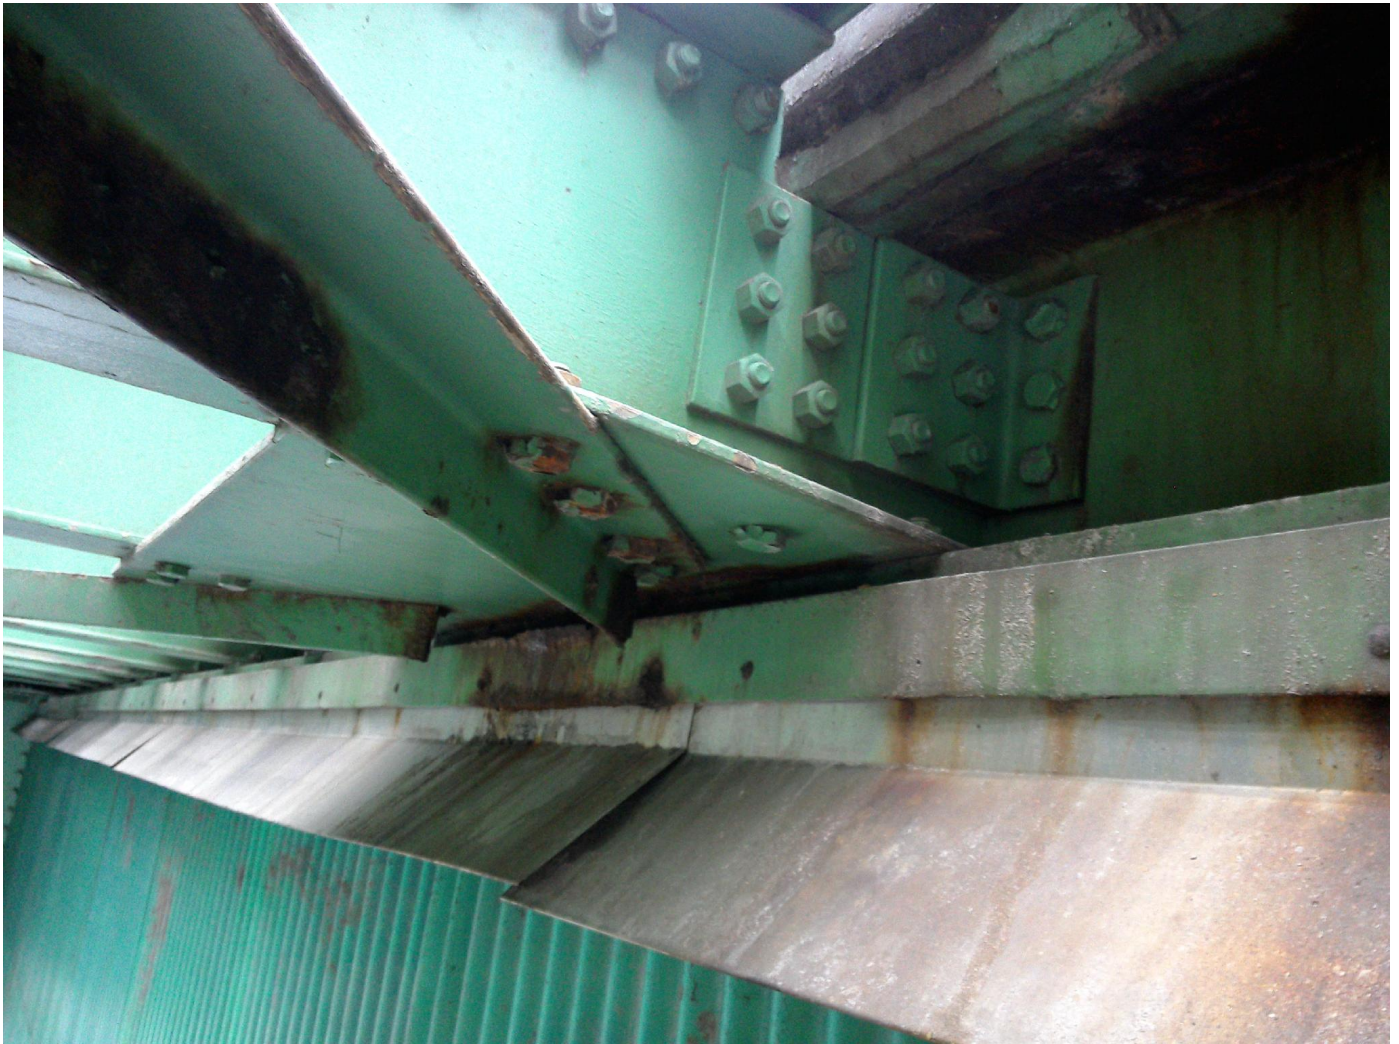
Corrosion of the cross members near pier 2.

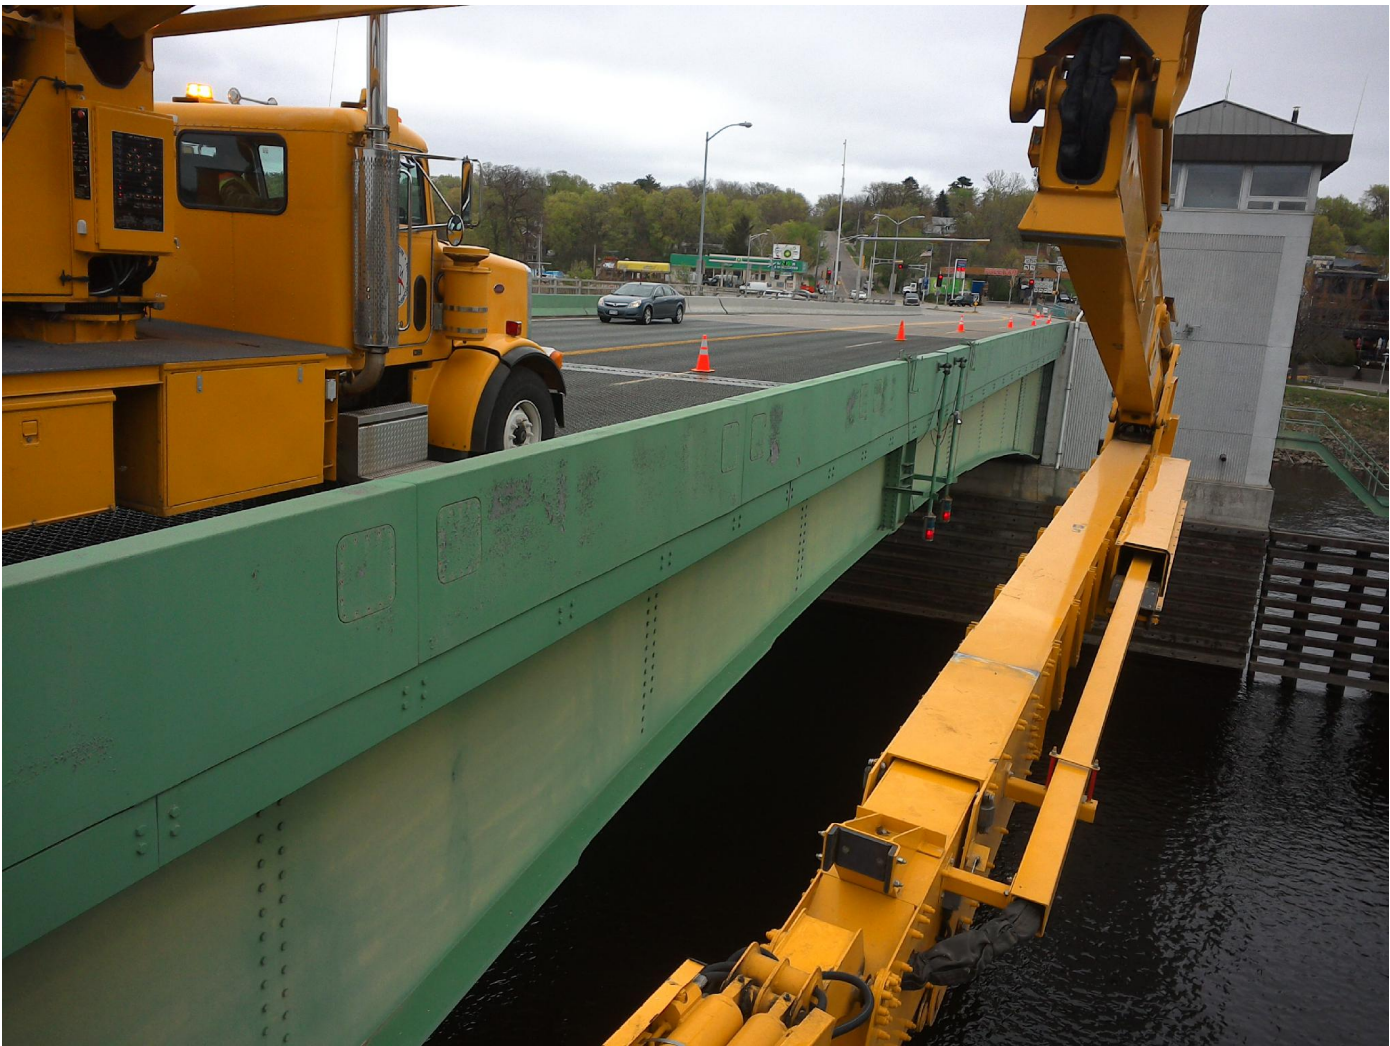
southside of girder 1 in bascule span. Chalking paint

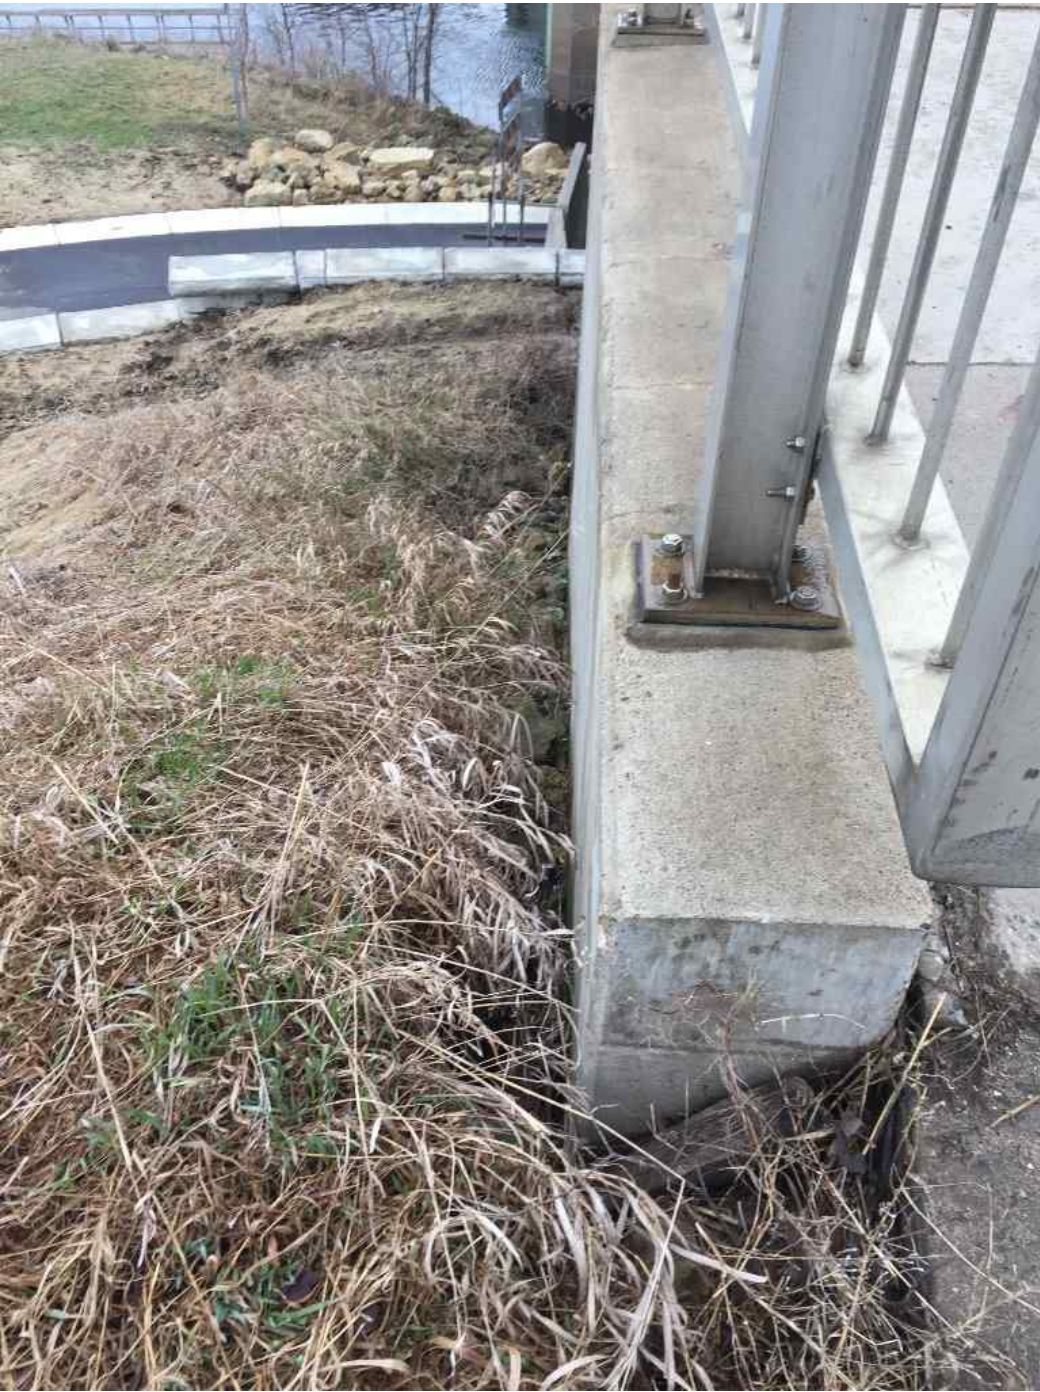
Routine  
Document Comment/Description  
Erosion around NW wing
