# Inspection Report for B-47-040

USH 10 over ST CROIX RIVER 01  
Apr 09,2018

Feature On: USH 10	Section Town Range: S09 T26N R20W	Structure Number: <b>B-47-040</b>
Feature Under: ST CROIX RIVER 01	County: PIERCE	
Location MINNESOTA STATE LINE	Municipality: PRESCOTT	Structure Name:

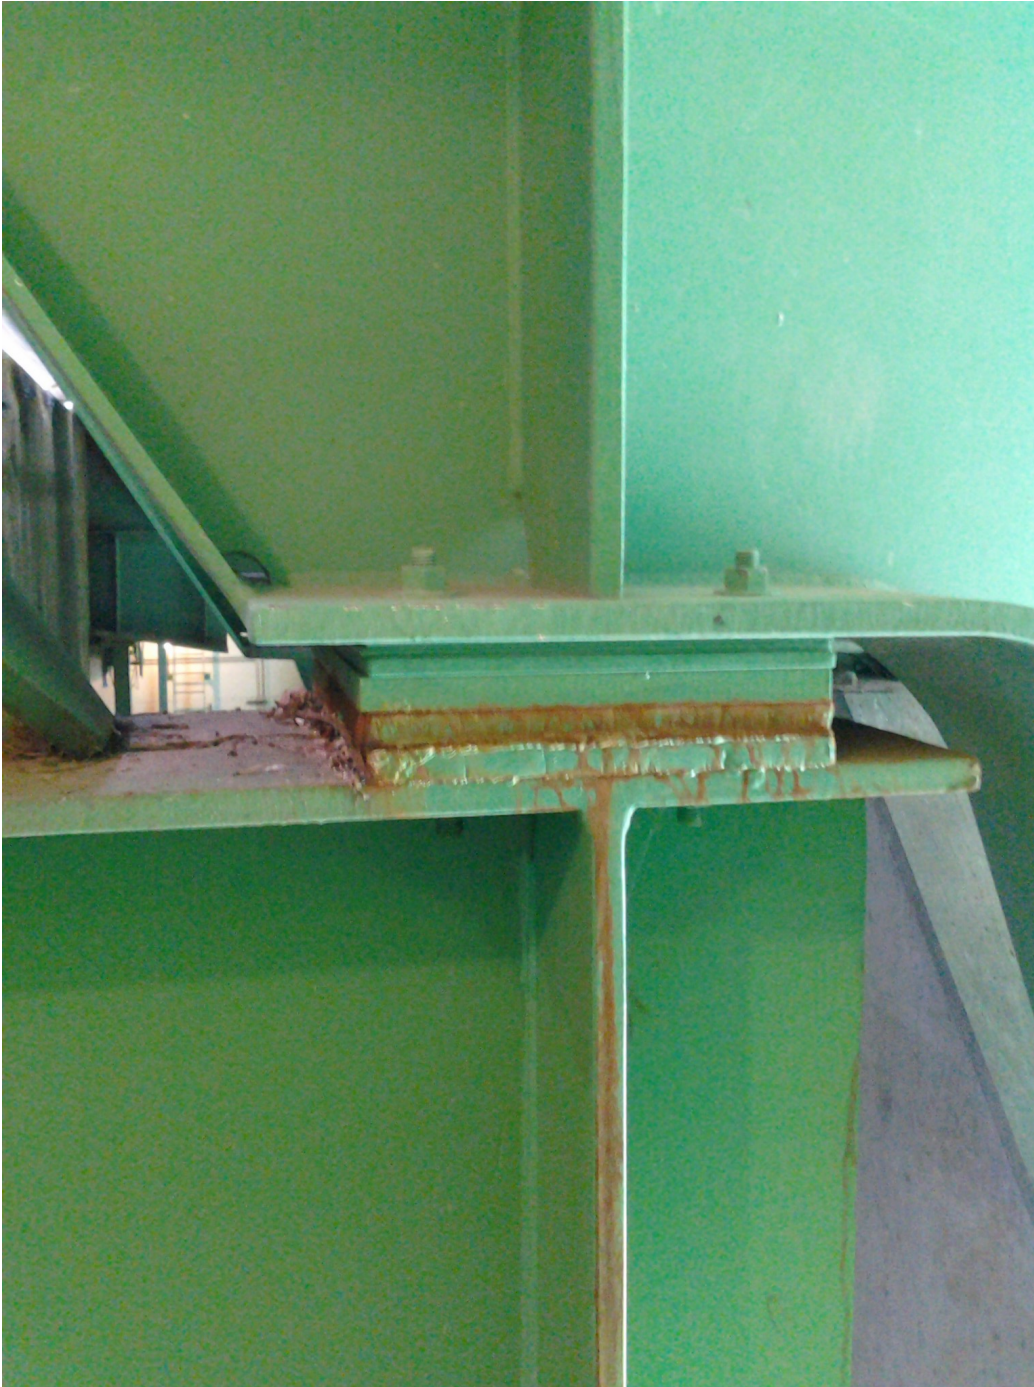
Bascule girder bearing plates (Southeast)

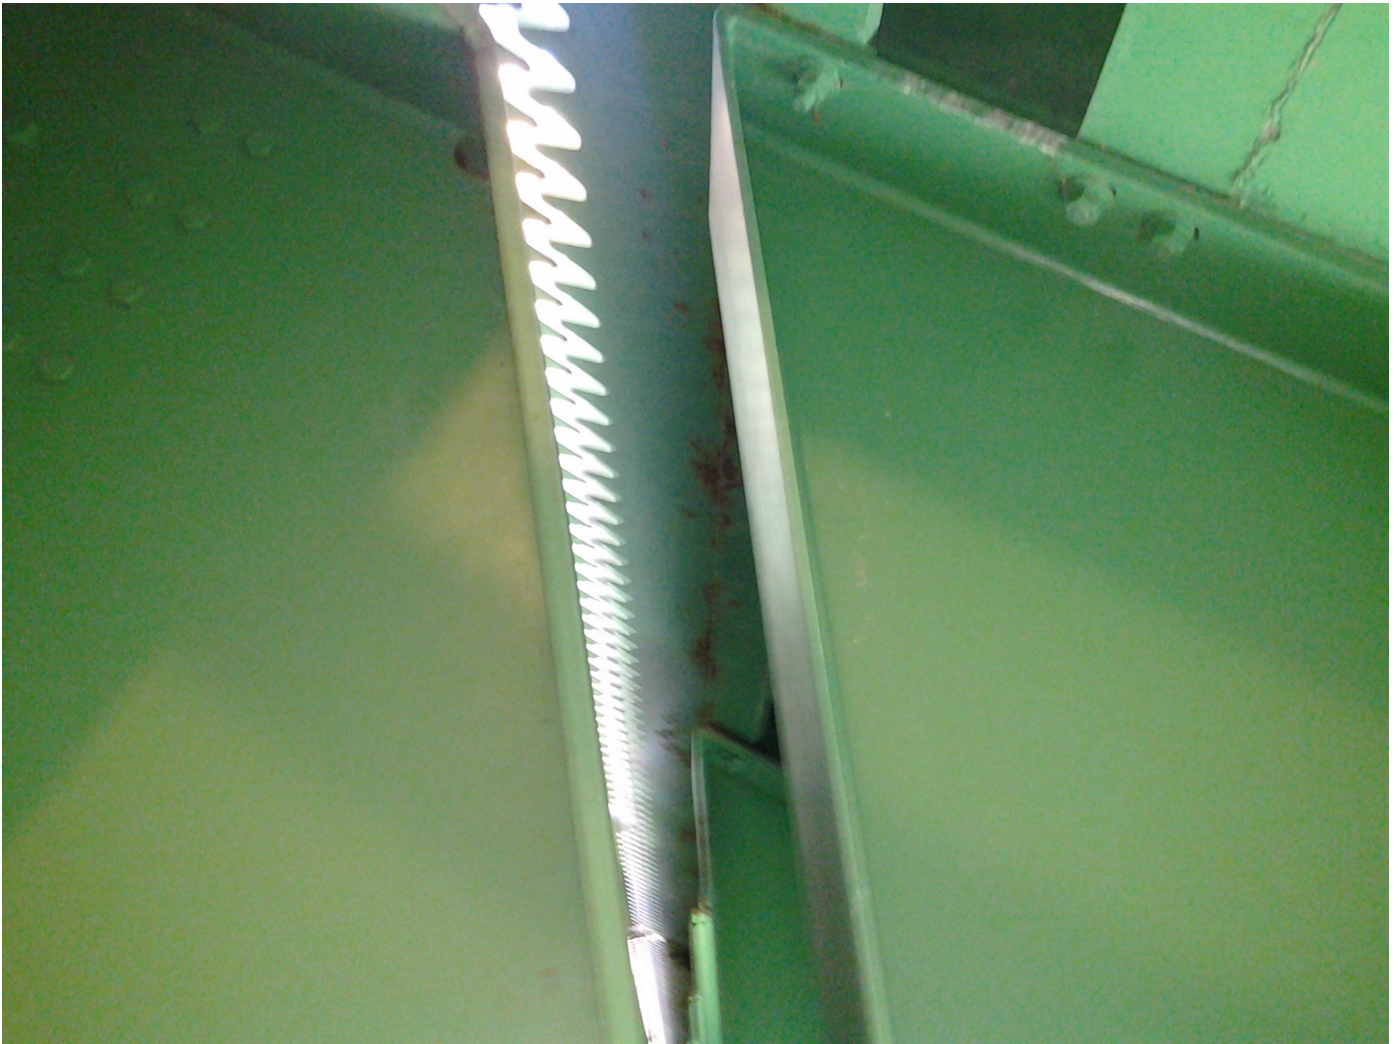
Wisconsin finger joint with spalling concrete under (Part of counterweight)

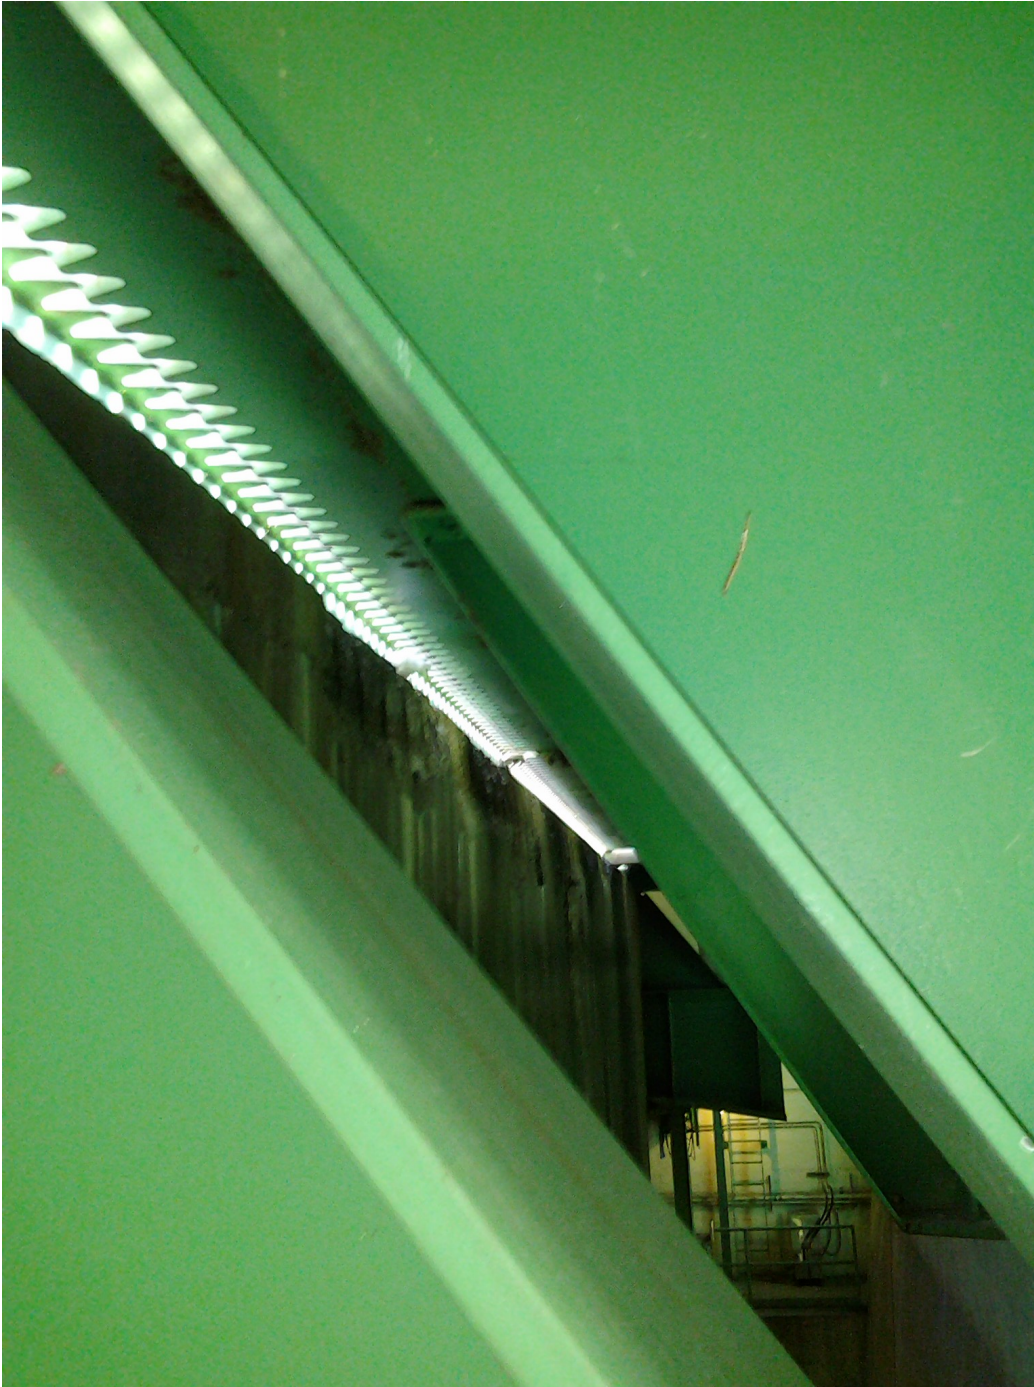
Wisconsin finger joint with spalling concrete under (Part of counterweight)

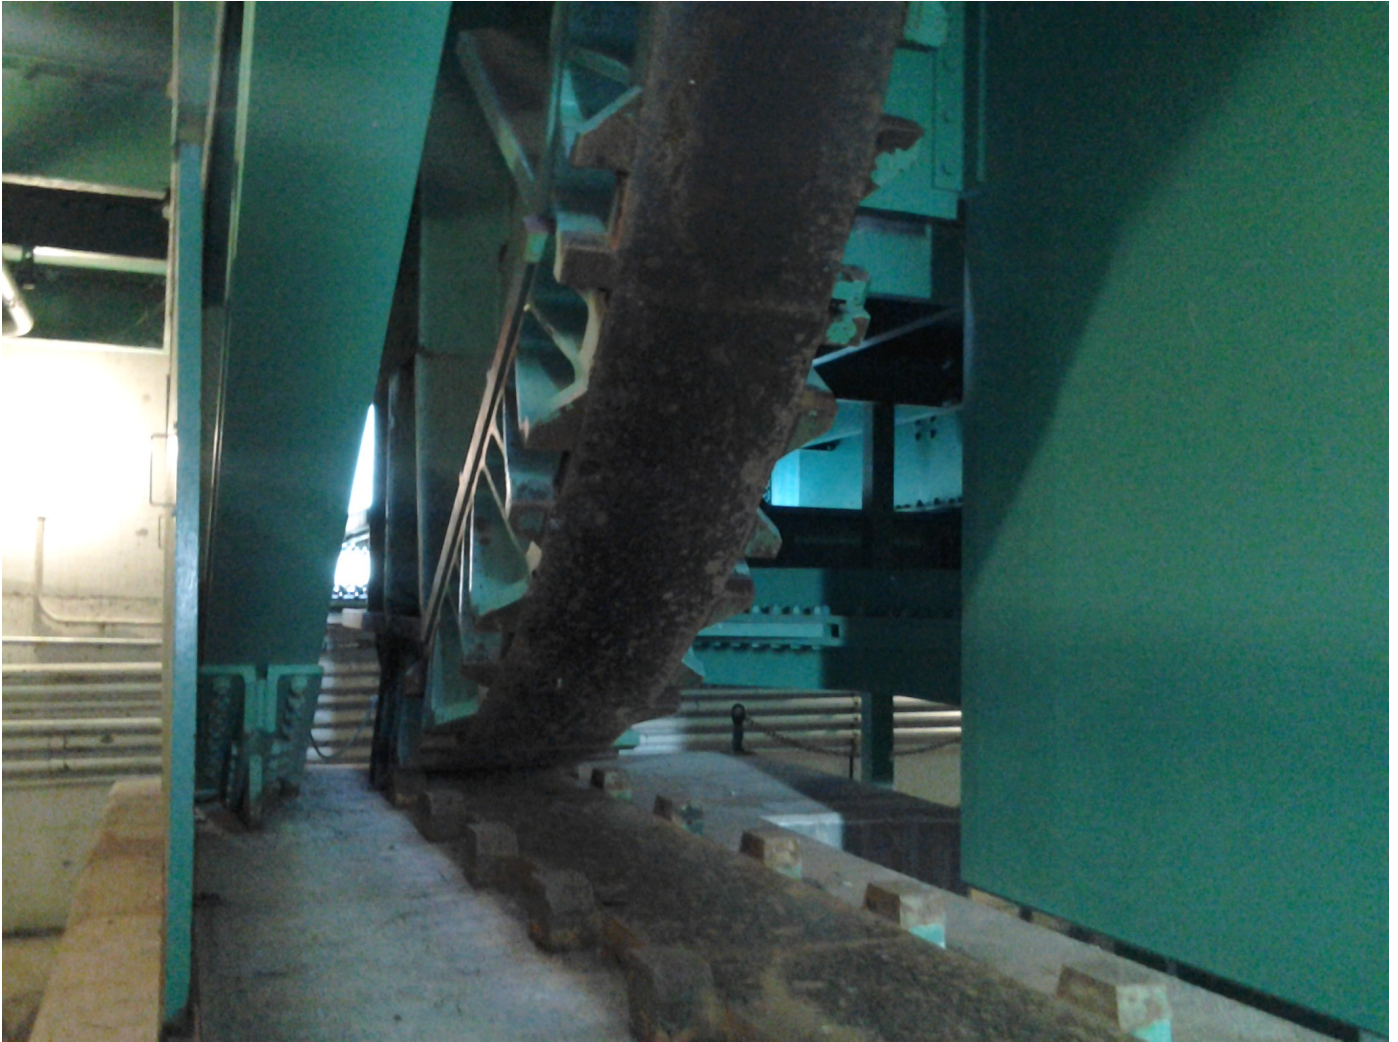
Main Rocker bearing at Southeast corner

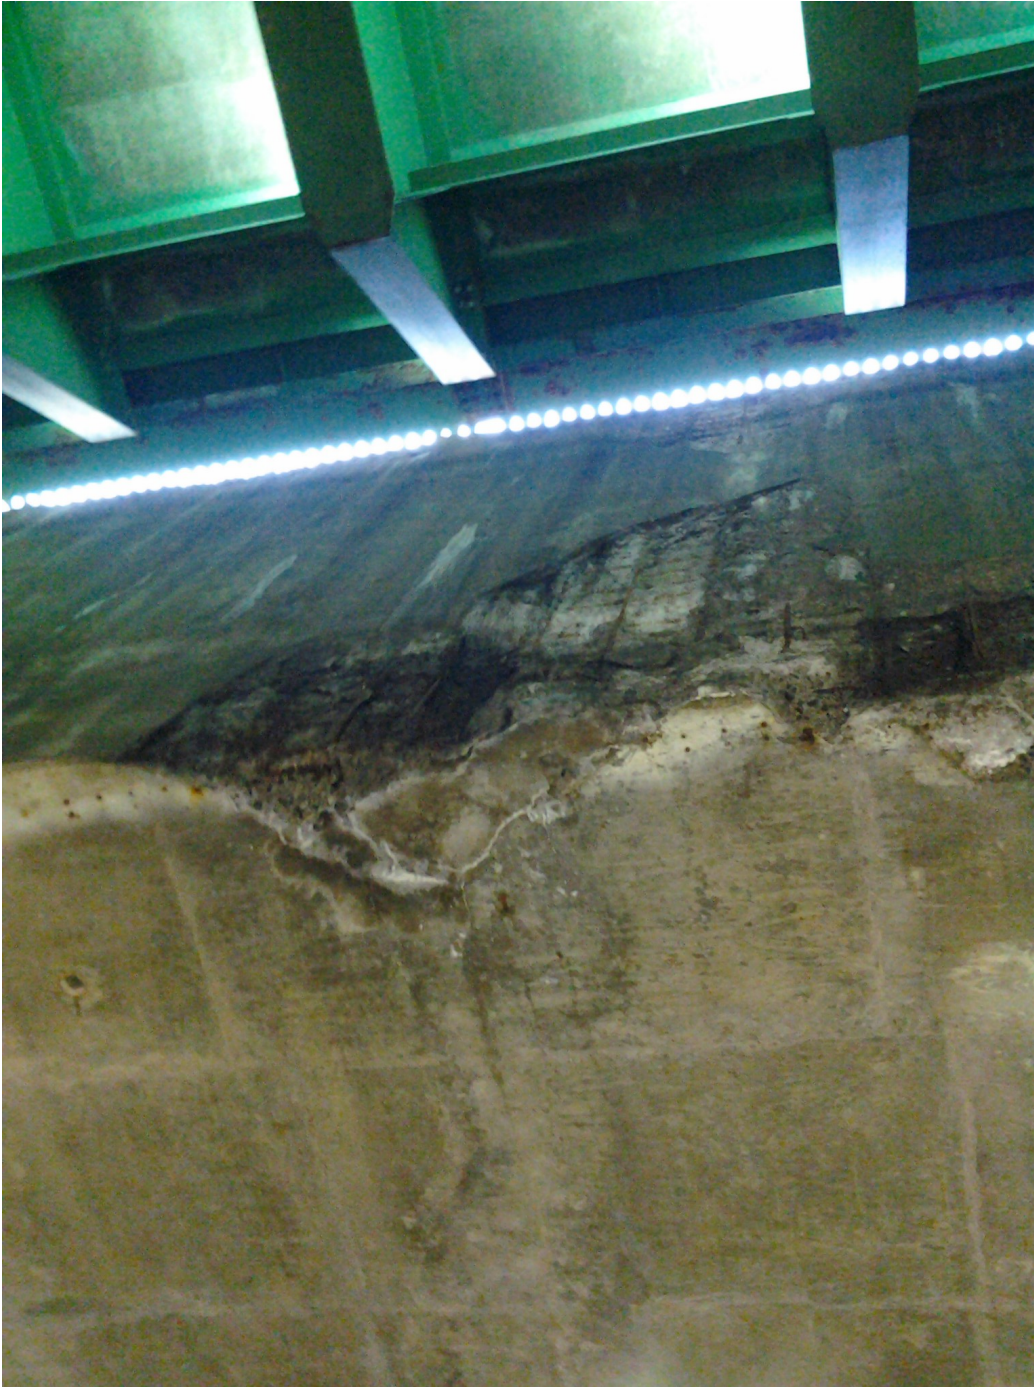
Bottom and face of counter weight (Wisconsin side)

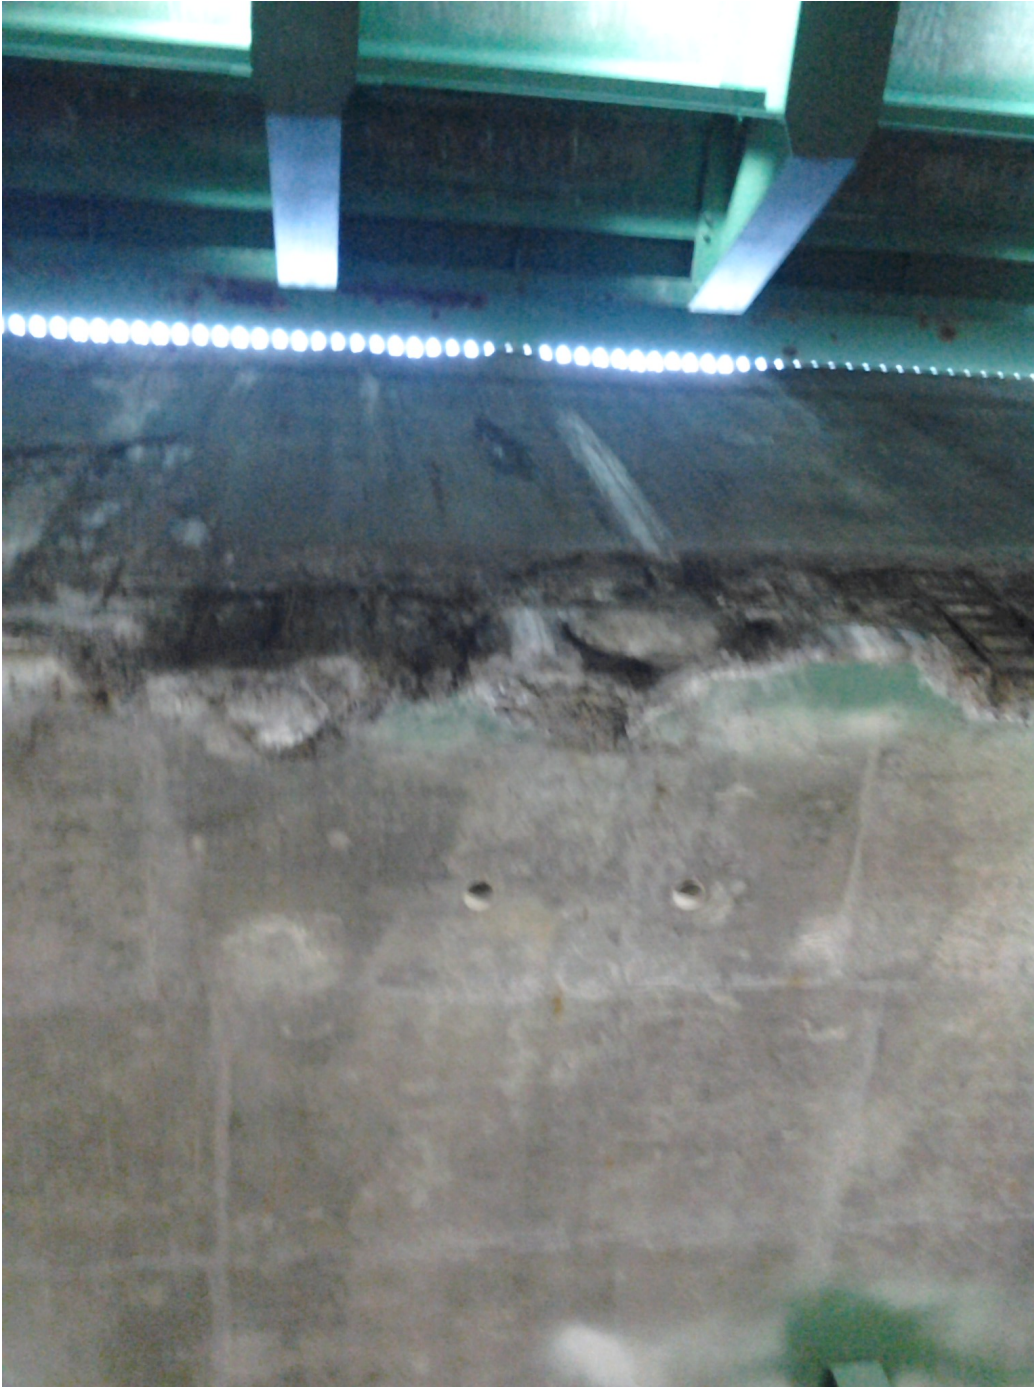
Bottom and face of counter weight (Wisconsin side)

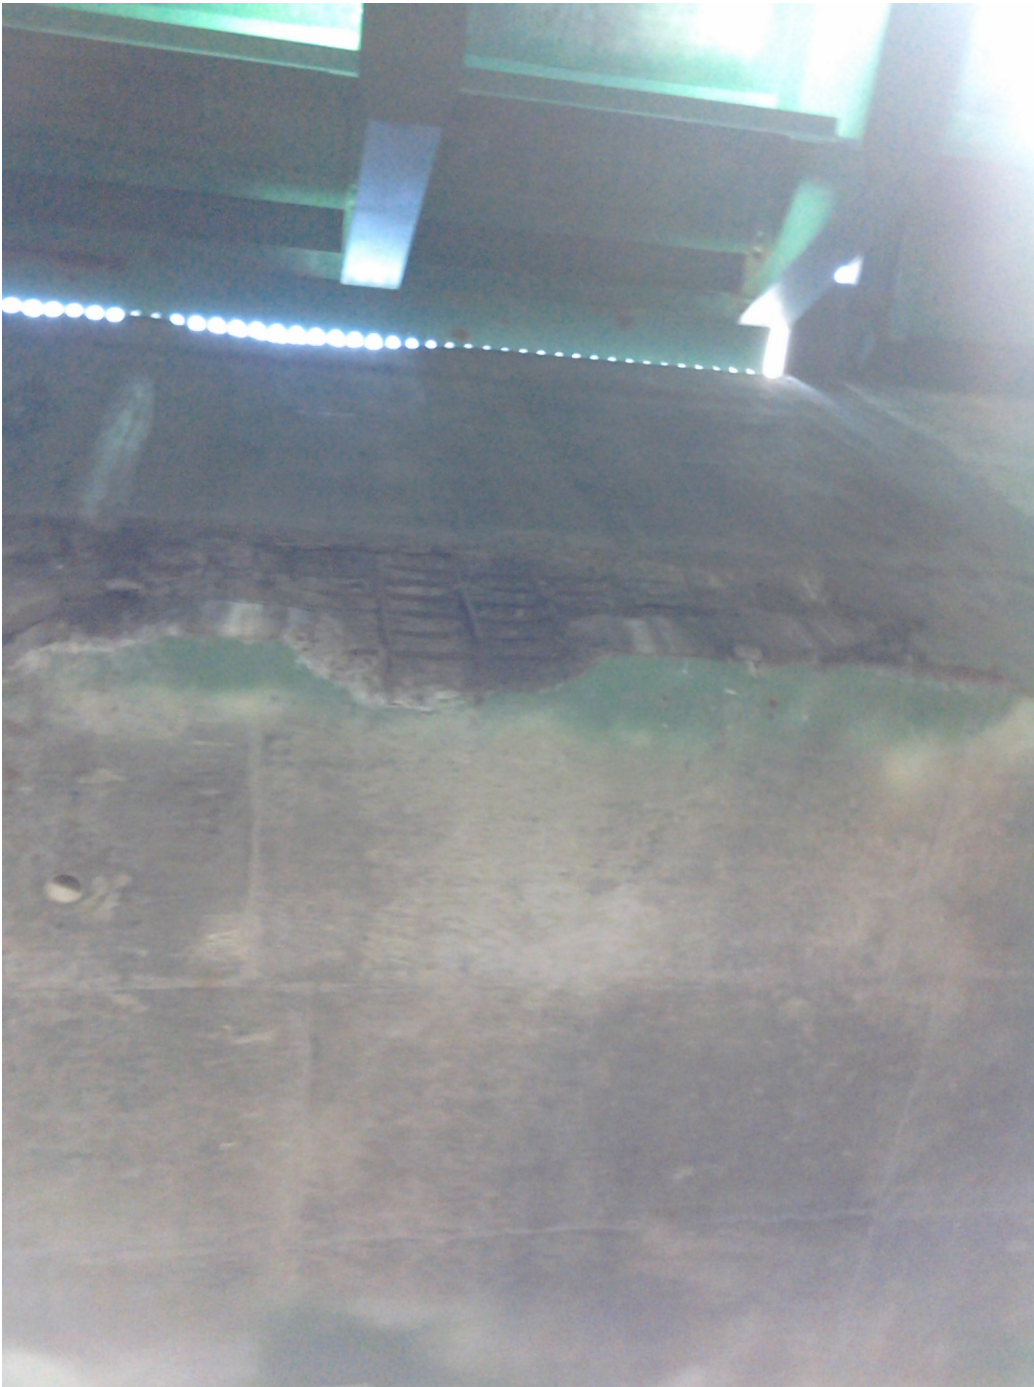
Bottom and face of counter weight (Wisconsin side)

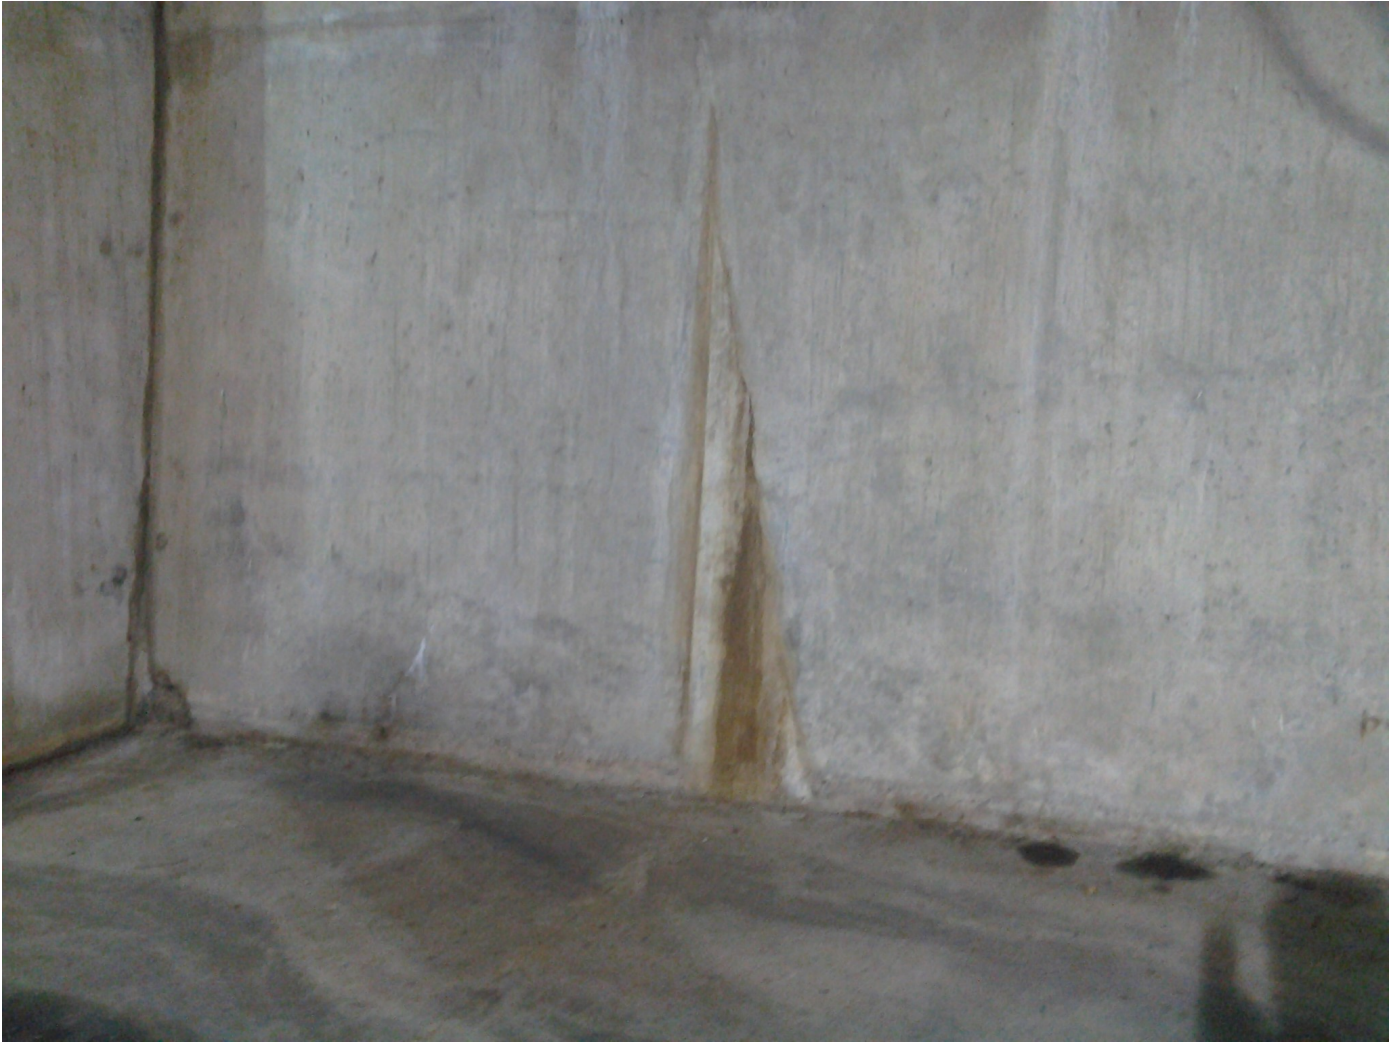
Cracks in the west wall of the east counterweight pit

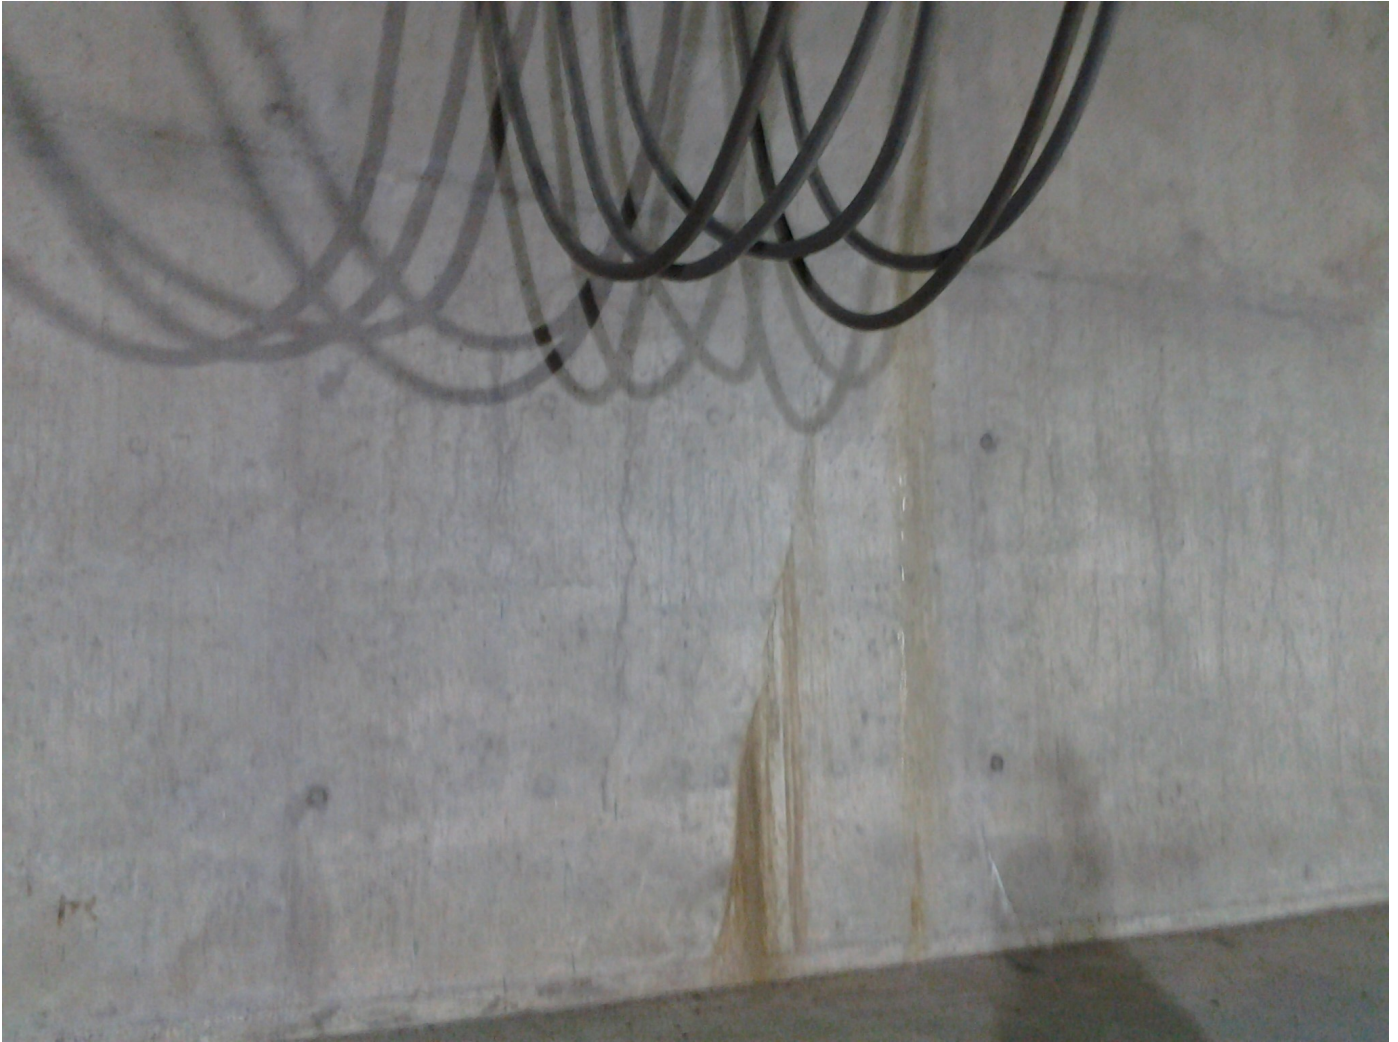
Cracks in the west wall of the east counterweight pit

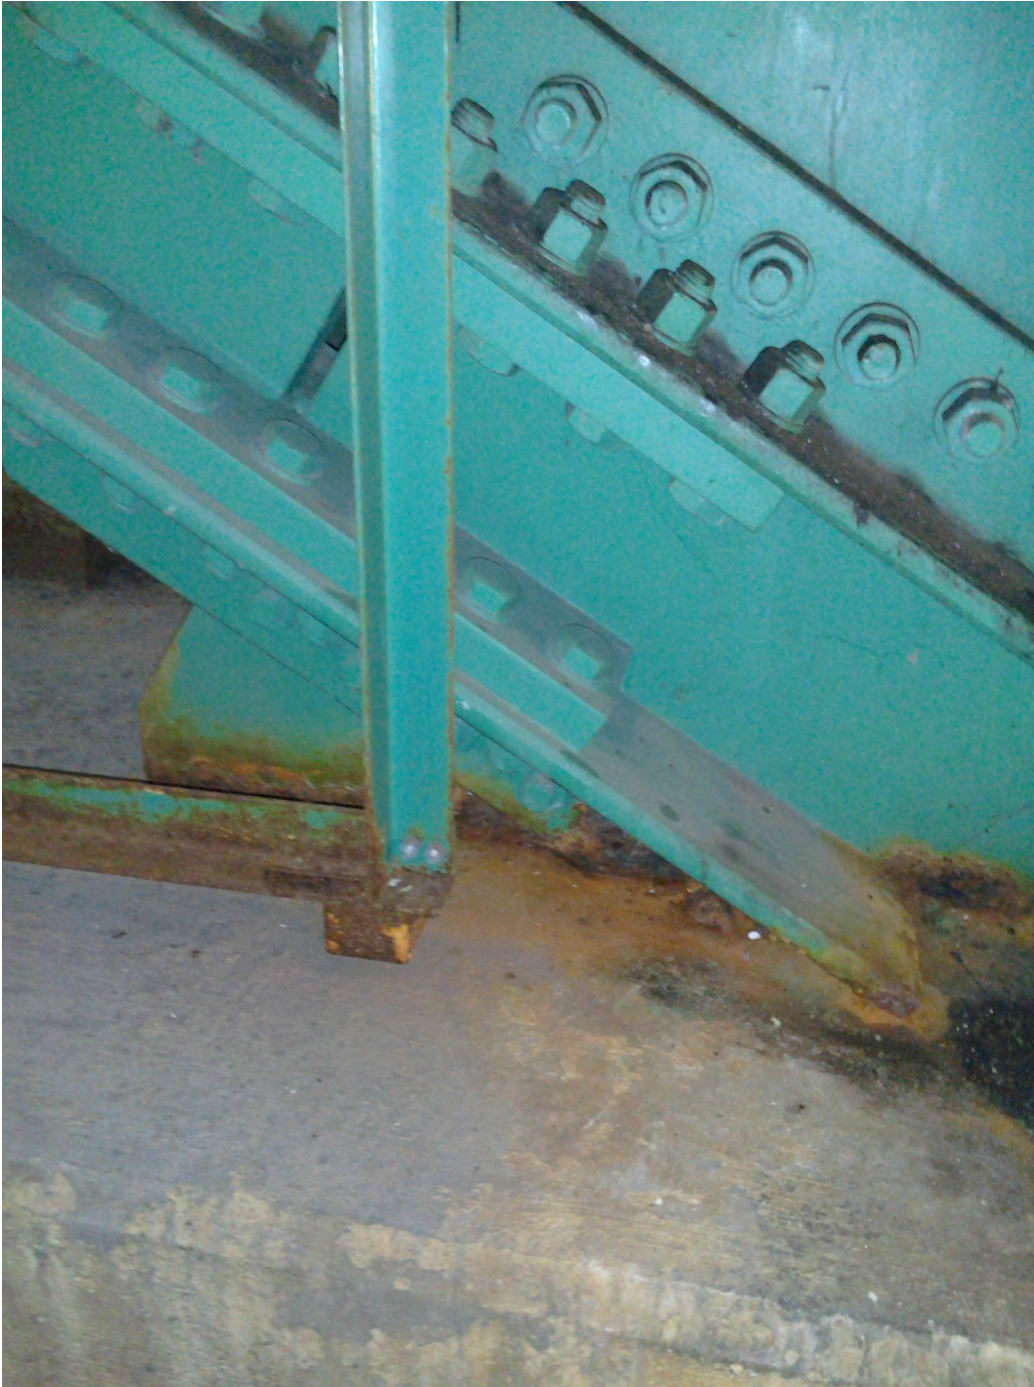
Northeast connection near the northeast rocker (minor corrosion)

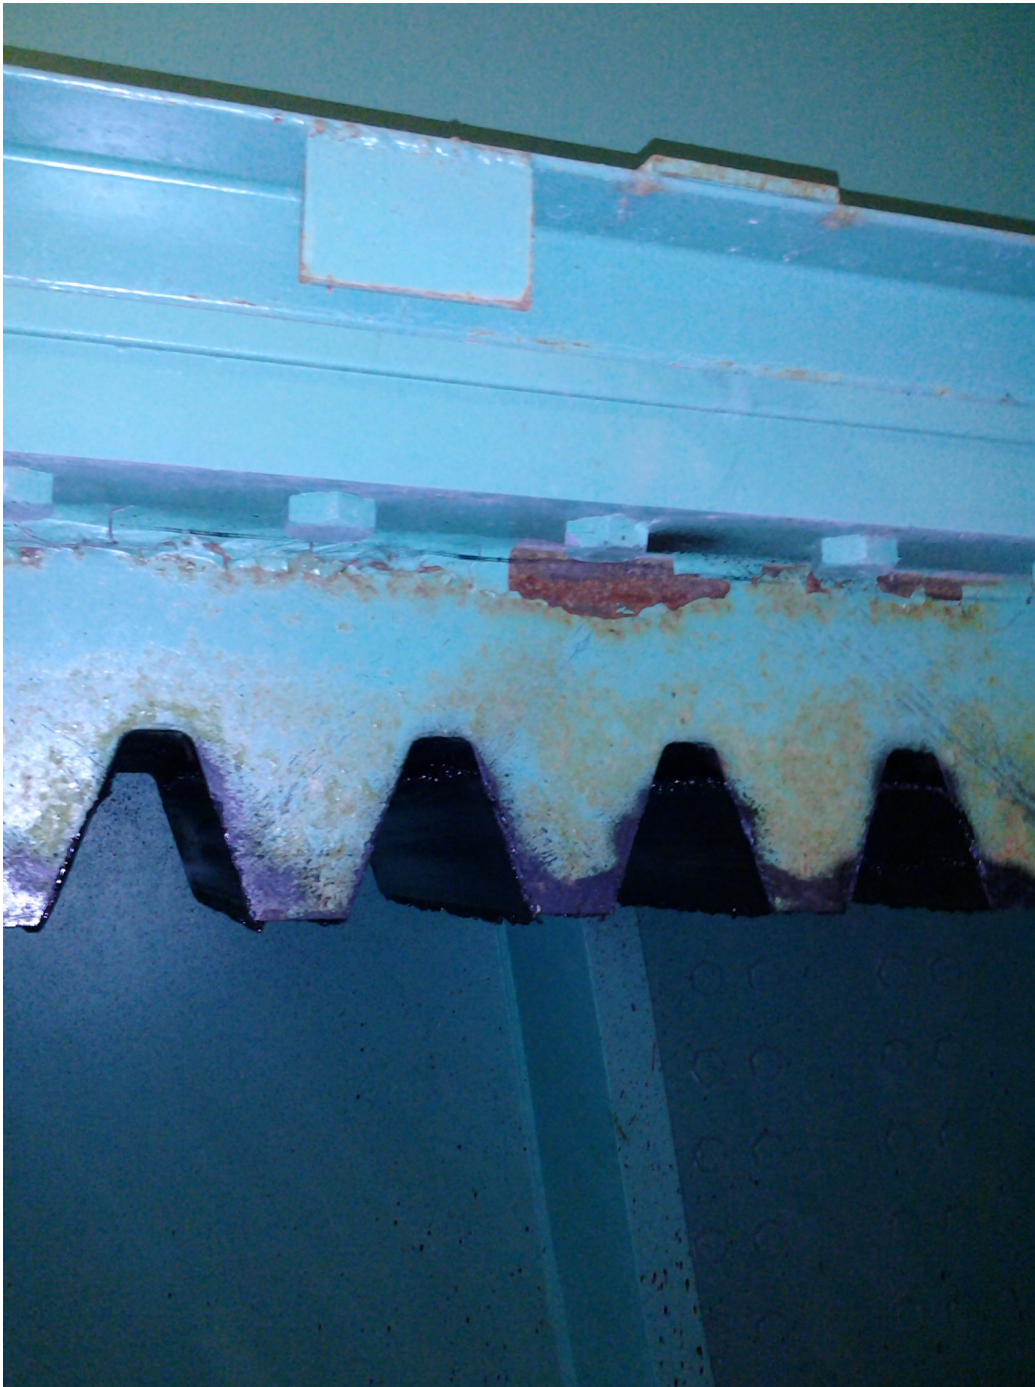
Minor rust on main spokes at the northeast rocker.

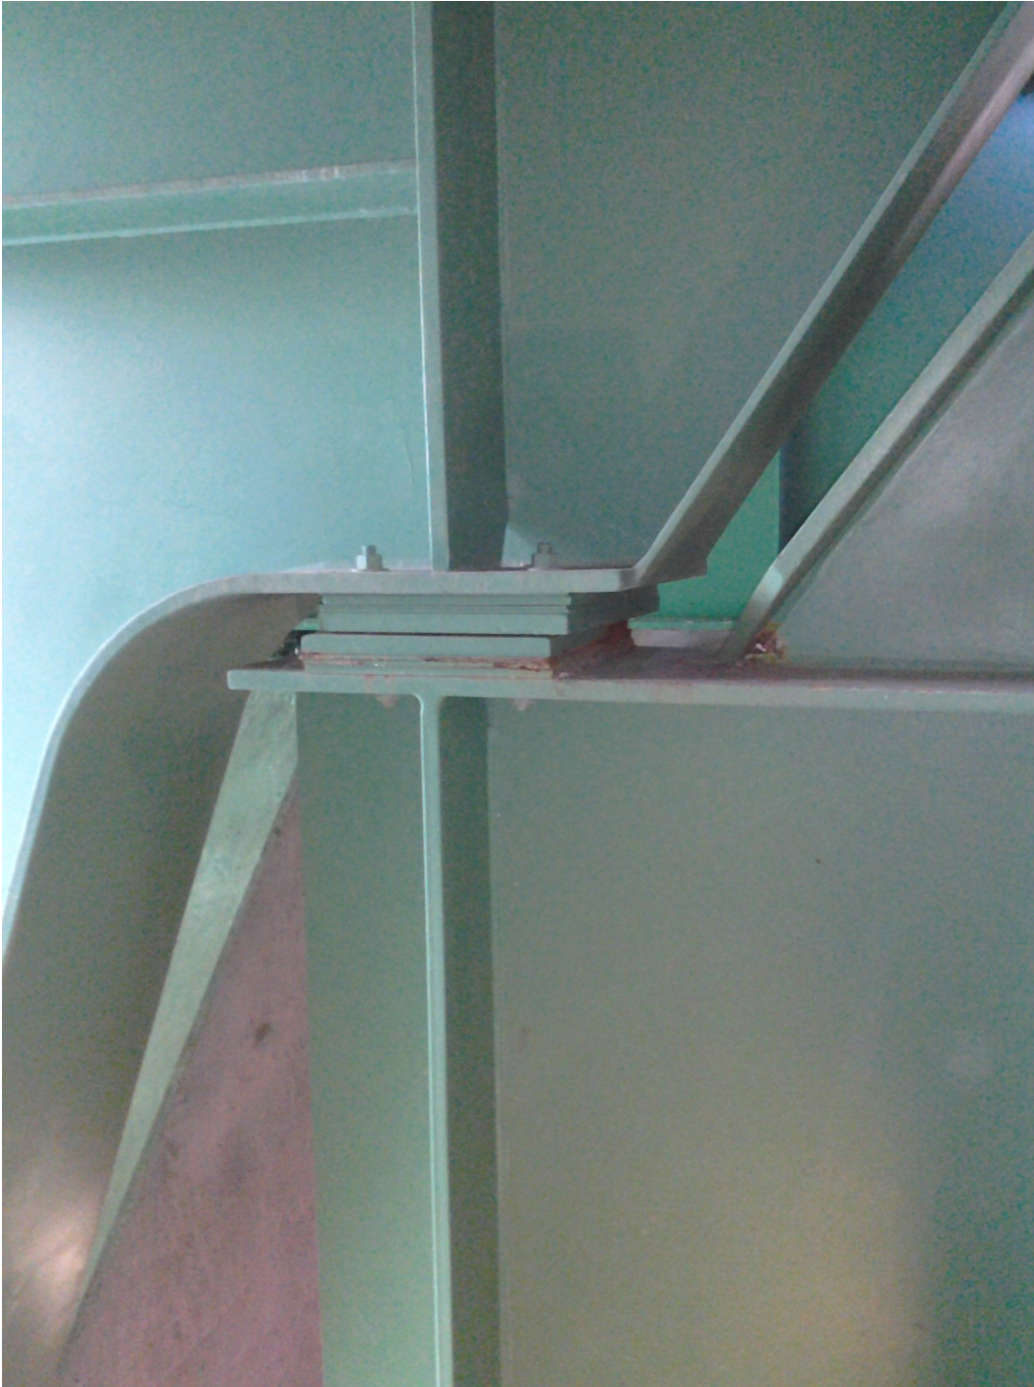
Bascule bearing plates at northeast corner. Minor misalignment (constructed that way)

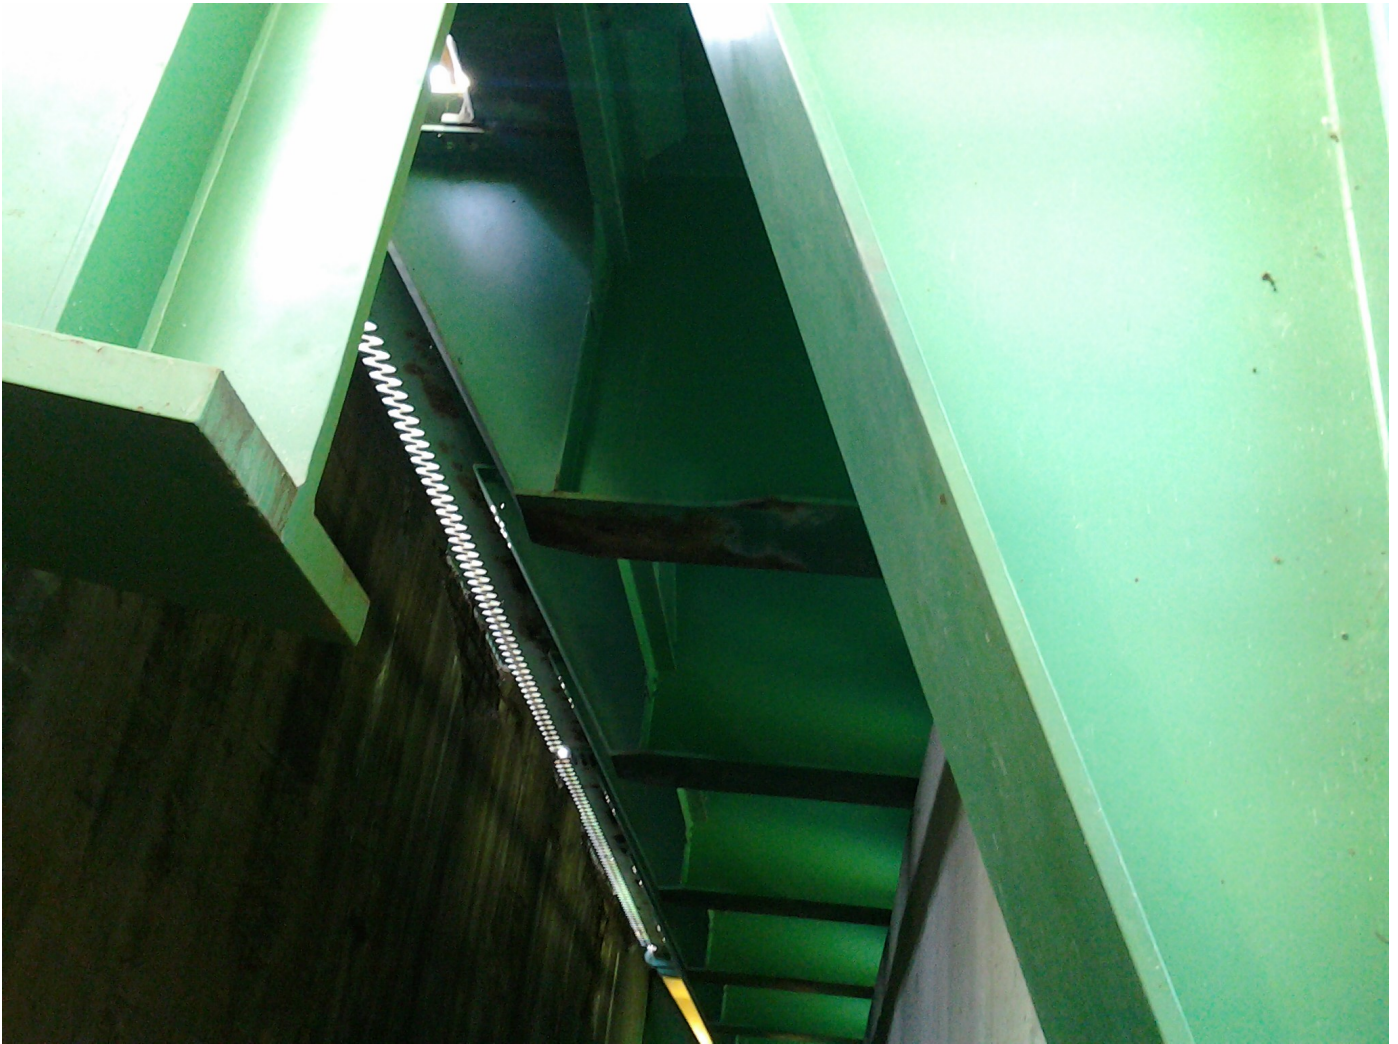
Minnesota side counterweight. Also, some corrosion under finger joint in the stringers.

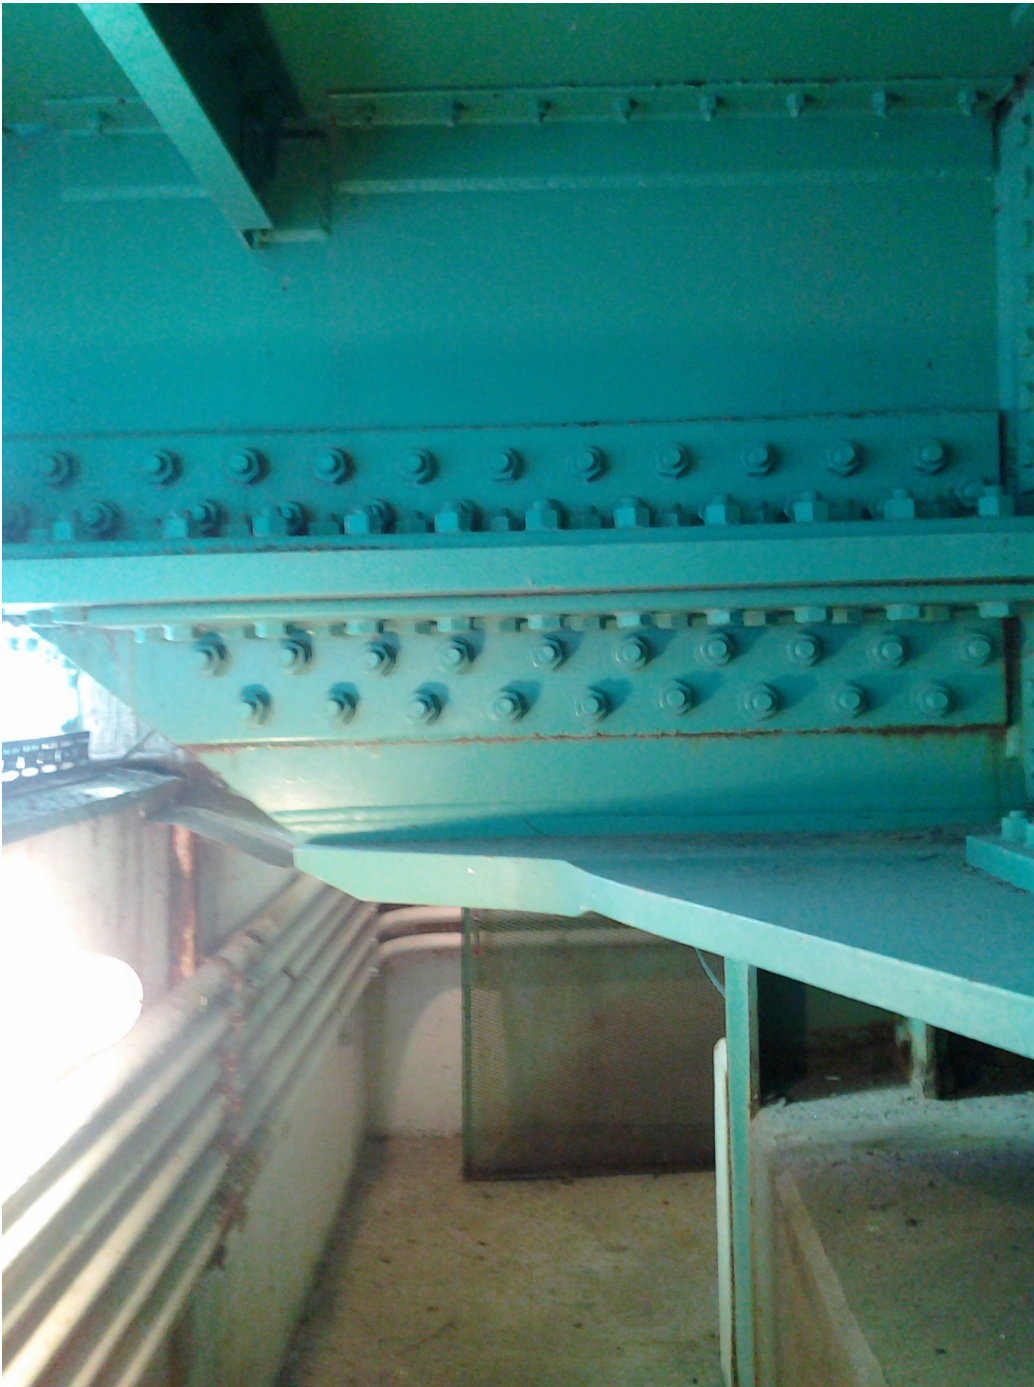
Minor corrosion in the southwest connection just in front of the counterweights.

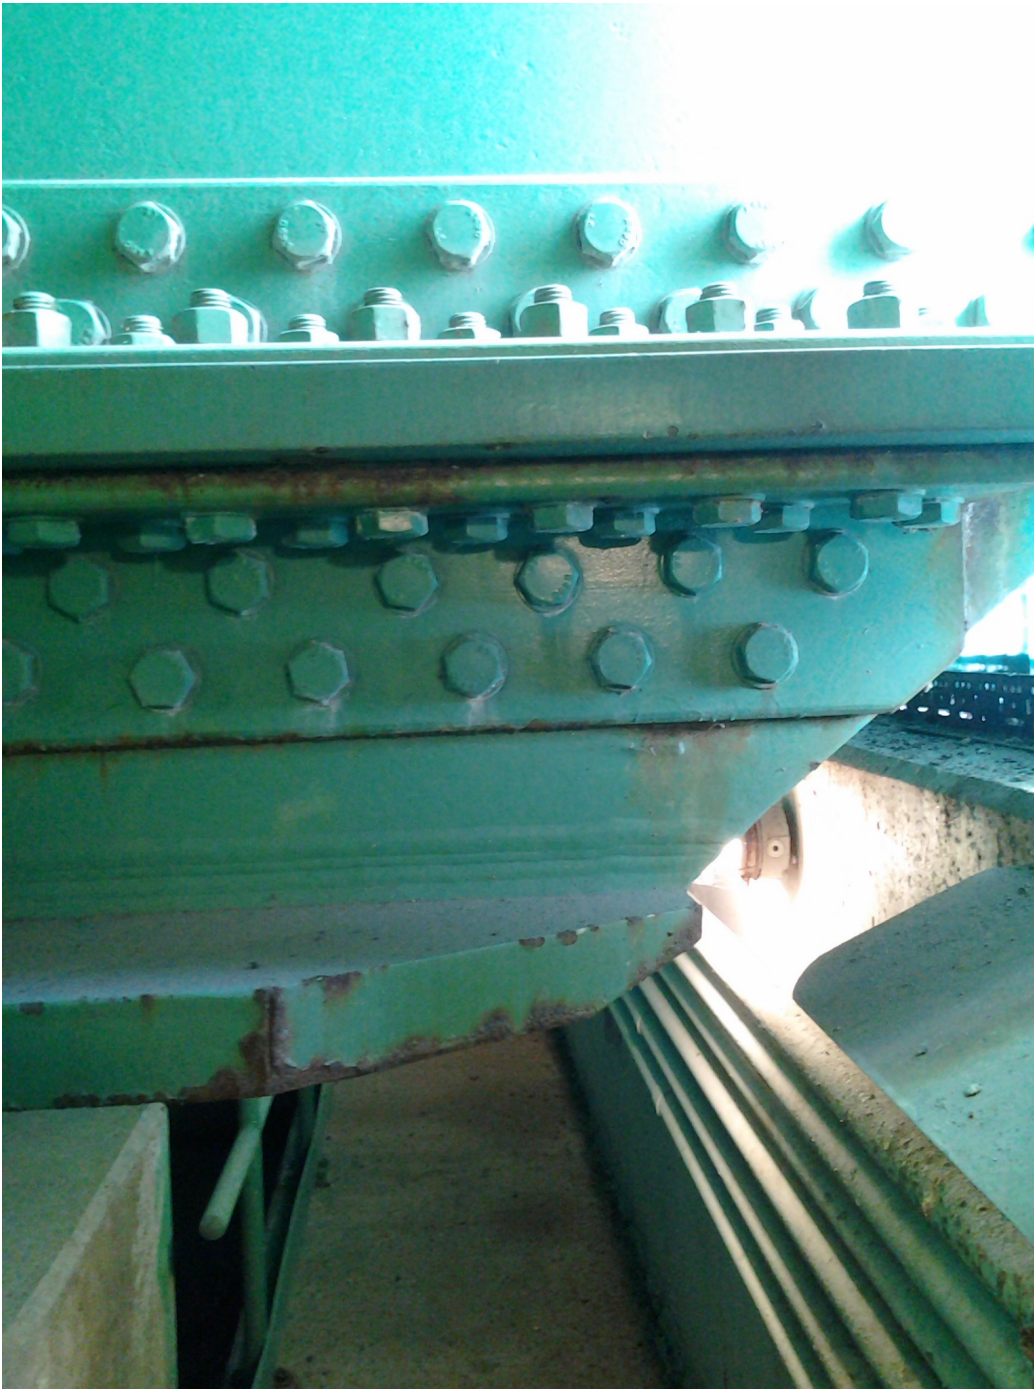
Minor corrosion in the southwest connection just in front of the counterweights. (backside)
