# Inspection Report for B-47-040

USH 10 over ST CROIX RIVER 01  
Apr 09,2018

Feature On: USH 10	Section Town Range: S09 T26N R20W	Structure Number: <b>B-47-040</b>
Feature Under: ST CROIX RIVER 01	County: PIERCE	
Location MINNESOTA STATE LINE	Municipality: PRESCOTT	Structure Name:

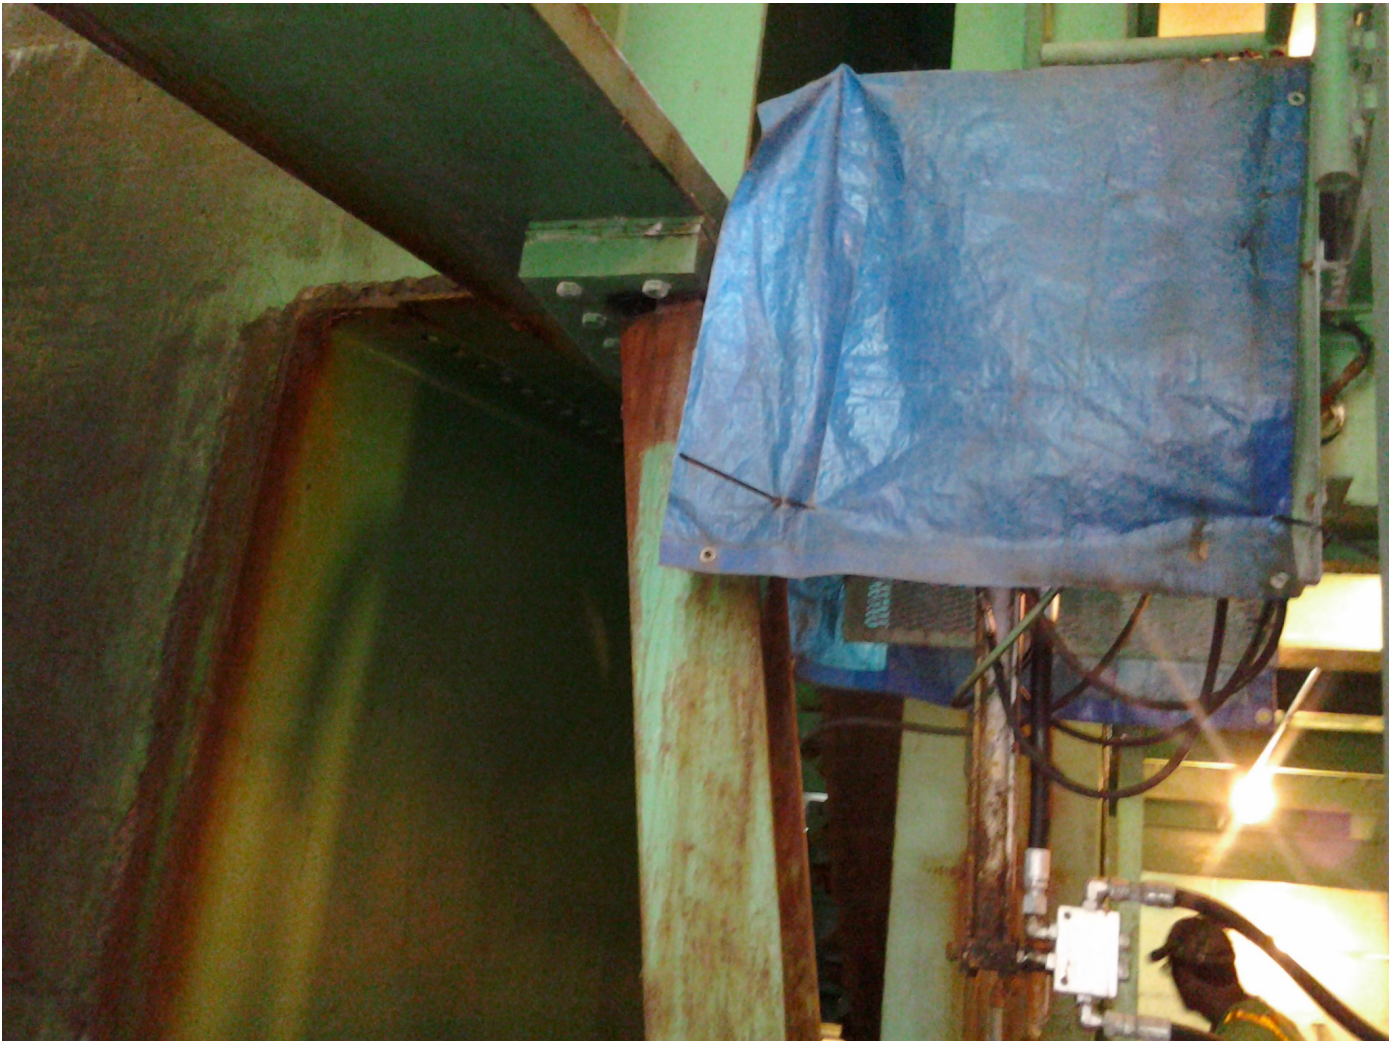
Southwest rear lock corrosion

Item	Priority	Recommended by	Status	Status change
<b>Misc - Paint Spot / Complete</b>	MEDIUM	Haig, Gregory (5014)	IDENTIFIED	06/02/15
Ends of Span 3 girders and surrounding areas will need paint soon.				
<b>Superstructure - Other Work</b>		Haig, Gregory (5014)	DEFERRED	04/30/18
Clean, paint and protect the southwest corner rear lock

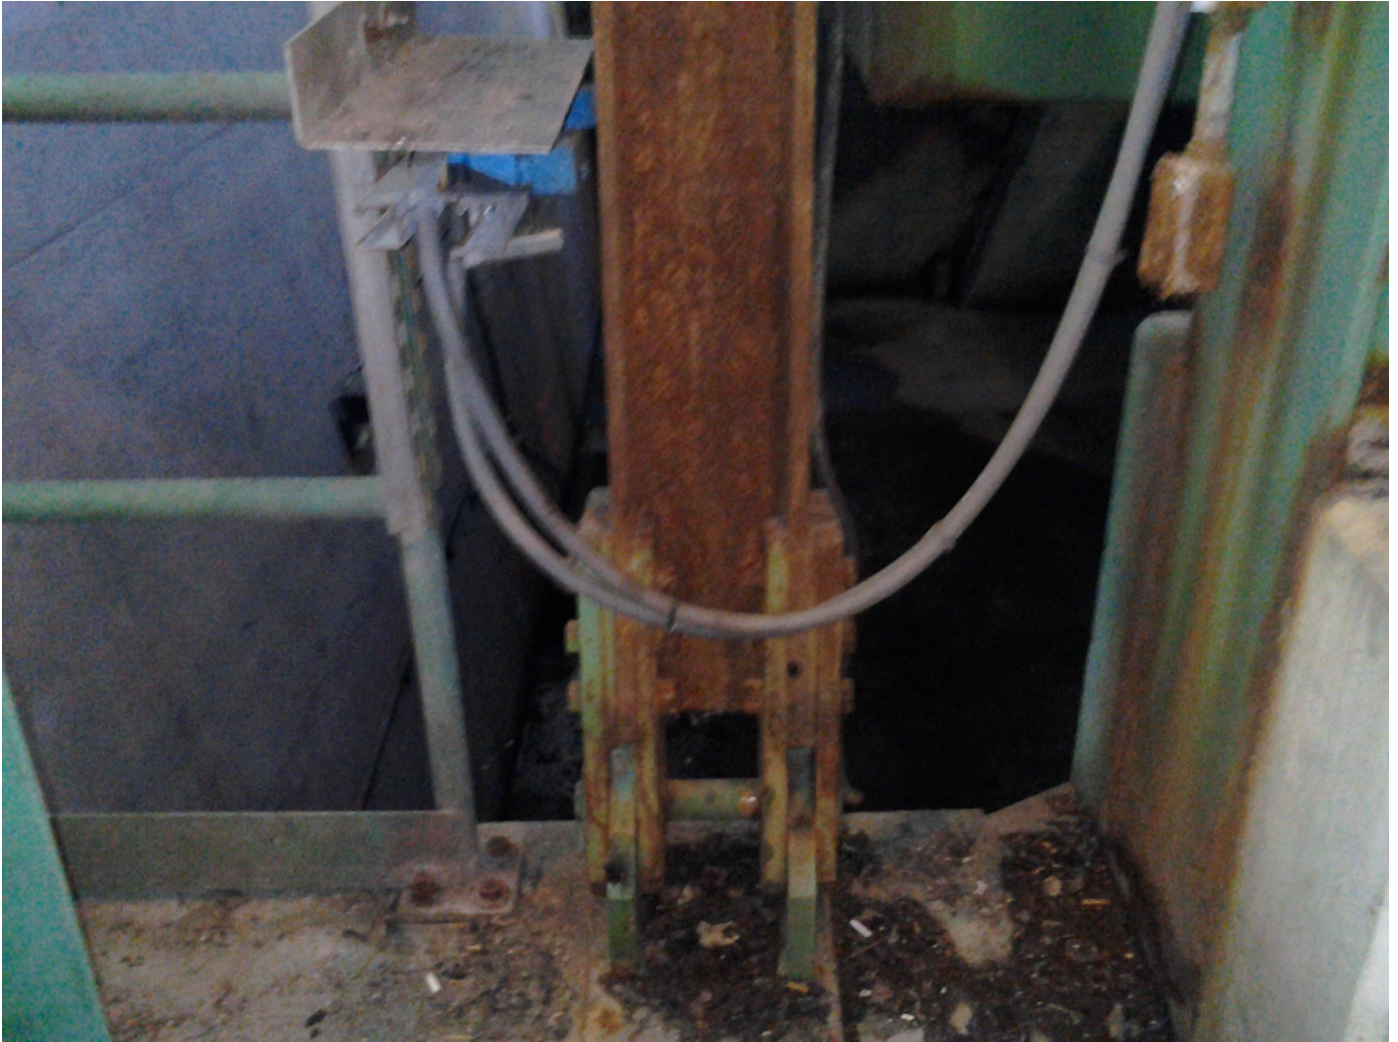
Southwest rear lock corrosion

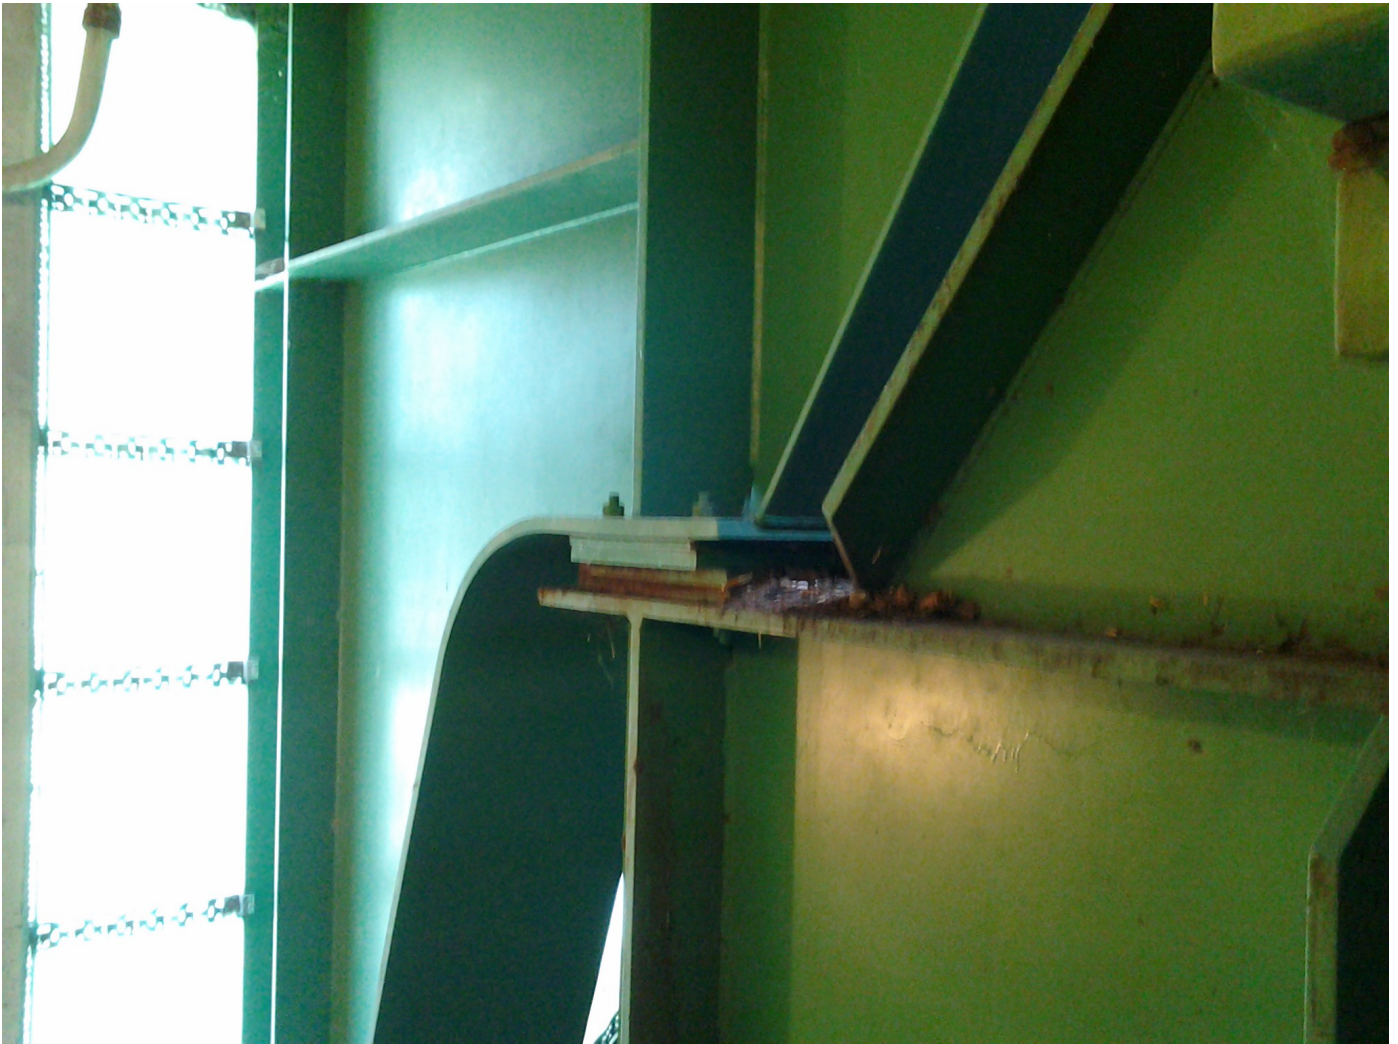
Southwest bascule bearing misalignment.

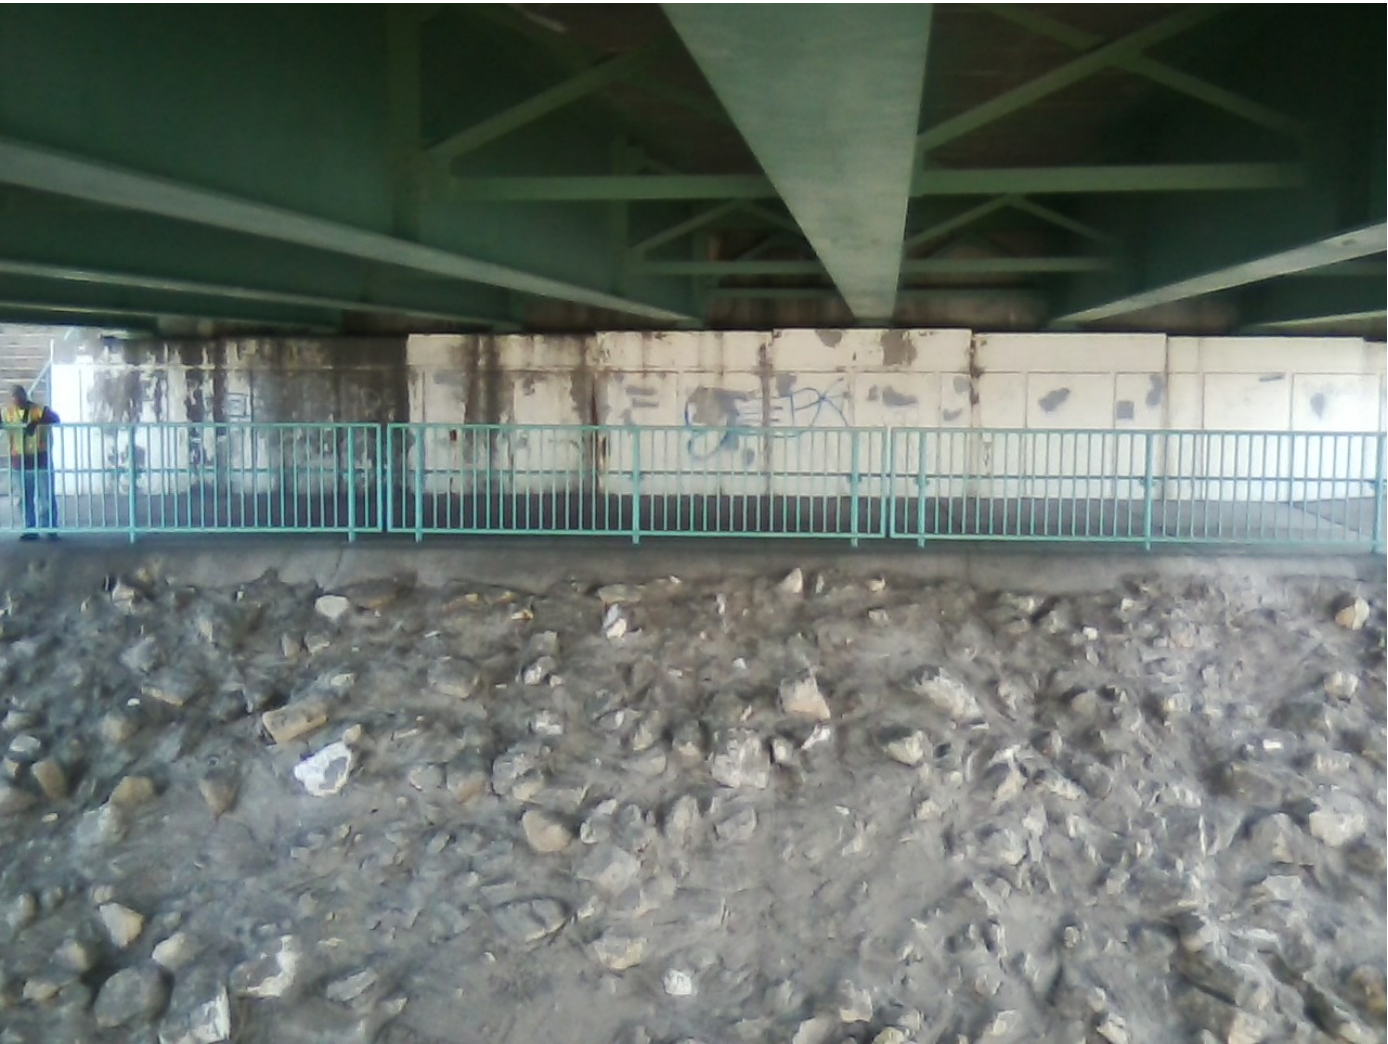
East abutment

Embankments appear stable. W. Abutment in good condition with few missing stones and exposed fabric. E. Abutment in fair condition with grouted riprap breaking apart and undermining at the shoreline.
---

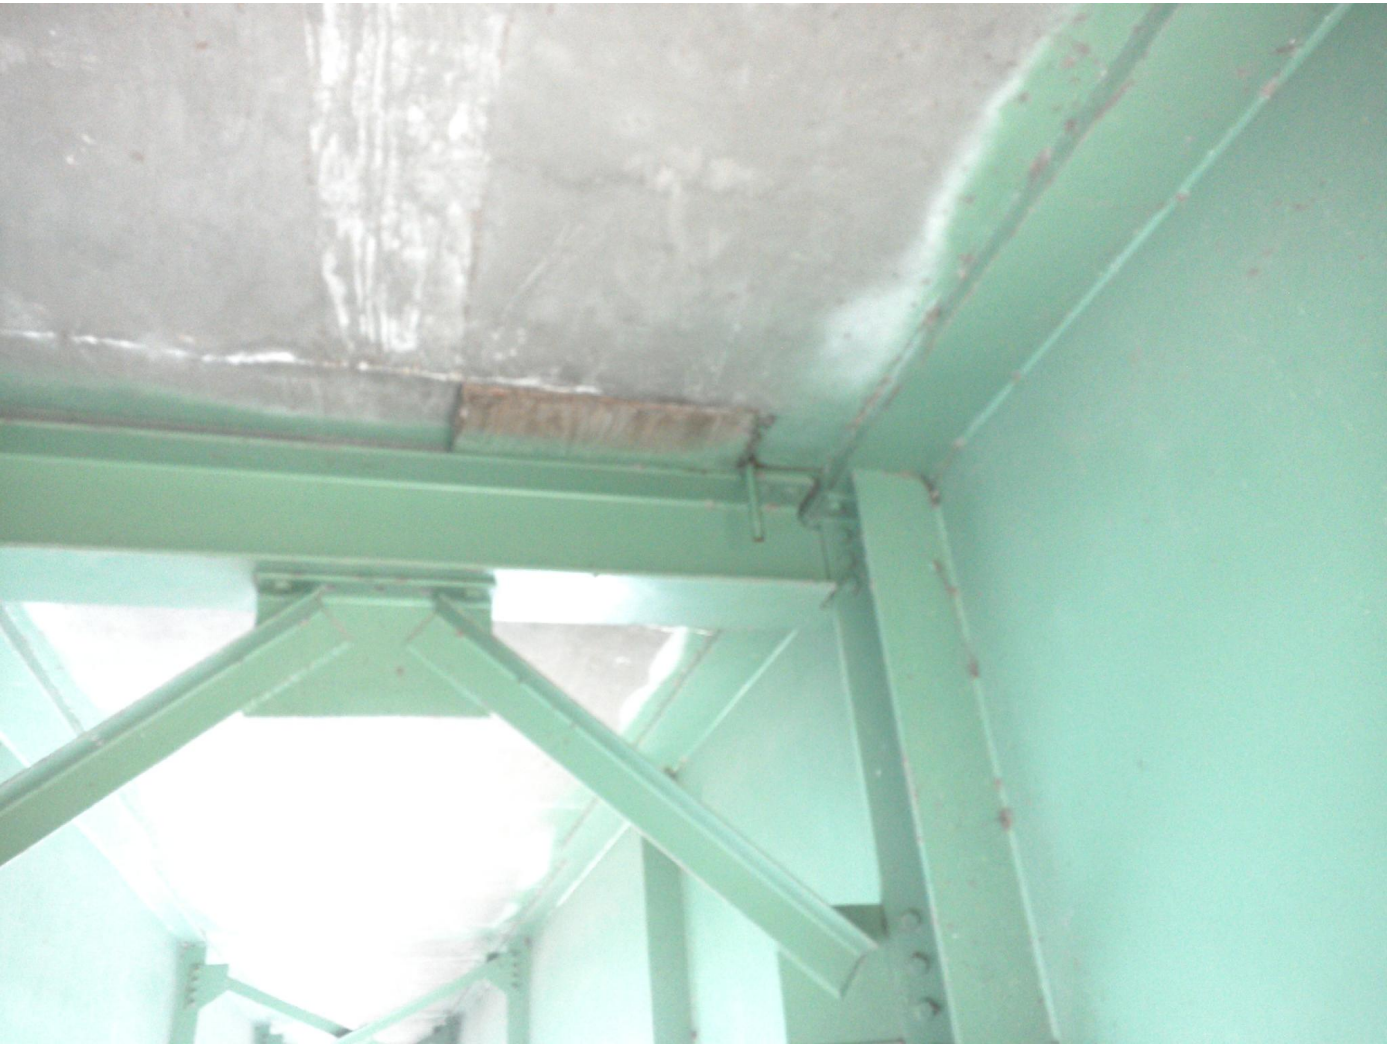
Bay 1 between girders 5 and 6 at pier 4. Plywood left from original construction.

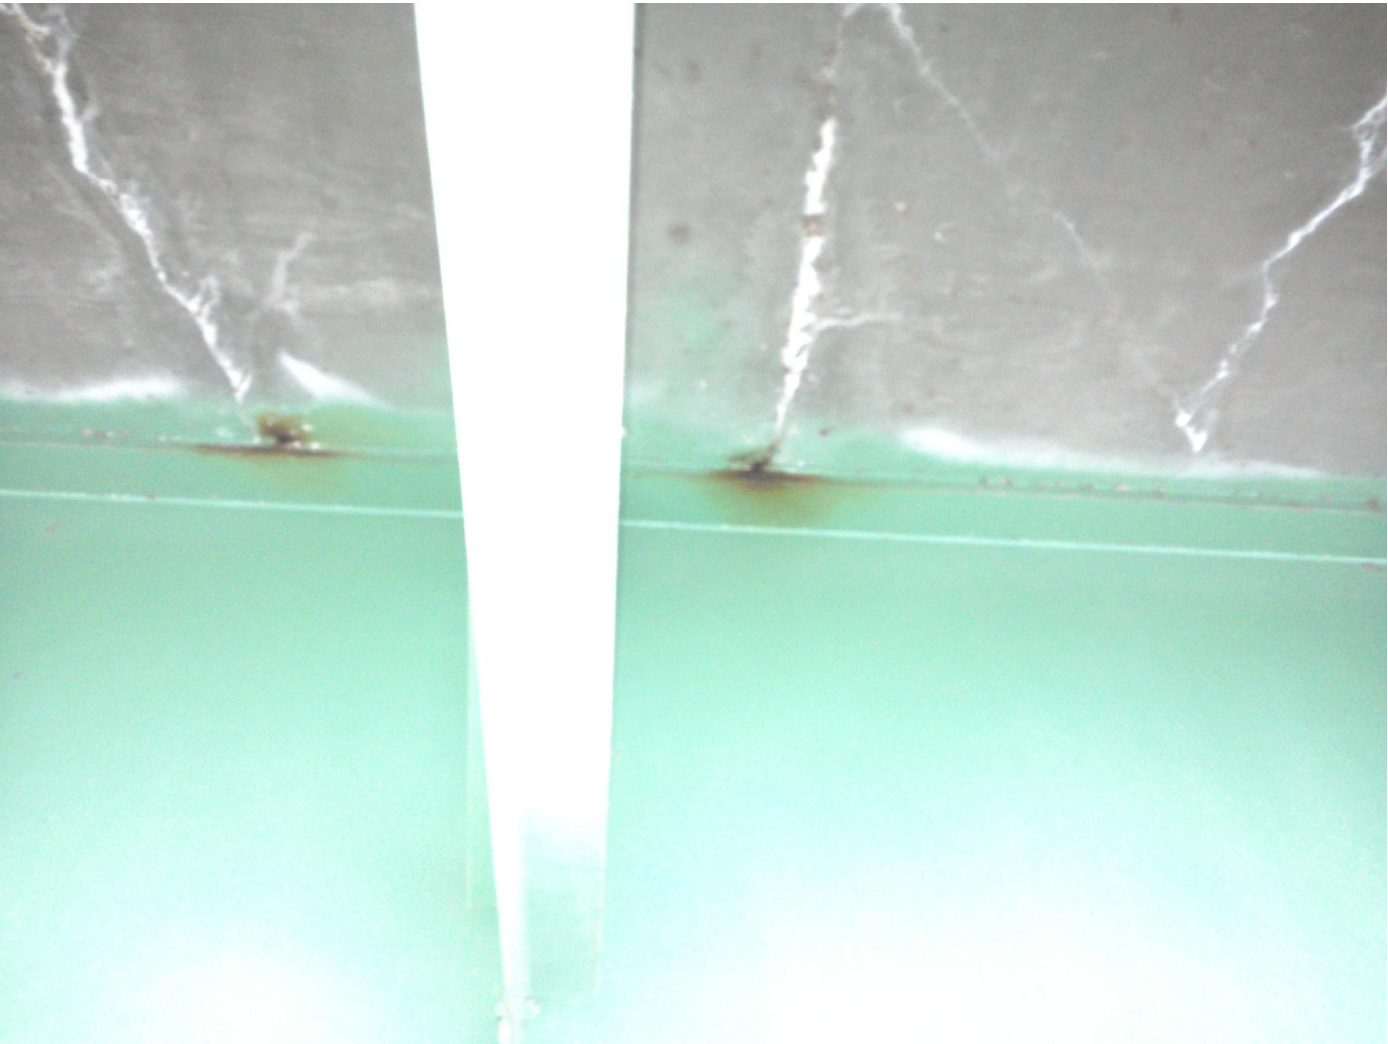
Rust staining on the bottom of the deck in span 4 between girders 4 and 5.

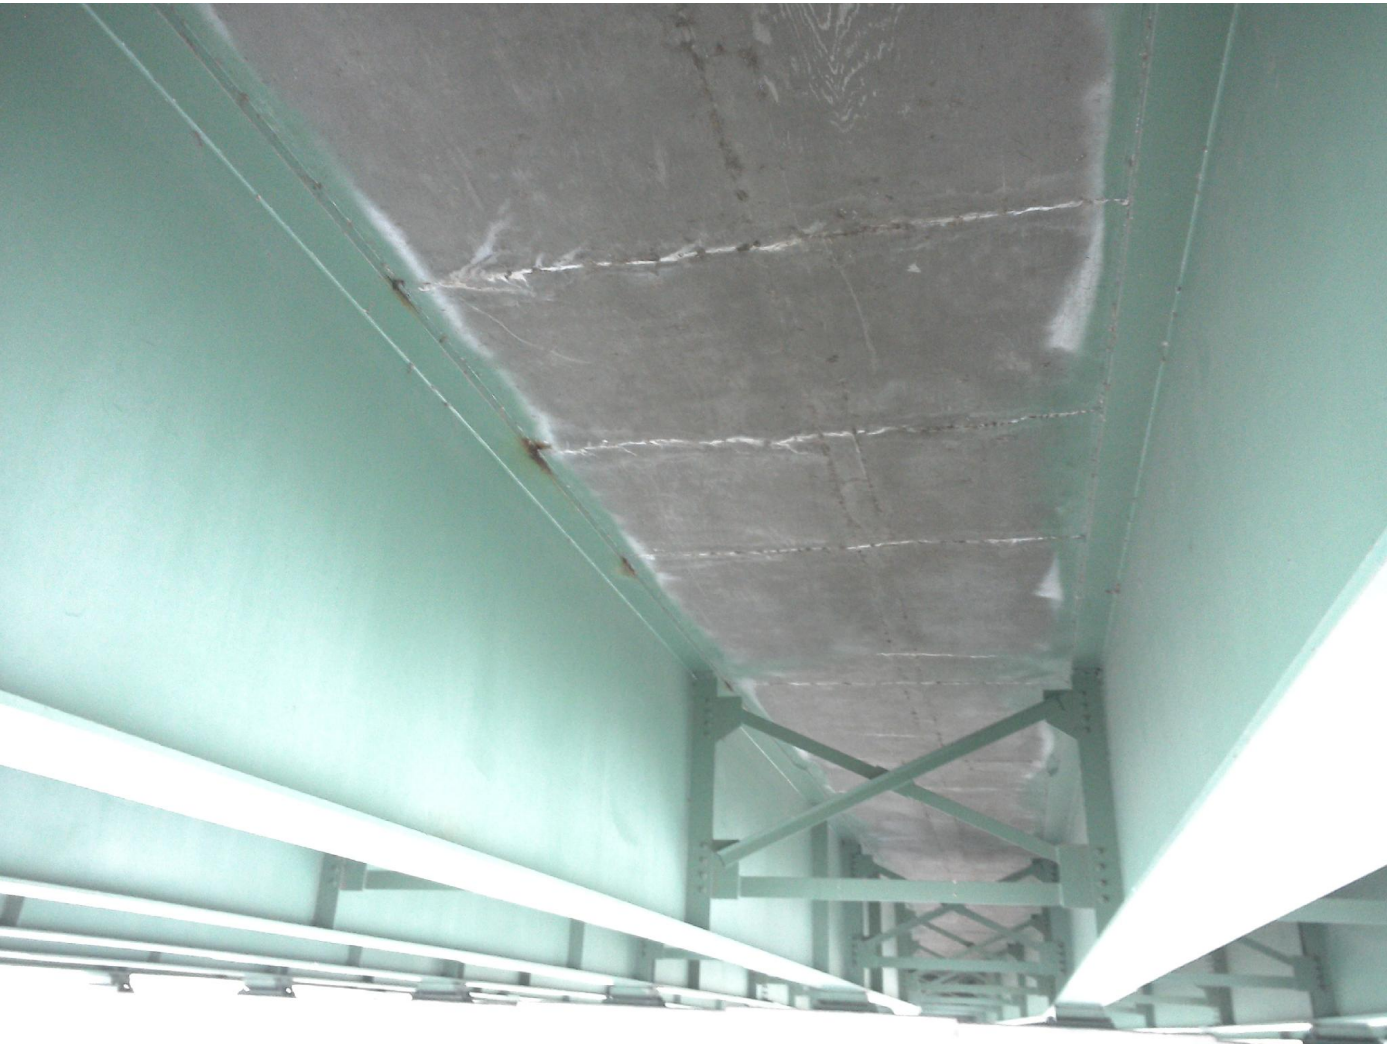
Rust staining on the bottom of the deck in span 4 between girders 4 and 5.

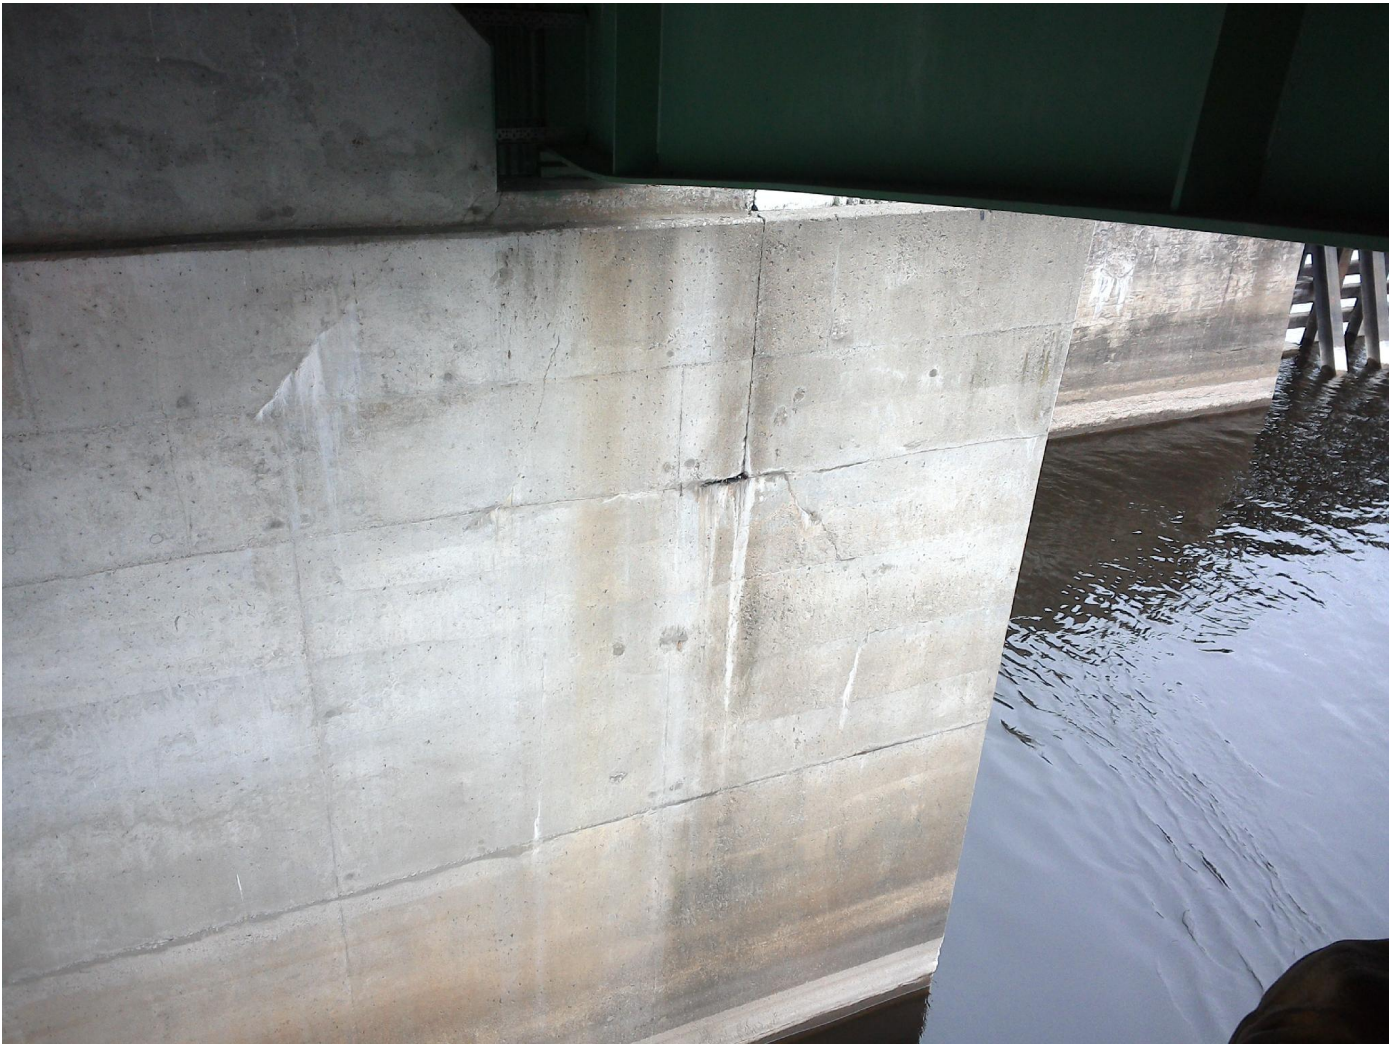
Cracks in pier 3. Looking west at the northwest corner.

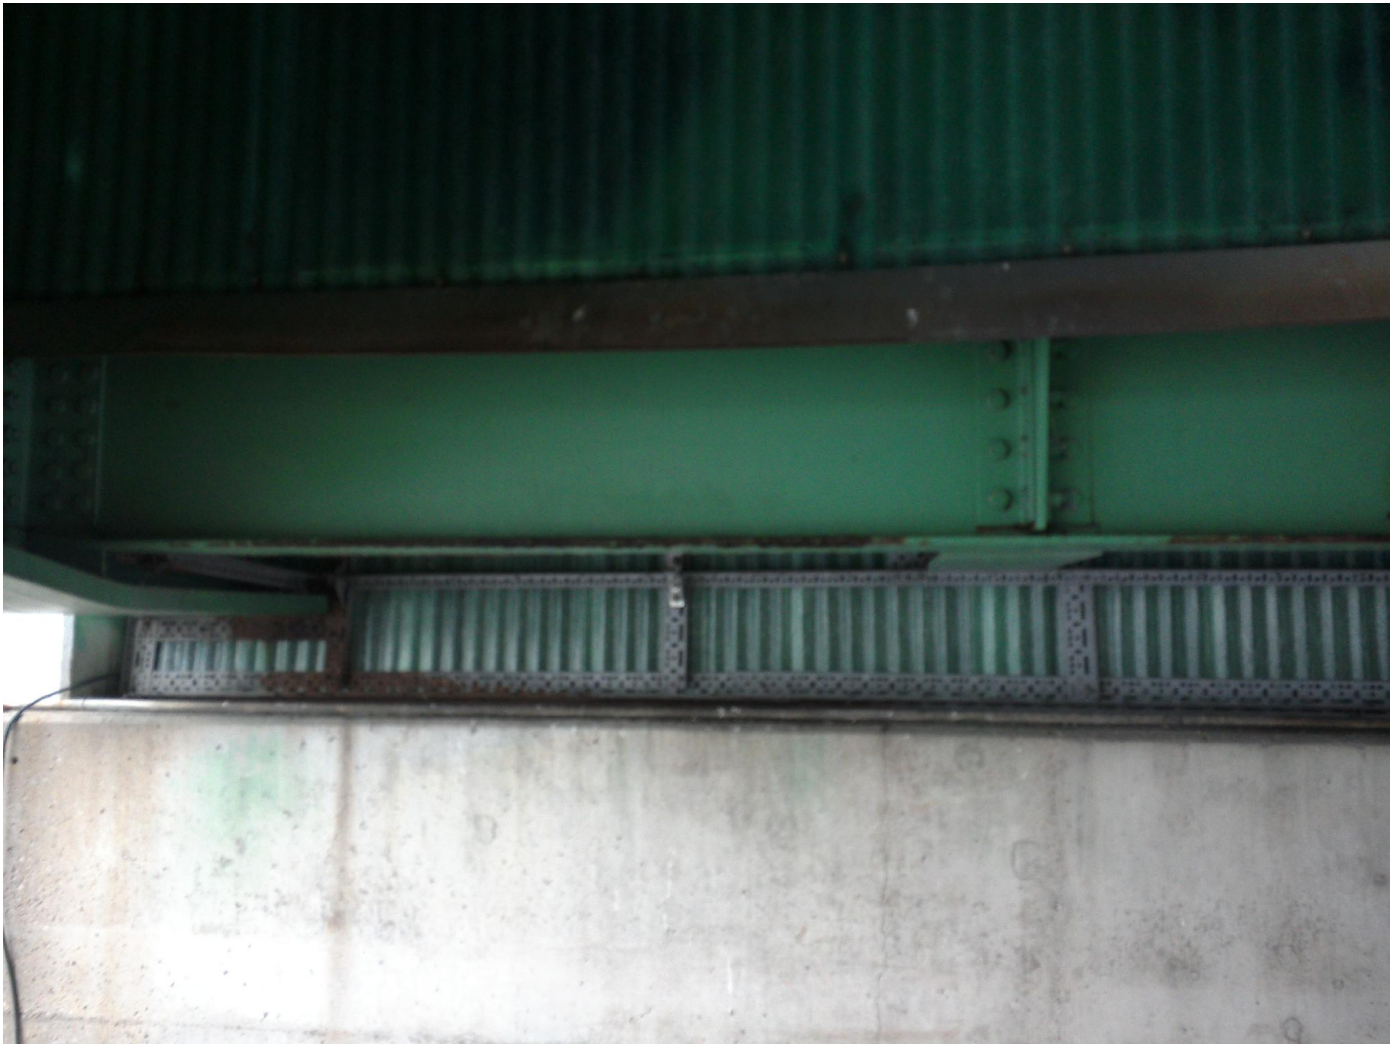
Diaphragm corrosion on the west side of pier 3.

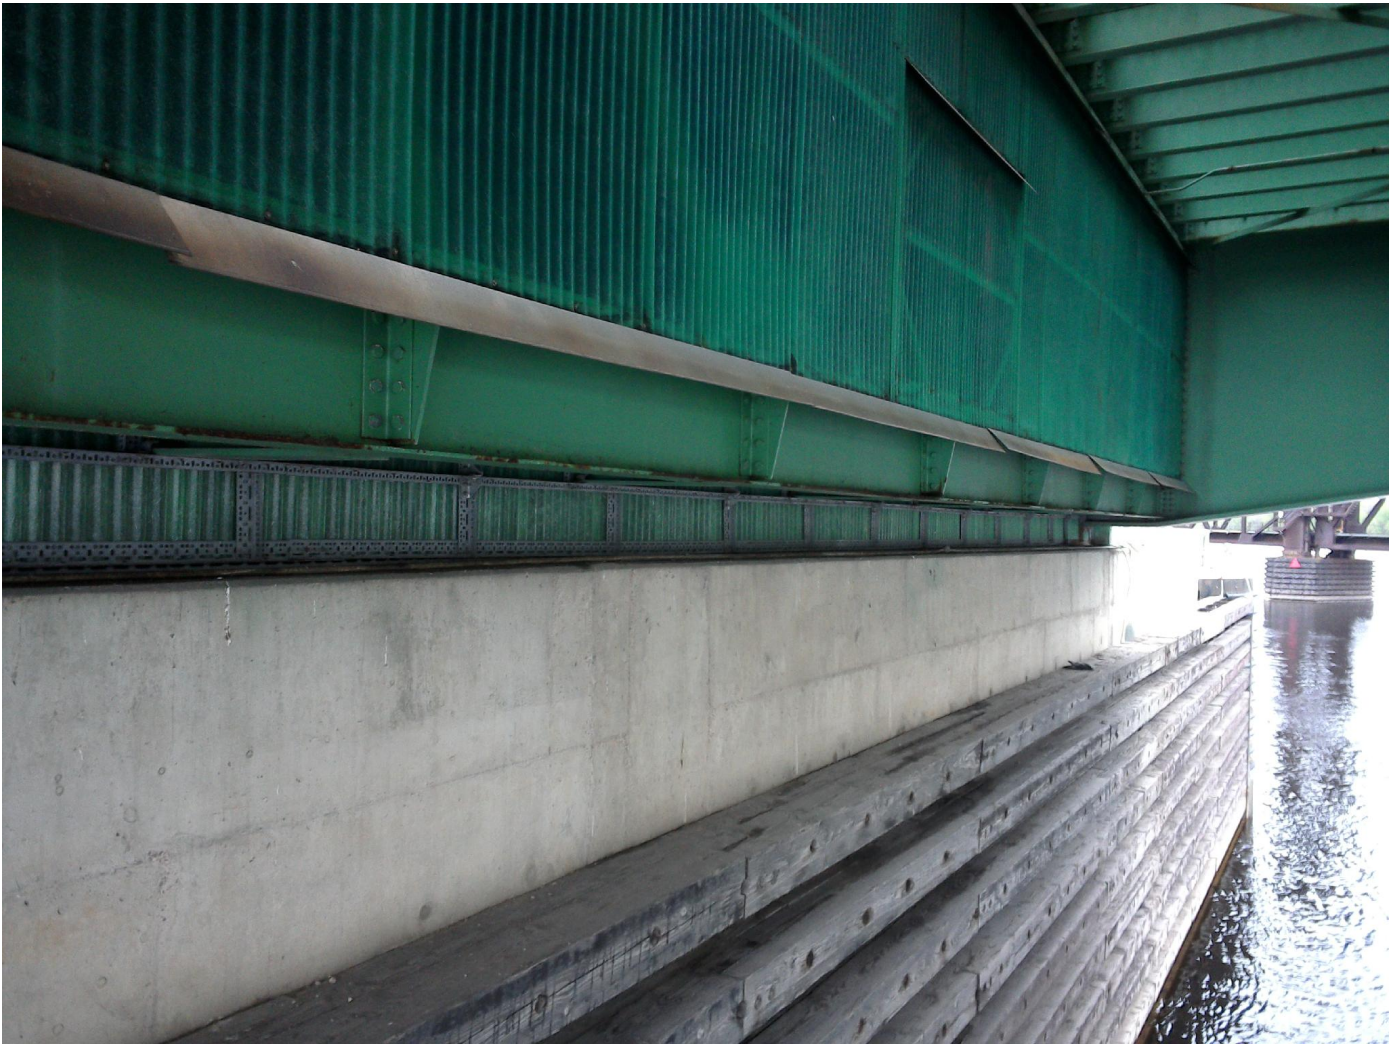
Diaphragm corrosion on the west side of pier 3.

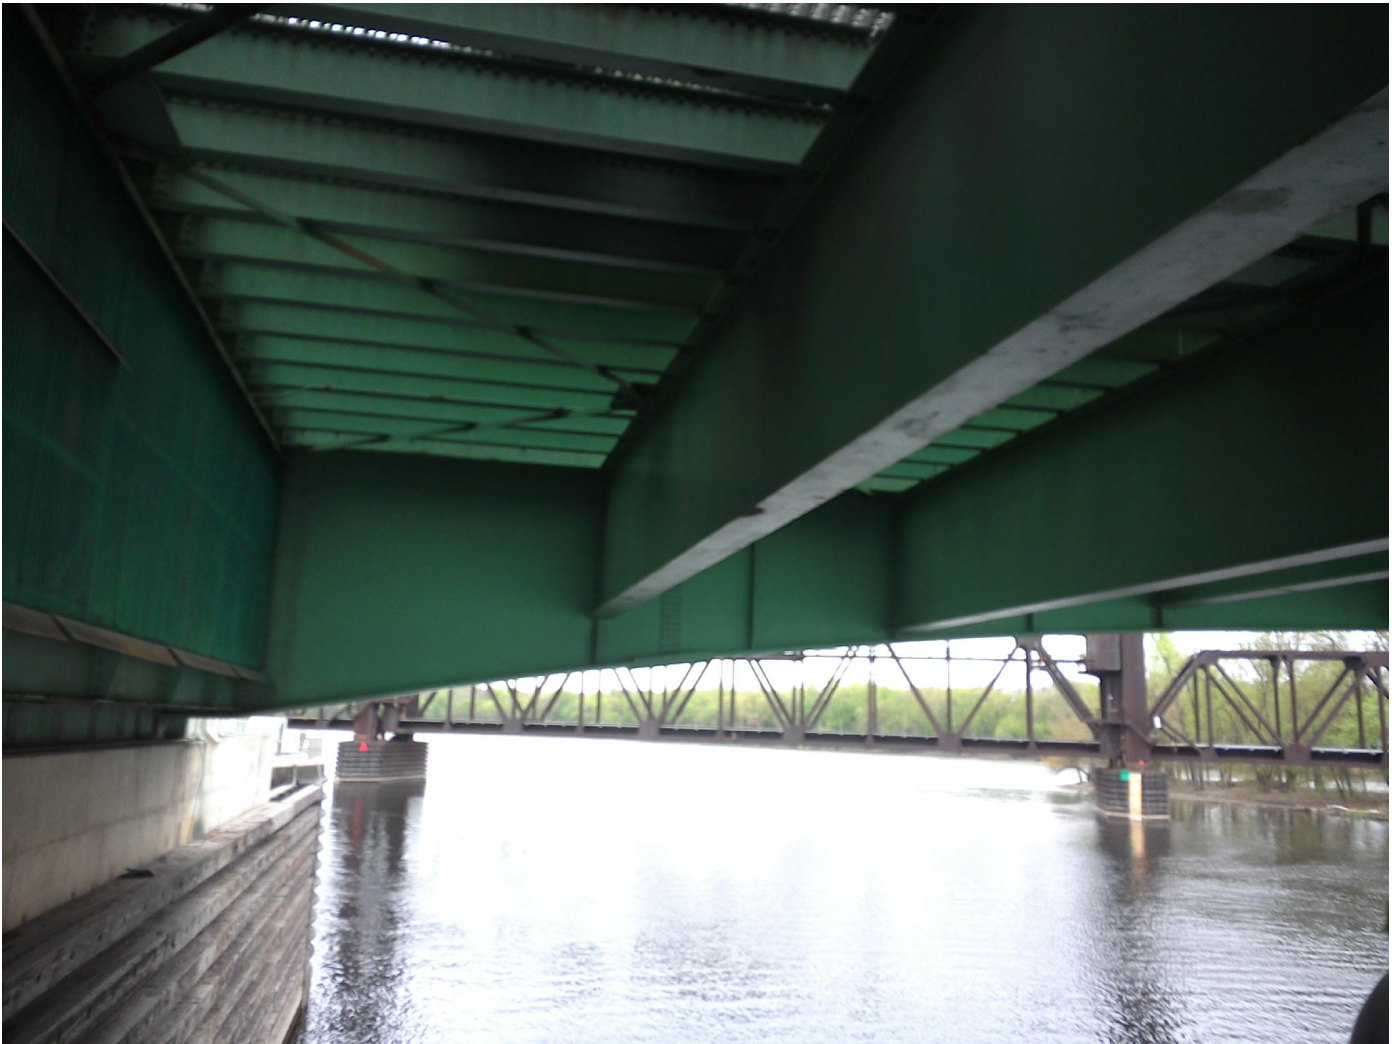
X	152		<b>Steel Floor Beam</b>	LF	652	601	51	0	0
		1000	Corrosion	LF		0	51	0	0
			The bascule span had approximately 3 ft. of exposed steel that is actively rusting in each floor beam.						
X	210		<b>Reinforced Concrete Pier Wall</b>	LF	215	161	50	4	0
			The concrete surfaces at Piers 1 through 4 were typically smooth, sound, and in good condition. Piers 2 east face and pier 3 west face have treated timbers bolted to them.						
		1130	Cracking (RC)	LF		78	50	4	0
			See attached sketches for cracks and locations.						
X	215		<b>Reinforced Concrete Abutment</b>	LF	130	124	6	0	0
		1130	Cracking (RC)	LF		0	6	0	0
			East abutment backwall has a couple hairline/medium horizontal/vertical cracks. Joints are leaking badly on to abutment footing causing staining. OLD NOTE: West abutment is moving East about 2", Dead men were place behind west abutment and abutment seems to have stablize. 2016- bearings appear to be about 4 in. off center at 50 degrees f. It appears to be the same as previous inspections.

Spot rusting in the bascule span floor beams.

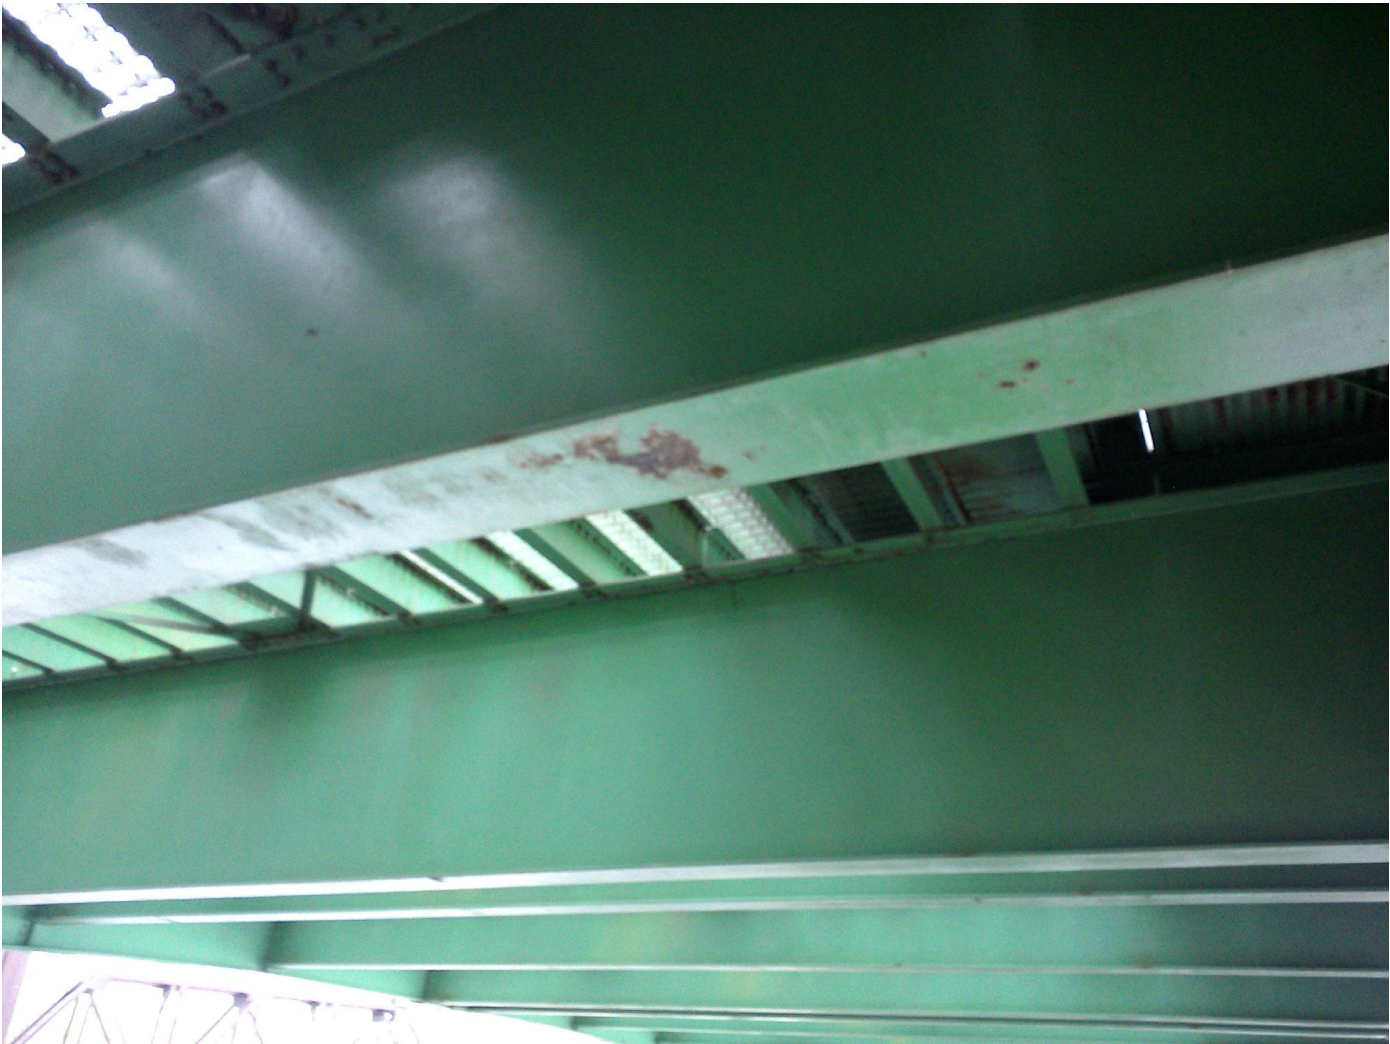
Spot rusting in the bascule span floor beams.

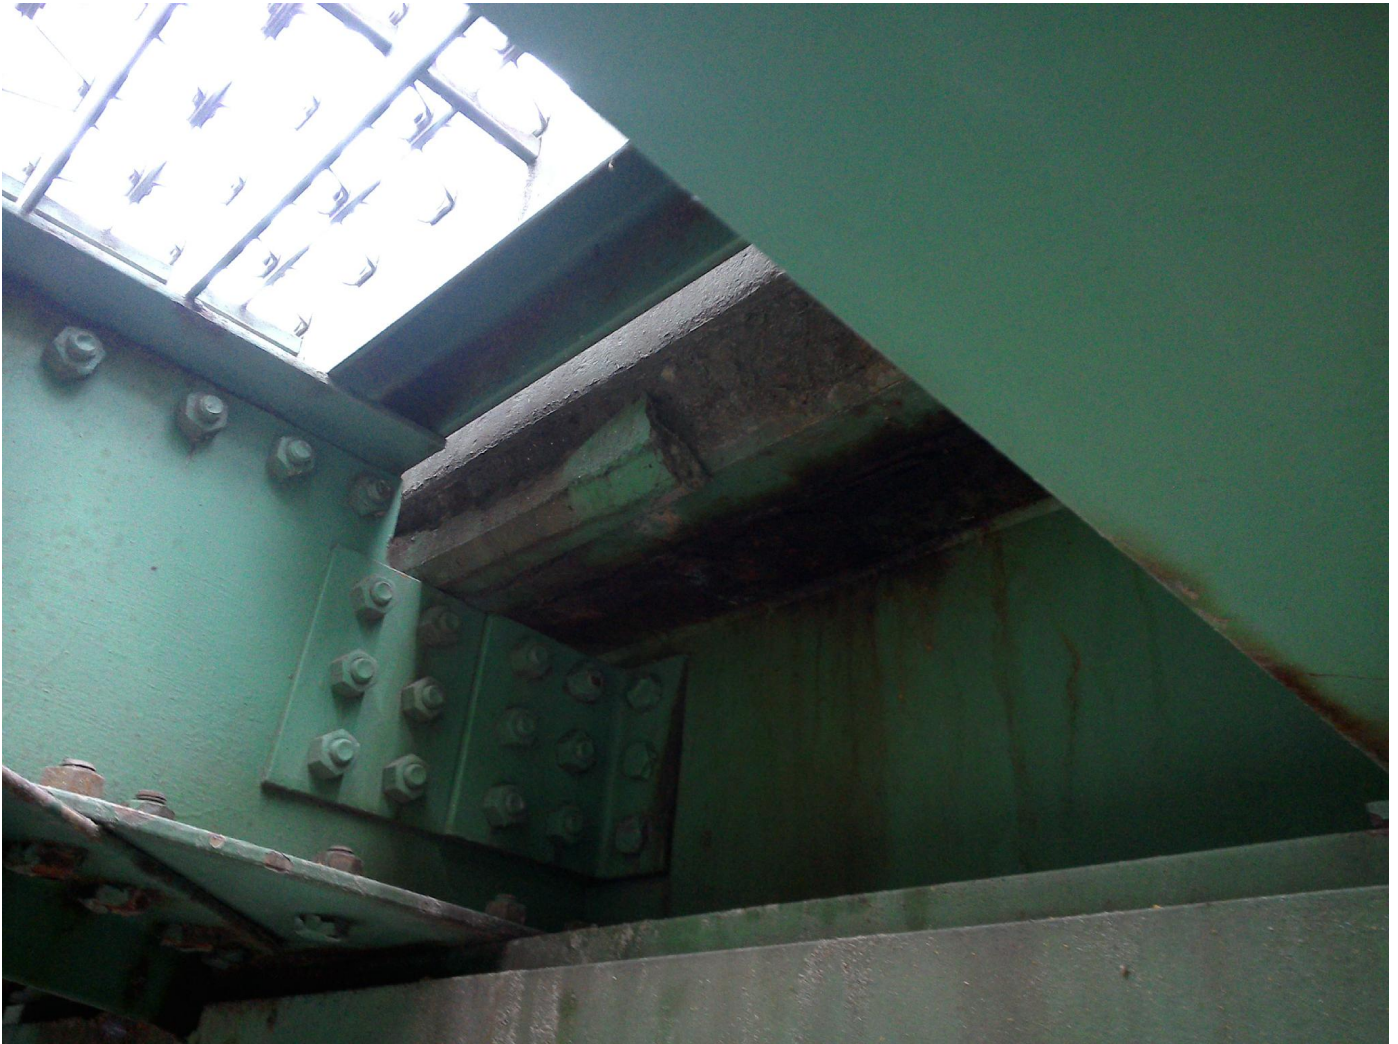
Spalled concrete at pier 3 on the bascule span side.

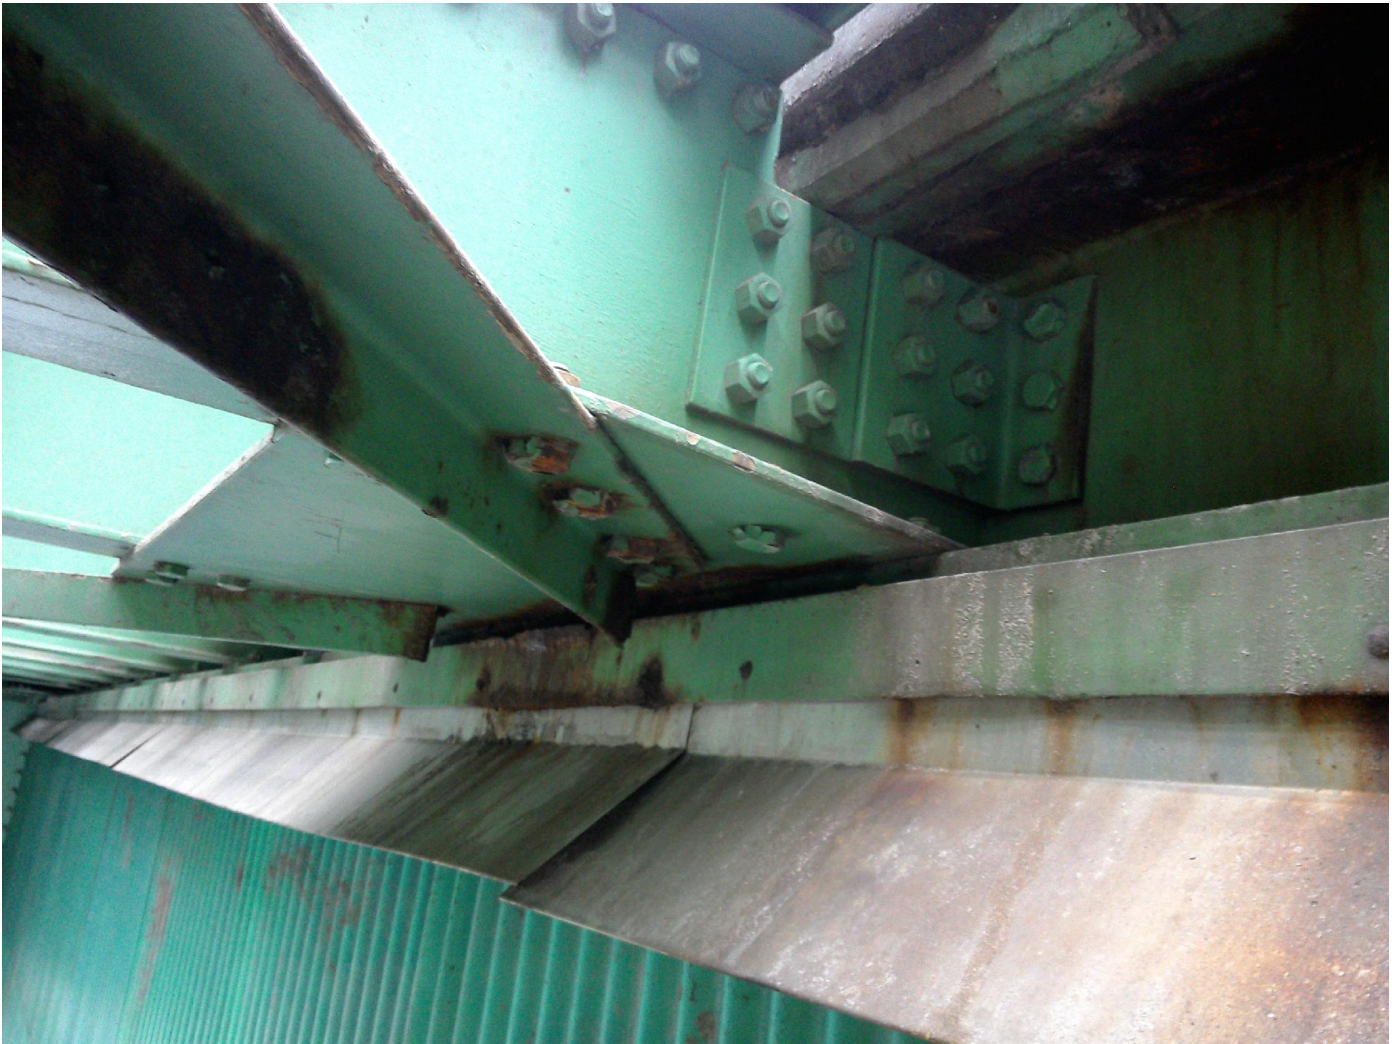
Corrosion of the cross members near pier 2.

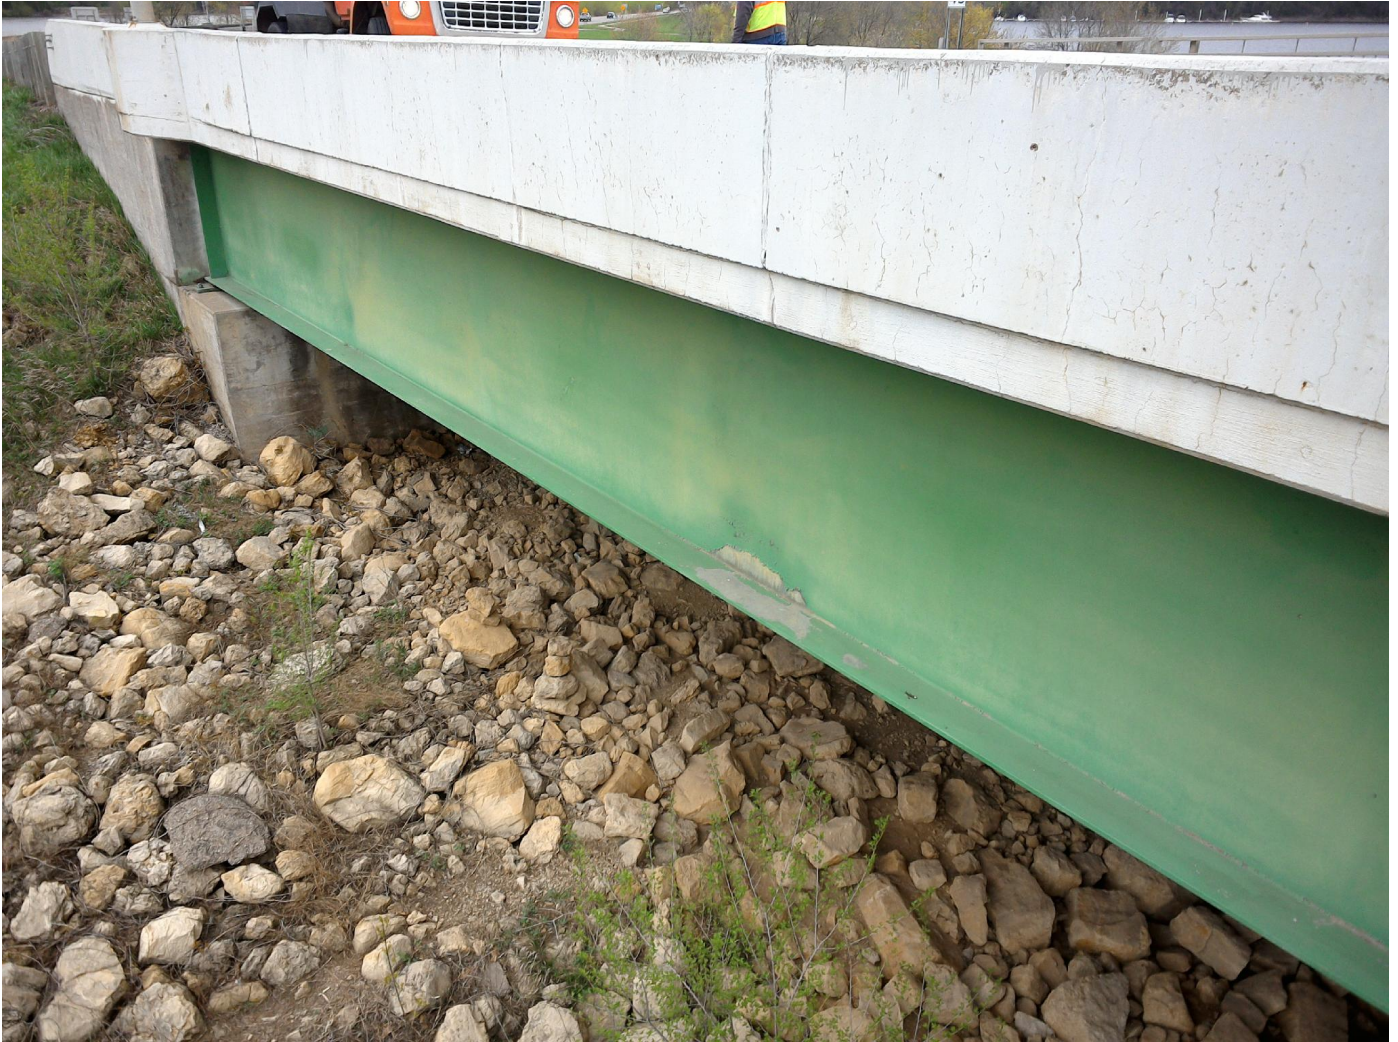
Span 1 southside chalking paint and exposed under coating.

May need to repaint or spot paint soon - detailed paint condition needed (i.e. top coat condition). A bike trail was constructed under span1 on the Minnesota end of the bridge in 2016. A retaining wall was also constructed as part of the bike trail. Both are owned and are to be maintained by Mn/DOT.
