# Inspection Report for B-47-040

USH 10 over ST CROIX RIVER 01  
Apr 09,2018

Feature On: USH 10	Section Town Range: S09 T26N R20W	Structure Number: <b>B-47-040</b>
Feature Under: ST CROIX RIVER 01	County: PIERCE	
Location MINNESOTA STATE LINE	Municipality: PRESCOTT	Structure Name:

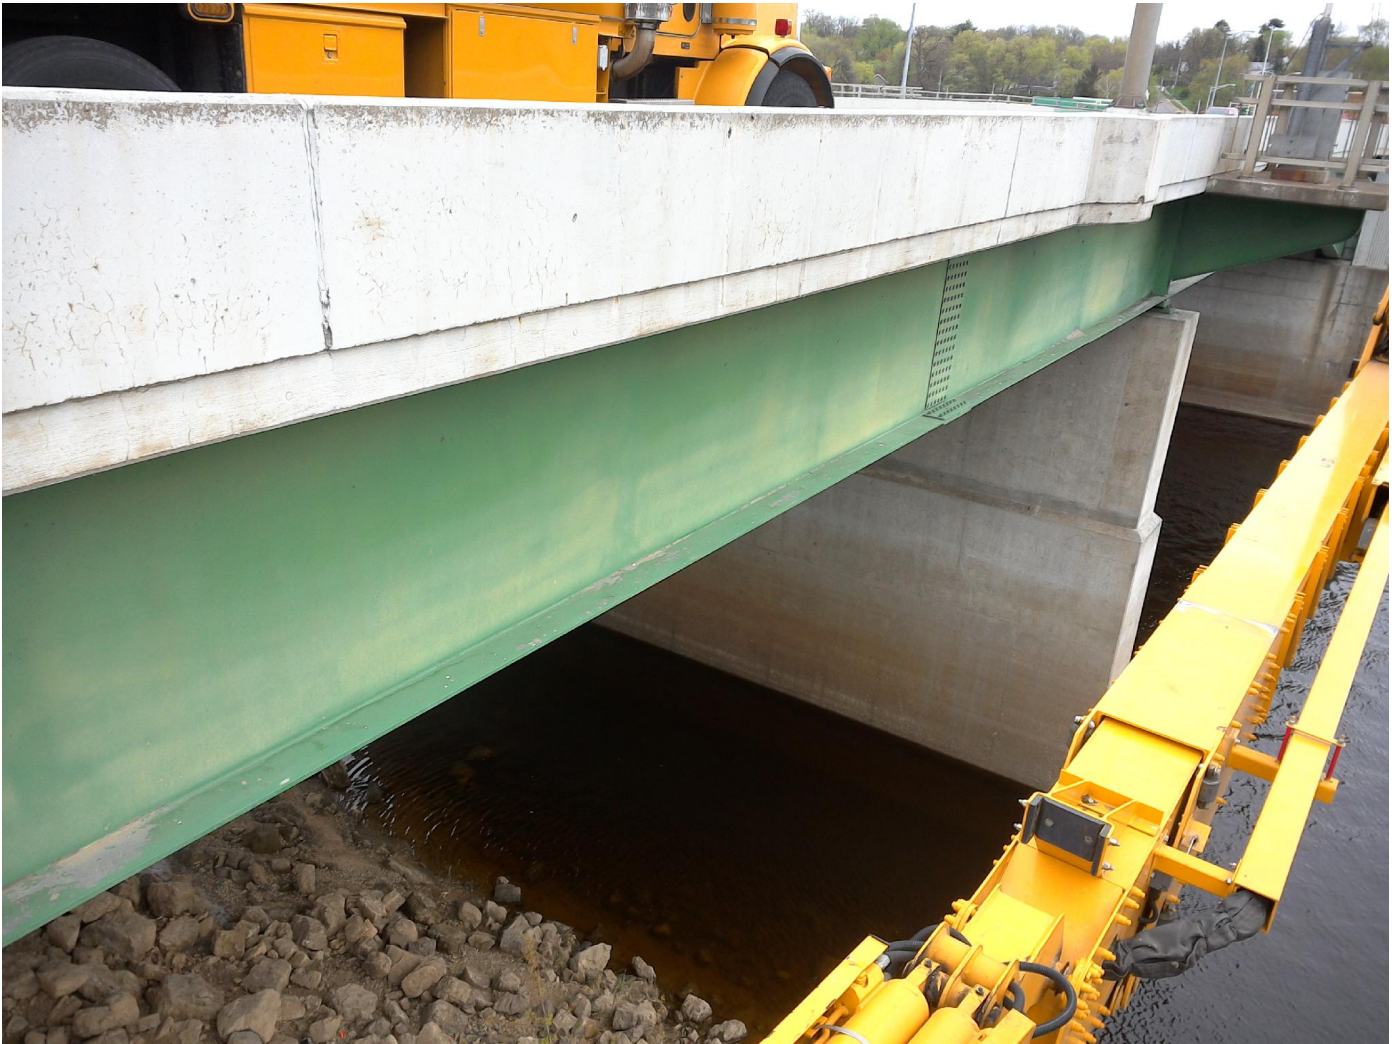
Span 1 southside chalking paint and exposed under coating.

May need to repaint or spot paint soon - detailed paint condition needed (i.e. top coat condition). A bike trail was constructed under span1 on the Minnesota end of the bridge in 2016. A retaining wall was also constructed as part of the bike trail. Both are owned and are to be maintained by Mn/DOT.

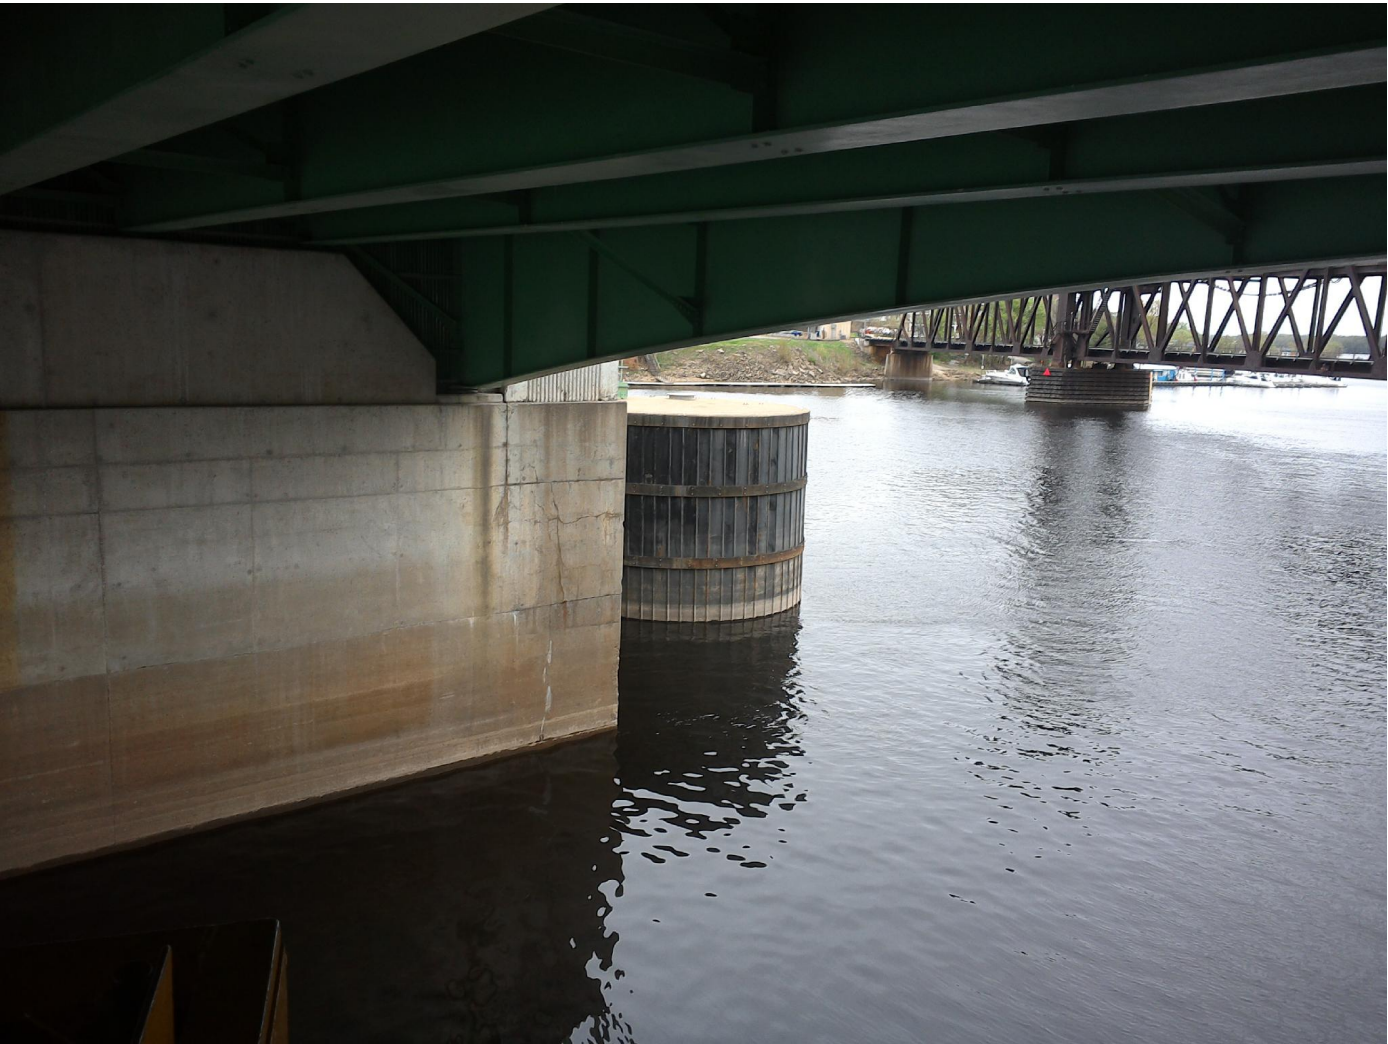
Cracking in pier 3 looking to the southeast.

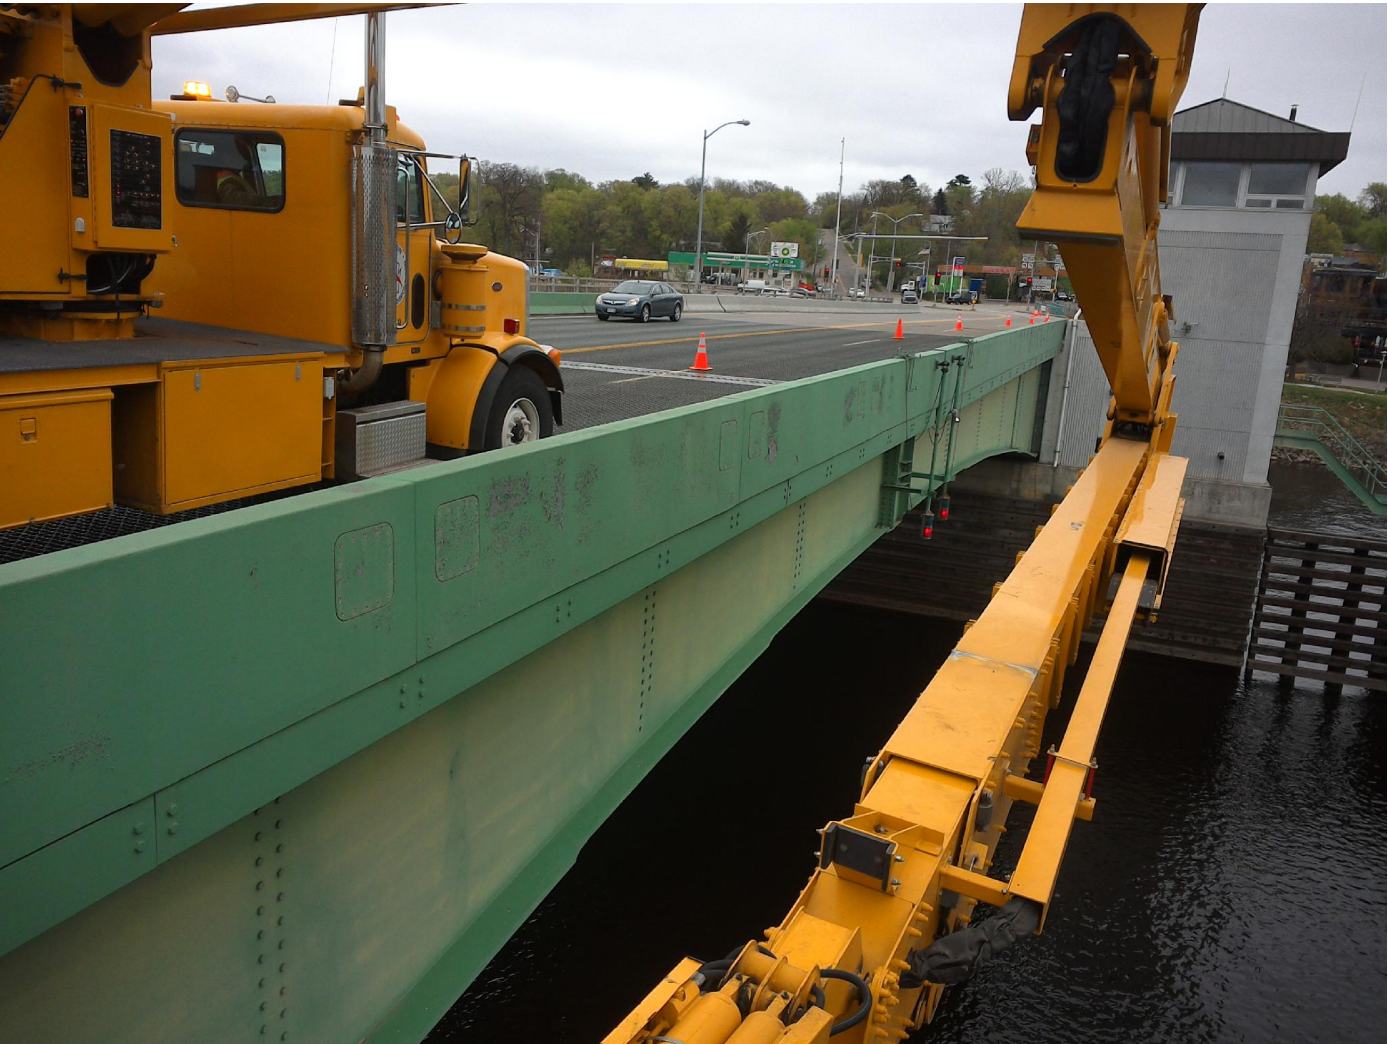
southside of girder 1 in bascule span. Chalking paint

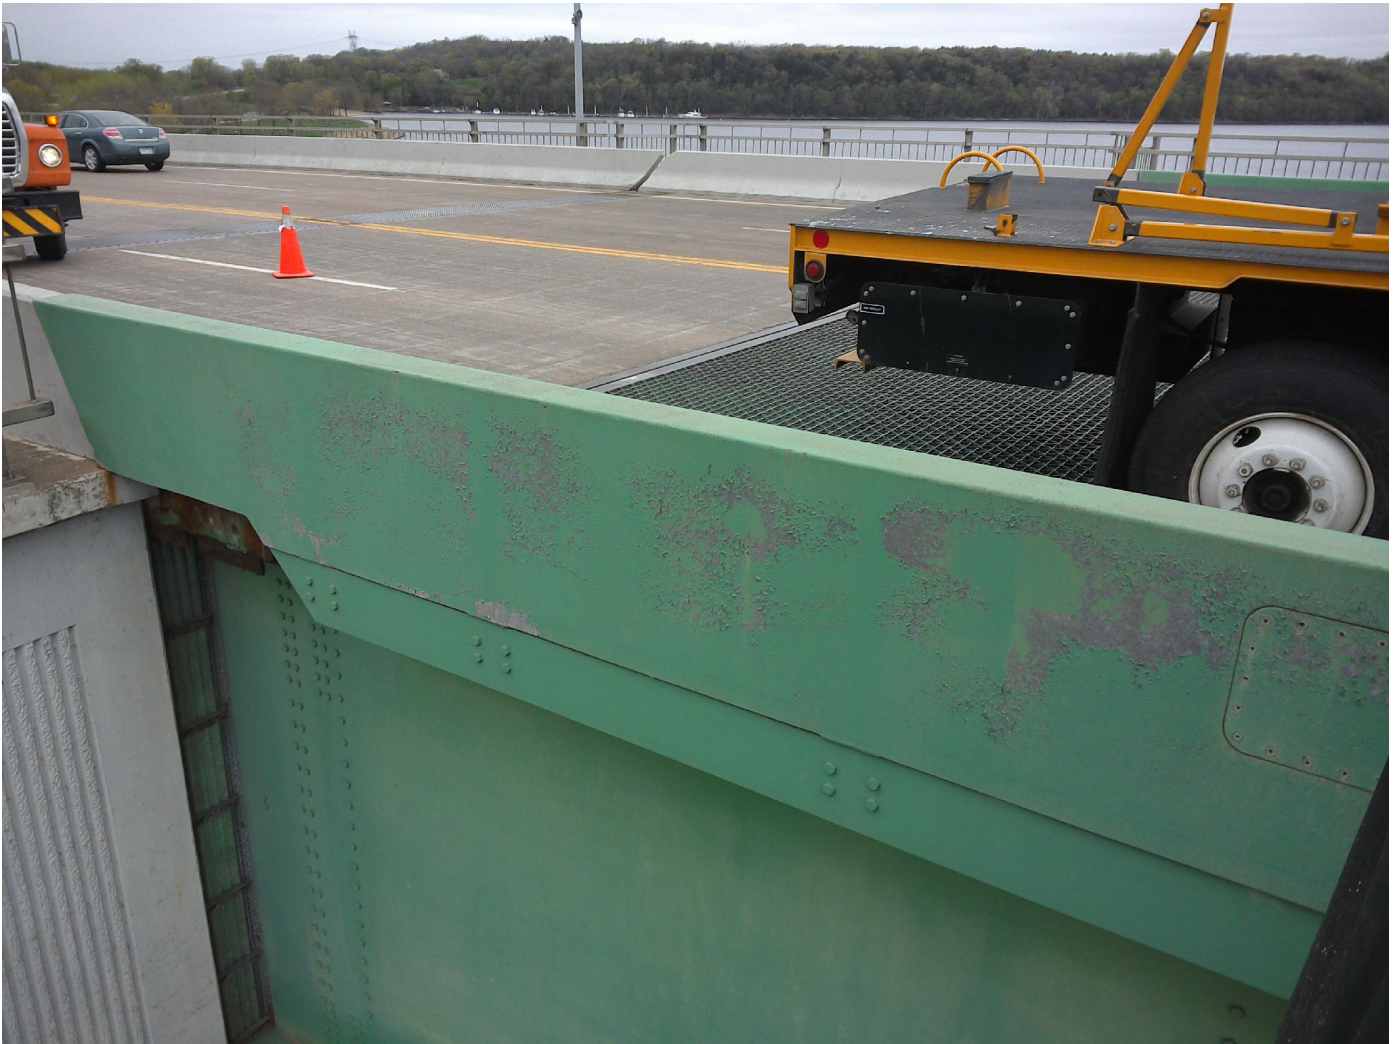
Loss of paint on galvanized steel parapet.

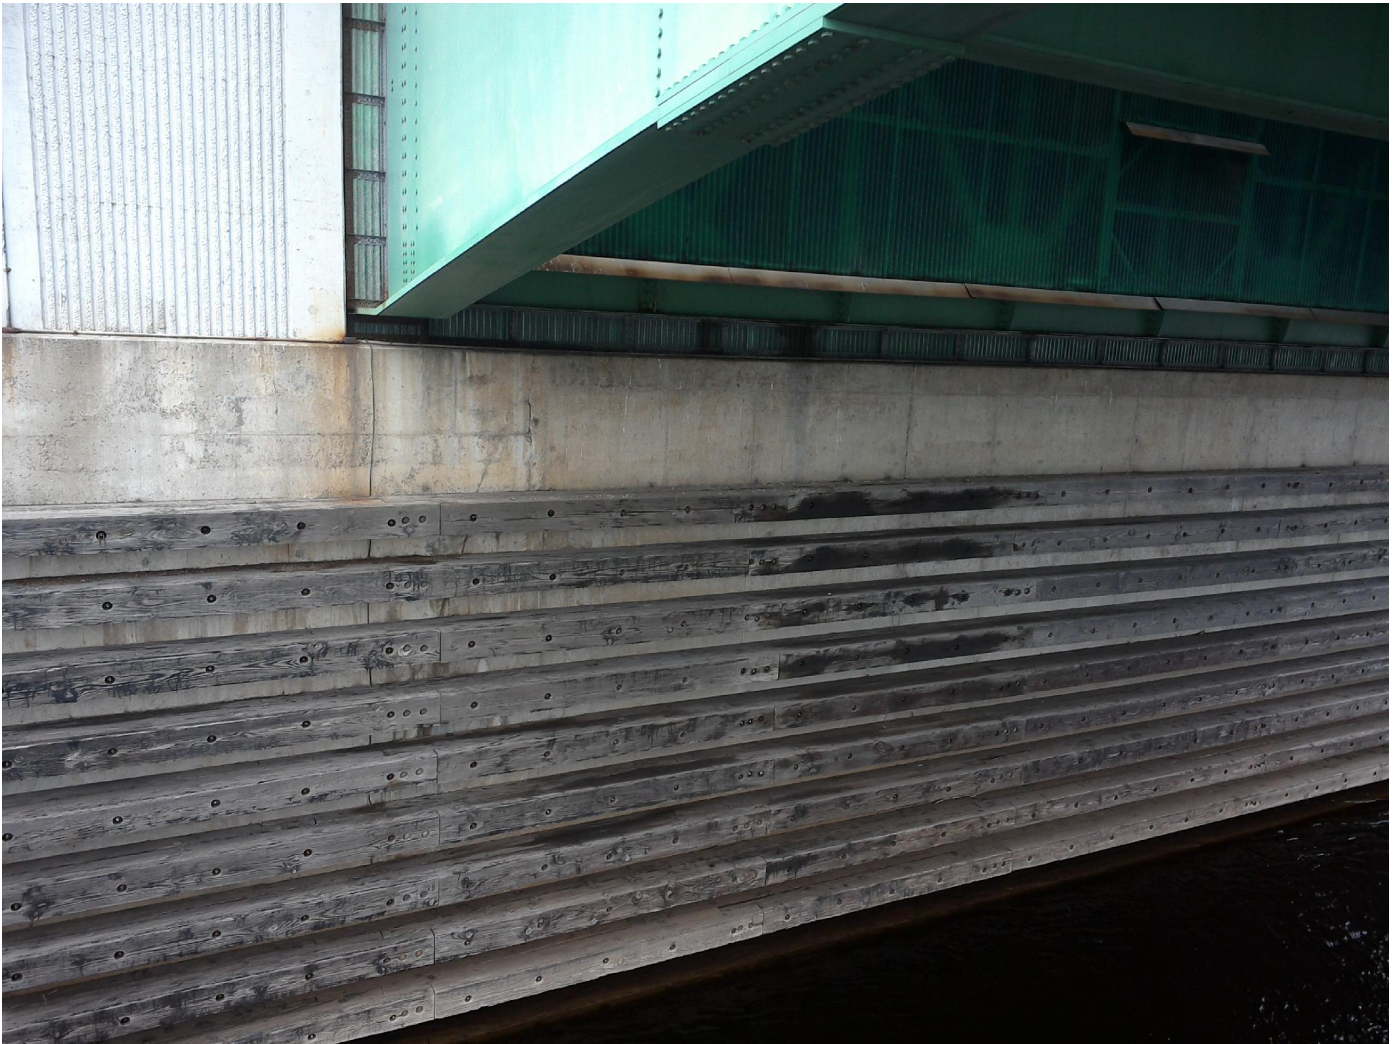
Pier 2 looking west cracking.

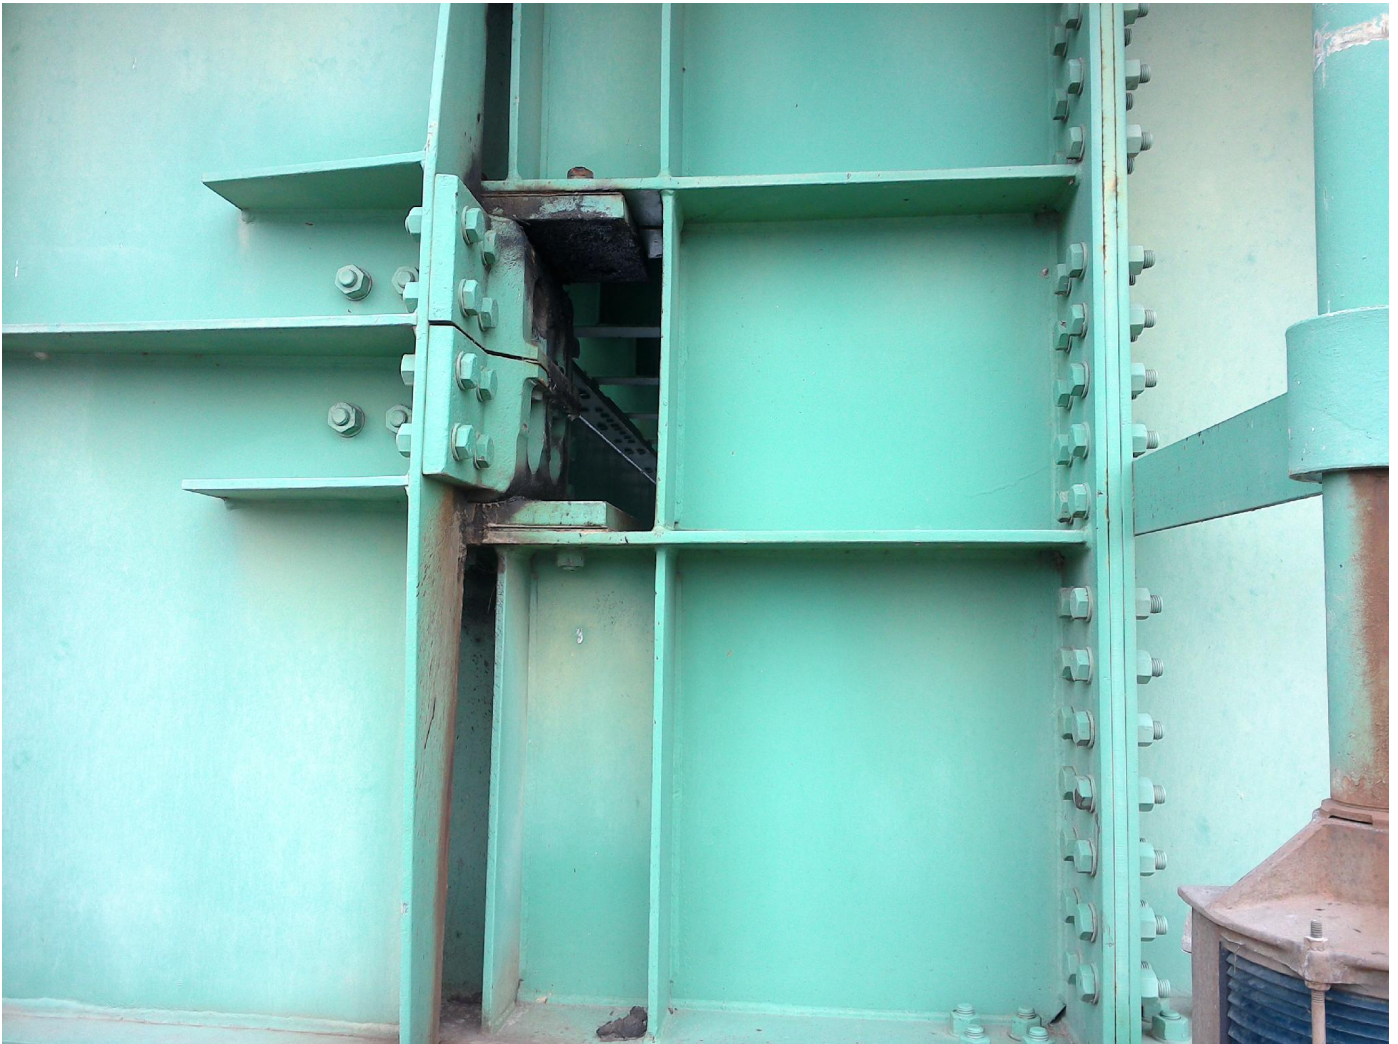
South bascule center joint. Wearing can be seen on the bottom plate.

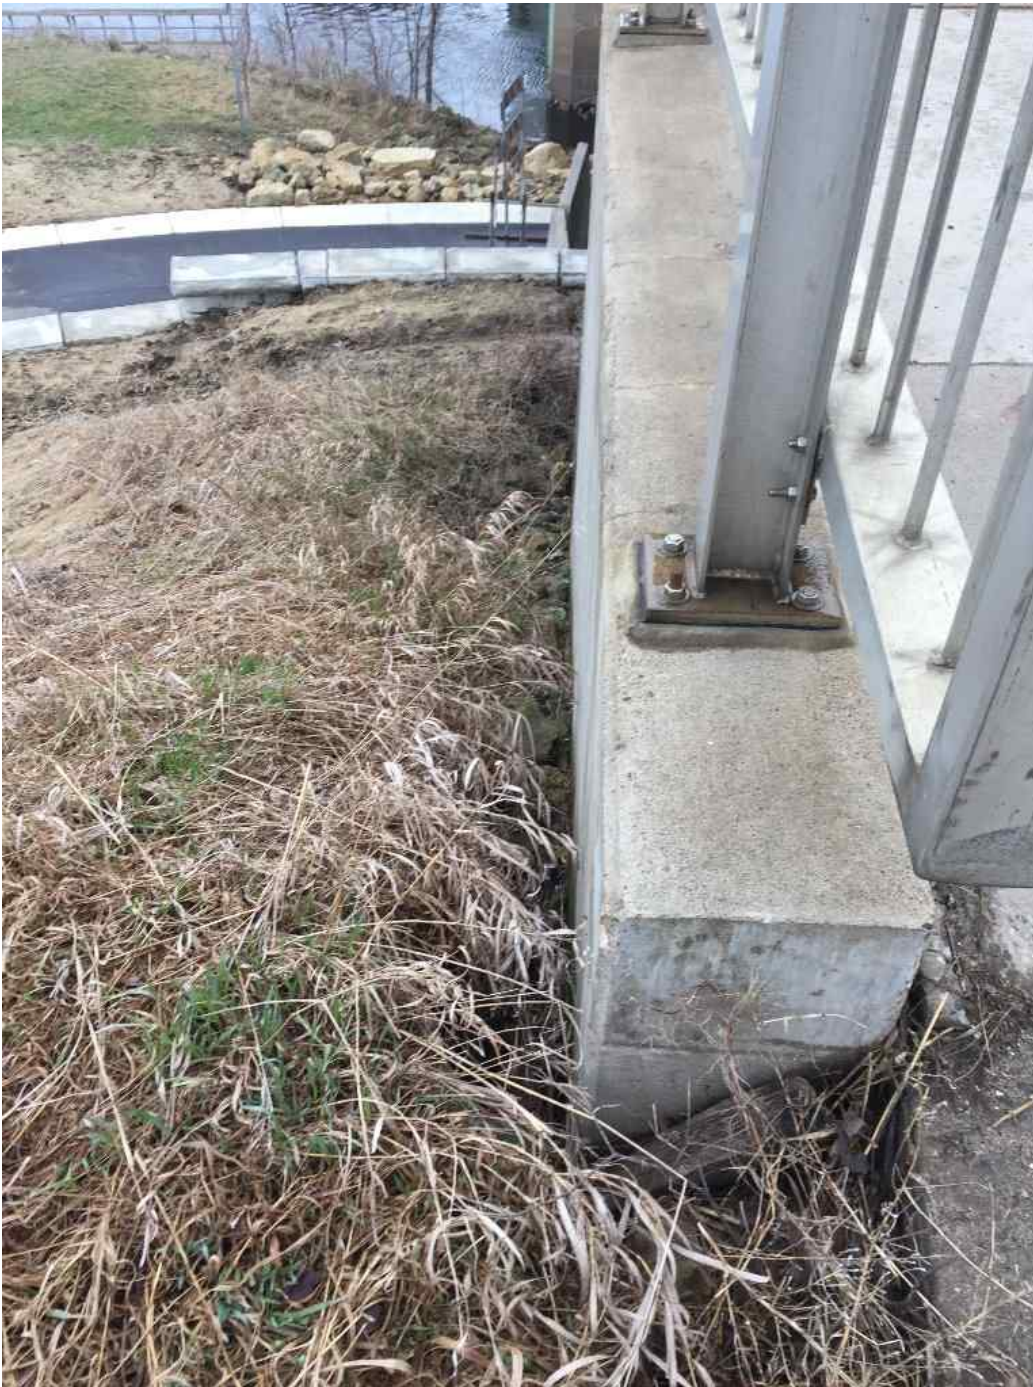
Erosion around NW wing
