REHABILITATION STRUCTURE SURVEY REPORT

| Design Project ID 1190-02-34 | Construction Project ID 1190-02-64 | Highway (Project Name) EAU CLAIRE - CHIPPEWA FALLS | | | | | | | | | | | | | | |
|---|--|--|---|---|---|---|---|---|---|---|---|---|---|--|--|---|
| Final Plan Due Date 05/01/2018 | Preliminary Plan Due Date 05/01/2018 | <input checked="" type="checkbox"/> Town <input type="checkbox"/> Village <input type="checkbox"/> City WASHINGTON | | | | | | | | | | | | | | |
| PS&E Date 08/01/2018 | Letting Date 02/12/2019 | County EAU CLAIRE | | | | | | | | | | | | | | |
| Structure Number B-18-37 | | Section 35 | Town 27N | Range 09W | | | | | | | | | | | | |
| Station 62+62.51 - 63+60.17 | Latitude: 444619.03 Longitude: 912540.6 | <input checked="" type="checkbox"/> YES <input type="checkbox"/> NO Structure Located on National Highway System | | | | | | | | | | | | | | |
| For Survey and CADD Files Horizontal Coordinate System: Vertical Datum: | | Traffic Forecast Data

**Inspection Report for
B-18-037**

Bridge Asbestos Inspection Report

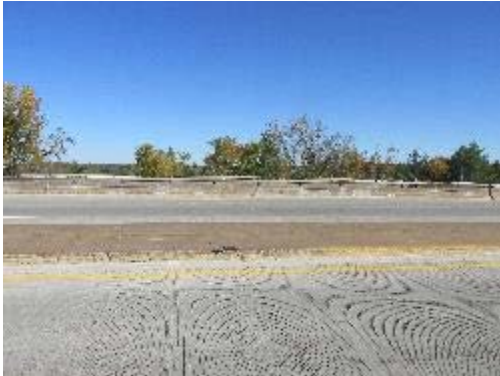
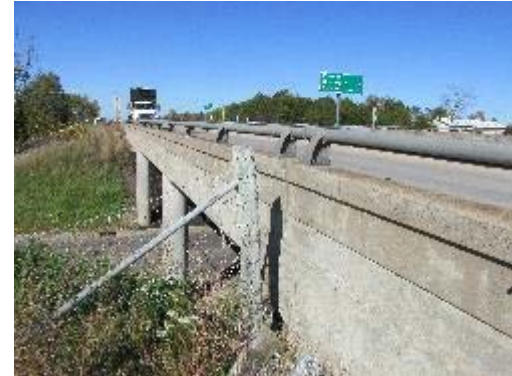
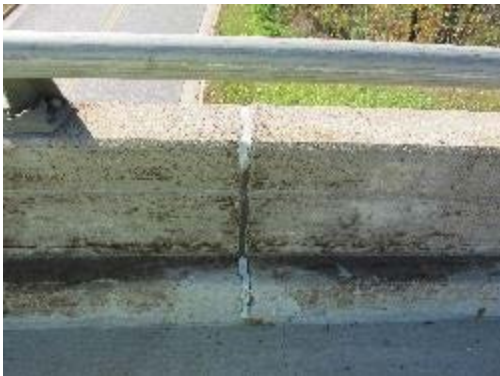
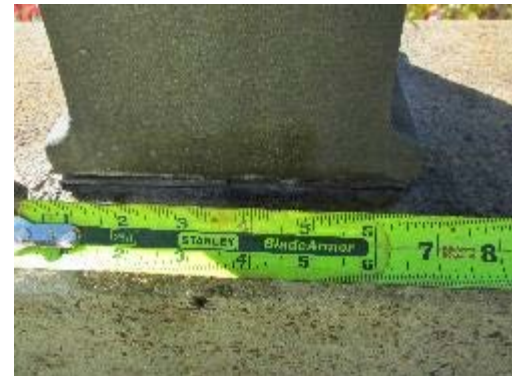
B-18-0037

On both of the bridges, the gaskets located under the railing attachment plates on the parapet tested positive for asbestos greater than 1% and is therefore regulated ACM. If the ACM will be disturbed during the planned overlays, the ACM must be removed prior to any work.

Gasket under railing attachment plate

Standard Special Provision (STSP) 203-005 should be incorporated into the specifications. If the ACM will not be disturbed during the planned overlays, STSP 107-120 should be included in the specifications.

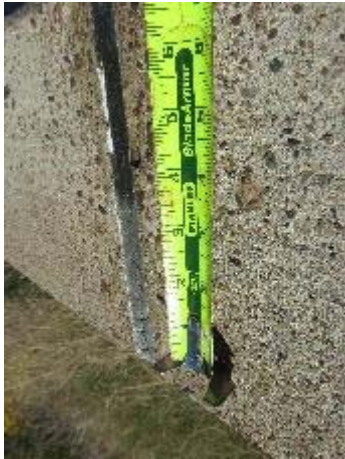
Caulk in parapet expansion joint

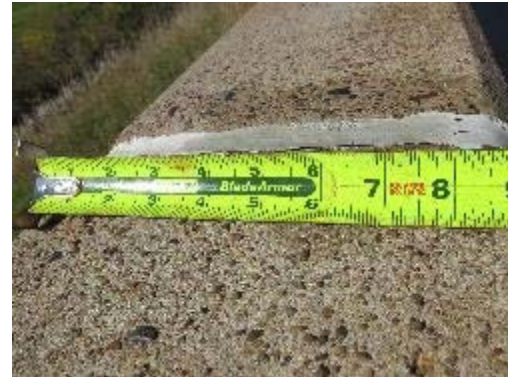
Caulk in parapet expansion joint

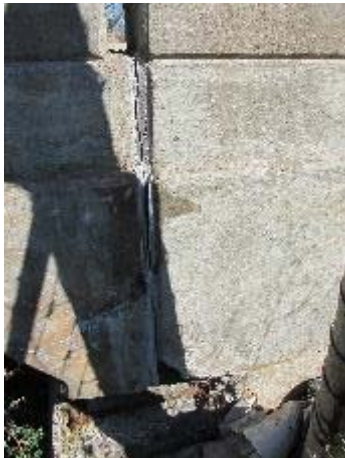
Caulk in abutment joint

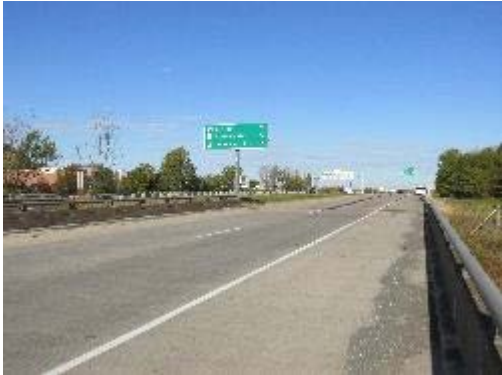
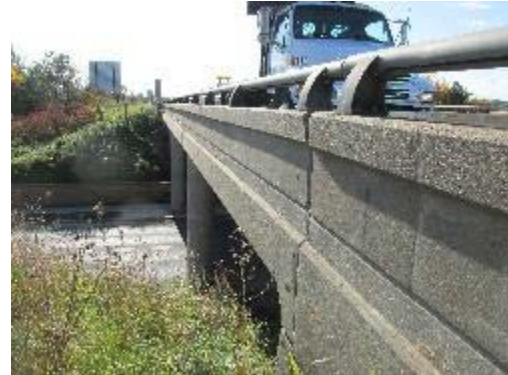
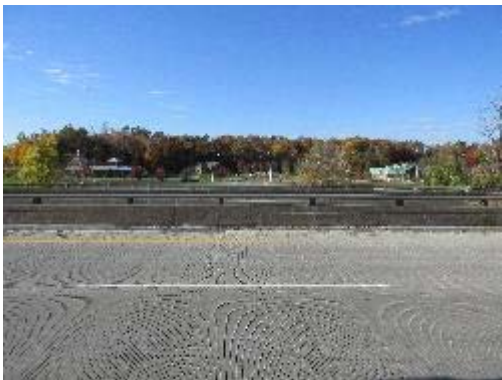
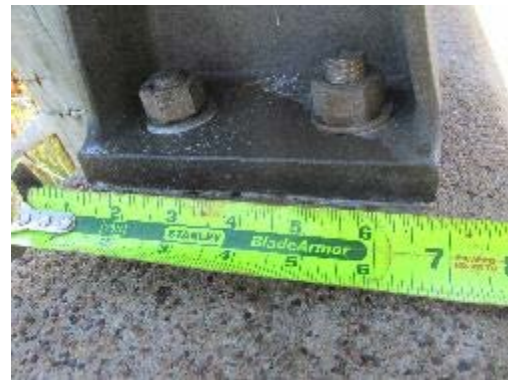
B-18-0038

Gasket under railing attachment plate

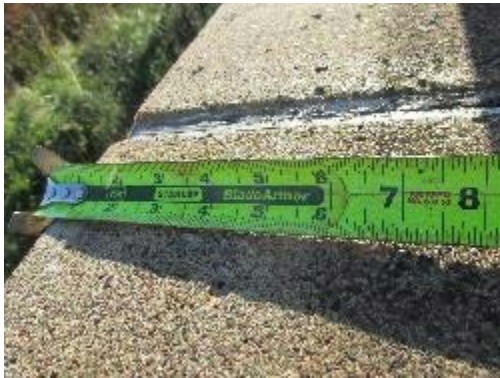
Caulk in parapet expansion joint

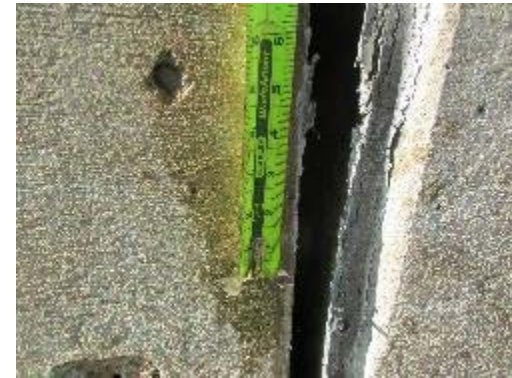
Caulk in abutment joint
