Asbestos-Containing Material (ACM) Inspection and Pre-Demolition Reconnaissance

462 and 466 USH 63
Shell Lake, Wisconsin

WisDOT Project ID #1560-31-21

December 2014

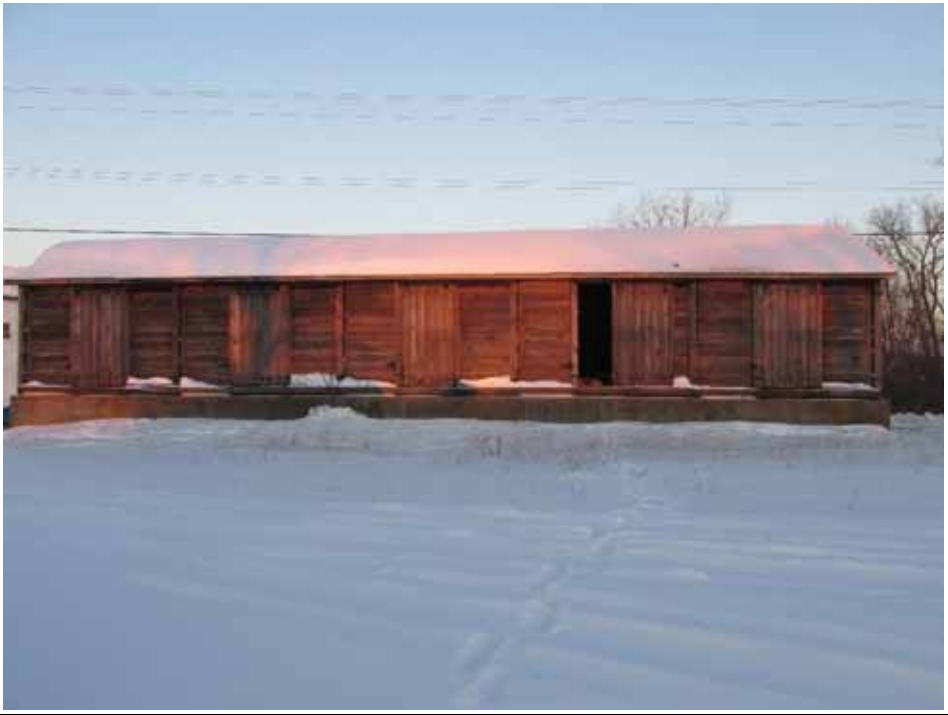
1	11/20/14		
Description 466 USH 63 – North coal storage building.

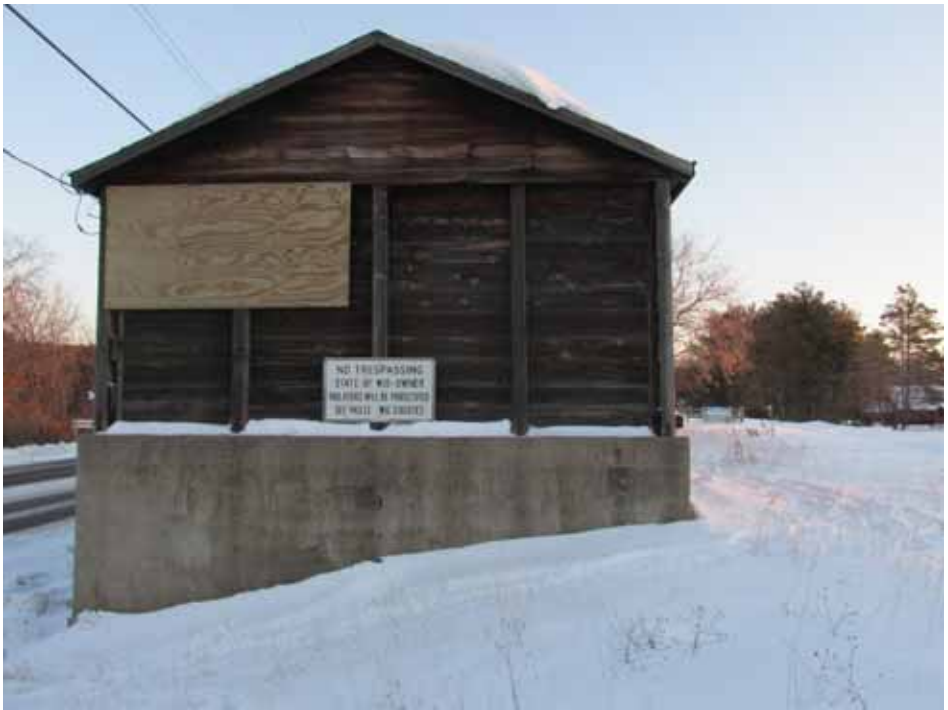
2	11/20/14	
Description 466 USH 63 – North coal storage building.

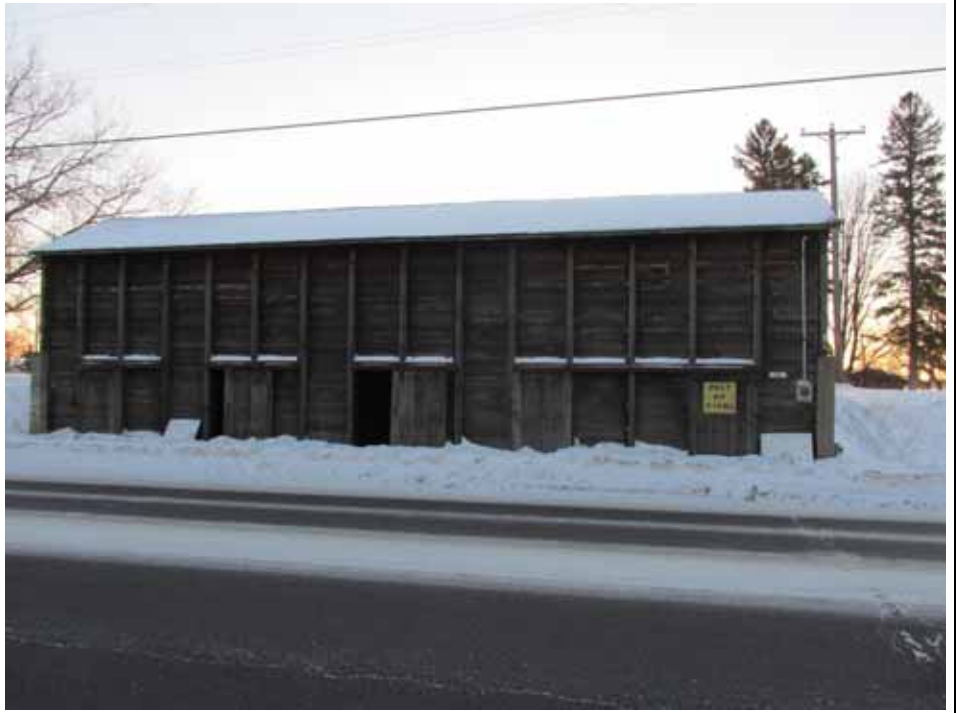
Description 466 USH 63 – North coal storage building.

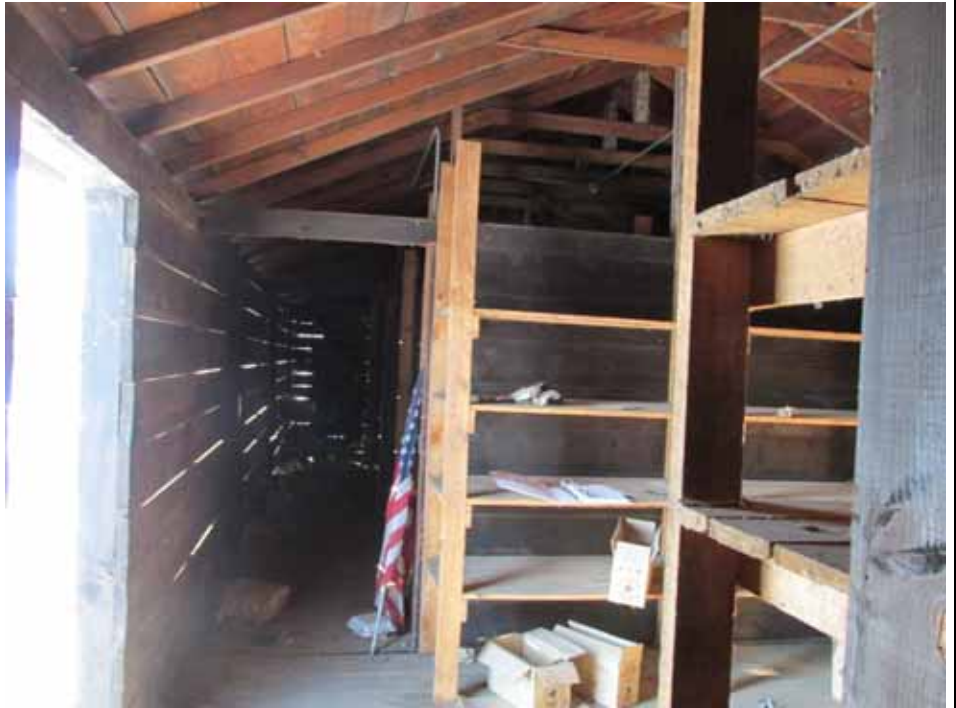
Description 466 USH 63 – Interior of building.

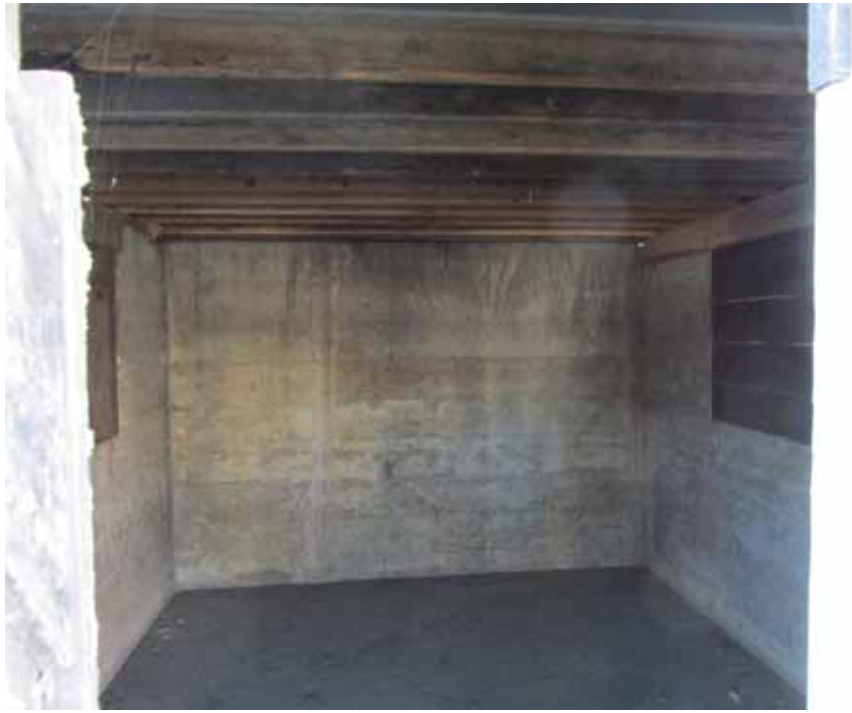
7	11/20/14		
Description 466 USH 63 – Interior of storage bin.

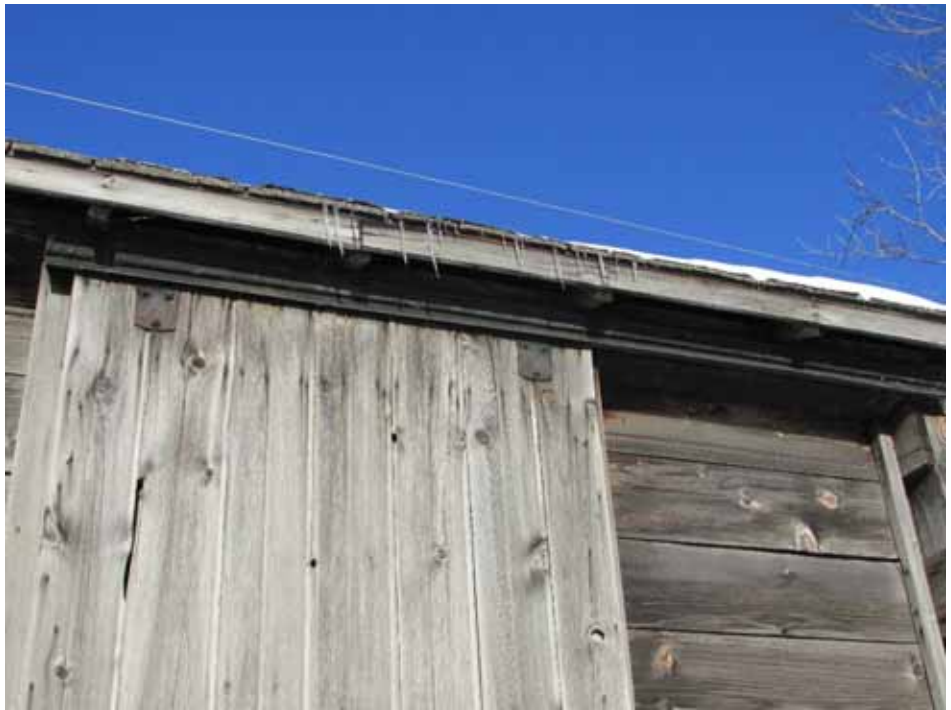
8	11/20/14		
Description 466 USH 63 – Sliding door.

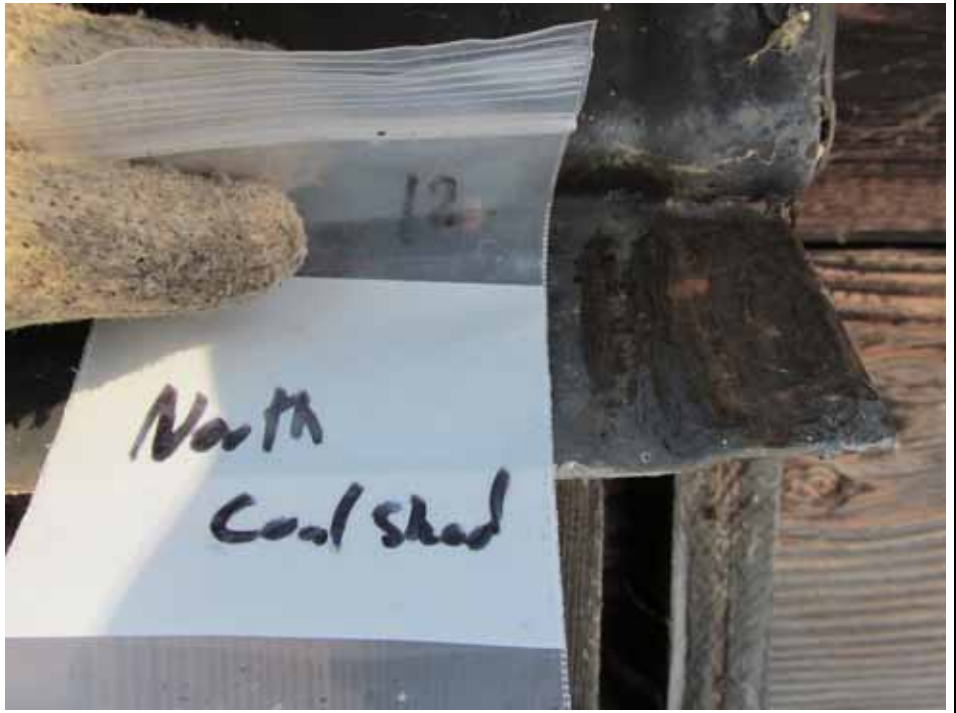
9	11/20/14		
Description 466 USH 63 – Paint on sliding door rail. Non-detect for ACM.			
Photo No.	Date

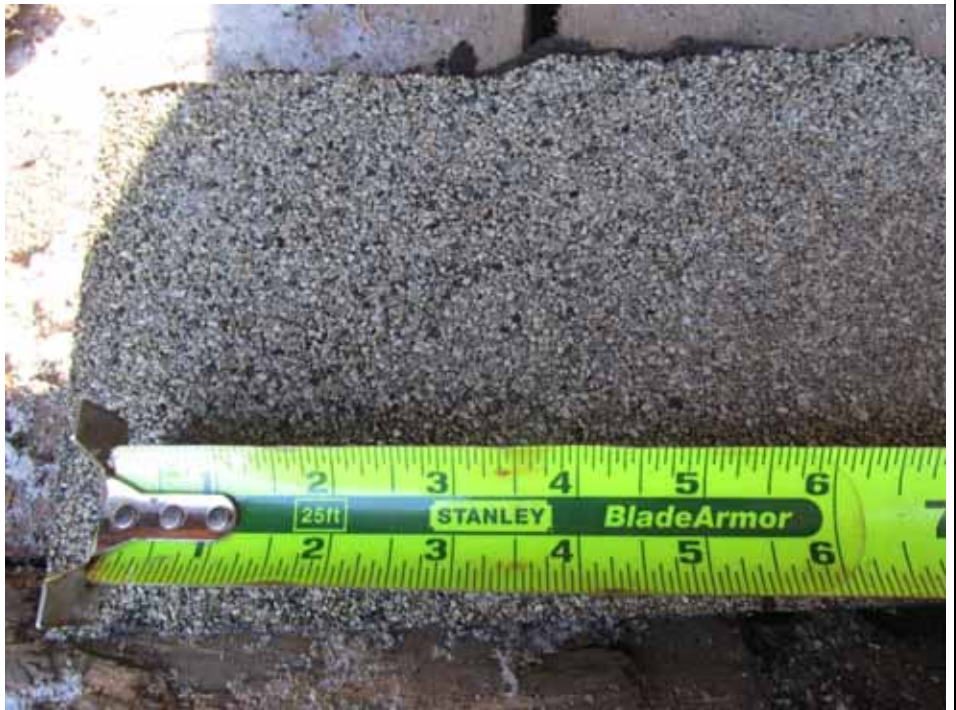
10	11/20/14		
Description 466 USH 63 – 1 st layer of shingles and tar. Non-detect for ACM.

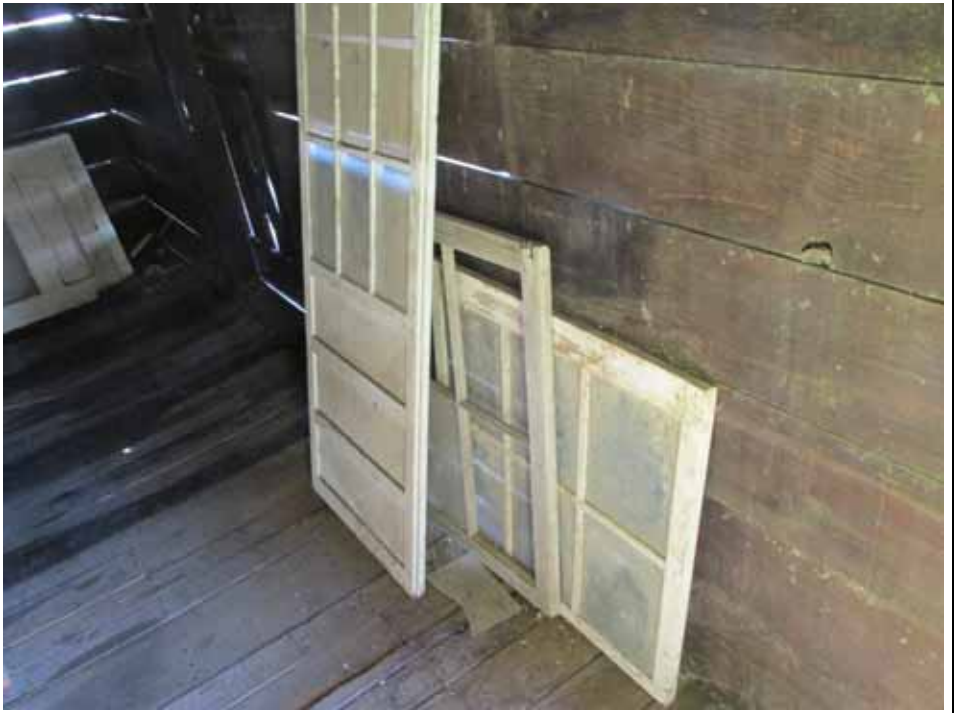
13	11/20/14		
Description 466 USH 63 – Doors and windows left in building. Glazing around glass in doors and windows was not sampled.

The ACM must be removed prior to demolition of the buildings. The cinder blocks, painted doors, window panes, benches, and carpeting located in the north coal storage shed at 466 USH 63 should be properly disposed of concurrent with the demolition of the buildings.

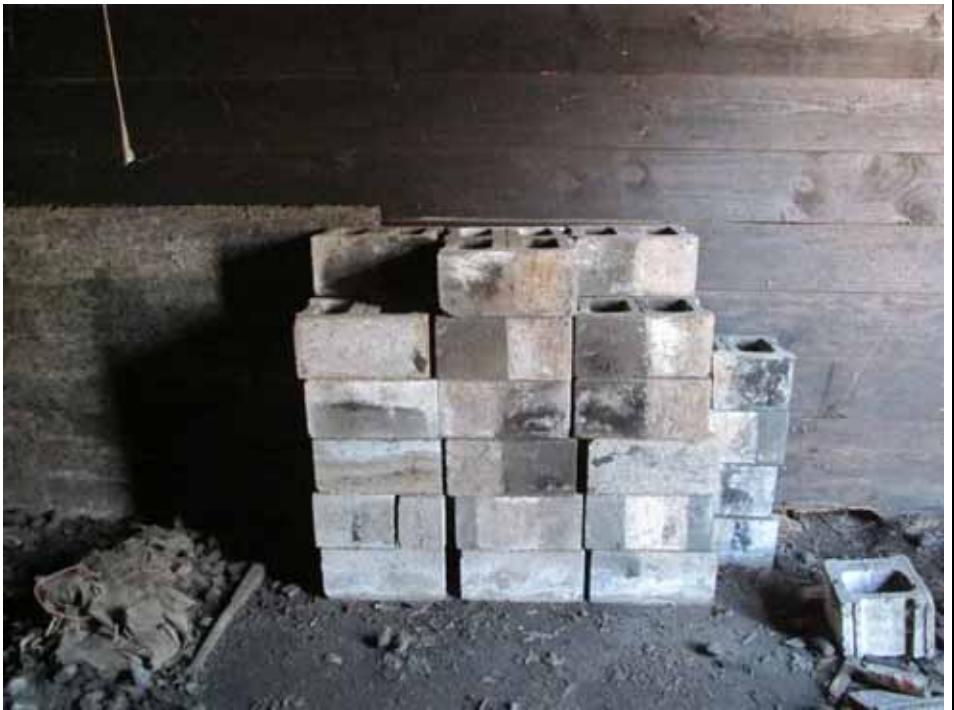
14	11/20/14	
Description 466 USH 63 – Cinder blocks left in building.

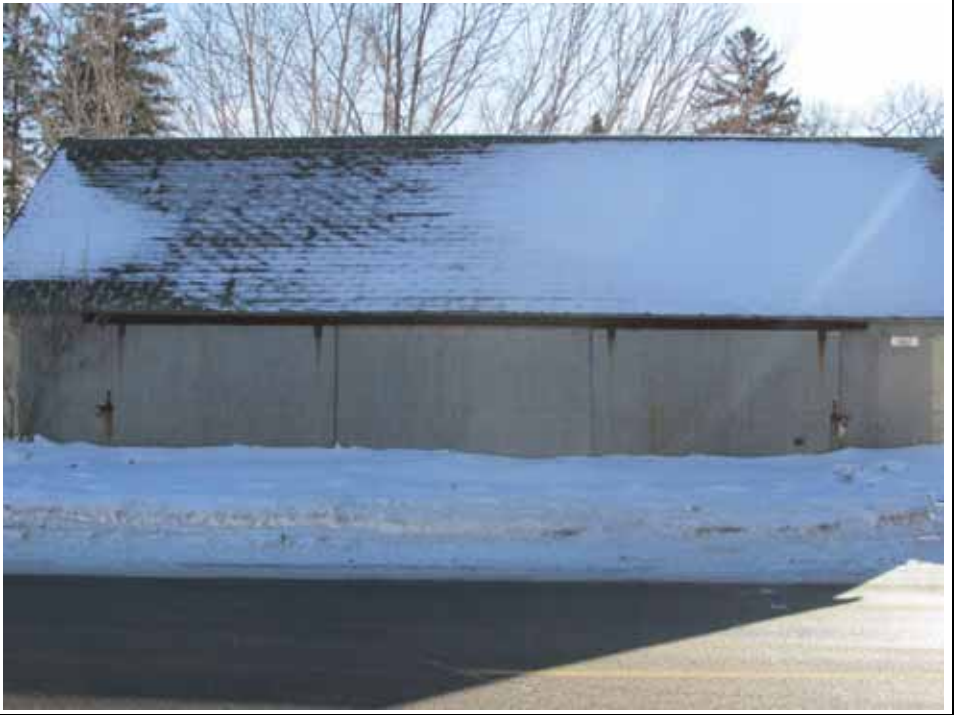
Description 462 USH 63 – South coal storage building.			
Photo No. 16	Date 11/20/14

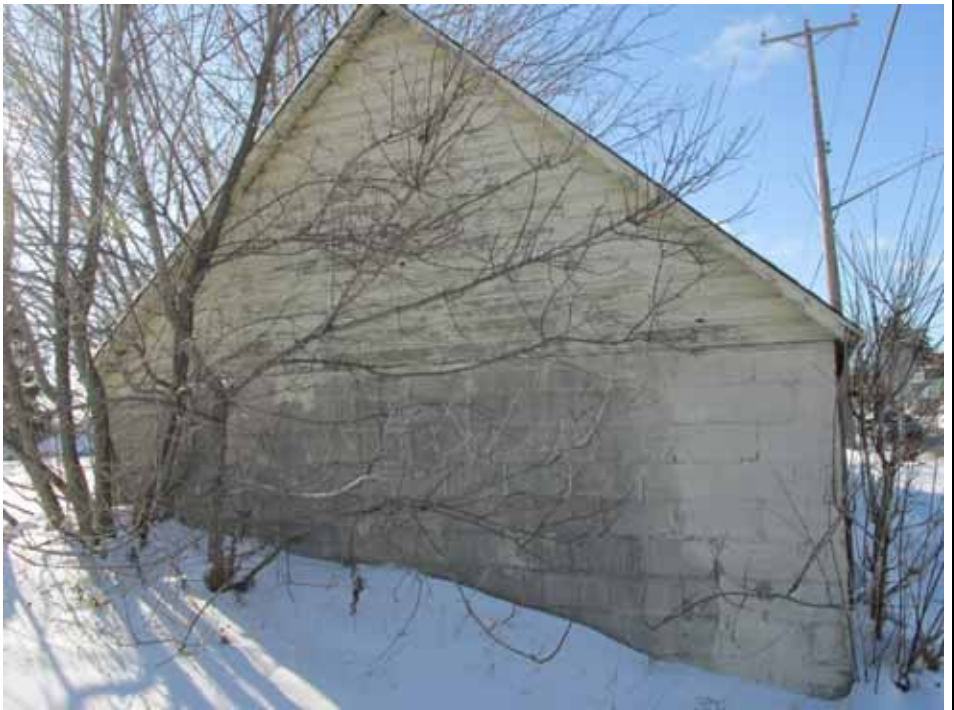
Description 462 USH 63 – South coal storage building.

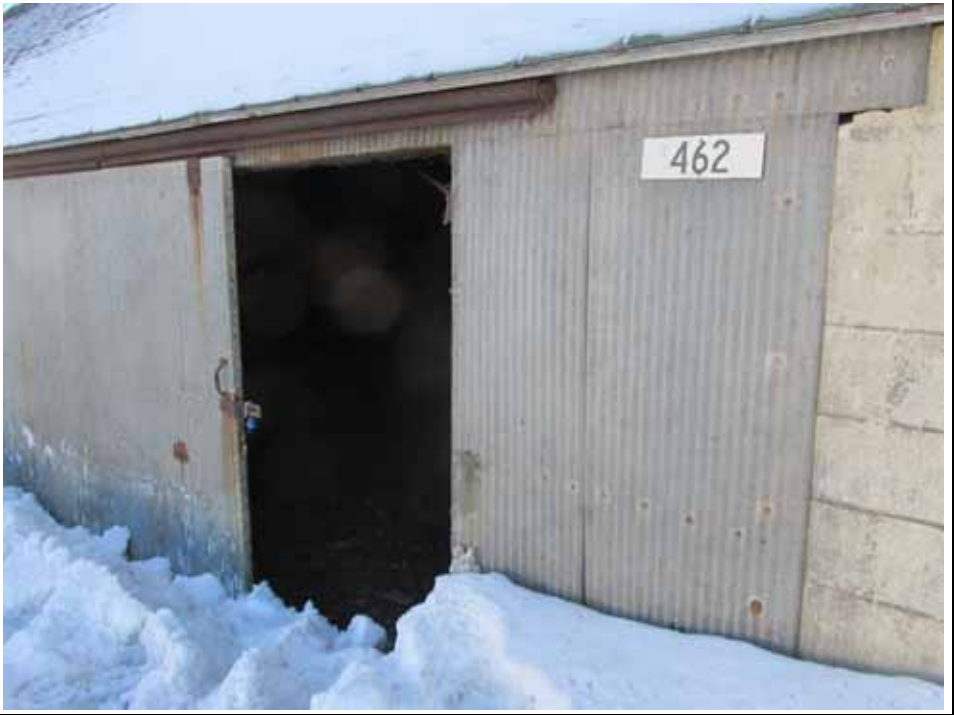
Description 462 USH 63 – South coal storage building.			
Photo No. 18	Date 11/20/14

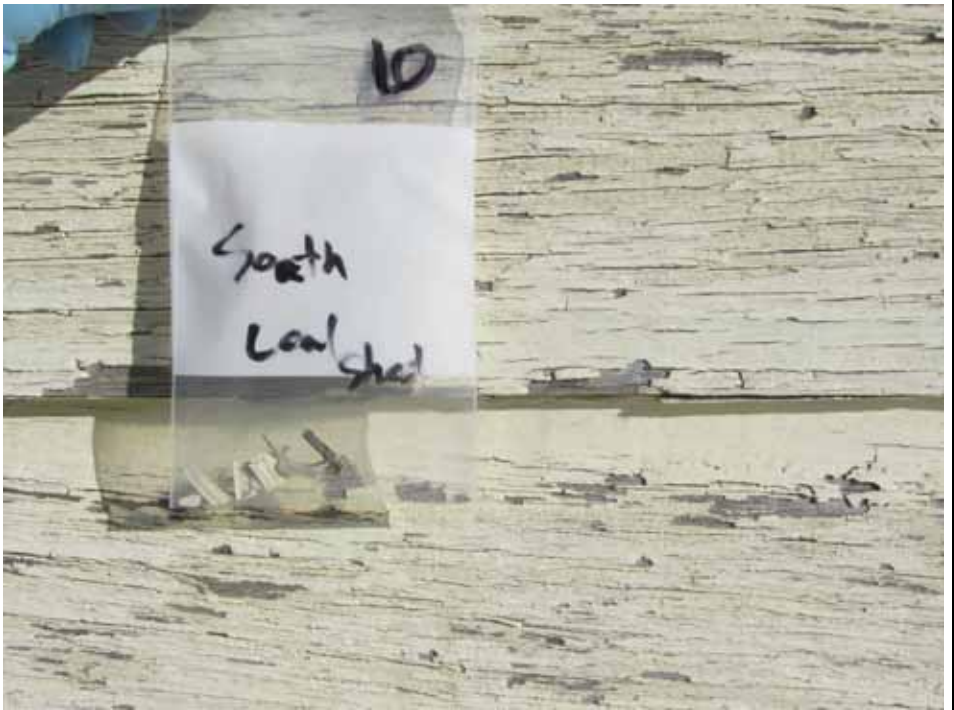
Description 462 USH 63 – Paint on exterior of building. Non-detect for ACM.

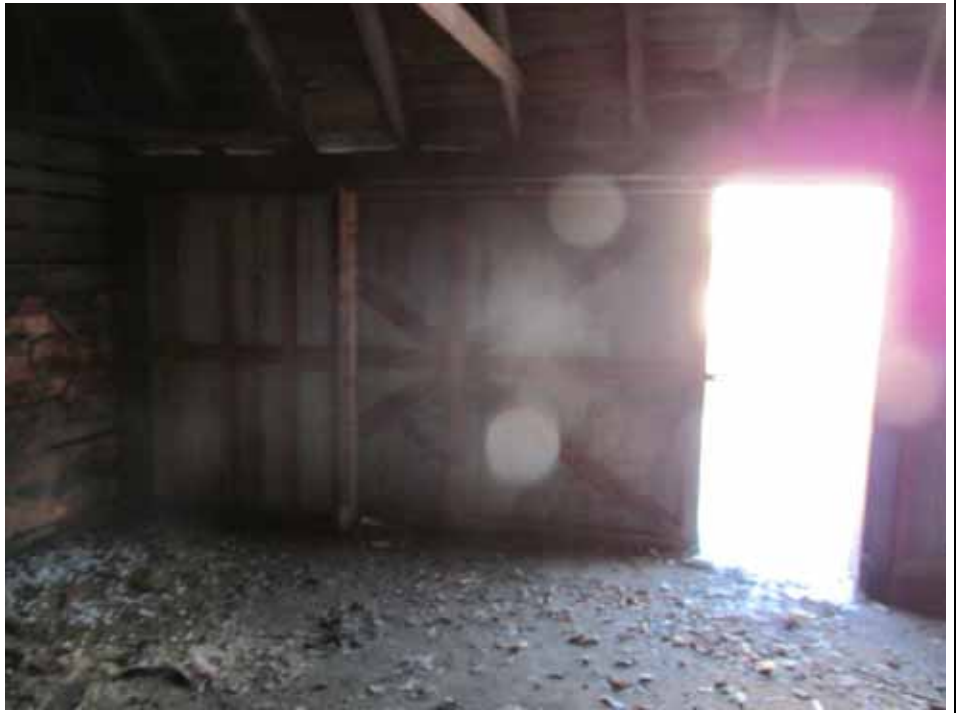
Description 462 USH 63 – Interior of building.			
Photo No. 20	Date 11/20/14

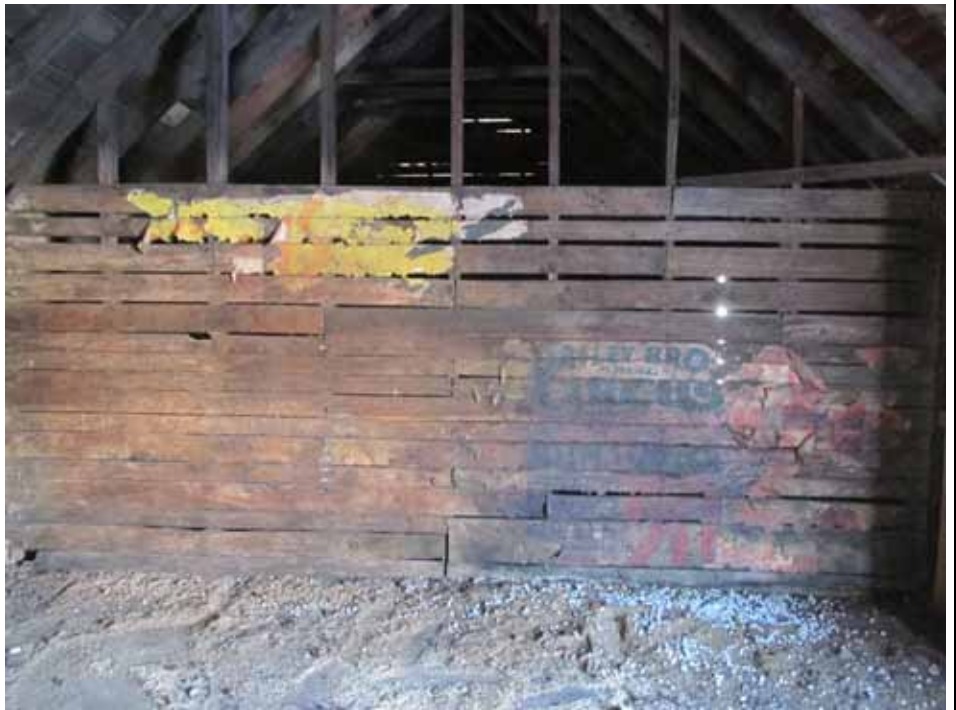
Description 462 USH 63 – Interior of building.

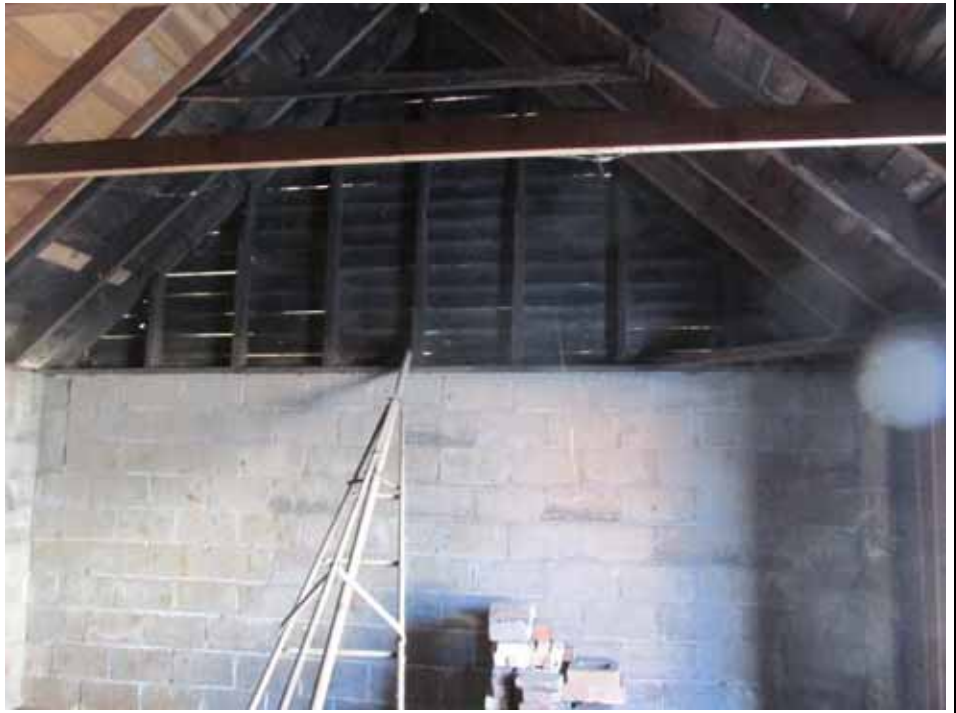
Description 462 USH 63 – Interior of building.			
Photo No. 22	Date 11/20/14

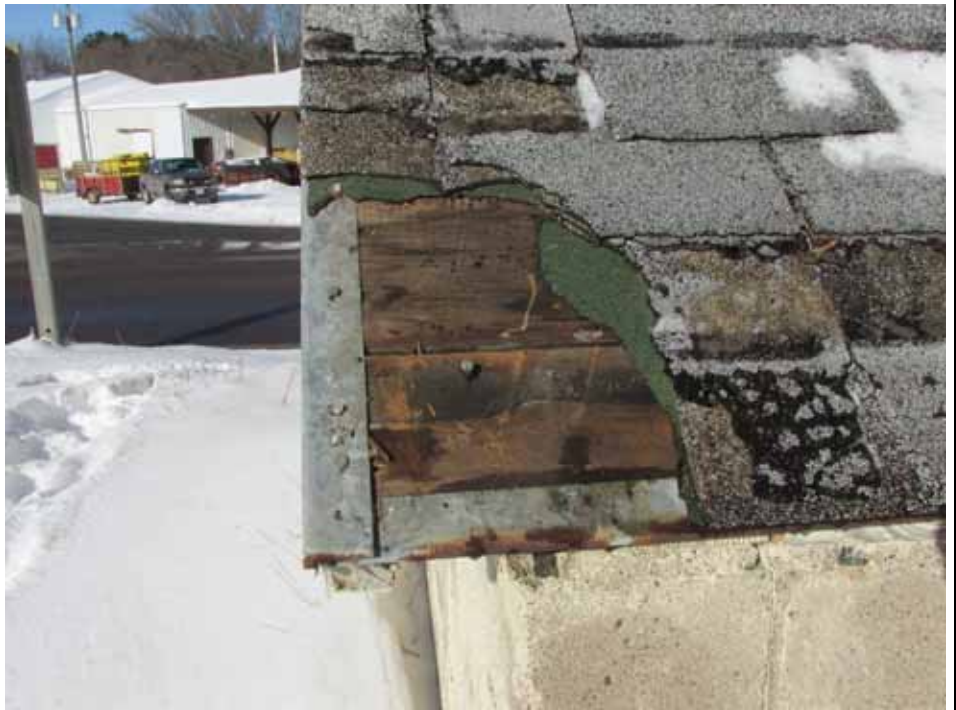
Description 462 USH 63 – Roof.

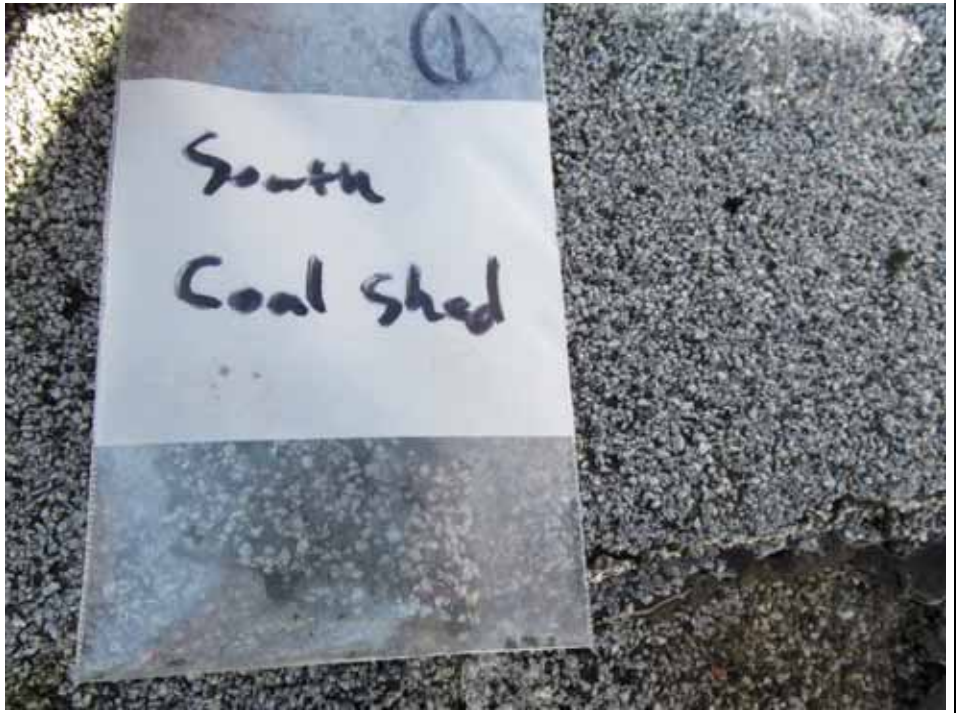
23	11/20/14		
Description 462 USH 63 – 1 st layer of shingles with tar. Non-detect for ACM.

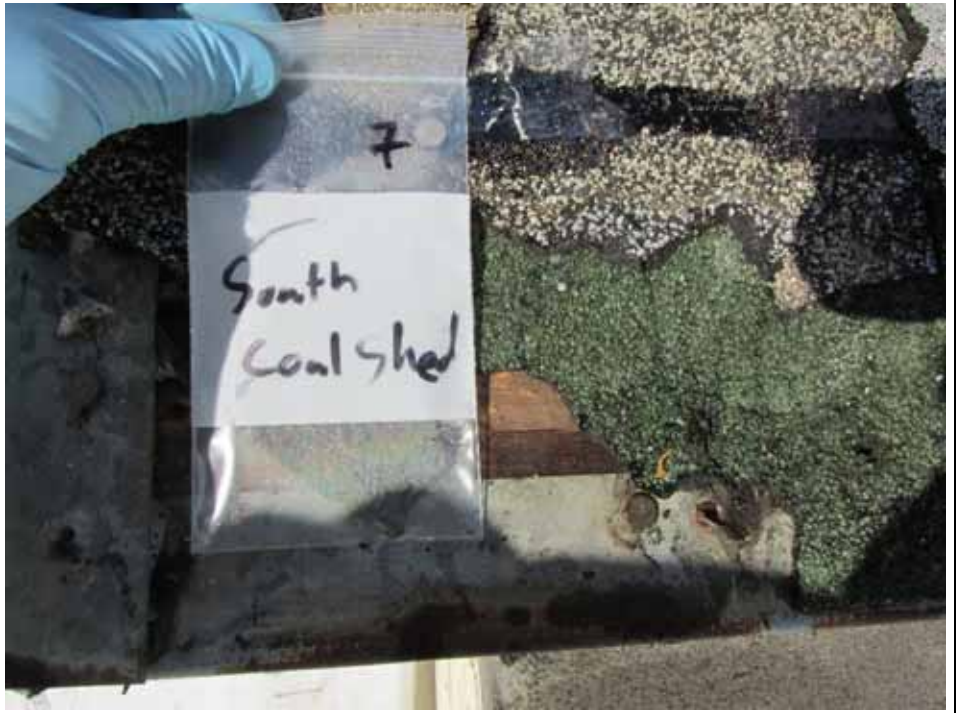
25	11/20/14		
Description 462 USH 63 – 3 rd layer of shingles with tar. Non-detect for ACM.
