## Bridge Asbestos Inspection Report

**WisDOT Project ID:** 1360-12-00  
**Structure Number:** B-40-0252  
**Structure Name:** 107th Street over STH 145  
**City/County:** City of Milwaukee, Milwaukee County  
**Lat/Long Coordinates:** 430838.72/ 880242.14  
**TRC Project Number:** 292179.0000.0000  
**Date Inspected:** February 22, 2018  
**Inspected By/License Number:** John Roelke, All-119523

## Bridge B-40-0252

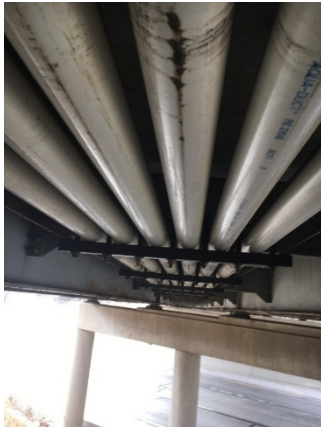
Utilities encased in PVC piping

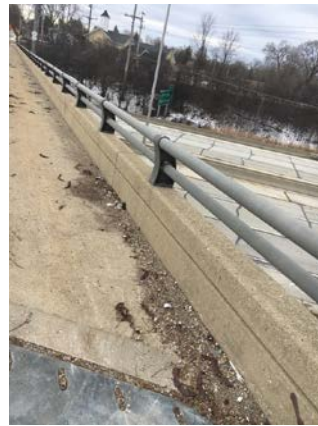
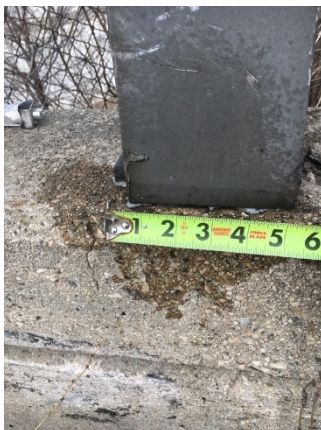
The gaskets located where the railing attaches to the concrete parapet tested positive for asbestos greater than 1% and is therefore regulated ACM. The ACM will be disturbed during the planned demolition and replacement. The ACM must be removed prior to any work. Standard Special Provision (STSP) 203-005 should be incorporated into the specifications.

Gasket under railing attachments

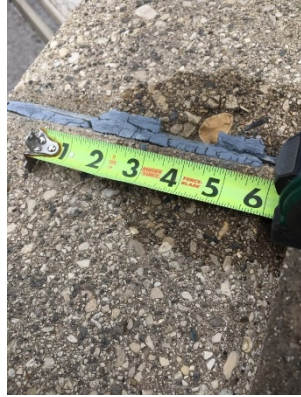
Gray caulk in parapet expansion joint,  
sidewalk joint

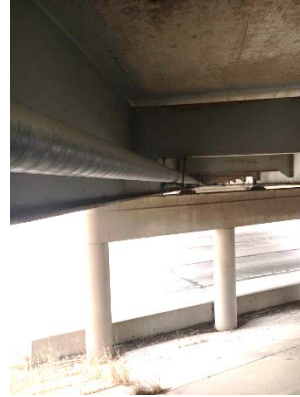
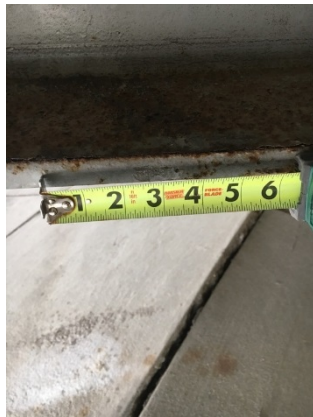
Silver paint on girder

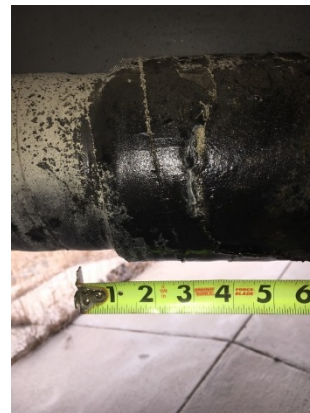
Black mastic on utility piping
