STATE OF WISCONSIN  
DEPARTMENT OF TRANSPORTATION

Inspection Report for  
B-40-252

N 107TH ST over STH 145-W FOND DU LAC AV  
Mar 27, 2018

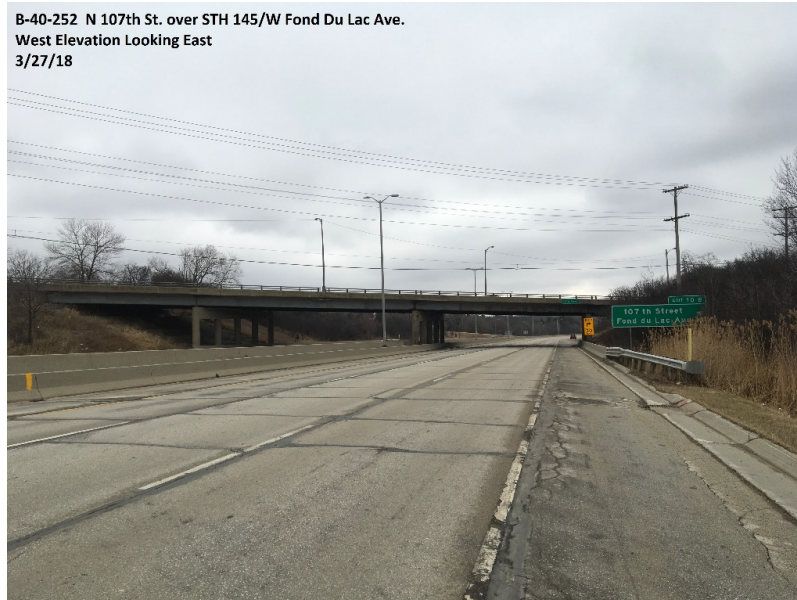
B-40-252 N 107th St. over STH 145/W Fond Du Lac Ave.  
West Elevation Looking East  
3/27/18

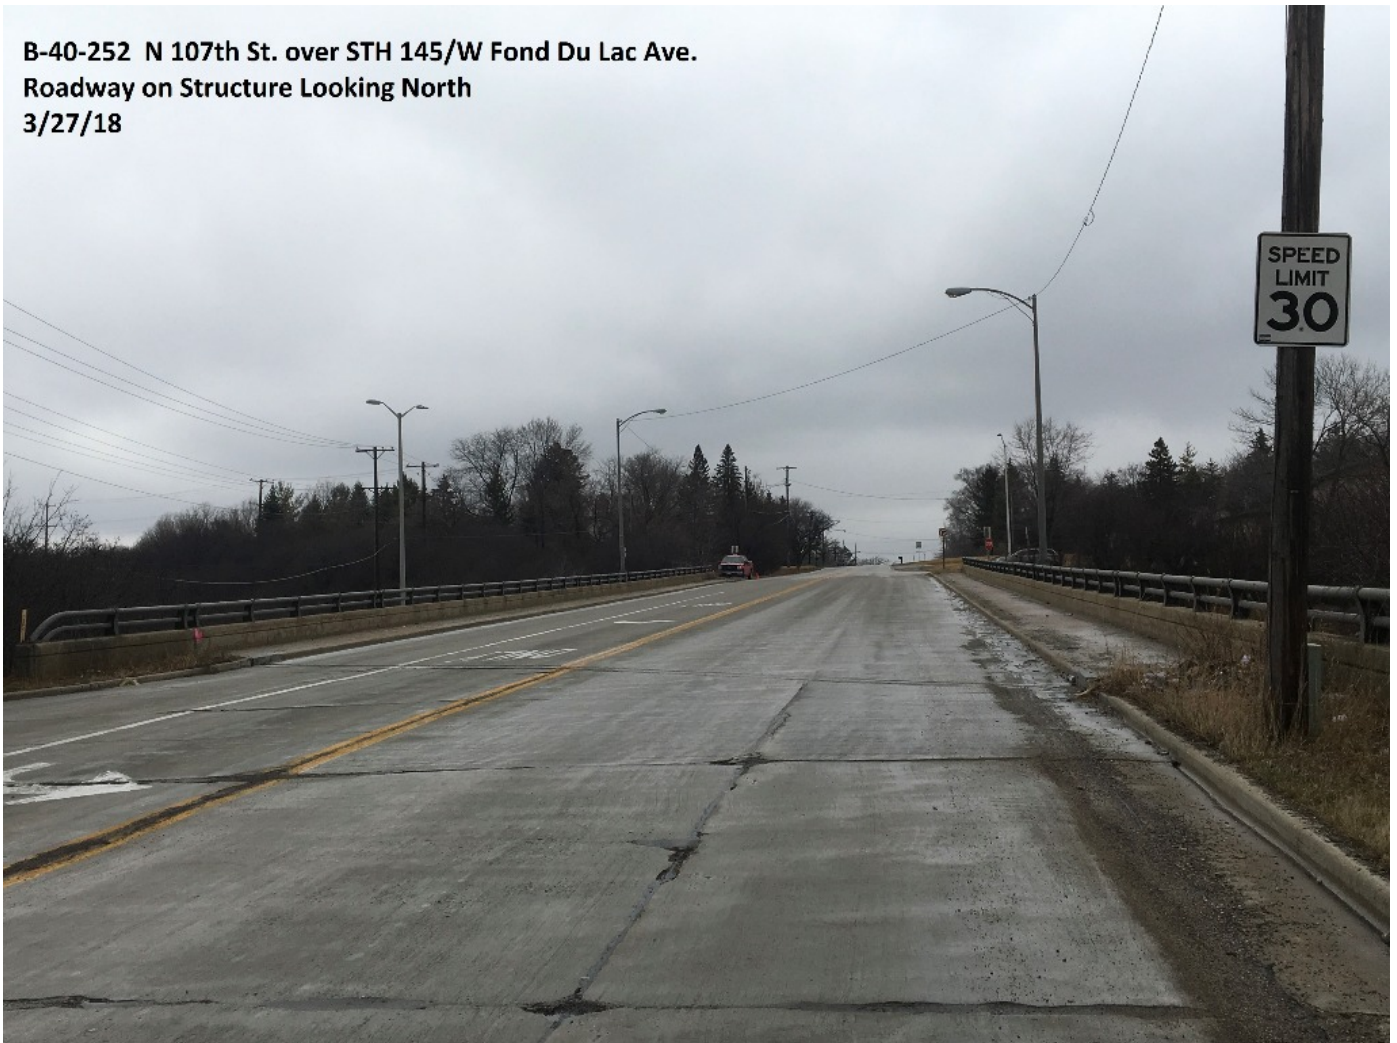
Roadway on structure looking North

**Roadway on Structure Looking North**

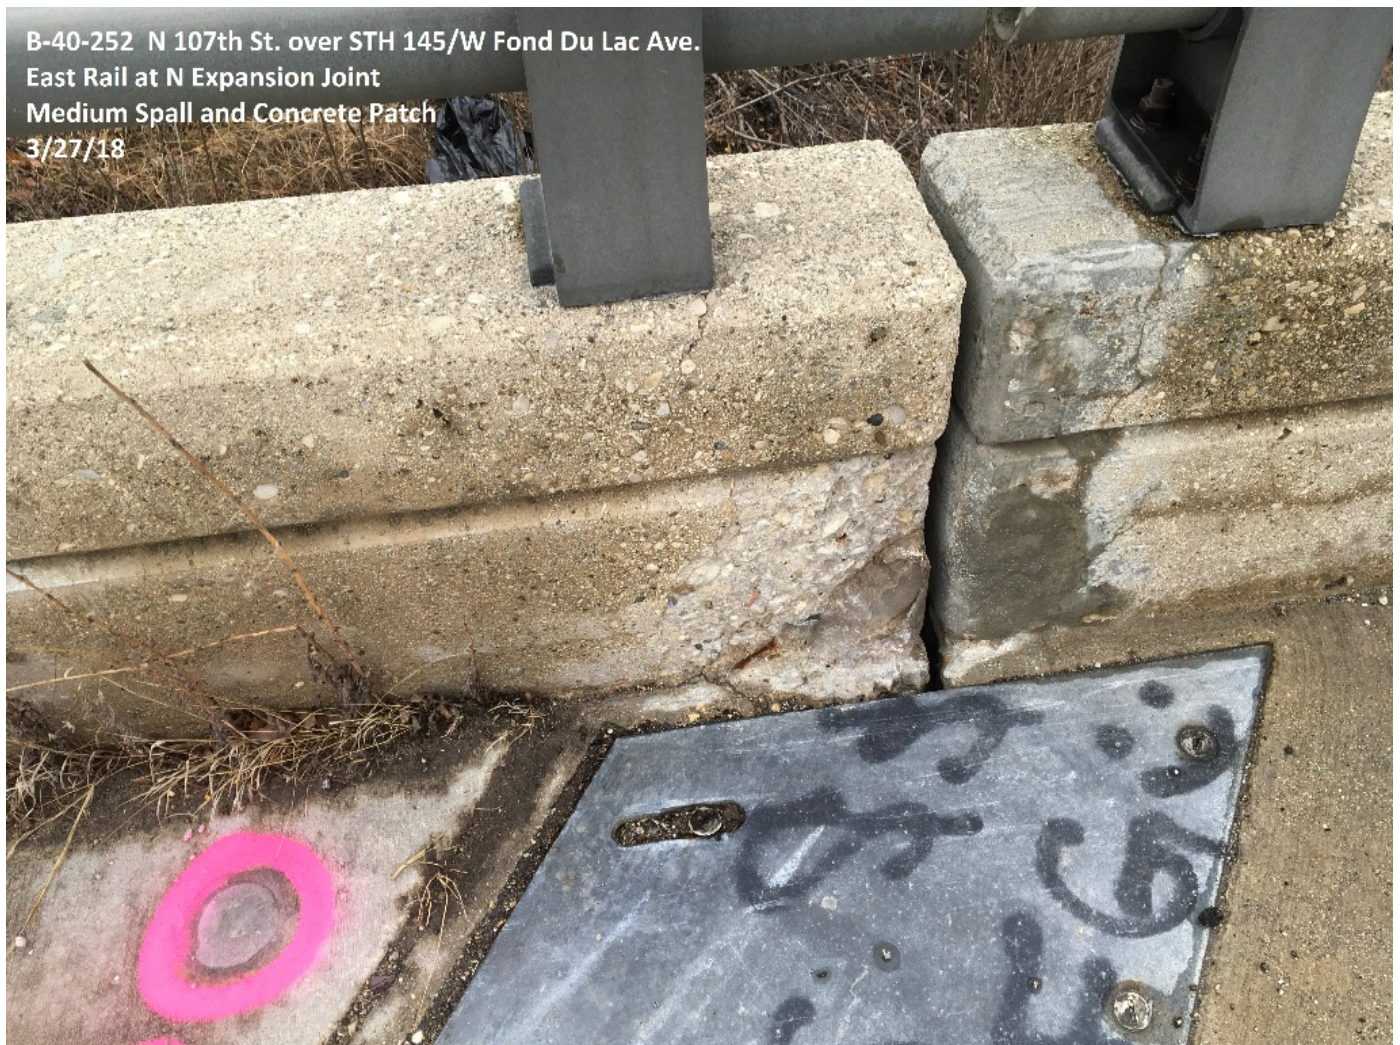
East parapet spall at north expansion joint

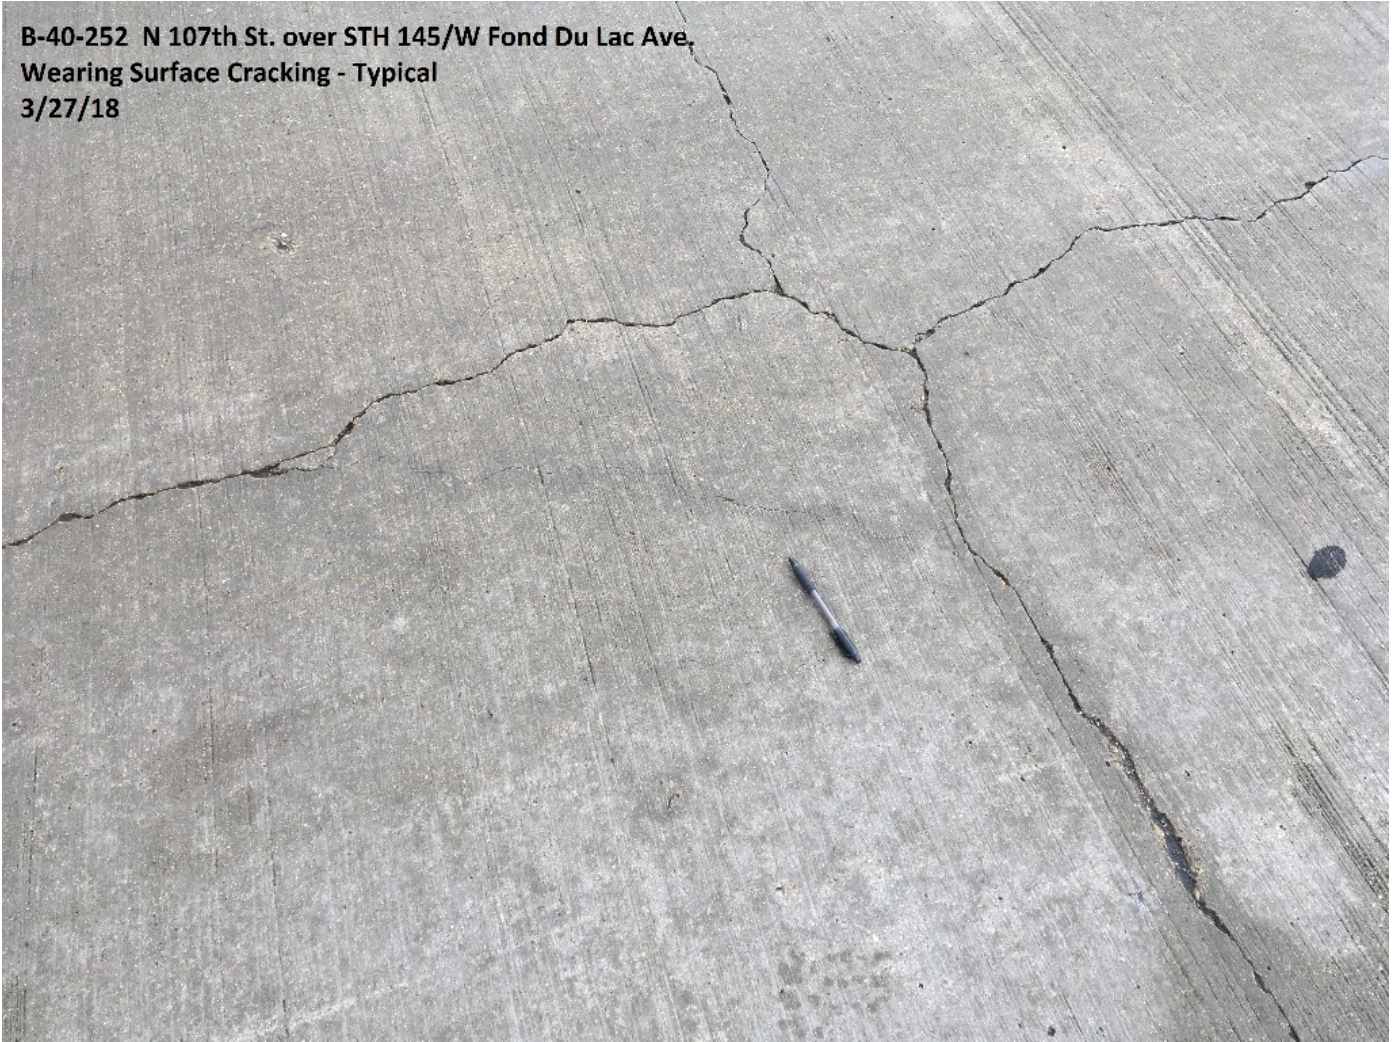
8514		Concrete Overlay	SF	10,974	0	3,363	7,611	0
		3210	Debonding/Spall/Patched Area/Pothole	SF		0	0	1,317	0
			<b>2004 IR: &lt;2% w/ small spalls, 2009 IR: 0-5% Delam and &lt;2% Spall, 2013 IR Indicated 5-10% Delamination and &lt;2% Spalling</b>						
		3220	Crack (Wearing Surface)	SF		0	3,363	6,294	0
			Span 1: Nar to Med map crkng - 25% CS3; Span 2: Nar to Med map crkng - 50% CS3; Span 3: Nar to Med map crkng - 75% CS3; Span 4: Med map crkng - <b>75%</b> CS3

Deck cracking - typical throughout entire deck

B-40-252 N 107th St. over STH 145/W Fond Du Lac Ave.  
Wearing Surface Cracking - Typical  
3/27/18

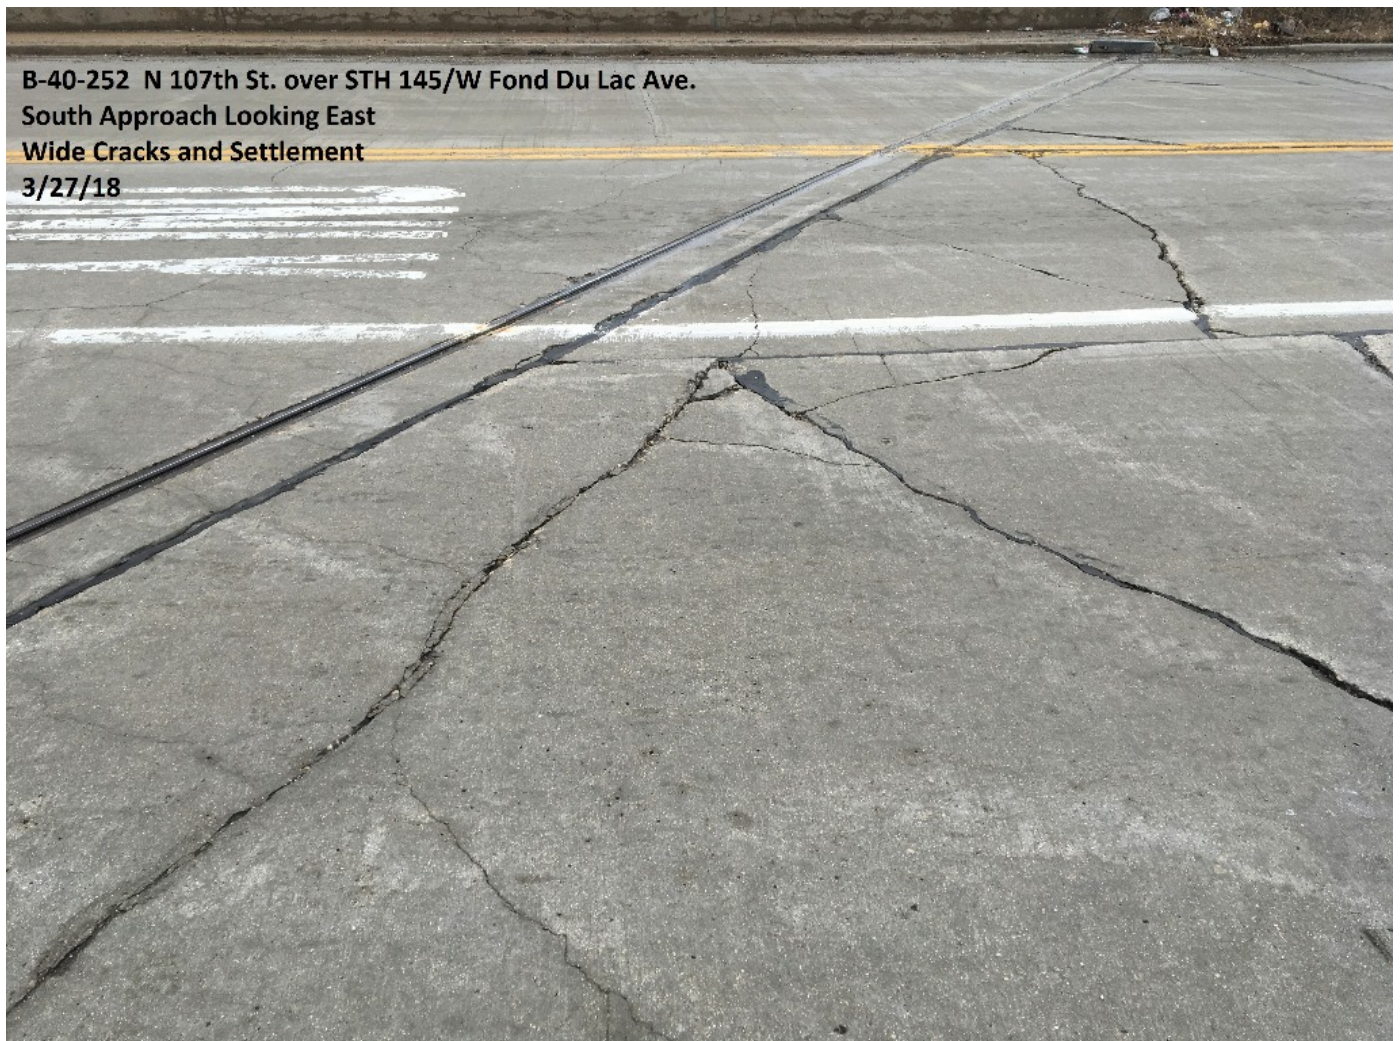
South Approach Looking East  
Wide cracks and settling

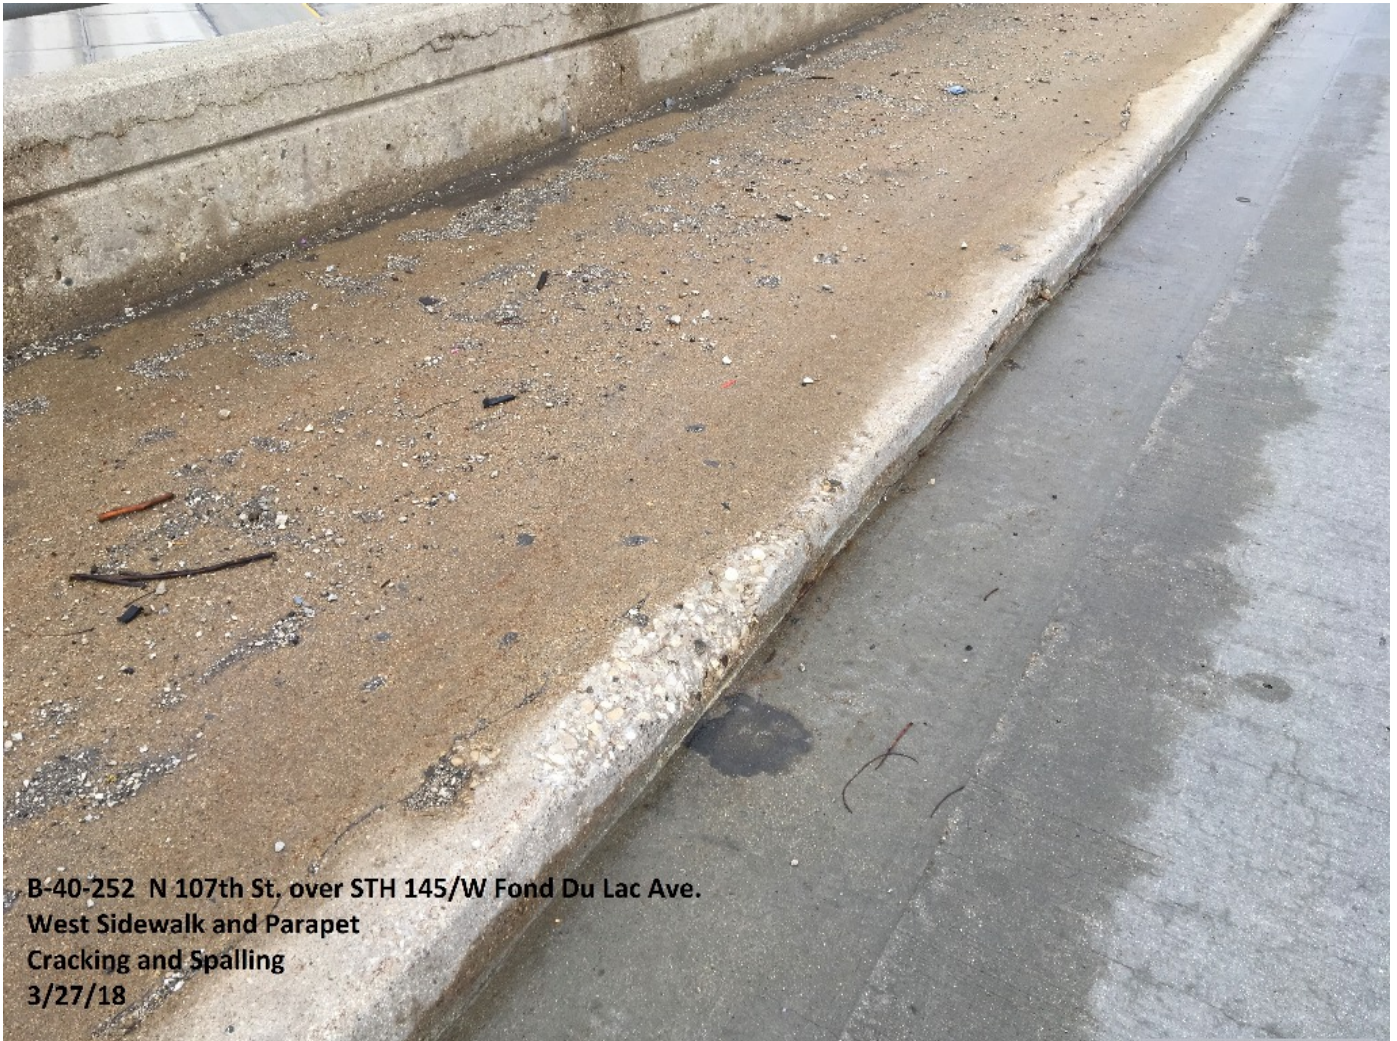
West Sidewalk - spalling along top inside

B-40-252 N 107th St, over STH 145/W Fond Du Lac Ave.  
West Sidewalk and Parapet  
Cracking and Spalling  
3/27/18

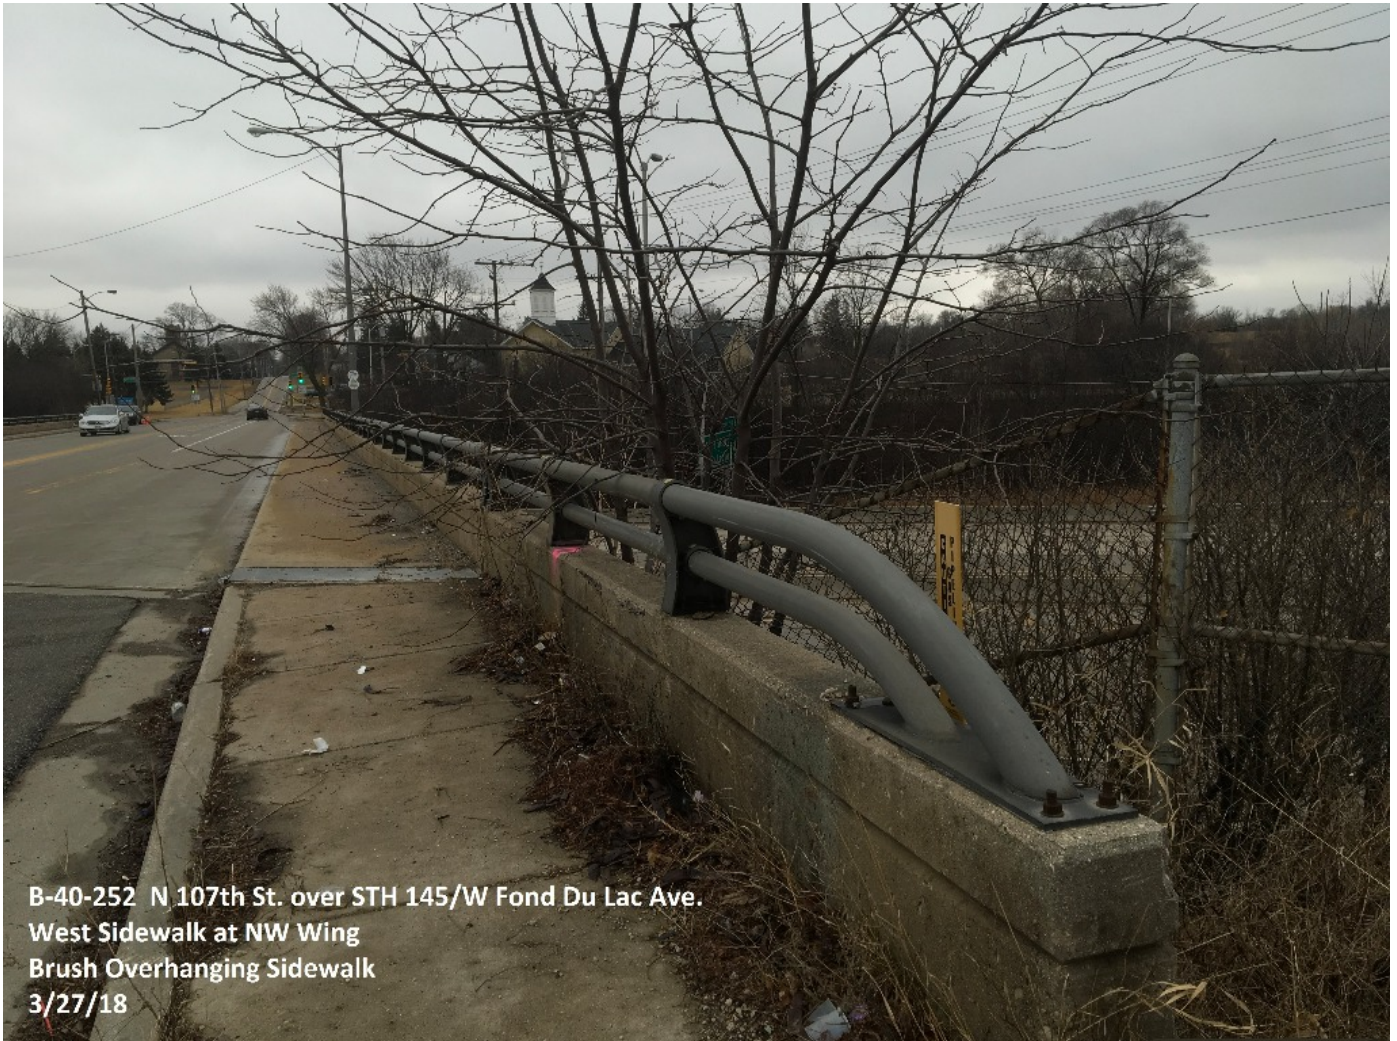
Northwest Wing - tree overhanging sidewalk

B-40-252 N 107th St. over STH 145/W Fond Du Lac Ave.  
West Sidewalk at NW Wing  
Brush Overhanging Sidewalk  
3/27/18

Cut brush on slopes at corners of bridge and tree overhanging sidewalk at NW Wing				
<b>IMP-Structure Replacement</b>	MEDIUM	Brooks, Julie (2017)	IDENTIFIED	04/20/18
2025 Recommended due to condition of deck, girders, possible tipping of abutments, broken bolts on hold-down bearings

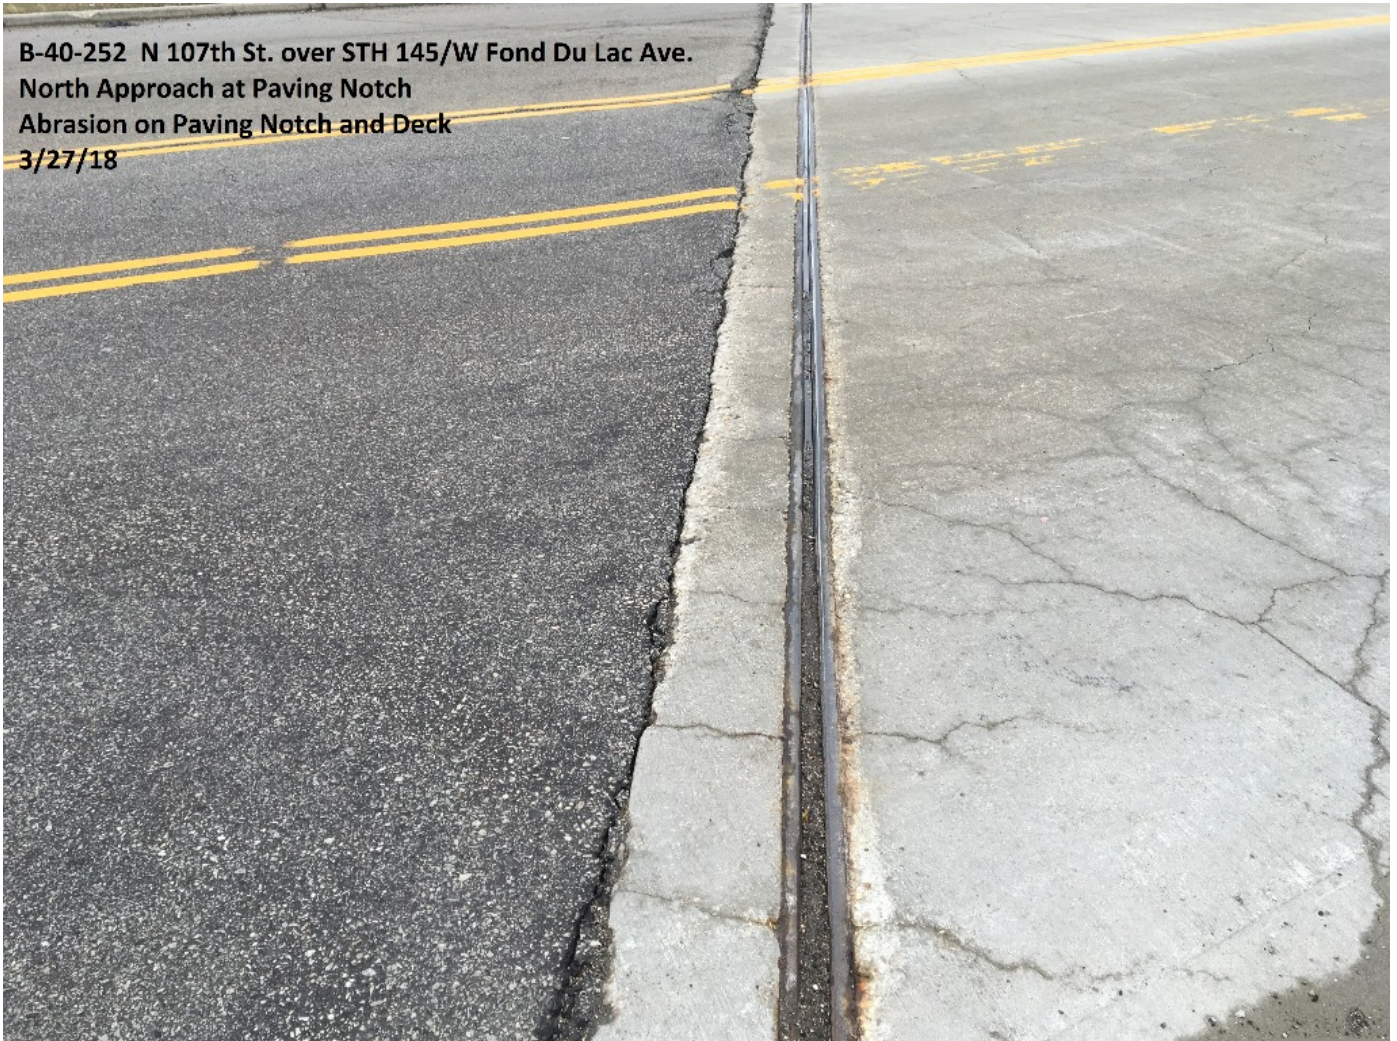
North Expansion Joint Looking East - Abrasion on deck and paving block

B-40-252 N 107th St. over STH 145/W Fond Du Lac Ave.  
North Approach at Paving Notch  
Abrasion on Paving Notch and Deck  
3/27/18

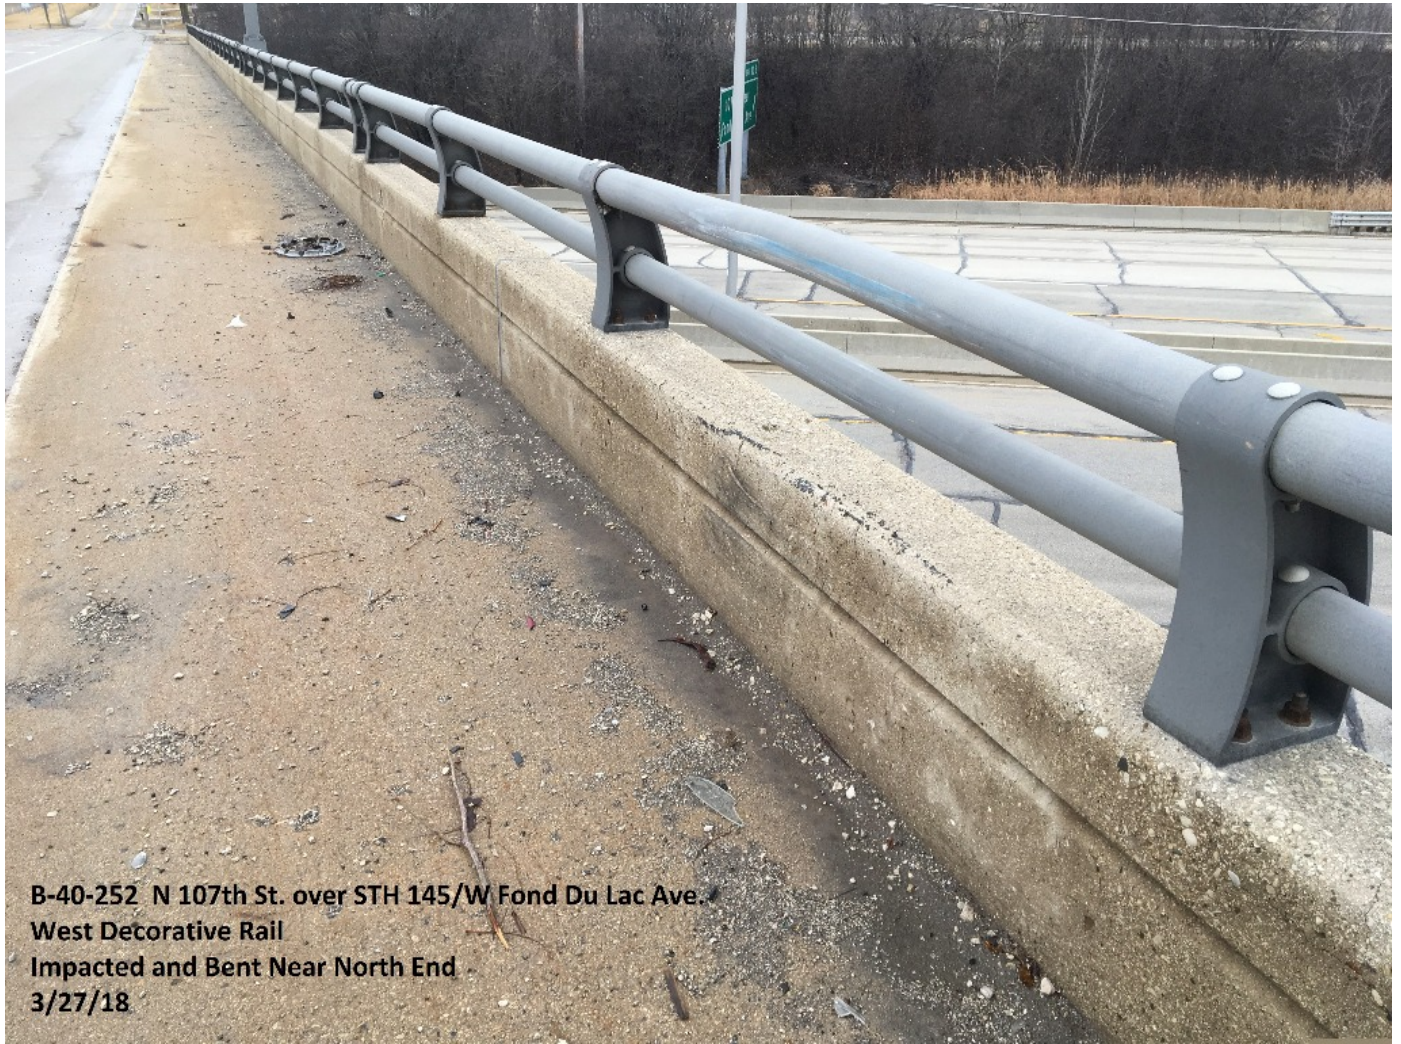
X	9335		<b>Decorative Rail</b>	EA	2	0	2	0	0
			E Rail: 1 Bolt missing, <b>Lt-moderate</b> rust @ anchor, impact scrapes W Rail: Minor impact damage with scrapes and one bent bottom rail over SB rdway at south end of rail, <b>bent top rail over NB lanes, missing set bolt at N end</b>						
X	9336		<b>Luminaire Bases</b>	EA	2	1	0	1	0
			<b>Spall with exposed rebar</b> under luminaire base <b>on west rail</b>

West tubular rail - bent outward

**B-40-252 N 107th St. over STH 145/W Fond Du Lac Ave.  
West Decorative Rail  
Impacted and Bent Near North End  
3/27/18**

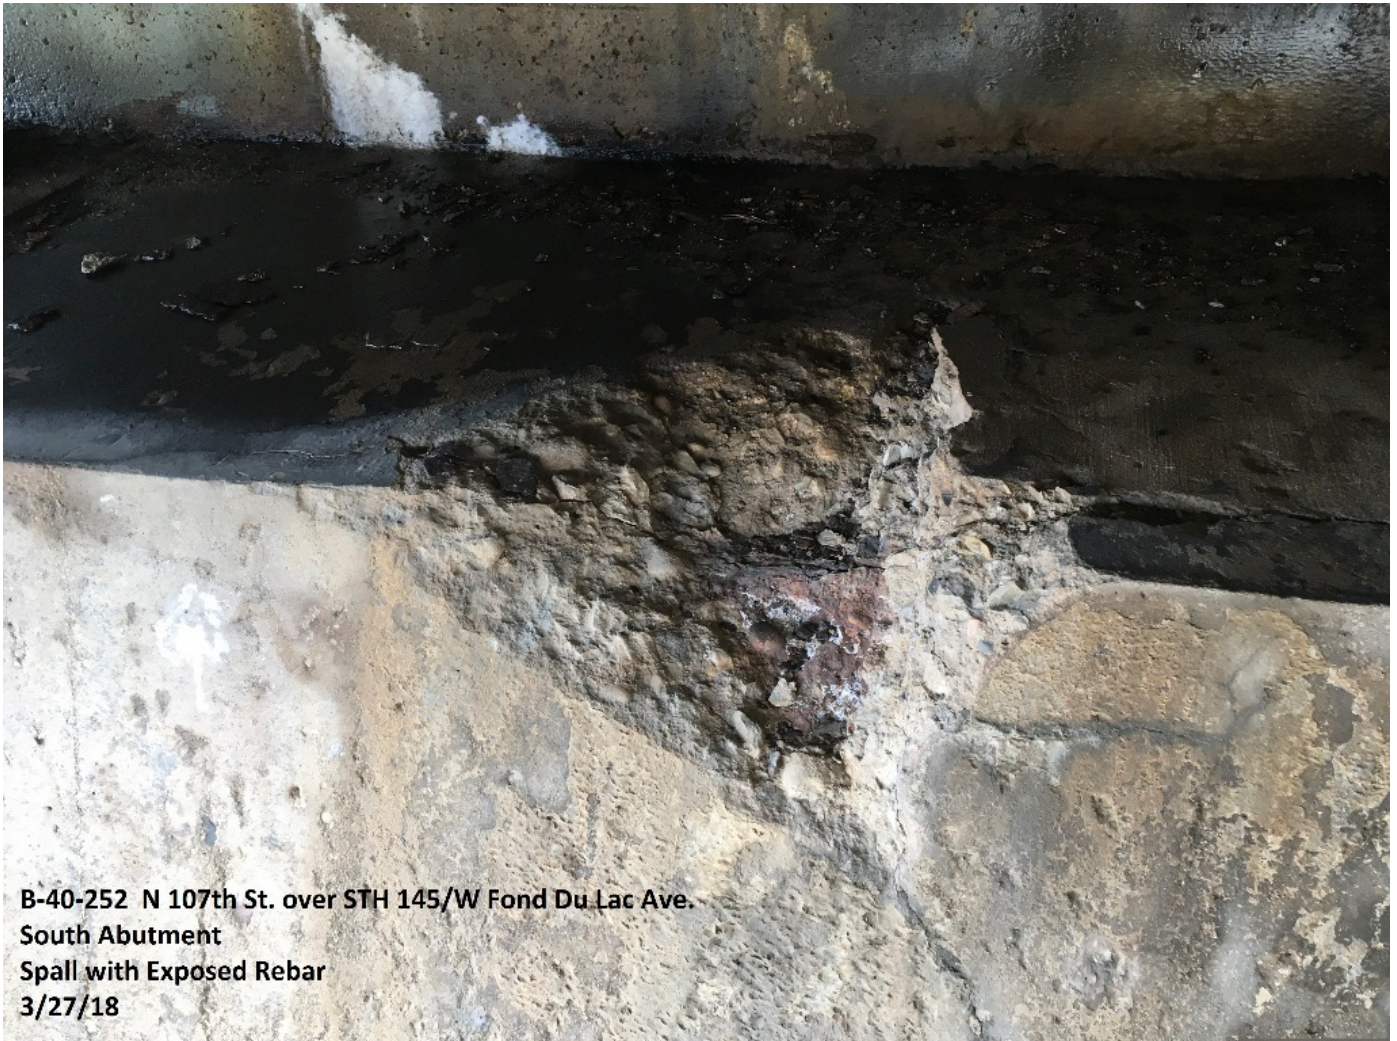
South Abutment - Spall with exposed rebar at beam seat

B-40-252 N 107th St. over STH 145/W Fond Du Lac Ave.  
South Abutment  
Spall with Exposed Rebar  
3/27/18

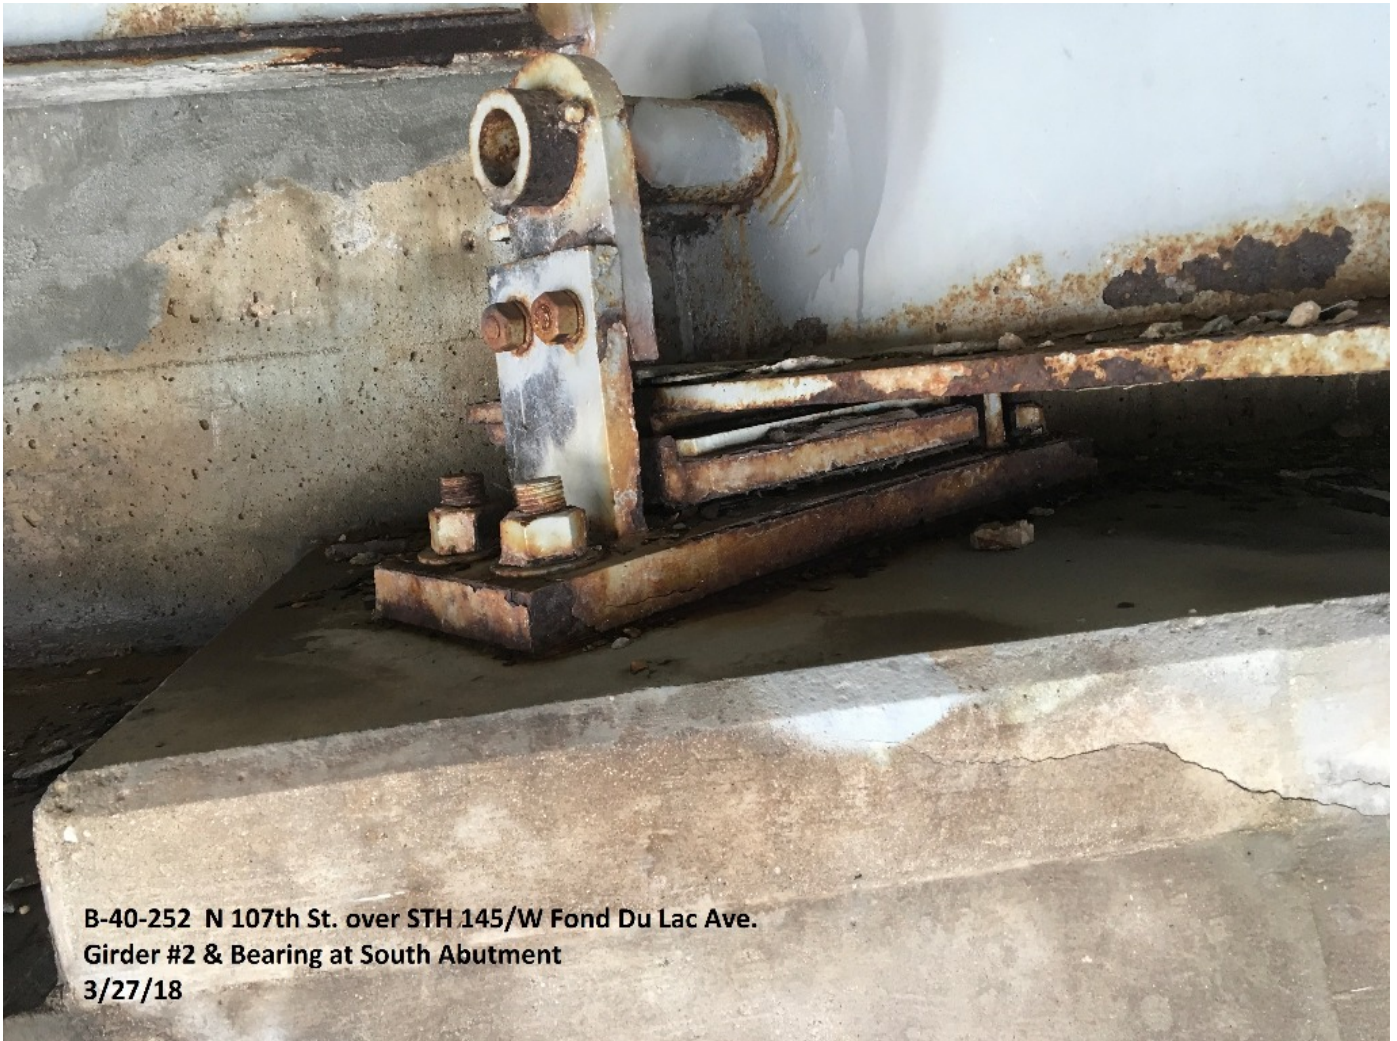
1020		Connection	EA		0	0	7	0
	2220		N Abut: <b>Connection</b> bolts sheared off at hold downs at 6 of 7 bearings; <b>S Abut: Bronze plate sliding out at G7</b>						
			Alignment	EA		0	0	7	0
			All girders over <b>P3</b> appear shifted slightly over bearing seats; <b>S Abut: All girders are at limit of expansion of bearings at 43 degrees, N Abut: 5 of 7 are at limits of expansion (some defects accounted for under</b>

Girder/Bearing #2 at South Abutment - at limit of expansion at 43 degrees

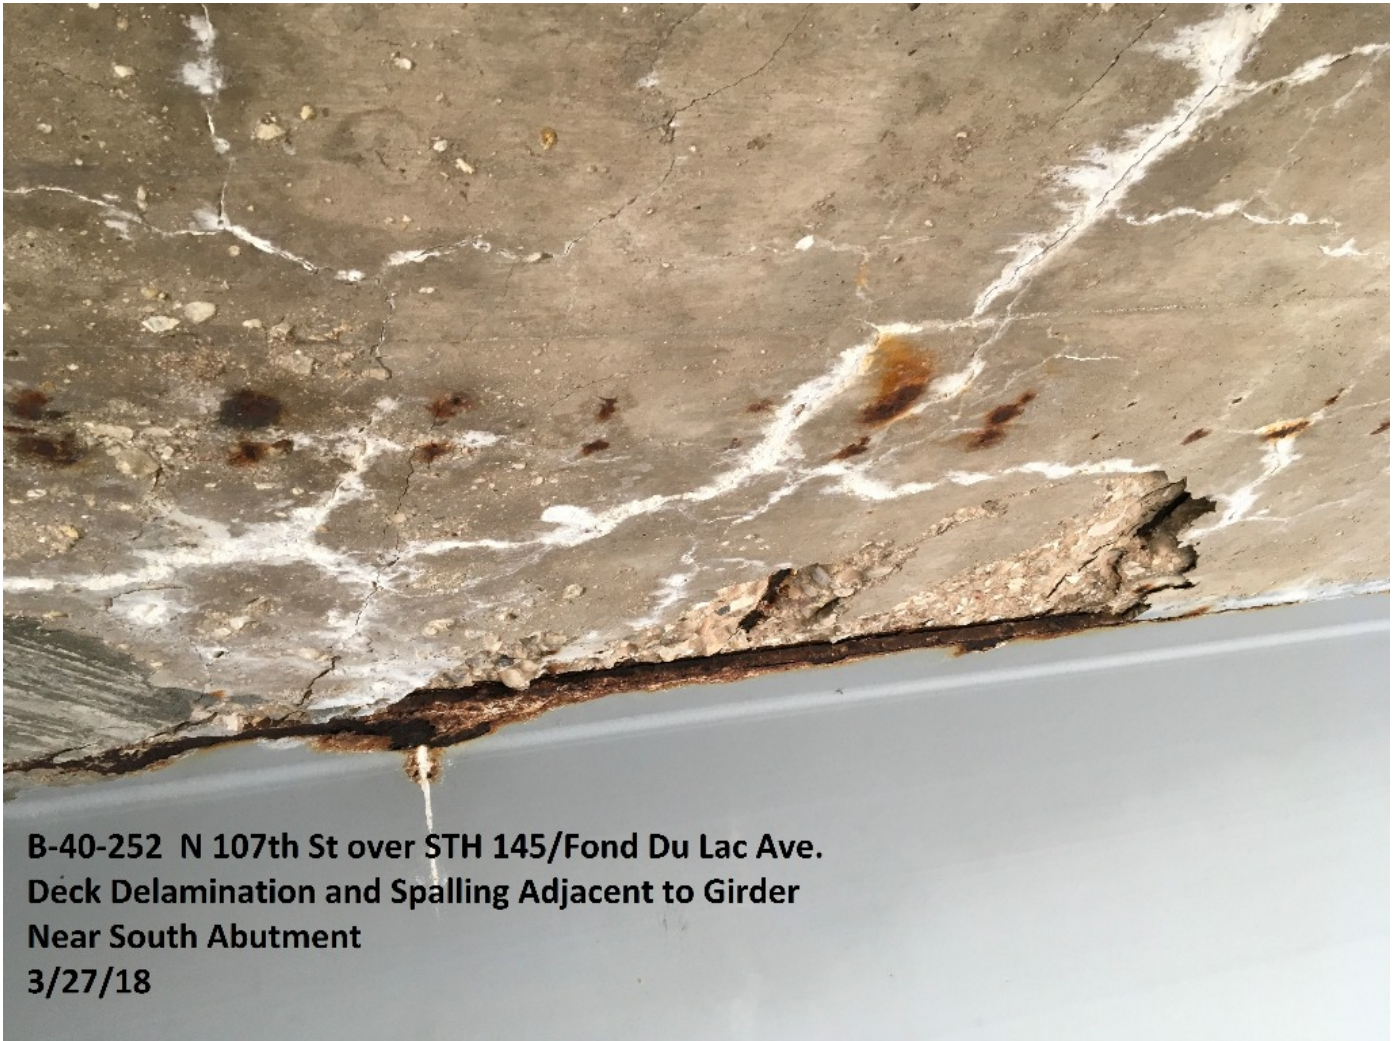
Deck delamination and spalling adjacent to girder near South abutment

**B-40-252 N 107th St over STH 145/Fond Du Lac Ave.  
Deck Delamination and Spalling Adjacent to Girder  
Near South Abutment  
3/27/18**

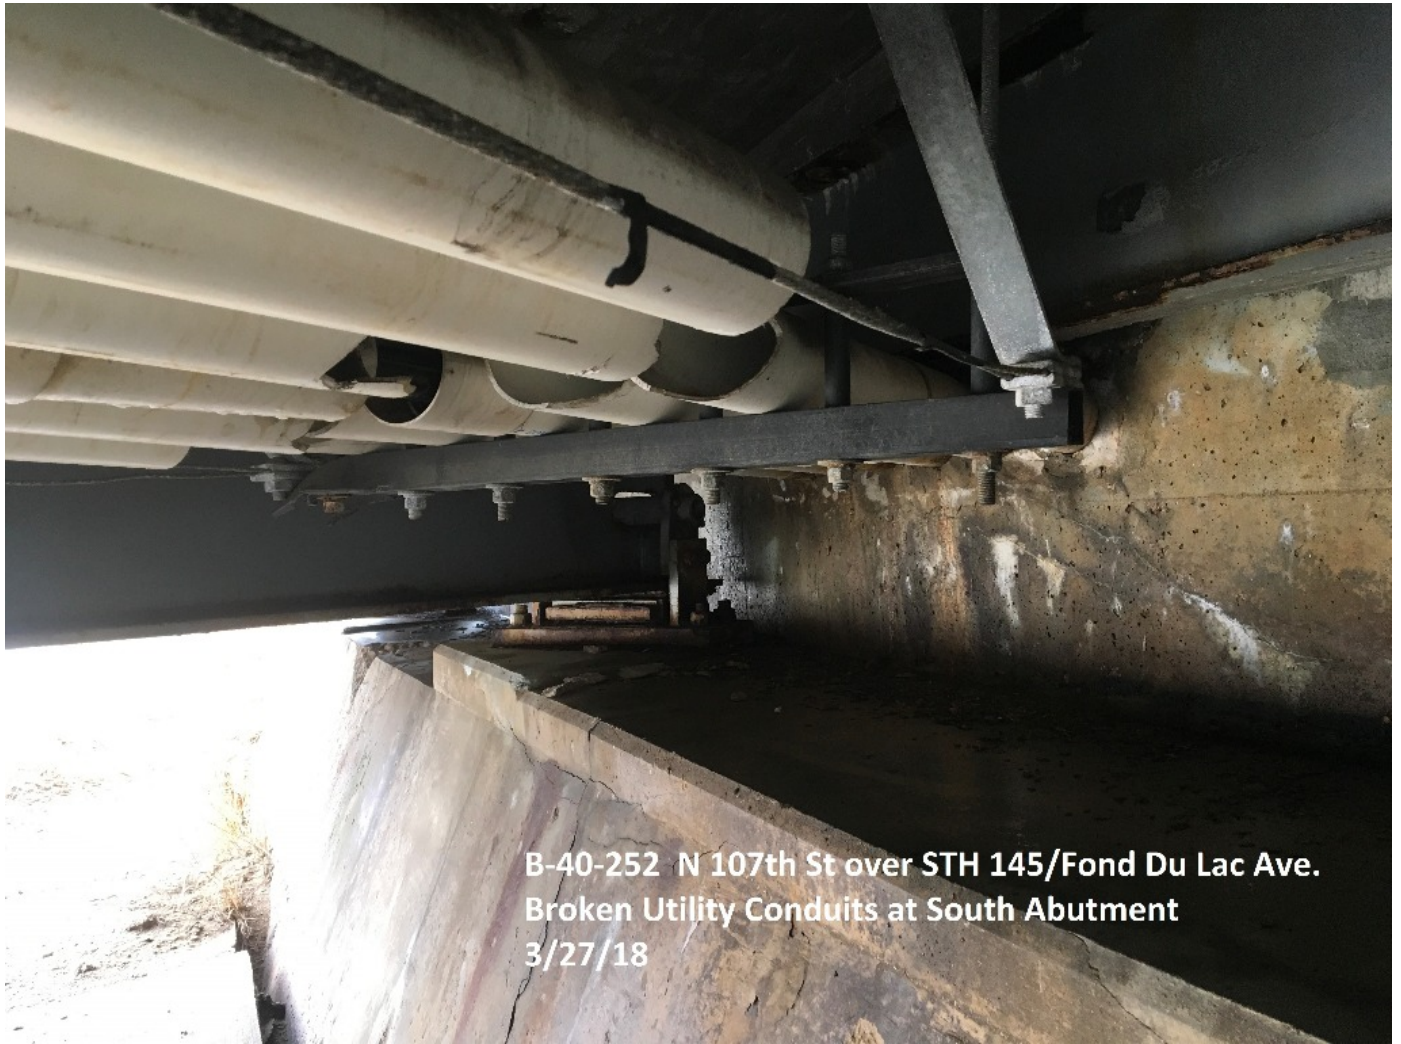
Broken utility conduit at South abutment

Item	Priority	Recommended by	Status	Status change
<b>Misc - Other Work</b>	HIGH	Sadowski, Jason (9593)	IDENTIFIED	05/14/14
Repair broken conduit hangers for 4 - duct package over WB shoulder. Consider replacement of corroded hangers. Or remove duct package altogether if no longer in use.				
<b>Misc - Remove/Monitor Loose Concrete</b>	HIGH	Buckett, Chris (9500)	IDENTIFIED	11/14/16
Possible loose delams over SB lanes 2 & 3 and Right Shoulder, over NB lane 3				
<b>Bearings - Repair / Replace</b>	MEDIUM	Sadowski, Jason (9593)	IDENTIFIED	05/14/14
Extend slots for hold down devices, and replace sheared bolts. Clean and paint corroded bearings at S. abutment. Replace keeper bars as needed. If bridge is scheduled for replacement, then no need for bearing work				
<b>Substructure - Other Work</b>	MEDIUM	Sadowski, Jason (9593)	IDENTIFIED	05/14/14
Concrete surface repair at Center pier				
<b>Misc - Cut Brush</b>	MEDIUM	Buckett, Chris (9500)	IDENTIFIED	11/14/16

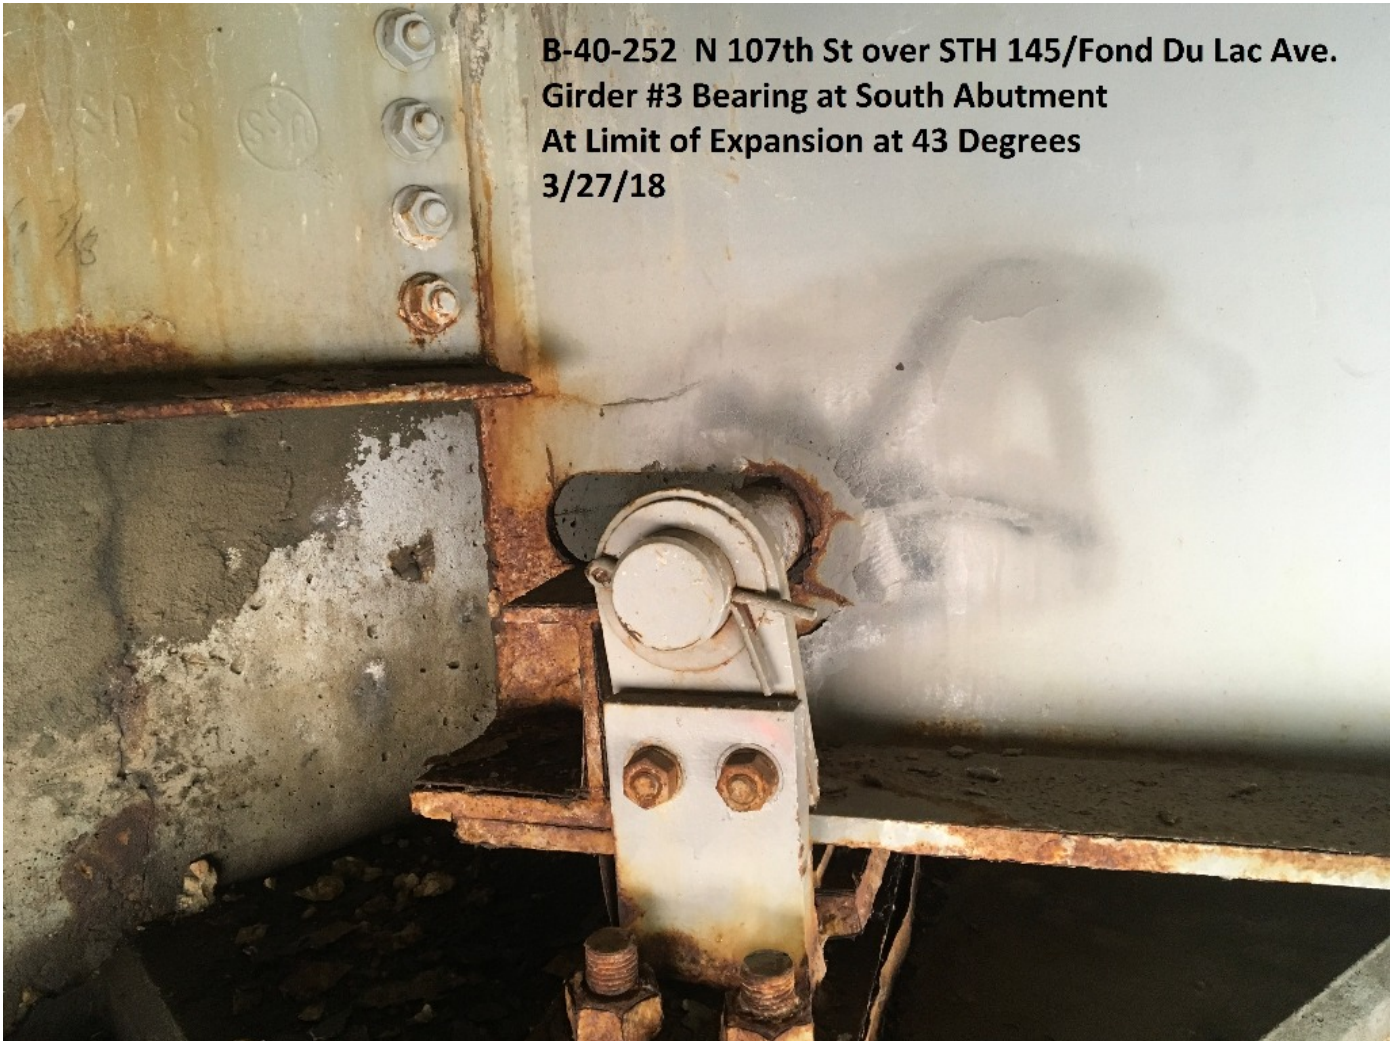
Girder/Bearing #3 at South Abutment at limit of expansion

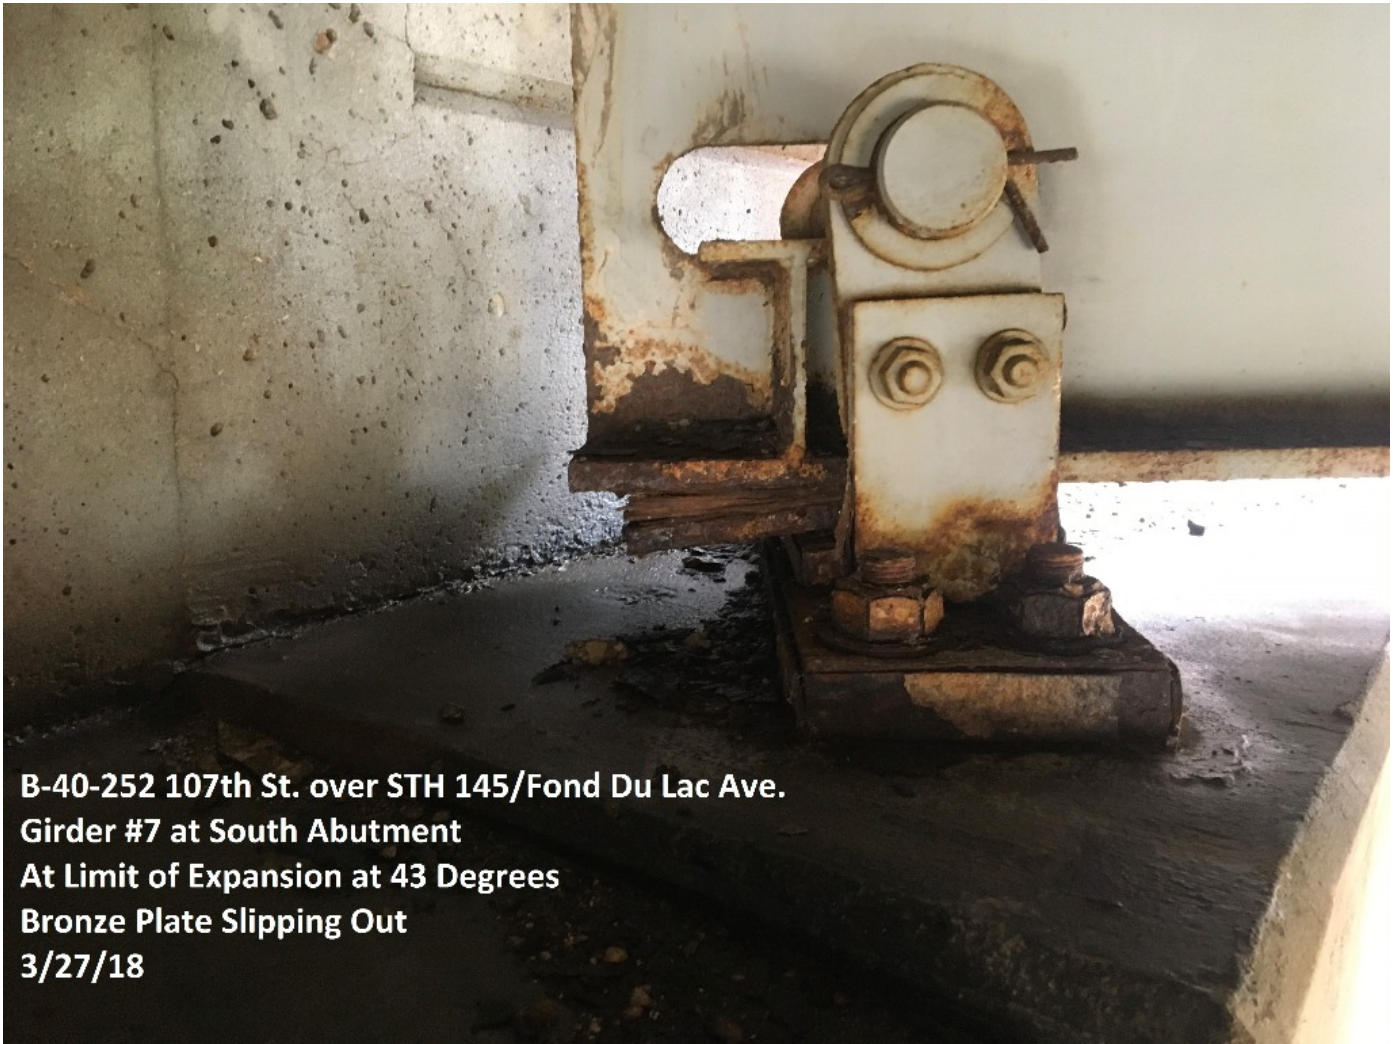
Girder/Bearing #7 at South Abutment - Corrosion, at limit of expansion, bronze plate slipping out

**B-40-252 107th St. over STH 145/Fond Du Lac Ave.  
Girder #7 at South Abutment  
At Limit of Expansion at 43 Degrees  
Bronze Plate Slipping Out  
3/27/18**
