STATE OF WISCONSIN  
DEPARTMENT OF TRANSPORTATION

Inspection Report for  
B-40-252

N 107TH ST over STH 145-W FOND DU LAC AV  
Mar 27, 2018

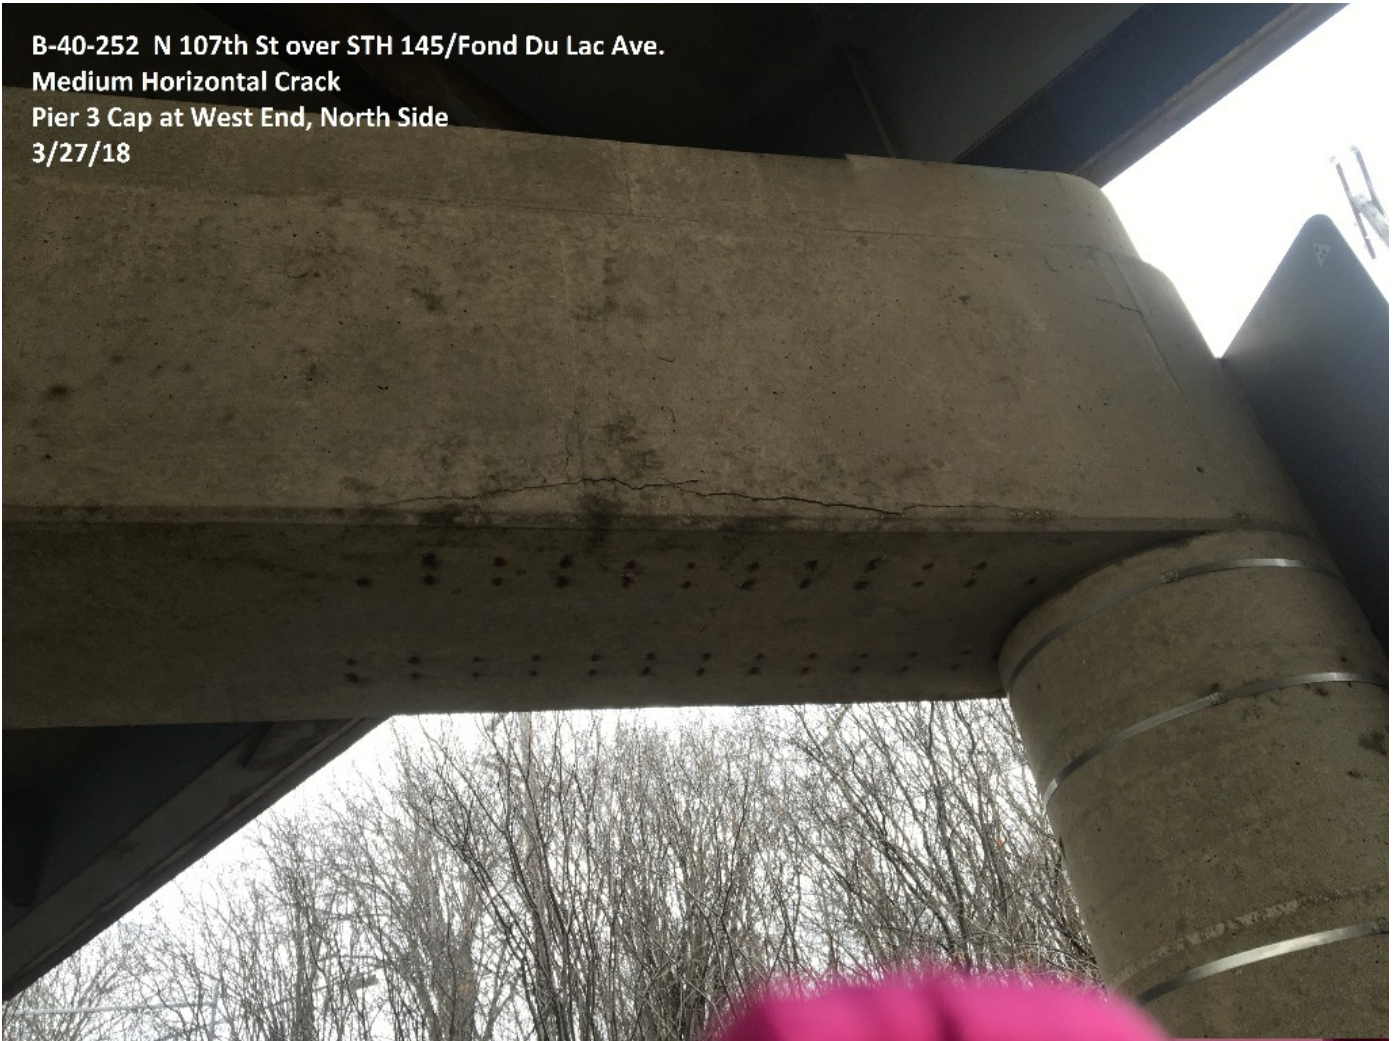
X	234		<b>Reinforced Concrete Cap</b>	LF	190	181	1	8	0
			<b>Piers are numbered N-S</b>						
	1080		Delamination - Spall - Patched Area	LF		0	1	3	0
			<b>P2: Large spall with exposed rebar at west end; P3: delam at W end</b>						
	1130		Cracking (RC)	LF		0	0	5	0
			<b>P3: Med</b> horiz. crk						
X	300		<b>Strip Seal Expansion Joint</b>	LF	144	0	144	0	0
			<b>Joints measured at East sidewalk at 43 degrees. S Joint: 5/8", N Joint: 5/8"</b>						
	2350		Debris Impaction	LF		0	144	0	0
			both joints filled with debris						
	2360		Adjacent Deck or Header Damage	LF		0	72	0	0
			N Abut: <b>Plow abrasion and</b> spalling <b>on deck</b> and <b>paving block in SB lanes, on paving block in NB lanes</b>						
X	311		<b>Moveable Bearing</b>	EA	28	0	14	14	0
			Located at N & S abuts, Piers 1 <b>&amp; 3; hold-down bearings at abutments</b>						
	1000		Corrosion	EA		0	14	0	0
			S Abut: Hvy rust, missing keeper bars; <b>P3: Moderate rust; P1: Med rust; N Abut: Med rust (some defects accounted for under connection and alignment)</b>

Pier 3 cap at West end - Medium horizontal crack

**Medium Horizontal Crack**

**Pier 3 Cap at West End, North Side**

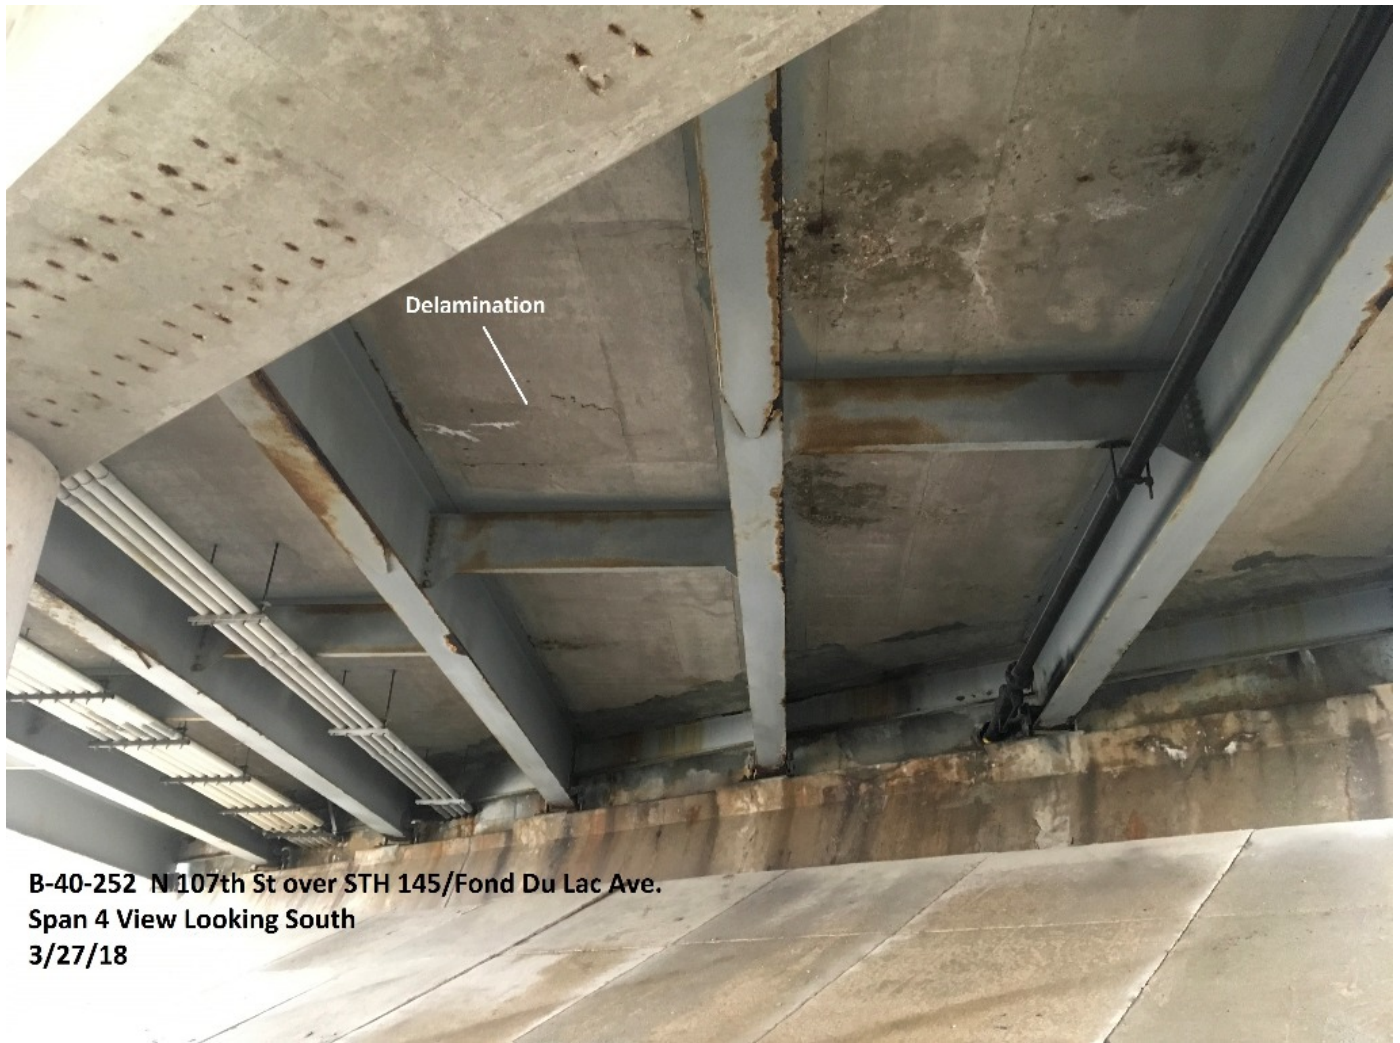
Routine  
Document Comment/Description  
Span 4 View Looking South

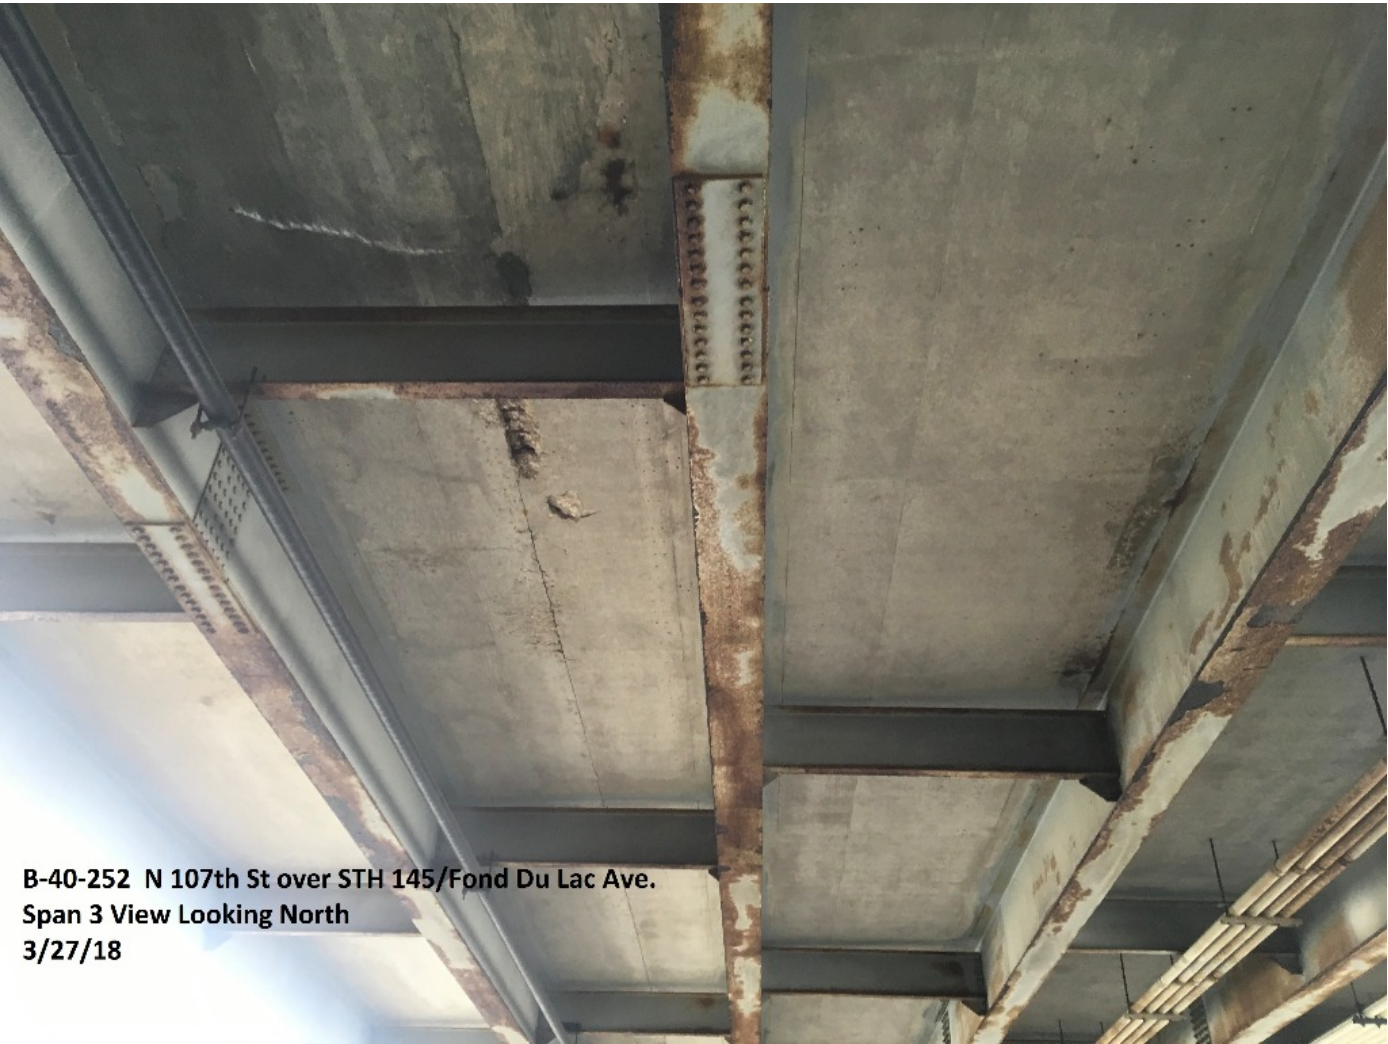
Span 3 Looking North, spalling with exposed rebar

B-40-252 N 107th St over STH 145/Fond Du Lac Ave.  
Span 3 View Looking North  
3/27/18

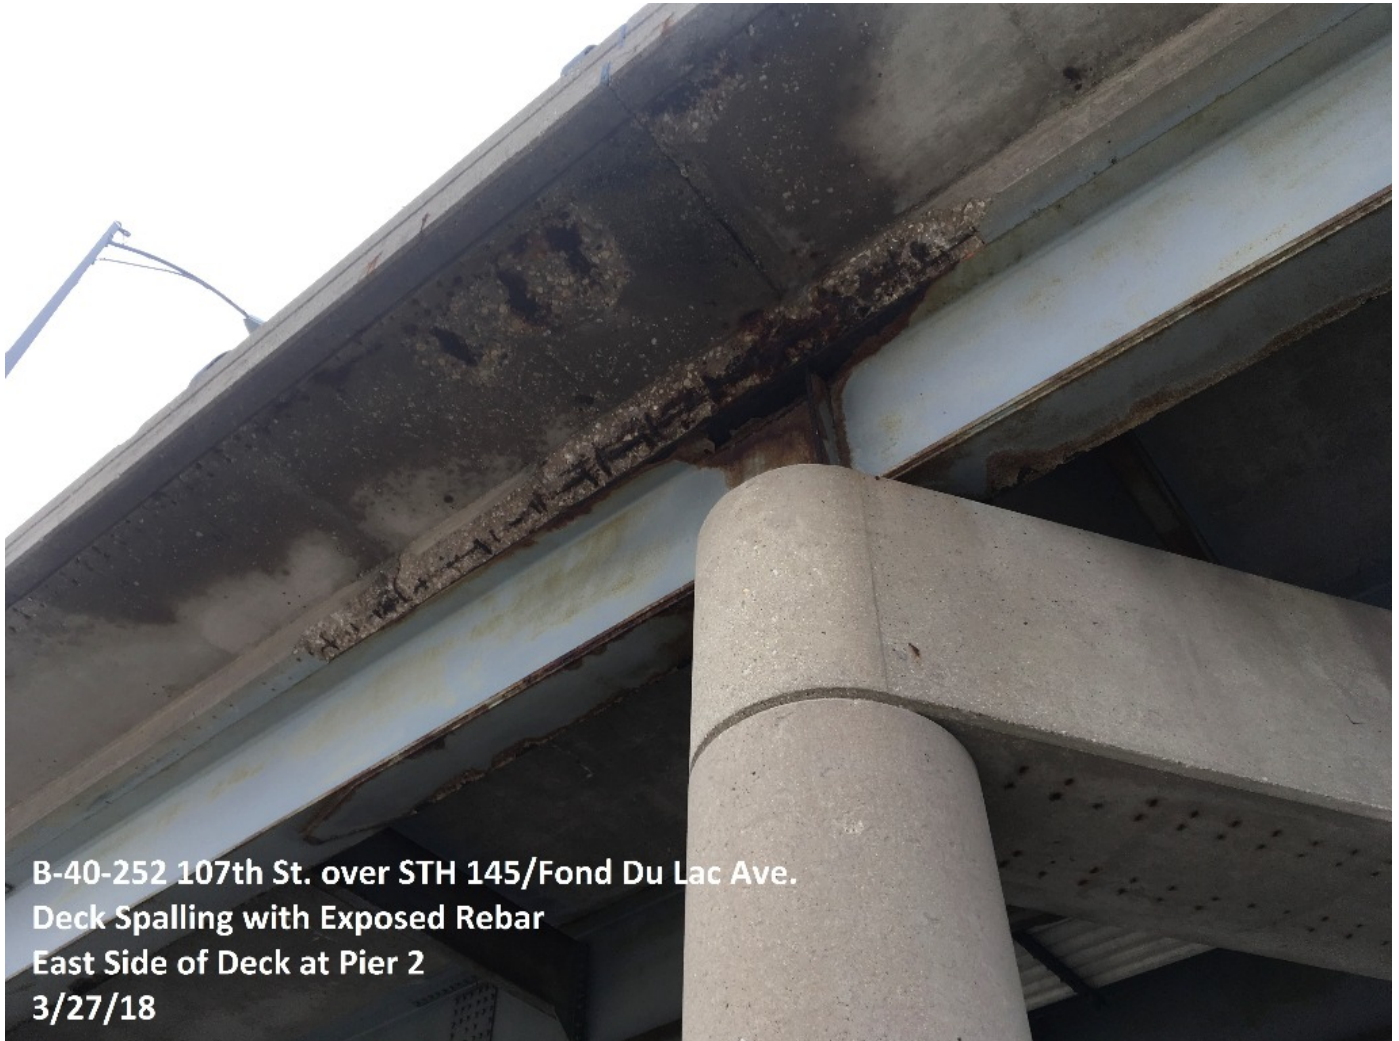
Deck spalling with exposed rebar in outer soffit and haunch above girder at pier 2

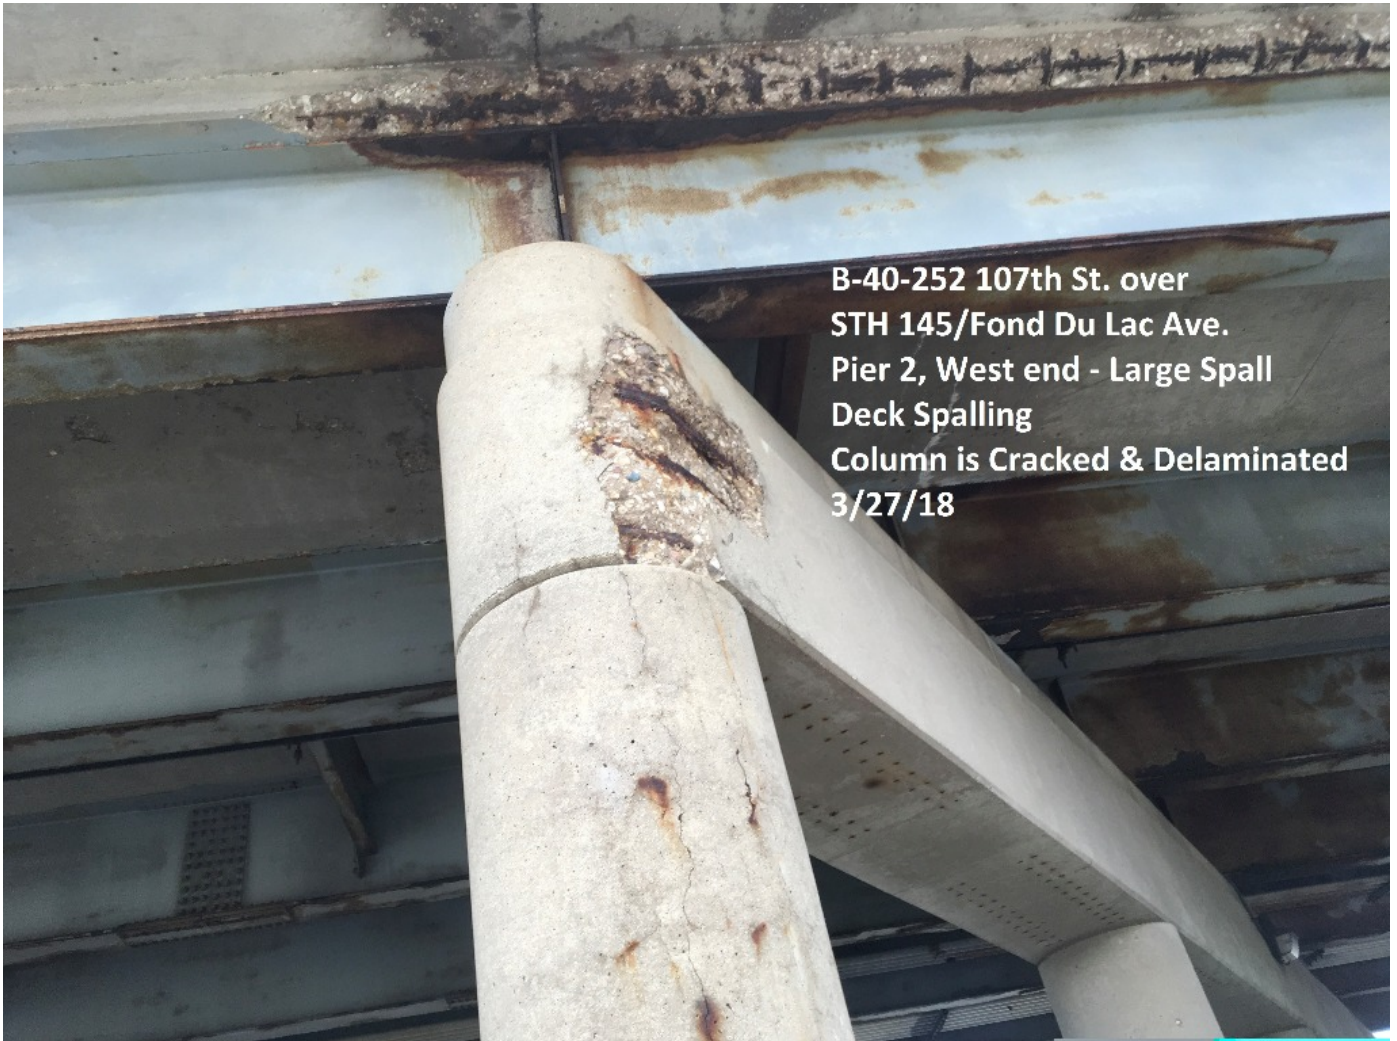
Pier 2 Cap at West end - Large spall with exposed rebar

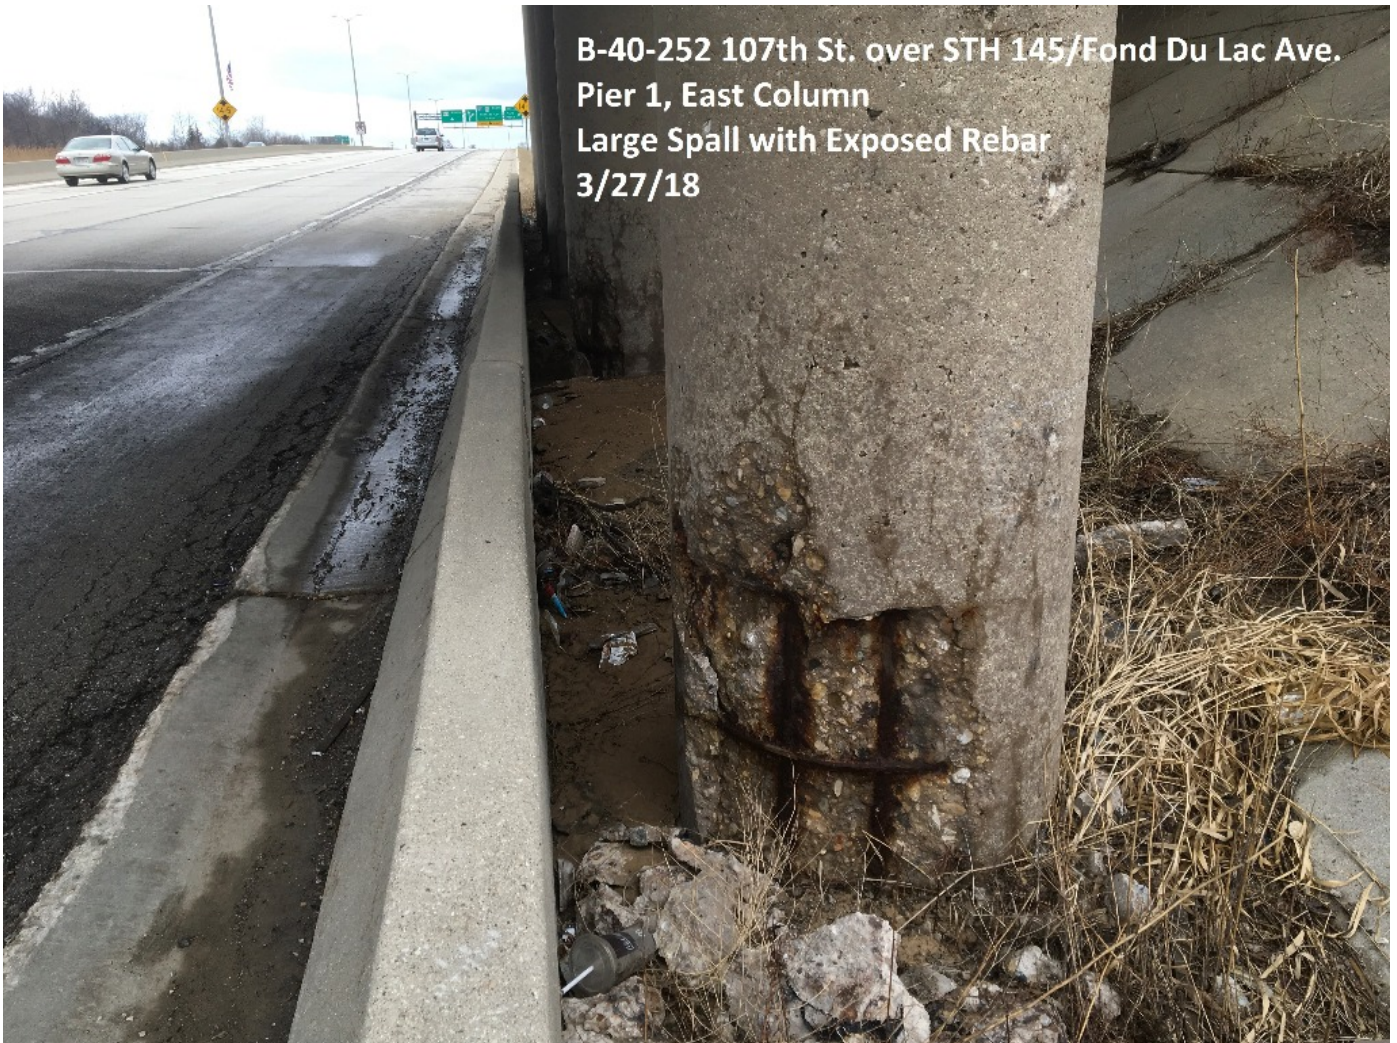
X	205		<b>Reinforced Concrete Column</b>	EA	15	1	0	14	0
			<b>Piers are numbered N-S, columns numbered W-E</b>						
	1080		Delamination - Spall - Patched Area	EA		0	0	14	0
			P1: <b>C1-3 delams at bottom and/or top, C4-5 spalls with exposed rebar</b> P2: <b>C1 spall with exposed rebar, C3 delam at bottom, C4 delam at bottom, C5 Cracked/delaminating patch</b> P3: <b>Failing patches on C2 &amp; 4, CS3 delams on C1,3,5</b>						
X	215		<b>Reinforced Concrete Abutment</b>	LF	137	22	82	33	0
			<b>Need to monitor abutments for possible tipping inward - bearings at limit of expansion</b>						
	1080		Delamination - Spall - Patched Area	LF		0	4	20	0
			S Abut: Lg <b>delams and spalls</b> on sill w/exp rebar - 20' CS3, <b>patch and small spall at east end backwall, delam in body at G6</b> N Abut: <b>delams at G5, small spall at CL Joint, spall at G4</b>						
	1130		Cracking (RC)	LF		0	78	13	0
			S Abut: Med crks on sill - <b>13' CS3, diagonal crack with efflorescence at west end, vertical cracks</b> N Abut: Nar crks that extend into bkwl -10' CS2, <b>Diagonal crack at NE and at G5,6</b> N. bkwl: <b>Nar/medium crack at base</b> for <b>most of</b> length at beam seat

Pier 1, East Column - Large Spall with exposed rebar

B-40-252 107th St. over STH 145/Fond Du Lac Ave.  
Pier 1, East Column  
Large Spall with Exposed Rebar  
3/27/18

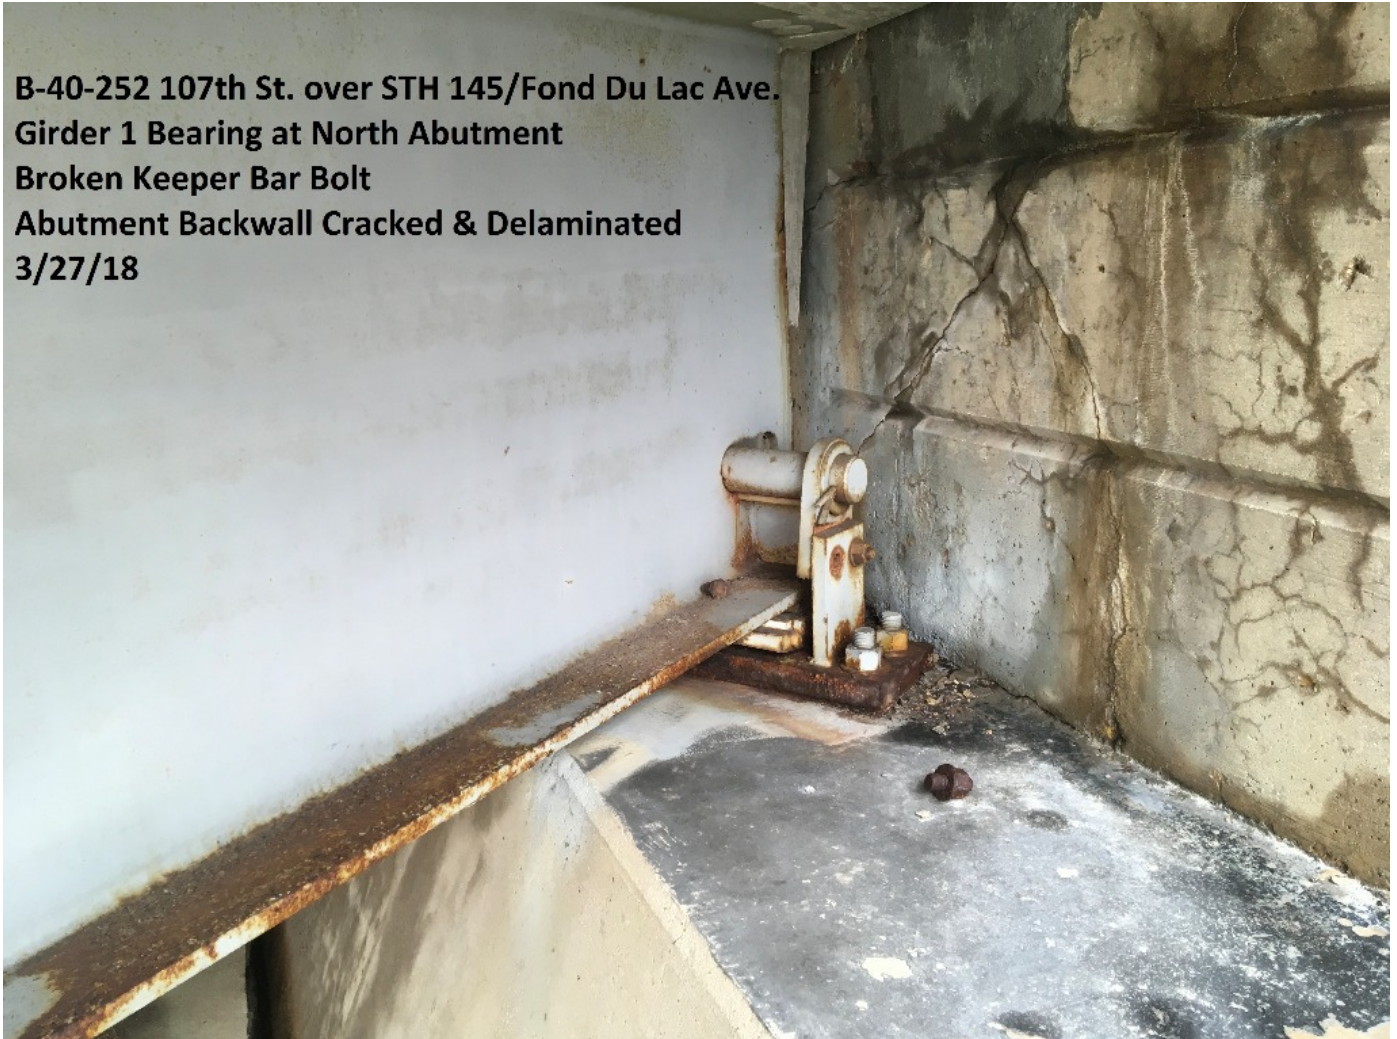
1020		Connection	EA		0	0	7	0
	2220		N Abut: <b>Connection</b> bolts sheared off at hold downs at 6 of 7 bearings; <b>S Abut: Bronze plate sliding out at G7</b>						
			Alignment	EA		0	0	7	0
			All girders over <b>P3</b> appear shifted slightly over bearing seats; <b>S Abut: All girders are at limit of expansion of bearings at 43 degrees, N Abut: 5 of 7 are at limits of expansion (some defects accounted for under</b>

N. bkwf sheared for nearly entire length at beam seat, both abuts may be rotating inward - Monitor
Bridge painted in 1988.

Girder/Bearing #1 at North Abutment - Broken keeper bar bolt, abument backwall is delaminated and cracked

**B-40-252 107th St. over STH 145/Fond Du Lac Ave.  
Girder 1 Bearing at North Abutment  
Broken Keeper Bar Bolt  
Abutment Backwall Cracked & Delaminated  
3/27/18**

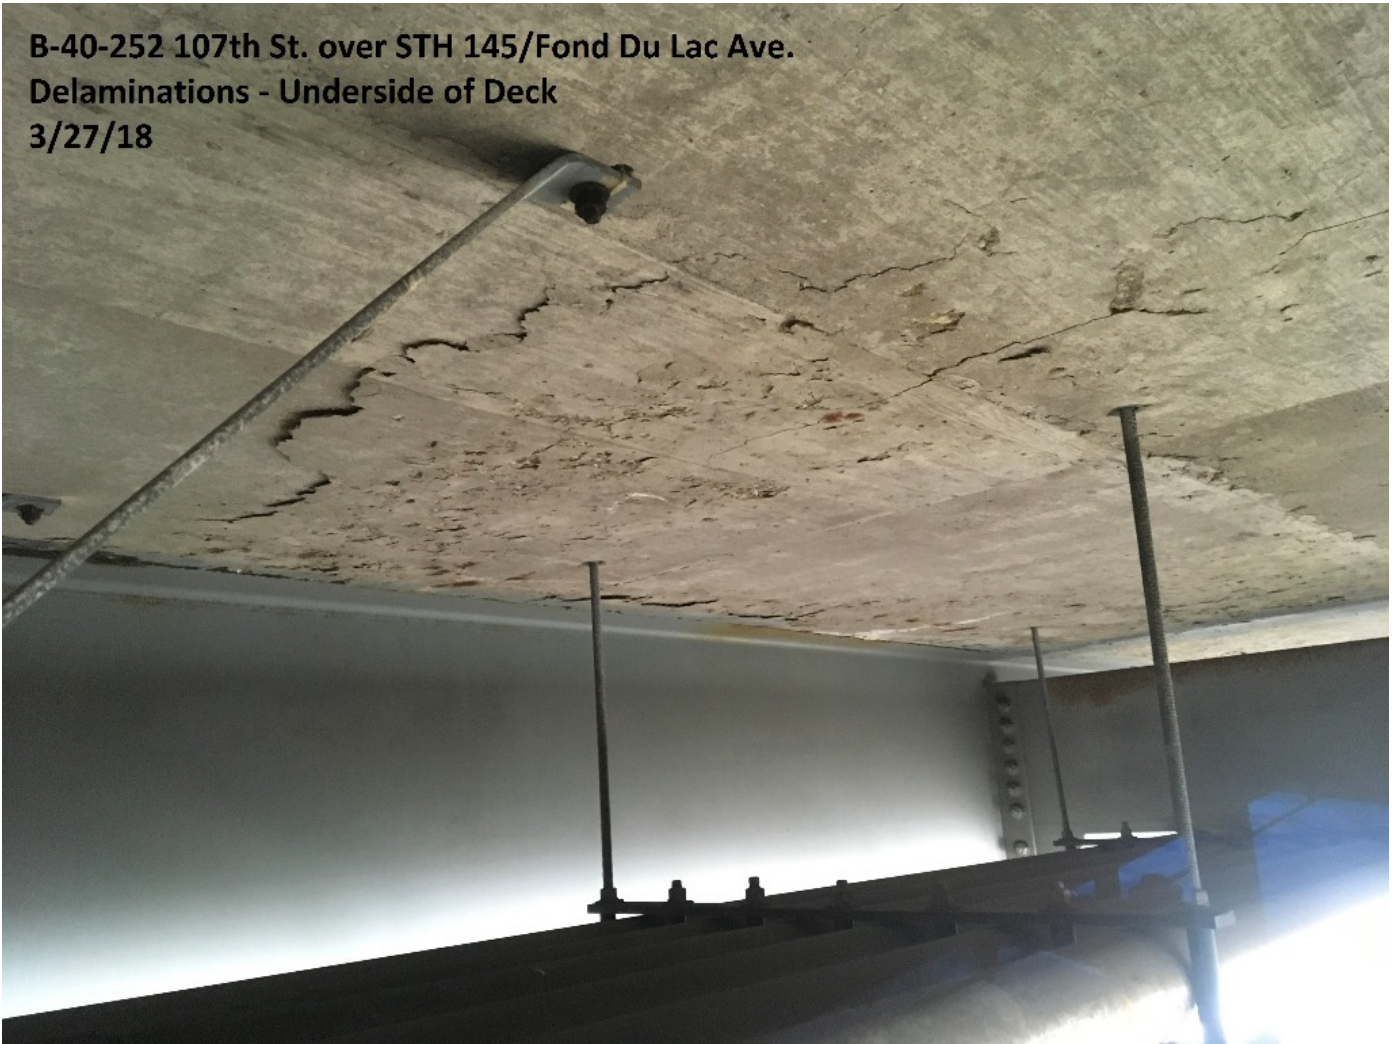
Deck Delaminations near North Abutment

**B-40-252 107th St. over STH 145/Fond Du Lac Ave.  
Delaminations - Underside of Deck  
3/27/18**
