# REHABILITATION STRUCTURE SURVEY REPORT

| Design Project ID<br>2040-20-00 | | Construction Project ID<br>2040-20-70 | | Highway (Project Name)<br>STH 100 EB BRIDGE OVER CNW RR | |
| Structure Number<br>B-40-0530 | | Section<br>27 | Town<br>5N | Range<br>22E | |

**B-40-0530 Deficiency Photographs**

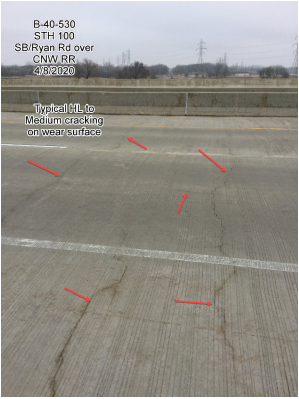
**Routine Item 8**

| Chk | Element | Defect | Description | UOM | Total | Quantity in Condition State | | | |
|---|---|---|---|---|---|---|---|---|---|
| | | | Few small spalls @ W. Header, Rt Shoulder. 2005 IR <0.1% Delam. 2009, 2013 IR 0.0% Delam. <b>2018 IR &lt;2% Delam, 0% Debonding.</b> | | | | | | |

Wear Surface

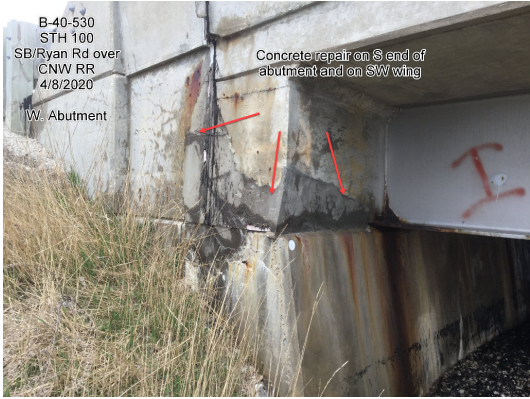
**Routine Item 15**

| W Abutment | <div><div><div>B-40-530<br/>STH 100<br/>SB/Ryan Rd over<br/>CNW RR<br/>4/8/2020<br/>W. Abutment</div><div>Concrete repair on S end of<br/>abutment and on SW wing</div></div></div> <div>b40-530_20_Rd15.jpg</div> |

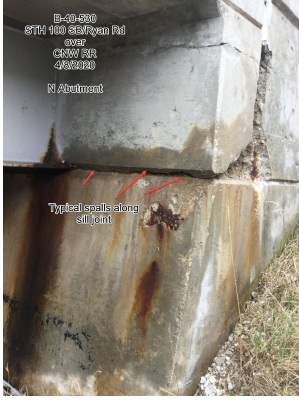
**Routine Item 16**

| W Abutment | <div><div><div>B-40-530<br/>STH 100 SB/Ryan Rd<br/>over<br/>CNW RR<br/>4/8/2020<br/>W Abutment</div><div>Typical spalls along<br/>all joint</div></div></div> <div>b40-530_20_Rd16.jpg</div> |

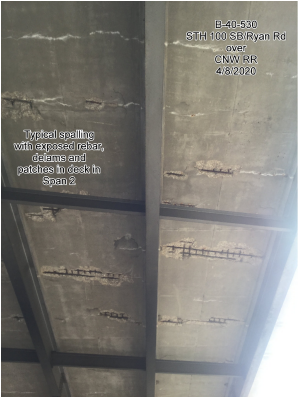
**Routine Item 18**

| Deck | <p>B-40-530<br/>STH 100 SB/Ryan Rd<br/>over<br/>CNW RR<br/>4/8/2020</p> <p>Typical spalling with exposed rebar, delamination and patches in Deck in Span 3</p> <p>b40-530_20_Rd18.jpg</p> |

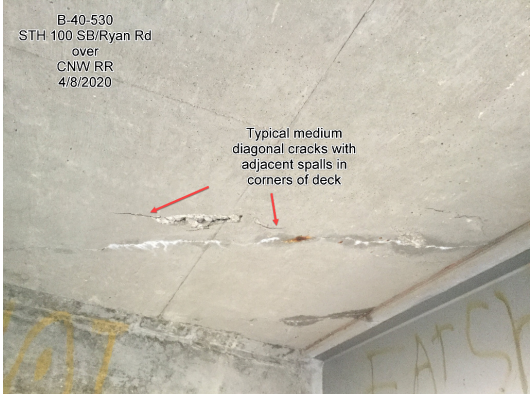
**Routine Item 19**

| Chk | Element | Defect | Description | UOM | Total | Quantity in Condition State | | | |
|---|---|---|---|---|---|---|---|---|---|
| | | | <b>Medium diagonal cracks in corners of deck with adjacent spalls/delams</b> | | | | | | |

| Deck | <p>B-40-530<br/>STH 100 SB/Ryan Rd<br/>over<br/>CNW RR<br/>4/8/2020</p> <p>Typical medium diagonal cracks with adjacent spalls in corners of deck</p> <p>b40-530_20_Rd19.jpg</p> |

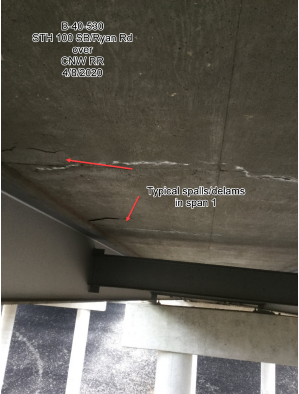
**Routine Item 20**

| Deck | <p>B-40-530<br/>STH 100 SB/Ryan Rd<br/>over<br/>CNW RR<br/>4/8/2020</p> <p>Typical spalls/delamination in span 1</p> <p>b40-530_20_Rd20.jpg</p> |

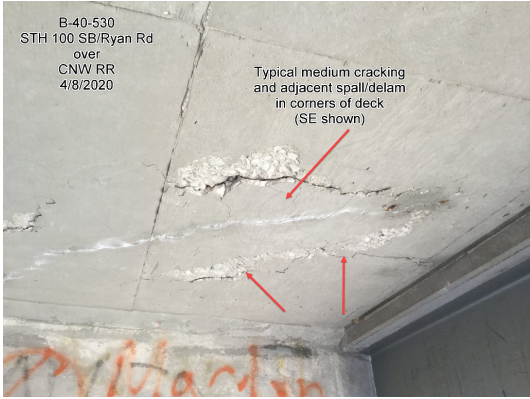
**Routine Item 21**

| Deck | <div><div><div>B-40-530<br/>STH 100 SB/Ryan Rd<br/>over<br/>CNW RR<br/>4/8/2020</div><div>Typical medium cracking<br/>and adjacent spall/delam<br/>in corners of deck<br/>(SE shown)</div></div><div>b40-530_20_Rd21.jpg</div></div> |

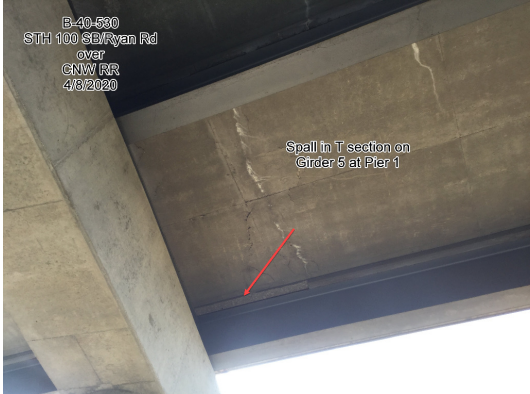
**Routine Item 22**

| Deck | <div><div><div>B-40-530<br/>STH 100 SB/Ryan Rd<br/>over<br/>CNW RR<br/>4/8/2020</div><div>Spall in T section on<br/>Girder 5 at Pier 1</div></div><div>b40-530_20_Rd22.jpg</div></div> |

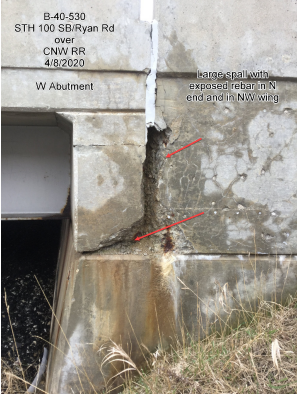
**Routine Item 23**

| | <div><div><div>B-40-530<br/>STH 100 SB/Ryan Rd<br/>over<br/>CNW RR<br/>4/8/2020</div><div>Large spall with<br/>exposed rebar in N<br/>end and in NW wing</div></div><div>W Abutment</div><div>b40-530_20_Rd24.jpg</div></div> |

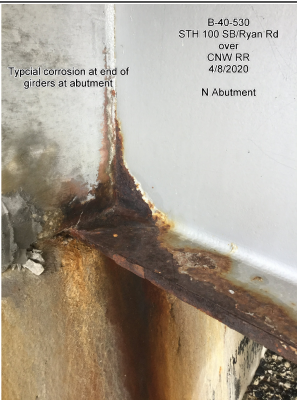
Routine Item 25

| Chk | Element | Defect | Description | UOM | Total | Quantity in Condition State | | | |
|---|---|---|---|---|---|---|---|---|---|
| | | | Heavy rust on bottom flange <b>and bottom of web</b> w/ minor section loss of encased girder ends <b>at abutments</b> , rust on edges of top & bottom flanges. Scat areas of spot and edge rust. | | | | | | |

Girder Corrosion

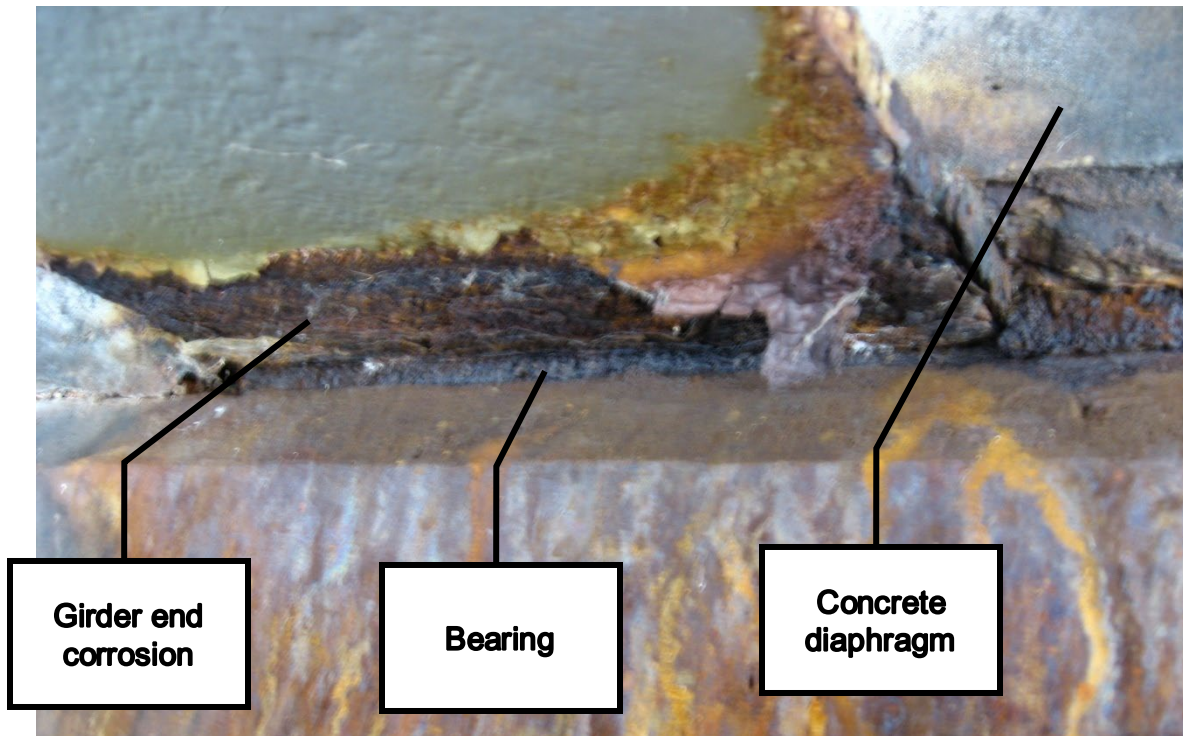
Corrosion on girder end (typical).

Also, the region maintenance staff recommend removing the concrete diaphragms around the girder ends to inspect for corrosion.

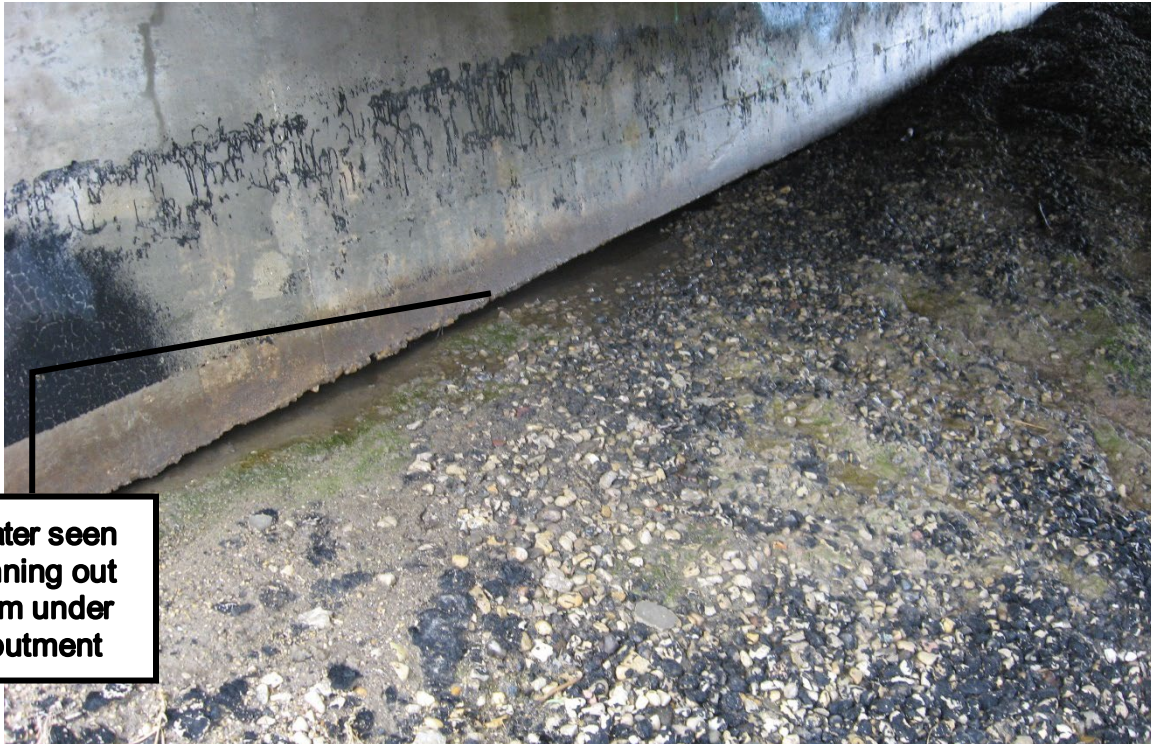
| Chk | Element | Defect | Description | UOM | Total | Quantity in Condition State | | | |
|---|---|---|---|---|---|---|---|---|---|
| | | | Resealed 2006; slopes have areas of loose aggregate. Undermined at N end of E abut. Both slopes settled. | | | | | | |

**Water seen  
running out  
from under  
abutment**

Settled slope paving at east abutment.

For the STH 100 EB bridge deck replacement (B-40-0530) project, there is a scope item we would like to bring your attention to. During a field review, we noticed water draining out from under the east abutment. There is a void under the abutment wall. We discussed this issue with our region maintenance staff and we believe the void may be caused from poor drantile operation behind the abutment wall. They recommend providing a detail for abutment drainage and filling the void with grout.

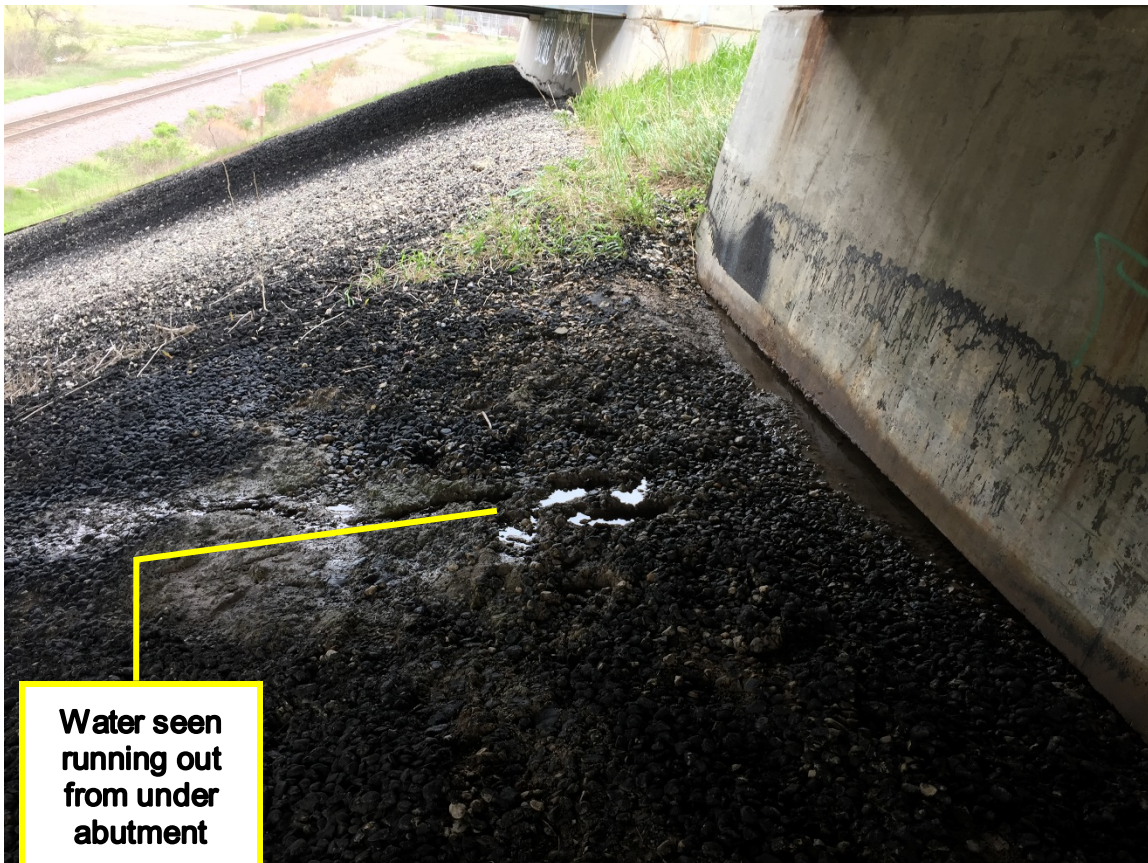
**Water seen  
running out  
from under  
abutment**

East abutment looking north.

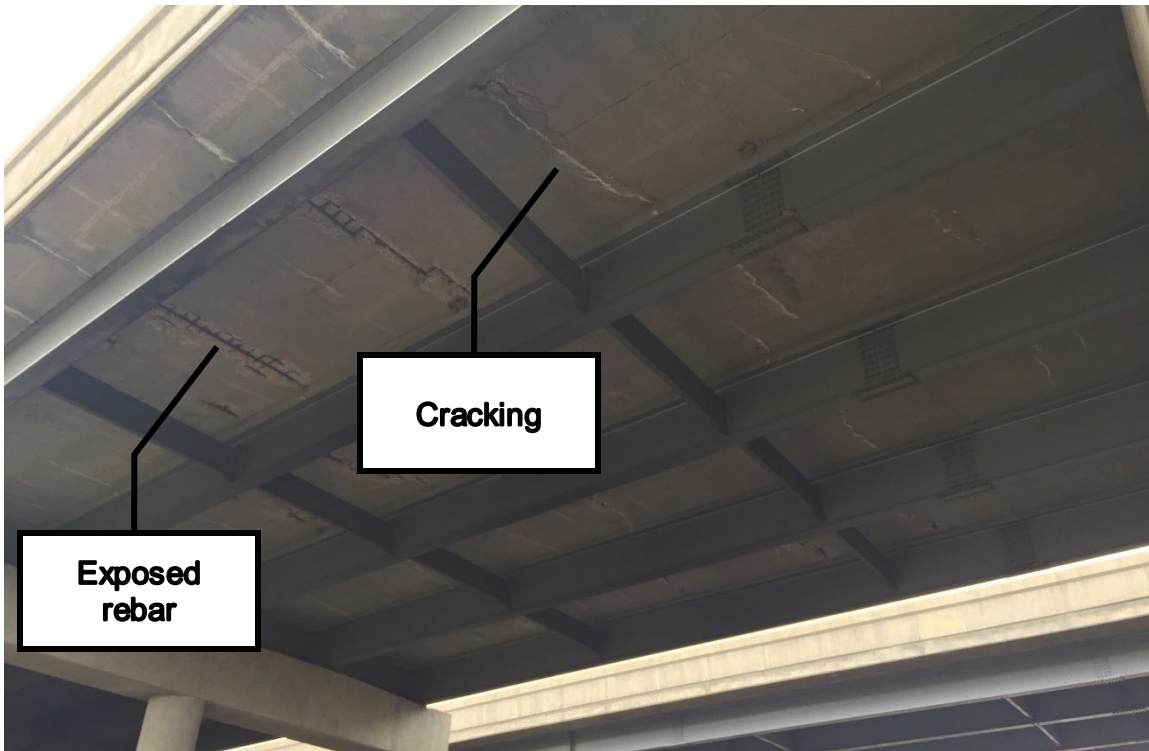
| Chk | Element | Defect | Description | UOM | Total | Quantity in Condition State | | | |
|---|---|---|---|---|---|---|---|---|---|
| | | | Spalls on underside of deck, some with exposed rebar and patches. Worst areas above RR tracks. <b>Spalls in T section over girder 5 at P1 Few spalls/delams in overhangs.</b> No loose concrete left all areas of concern have been removed | | | | | | |

Underside deck condition of span 2.

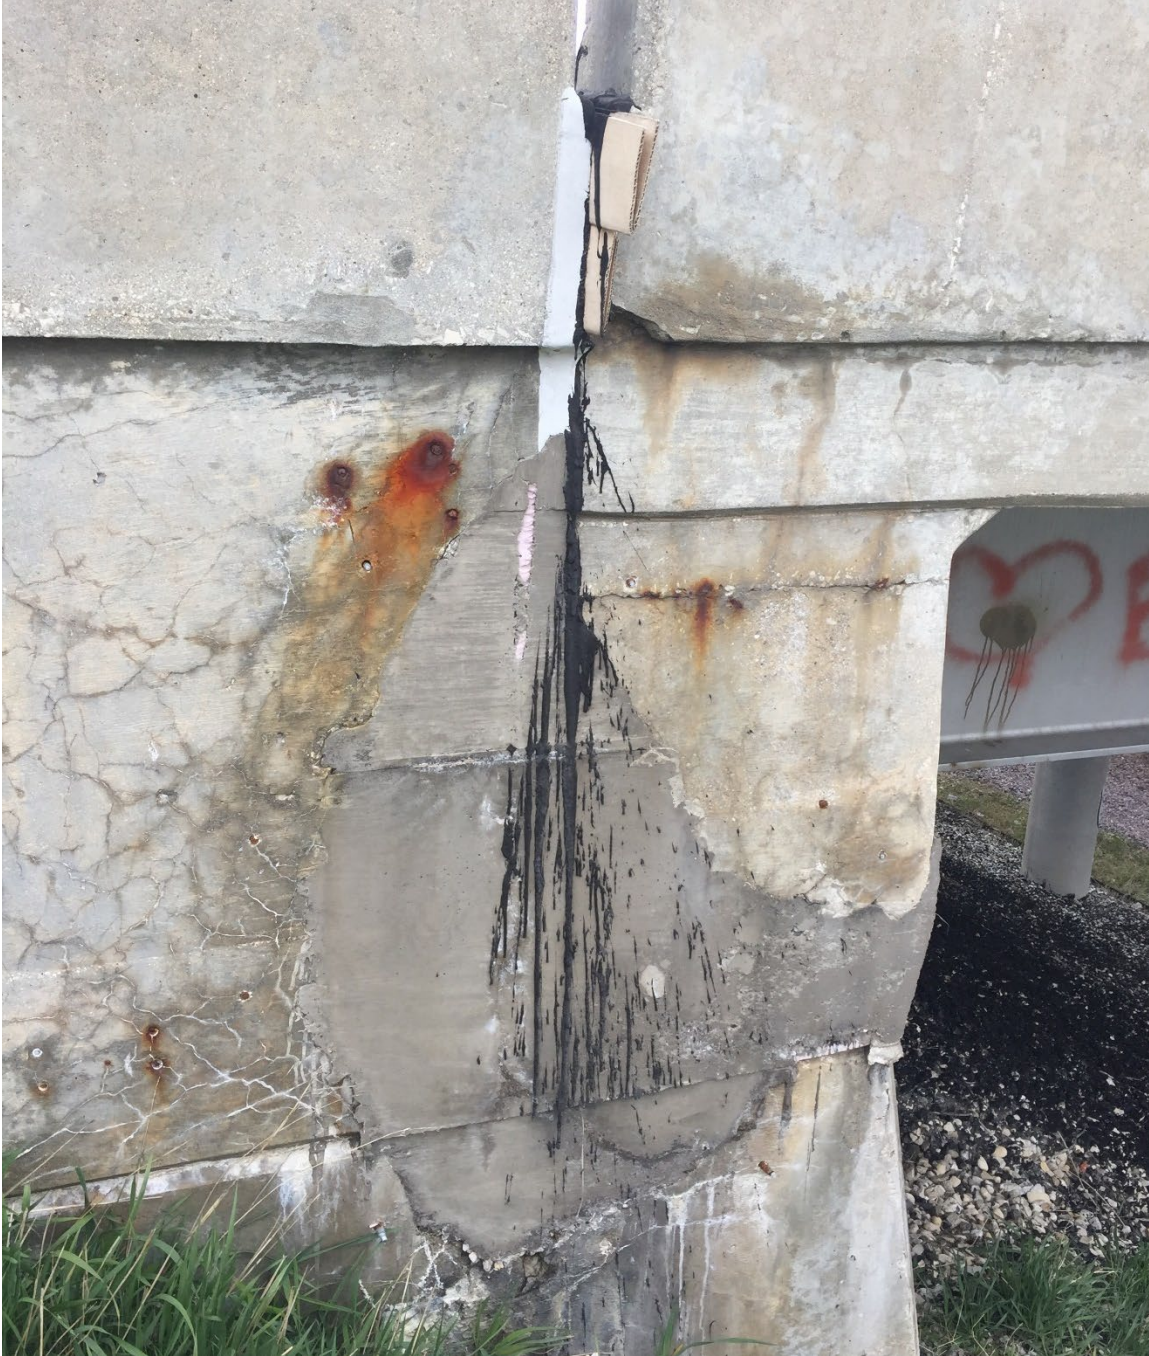
Concrete patch on SW abutment corner.

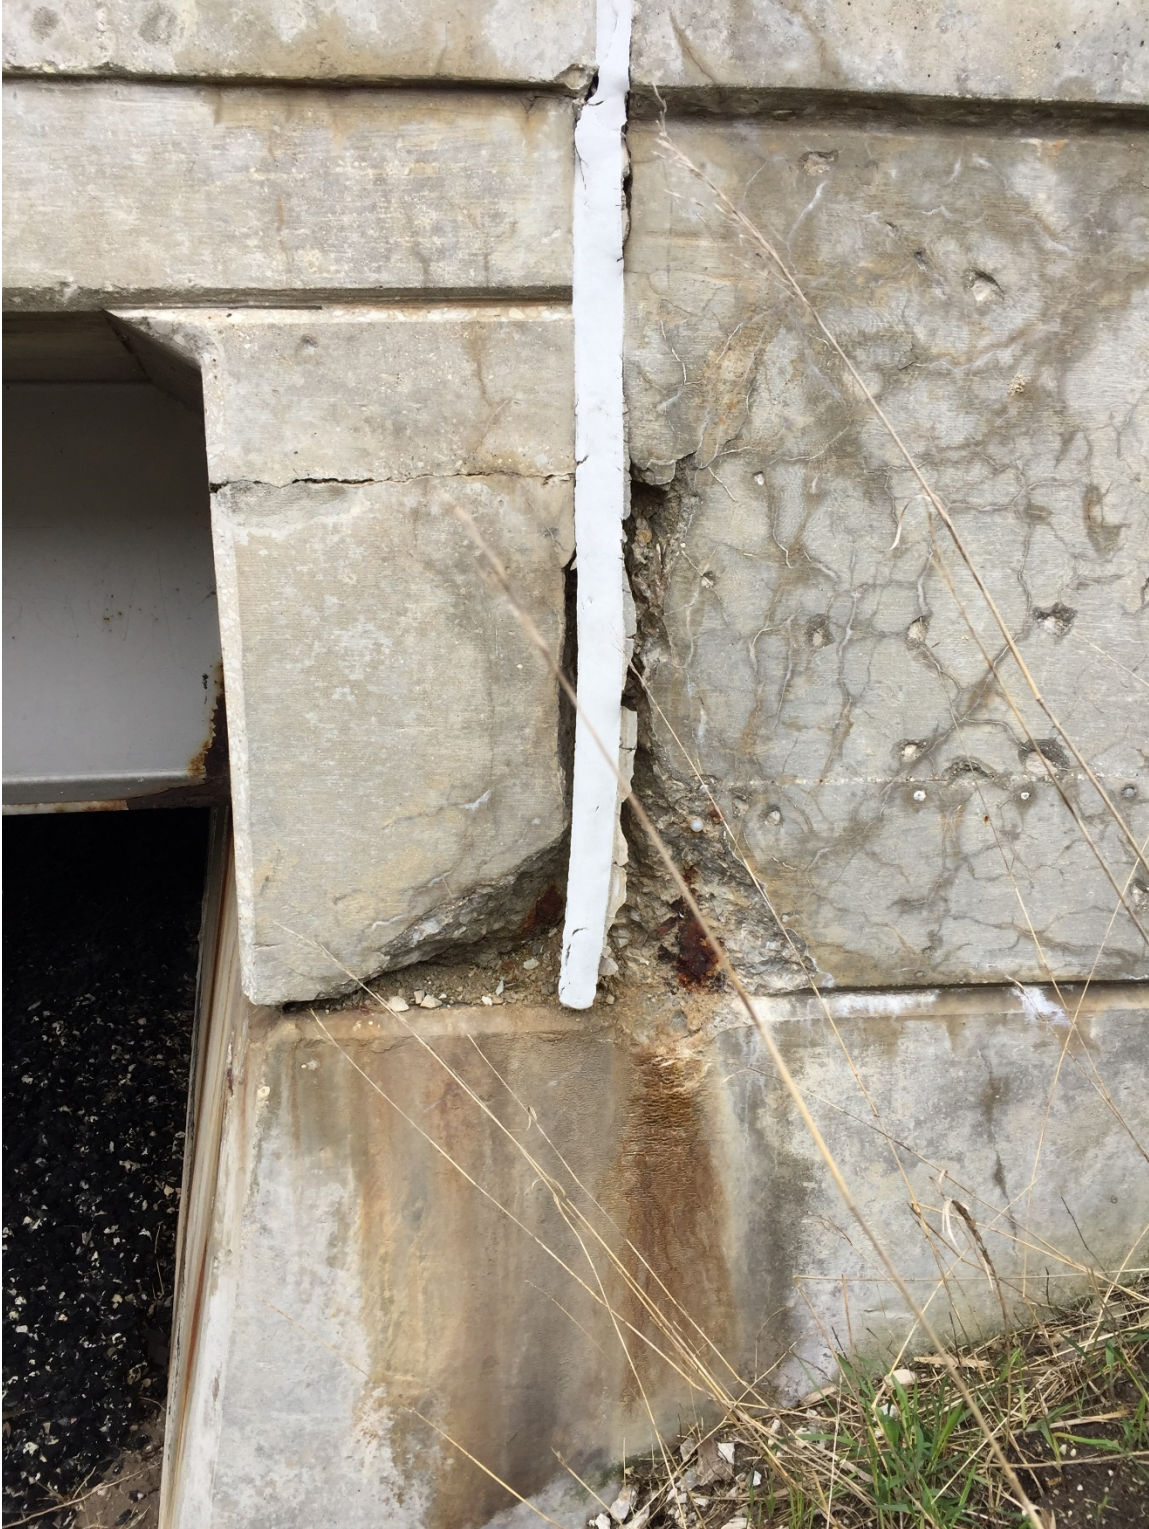
Concrete condition on SE abutment corner.

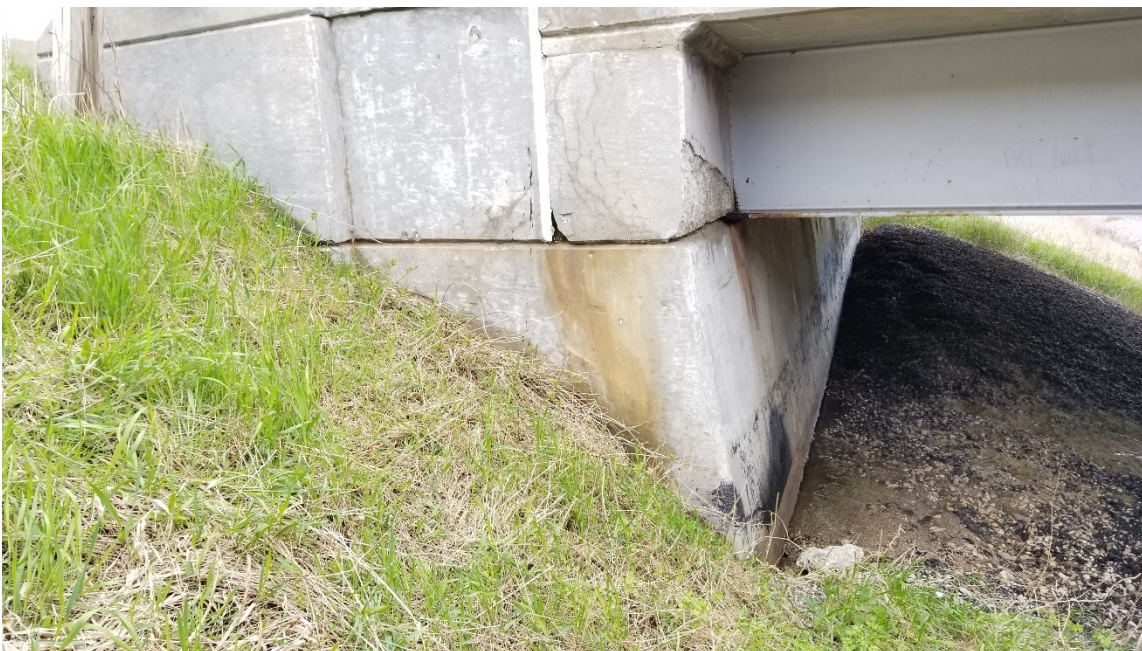
Concrete condition on NE abutment corner.

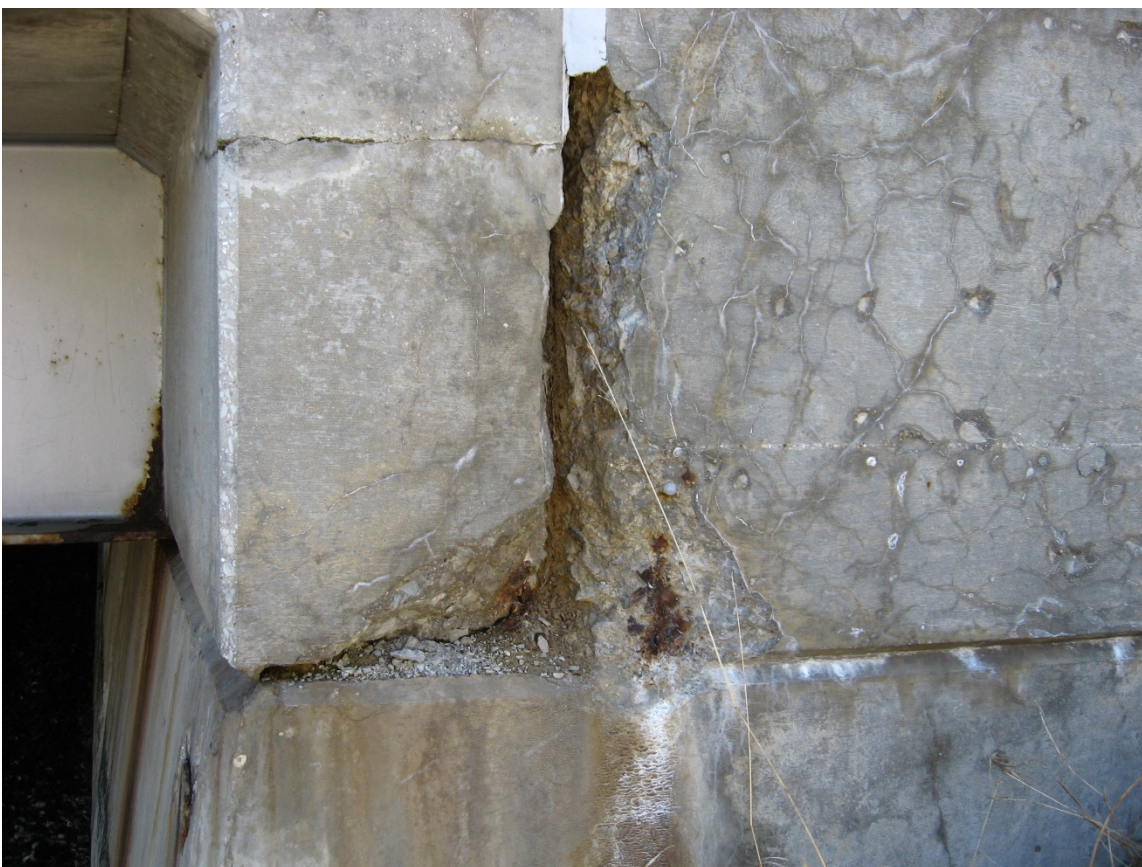
Concrete condition on NW abutment corner.

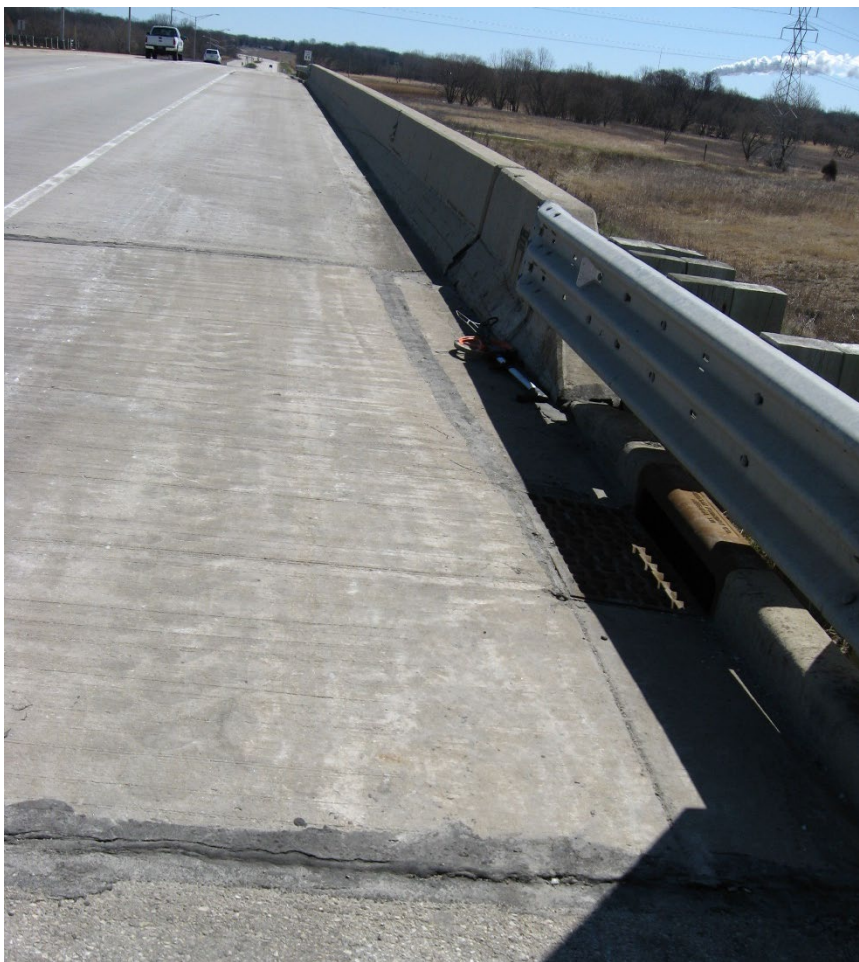
South parapet.

Existing parapet not to standard; replace with 42SS parapet

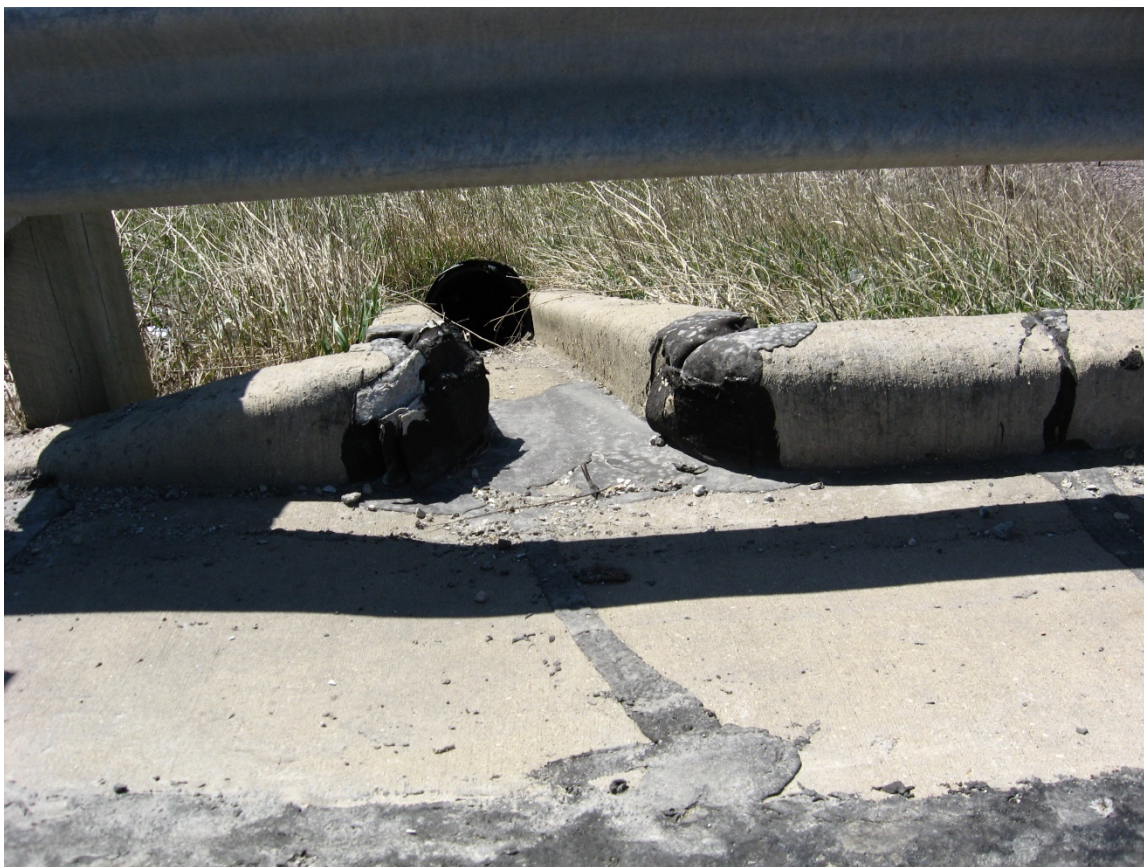
| Chk | Element | Defect | Description | UOM | Total | Quantity in Condition State | | | |
|---|---|---|---|---|---|---|---|---|---|
| | | | Approach drain at SW <b>with cracking of rings</b> , drainage flume at SE broken away water not reaching flume. NE/NW corners water not getting off bridge going through joint and around railing /WW joint into abutment backwall. | | | | | | |

SE flume.

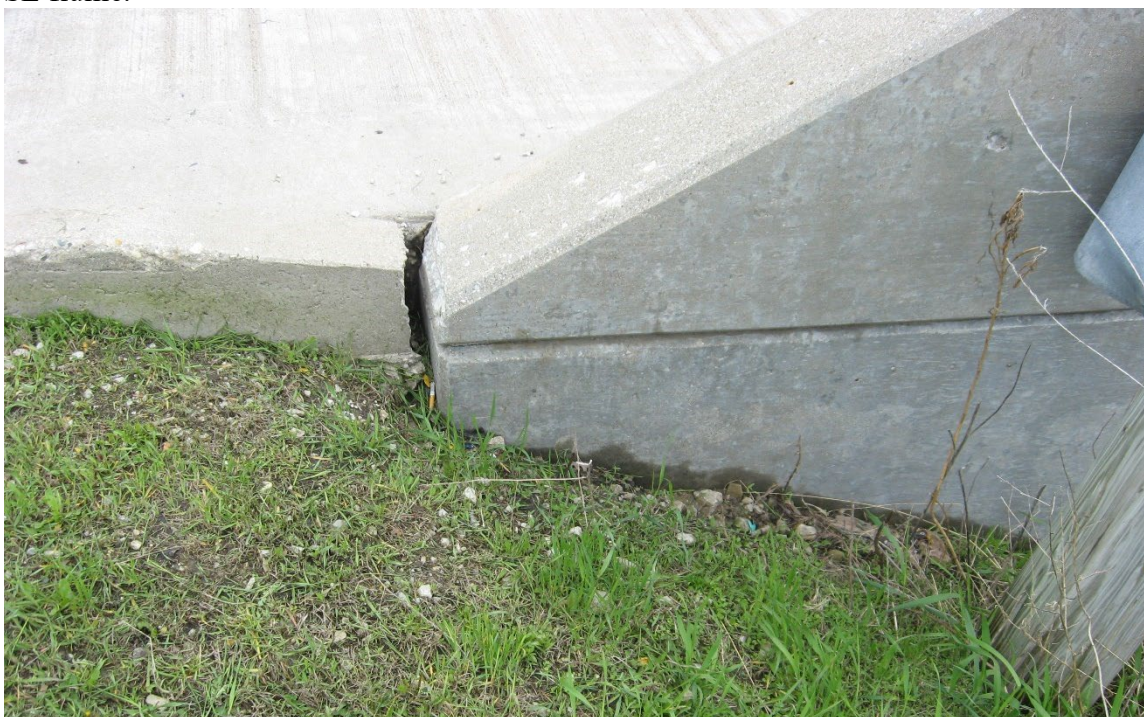
Joint at NE parapet and curb. Typical of all four corners.

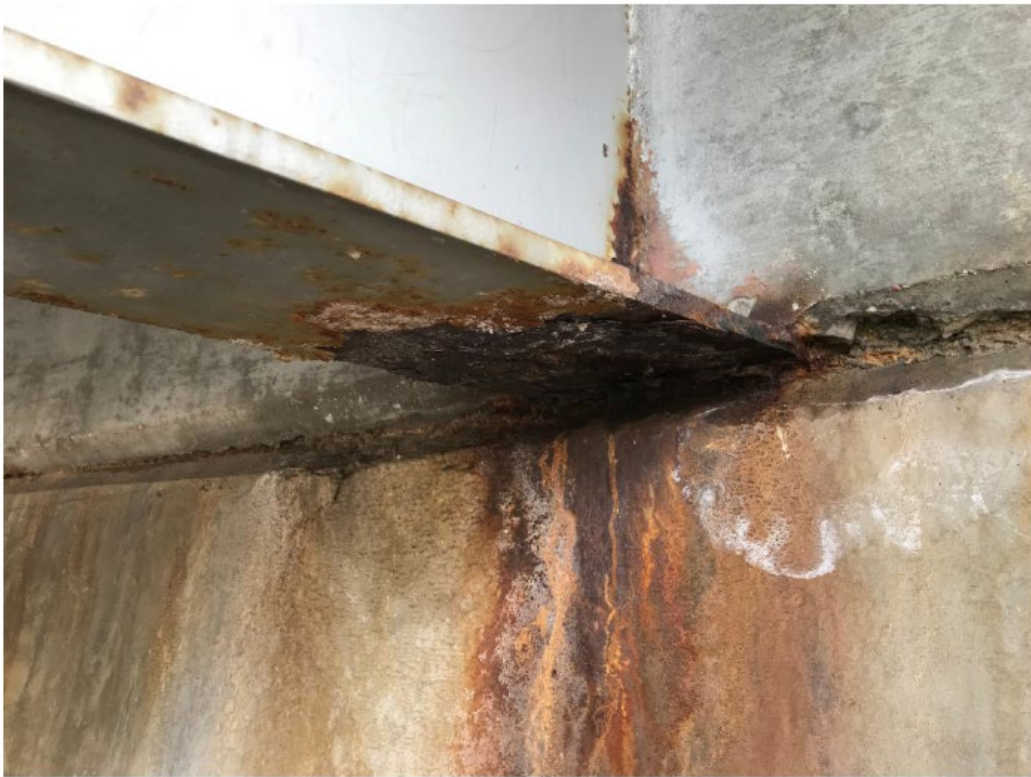
This picture is from the 2018 inspection report, describing the corrosion and section loss as “typical”. With the major scope of a new deck, I wouldn’t think we would want to leave this unaddressed for the next 50 years, especially with known drainage issues. Corrosion is both at the bearing area of the bottom flange and extending into the web. Original comments were made after discussions with Dan Jashinsky, who has seen similar structures with corrosion of the embedded beams after the diaphragms have been removed in past construction projects. The second photo shows severe deterioration of the backwall/diaphragm at the corner, also occurring at other locations. In order to correct the drainage, protect the piles, and add corrosion protection to the bearing area of the beams, I continue to recommend removal and replacement of the backwall/diaphragms as part of the deck replacement – does BOS concur?

Corrosion at Girder #1 end at west abutment - typical.

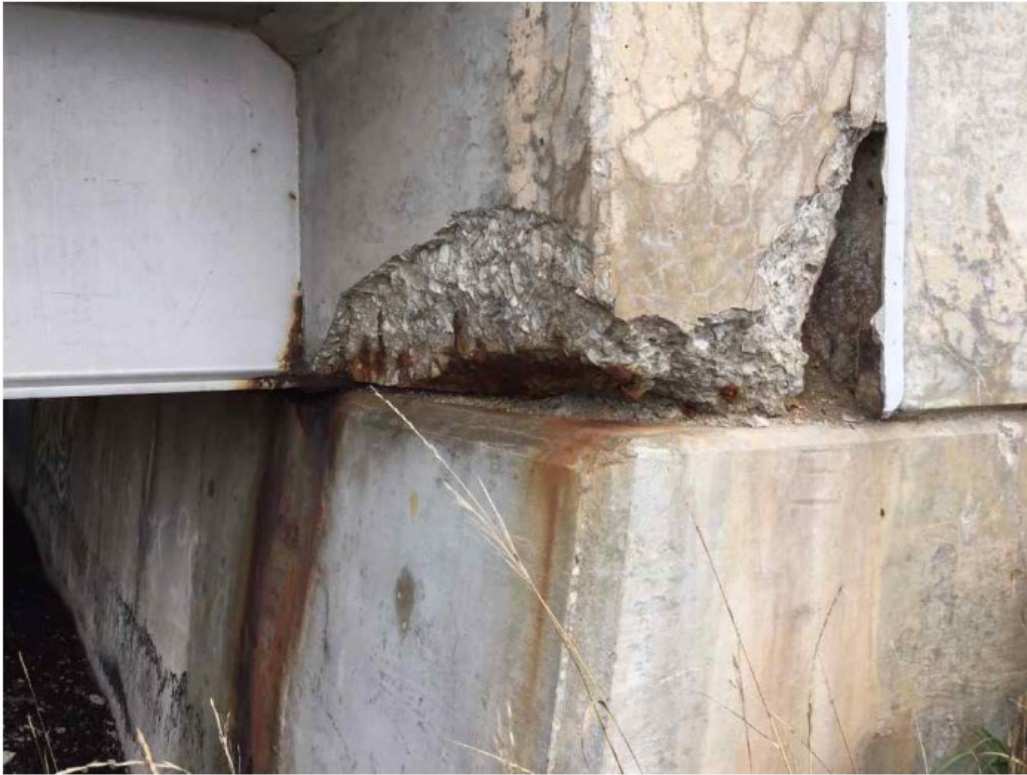
SE abutment corner spalled and failing caused by failed drainage above allowing water to exit bridge above this area onto abutment corner.  
Photo copied from 2016 inspection report - no change 2018.
