# STRUCTURE INVENTORY REPORT

Project 2150-00-01 Date 4/24/2019 Crew WFF/SAS Point # 10738

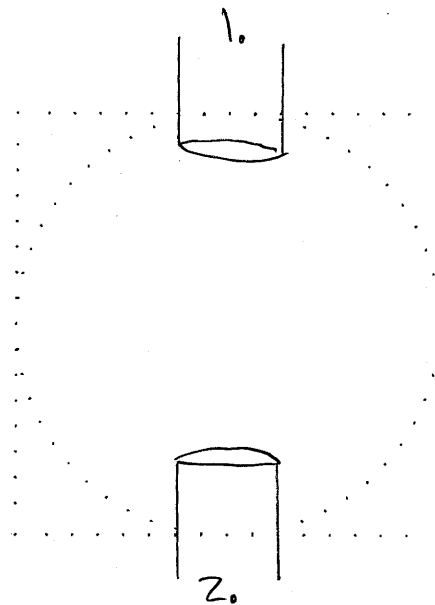
Condition / Notes unable to open / North pipe unable to measure

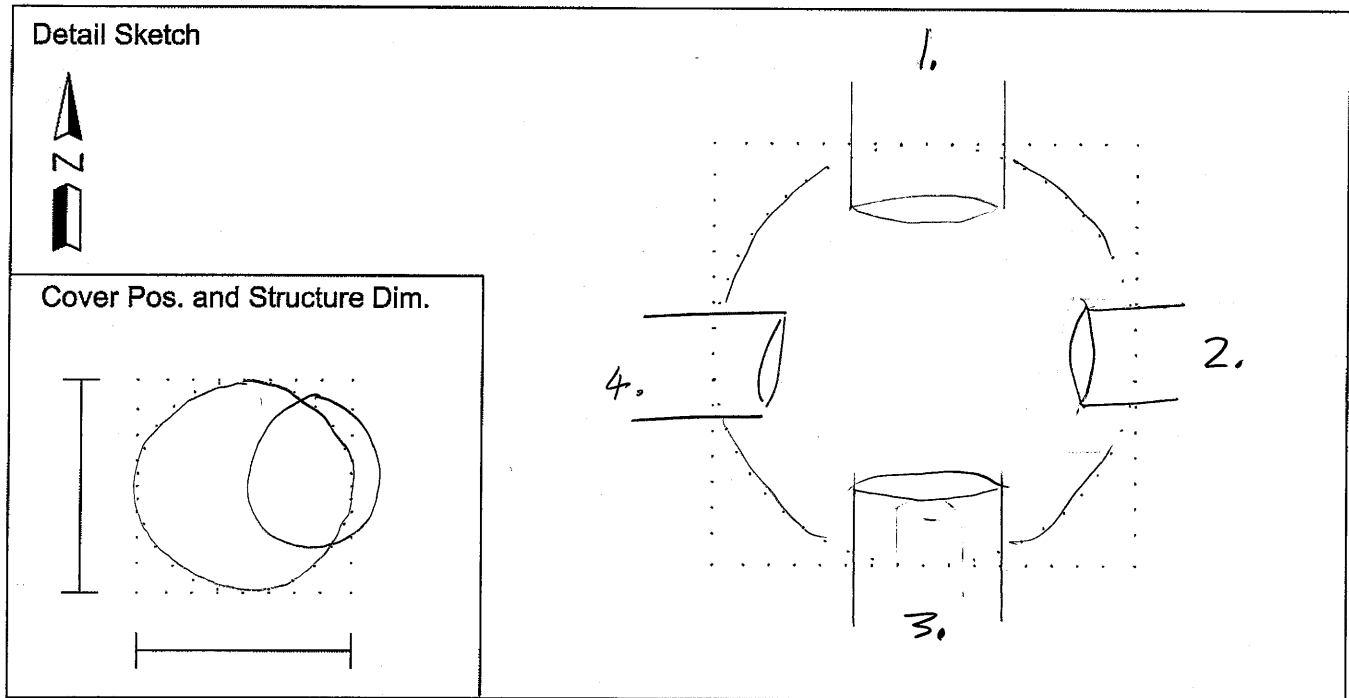
Condition / Notes # 4 12 in RCP / unable to measure

Condition: ☒ Good ☐ Fair ☐ Poor

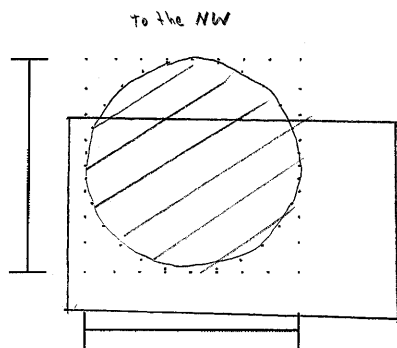
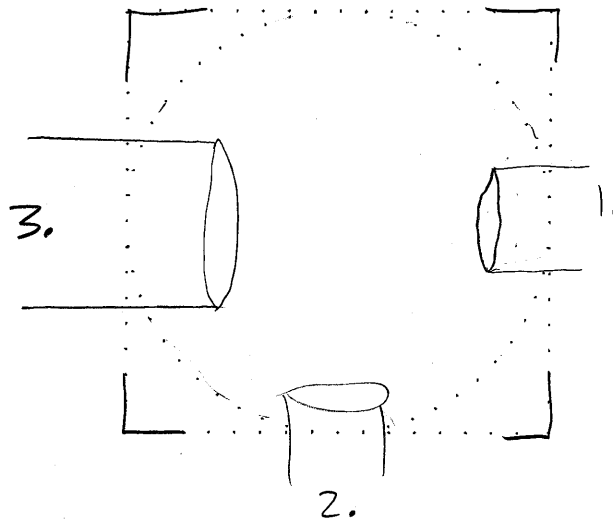
Condition / Notes South pipe / unable to measure

Condition: ☐ Good ☒ Fair ☐ Poor
