## Inspection Report for B-13-254

## ATWOOD AVE over STARKWEATHER CREEK Oct 26,2018

## BRIDGE INSPECTION REPORT Wisconsin Department of Transportation DT2007 2003 s.84.17 Wis. Stats.

Feature On: ATWOOD AVE	Section Town Range: S08 T07N R10E	Structure Number:	
Feature Under: STARKWEATHER CREEK	County: DANE	B-13-254	
Location 1.0M S JCT USH 151	Municipality: MADISON	Structure Name:

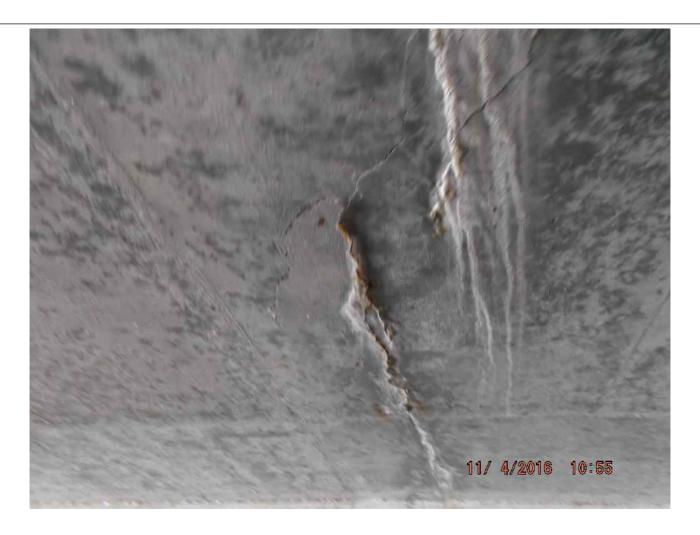
page 6 Structure No.:B-13-254

Routine
Document Comment/Description
spall underside westerly side

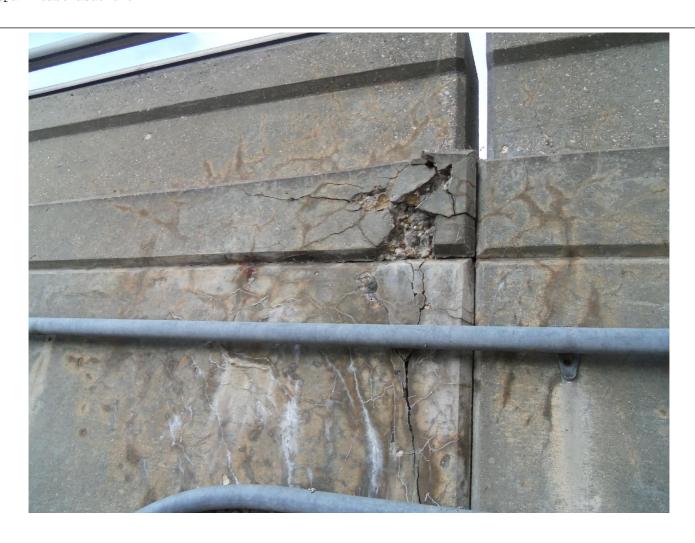
page 7 Structure No.:B-13-254

<del></del>						
			Reinforced Concrete Abutment	LF	120	95	20	5	0
Χ	215								
			Delamination - Spall - Patched Area	LF		0	0	2	0
		1080	1' x 2' Spall south side of East Abutment.						
			Cracking (RC)	LF		0	20	5	0
		1130	Narrow to Wide Cracks.						
			Reinforced Concrete Bridge Rail	LF_	158	0	158	0	0
Χ	331								
							45		
			Delamination - Spall - Patched Area	LF		0	15	0	0
		1080	Patched Spalls are sound.						
			One altie of (DO)	1			450		
			Cracking (RC)	LF		0	158	0	0
		1130	narrow cracking throughout						
			In the same I Miles would			4			
V	0.400		Integral Wingwall	EA	4	4	0	0	0
Χ	8400

## Routine Document Comment/Description Spall east abutment

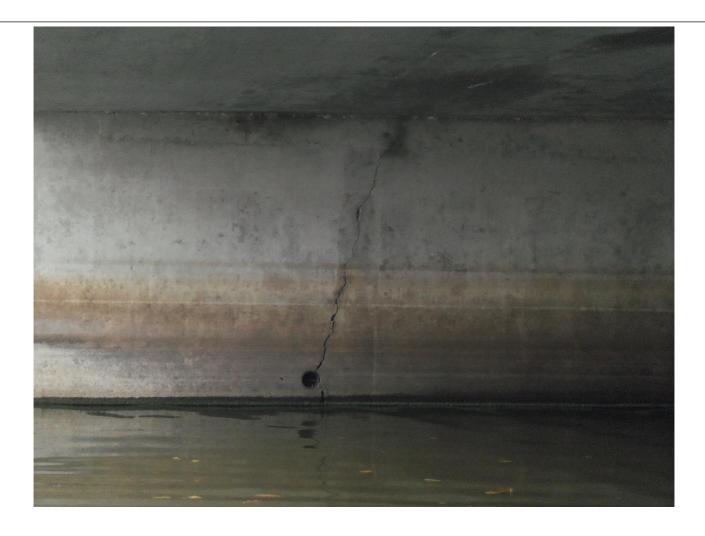
page 8 Structure No.:B-13-254

## Routine Document Comment/Description wide crack west abutment

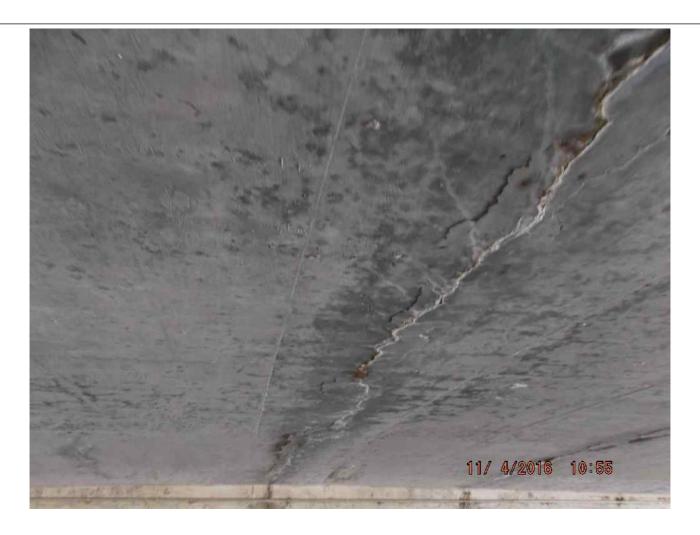
page 9 Structure No.:B-13-254

Quantity in Co	ondition State	
Chk	Element	Defect	Description	UOM	Total	1	2	3	4
			Reinforced Concrete Slab	SF	2,909	0	2,604	305	0
X	38								
			Delamination - Spall - Patched Area	SF		0	0	55	0
		1080	2 wide cracks mid span with delamination on under	erside -	Patched in	2017	'		
			Cracking (RC)	SF		0	2,604	250	0
		1130	Narrow and Medium Cracking Throughout. Thin Polymer Overlay installed 2017. Cracks on underside also repaired in 2017.						
			Thin Polymer Overlay	SF	2,909	2,909	0	0	0
	8513		Added in 2017.		•		·

Routine Document Comment/Description mid span spall on underside

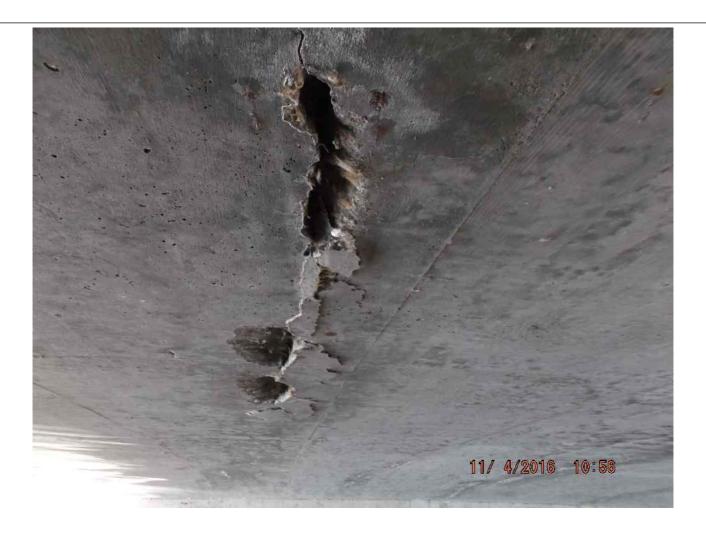
page 10 Structure No.:B-13-254

Routine
Document Comment/Description
underside spall easterly side

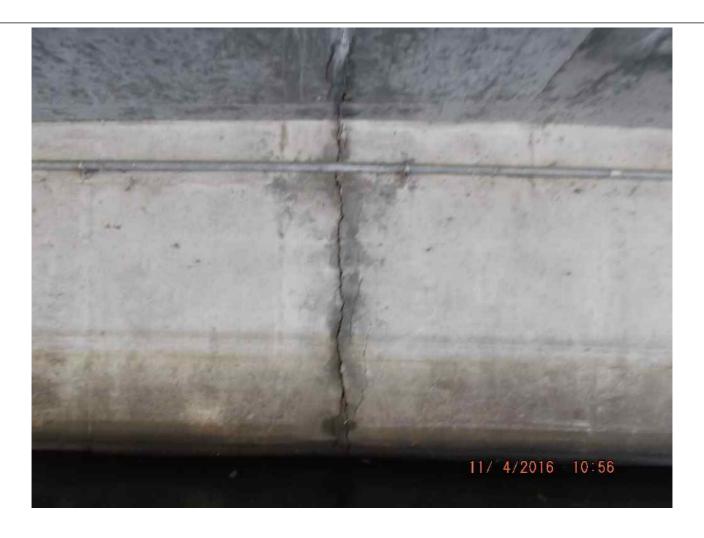
page 11 Structure No.:B-13-254

## Routine Document Comment/Description wide crack east abutment

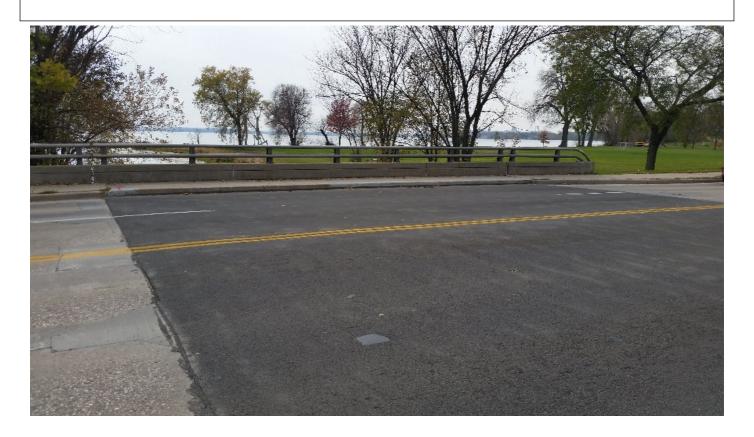
page 12 Structure No.:B-13-254

Routine
Document Comment/Description
Overlay and Sidewalk repair, south side.

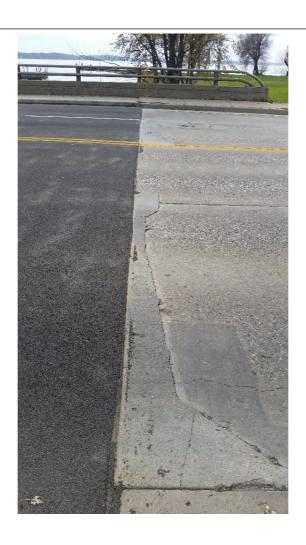
page 13 Structure No.:B-13-254

## Routine Document Comment/Description West Approach Spall Repairs

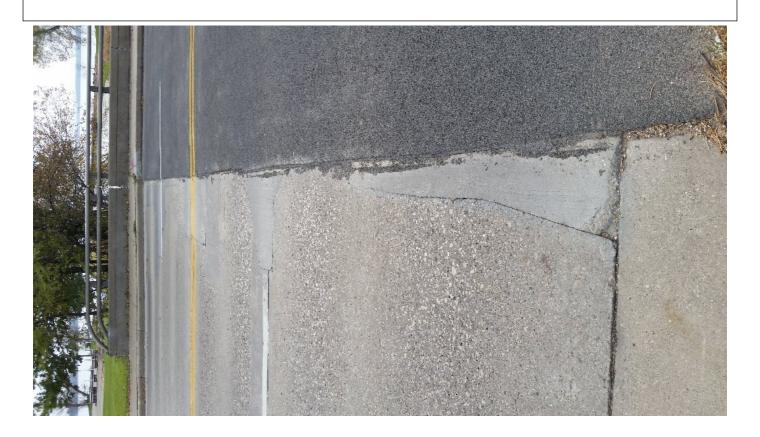
page 14 Structure No.:B-13-254

# Routine Document Comment/Description East Approach

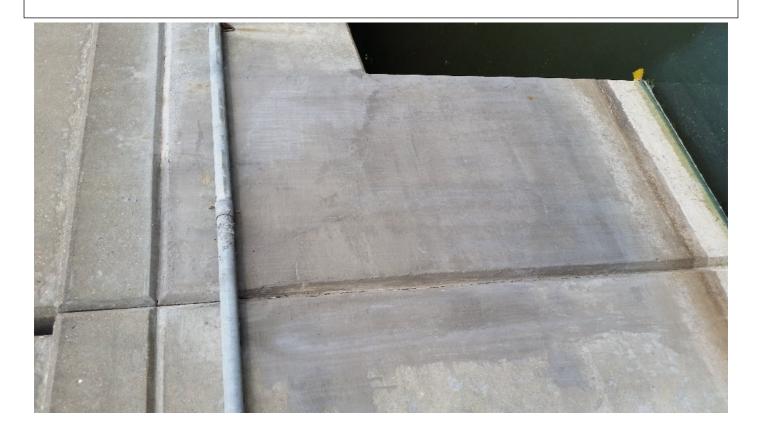
page 15 Structure No.:B-13-254

Patch, SW Corner

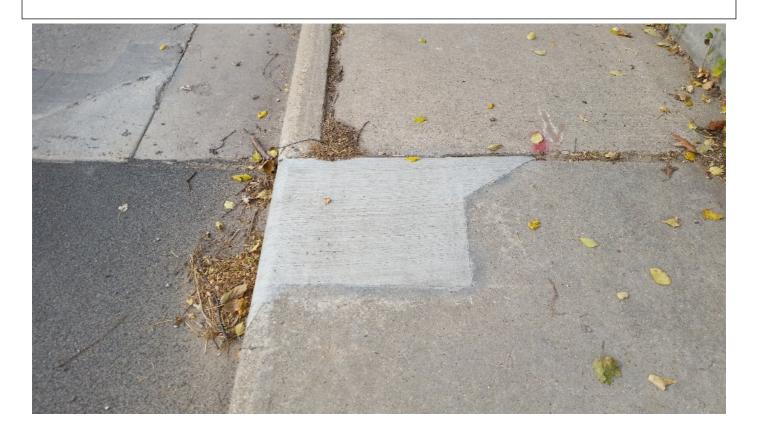
page 16 Structure No.:B-13-254

# Routine Document Comment/Description North Side Curb Repair
