# **B-14-0110\_oth**

## Bridge Asbestos Inspection Report

Inspection Report for  
**B-14-110**

STH 28 over IH 41  
Aug 14, 2018

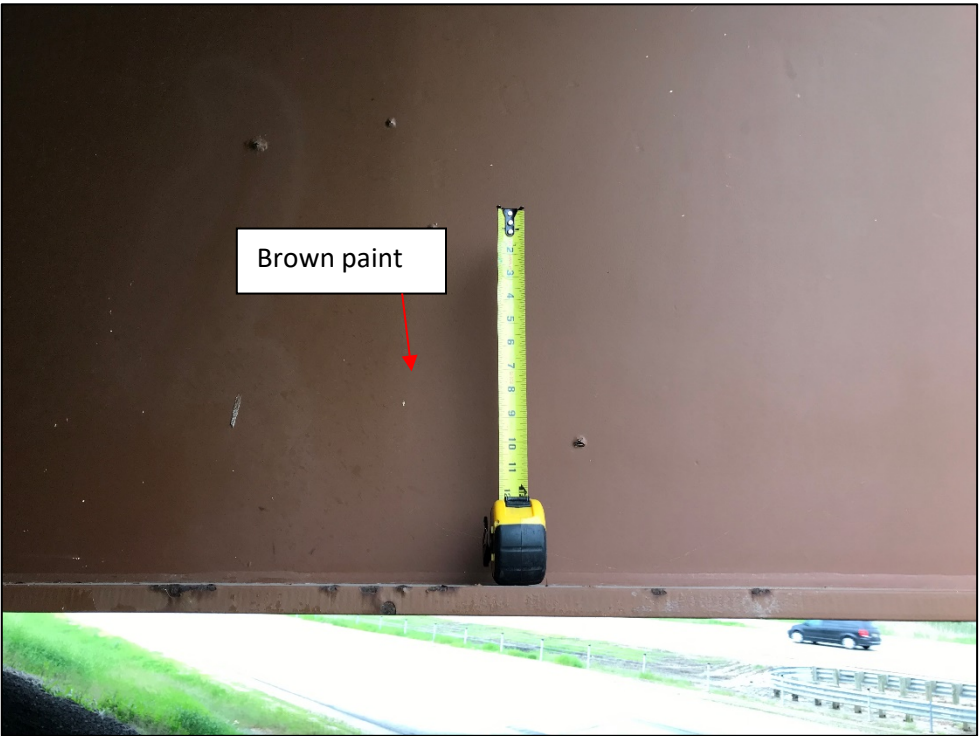
| <b>PHOTOGRAPH NO: 4</b> | |

| <b>DESCRIPTION:</b><br><br>Looking at the brown paint on the steel girder system. The brown paint is not ACM. | |

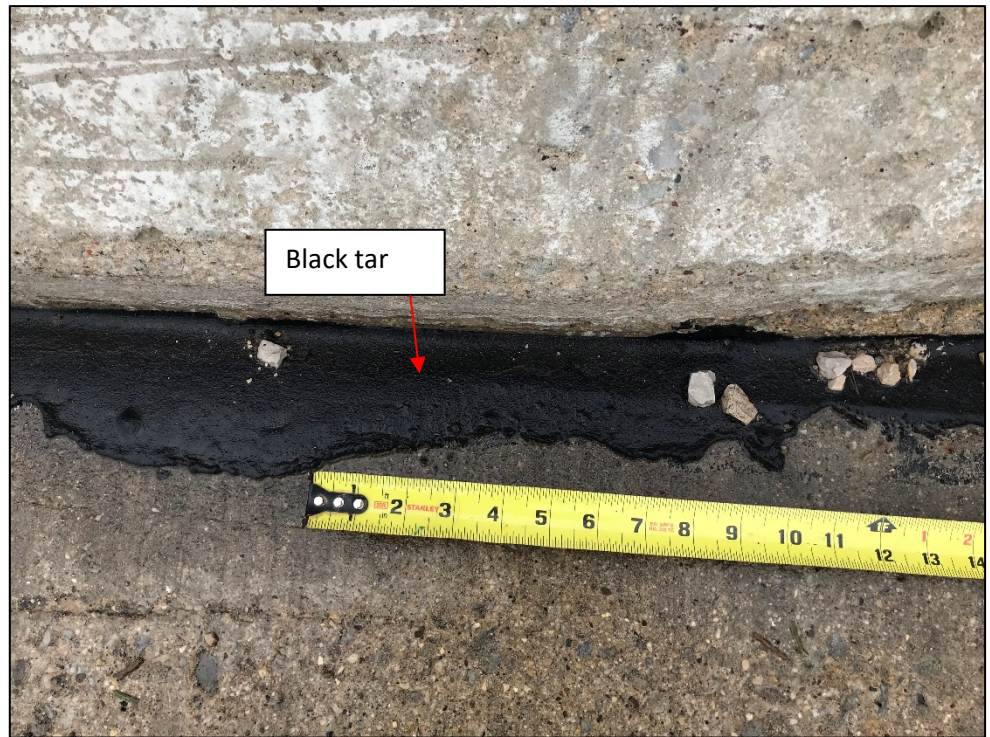
**PHOTOGRAPH NO: 5**

Looking at the black tar found on the deck joints and median. The black tar is not ACM.

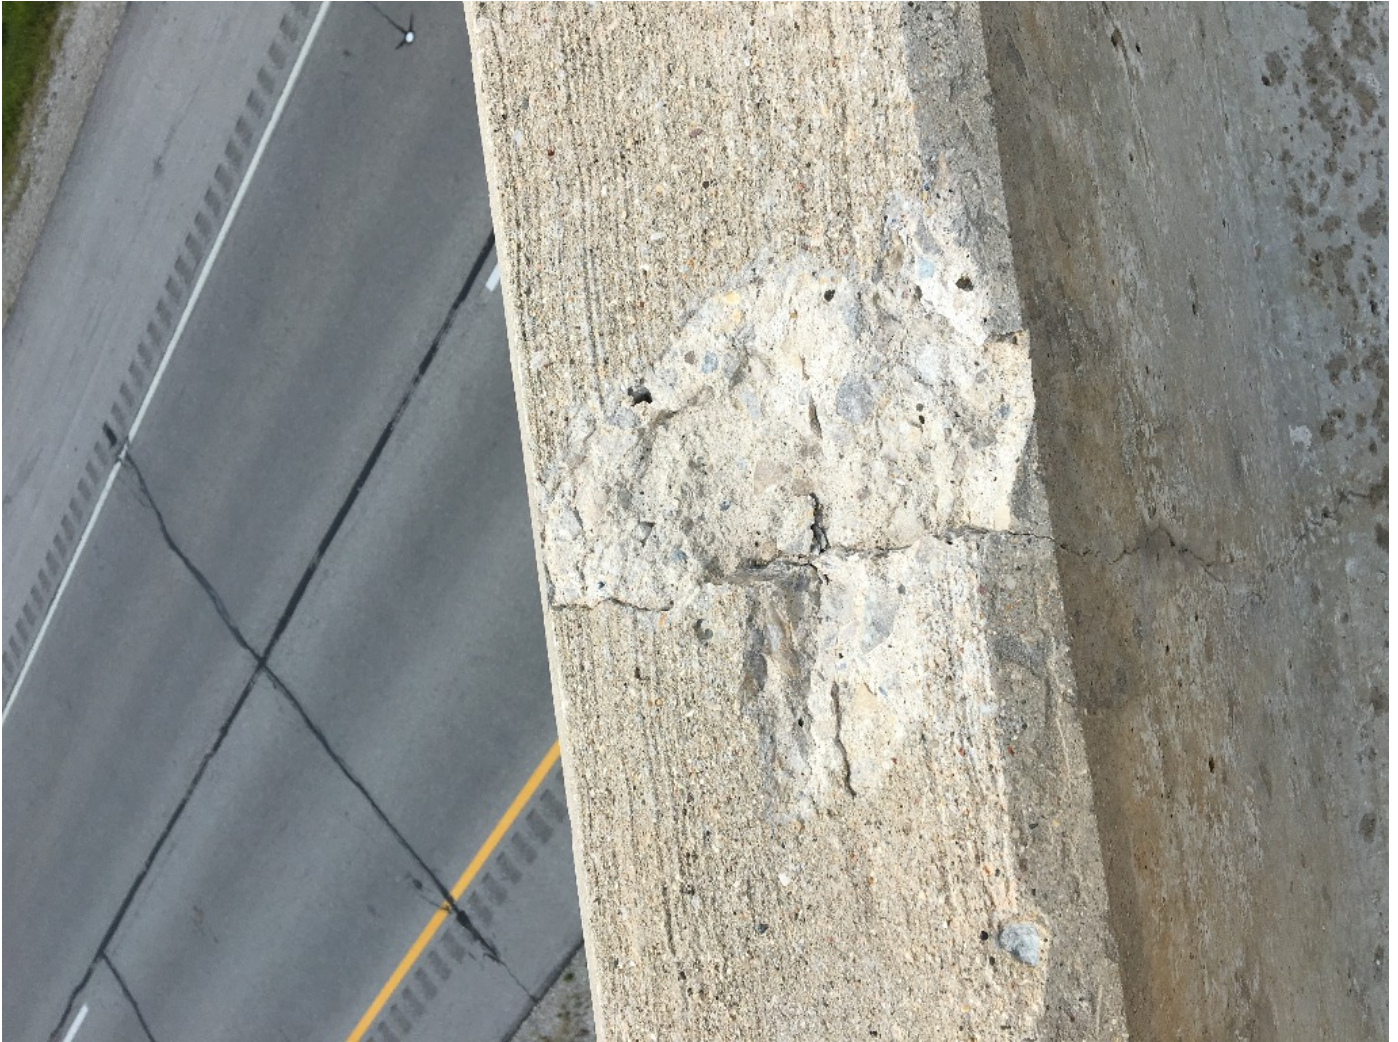
| | | 1080 | Delamination - Spall - Patched Area<br><b>Shallow spall N side, near pier. Spall bottom face, N rail S2, Spall top of S rail near pier.</b> | LF | | 0 | 3 | 0 | 0 |

spall S top of parapet wall

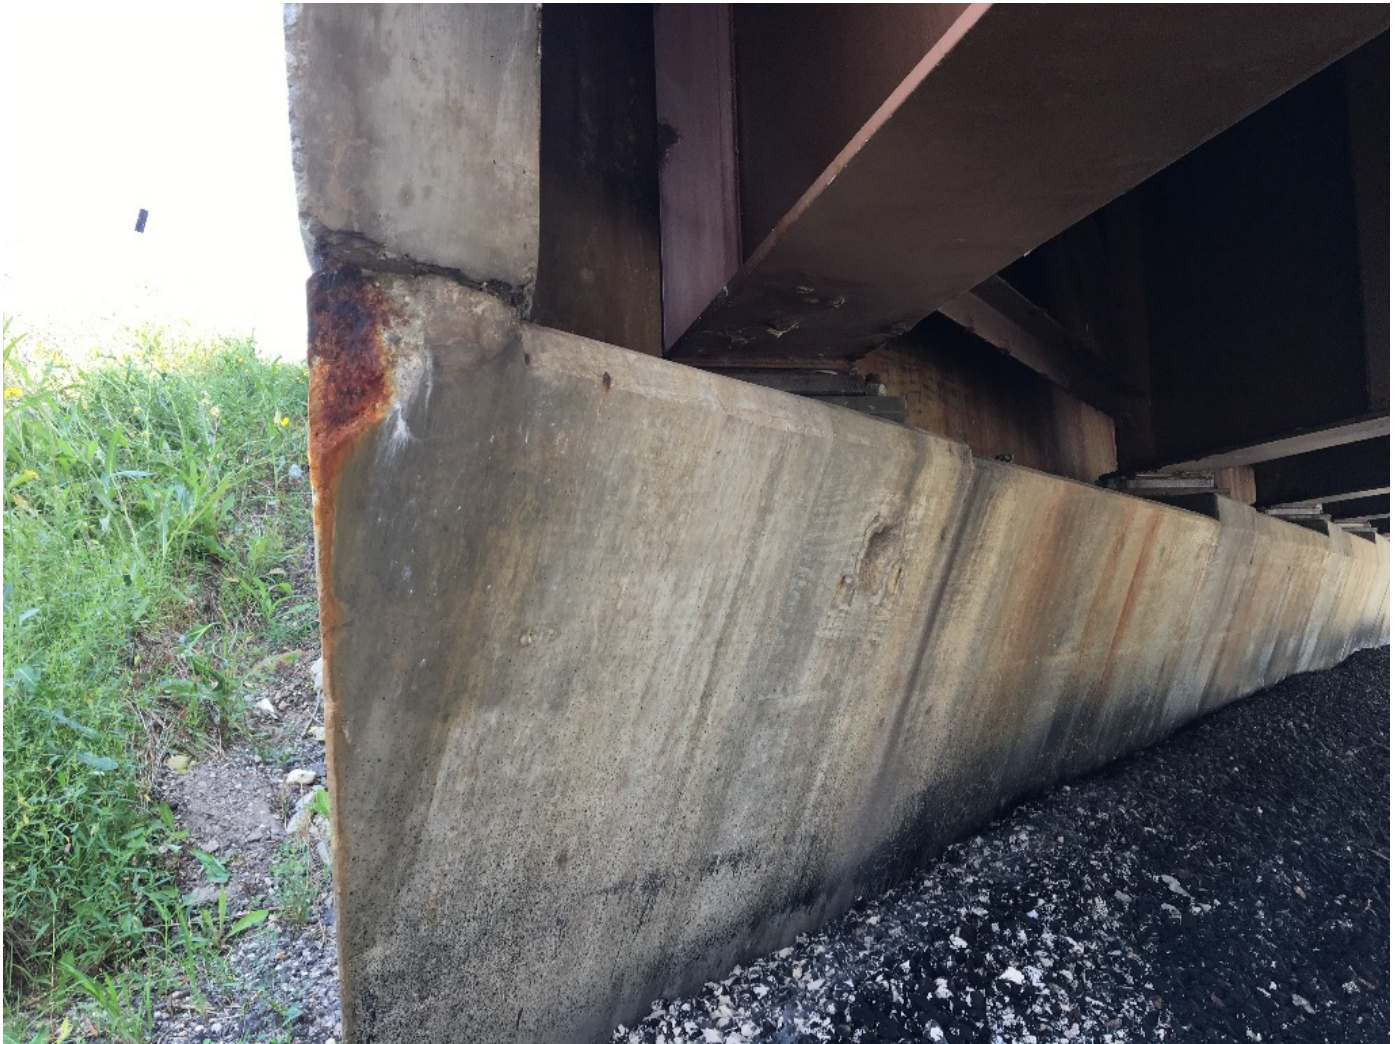
| Chk | Element | Defect | Description | UOM | Total | Quantity in Condition State | | | |
|---|---|---|---|---|---|---|---|---|---|
| | | 1080 | Delamination - Spall - Patched Area<br>One small spall east abutment <b>N end. E abut couple spalls no exp. steel, (1) has rust staining. SE corner large spall @ abut/backwall/wing area. Cracking, rust staining w/ heavy effl.</b> | LF | | 0 | 0 | 4 | 0 |

E abut spalls w/ rust staining

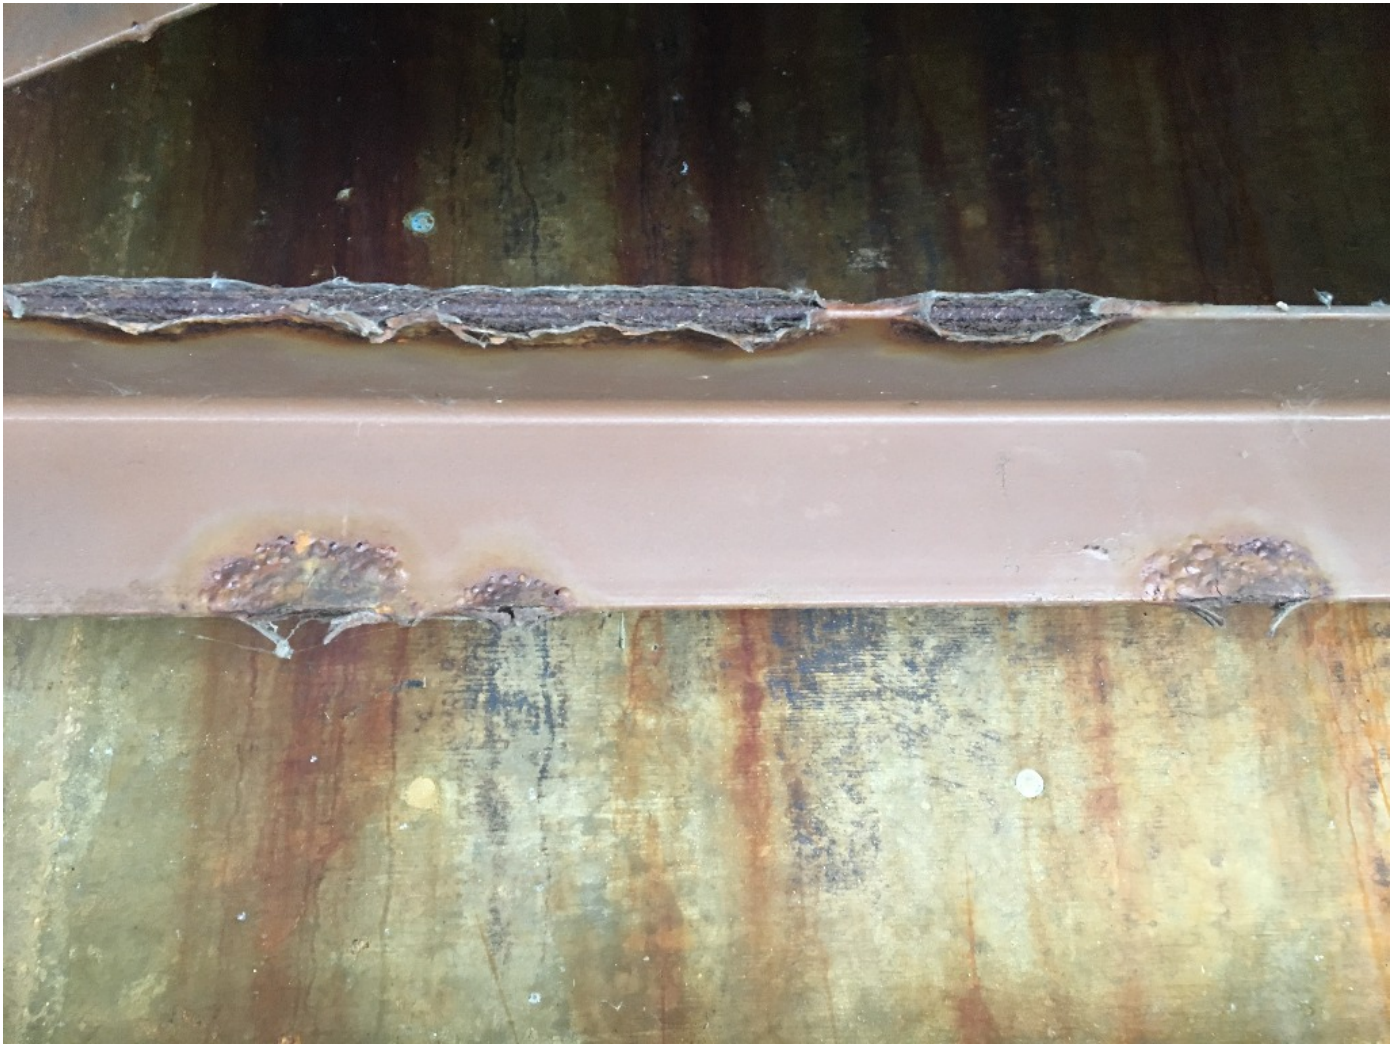
| Chk | Element | Defect | Description | UOM | Total | Quantity in Condition State | | | |
|---|---|---|---|---|---|---|---|---|---|
| X | 9167 | | <b>Steel Diaphragm</b><br>Corrosion on several at the abuts. Rust spots throughout. | EA | 107 | 50 | 41 | 16 | 0 |

Diag. steel, pack rust failing paint.

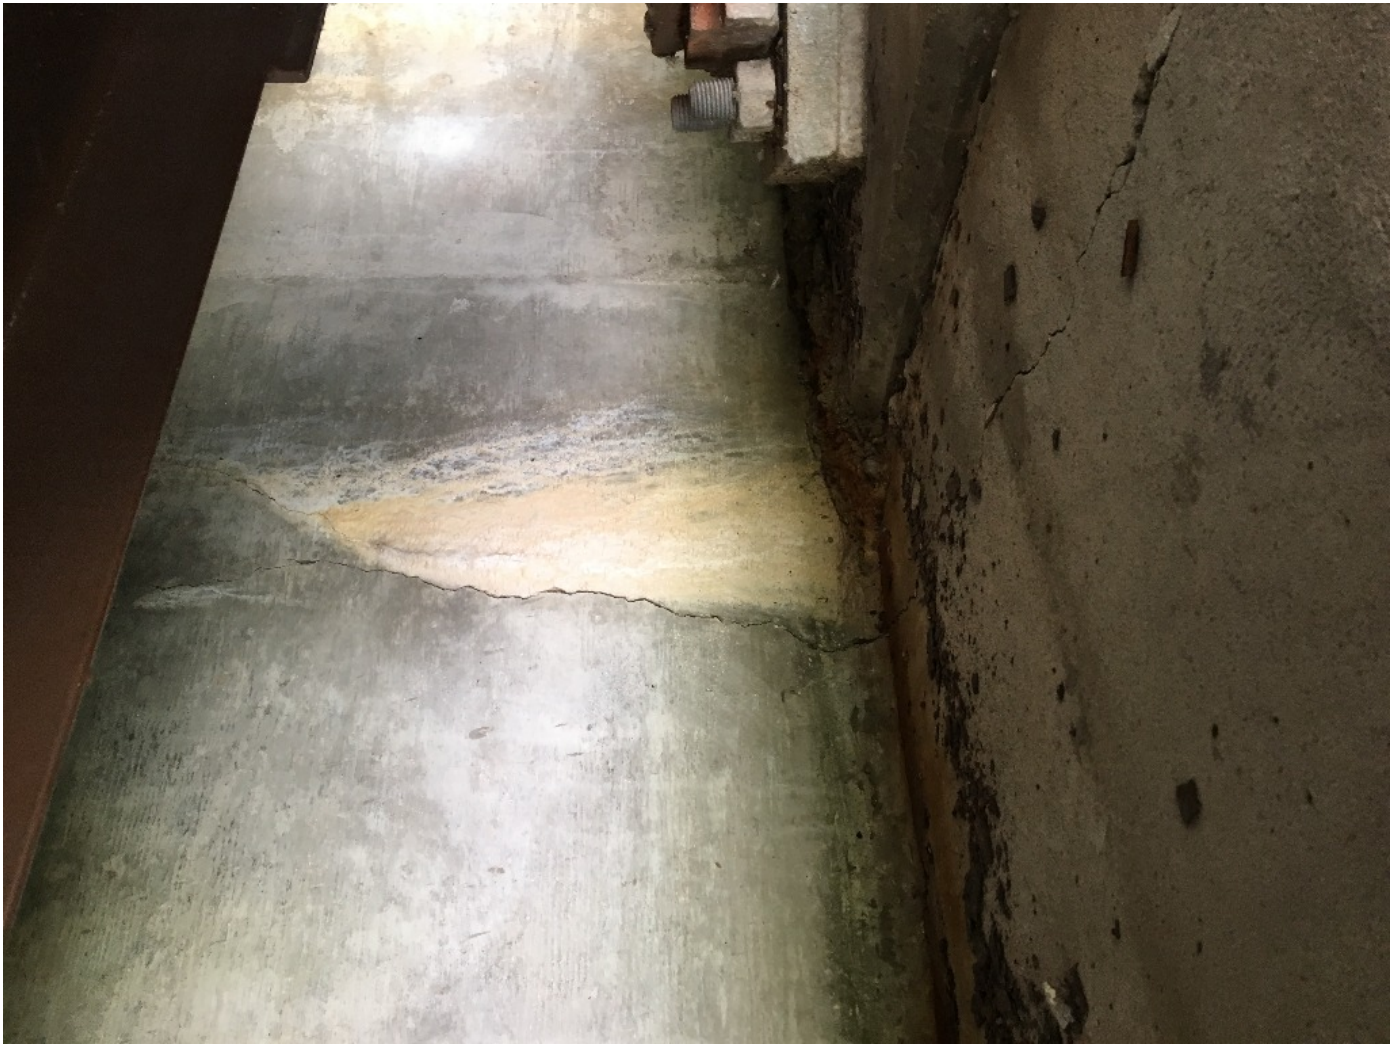
| Chk | Element | Defect | Description | UOM | Total | Quantity in Condition State | | | |
|---|---|---|---|---|---|---|---|---|---|
| X | 215 | 1130 | Cracking (RC)<br><b>Couple light vertical cracks in both abut bodies. N abut vertical cracks w/ no leaching in back wall. S abut vertical cracks w/ moderate to heavy leaching in the back wall also long. cracking near top of abut body.</b> | LF | | 0 | 34 | 2 | 0 |

Mod. leaching light crack E abut mid span

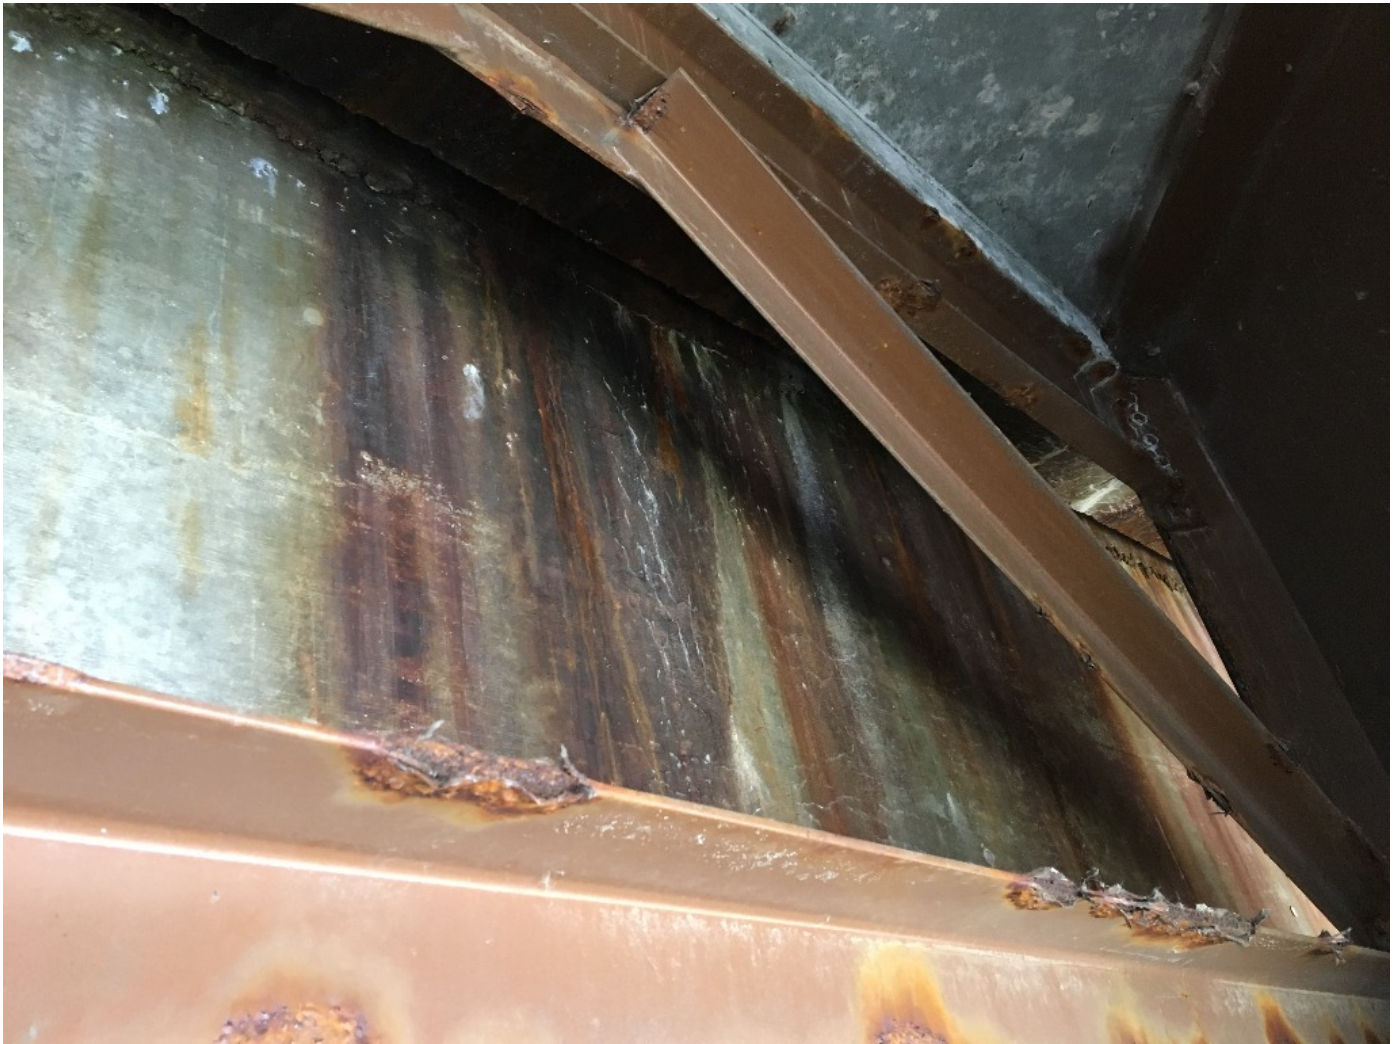
| Chk | Element | Defect | Description | UOM | Total | Quantity in Condition State | | | |
|---|---|---|---|---|---|---|---|---|---|
| | | | Vertical cracks with moderate leaching in E. backwall. Vertical cracks with no leaching in west backwall. Spall in east abutment north end. Back wall all rust stains. <b>SW corner has high rusty steel. NW has electrical box.</b> | | | | | | |

Rust staining entire E abut back wall

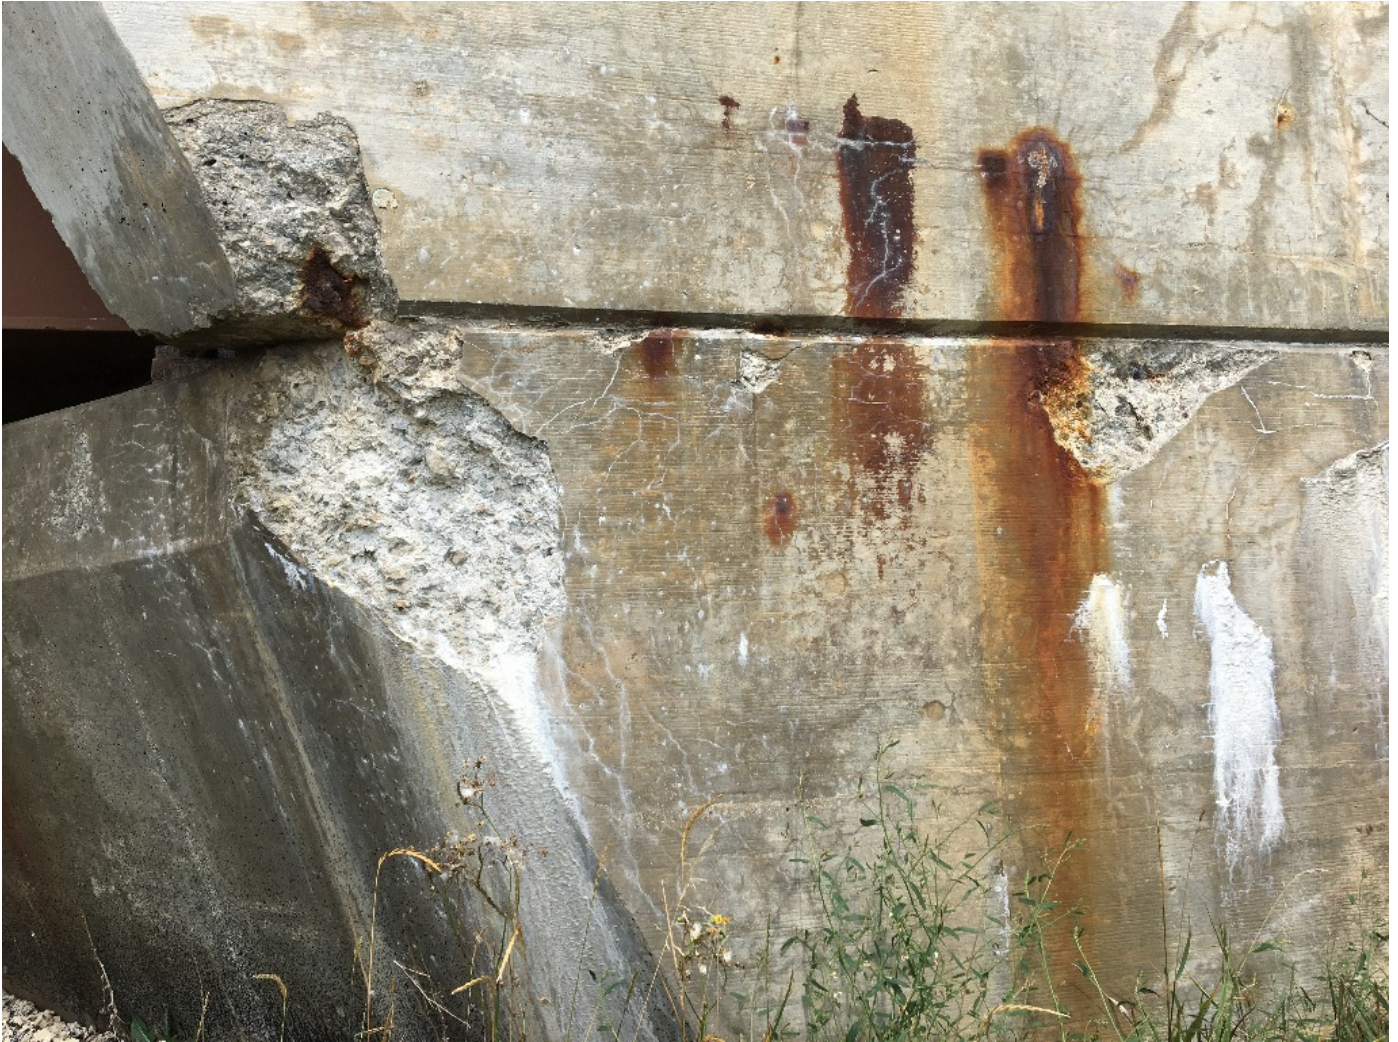
SE corner spall @ abut, cracking w/ mod effl., rust staining, map cracking w light eff.

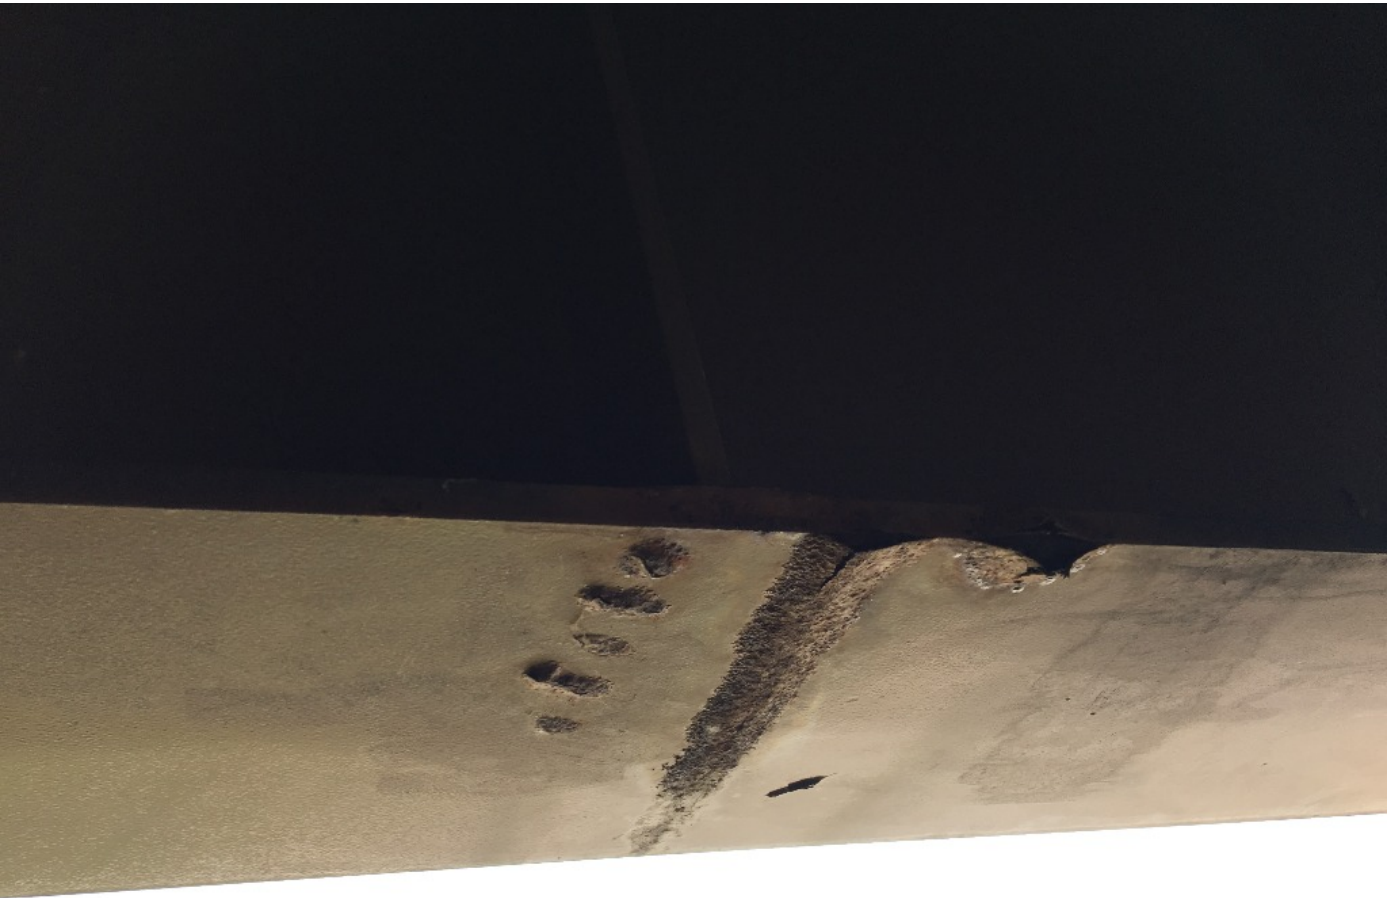
| Chk | Element | Defect | Description | UOM | Total | Quantity in Condition State | | | |
|---|---|---|---|---|---|---|---|---|---|
| | | 8516 | Painted Steel<br>Rust developing on bottom flanges and diaphragms throughout. Pack rust at ends by stiffeners. | SF | 26,939 | 26,443 | 480 | 16 | 0 |

Painted steel failure @ pack rust are @ flange bottoms and ends

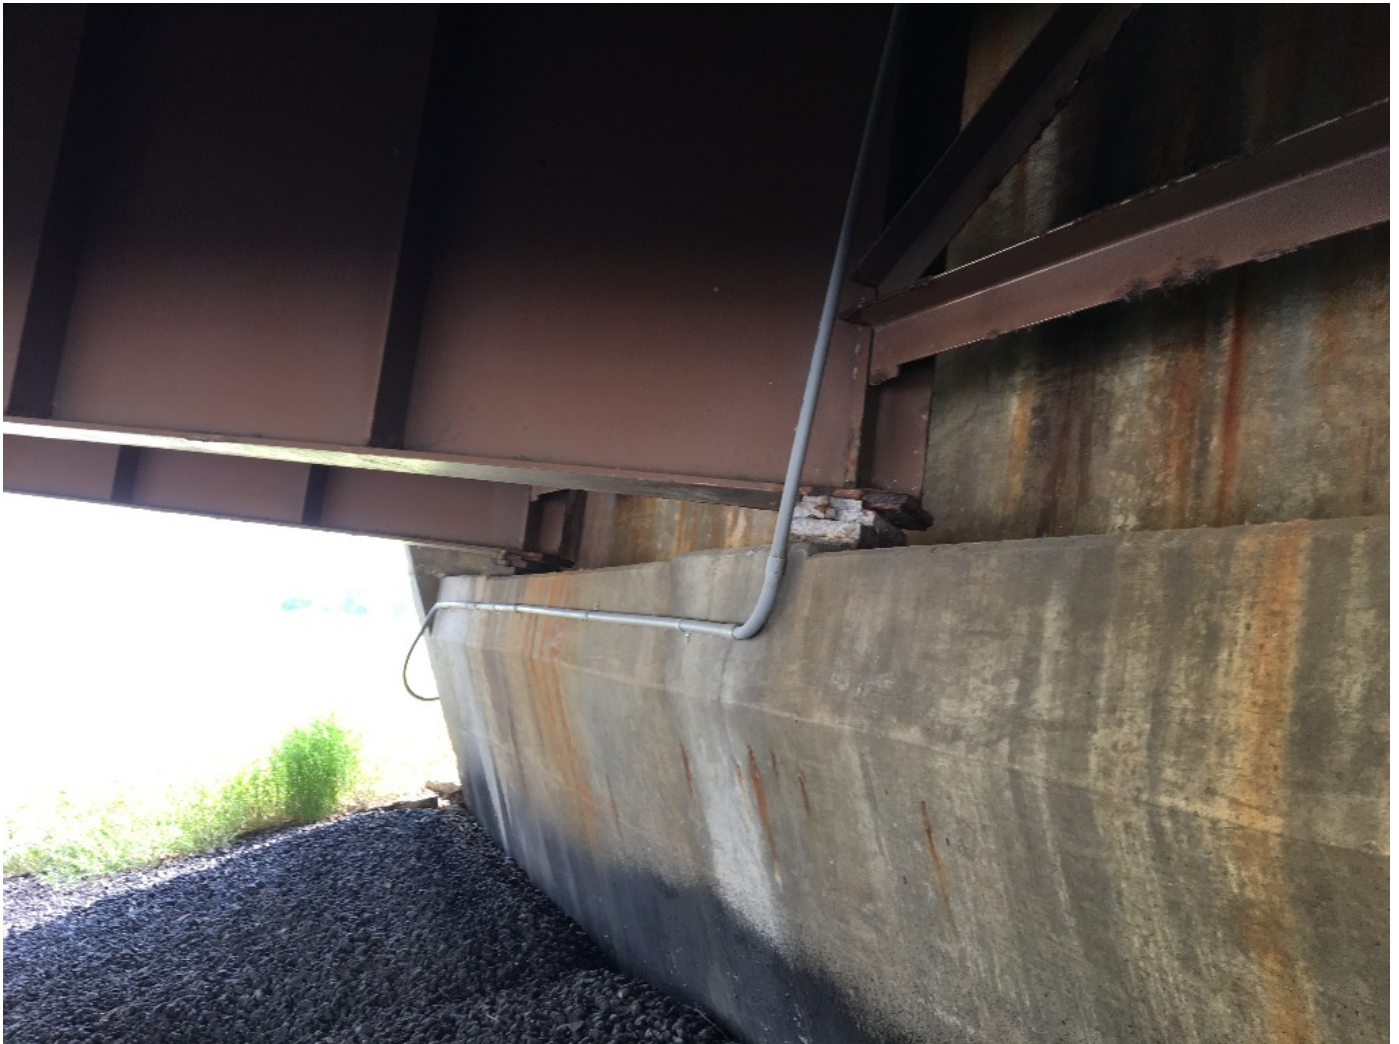
Electrical W abut/weather station.

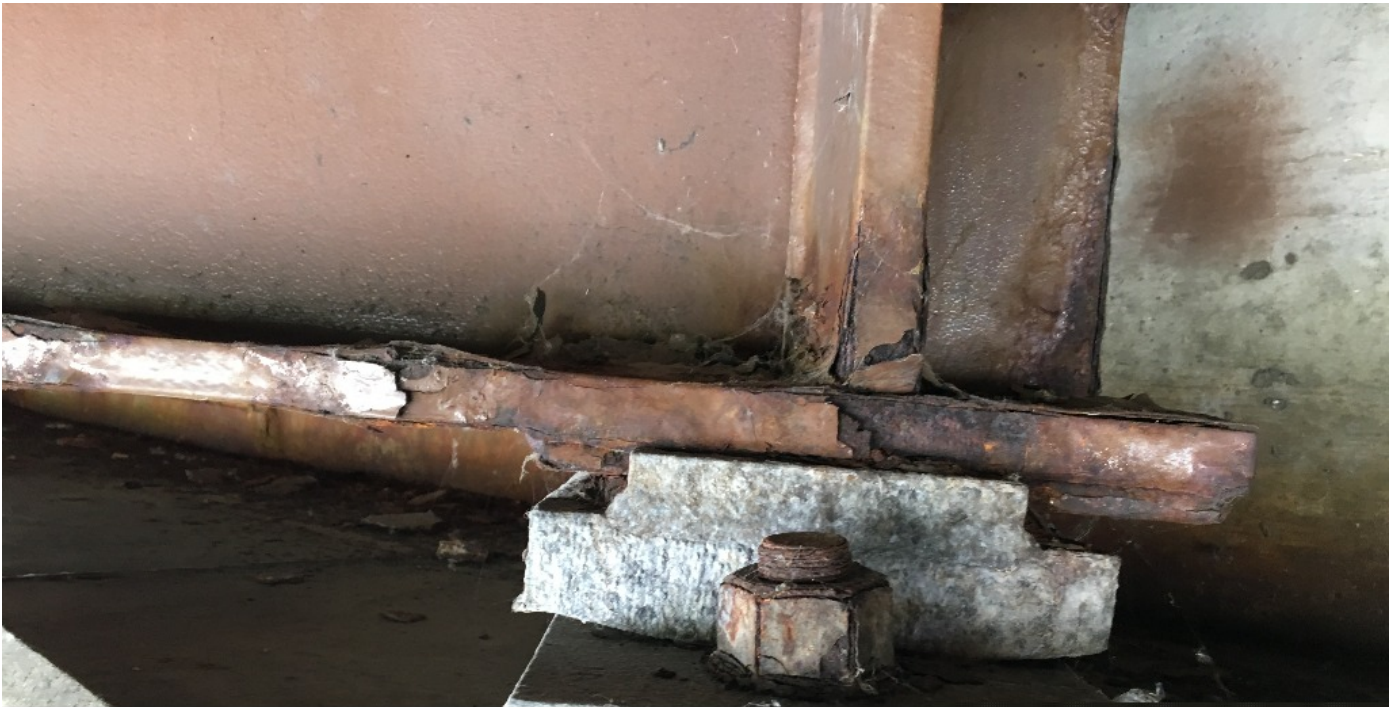
| Chk | Element | Defect | Description | UOM | Total | Quantity in Condition State | | | |
|---|---|---|---|---|---|---|---|---|---|
| | | 1000 | Corrosion<br><b>Rust developing on bottom flanges throughout. pack rust at ends by stiffeners.</b> | LF | | 0 | 240 | 16 | 0 |

Girder end rusting, flaking, pack rust, rusting on bearings, E end appears worse.
