# **B-14-0116\_oth**

## Bridge Asbestos Inspection Report

**Structure Number:** B-14-0116

**Structure Name:** Soo Road over IH 41

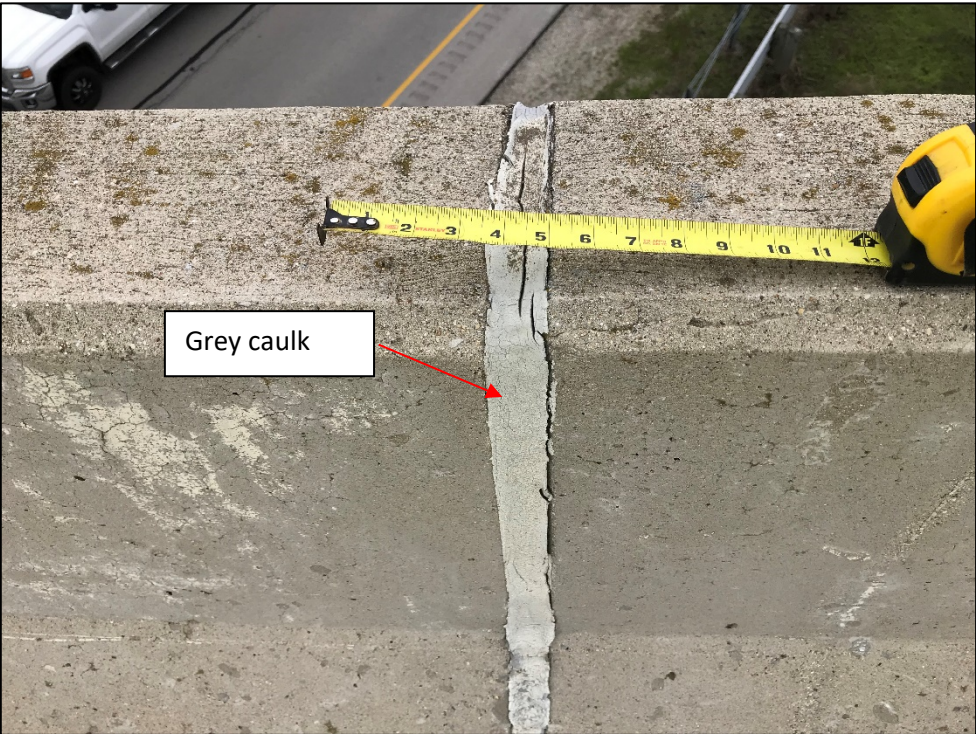
<p><b>PHOTOGRAPH NO: 4</b></p>

<p><b>DIRECTION: N</b></p>	
<p><b>DESCRIPTION:</b></p> <p>Looking at the grey caulk on the wall joint. The grey caulk is ACM (2% chrysotile asbestos).</p>

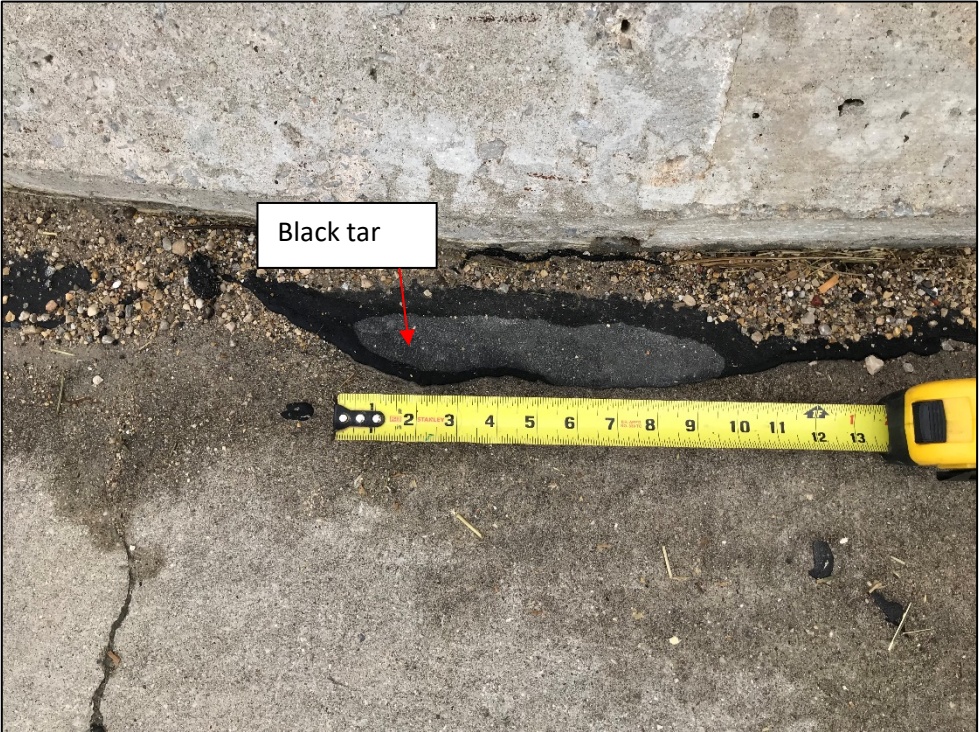
<p><b>PHOTOGRAPH NO: 5</b></p>

<p>A photograph showing a close-up of a concrete deck joint. A thick, dark, irregularly shaped mass of black tar is visible along the joint. A yellow measuring tape is placed horizontally below the tar, showing measurements from approximately 2 to 13 inches. A red arrow points from a white box labeled 'Black tar' to the tar mass. The background shows a concrete surface and some gravel.</p>
<p><b>DIRECTION:</b> Down</p>	
<p><b>DESCRIPTION:</b></p> <p>Looking at the black tar found on the deck joints. The black tar is not ACM.</p>

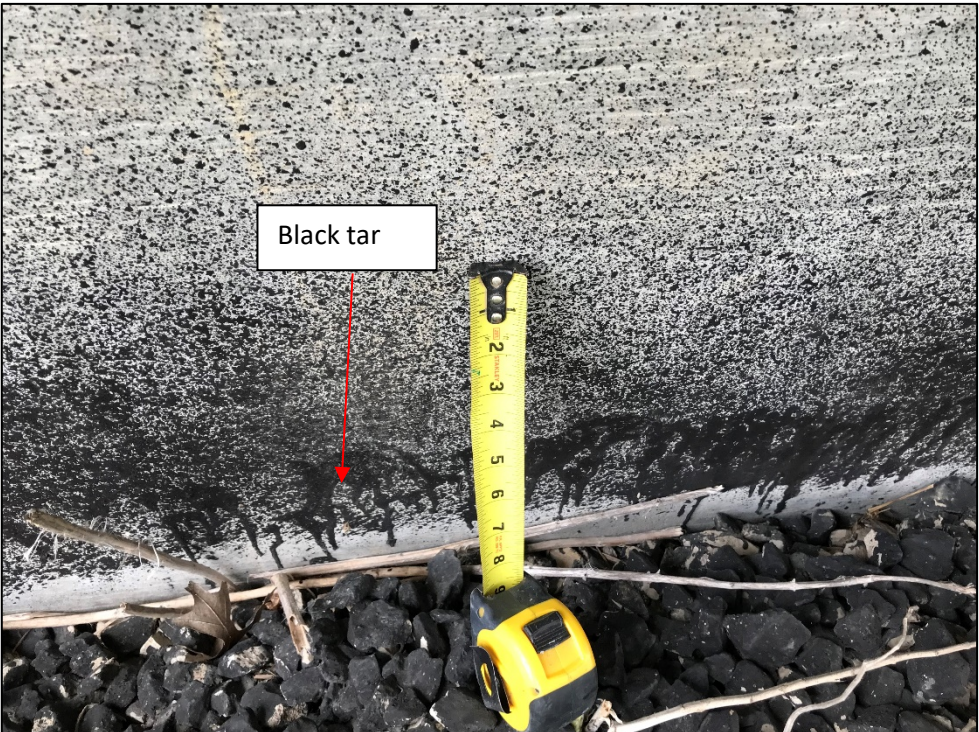
<p><b>PHOTOGRAPH NO: 6</b></p>

<p>A photograph showing a close-up of a concrete abutment base. A thick, dark, irregularly shaped mass of black tar is visible on the base. A yellow measuring tape is placed vertically next to the tar, showing measurements from approximately 2 to 9 inches. A red arrow points from a white box labeled 'Black tar' to the tar mass. The background shows a concrete surface and some gravel.</p>
<p><b>DIRECTION:</b> E</p>	
<p><b>DESCRIPTION:</b></p> <p>Looking at the black tar found on the abutment base. The black tar is not ACM.</p>

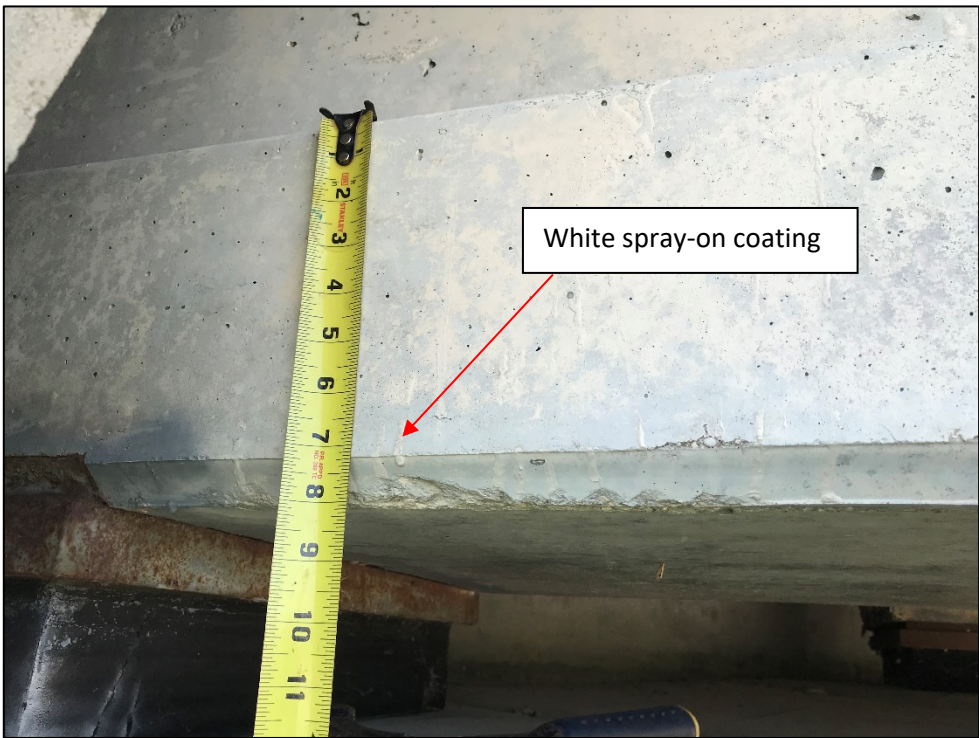
<b>PHOTOGRAPH NO: 8</b>

<b>DIRECTION: S</b>	
<b>DESCRIPTION:</b>  Looking at the white spray-on coating from the concrete spans. The coating is not ACM.

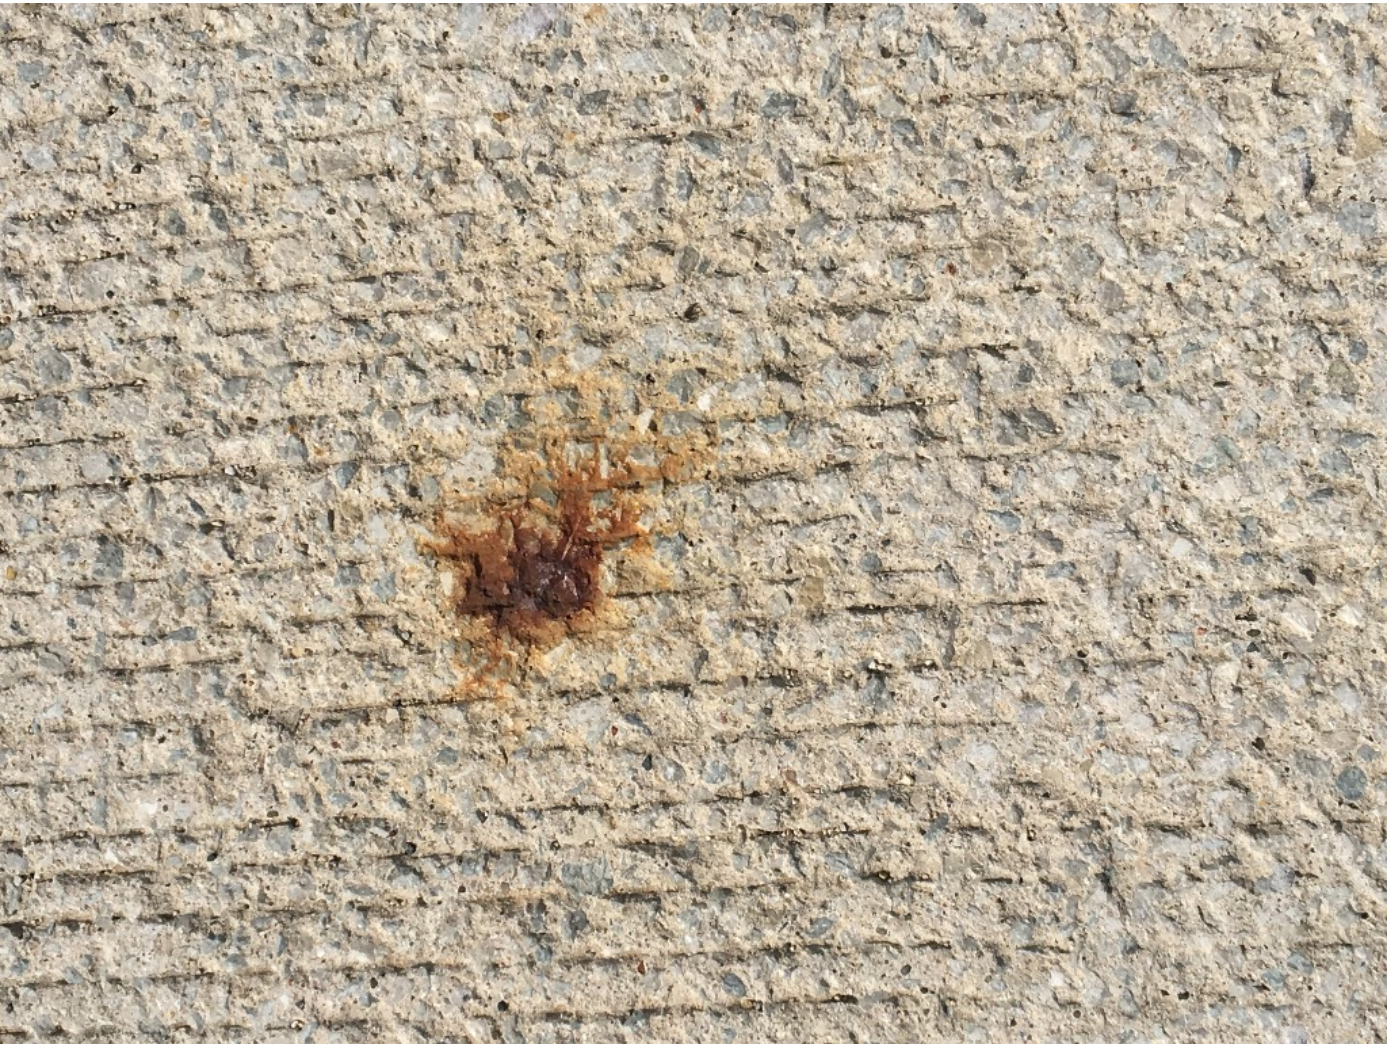
Routine  
Document Comment/Description  
rust stain mid deck

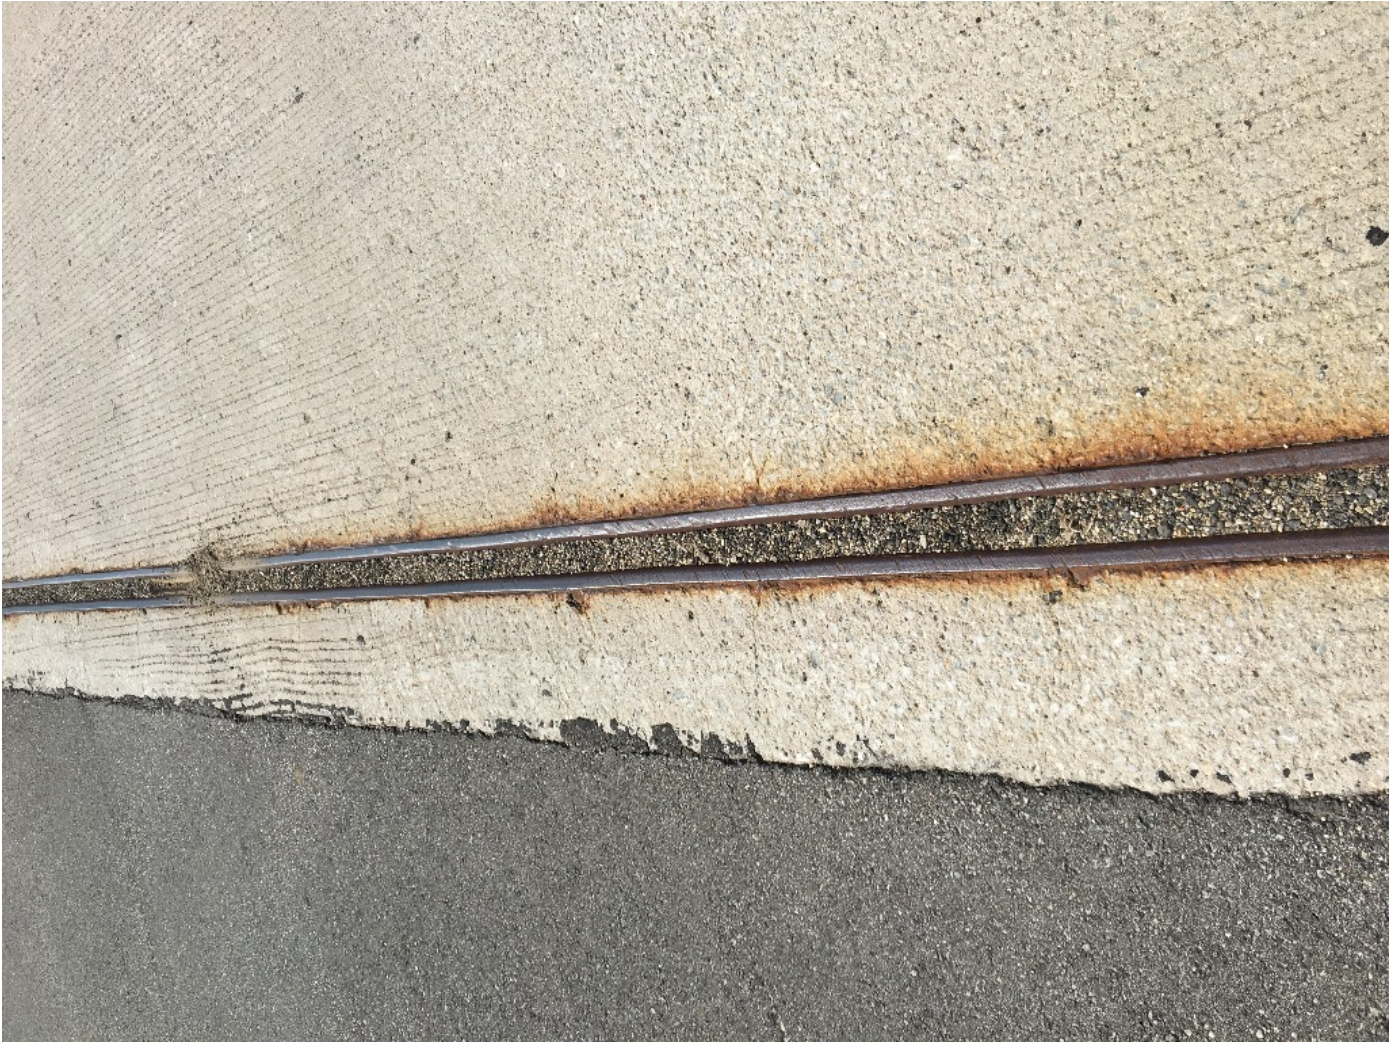
E strip seal (W is similar) impacted w/ debris

Item	Priority	Recommended by	Status	Status change
<b>IMP-Thin Epoxy Overlay</b>	HIGH	Tripoli, Bonnie (1012)	IDENTIFIED	08/21/14
Program epoxy-type overlay to protect deck from snowmobiles.				
<b>IMP-Thin Epoxy Overlay</b>	HIGH	Katzner, Steven D (1011)	IDENTIFIED	09/14/16
Place polymer overlay.				
<b>Drainage - Repair Washouts / Erosion</b>	MEDIUM	Tripoli, Bonnie (1012)	IDENTIFIED	08/21/14
Repair washout at NW corner. Again 2018				
<b>Deck - Clean and Sweep Deck/Drains</b>	MEDIUM	Lammert, Terry (1018)	IDENTIFIED	09/11/18
Sweep deck				
<b>Expansion Joints - Clean</b>	MEDIUM	Lammert, Terry (1018)	IDENTIFIED	09/11/18
Remove debris from strip seals.

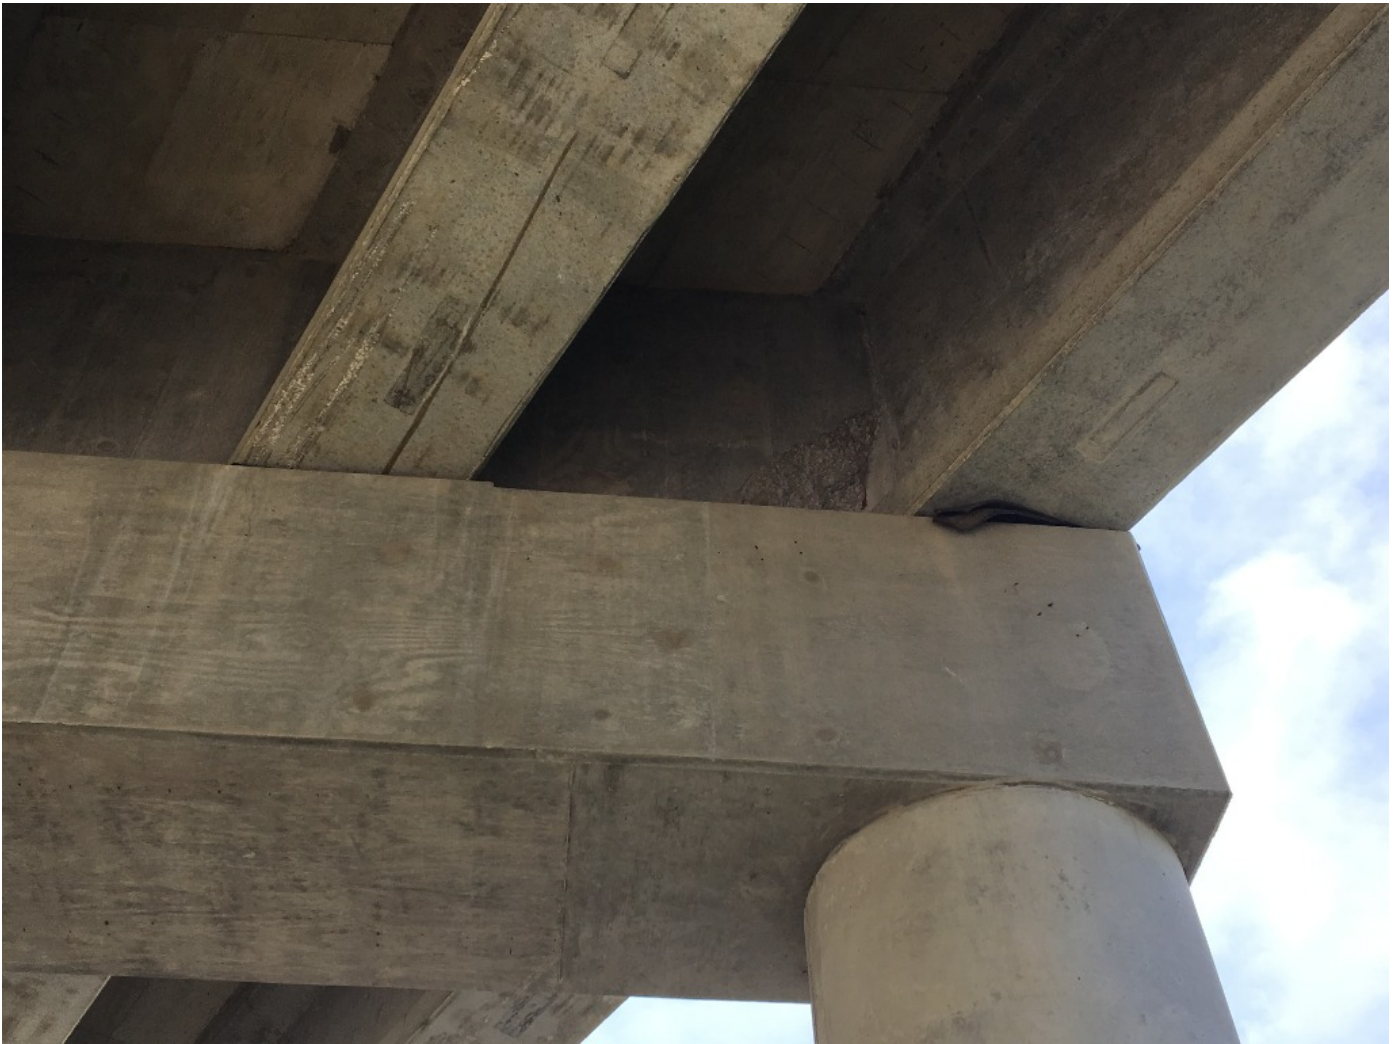
ON THE WEST ABUTMENT, ALL 5 OF THE ELASTIC BEARINGS ARE TIPPED BACK, SO THAT THE FRONT EDGE IS ABOUT 0.5' OFF THE BEARING SEAT. ALSO, SOME VERTICAL CRACKS ARE PRESENT IN THE RUBBER MATERIAL.

E face B1 large corner spall in conc. diag. bearing rubber slippage
