# Inspection Report for B-24-009 ( PUCKYAN RIVER CROSSING. )

STH 23 over PUCKYAN RIVER  
Jun 19,2017

**BRIDGE INSPECTION REPORT**  
**Wisconsin Department of Transportation**  
**DT2007 2003 s.84.17 Wis. Stats.**

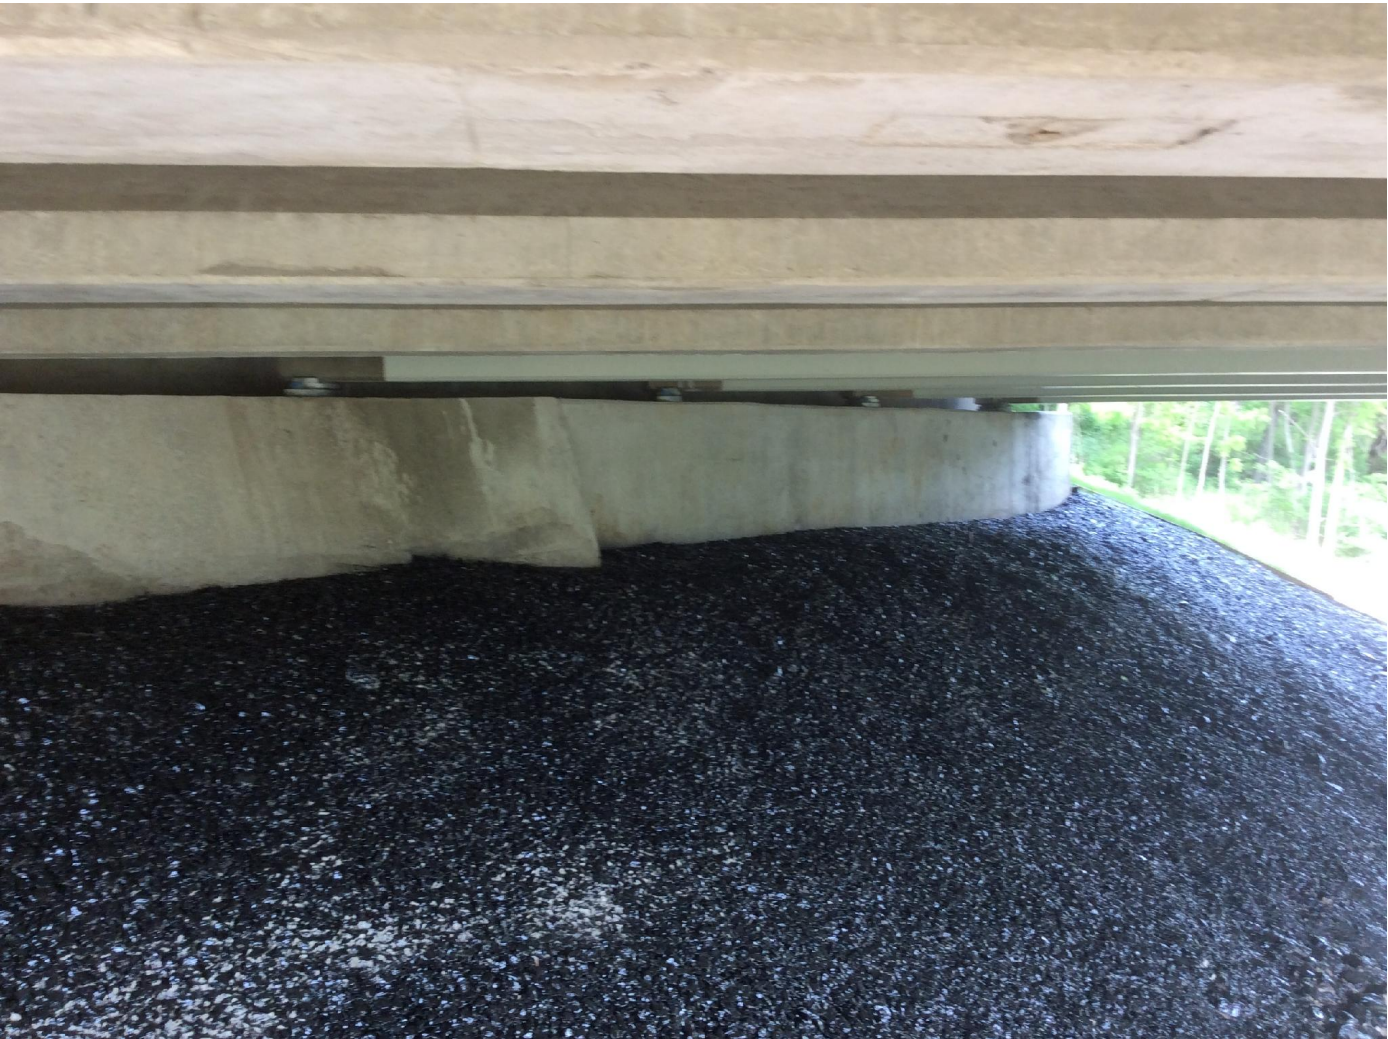
TYPICAL ABUTMENT AND SLOPE PAVING

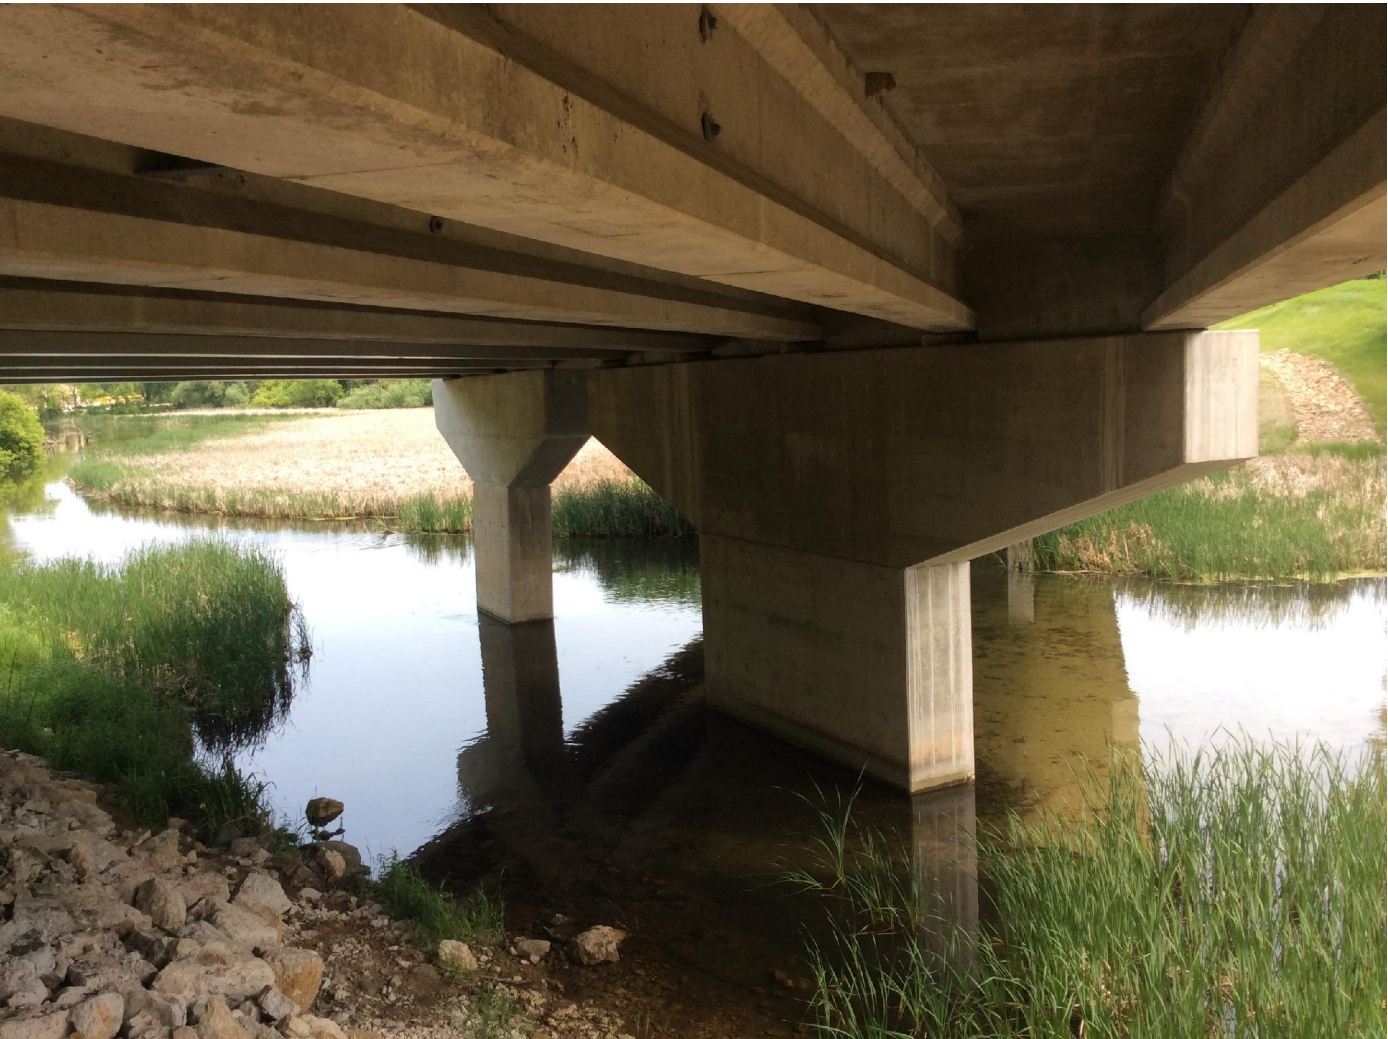
TYPICAL PIER AND WIDENING

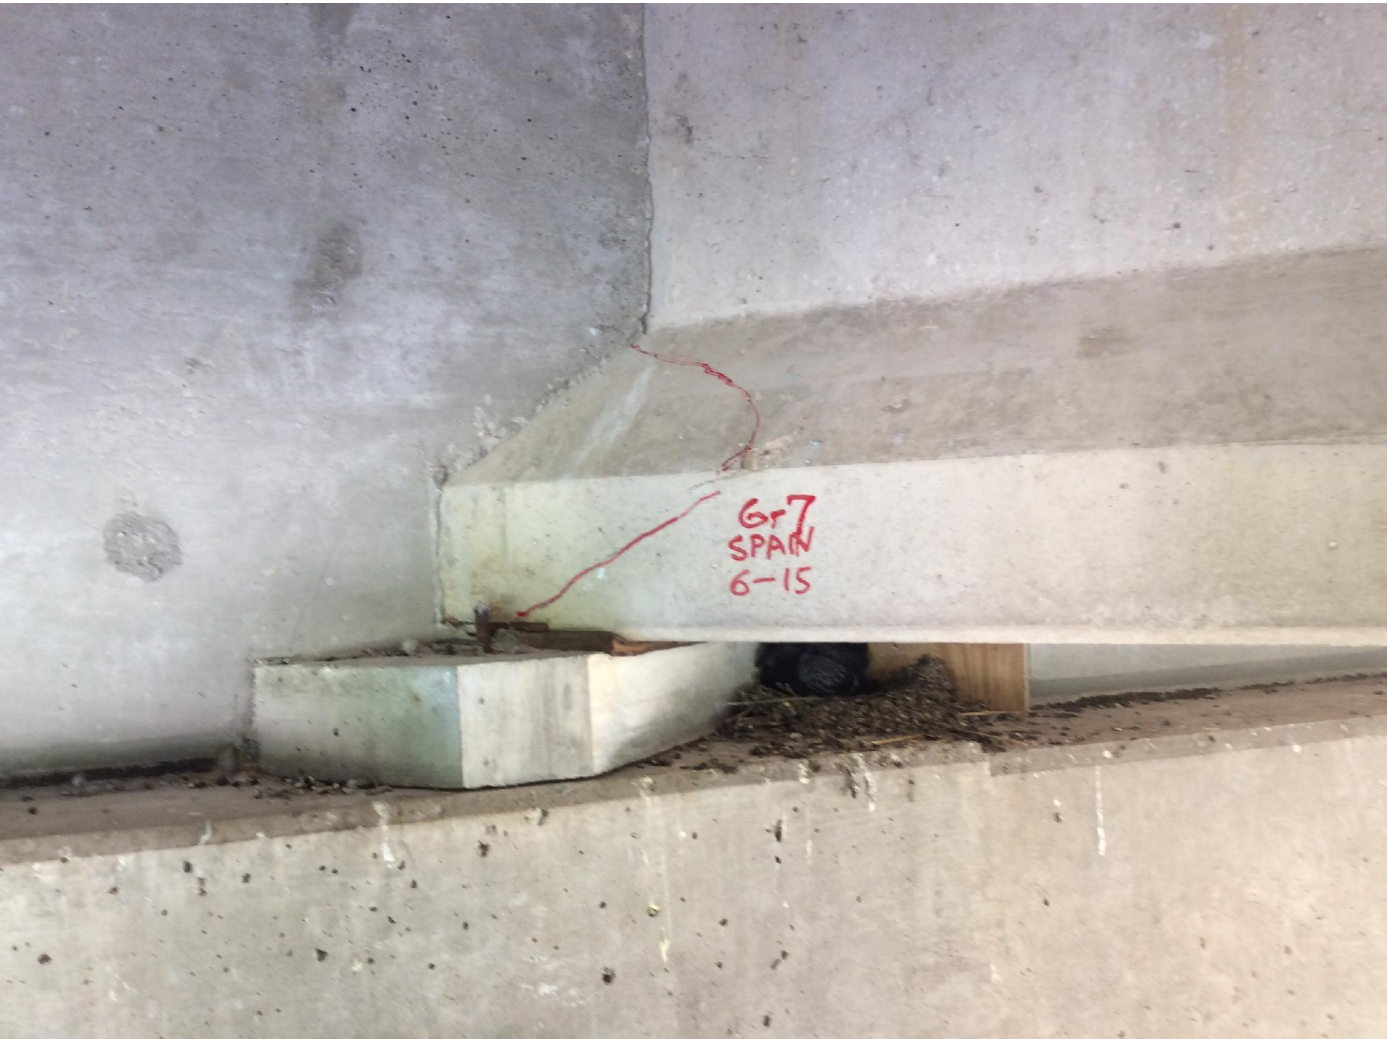
GIRDER END CRK/DELAM (2015)

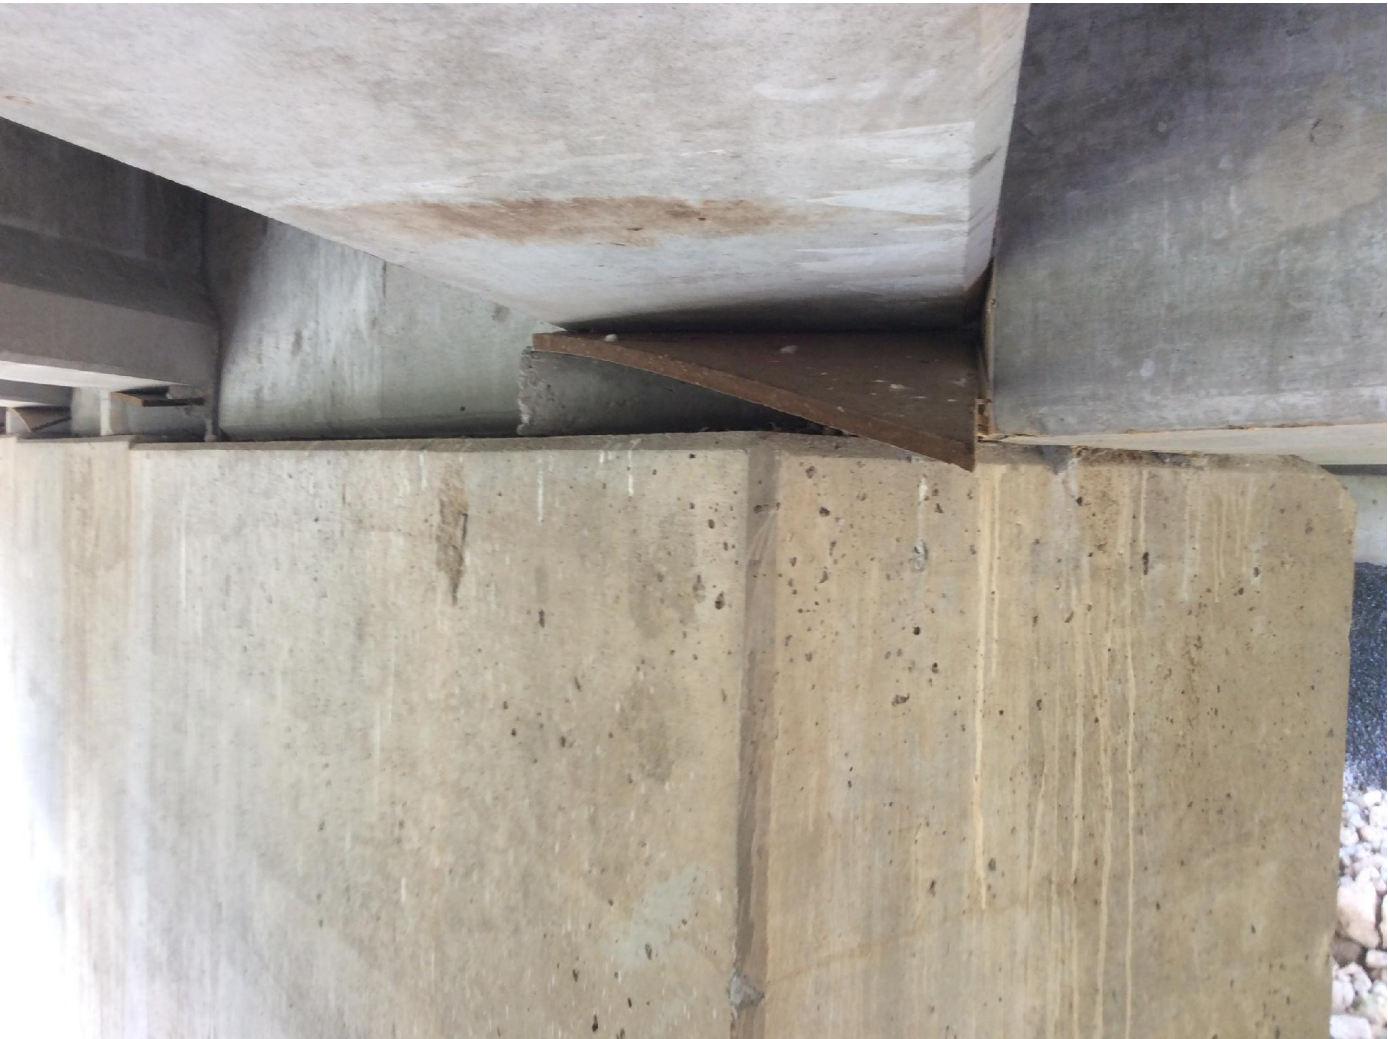
GIRDER FELT WORKING OUTWARD OR NOT CUT OFF.

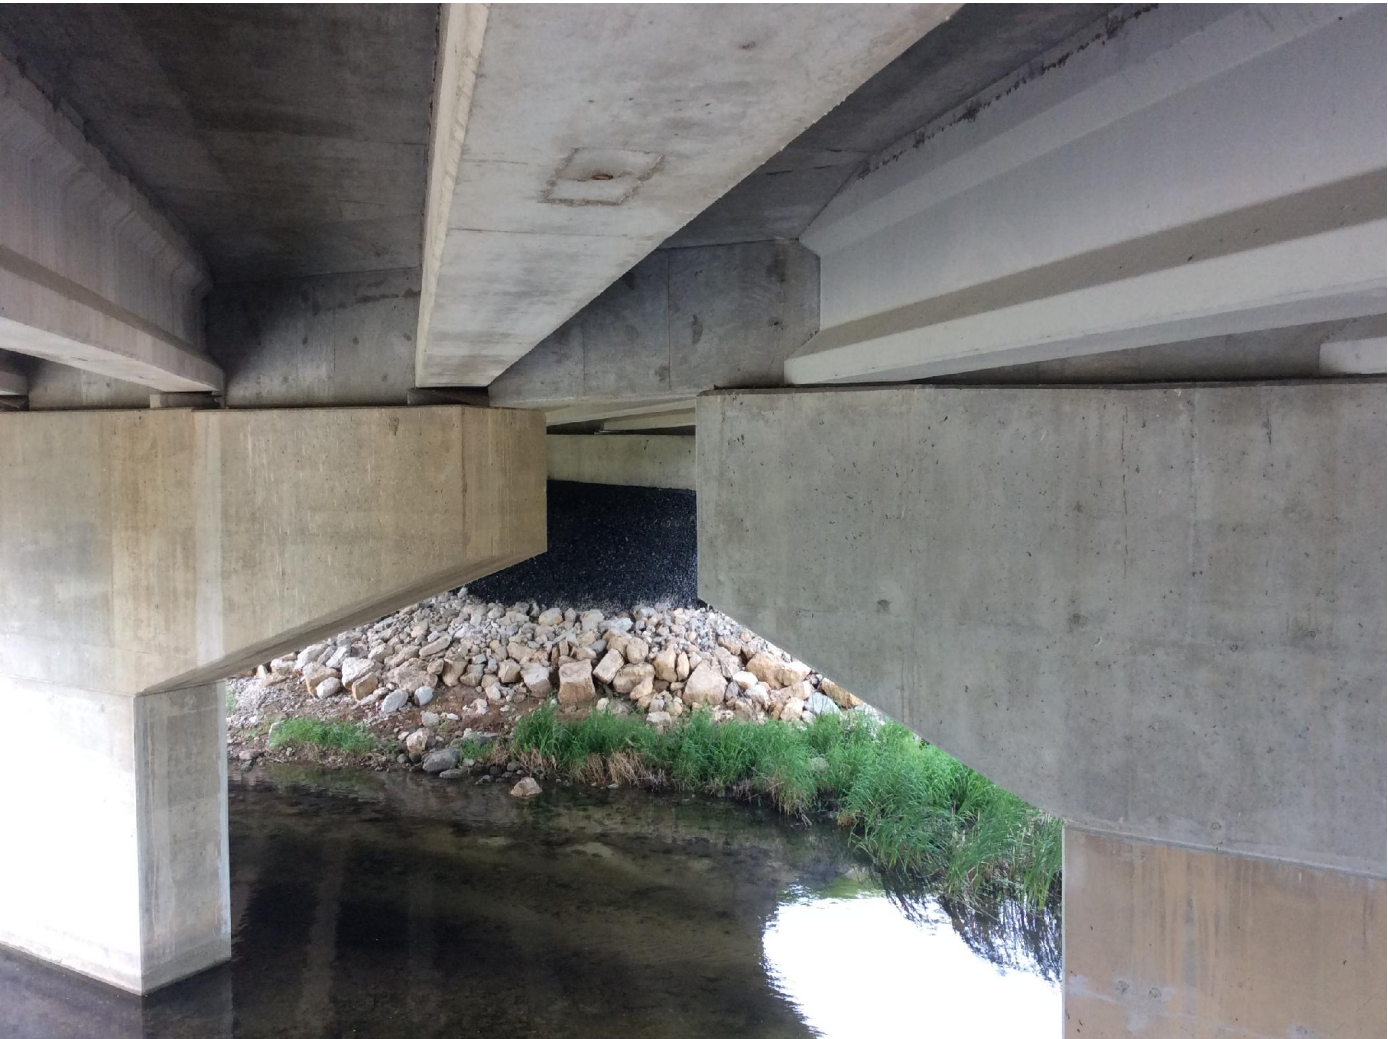
APPEARS PIER 1 EXTENSION BUILT +/- 6" FURTHER NORTH THAN OTHERS. EVIDENT IN DIAPHRAM CONNECTIONS IN THIS BAY.
---

PIER WIDENING

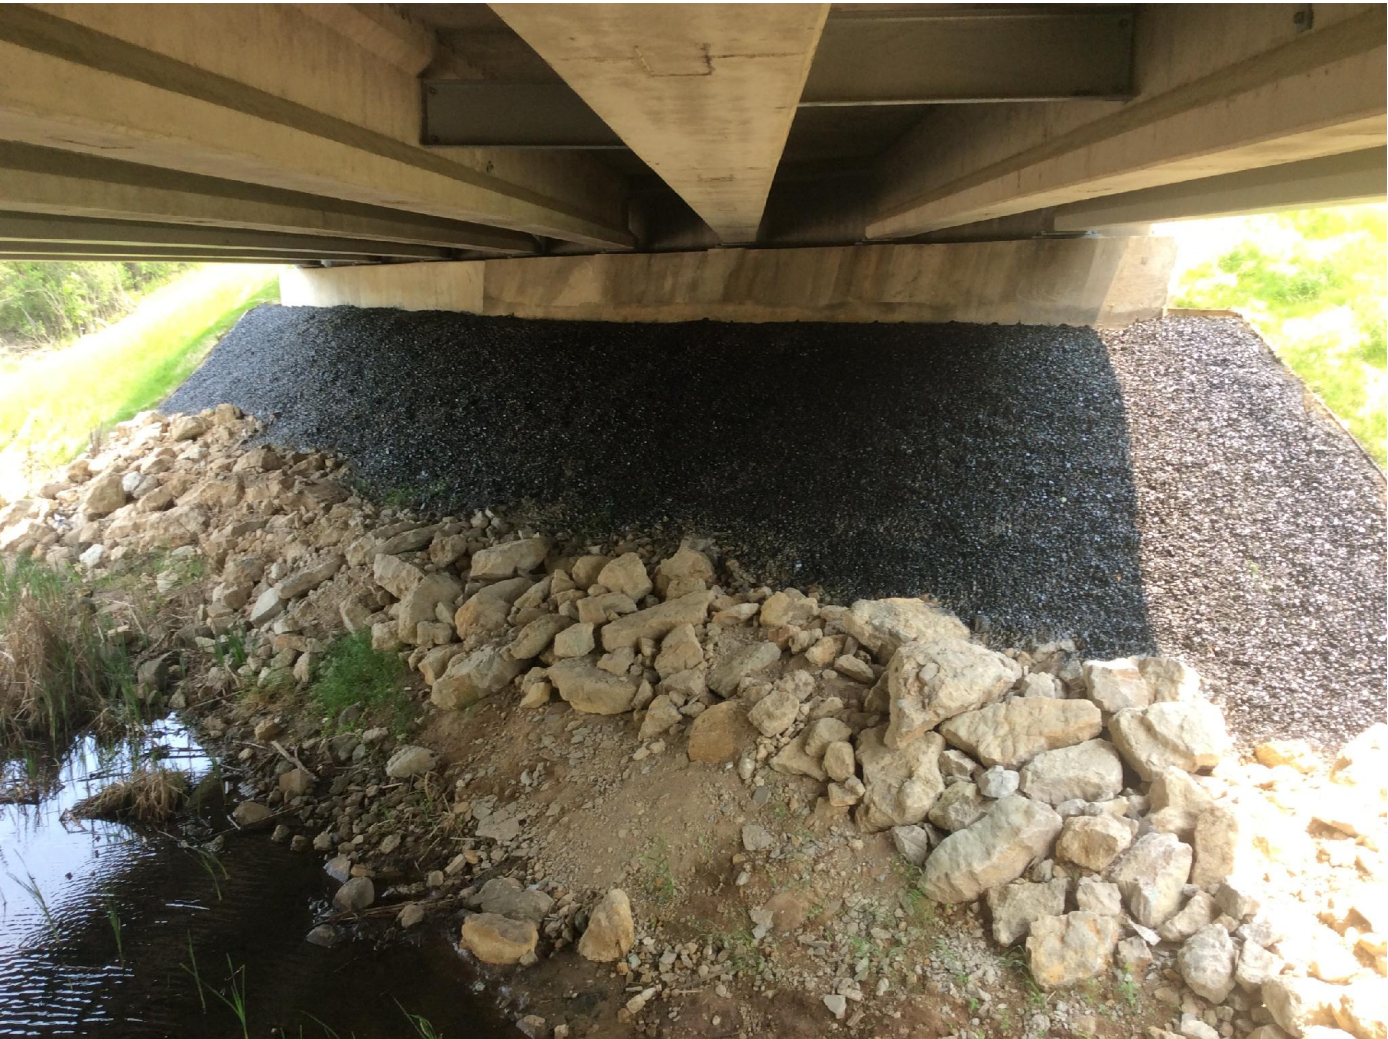
ABUTMENT SLOPES - TYPICAL

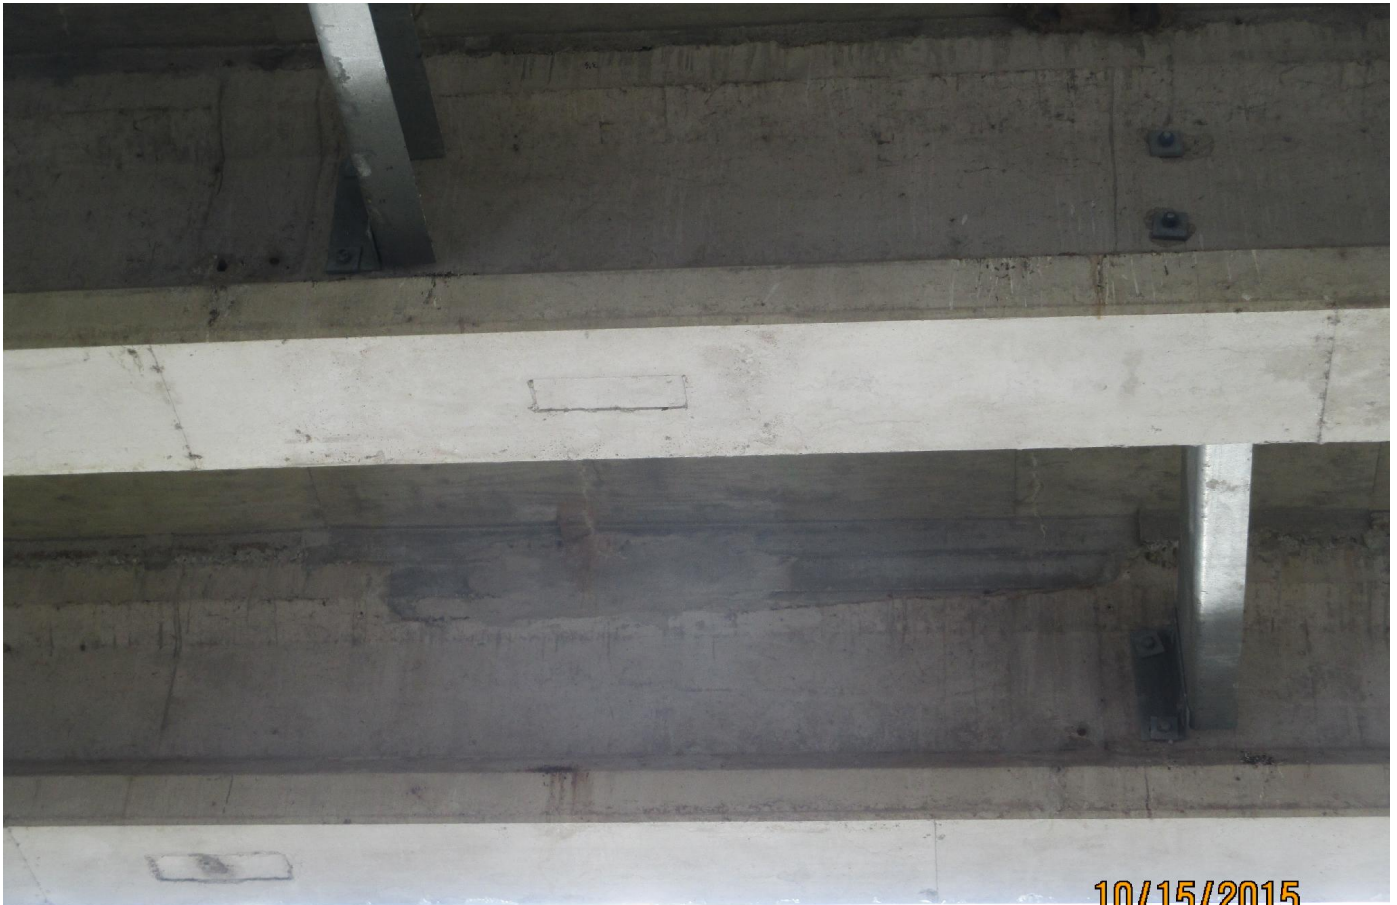
G8 (FORMER G5), SPAN 2. PATCH 2014.

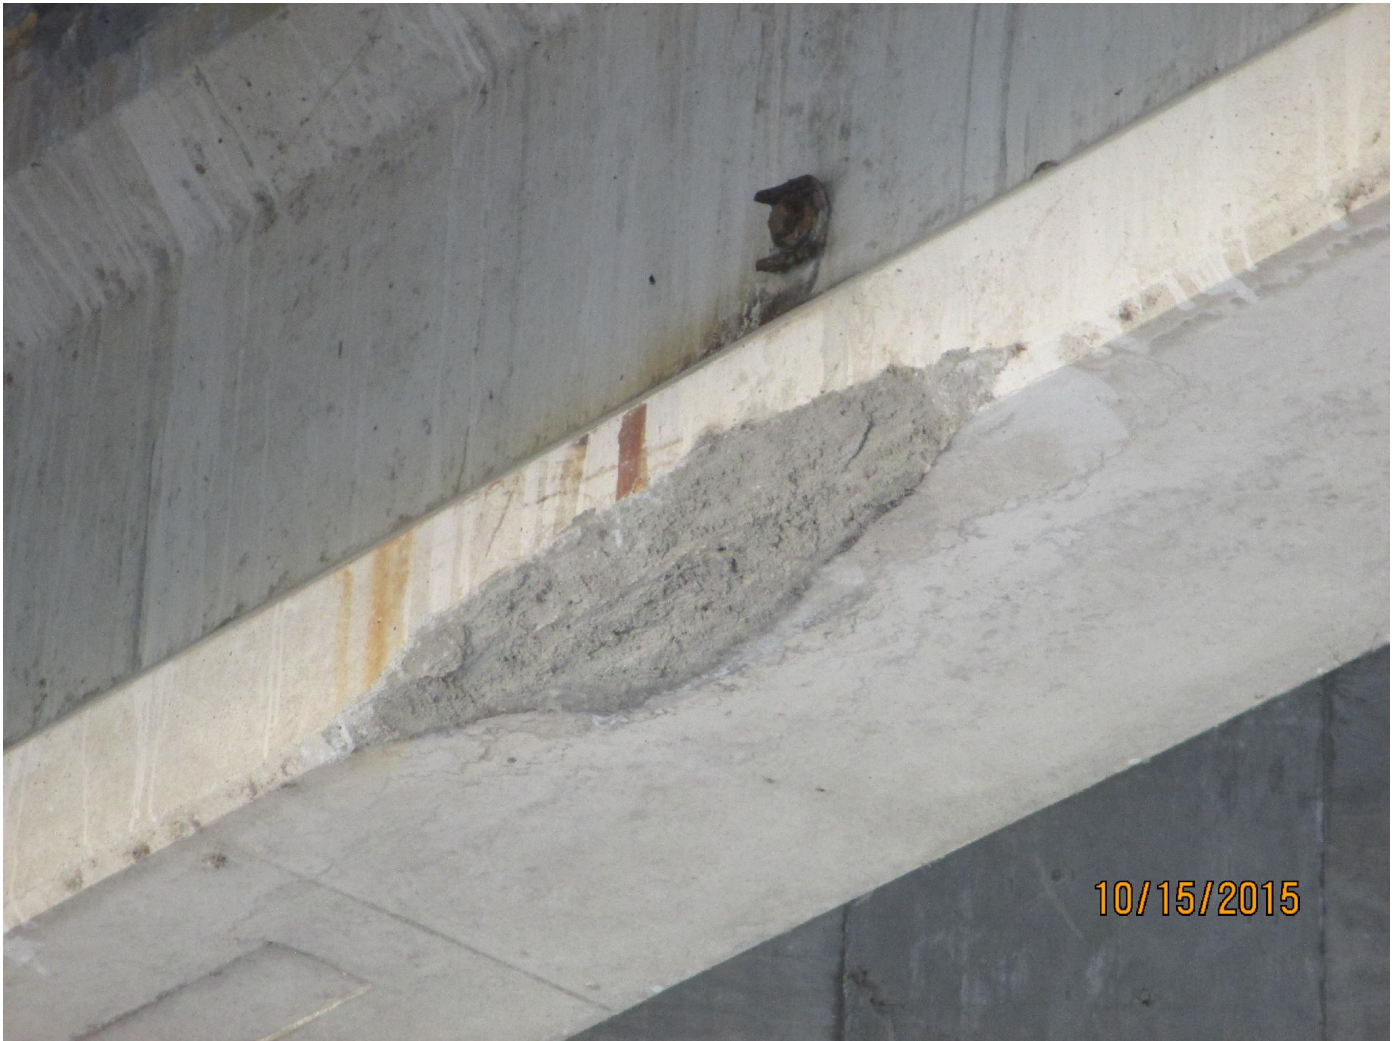
G4 SPAN 3 PATCH

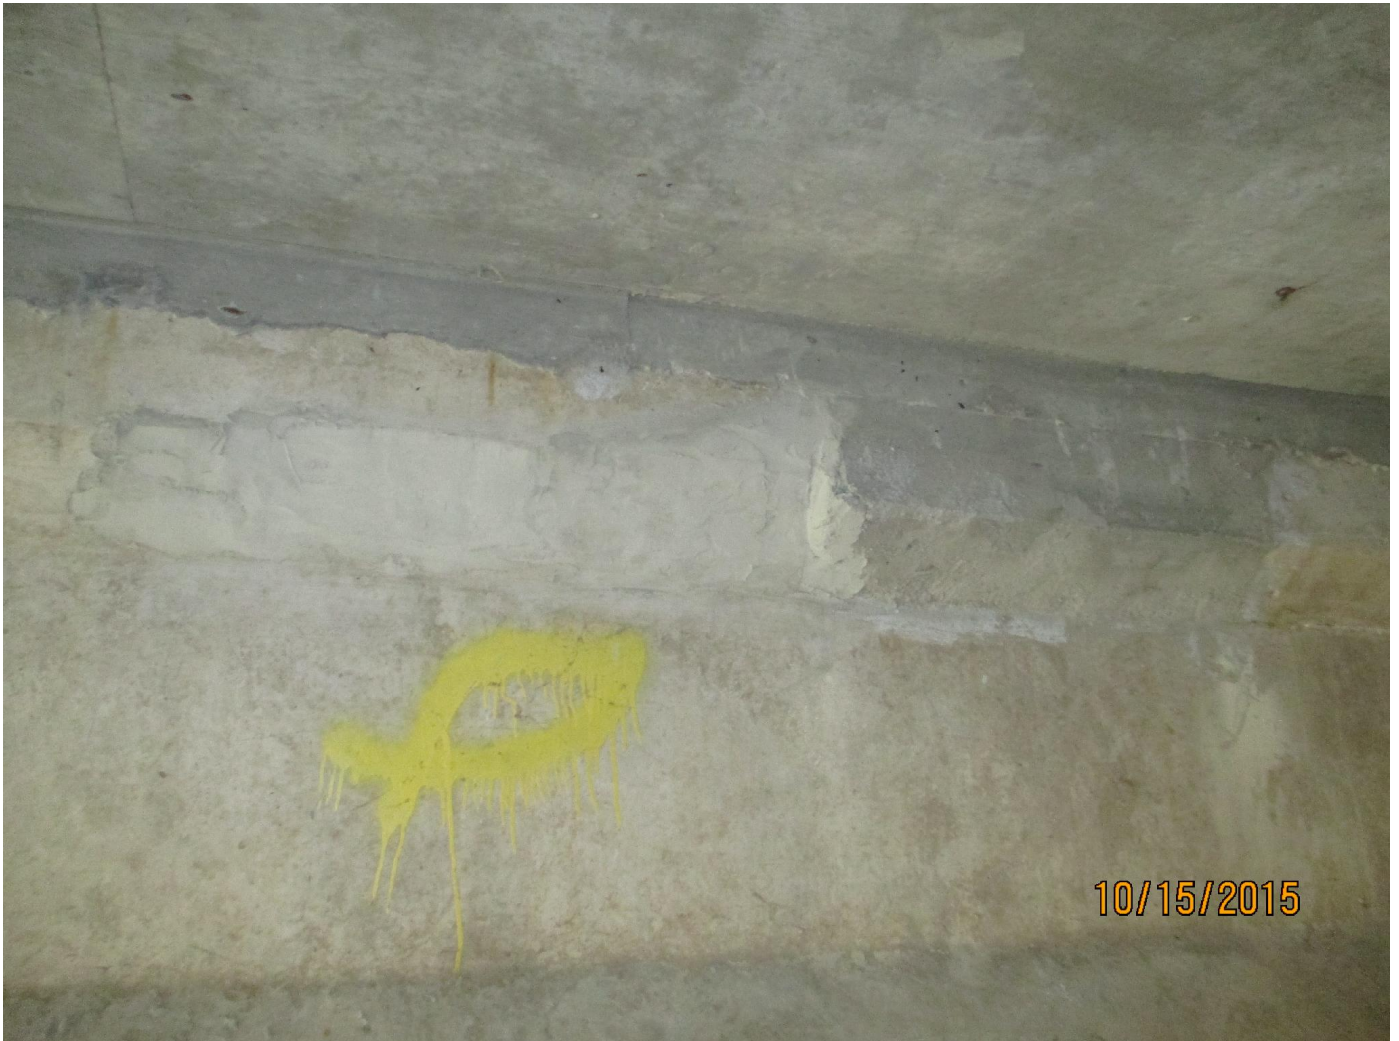
FORMER G5 NEAR EAST ABUT

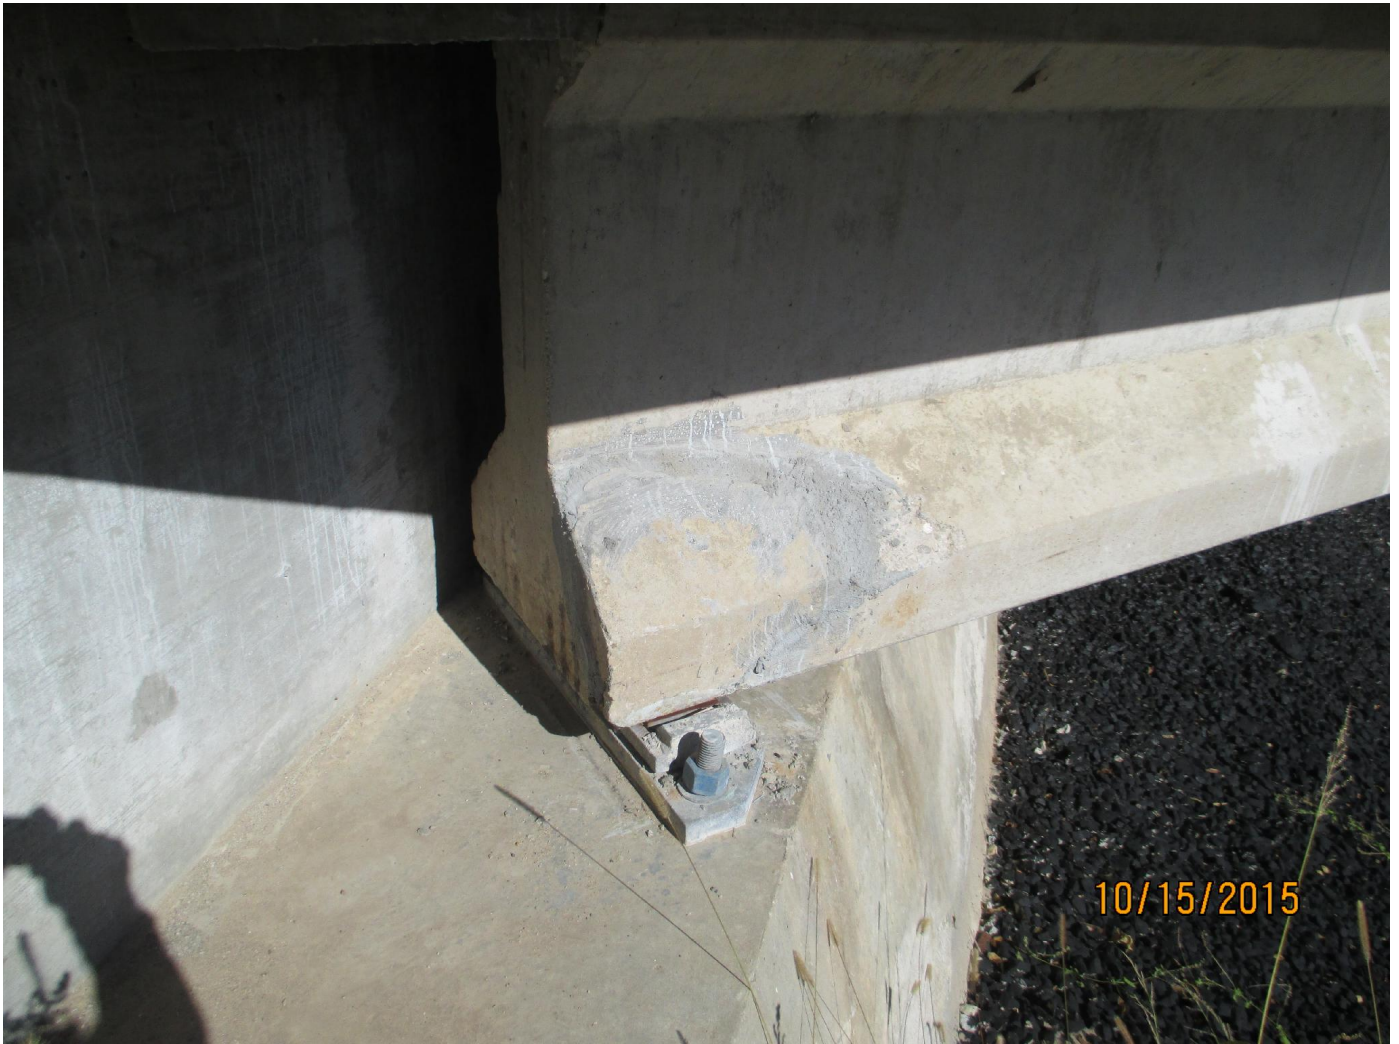
FORMER G5 AT WEST ABUTMENT. PATCHED DELAM (2014).

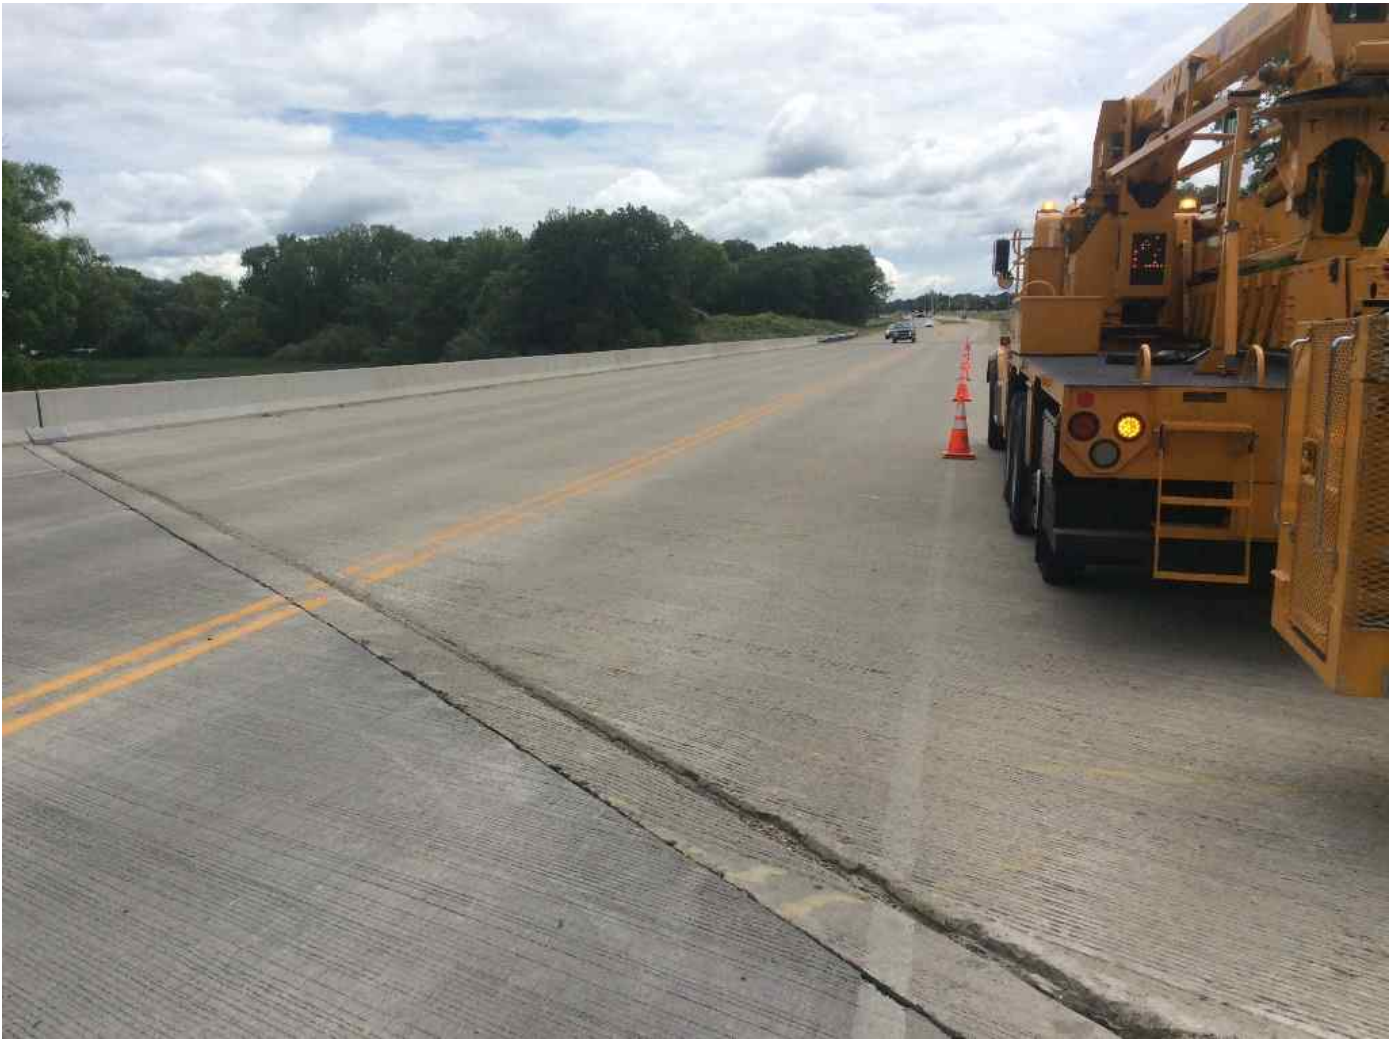
TYPICAL BRIDGE DECK LOOKING EAST.

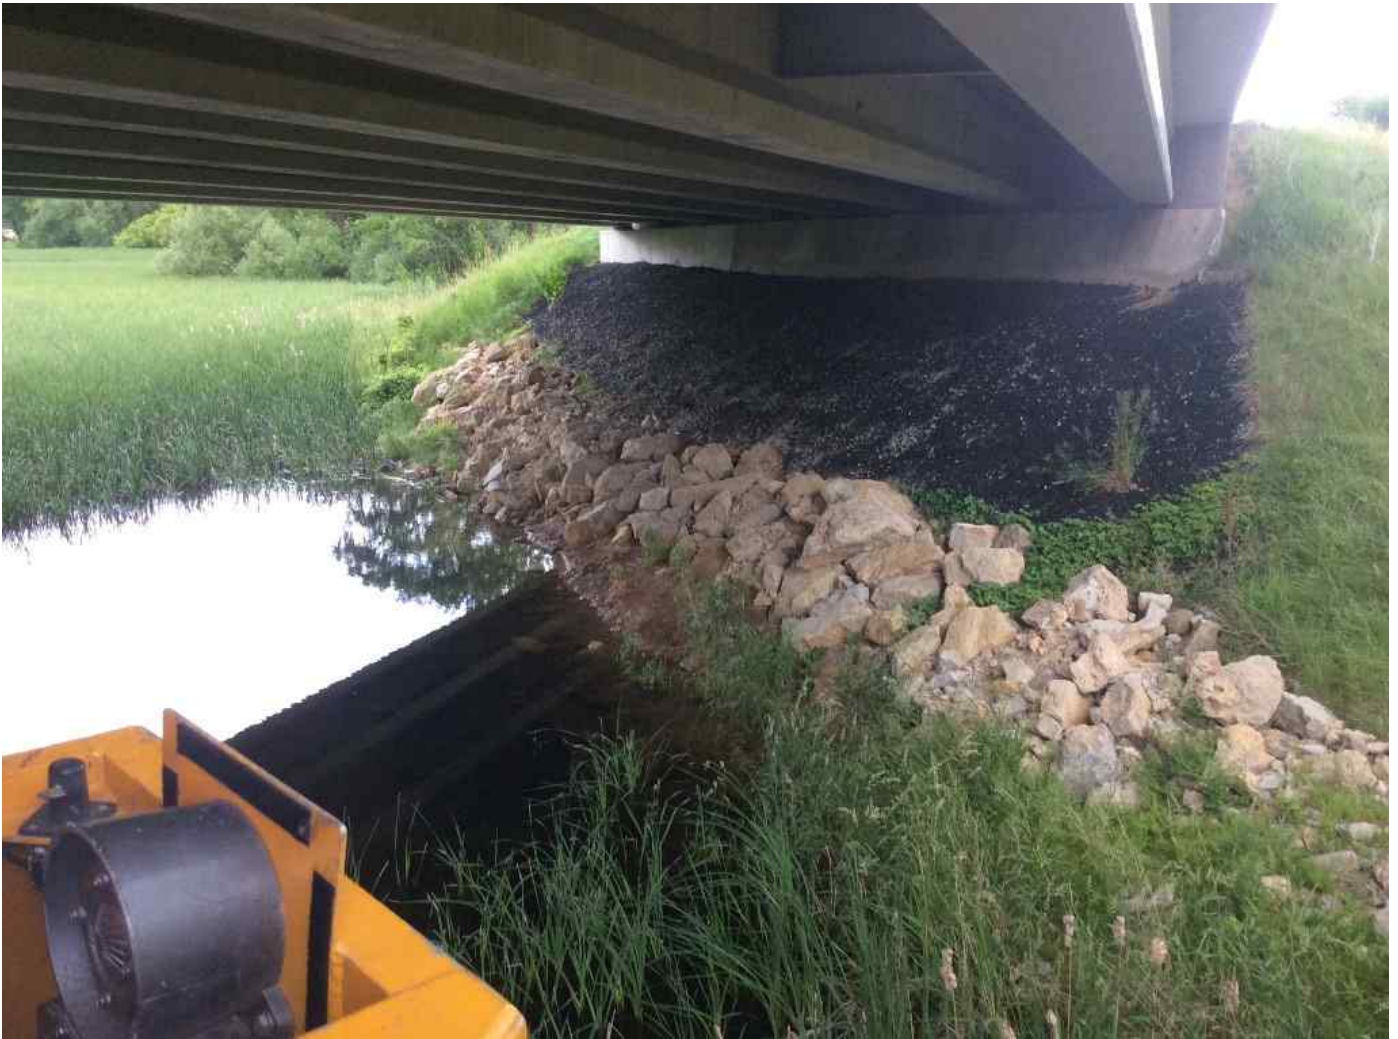
TYPICAL ABUT AND SLOPE PAVING W/RIPRAP.

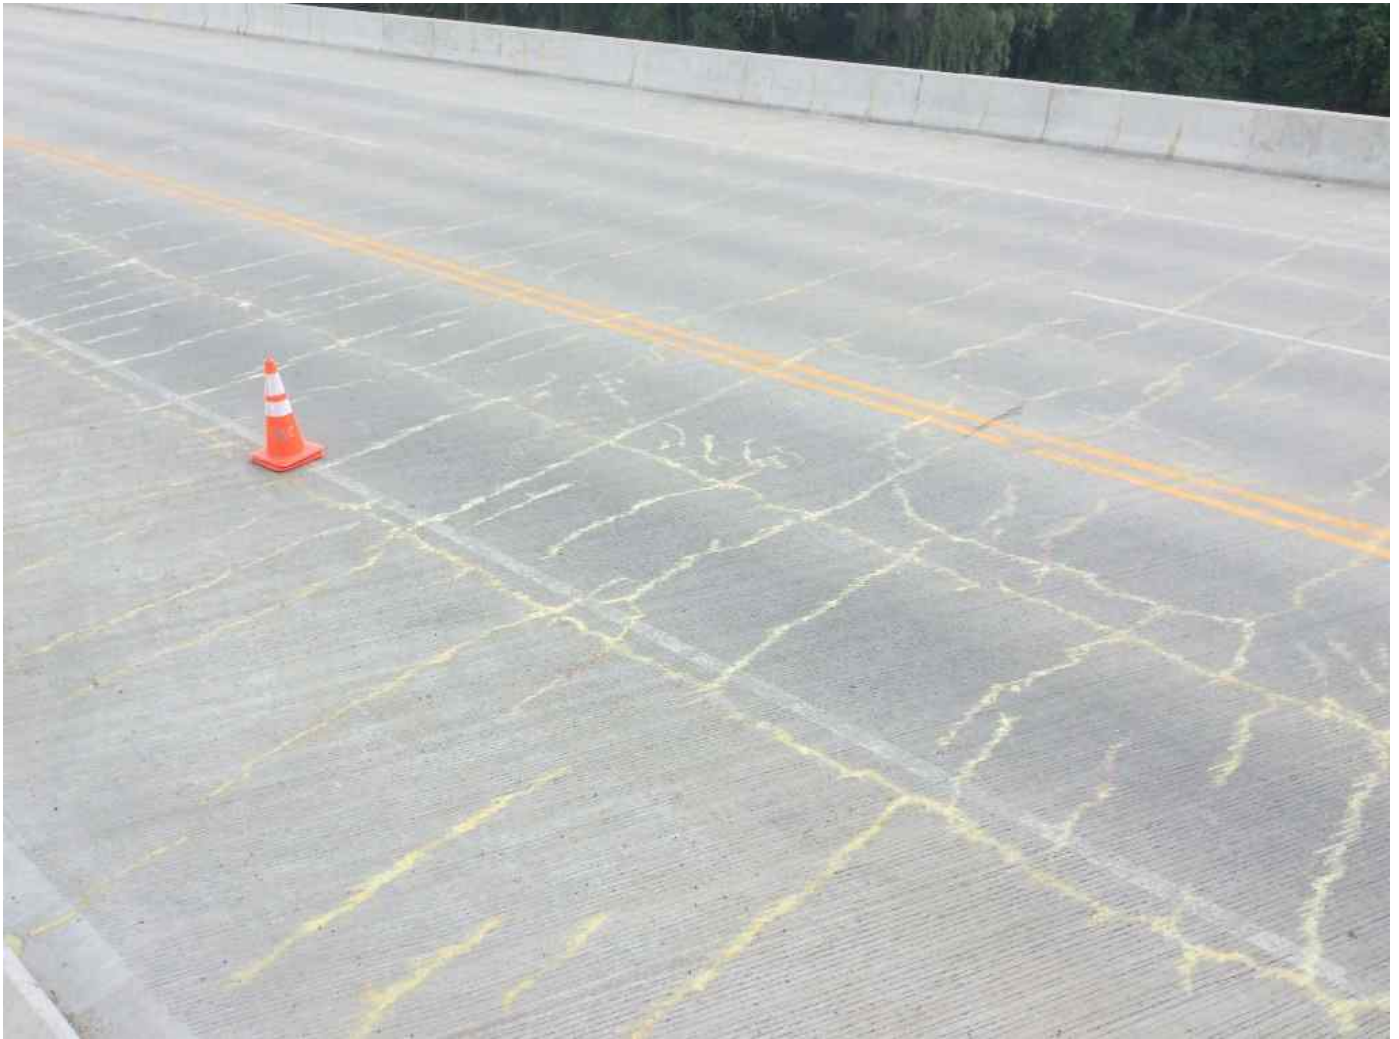
Chk	Element	Defect	Description	UOM	Total	Quantity in Condition State			
						1	2	3	4
X	12		<b>Reinforced Concrete Deck</b>	SF	19,760	18,560	1,200	0	0
			WIDENED & REDECKED 2014.						
		1080	Delamination - Spall - Patched Area	SF		0	0	0	0
		1130	Cracking (RC)	SF		0	1,200	0	0
			<b>SPAN 1: 6 FULL WIDTH TRANSV CRACKS ALONG SKEW; 360 SF IN C2. SPAN 2: 7 FULL WIDTH TRANSV CRACKS ALONG SKEW; 420 SF IN C2. SPAN 3: 7 FULL WIDTH TRANSV CRACKS ALONG SKEW; 420 SF IN C2.</b>						
	8000		Wearing Surface (Bare)	SF	19,760	17,760	2,000	0	0
			2014.						
		3220	Crack (Wearing Surface)	SF		0	2,000	0	0
X	109		<b>Prestressed Concrete Open Girder</b>	LF	1,653	1,630	21	2	0
			3 NORTH GIRDER LINES ADDED 2014 (G1A-G1C WITH G1C NORTHLY GIRDER); SEVERAL INDIVIDUAL GIRDER REPLACEMENTS IN EXISTING 5 GIRDER LINES (FORMER G1 IN SPAN 1, G8 IN -SPAN 4. <b>8 TOTAL-45 INCH GIRDERS.</b>						
		1080	Delamination - Spall - Patched Area	LF		0	21	2	0

SIGNIFICANT LONG AND TRANS CRACKS ACROSS DECK.

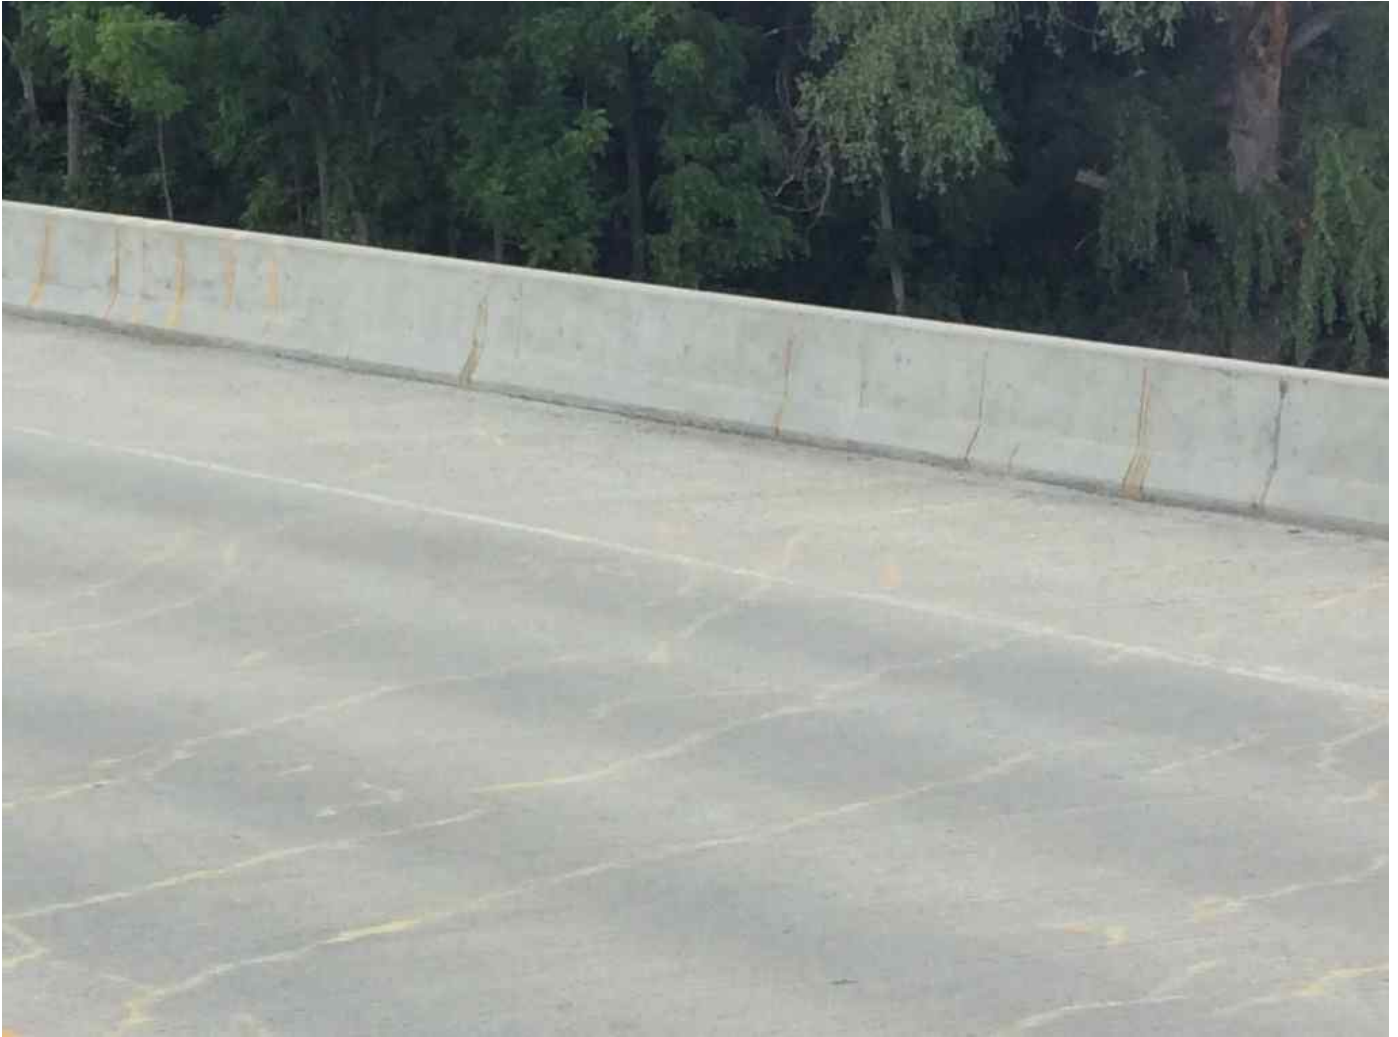
TRANS CRACKS ACROSS DECK FULL WIDTH.
