**SITE PHOTOGRAPHS
FOR
STRUCTURE
SURVEY REPORT**

**USH 53 SB Over CTH AA
B-3-16
TOWN OF DOVRE, WI
BARRON COUNTY**

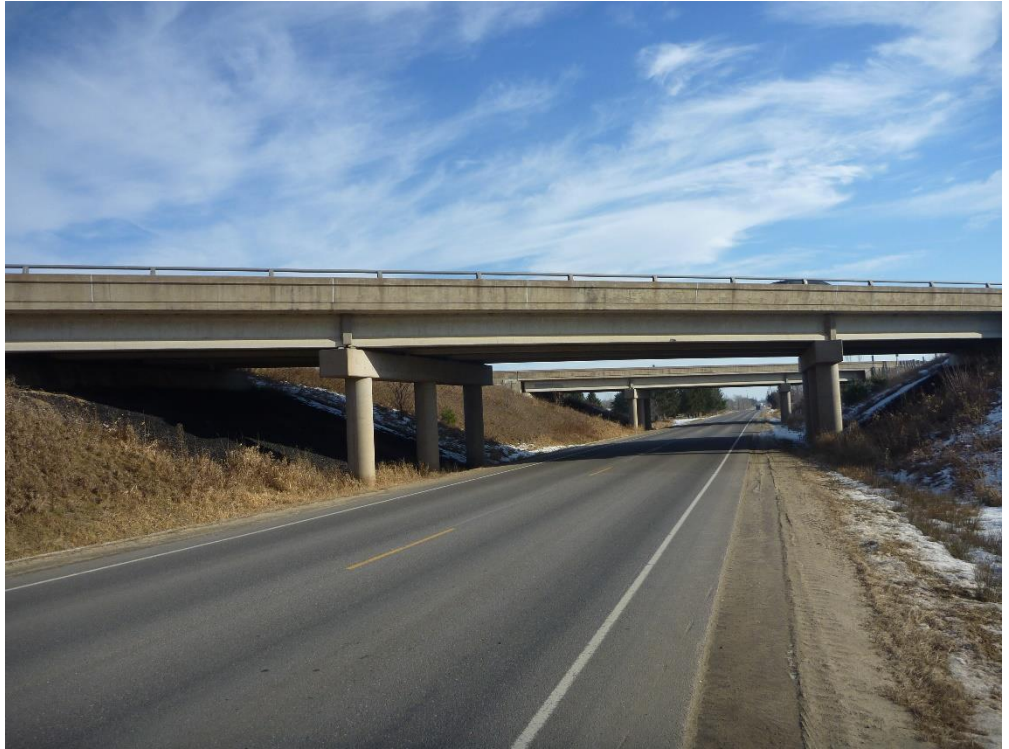
View from CTH AA looking east at B-3-16.

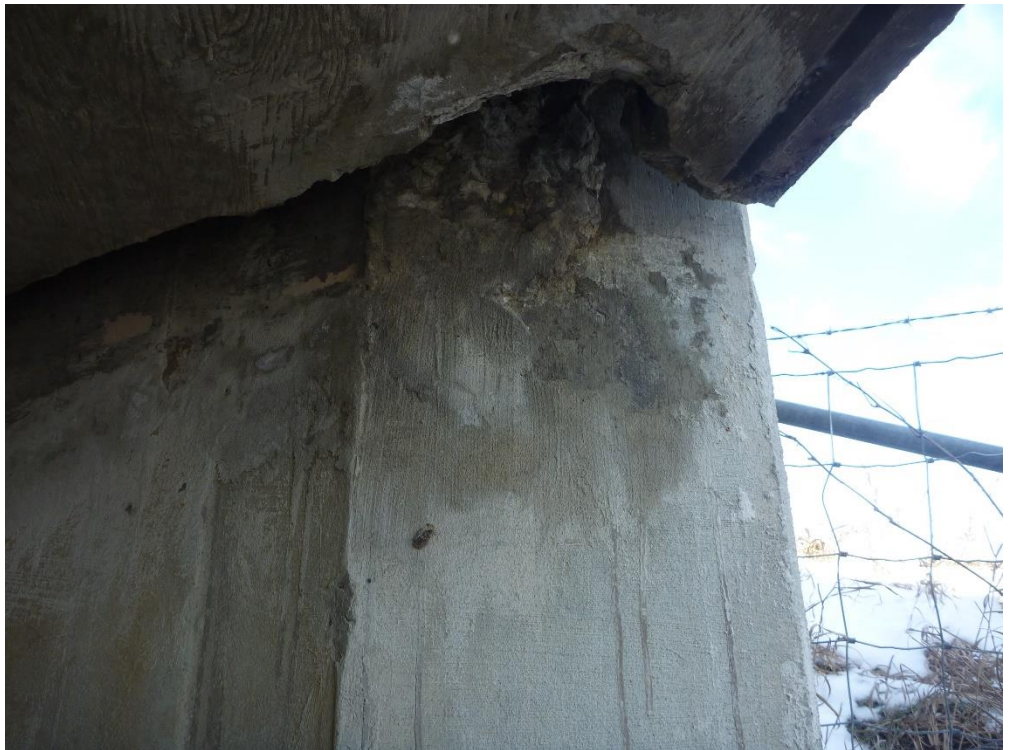
View of concrete spalling at the underside of deck at east end of north abutment of bridge B-3-16.

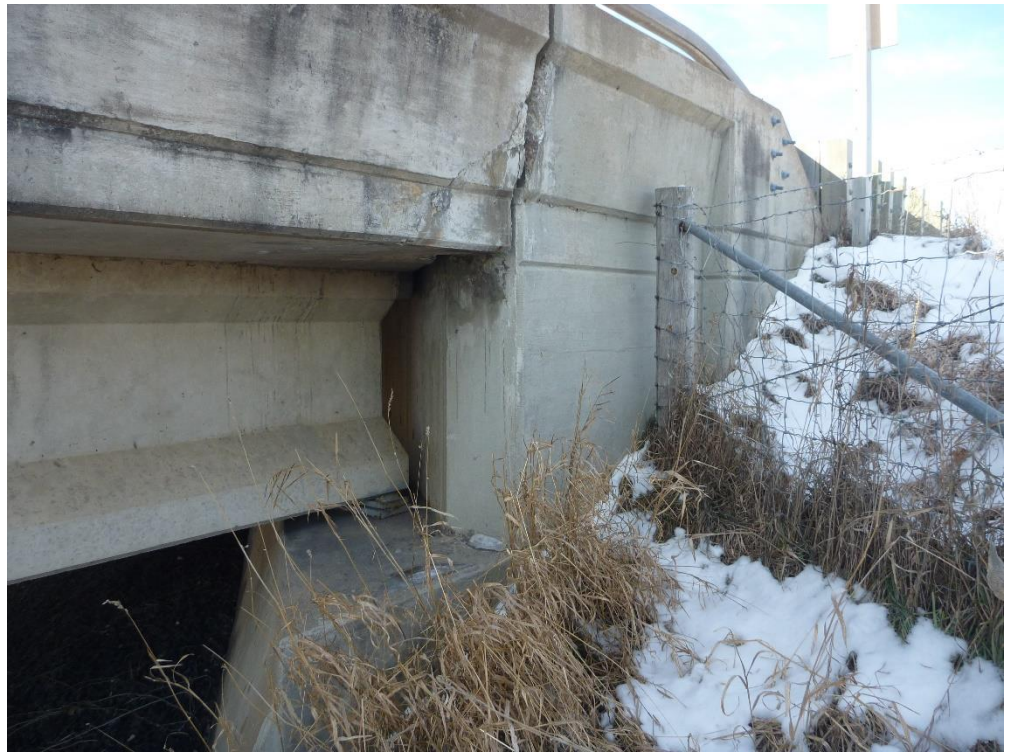
Typical view of upper wing on B-3-16. Upper wings to be replaced during rehabilitation.

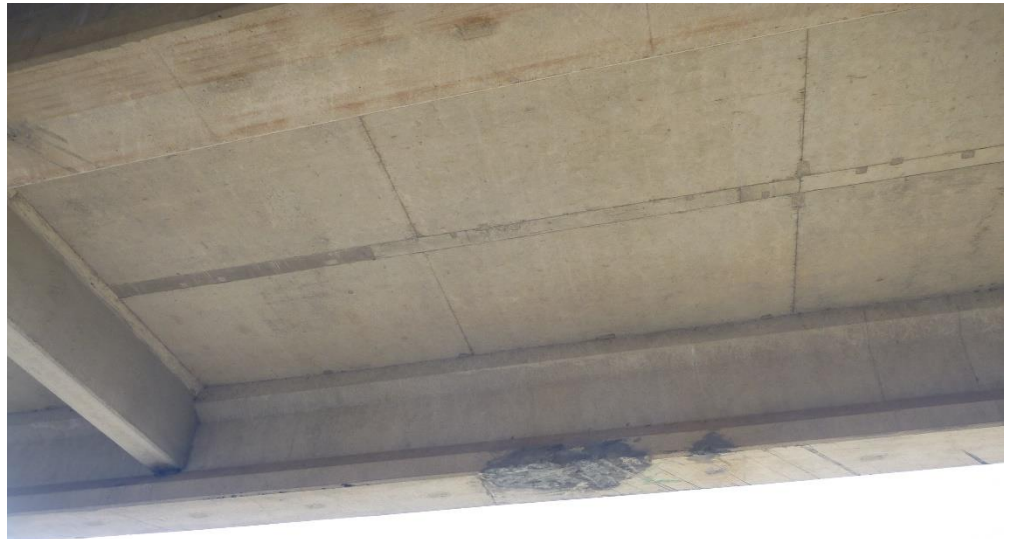
Damaged girder in span 2 on B-3-16. Girder to be replaced.

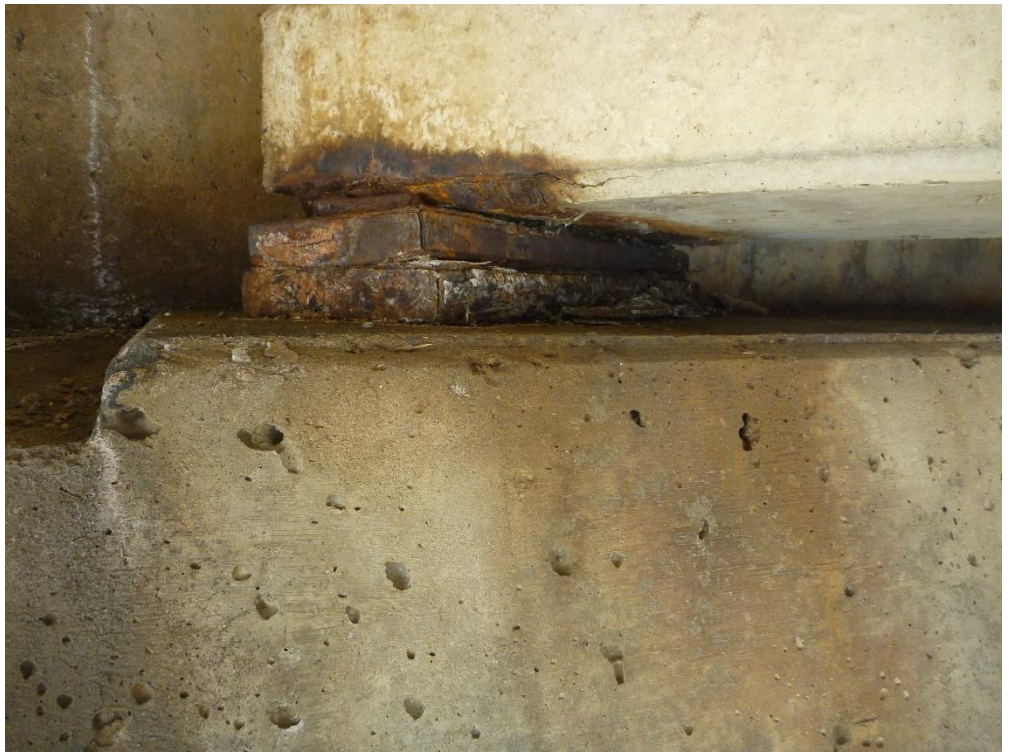
Typical view of bearing on B-3-16. All north abutment bearings to be replaced in rehabilitation.

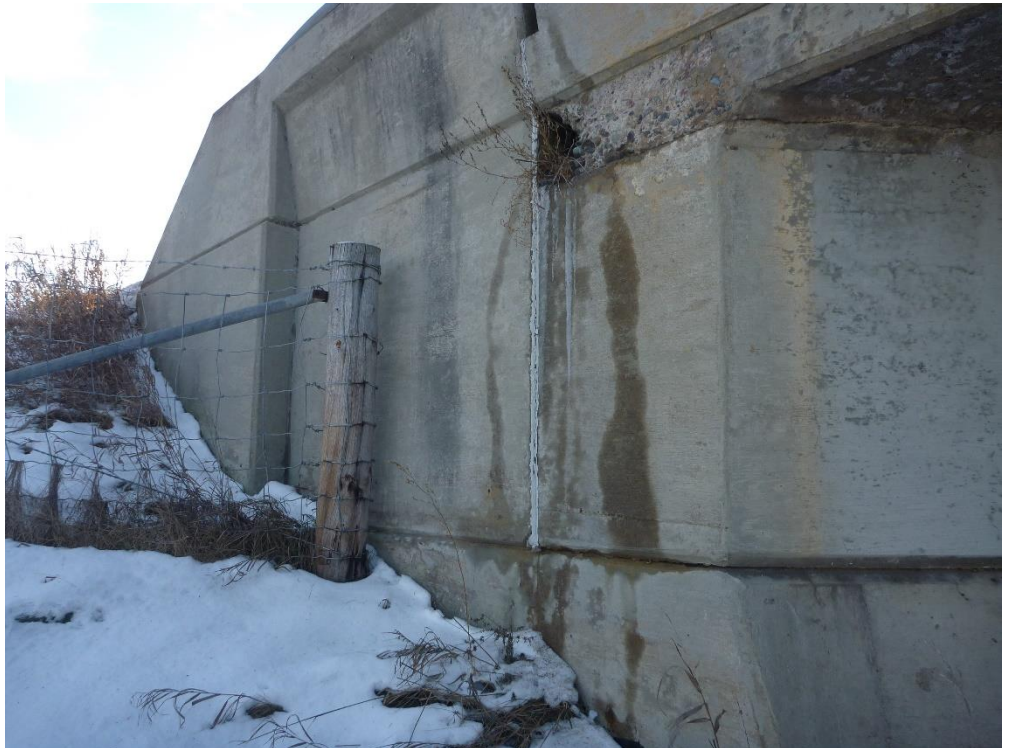
View of wing on B-3-16 with spalling on deck section at abutment.

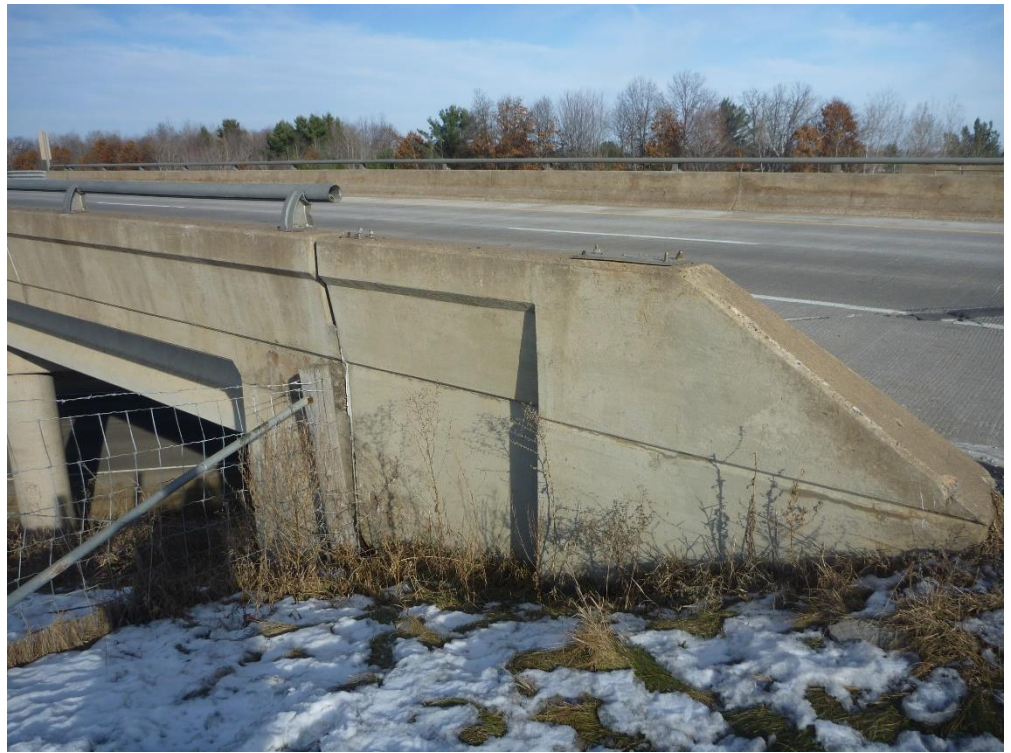
Upper wing on B-3-16
missing a railing section.

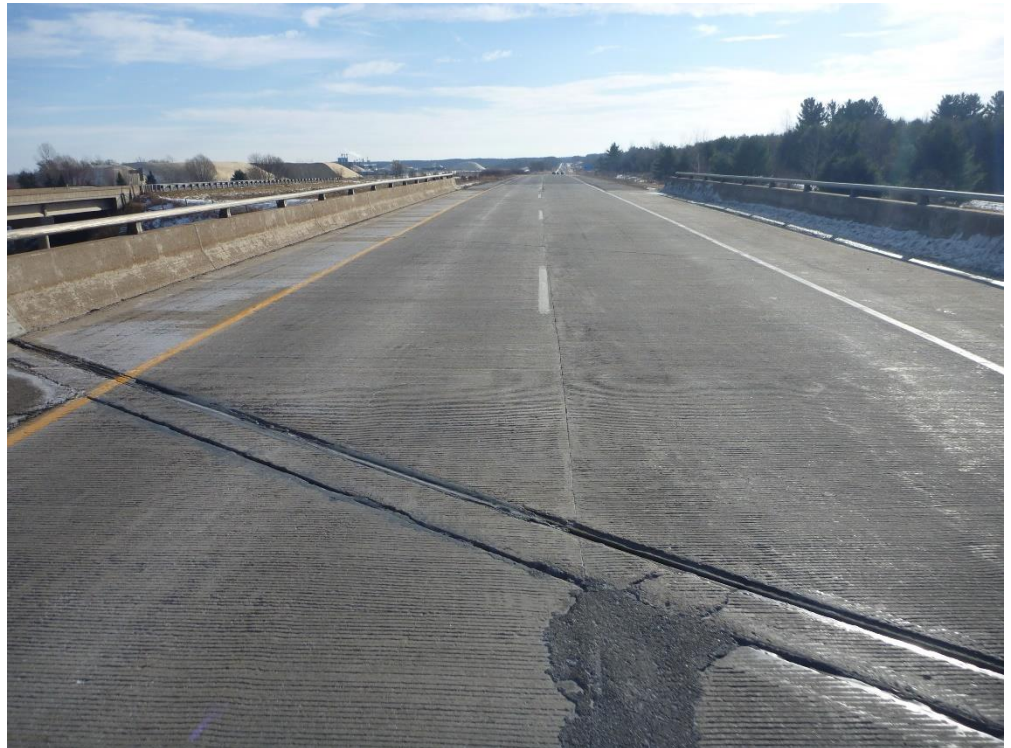
View from roadway
looking south at B-3-16.
Bridge deck, parapets,
and railings to be
removed during rehab.
