SELECT AS-BUILT DRAWINGS

STRUCTURE B-3-18

U.S.H. 53 OVER C.T.H. "A"

Inspection Report for
B-03-018

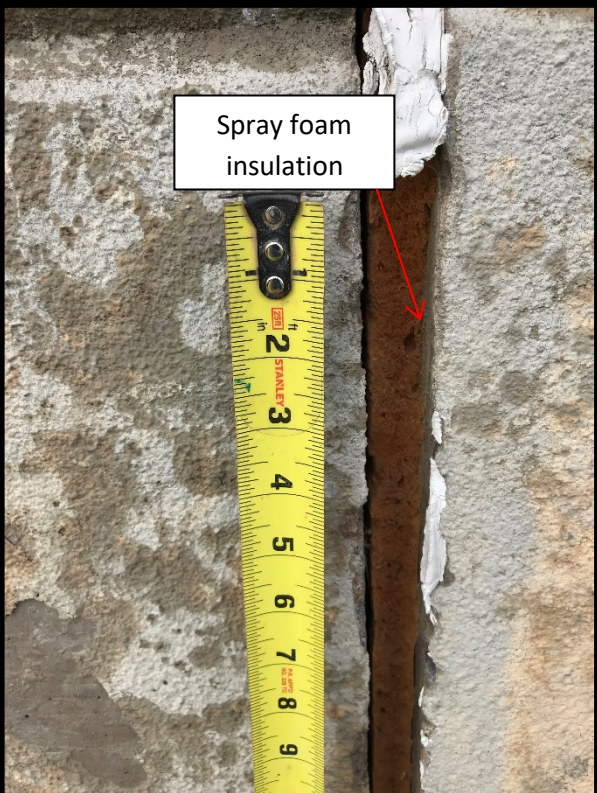
PHOTOGRAPH NO: 4

DIRECTION: SE	
DESCRIPTION: View of the spray foam insulation between the bridge deck and abutment. The spray foam insulation is not ACM.

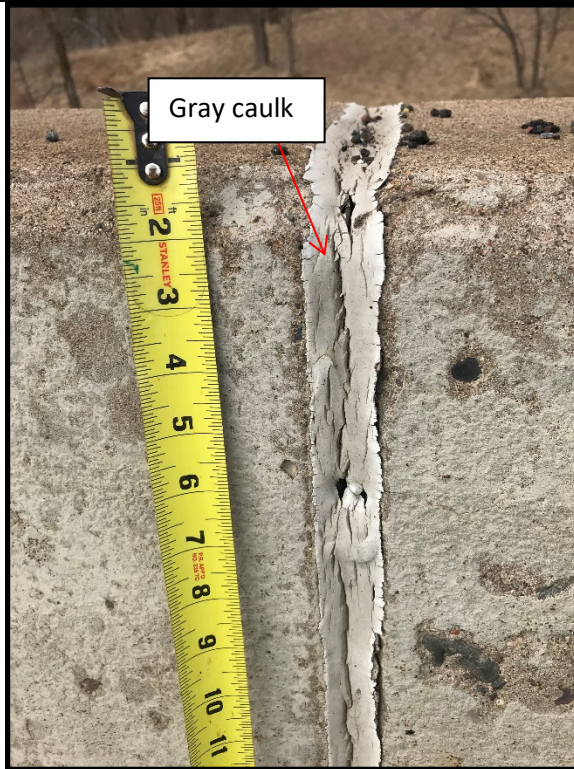
PHOTOGRAPH NO: 5	
DIRECTION: SW	
DESCRIPTION: View of the gray caulk on the bridge wall joints and abutment joints. The gray caulk is not ACM.

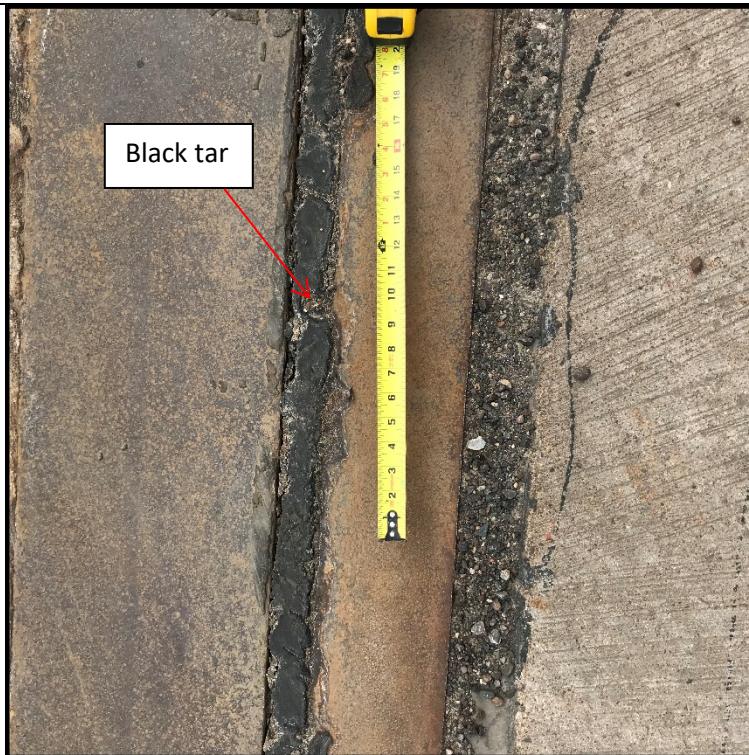
PHOTOGRAPH NO: 6	
DIRECTION: Down	
DESCRIPTION: View of the black tar on the bridge deck. The black tar is not ACM.

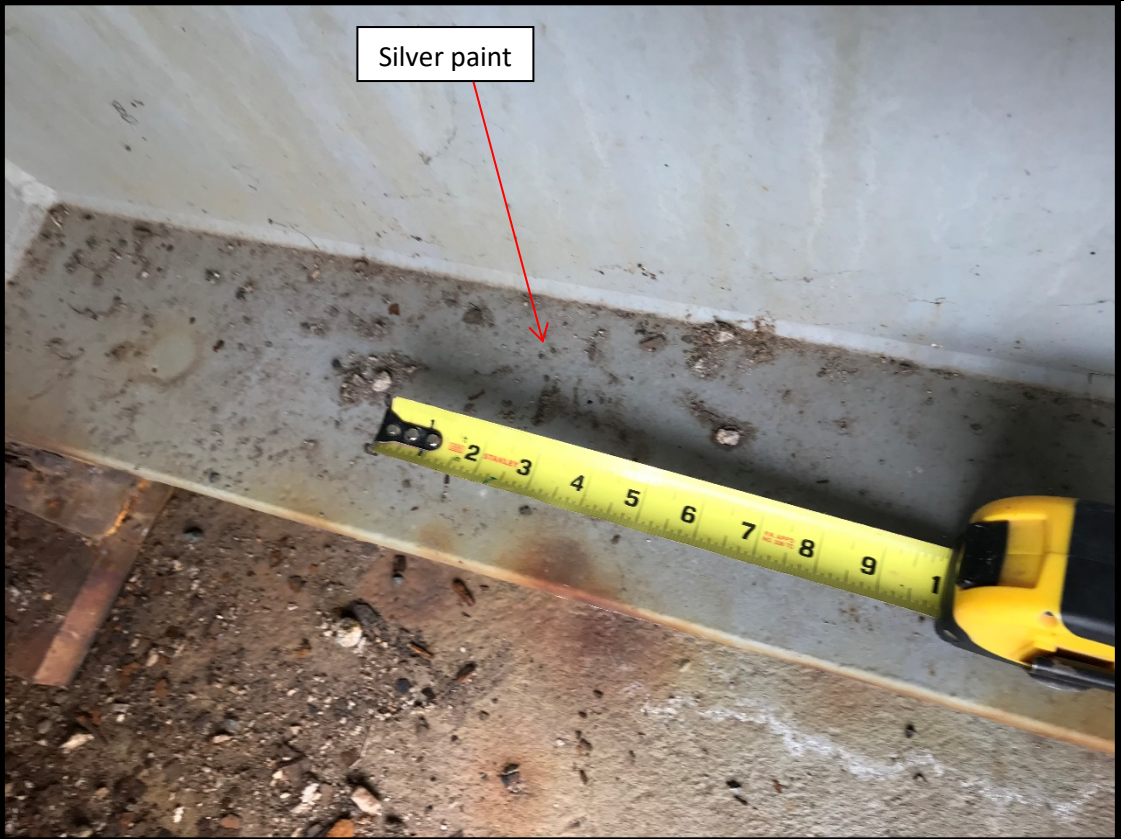
PHOTOGRAPH NO: 7

DIRECTION: Down	
DESCRIPTION: View of the silver paint on the steel I-beam spans and on the steel plates between the span and abutment beneath the bridge deck. The silver paint is not ACM.

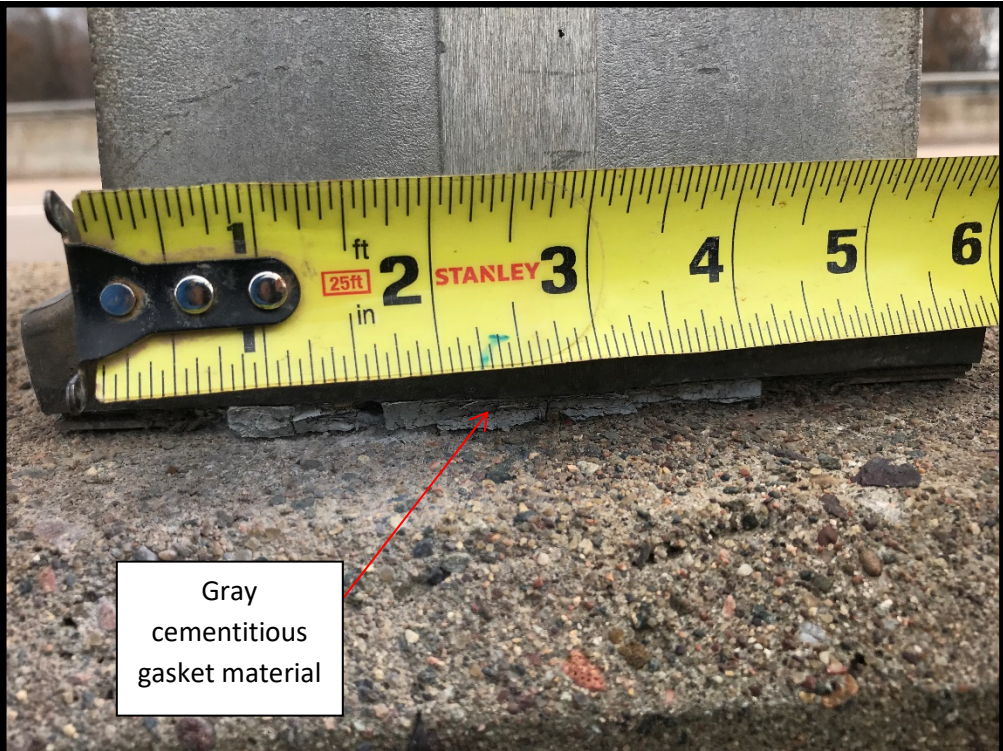
PHOTOGRAPH NO: 8

DIRECTION: E	
DESCRIPTION: View of the gray gasket material between the bridge railing plates and the bridge walls. The gray gasket material is non-friable ACM containing 2% Chrysotile asbestos.

Asbestos-containing material is present in Structure B-03-018. Standard Special Provision (STSP) 107-120 shall be included in the plans. If the bridge rails are disturbed during renovation activities, then Standard Special Provision (STSP) 203-005 shall be included in the plans and abatement would be required. The contractor will be responsible for completion of the Notification of Demolition and/or Renovation (DNR form 4500-113) if required. A copy of the inspection report is available from the region office.

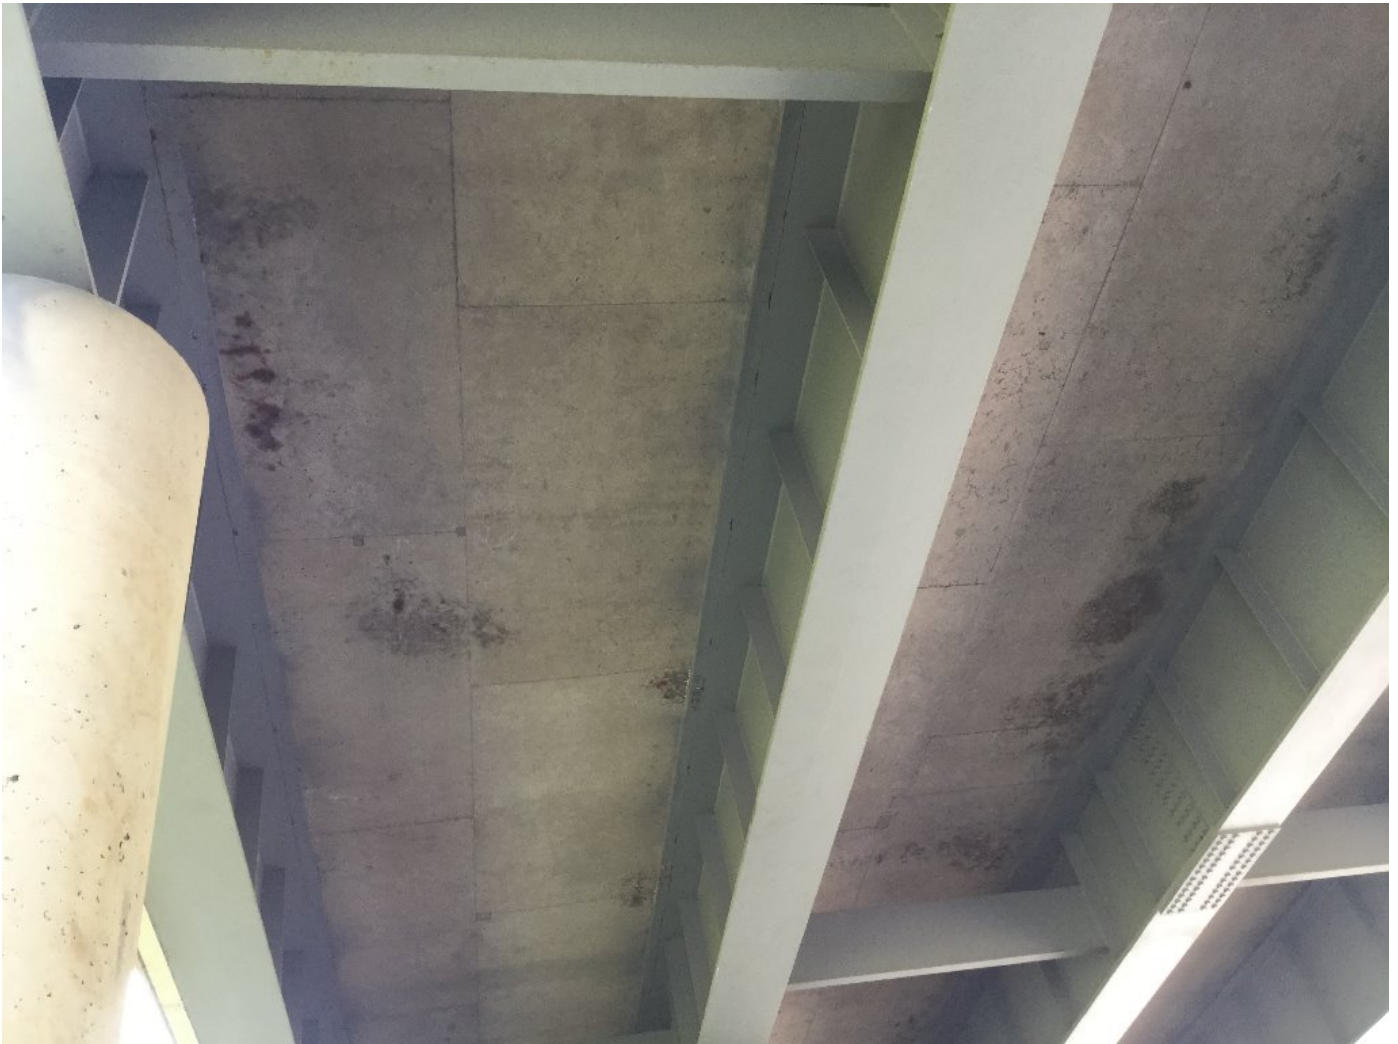
Typical underdeck deterioration

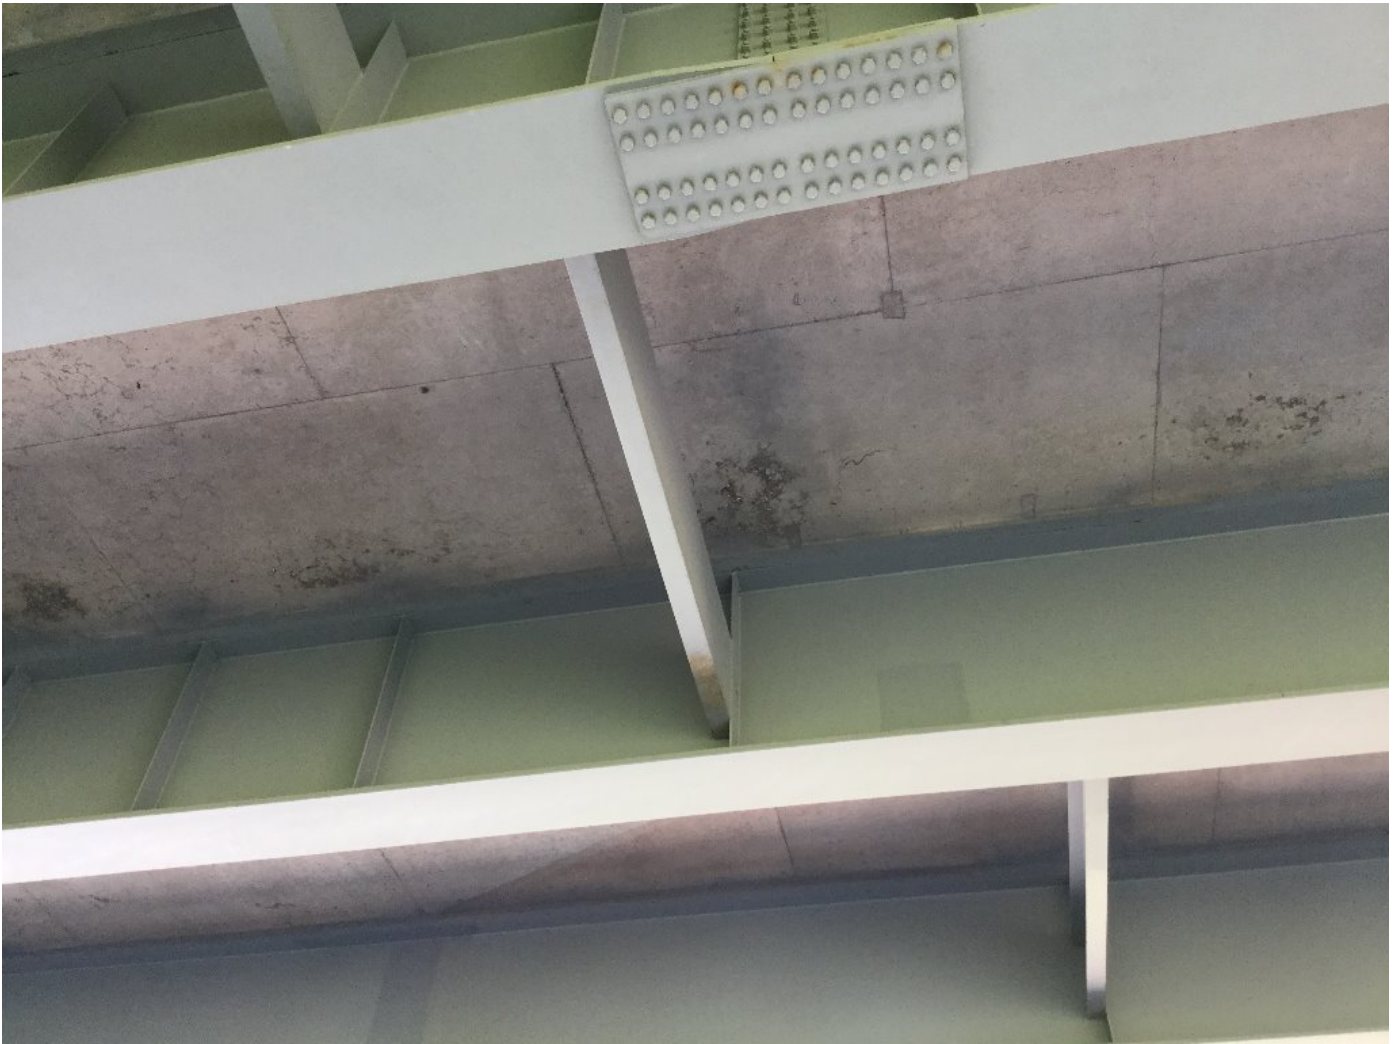
Typical underdeck deterioration

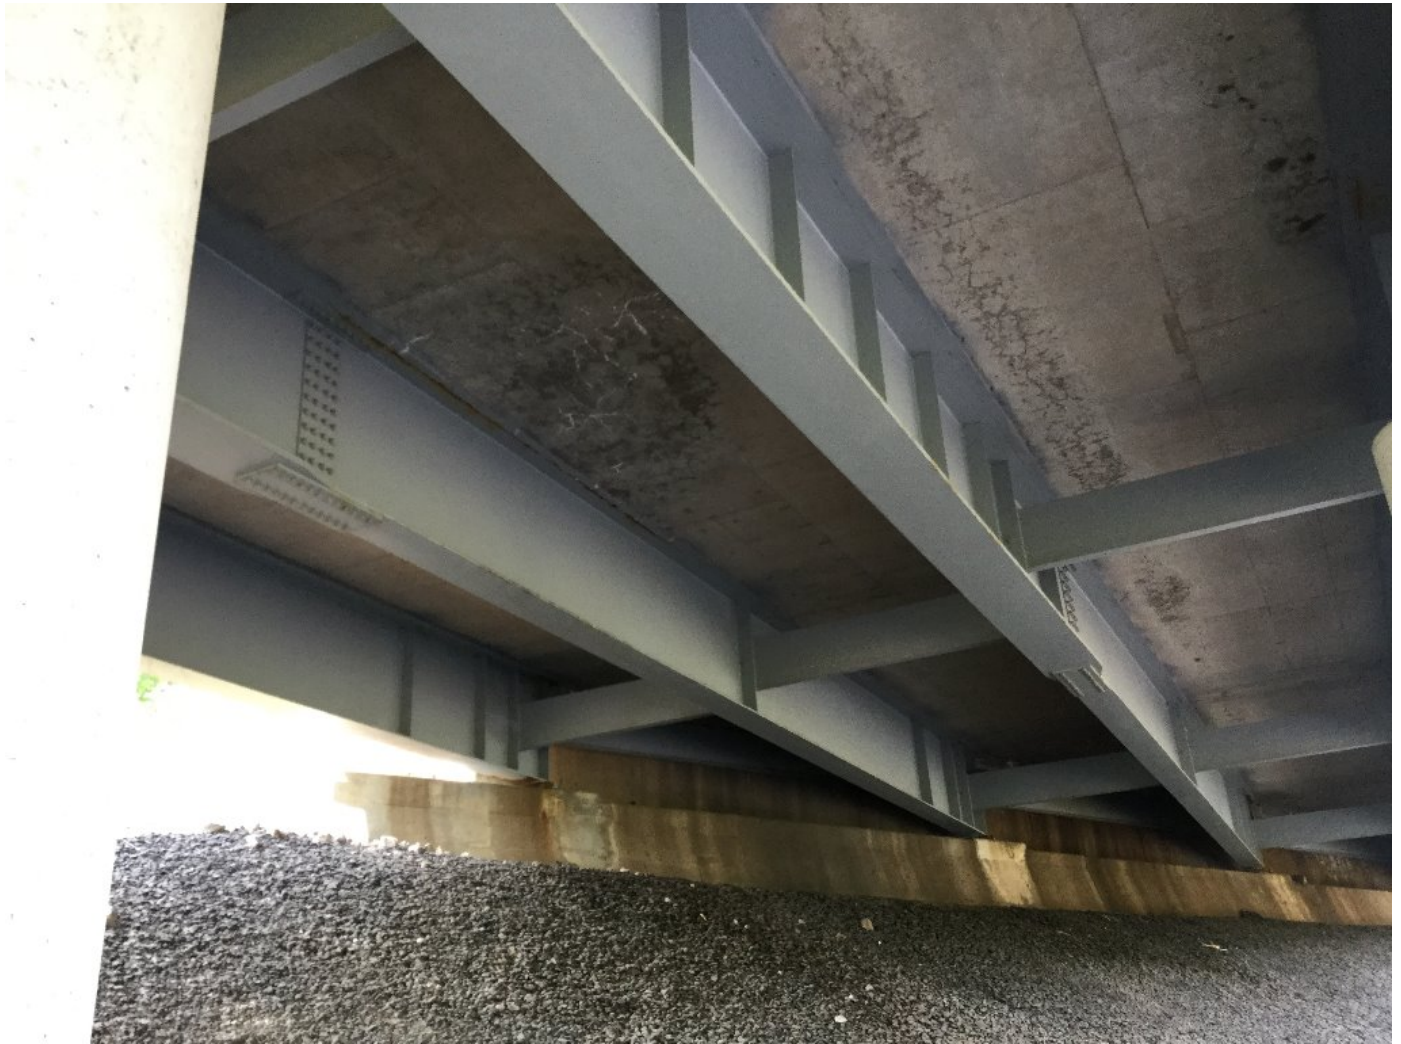
Typical underdeck deterioration
