**SITE PHOTOGRAPHS
FOR
STRUCTURE
SURVEY REPORT**

**USH 53 SB Over CTH A
B-3-18
TOWN OF DOVRE, WI
BARRON COUNTY**

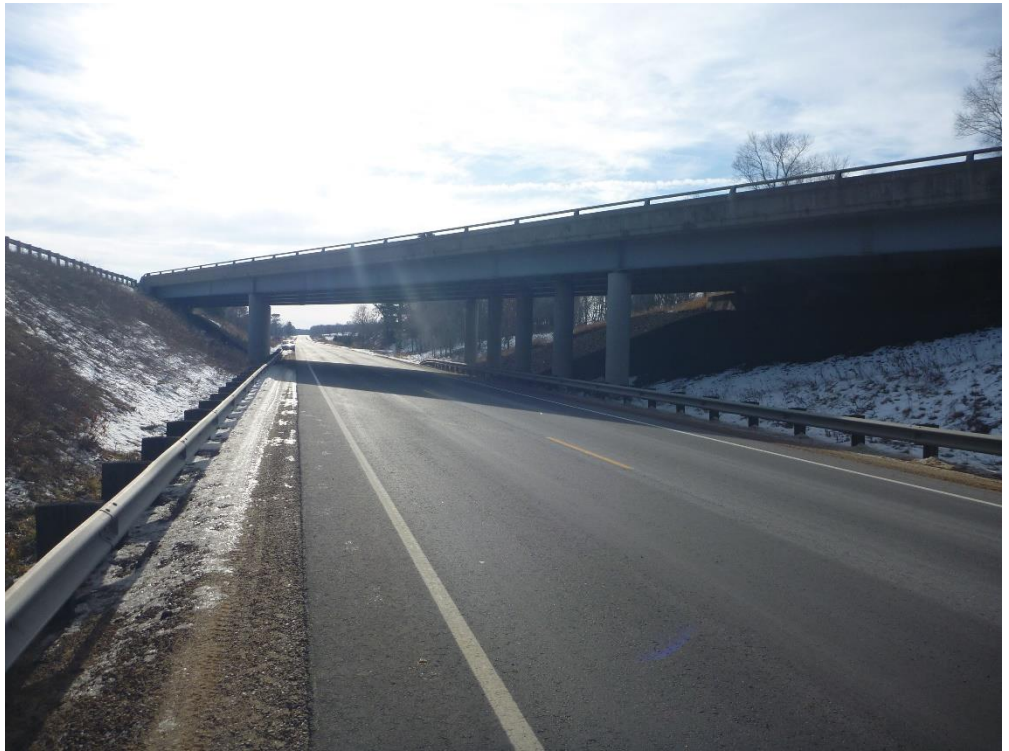
View from CTH A looking west at B-3-18.

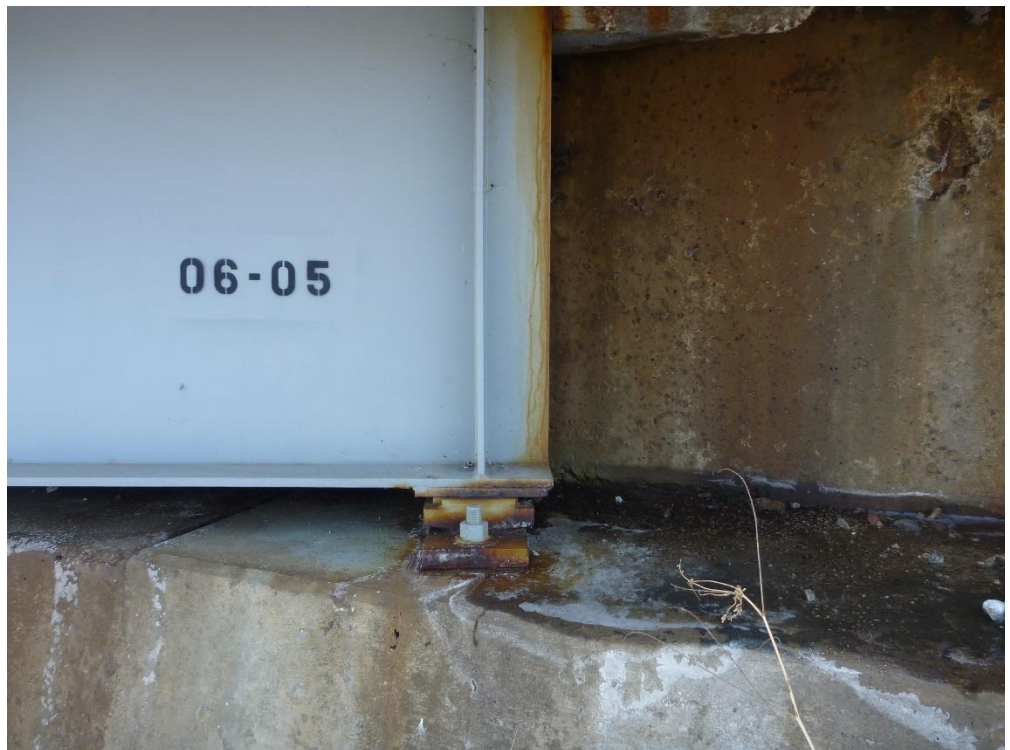
View looking at girder end and bearing of B-3-18. All bearings will be replaced during rehabilitation with either steel or elastomeric bearing pads. The top flanges of the girders will be repainted prior to the placement of the new concrete deck.

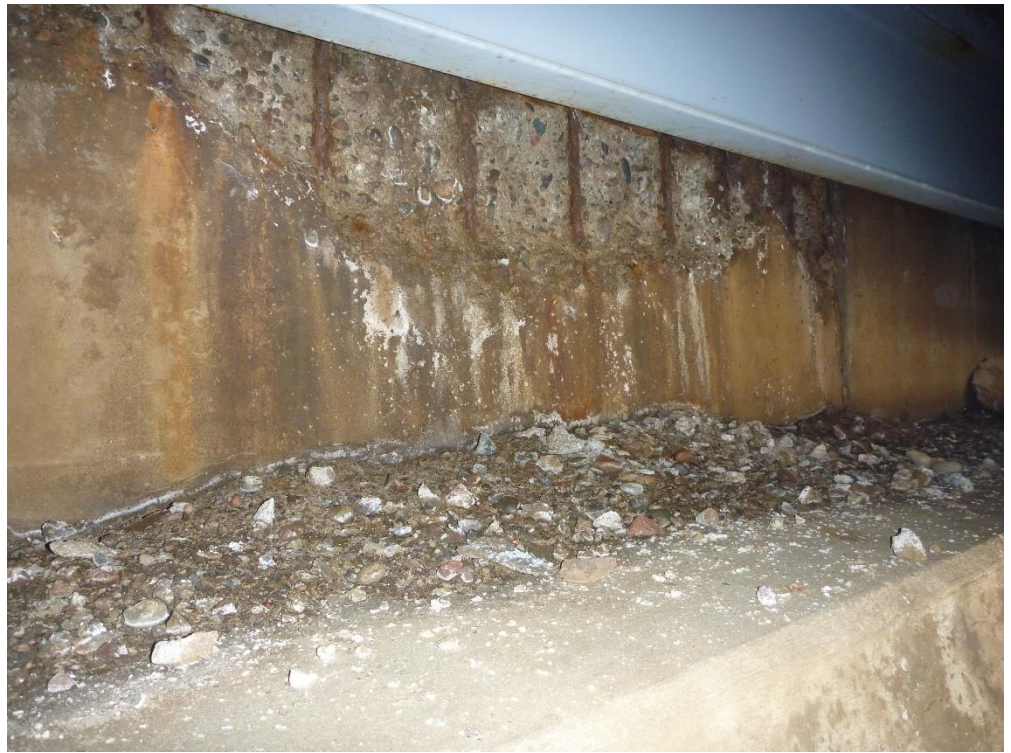
View of the north abutment backwall of B-3-18 with concrete spalls.

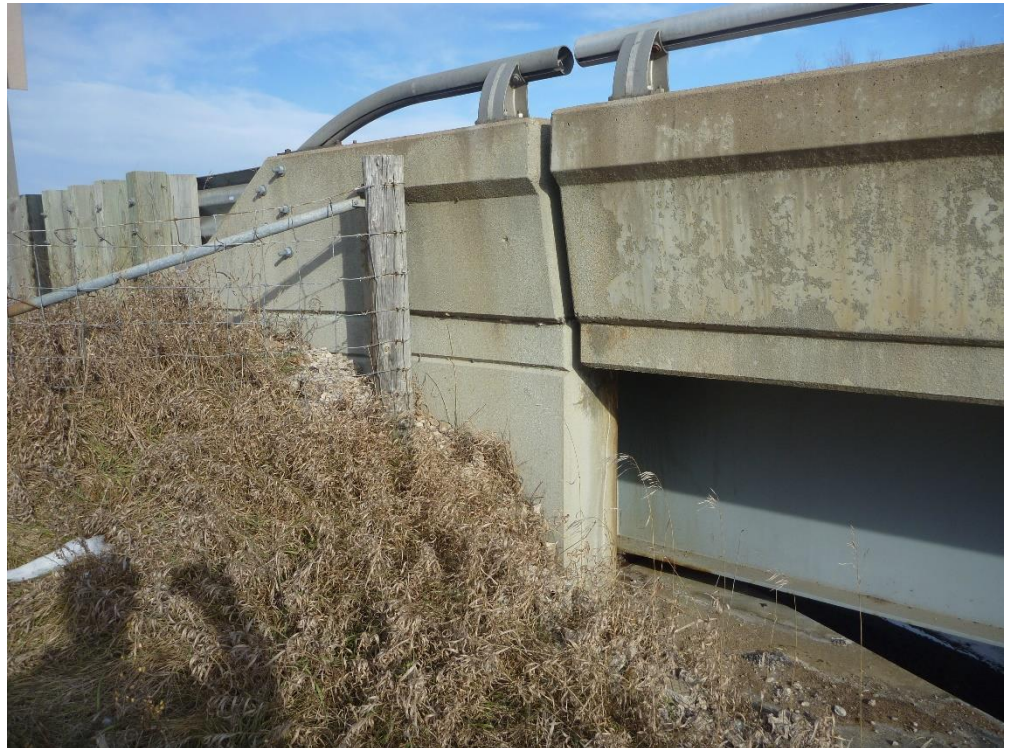
Typical view of upper wing on B-3-18 to be replaced during rehabilitation.

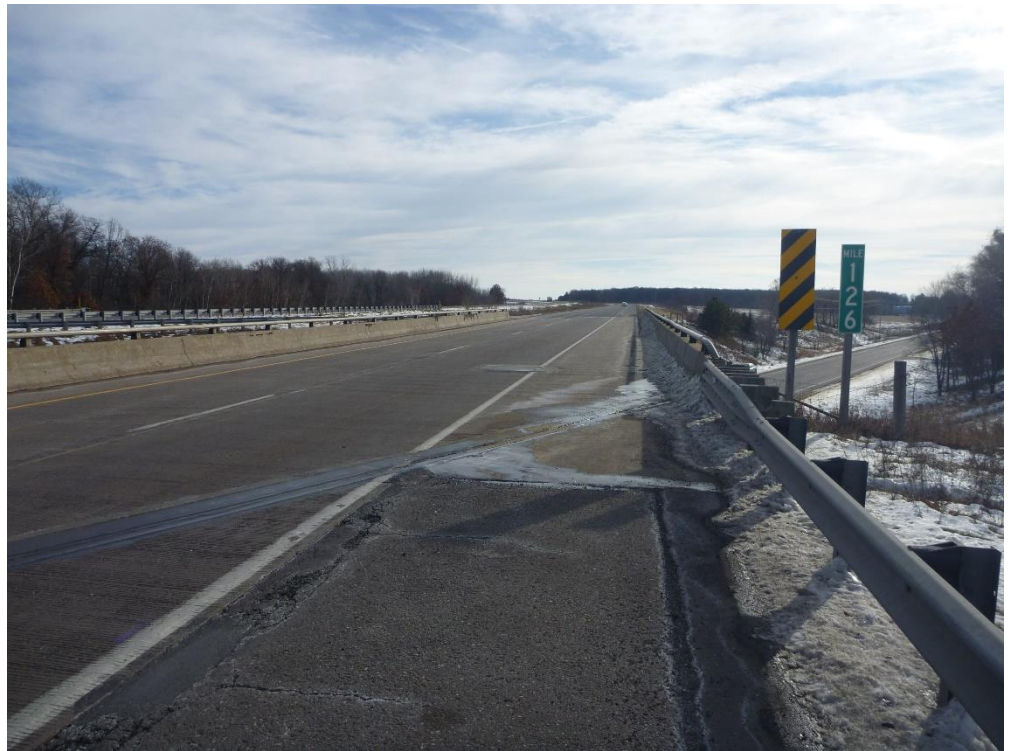
View from roadway looking south at B-3-18. Concrete deck and parapets to be replaced during rehabilitation.

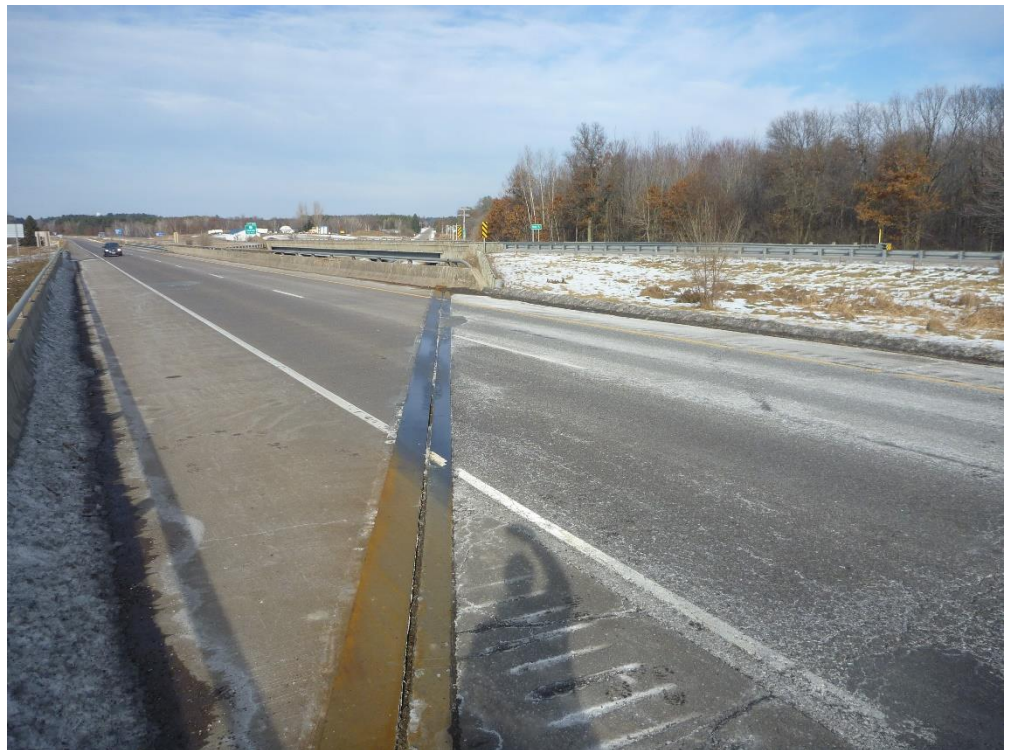
View from roadway looking north at B-3-18. Concrete deck, railing and parapets to be removed during rehabilitation.

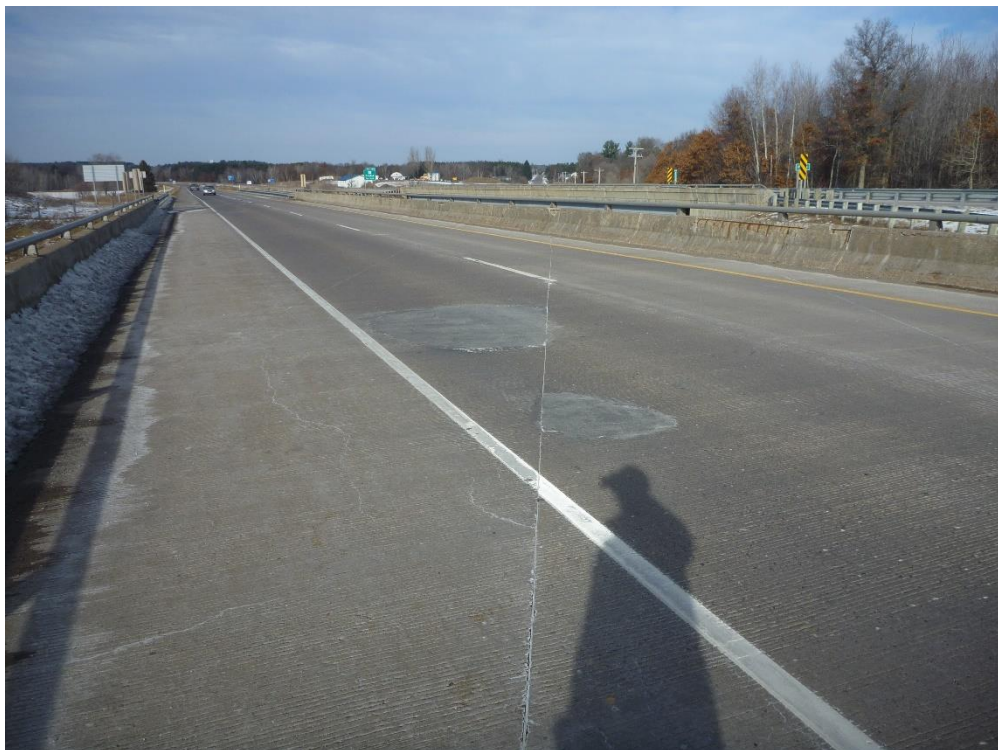
View of bridge deck on B-3-18. Concrete deck, railing, and parapets to be removed during rehab.

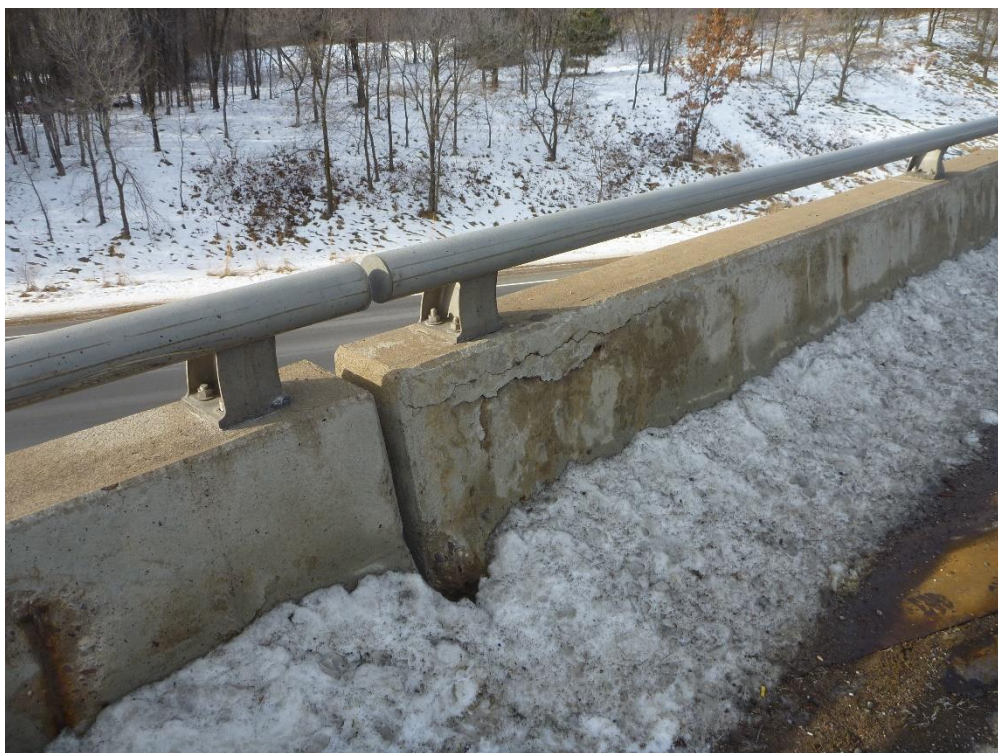
Typical cracking and spalling at concrete parapets on B-3-18.
