STATE OF WISCONSIN DEPARTMENT OF TRANSPORTATION

## Inspection Report for B-03-019

## USH 53 NB over A Jun 23,2017

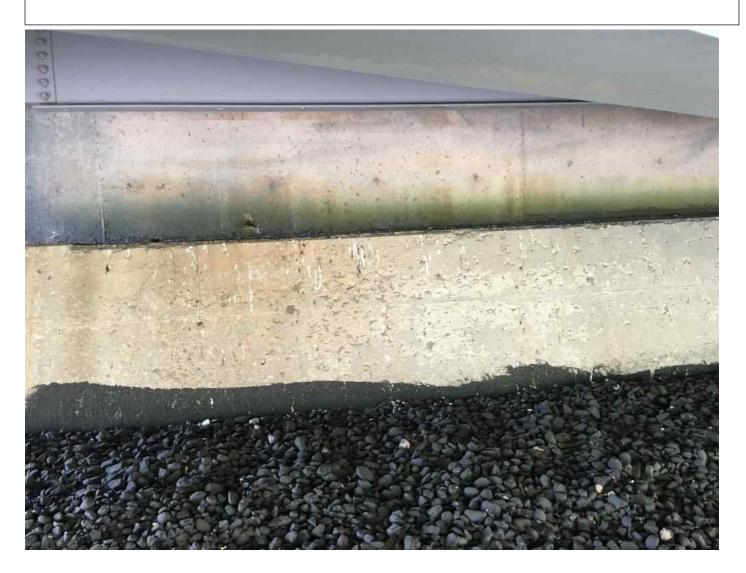
Routine Document Comment/Description Bay 4 south abutment - surface concrete deterioration
