STRUCTURE B-3-20
U.S.H. 53 OVER CHETEK RIVER

Bridge Asbestos Inspection Report

WisDOT Project ID: 1196-04-02
Structure Number: B-03-020
Structure Name: USH 53 SB over Chetek River
City/County: Town of Chetek, Barron County, Wisconsin
GEI project Number: 1901822
Date Inspected: April 4, 2019
Inspected by: Kyle C. Sandmire
Asbestos Inspector License Number: All- 217616
Consultant Company: GEI Consultants, Inc.

Inspection Report for
B-03-020 (USH 53 SB)

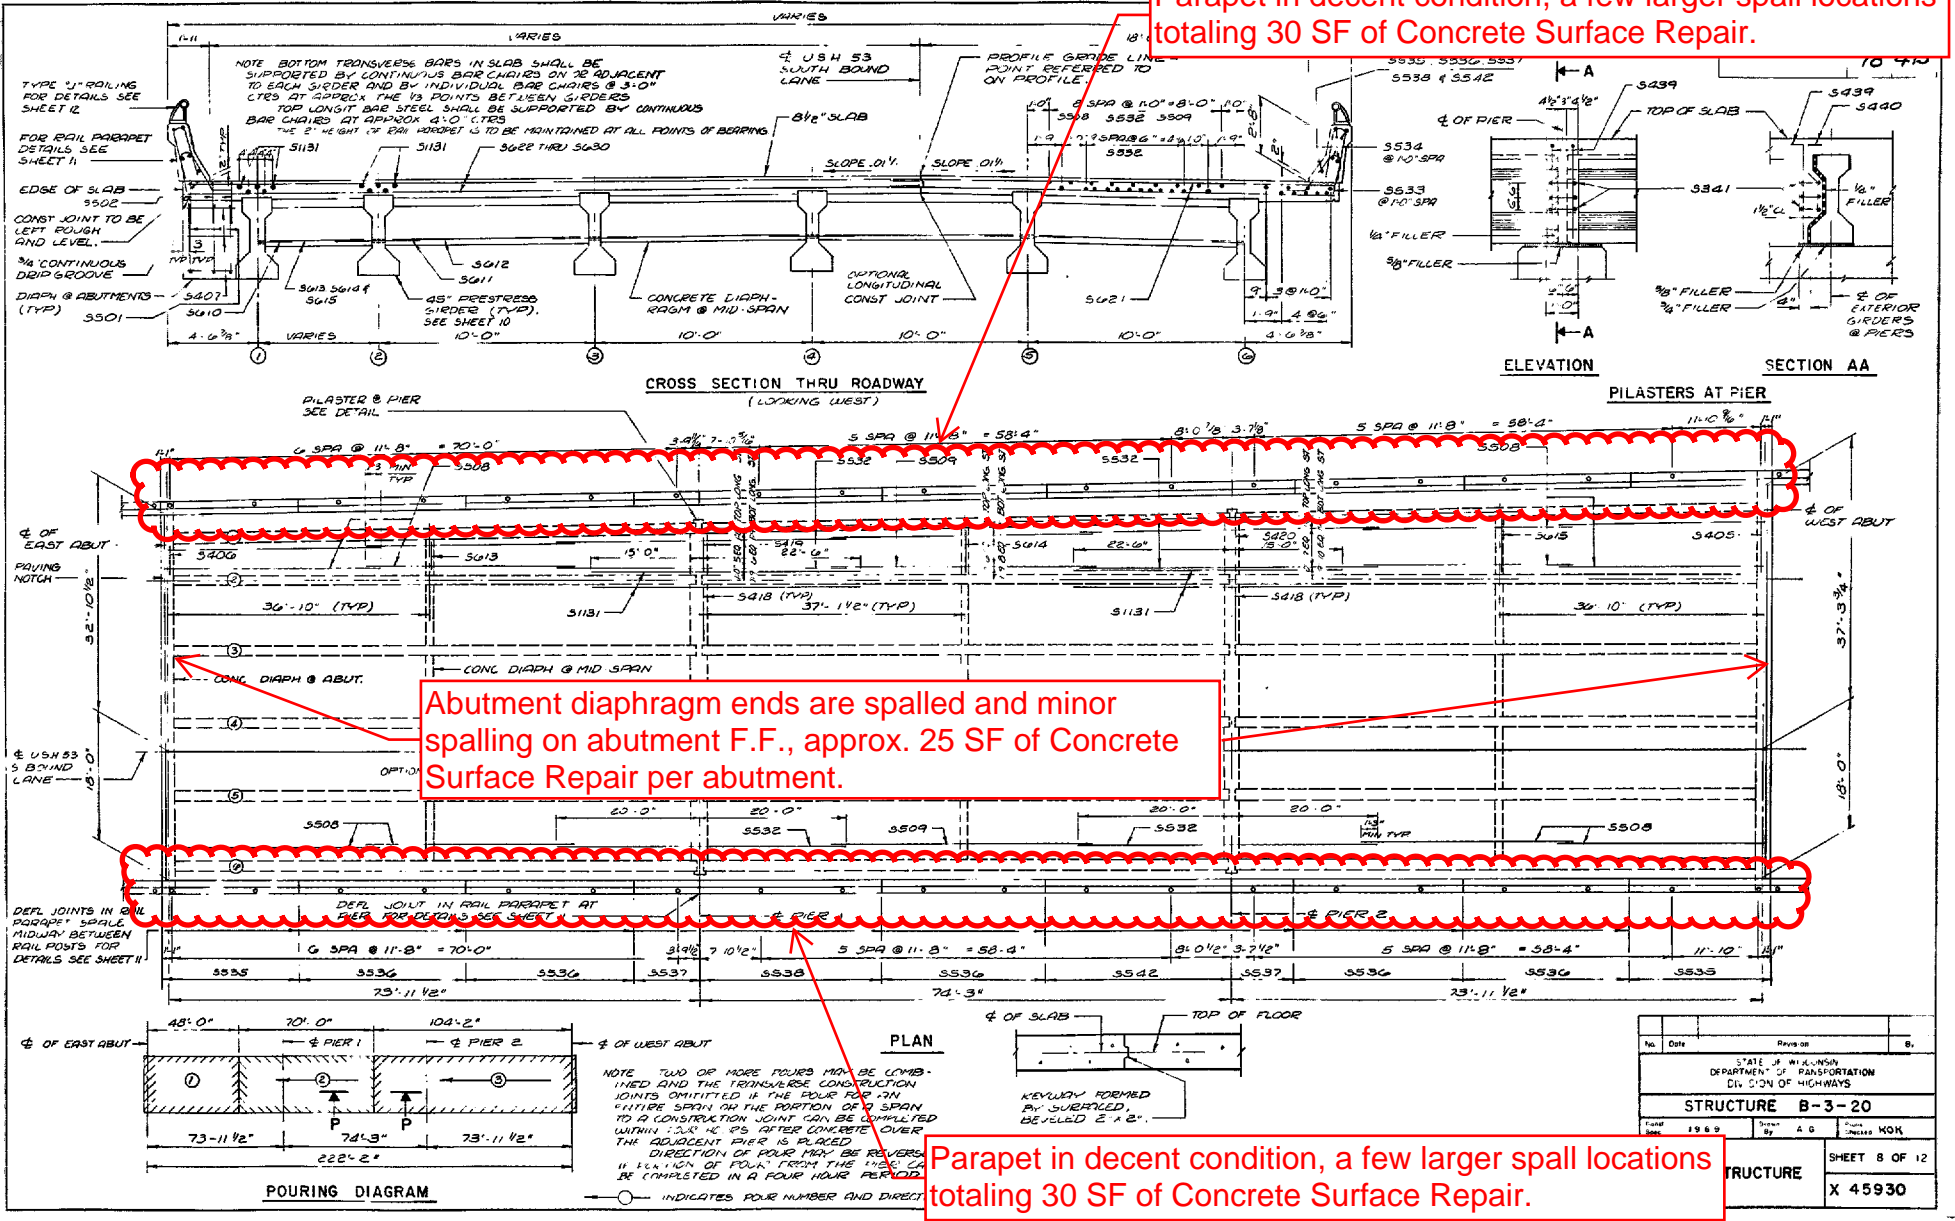
Parapet in decent condition, a few larger spall locations totaling 30 SF of Concrete Surface Repair.

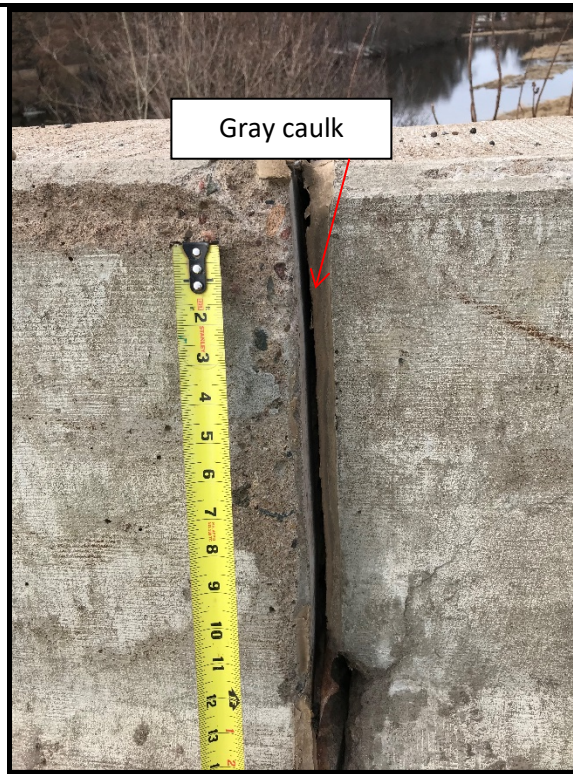
PHOTOGRAPH NO: 4	
DIRECTION: SW

View of the gray caulk on the bridge wall joints and abutment joints. The gray caulk is not ACM.

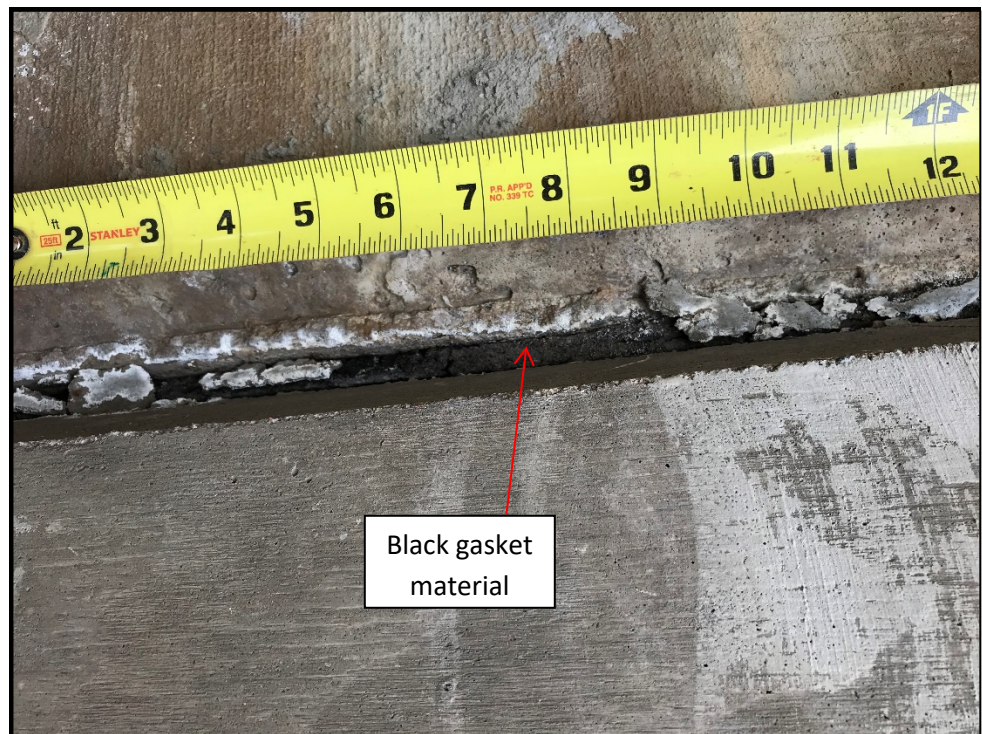
PHOTOGRAPH NO: 5

View of the black gasket material between the bridge deck and abutment. The black gasket material is not ACM.

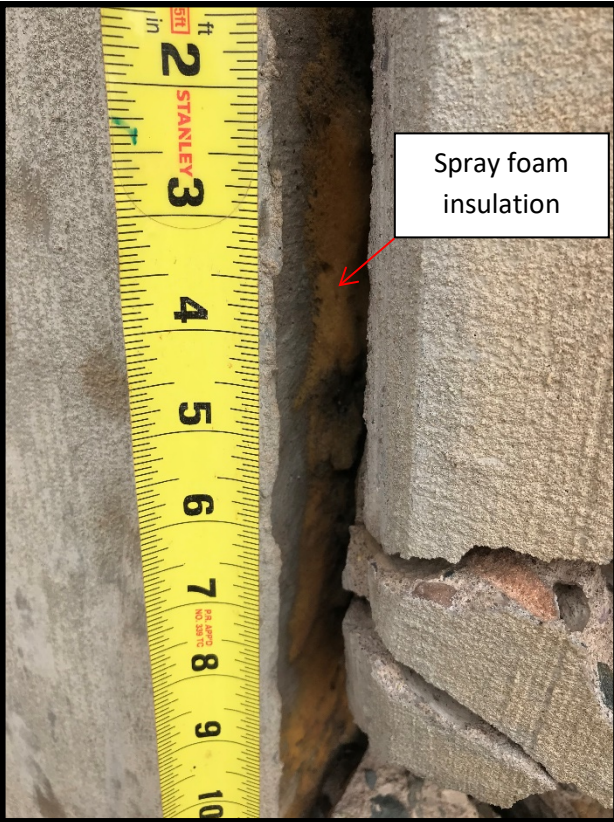
PHOTOGRAPH NO: 6

DESCRIPTION: View of the spray foam insulation between the bridge deck and abutment. The spray foam insulation is not ACM.
