**SITE PHOTOGRAPHS
FOR
STRUCTURE
SURVEY REPORT**

**USH 53 SB Over Chetek River
B-3-20
TOWN OF CHETEK, WI
BARRON COUNTY**

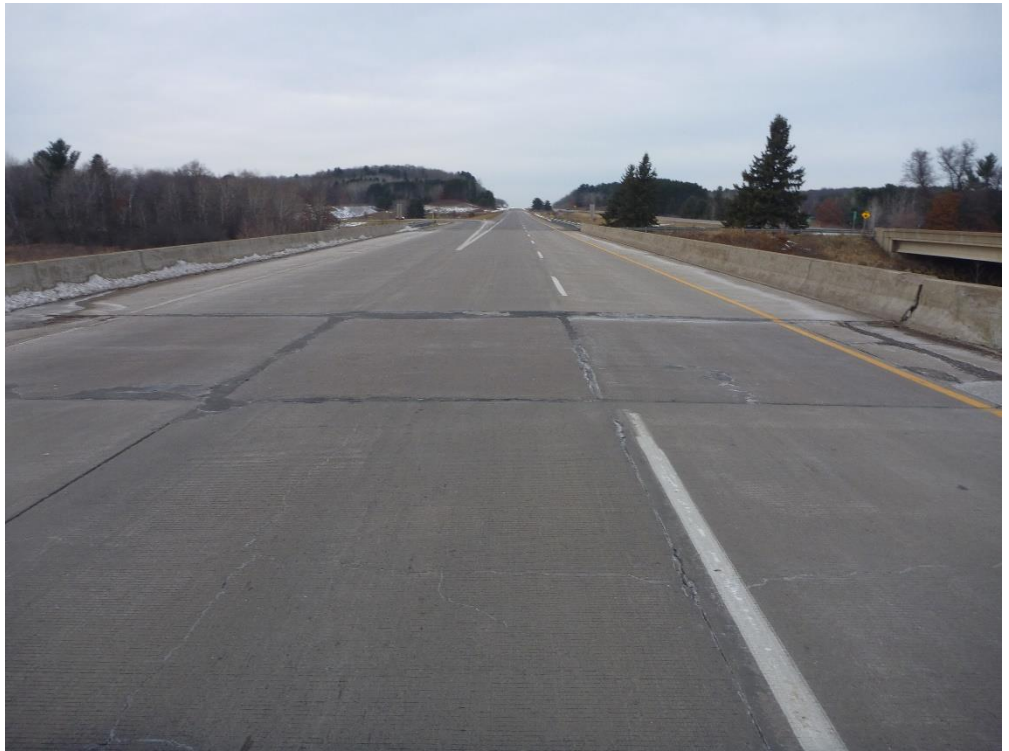
View from USH 53 SB
looking north at B-3-20.
Approaches to be replaced
during rehabilitation.

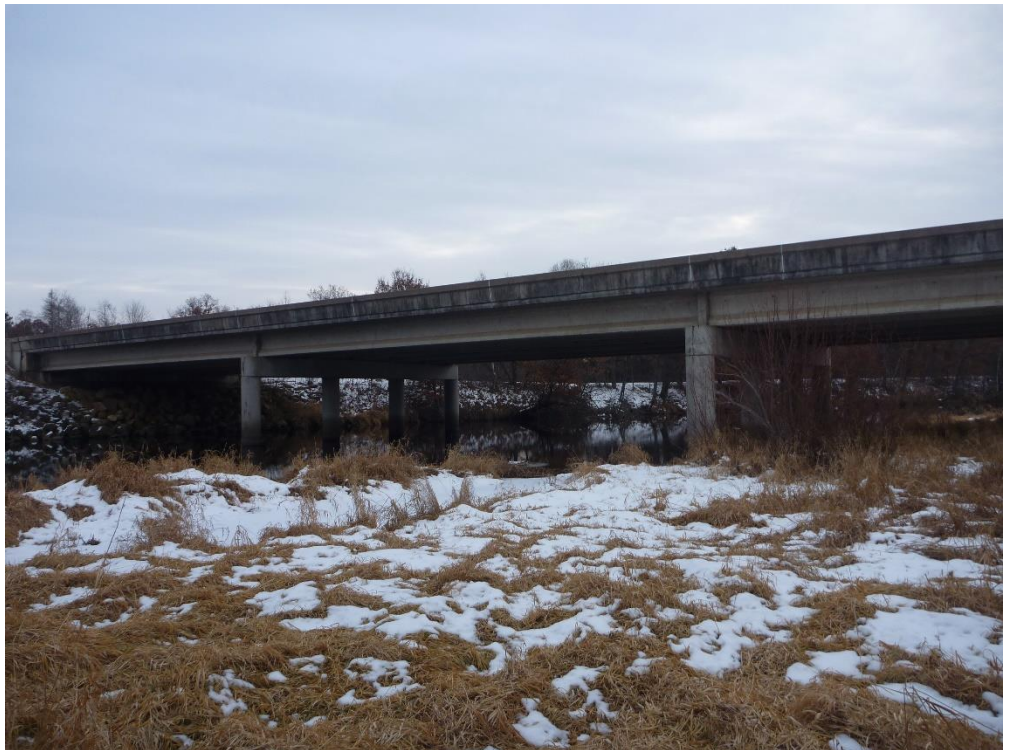
View looking west at
substructure of B-3-20.

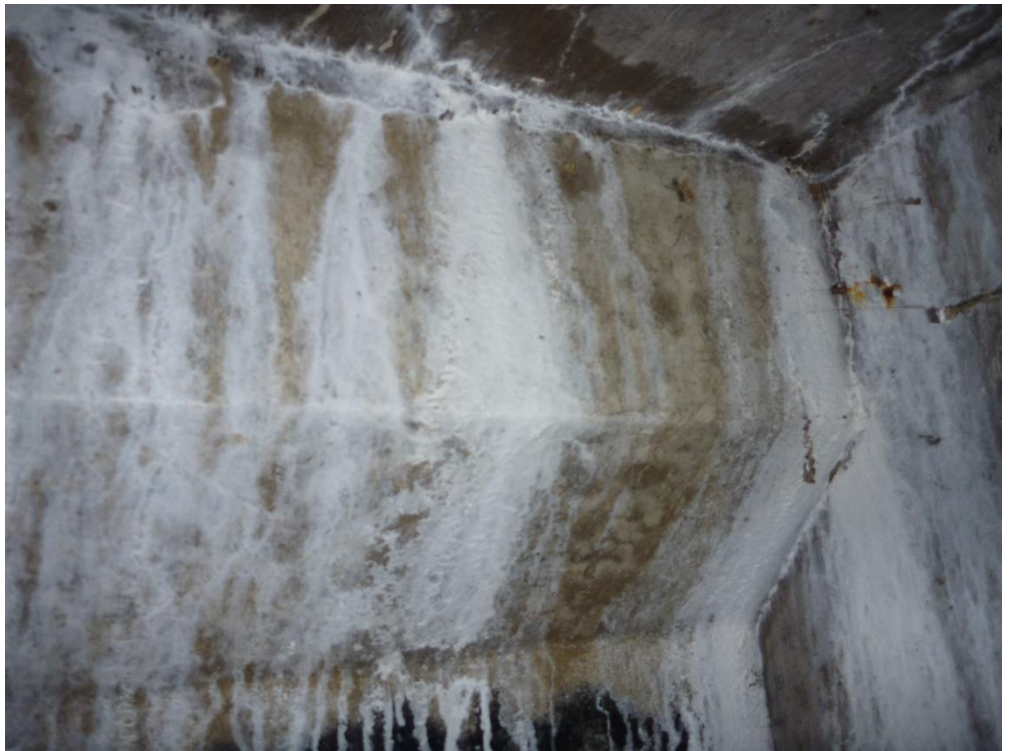
Typical view of chloride attack at ends of prestressed girders. Ends of all girders to be cleaned and epoxy coated during rehabilitation.

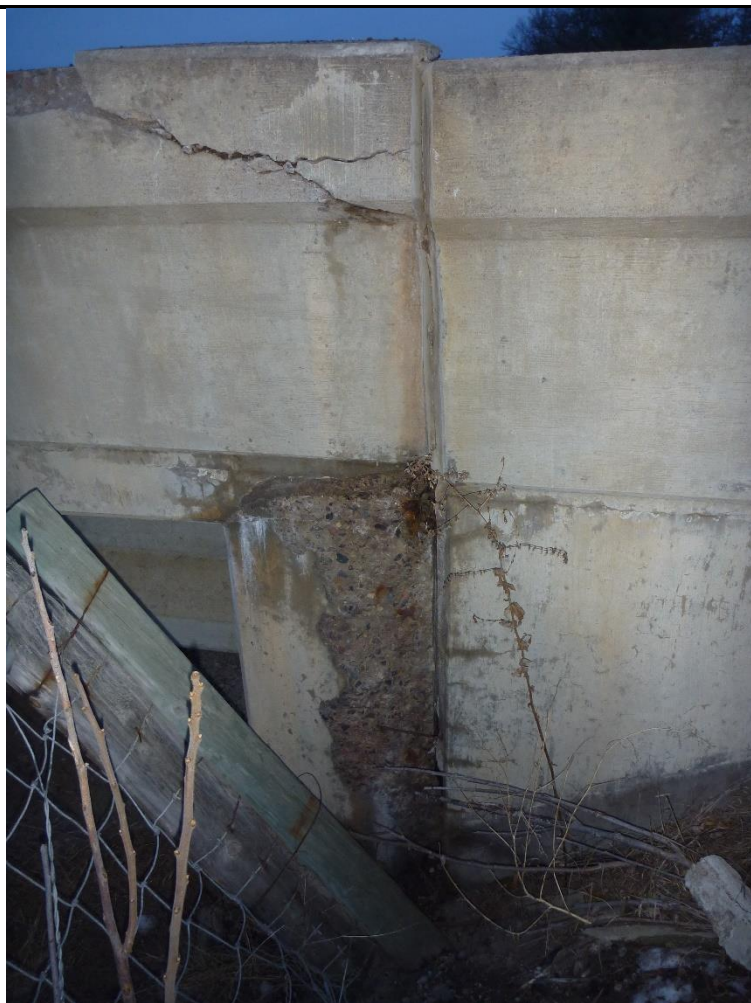
View of concrete parapet and abutment concrete spalling at B-3-20. End 1-foot of abutment diaphragms to be replaced.

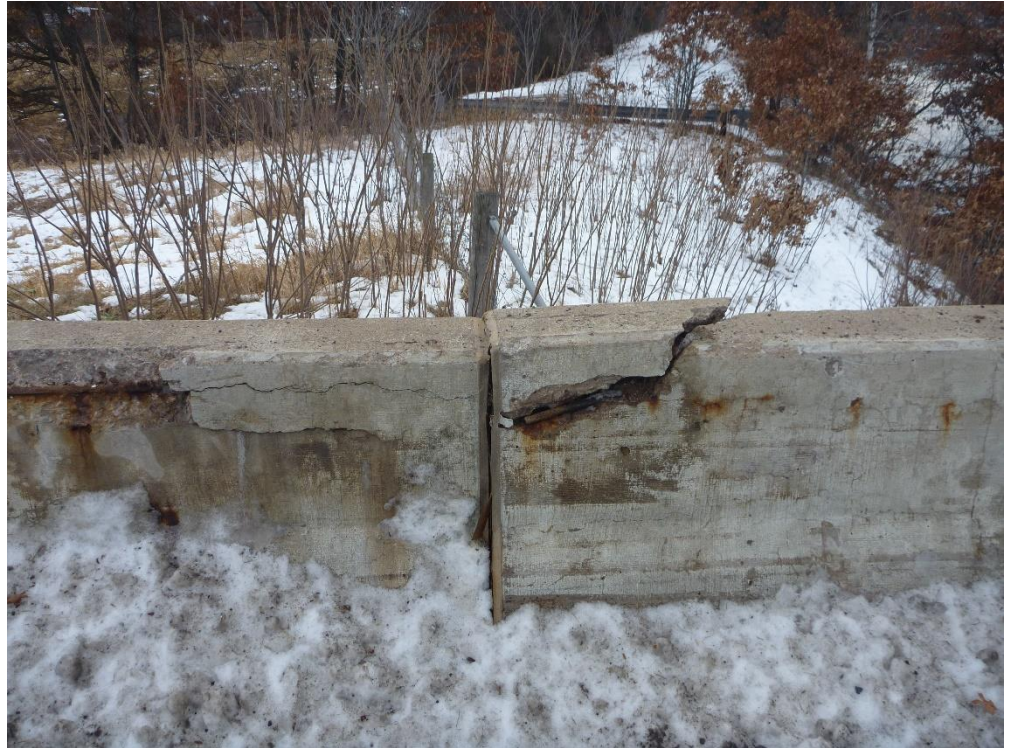
Typical spalling on concrete parapet of B-3-20. Concrete parapet to be repaired during rehabilitation.

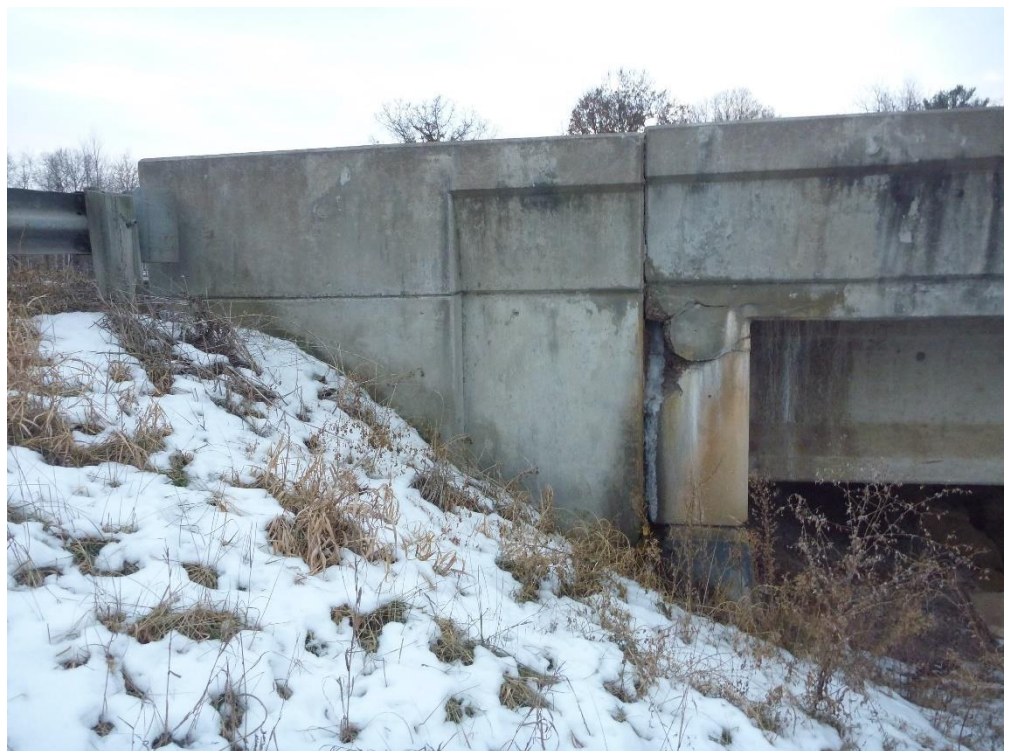
Typical view of wing and parapet at B-3-20. Entire wings and abutment end diaphragms to be replaced during rehab.

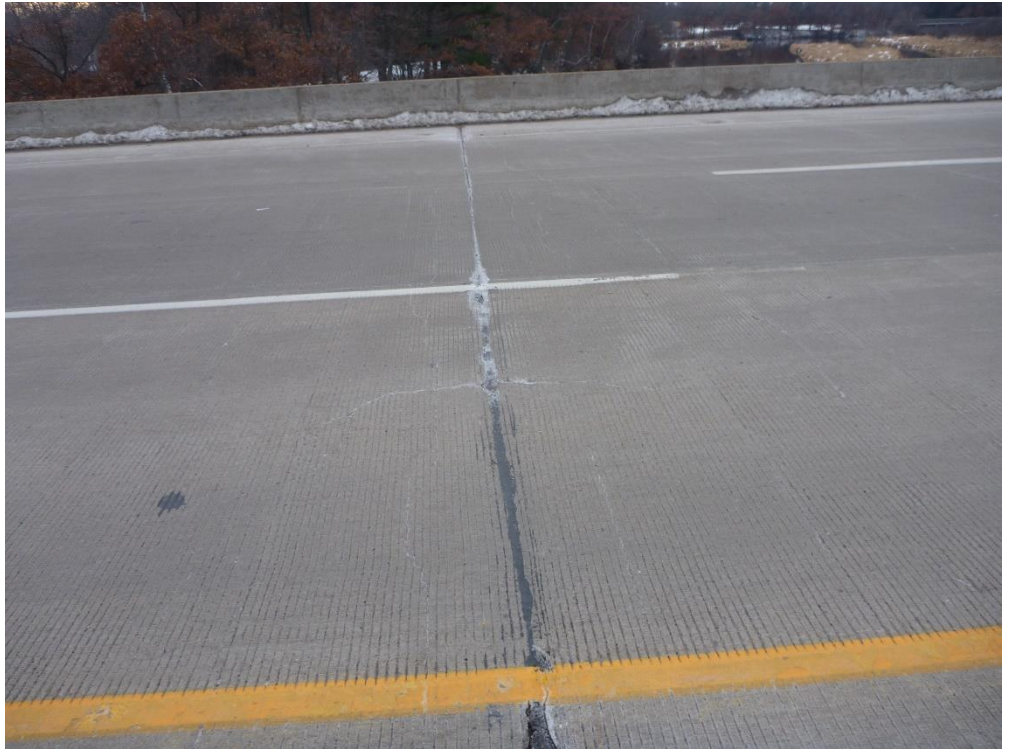
Typical existing concrete overlay cracking and popouts at overlay joints.

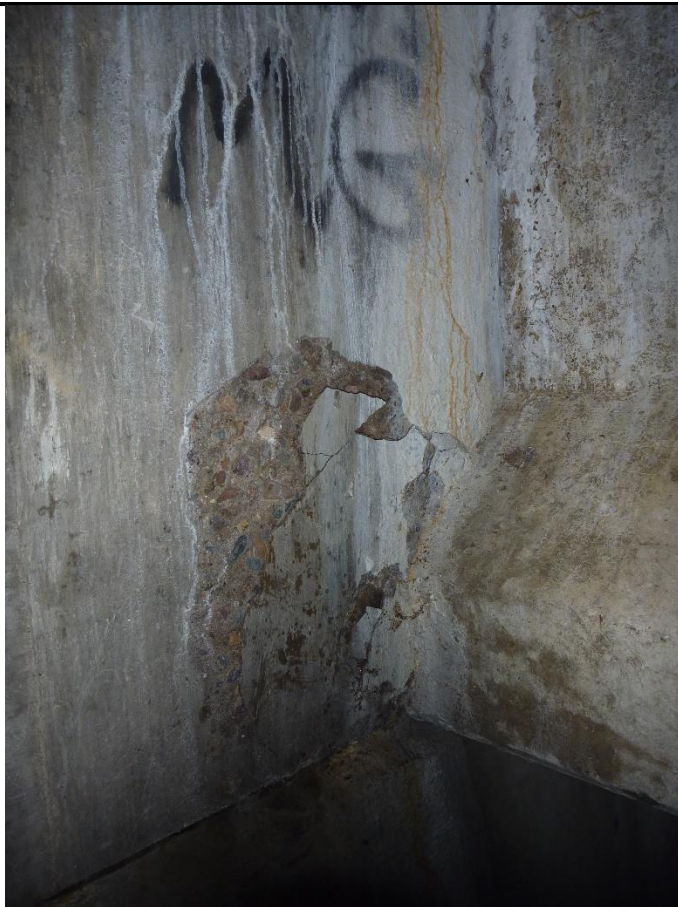
Spalling at abutment backwall.
