Inspection Report for B-03-023 (USH 53 NB)

USH 53 NB over CTH I Jun 08,2017

B-03-023 USH 53 NB over CTH I

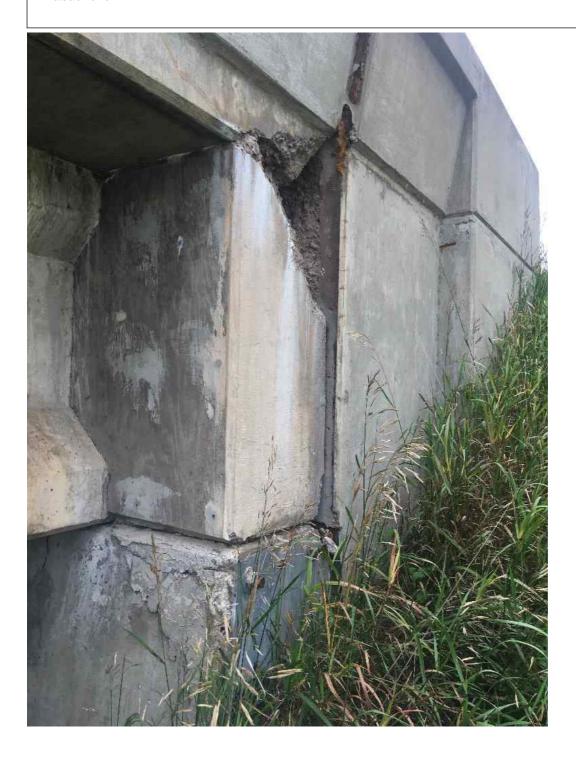
Routine Document Comment/Description NE abutment

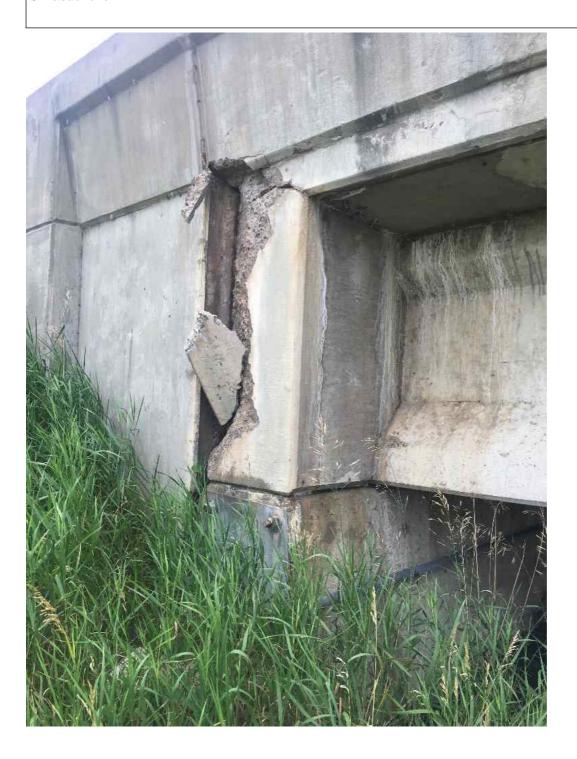
Routine Document Comment/Description SE abutment

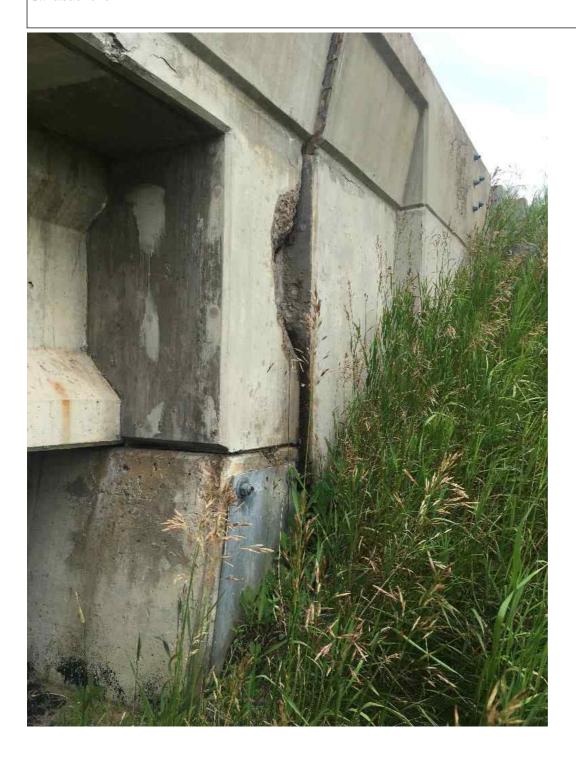
Routine Document Comment/Description SW abutment
