**SITE PHOTOGRAPHS
FOR
STRUCTURE
SURVEY REPORT**

**USH 53 SB Over CTH I
B-3-24
TOWN OF CHETEK, WI
BARRON COUNTY**

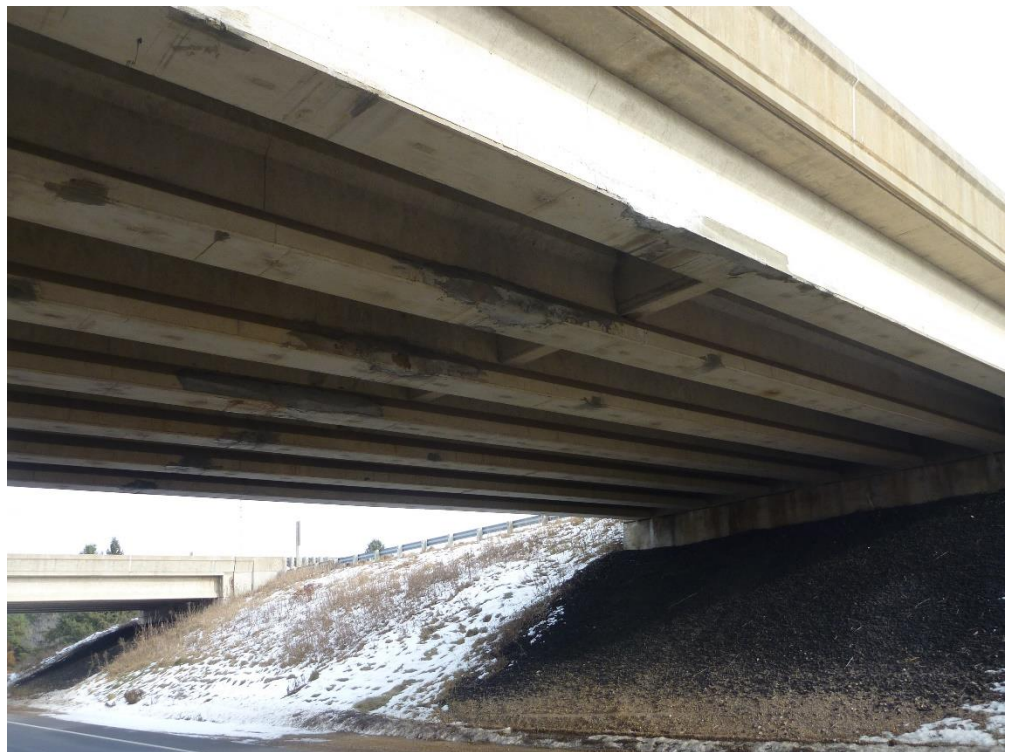
View from CTH I looking at damaged and previously repaired girder locations in span 1 of B-3-24. Girder to be repaired during rehab.

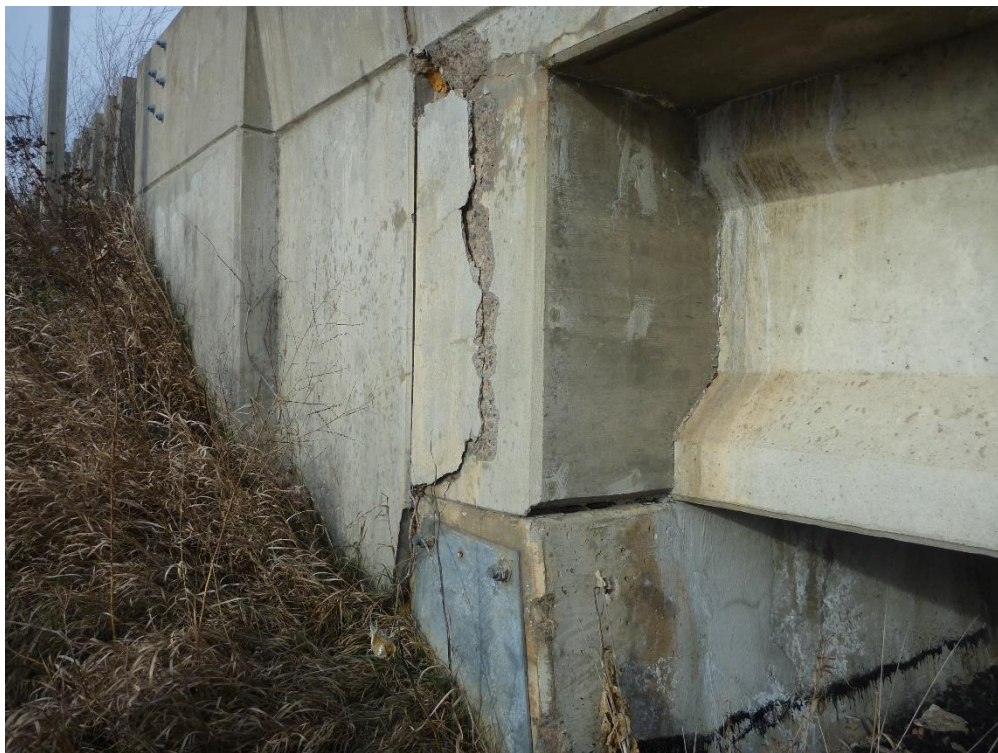
View of northwest wing on B-3-24. All wings for the structure will be removed to the footings and replaced during rehabilitation. End 1-foot of abutment diaphragms to be removed and replaced.

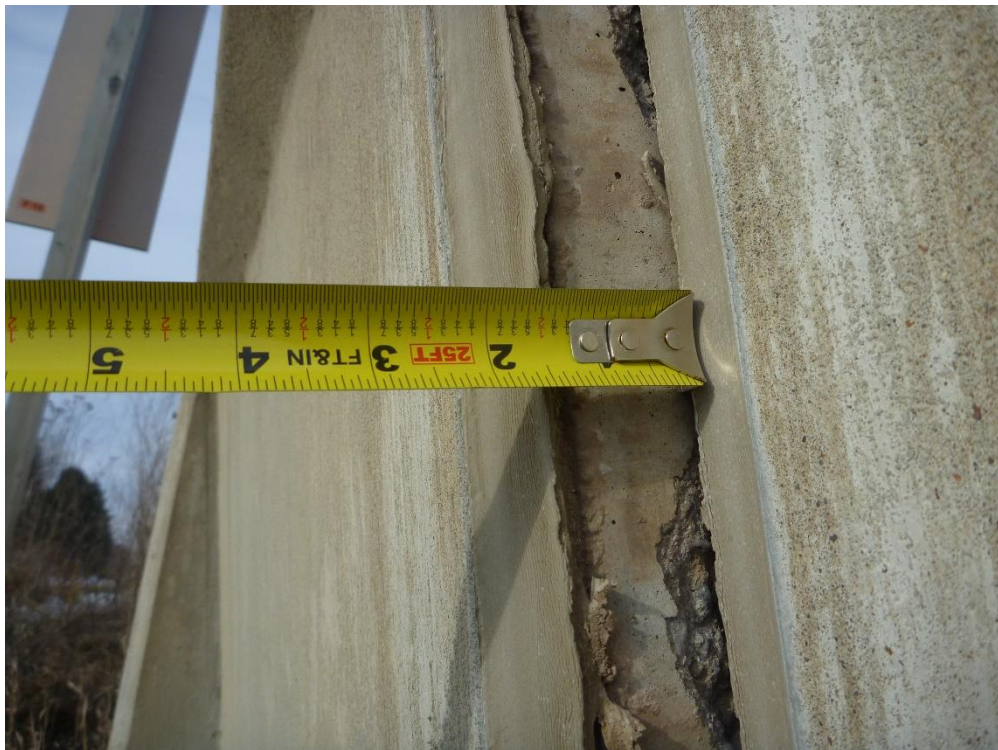
Wing movement at the northwest wing of B-3-24.

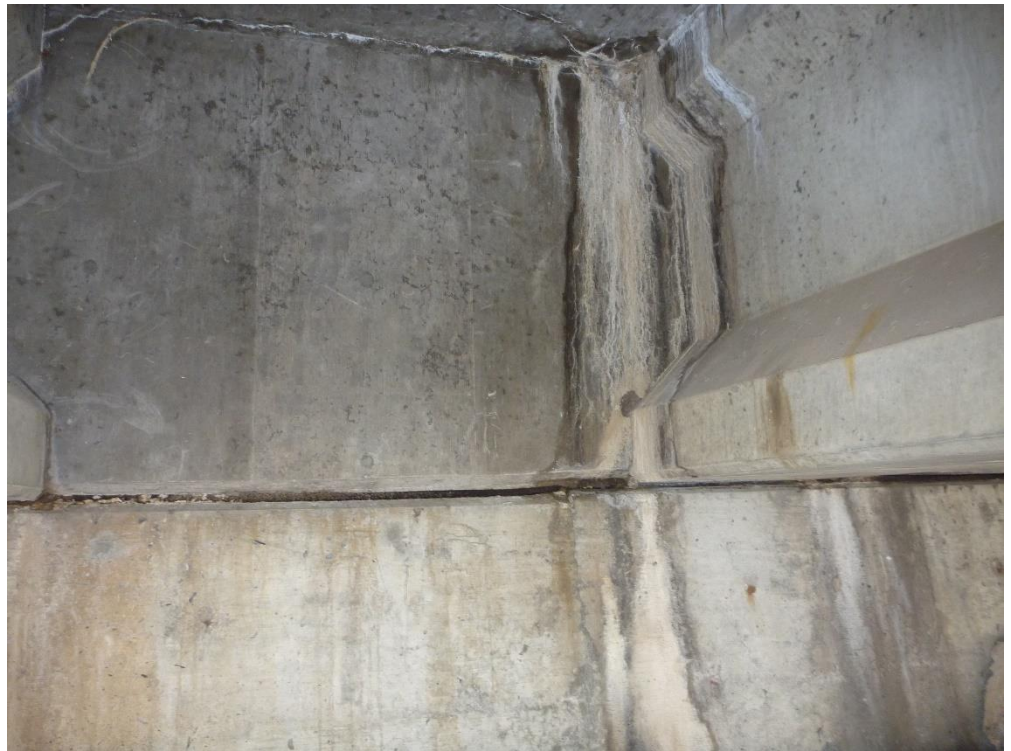
Typical chloride attack at girders of B-3-24. Girders will be cleaned and epoxy coated during rehab.

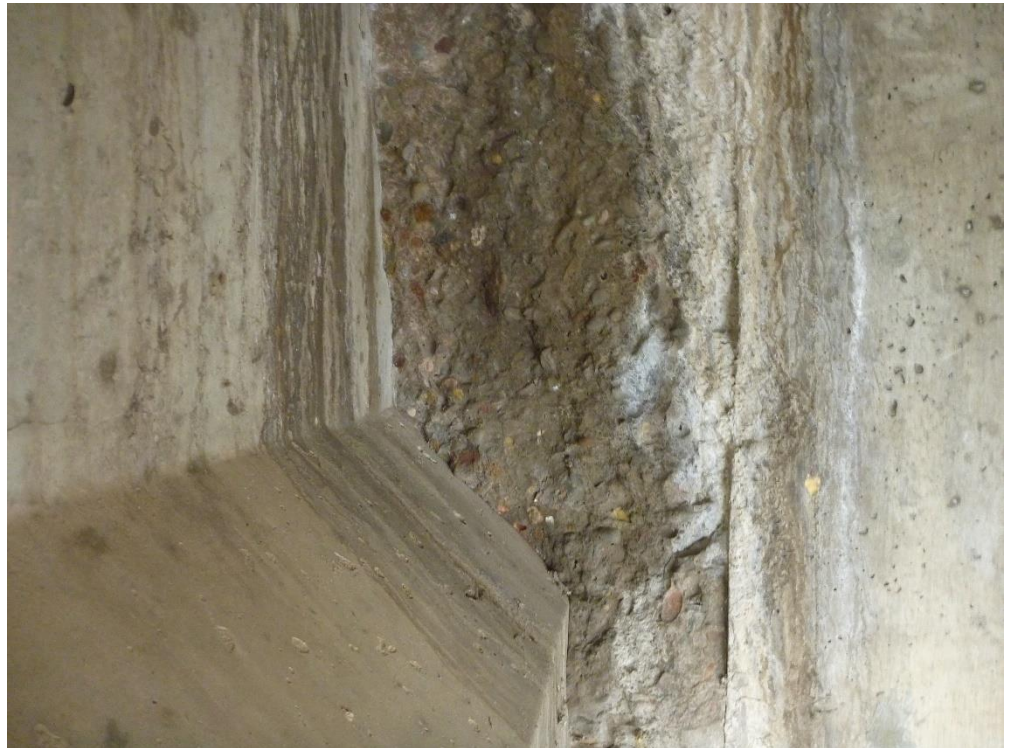
Concrete spalling and chloride attack at the north abutment.

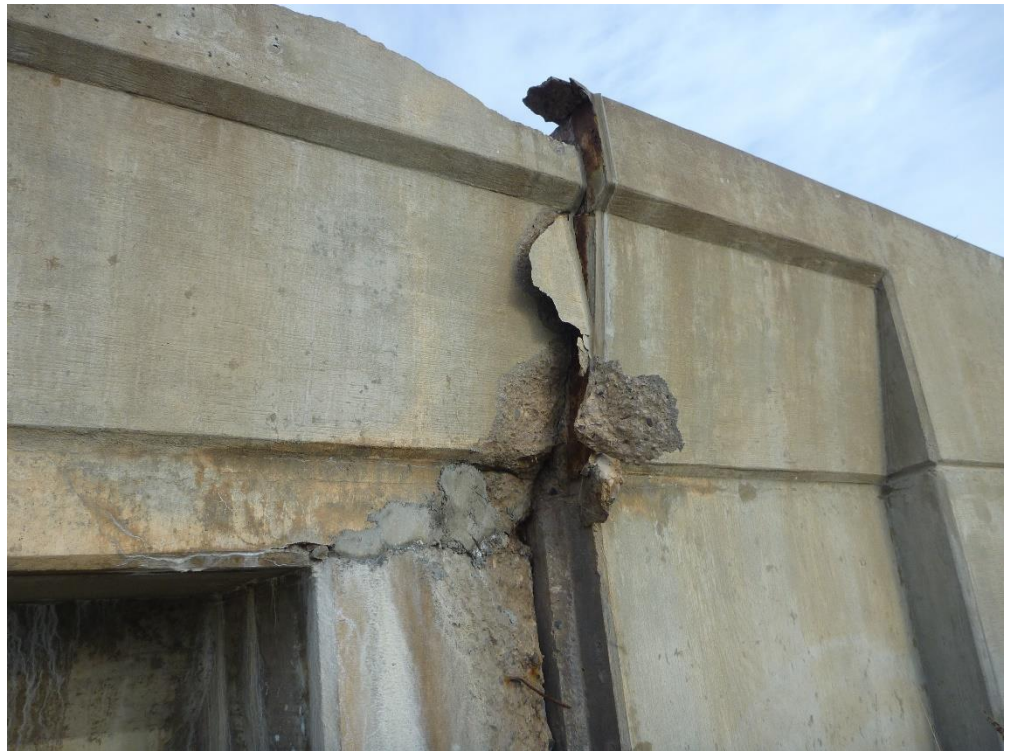
Wing movement and concrete spalling at southwest wing of B-3-24.

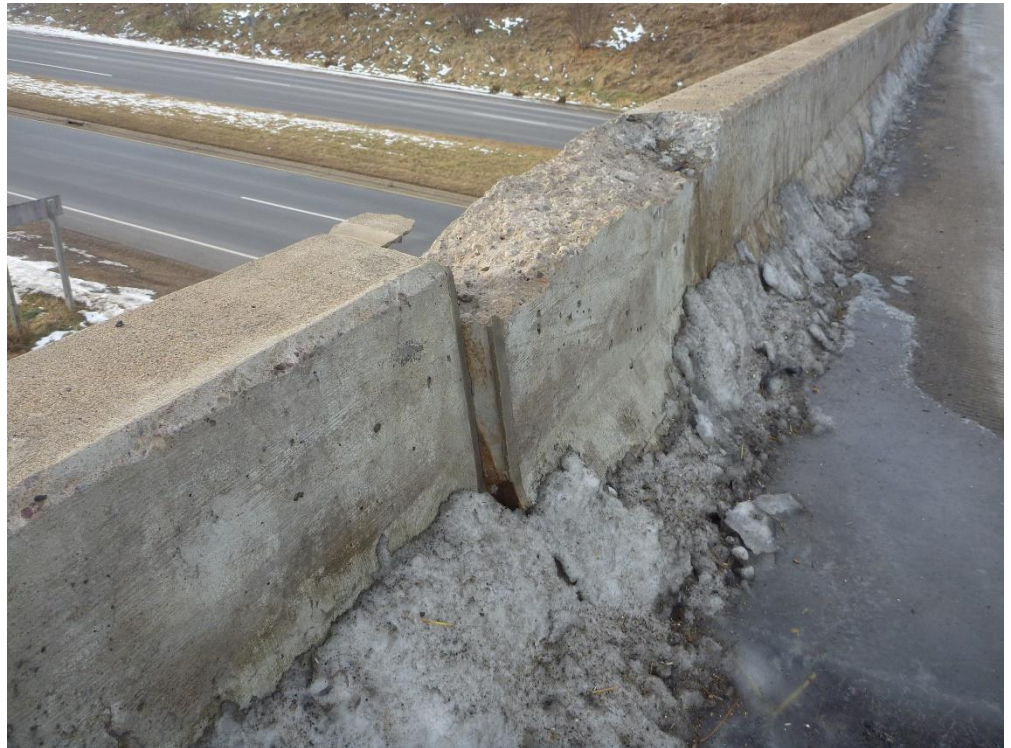
Concrete spalling of parapet on B-3-24.

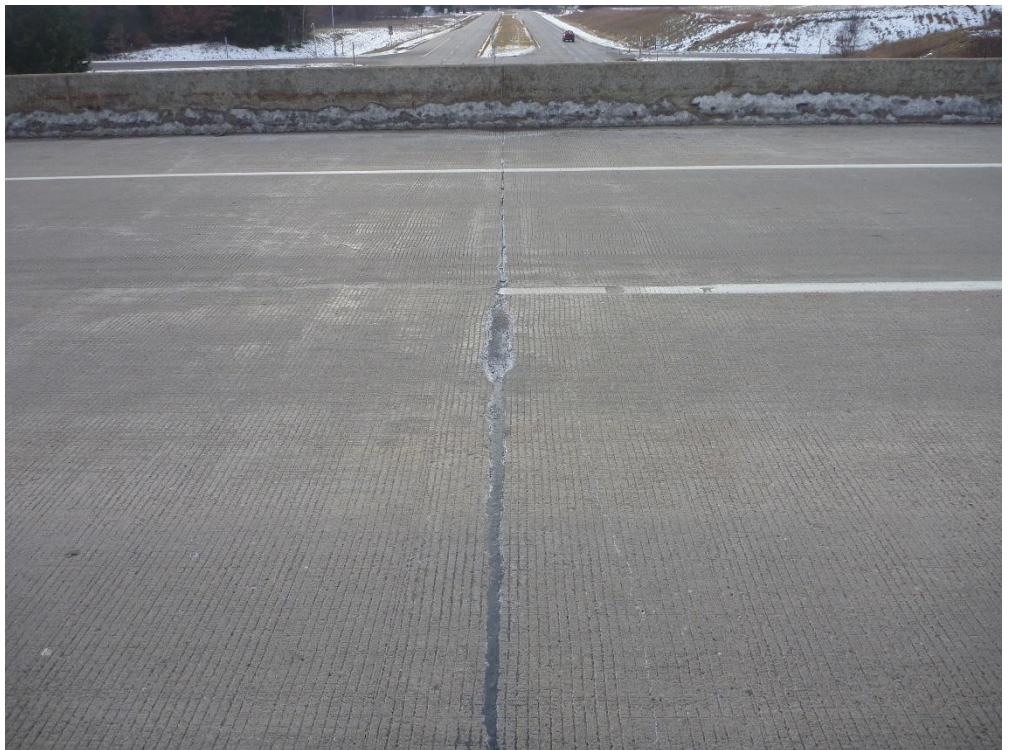
Typical cracking and
popouts at joints in
existing concrete overlay.
