STATE OF WISCONSIN  
DEPARTMENT OF TRANSPORTATION

Inspection Report for  
**B-03-025**

USH 53 NB over KNAPP ST  
Jun 09,2017

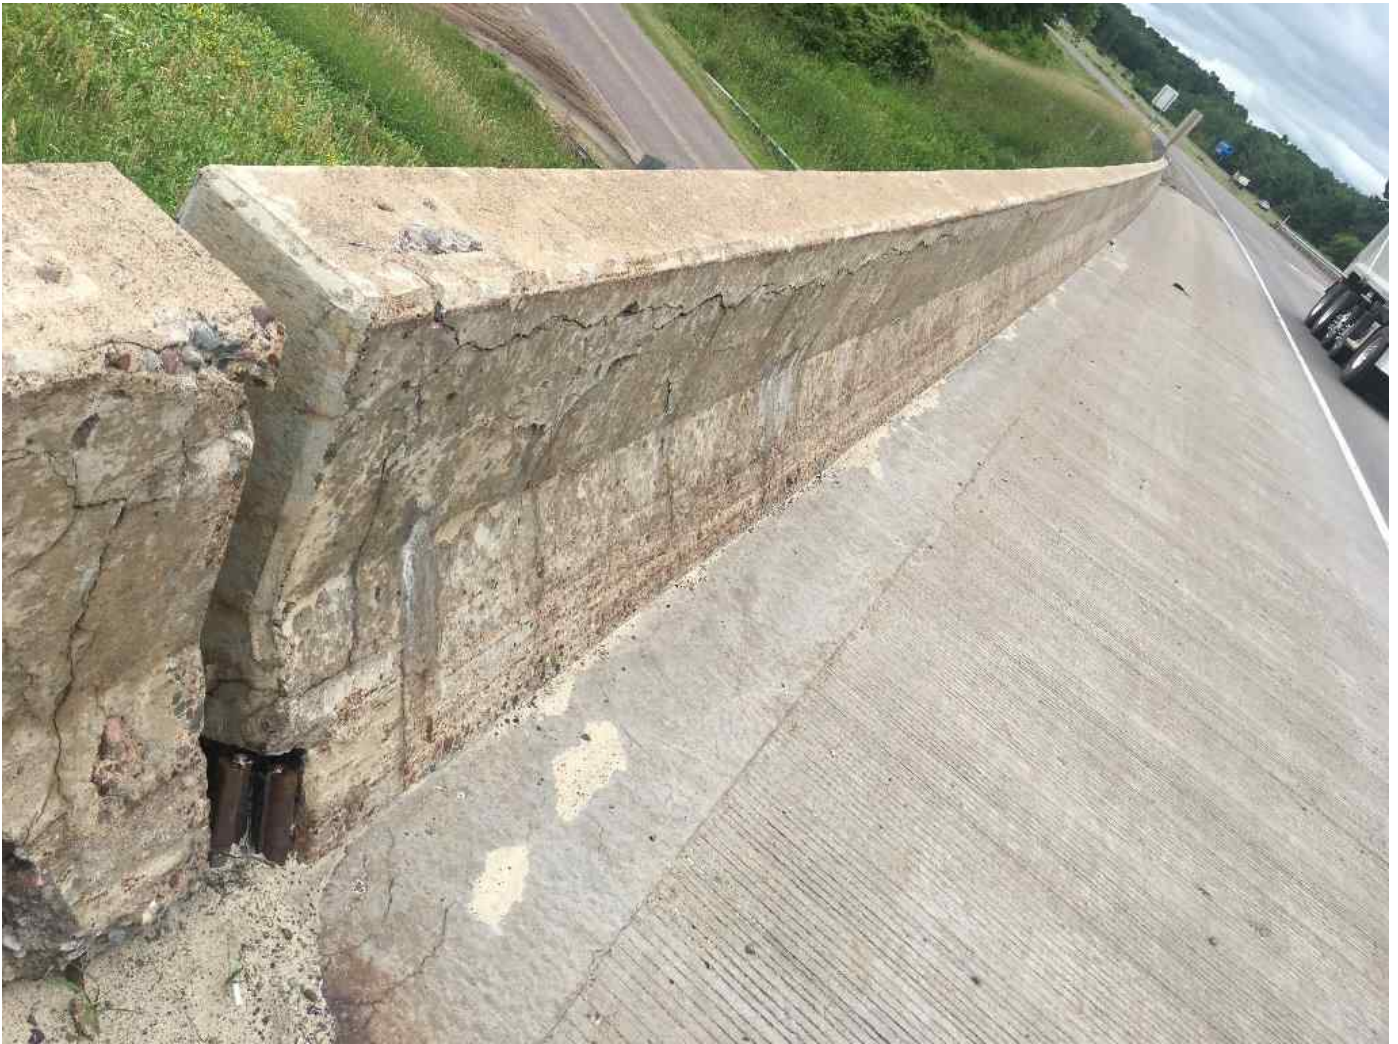
East parapet - horiz cracking

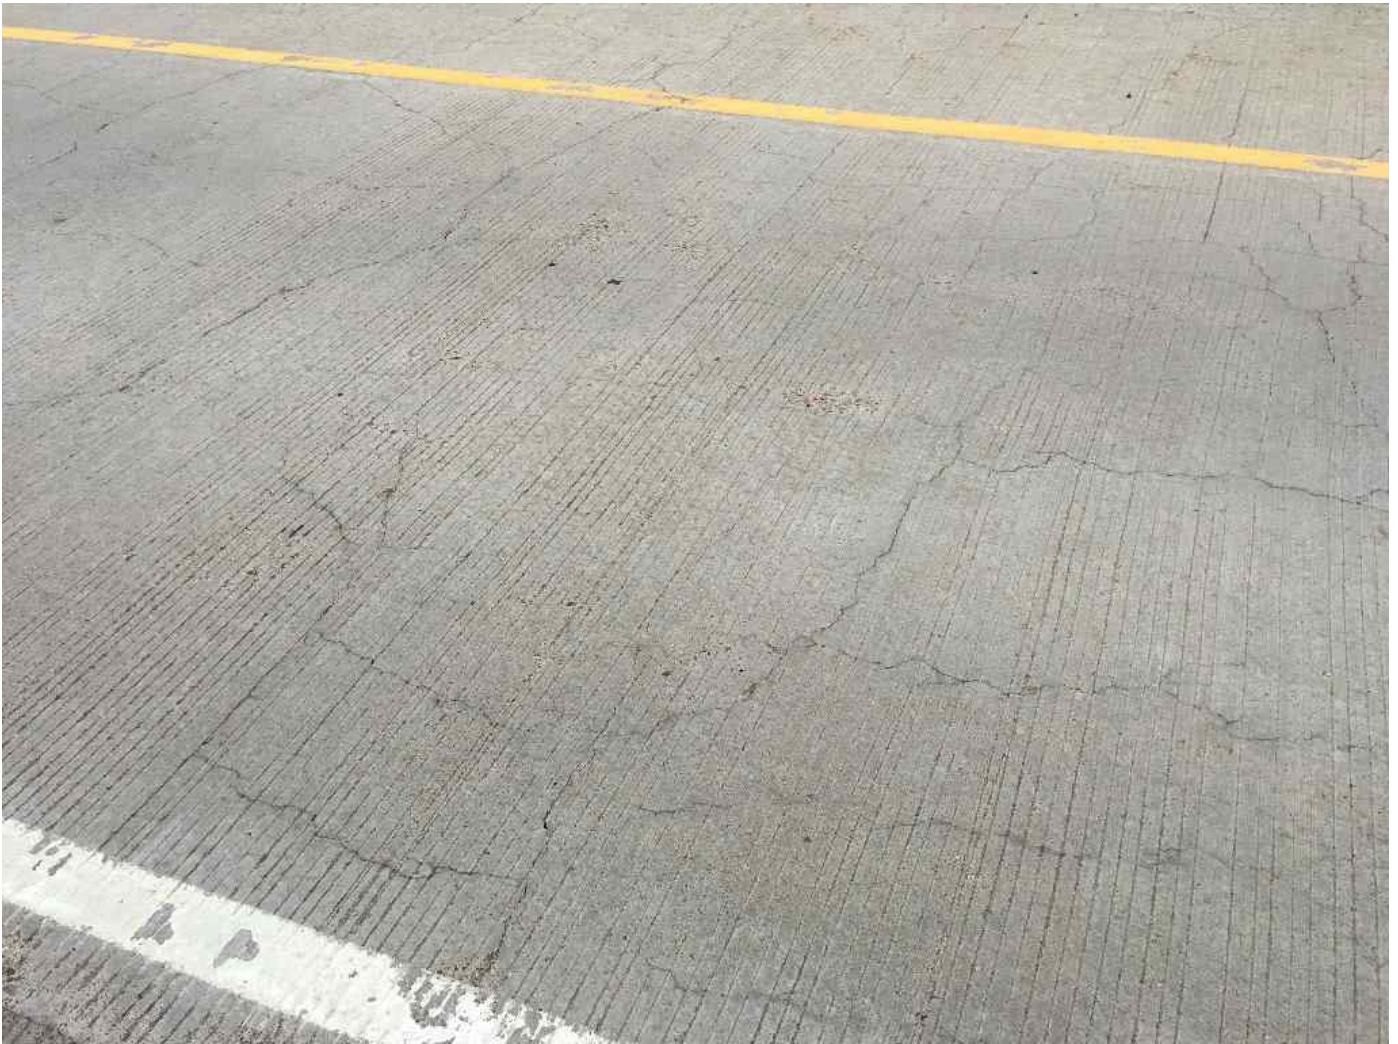
Typ deck map cracking

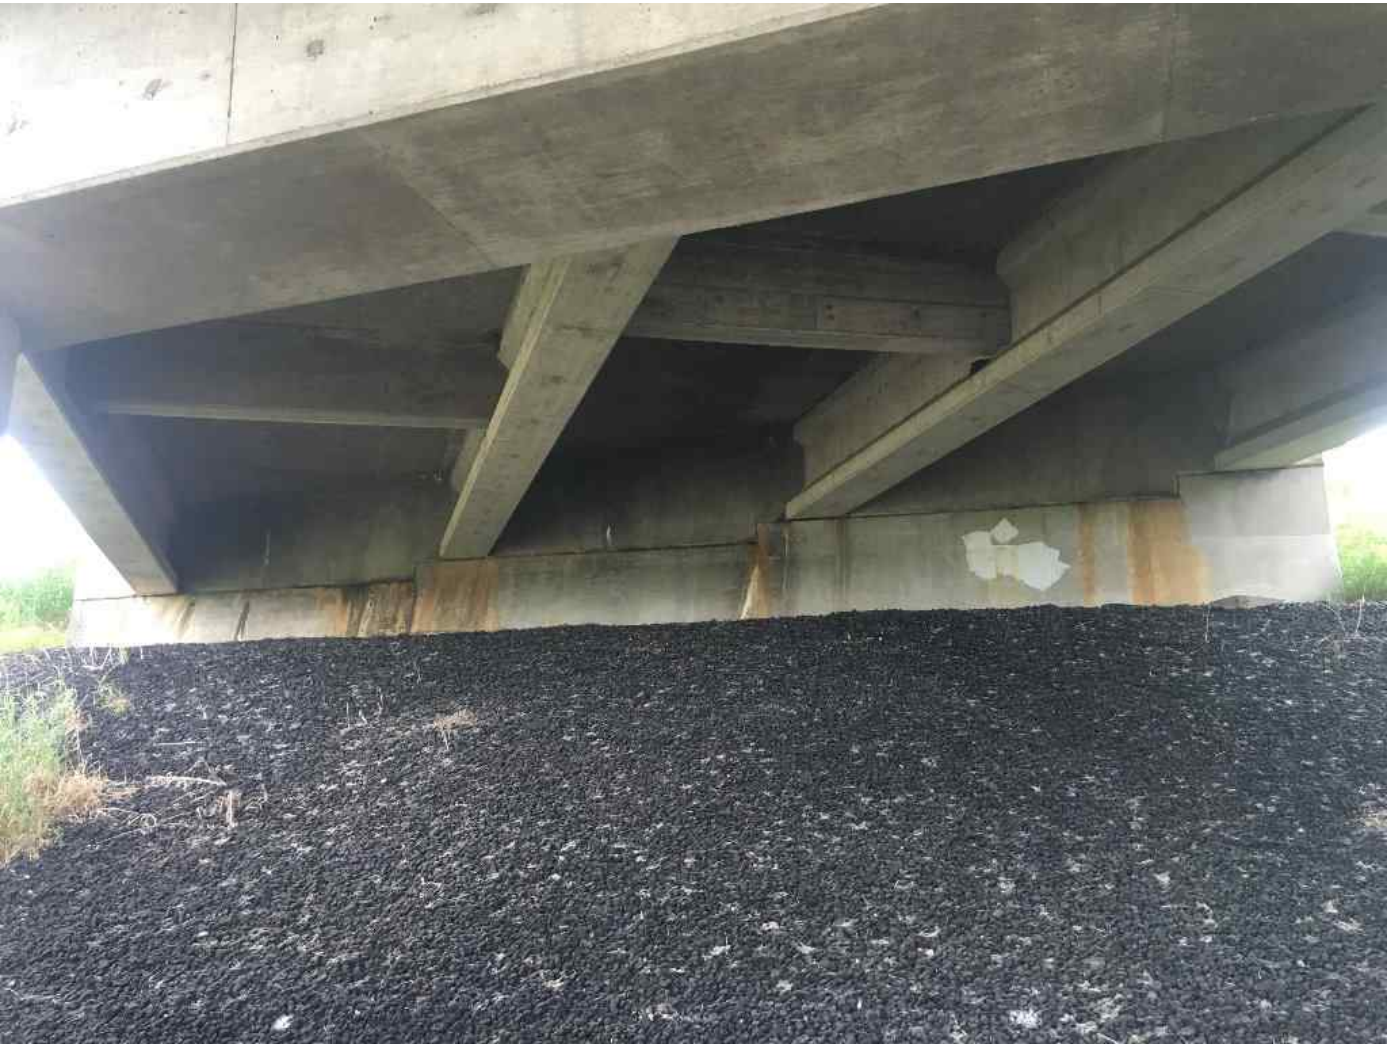
South abutment

1080	Delamination - Spall - Patched Area S ABUT G1 SPL CS3 1LF   G2 SPL CS3 1LF   G4 SPL CS3 1LF   E SPL CS3 1LF.	LF		0	0	4	0
		1130	Cracking (RC) 6/16/2015 S ABUT CRK CS2 4LF. 6/16/2015 N ABUT CRK CS2 8LF.	LF		0	12	0	0

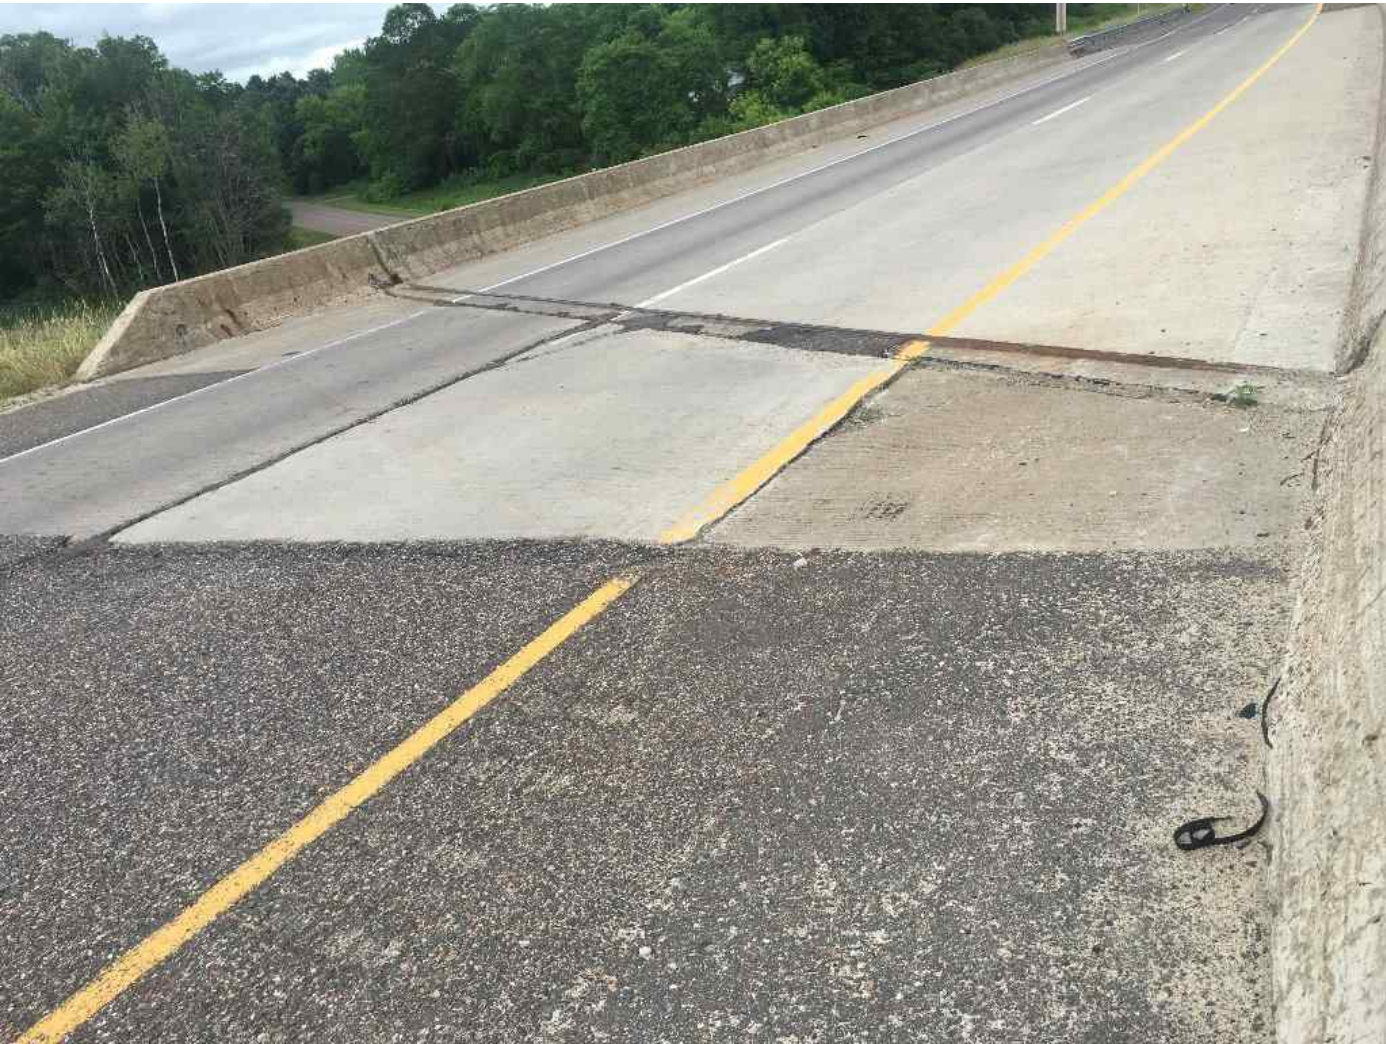
Routine  
Document Comment/Description  
North approach and joint

Item	Priority	Recommended by	Status	Status change
<b>Approach - Other Work</b>	HIGH	Kurtz, William G (8008)	IDENTIFIED	06/18/15
Repair the APPR Drainage inlet.				
<b>Substructure - Other Work</b>	MEDIUM	Kurtz, William G (8008)	IDENTIFIED	06/18/15
Seal concrete columns.				
<b>Misc - Cut Brush</b>	LOW	Kurtz, William G (8008)	IDENTIFIED	06/18/15
Remove vegetation from structure.
