## Bridge Asbestos Inspection Report

**WisDOT Project ID:** 1196-04-02  
**Structure Number:** B-03-026  
**Structure Name:** USH 53 SB over Knapp Street  
**City/County:** Town of Prairie Lake, Barron County, Wisconsin  
**GEI project Number:** 1901822  
**Date Inspected:** April 4, 2019  
**Inspected by:** Kyle C. Sandmire  
**Asbestos Inspector License Number:** All- 217616  
**Consultant Company:** GEI Consultants, Inc.

# BRIDGE INSPECTION REPORT

Inspection Report for  
B-03-026

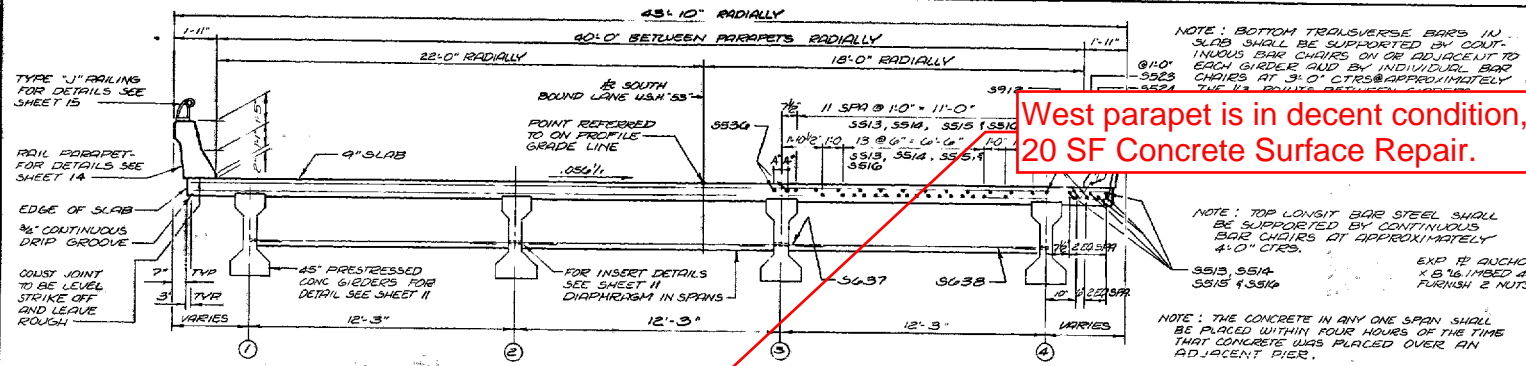
West parapet is in decent condition, approx. 20 SF Concrete Surface Repair.

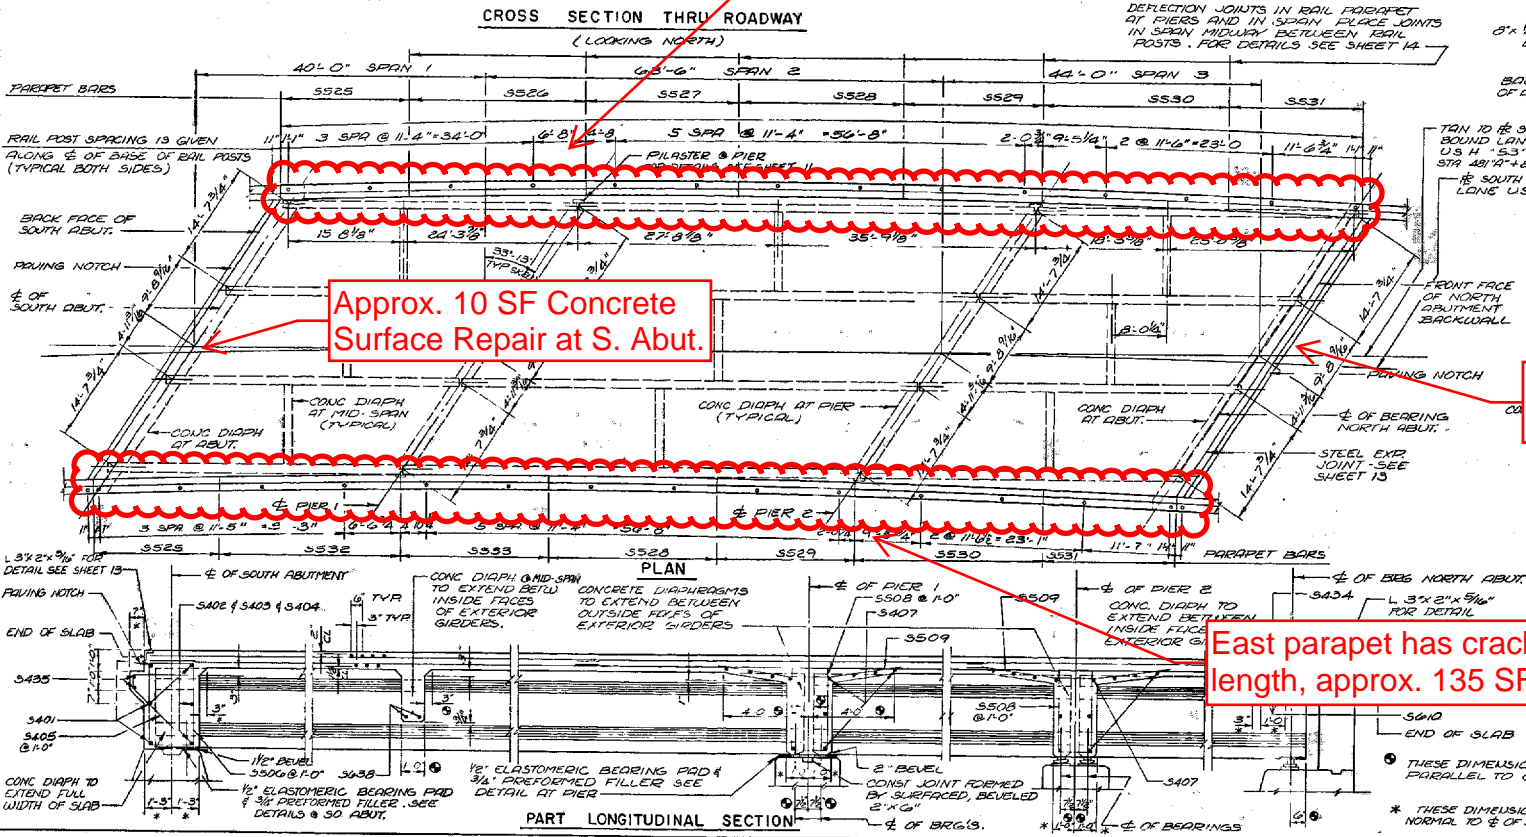
Approx. 10 SF Concrete Surface Repair at S. Abut.

Approx. 15 SF Concrete Surface Repair at N. Abut.

East parapet has crack at top nearly the full length, approx. 135 SF Concrete Surface Repair.

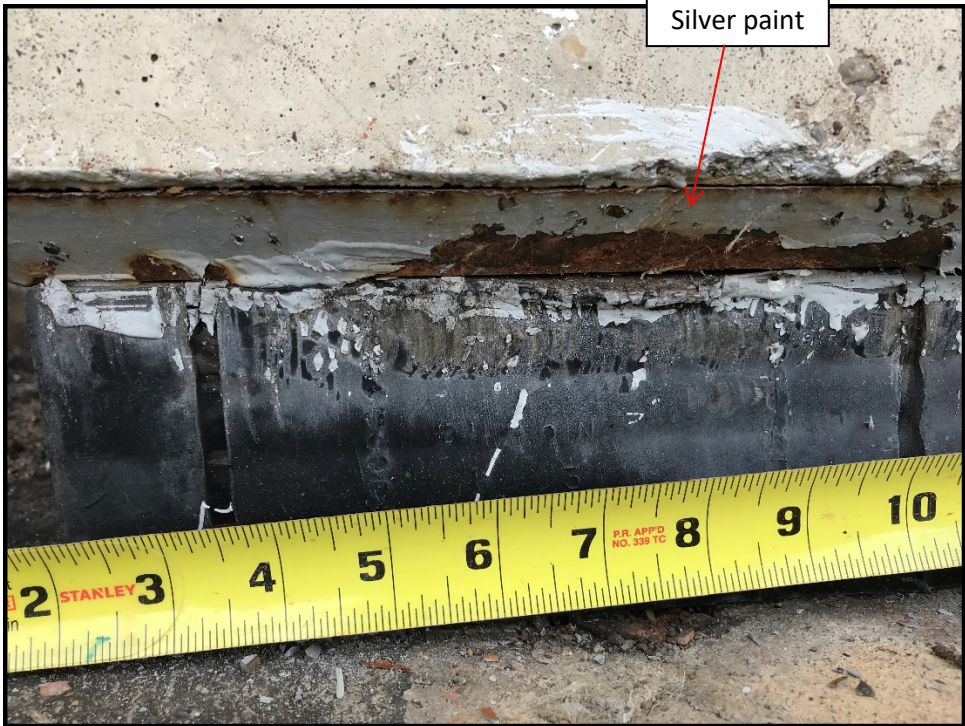
<b>PHOTOGRAPH NO: 4</b>

<b>DIRECTION: NE</b>	
<b>DESCRIPTION:</b>  View of the silver paint on the steel plates between the north bridge deck and abutment. The silver paint is not ACM.

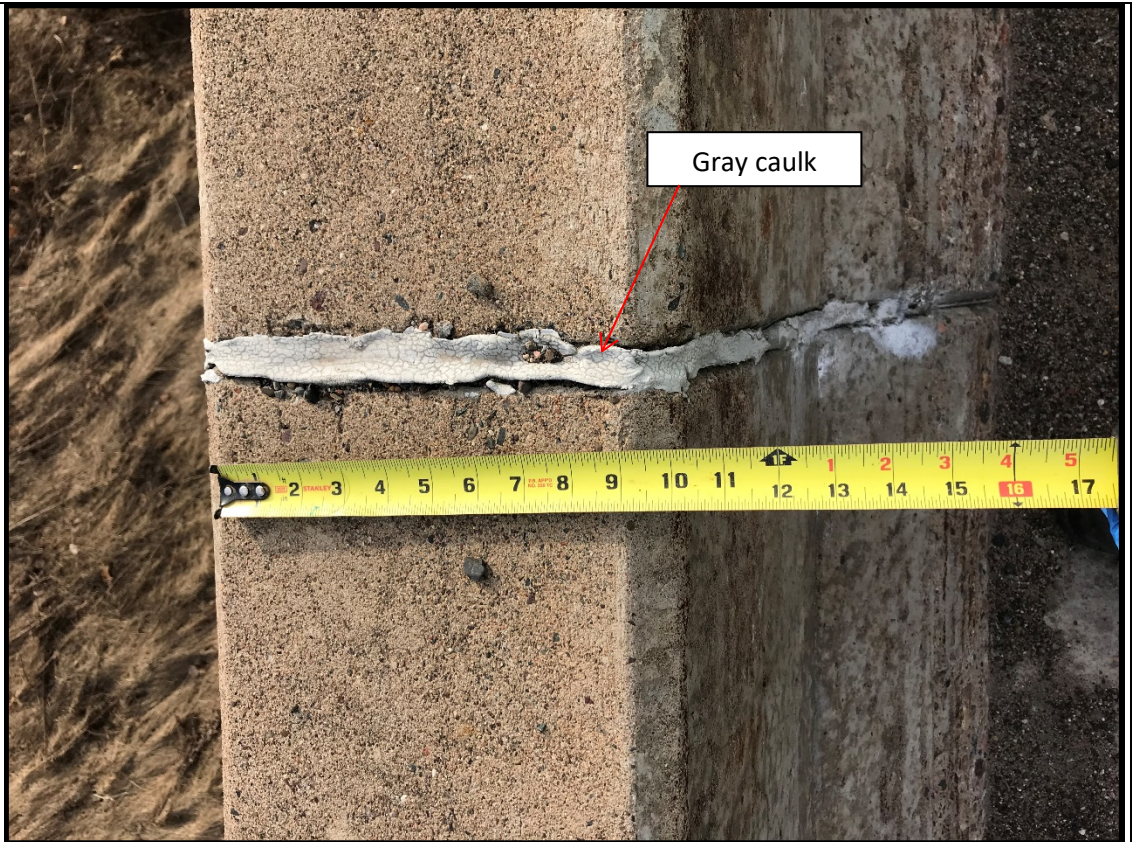
**PHOTOGRAPH NO: 7**

View of the gray caulk on the bridge wall joints and abutment joints.

**The gray caulk is non-friable ACM containing 2% Chrysotile asbestos.**

Asbestos-containing material has been found in Structure B-03-026. Standard Special Provision 203-005 shall be included in the plans and abatement will be required. The contractor will be responsible for completion of the Notification of Demolition and/or Renovation (DNR form 4500-113) if required. A copy of the inspection report is available from the region office.

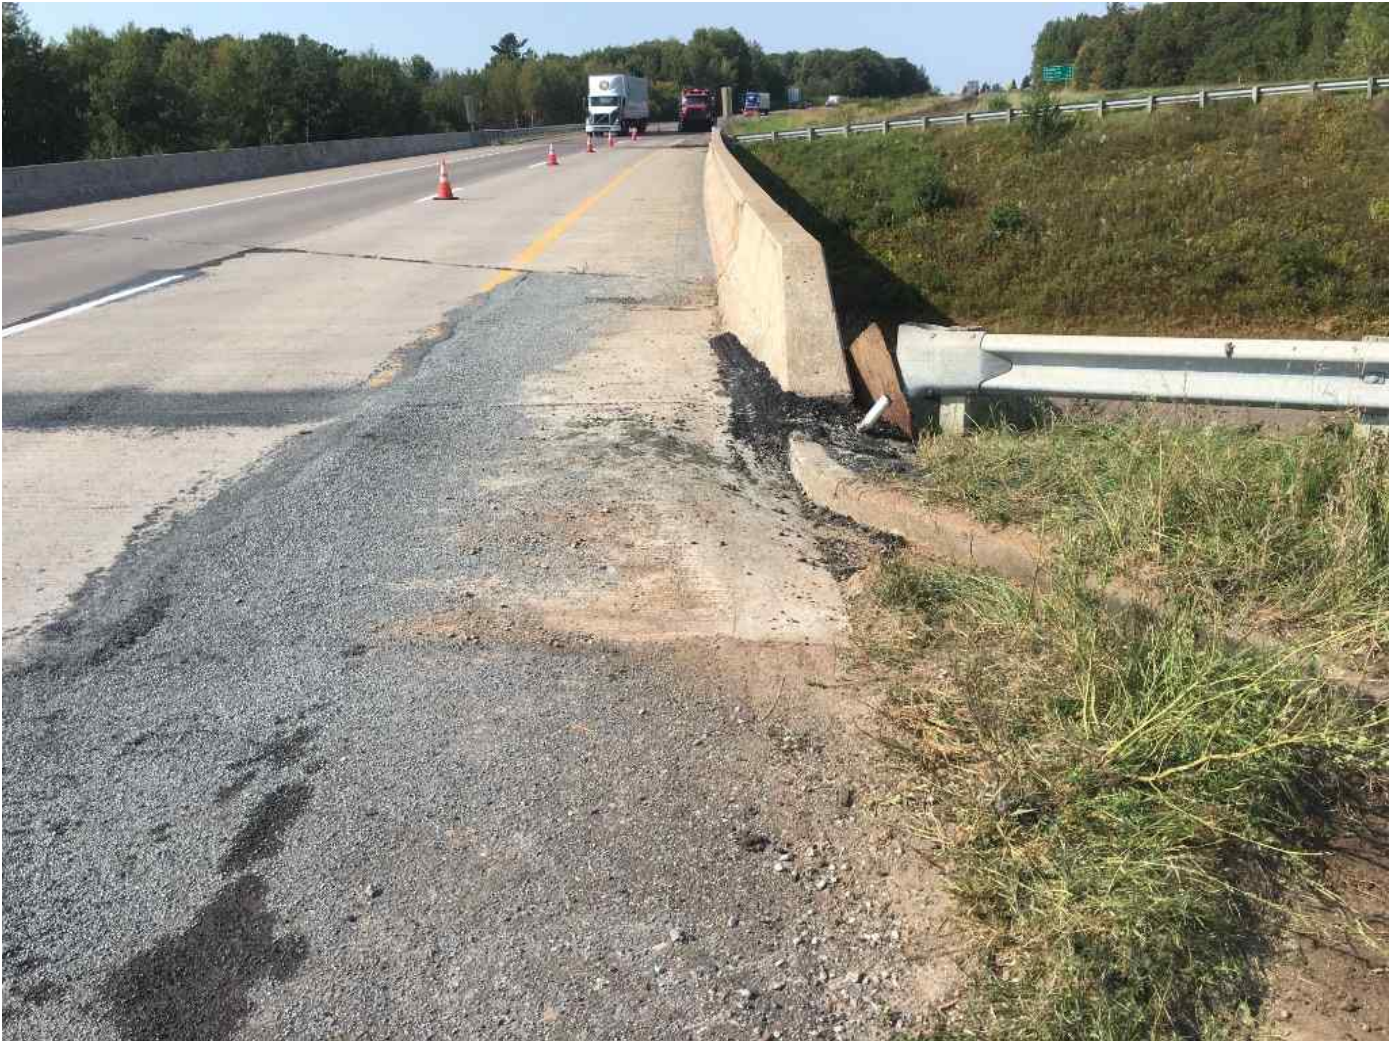
SE approach. Void under shoulder filled and asphalt "flume" along wing to direct to concrete flume.

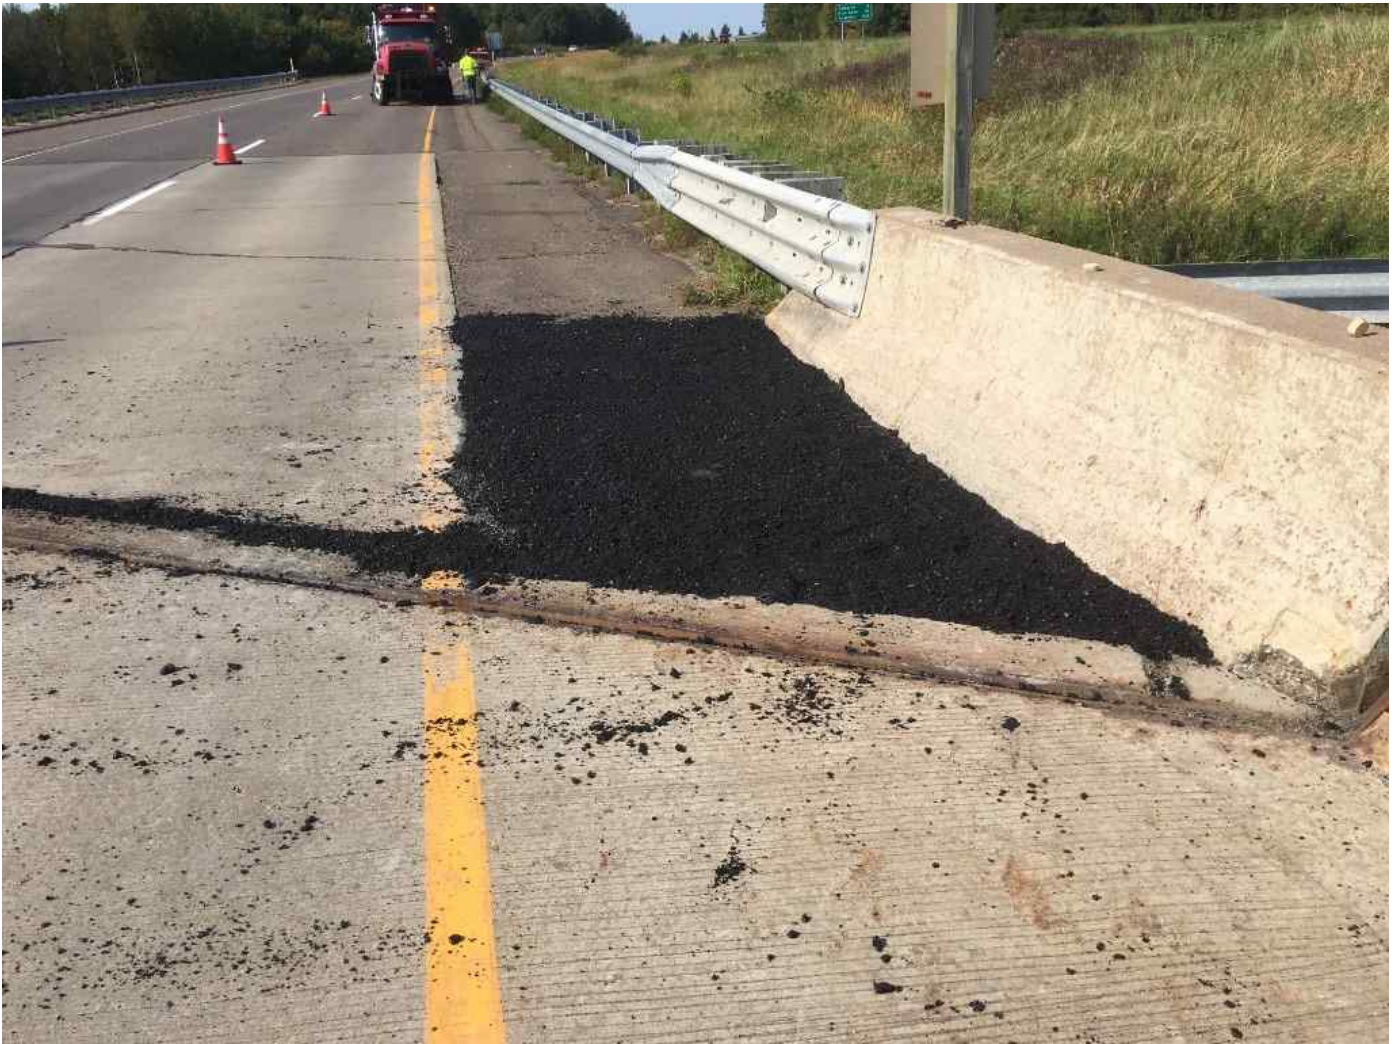
Ne approach shoulder.
